NASA
Technical Memorandum 86939

Experimental Study of Ceramic-Coated Tip Seals for Turbojet Engines

EXPERIMENTAL STUDY OF CERAMIC-COATED TIP SEALS FOR TURBOJET ENGINES

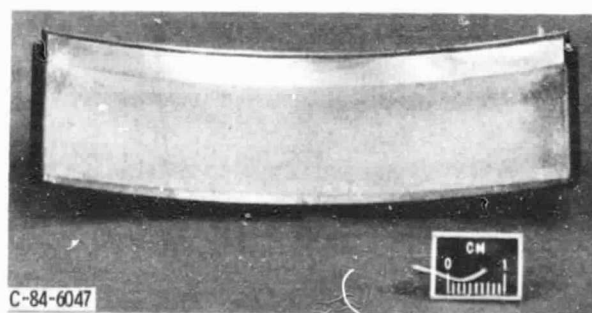
One $\text{ZrO}_2\text{-}8\text{Y}_2\text{O}_3$ ceramic shroud section (position 6) along with a typical cross section, has been metallographically examined (by Gary Liotta of General Electric, Lynn, Mass.). The front surface of shroud 6 was reasonably smooth without visible defects (fig. 9). Some slight erosion was evident, along with a small amount of ceramic darkening. At a magnification of 32 (fig. 14), the back surface showed cracking in the bond coat along the trailing edge and extending back into the ceramic flowpath surface. Some ceramic cracking was also evident along the leading edge, along with some "micro" surface cracks. The right end of the shroud showed both vertical and bond-line cracking. Of the total perimeter length of 24.4 cm (9.6 in), 9 cm (3.6 in), or approximately 37.5 percent, was cracked.

Figure 9. - Shroud segment 6 after 1001 cycles - hot-gas side.

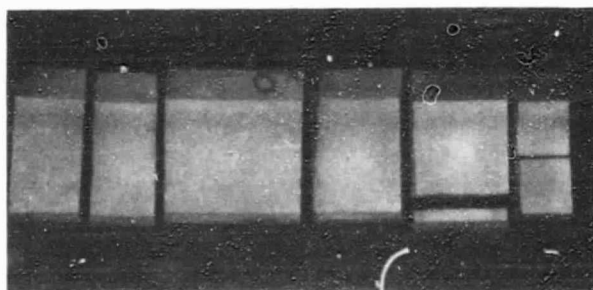
Examination of several sections through the ceramic shroud components (e.g., fig. 11) revealed nonuniform ceramic coating thicknesses as a result of spraying and grinding.²

For the sectioned shroud (fig. 11), the bond coat was 1.14 to 1.27 mm (0.045 to 0.050 in) thick. Adjacent to the leading and trailing edges the bond coat was about 50 percent dense (fig. 15). Vertical cracking was also evident in the bond coat.

The ceramic top coat was 0.76 to 0.98 mm (0.030 to 0.039 in) thick. Probably this was closer to 1.27 mm (0.050 in) before grinding. The bond coat had cracked at the trailing edge (fig. 15(b)); the crack extended almost 1.9 mm (0.075 in) from the trailing edge to the leading edge and 12.7 mm (0.500 in) from right to left.

Figure 11. - Shroud sections used in metallographic analysis.

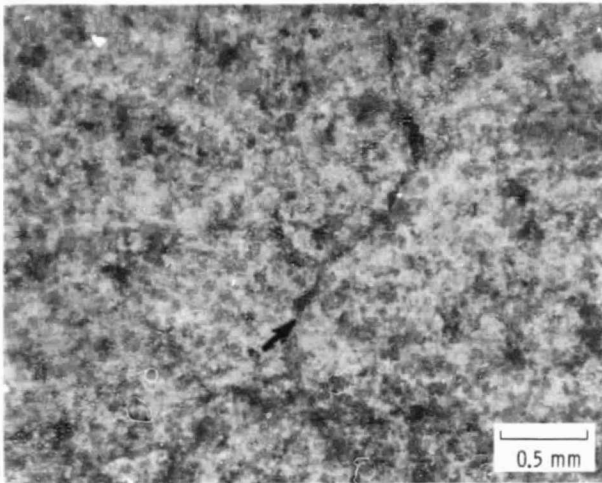
A macrograph of a shroud section (fig. 12(a)) shows surface cracking. On an average the "mudflat" cracks were hexagonally spaced by about 1.5 mm. Such large cracks probably were preceded by microfracturing. These cracks tended to penetrate to the bond-coat interface (fig. 12(b)), where cracking appeared either to terminate or, in some instances, to spread axially and perhaps circumferentially. These cracks are probably responsible for the shroud's ability to withstand thermal cycling when an elastic analysis produces stresses beyond the rupture limit. Such inelastic behavior also limits the life of the component: as microfracturing effects become prominent, the structure weakens and eventually fails.

(a) Typical flow path crack.

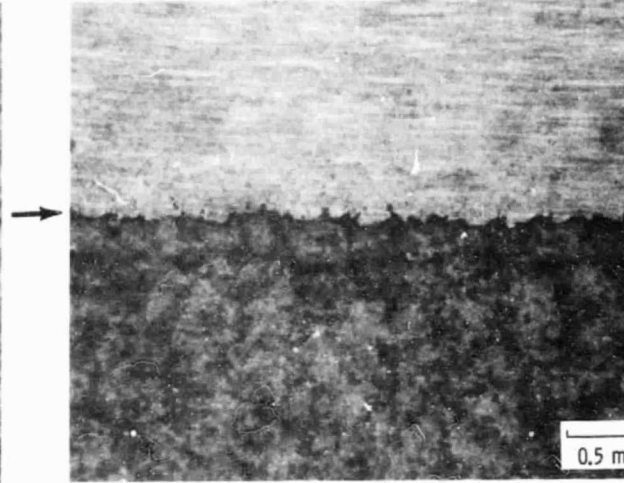
(b) Ceramic crack leading edge.

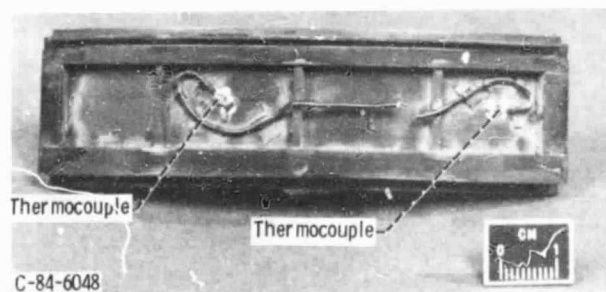
²The wet grind left a residue on the coolant passage that provided flow visualization of jet impingement patterns (e.g., see fig. 13).

Figure 13. - Shroud segment 6 after 1001 cycles - back side.

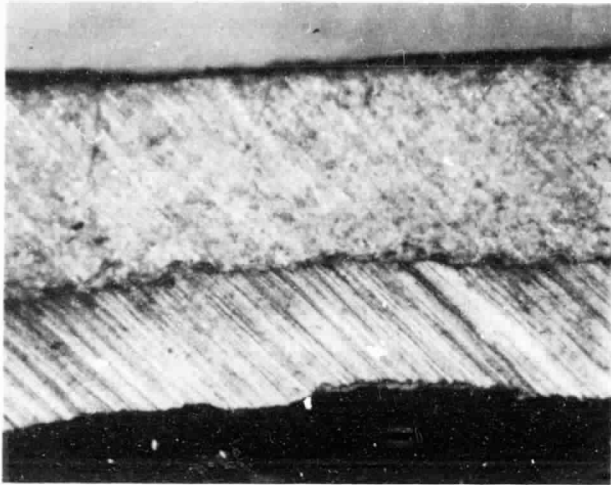
(a) Ceramic and frame crack trailing edge.

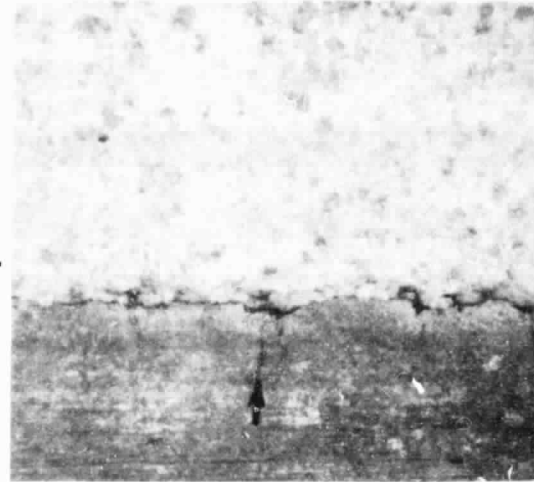
(b) Right-end bond line and vertical crack.

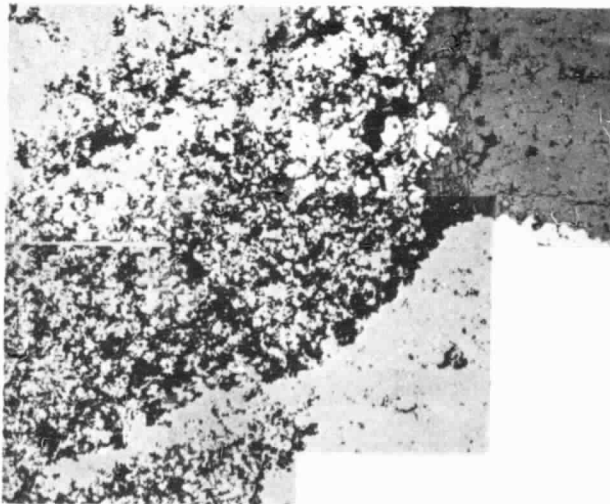
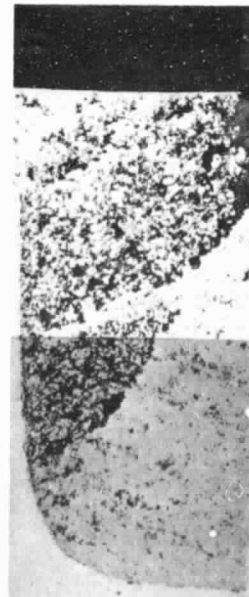
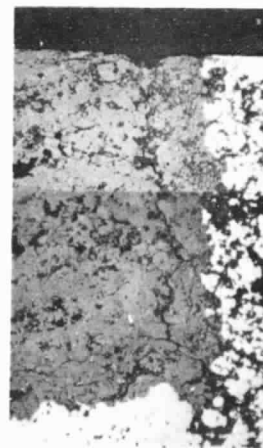
The metallic bond coat exhibited considerable porosity predominantly as a result of pullout during metallographic polishing, which was optimized to reveal the ceramic microstructure. Extensive porosity adjacent to the leading and trailing edges was due to the geometry of the part not having been optimized for plasma spray coating. There was no evidence of any significant oxidation or beta-phase (NiAl) depletion of the NiCoCrAlX bond coat. The

Figure 15. - Low density in bond coat adjacent to leading and trailing-edge frames.

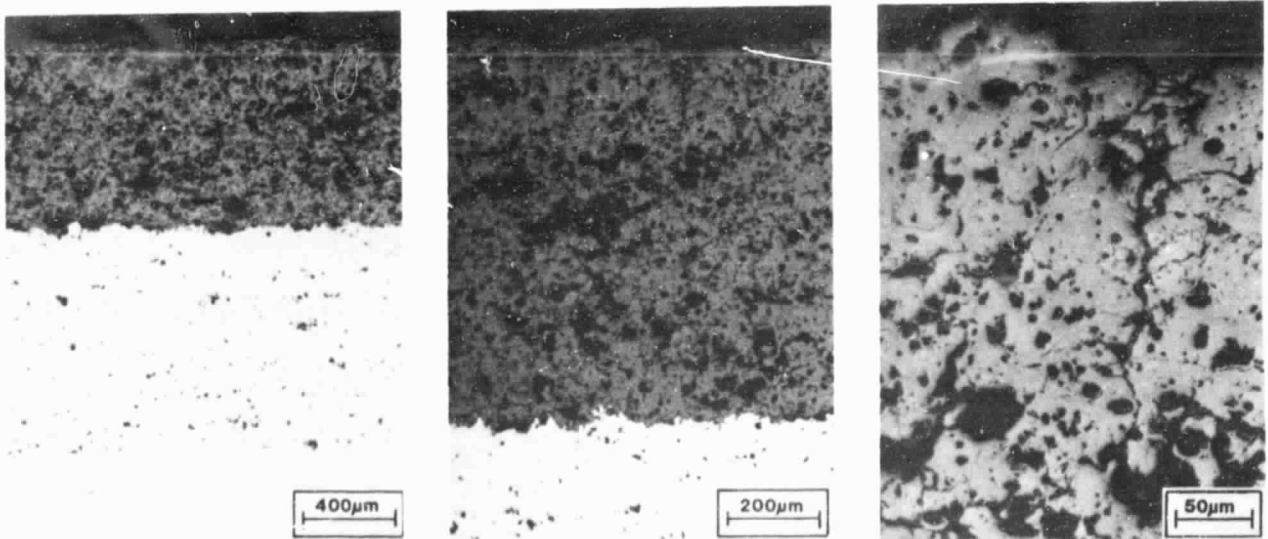
A pretest micrograph (fig. 17(a)) of a quality control specimen that was not run in the engine revealed some vertical cracking, which provides strain relief. The post-test ceramic coating microstructure (figs. 17(b) and (c)) revealed extensive segmentation, commonly called mudflat cracking, and some local areas of lateral cracking and large porosity. Apparently some densification of the ceramic occurred. However, caution must be exercised as microstructures are very dependent on metallographic polishing methods.

(a) Pretest microstructure; cross section B-B.

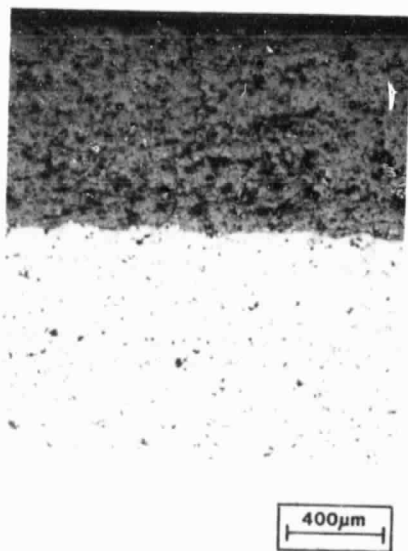
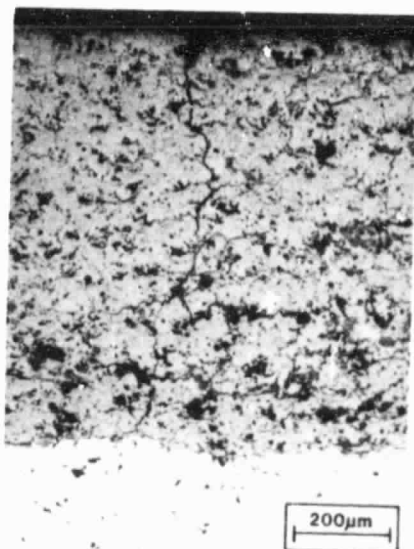
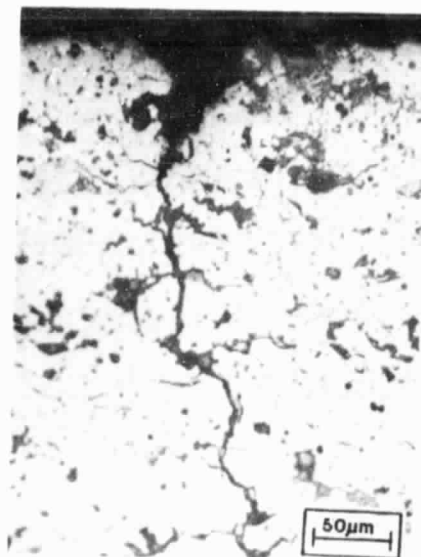
(b) Post-test microstructure; cross section A-A.

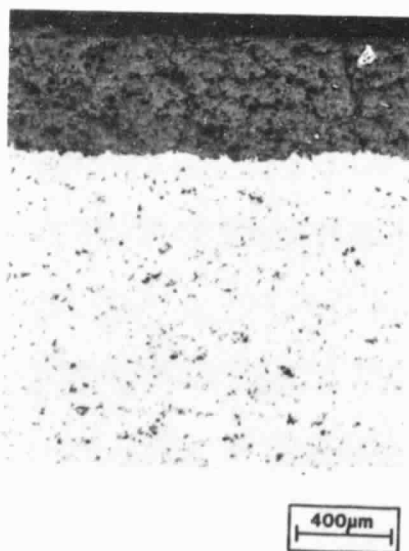
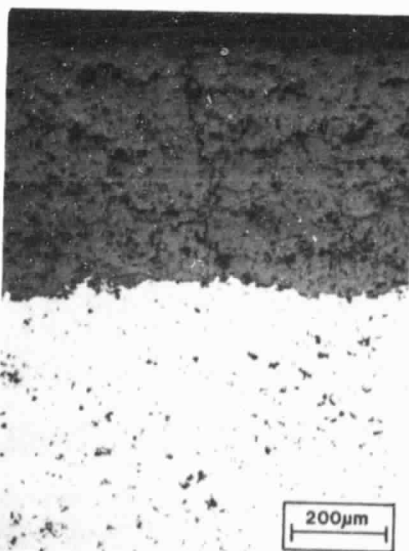
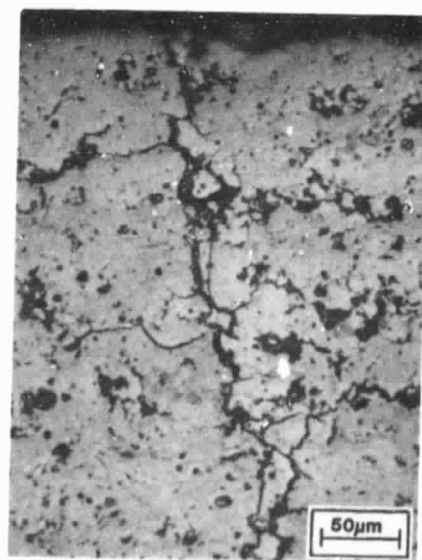
(c) Post-test microstructure; cross section B-B.
