NICKEL-HYDROGEN CELL TEST PROGRAM SUMMARY

Vernon C. Mueller

McDonnell Douglas Astronautics Company - St. Louis Division

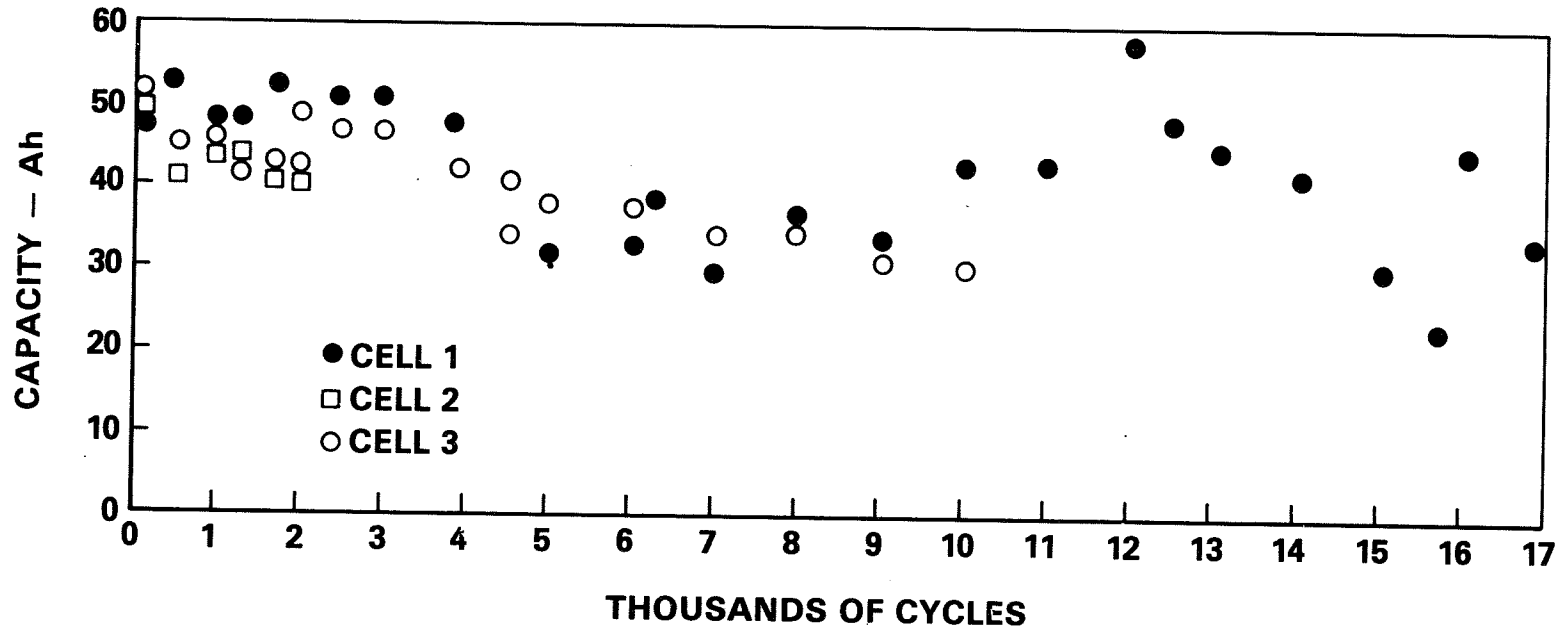
Figure 5. Cell Measured Capacity versus Cycles

Cycling test trend data is shown in Figures 4 and 5. Cell 2 had recurring problems with low EOD voltage. At cycle 2473, cycling was stopped to perform a capacity check. Following the capacity check, Cell 2 failed to recharge. Three days later, a 5-ampere charge was again attempted, but Cell 2 failed to respond. Apparently an internal short had developed and the cell was removed from test. Cells 1 and 3 continued to cycle with relatively few problems. Degradation of EOD voltage and reduction of measured capacity was observed, as noted in Figures 4 and 5. Cell 3 failed abruptly after completing 10,080 charge/discharge cycles. Evidently, a massive short had developed, as evidenced by a high cell temperature. At this point, the cell was disconnected electrically, but physically left in the test fixture.

At Cycle 11891, Cell 1 was inadvertently overcharged for 20 hours, with a total input energy of 118.4 ampere-hours due to an equipment malfunction. There was no apparent cell damage; therefore, the cell was returned to cycling after equipment repair. The effect of this long overcharge can be seen in the increase in measured capacity after Cycle 12015. Measured capacity was 59 ampere-hours at this point.

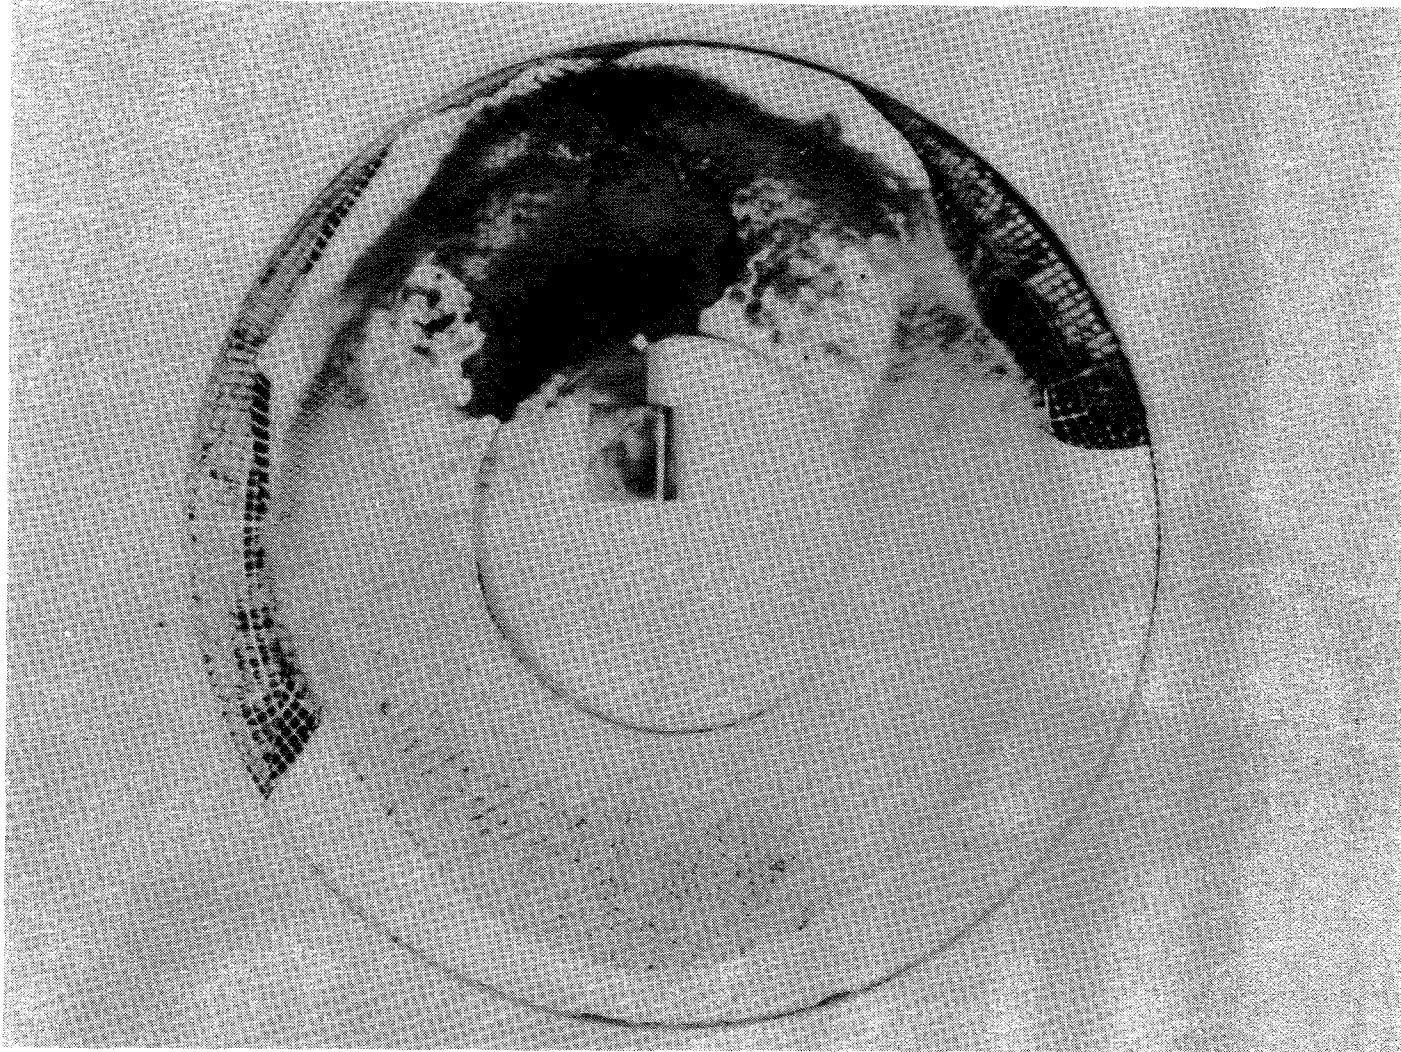
Figure 8. Cell 1 Negative Plate 35 and Gas Screen

An electrode-by-electrode disassembly revealed shorting of adjacent positive and negative plates at the inner perimeter of the plates in the area where the negative leads attach. Active material from the positive plate was imbedded in the adjacent negative in many cases. Also, the gas screen between negative and positive plates had melted and shrunk and was fused to the teflon coated side of the negative plate. Most severe damage to the gas screen was at a point where shorting had occurred at the negative lead to plate attachment. As the gas screen shrunk, it apparently fused to the outer periphery of the negative plate and peeled the teflon backing away from the underlying screen structure. Figure 8 is a photograph of negative plate 35 showing active material from positive plate 34 imbedded at the inner periphery where the negative lead attaches to the tab. Note also how the gas screen peeled back the teflon coating as it shrank due to heating. Gas screen shrinkage, melting, and fusing to the negative plate, and shorting of positive and negative electrodes extended throughout the stack assembly. Pin holes were found in many of the negative plates, indicating that "popping" occurred. As disassembly progressed toward the positive end of the electrode stack assembly, the plates became more planar.
