STRUCTURAL LOADS PRELIMINARY RESULTS

Emilio Alfaro-Bou
NASA Langley Research Center
Hampton, Virginia

NASA/FAA Government/Industry CID Workshop
NASA Langley Research Center
April 10, 1985

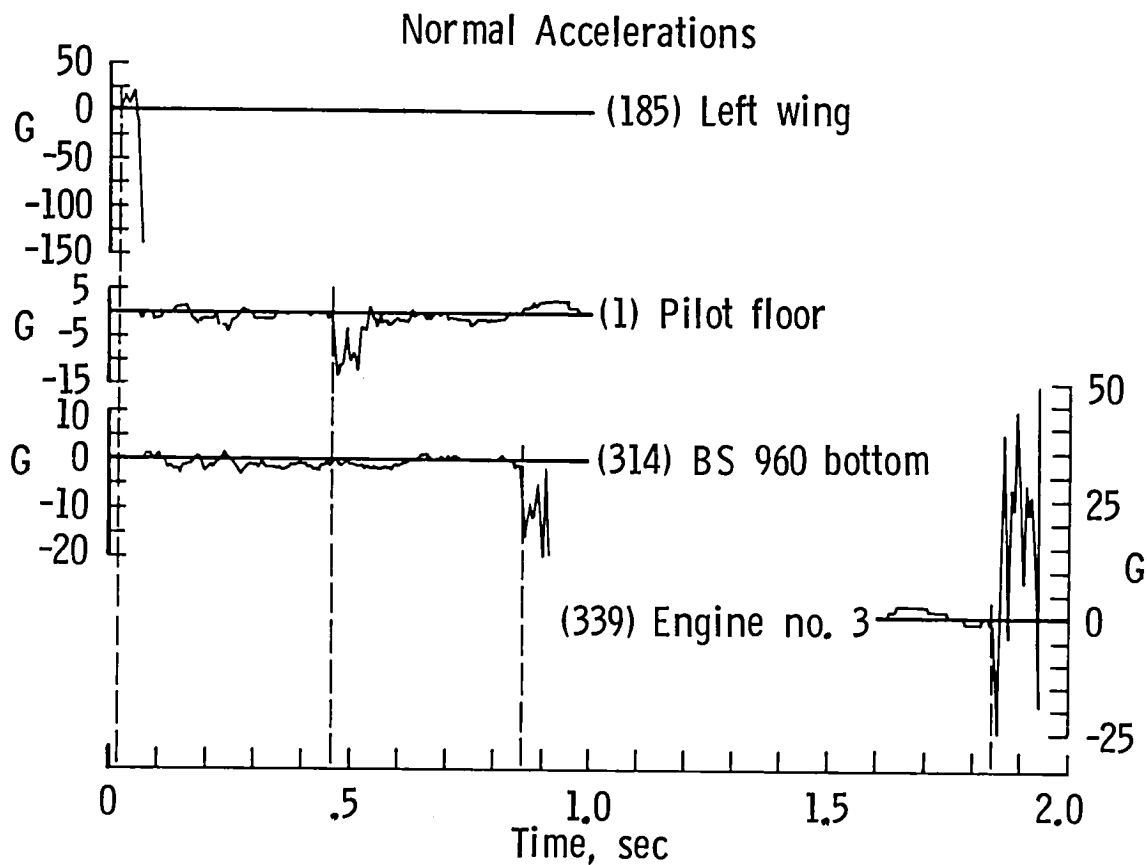
C.I.D. SEQUENCE OF EVENTS

The sequence of events during the impact of the airplane to the ground started with the left wing touching the ground at 9 hr 22 min 11.02 sec in a -12 degree roll. As the airplane continued its descent it pitched down about 3 degrees and the forward cabin at Body Station 380 hit the ground at 11.46 sec. The airplane continued to slide and to rotate downward and the bottom of the fuselage at Body Station 960 hit the ground at 11.86 sec. Sliding continued and the airplane yawed to the left until engine #3 hit the wing cutters at 12.843 sec. The airplane stopped moving at 9 hr 22 min 21 sec.

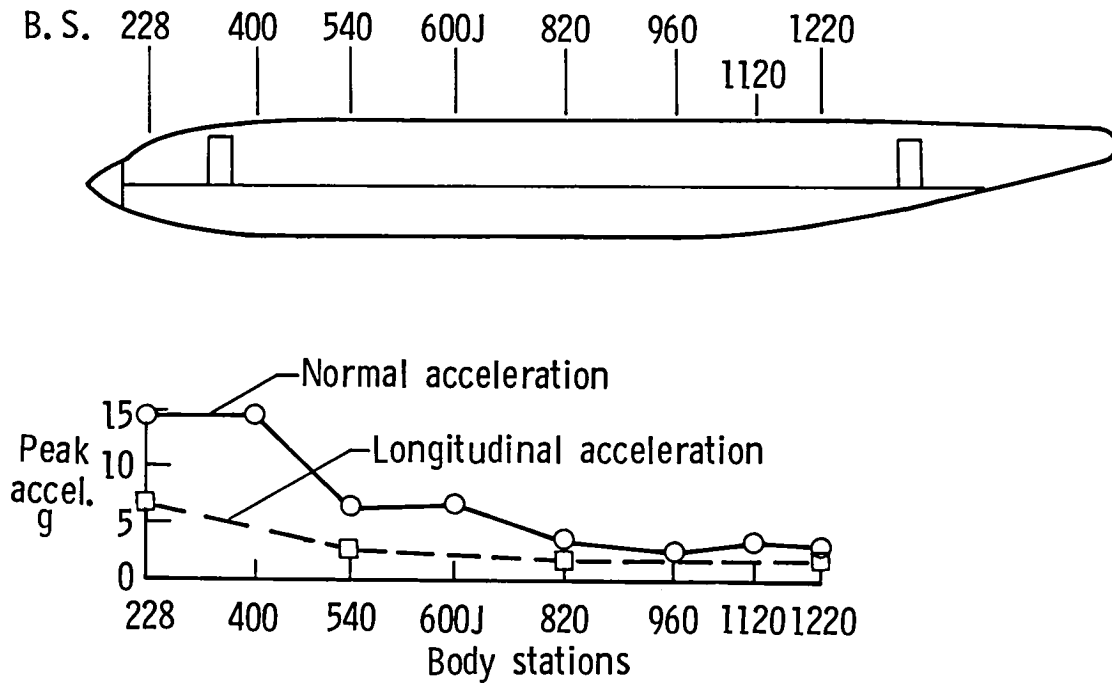
FLOOR ACCELERATION PEAKS DISTRIBUTION

The distribution of acceleration peaks in the normal direction from front to rear of the fuselage shows higher accelerations at the front of the airplane diminishing toward the rear. Under the pilot seat and at Body Station 400 acceleration peaks of 14 g were recorded. Body Station 380 was the area of the fuselage's initial contact with the ground due to the 3 degree pitch down of the airplane. The normal accelerations decrease to 6 and 7 g's in Body Stations 540 and 600J respectively and continue to decrease to less than 5 g toward the rear of the airplane.

The longitudinal accelerations follow a similar pattern: higher at the front of the airplane (6 g) where the fuselage initial impact with the ground occurred and diminishing toward the rear (2 g).

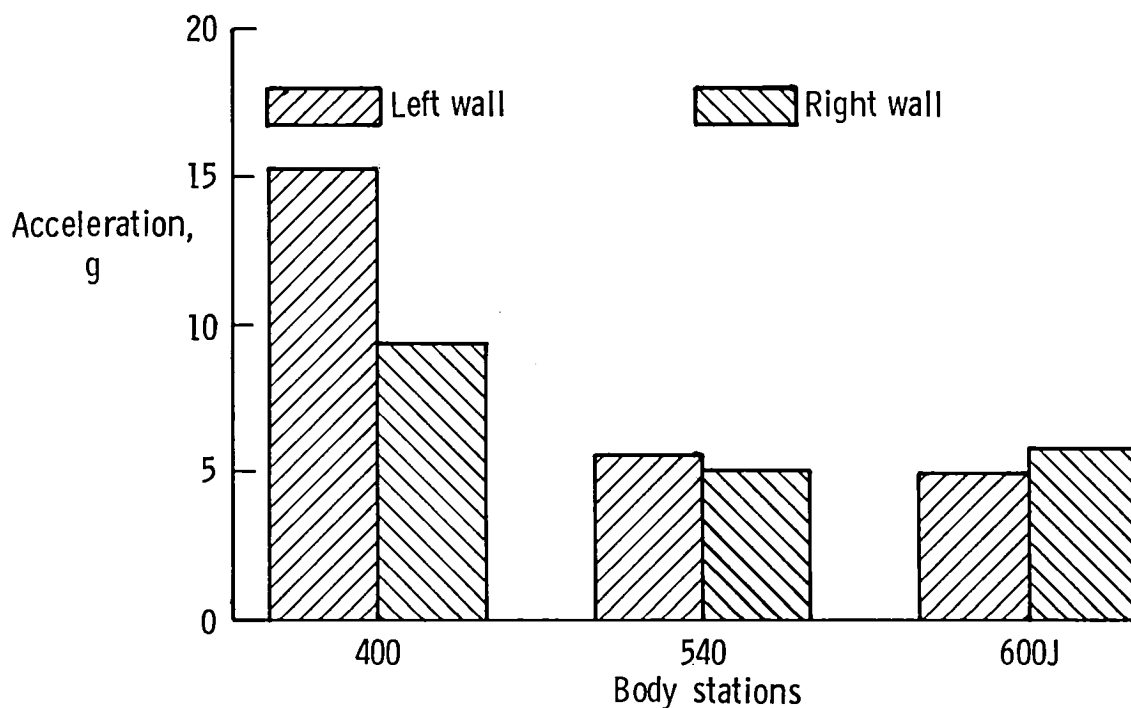
C.I.D. VERTICAL FLOOR ACCELERATION

The left side of the airplane forward of Body Station 540 experienced higher accelerations than the right side. At Body Station 540 and rearward the difference in acceleration between left and right sides is about +1 g. The magnitude of the accelerations seemed to vary with the contact position of the fuselage with the ground. The airplane had a negative roll (left) and the fuselage impacted pitched down. At this time the acceleration on the left side at the point of impact is higher. As the fuselage continues to pivot down and rotate to the right the difference in acceleration between right and left sides becomes smaller.

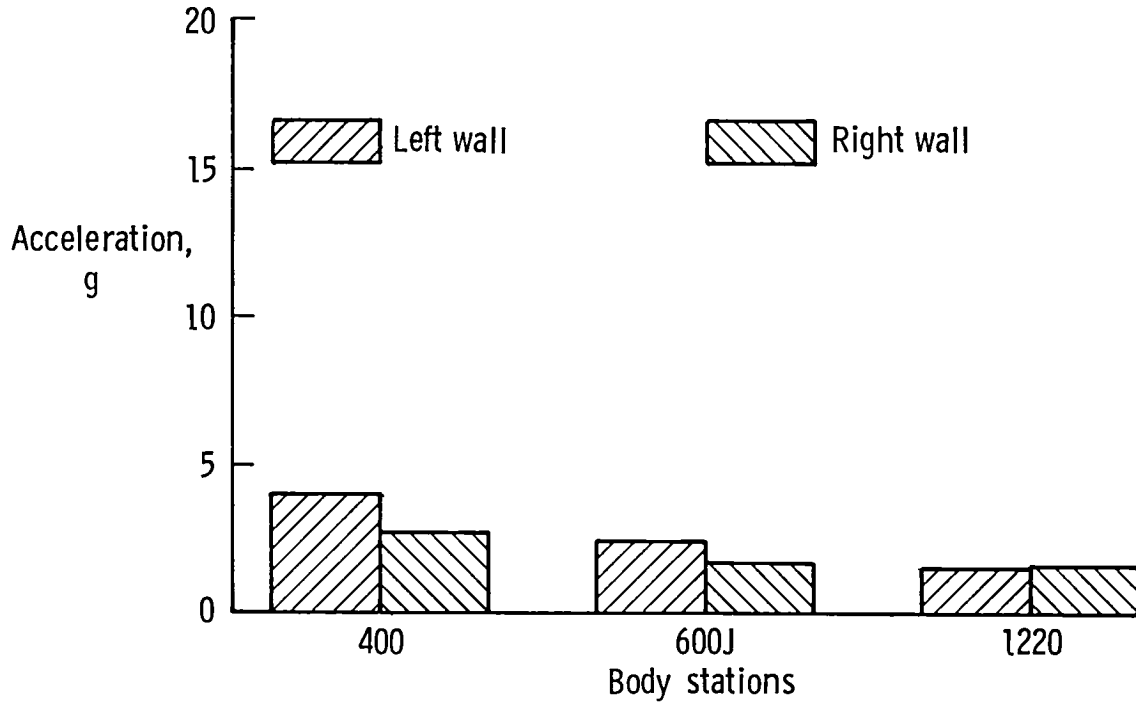
C.I.D. LONGITUDINAL FLOOR ACCELERATION

Similar to the pattern of the vertical accelerations, the longitudinal accelerations are also higher on the left side toward the front of the fuselage with the difference between left and right values diminishing toward the rear.

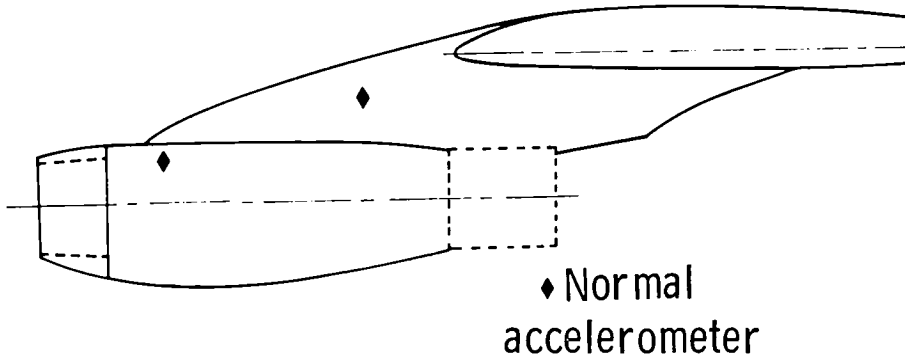
INBOARD NACELLE AND STRUT

On the left wing an acceleration peak of 36 g was obtained toward the front of the inboard pylon and 150 g in the rear of the pylon. On the right wing an acceleration peak of 5 g was obtained toward the front of the inboard pylon and 29 g in the rear of the pylon.

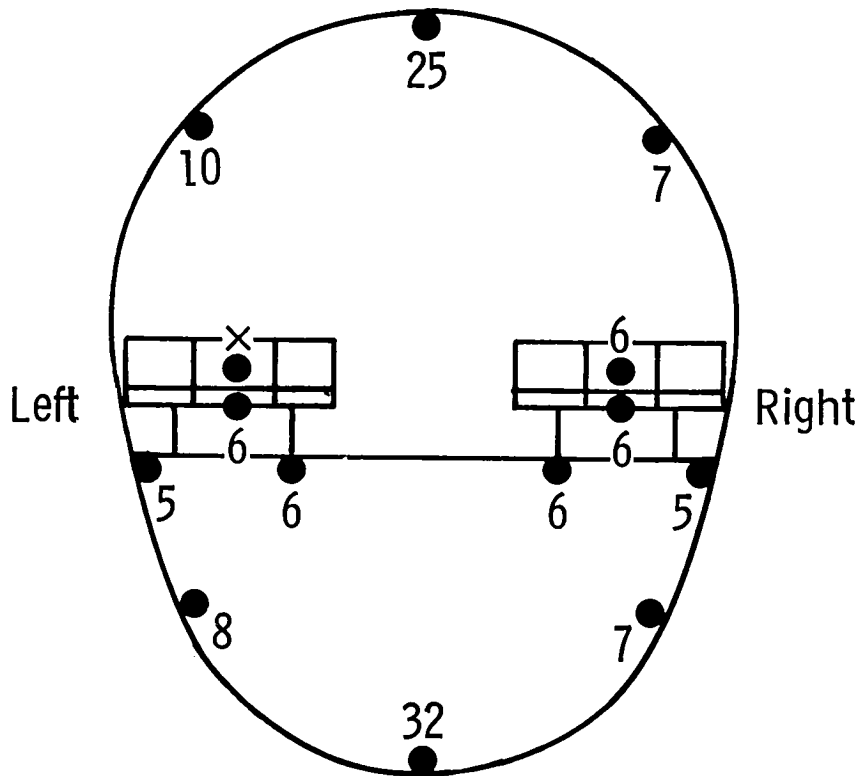
BODY STATION 540

This is a cross section of the instrumented frame at Body Station 540. The values shown are normal acceleration peaks recorded at those locations to determine the transmission of pulses from the ground up. Peak accelerations obtained were 32 g at the bottom, 7 - 10 g at the subfloor and upper wall, 6 g at the floor, and 25 g at the roof of the fuselage. On the seat frame and dummy pelvis, an acceleration of 6 g was obtained.

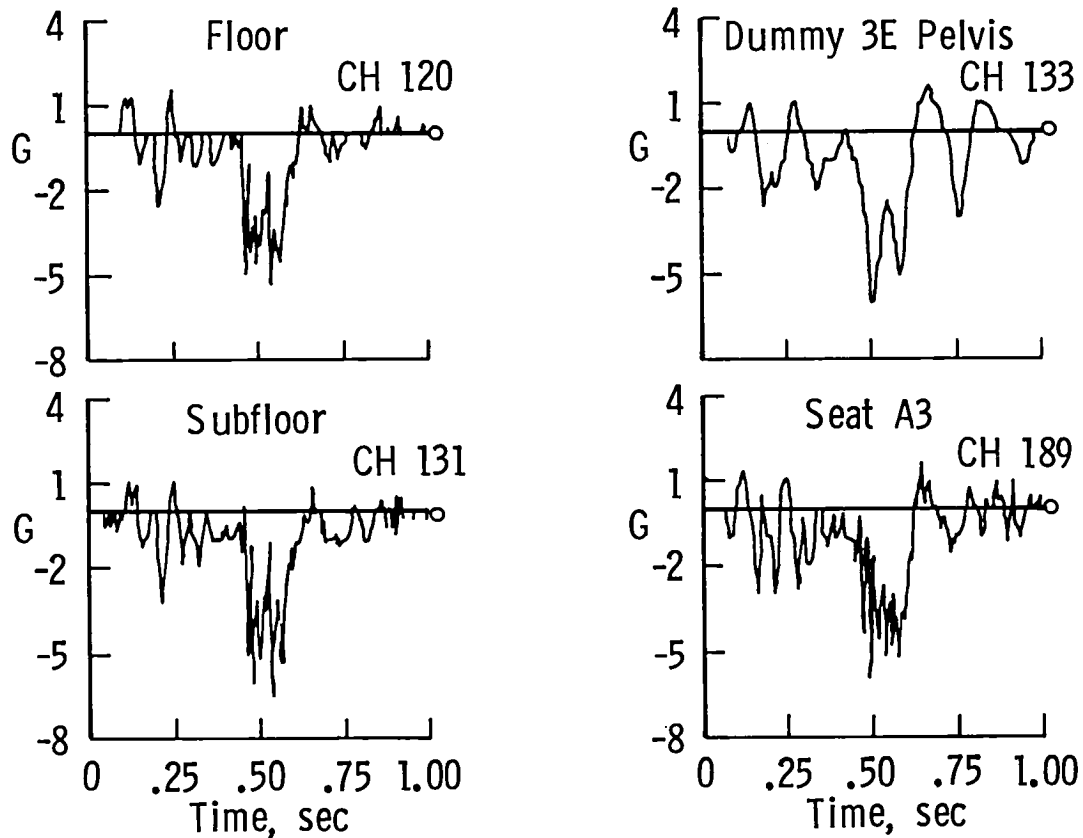
BODY STATION 540: NORMAL ACCELERATIONS

These acceleration time histories were measured on the right side of frame #2 at Body Station 540. The subfloor trace shows acceleration peaks of 7 g. At the floor-wall intersection the acceleration is 5 g. The acceleration on the seat frame is 6 g and at the dummy pelvis the acceleration is 6 g.

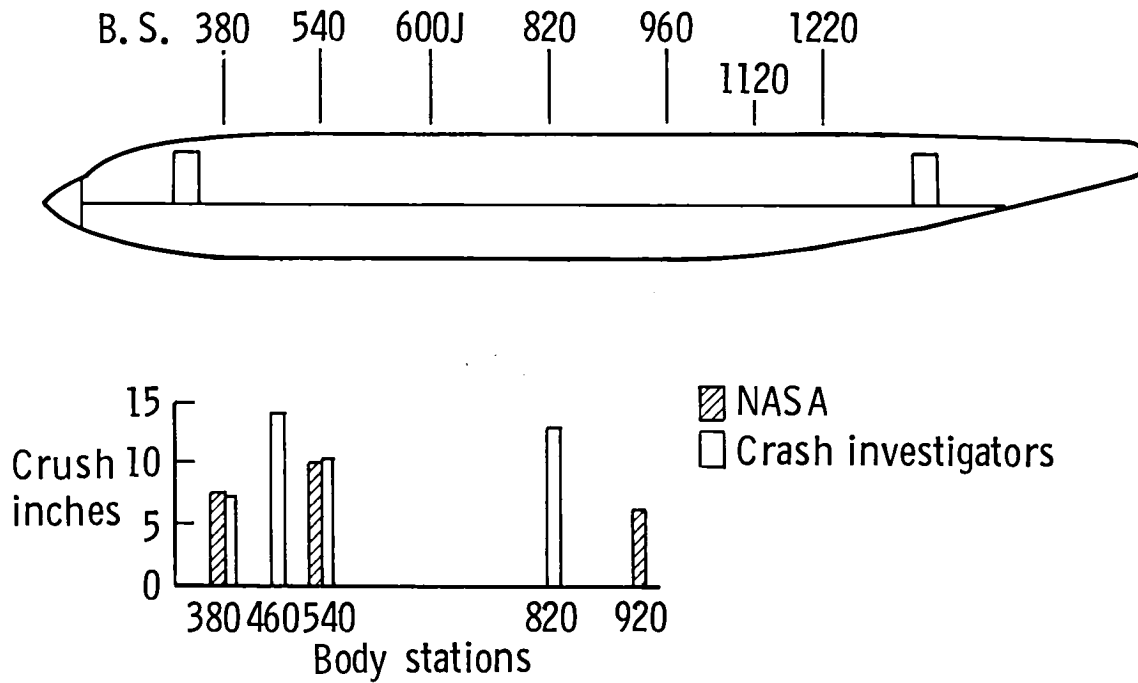
FUSELAGE CRUSH (PRELIMINARY)

A NASA team and a crash investigators team measured the crush of the fuselage bottom. The crush measured by the NASA team was 7" at Body Station 380, 10" at Body Station 540, and 7" at Body Station 920. The crush measured by the crash investigators team was 7" at Body Station 380, 14" at Body Station 460, 10" at Body Station 540, and 13" at Body Station 820. Both teams had good agreement in the crush measurements at Body Station 380 and Body Station 540. At the other body stations measurements were made by only one team.
