CONTROLLED IMPACT DEMONSTRATION
ON-BOARD (INTERIOR) PHOTOGRAPHIC SYSTEM

Clyde J. May
NASA Langley Research Center
Hampton, Virginia

NASA/FAA Government/Industry CID Workshop
NASA Langley Research Center
April 10, 1985

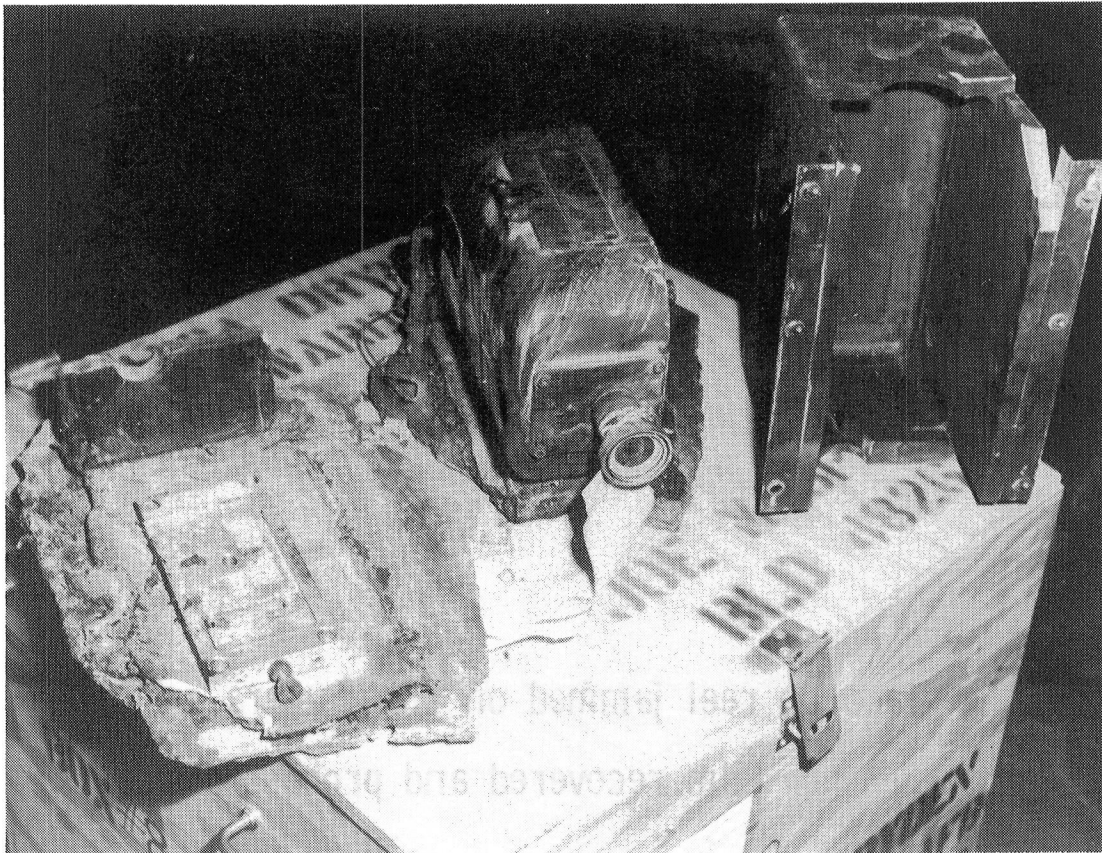
Figure 19

POST CRASH PHOTO OF CAMERA, HEATSHIELD AND MOUNTING PLATE (FRONT VIEW)

The post crash condition (front view) of a typical camera, heatshield and mounting bracket is shown in Figure 19. The heat resistant material under the camera and the heatshield provided excellent protection for the camera despite the fact that the aluminum mounting bracket practically melted away. The smoke deposits on the camera housing was cleaned off revealing the original paint hardly scorched.

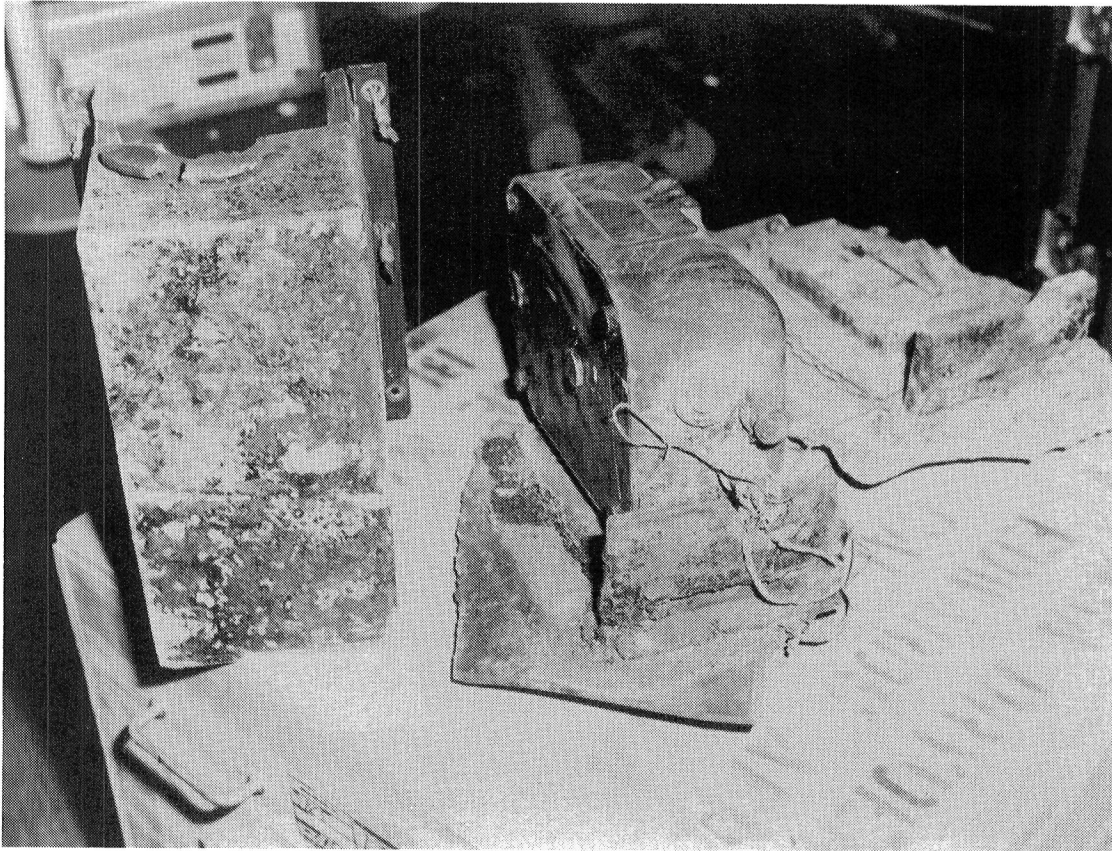
POST CRASH PHOTO OF CAMERA, HEATSHIELD AND MOUNTING PLATE (REAR VIEW)

Figure 20 is the rear view of the same camera and other hardware shown in Figure 19.

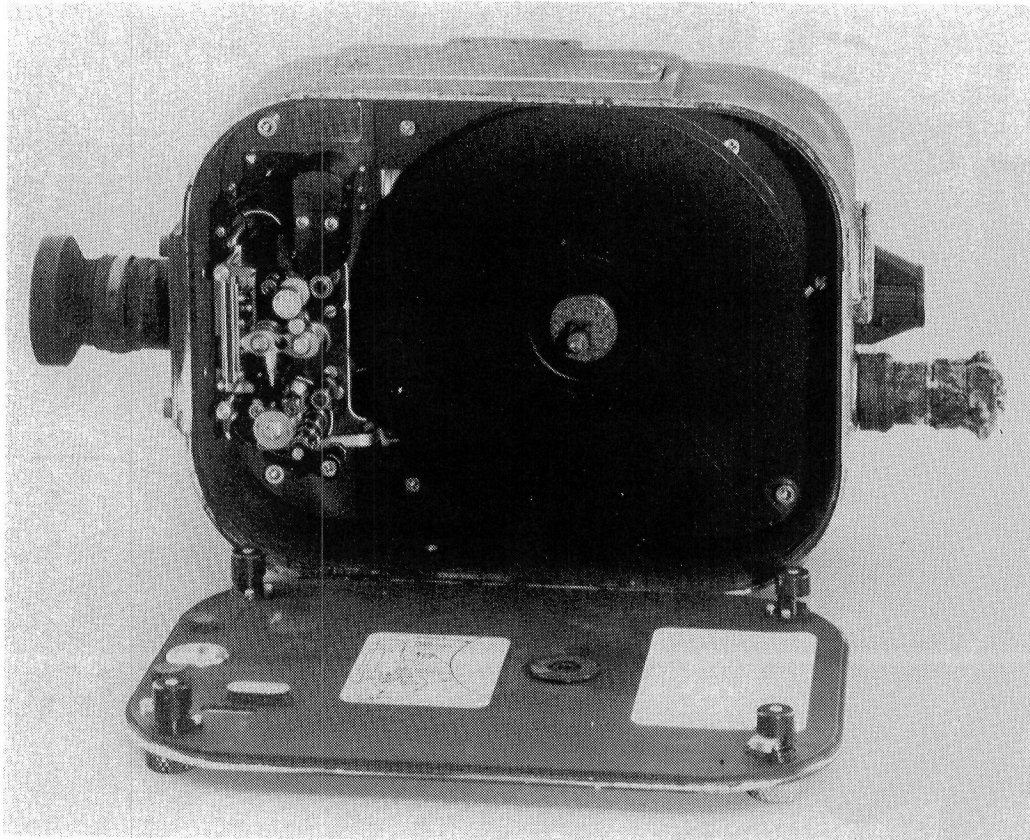
Figure 21

POST CRASH PHOTO OF CAMERA (INTERIOR VIEW)

The interior of the cameras were surprisingly clean when opened after the crash (Fig. 21). The lenses were destroyed, however, and the portion of the electrical connectors protruding from the heatshield was melted.

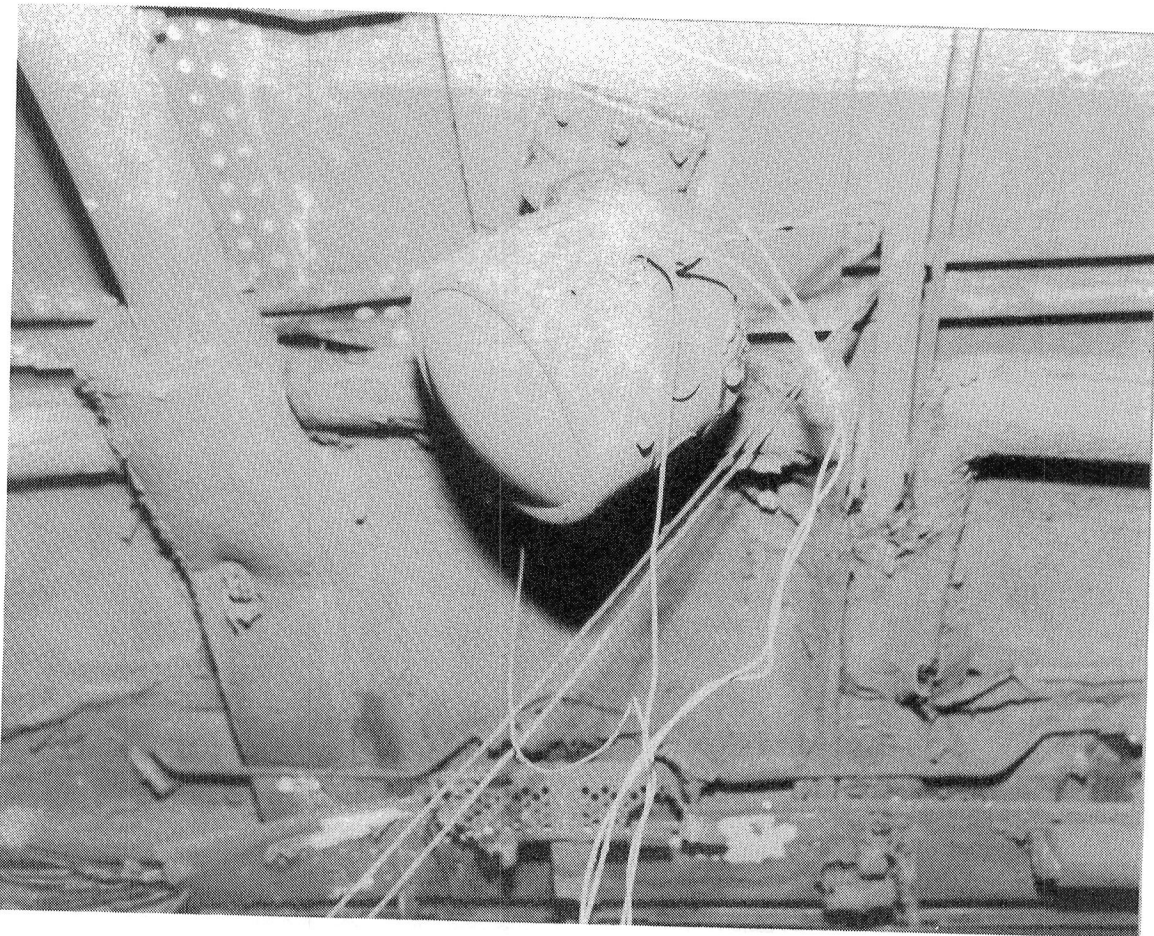
Figure 26

POST CRASH PHOTO OF LIGHT FIXTURE

This photograph of one light fixture (Fig. 26) was taken shortly after the crash. It is obvious that the assembly, as did all 24, survived the crash with no physical damage. However, the extreme heat did melt the wires and polyurethane material.

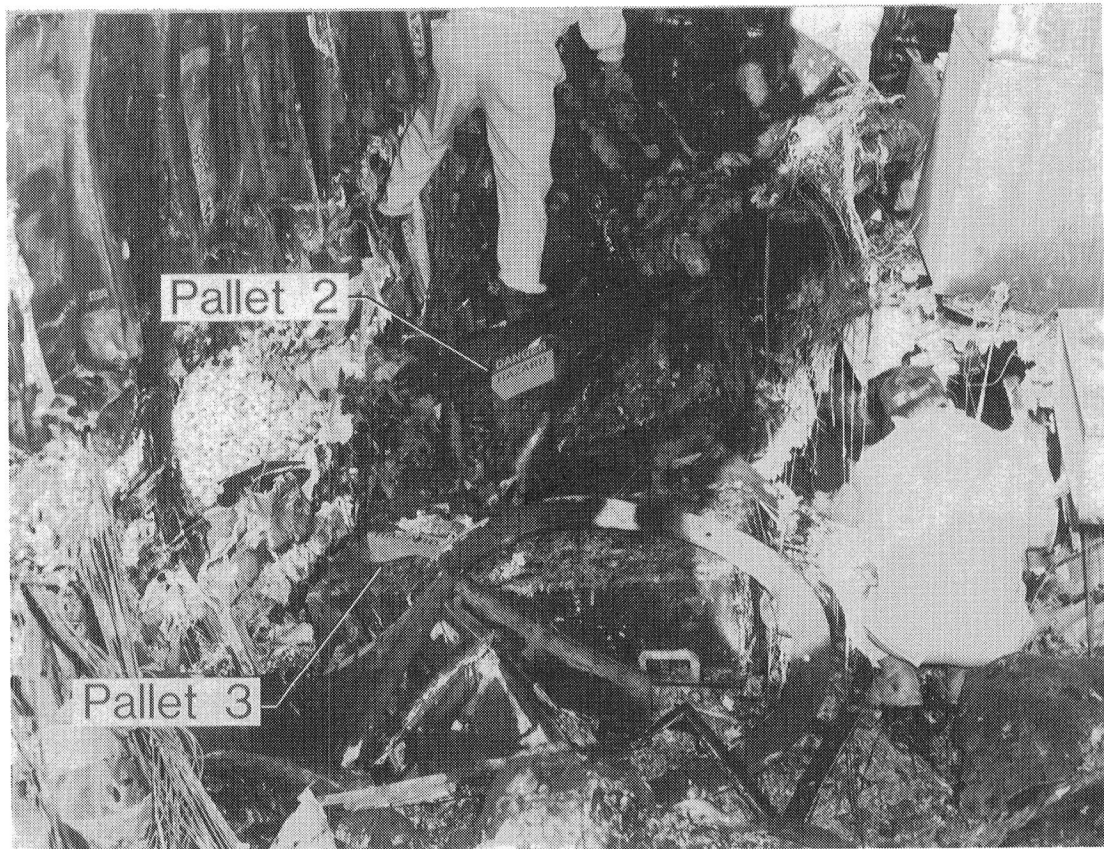
Figure 27

POST CRASH POSITION OF PHOTO PALLETS 2 & 3

Photo power pallets 2 and 3, which were located just aft of the left wing, are hardly discernible among the debris (Fig. 27). They fell through the floor, as did the other pallets, when the floor melted away. Red tags were placed on each unit by the safing crew, to indicate a possible personnel hazard because they still contained batteries.

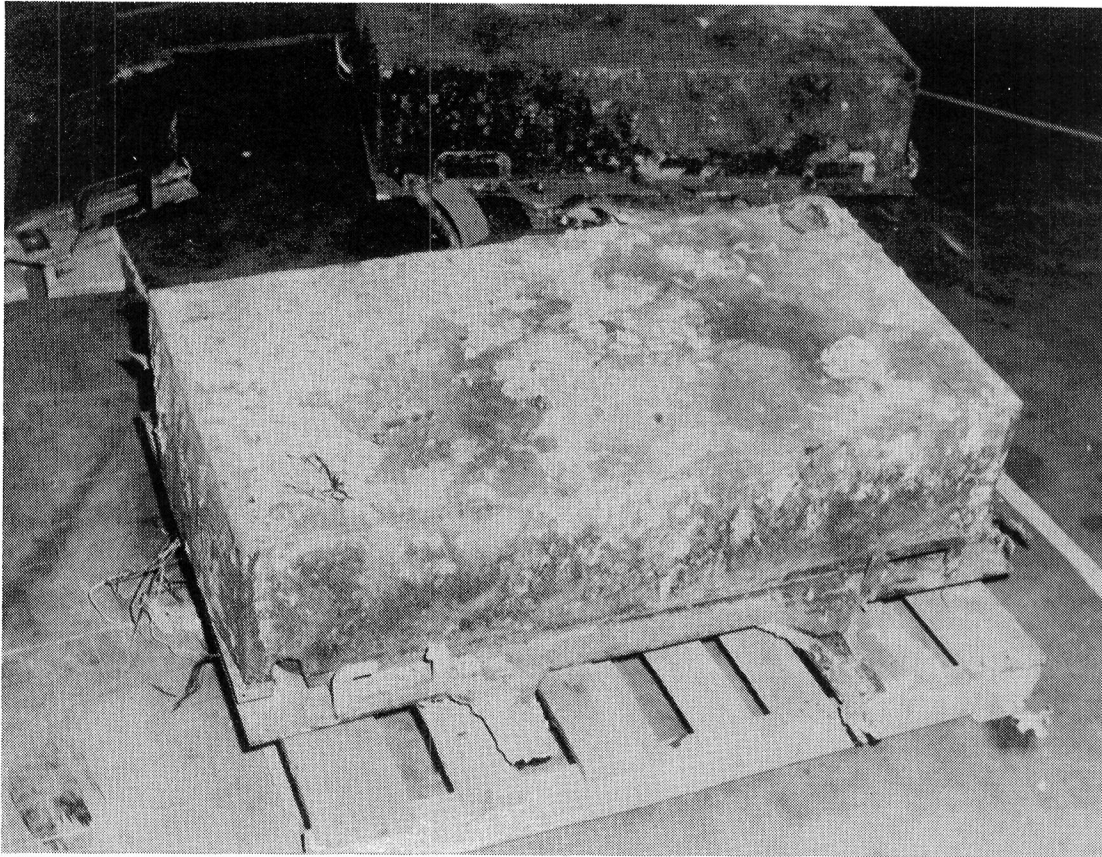
Figure 28

PHOTO PALLET NO. 3 - POST CRASH CONDITION (WITH HEATSHIELD)

Photo pallet No. 3 after removal from the aircraft (Fig. 28). The heatshield damage looks worse than it really was. Only the outer coating was partially burned away.

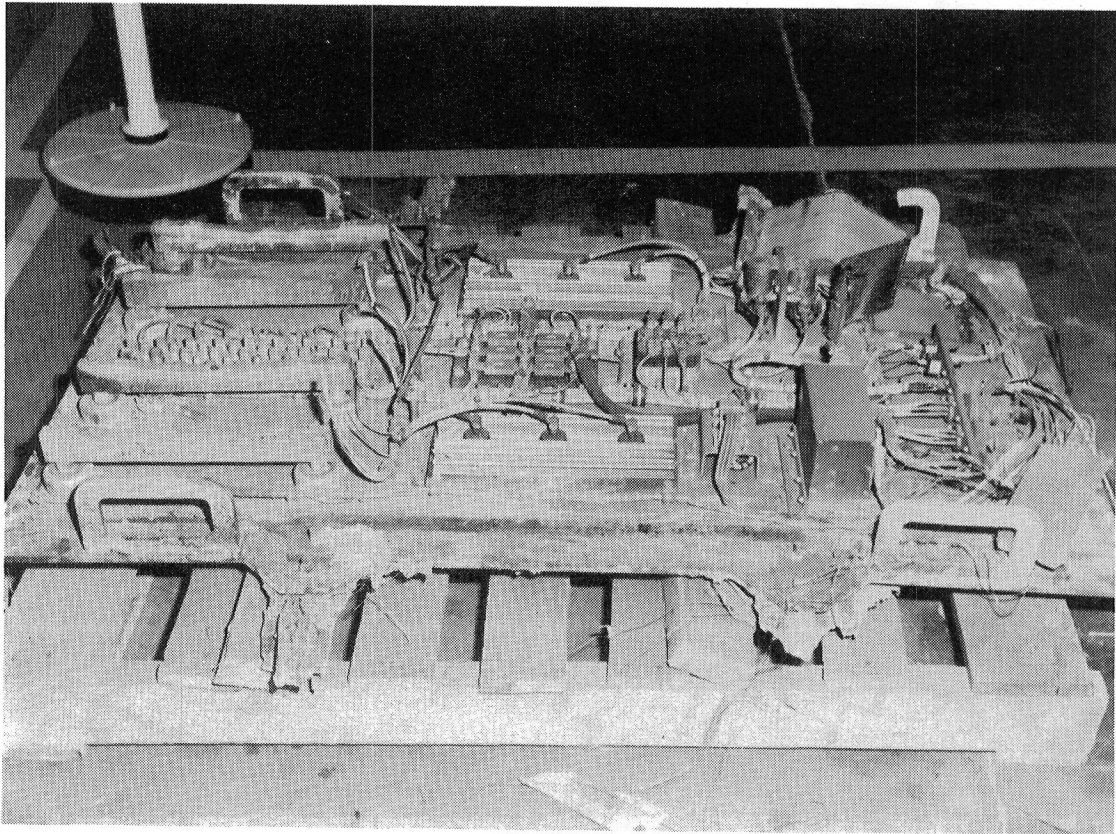
Figure 29

PHOTO PALLET NO. 3 - POST CRASH CONDITION (HEATSHIELD REMOVED)

Except for smoke deposits, there was surprisingly little damage to the pallet components when the heatshields were removed. Pallet number 3 (Fig. 29) was one of the worst and except for the batteries (not shown), fuses and wiring, most of the other hardware could have been salvaged.
