CID-720 AIRCRAFT
LaRC PREFLIGHT HARDWARE TESTS:
DEVELOPMENT, FLIGHT ACCEPTANCE AND QUALIFICATION

J. D. Pride
NASA Langley Research Center
Hampton, Virginia

NASA/FAA Government/Industry CID Workshop
NASA Langley Research Center
April 10, 1985

Development, flight acceptance and qualification

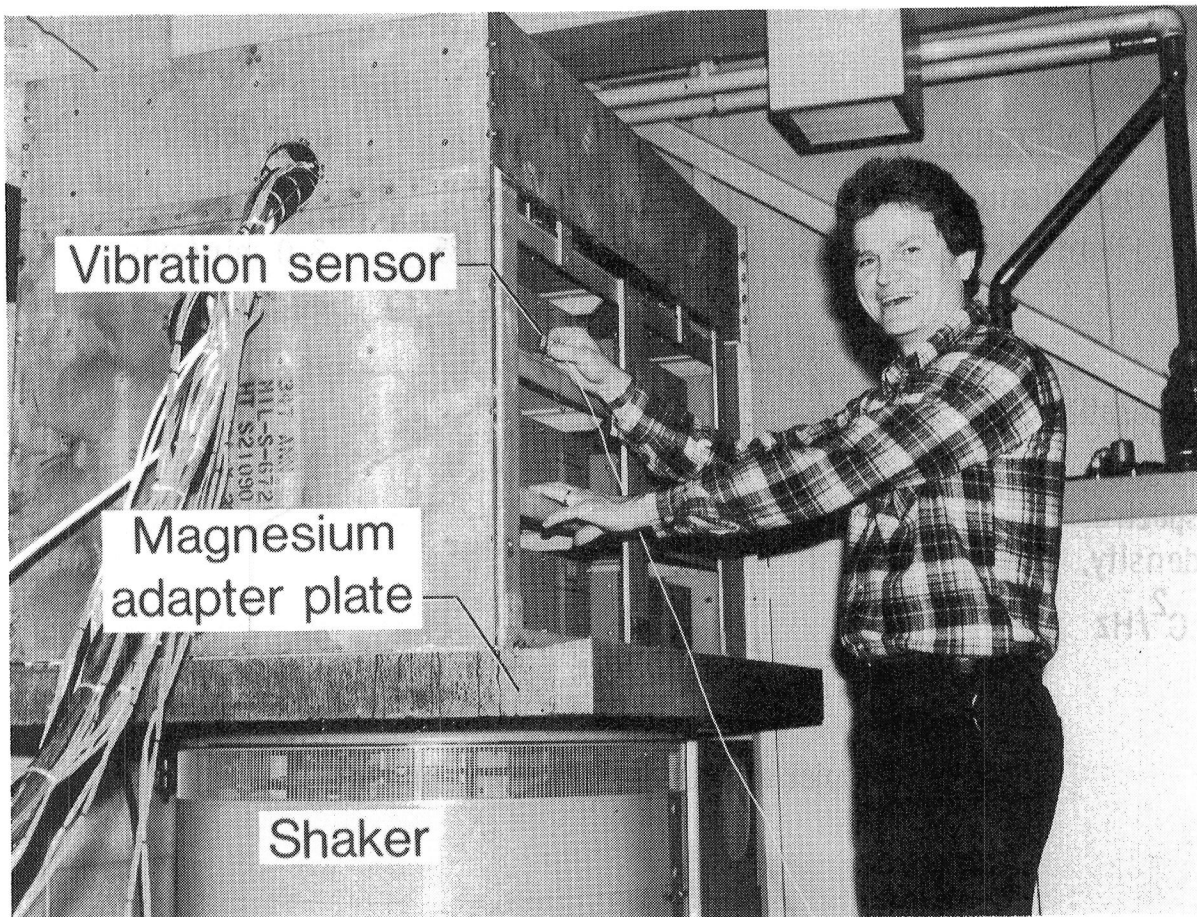
VIBRATION TEST
DAS - MAIN ELECTRONIC PALLET

The vibration test profile was input to the test article, mounted to a damped 4 inch thick magnesium adapter plate. The 17,000 force-pound shaker is shown in the vertical position with the adapter plate and approximately 900 pound DAS main electronic pallet mounted. The technician is shown placing accelerometers on each of the four shelves of the pallet unit, which has one heat shield side cover removed. The shaker was rotated 90 degrees and attached to a large slippery table for vibration of the longitudinal and transverse axes. The multicable harness was attached to the pallet components and the system was under power during the complete vibration test series. No major resonance conditions or abnormalities were evidenced during this test series.

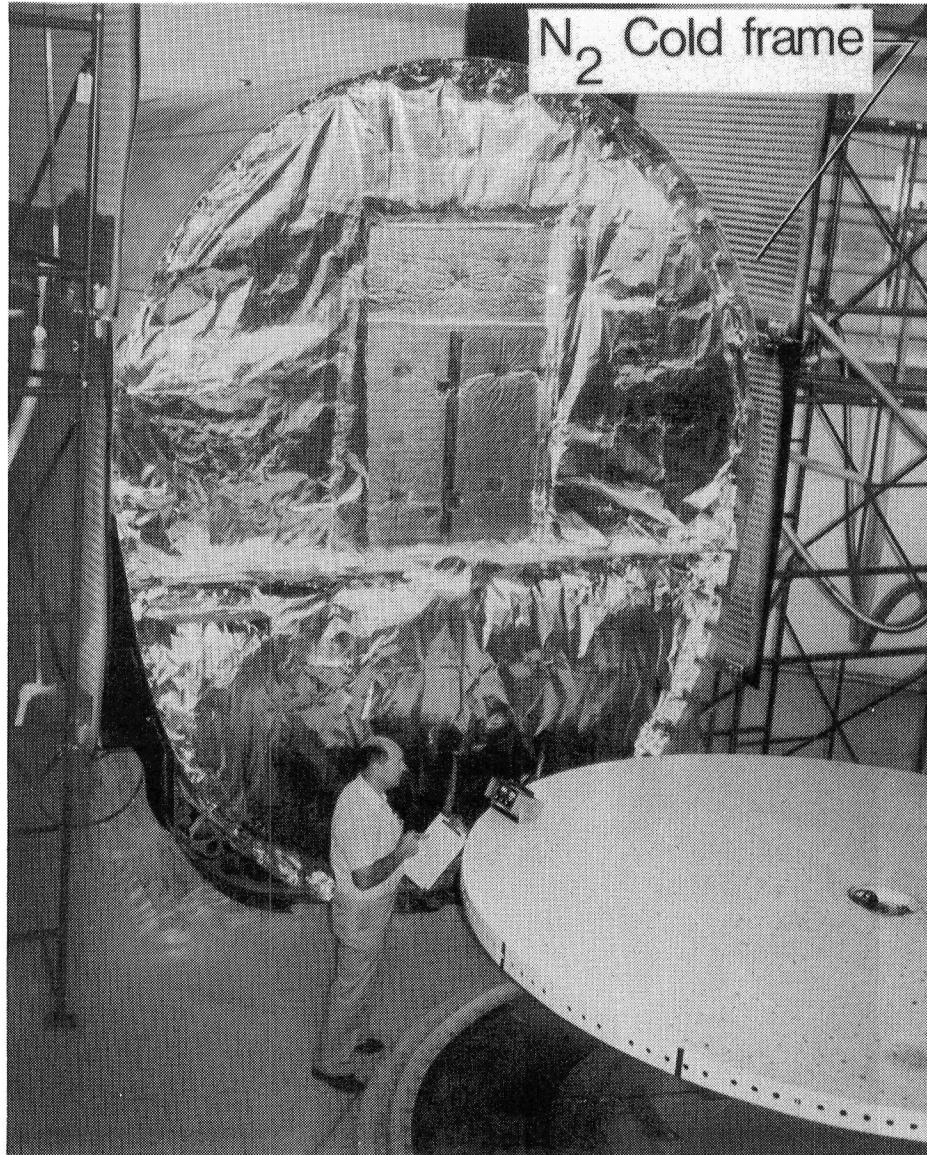
THERMAL (COLD) TEST

The full-size B-720 fuselage section was also used for the thermal (cold) test in the thermal vacuum facility. Large nitrogen cold frames were positioned adjacent to the fuselage section and temperature inside the fuselage was chilled by radiating heat away from the fuselage section to the cold frames. All of the test articles were operational through the cold temperature test environment. No major discrepancies or failures were detected throughout the thermal testing.

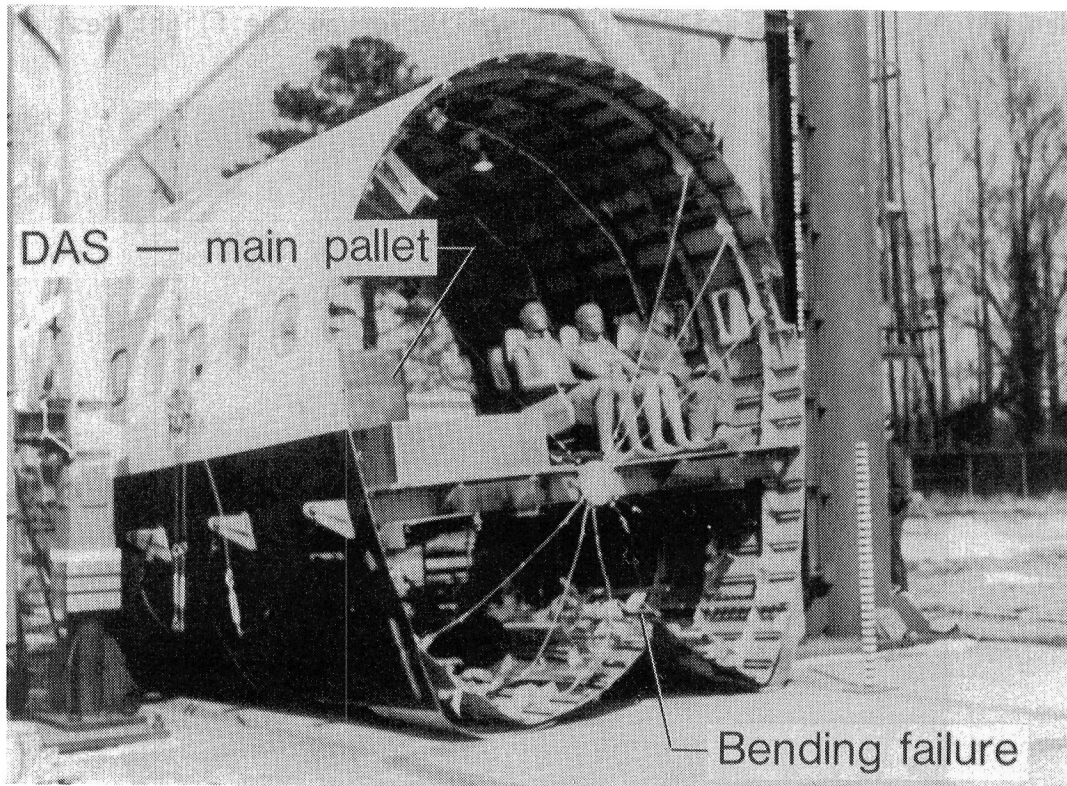
720 FUSELAGE (AFTERBODY) DROP TEST SHELL FAILURE
FLIGHT SYSTEMS OPERATIONAL

At impact, the lower fuselage shell failed where keel formers sheared and local bending occurred. A secondary bending and buckling occurred along the cargo shell sidewall. These structural failures absorbed considerable impact energy and contributed to reduced shock levels along the floor line where seats and pallets are mounted. All units were inspected after this test and shown to be qualified for flight test service.

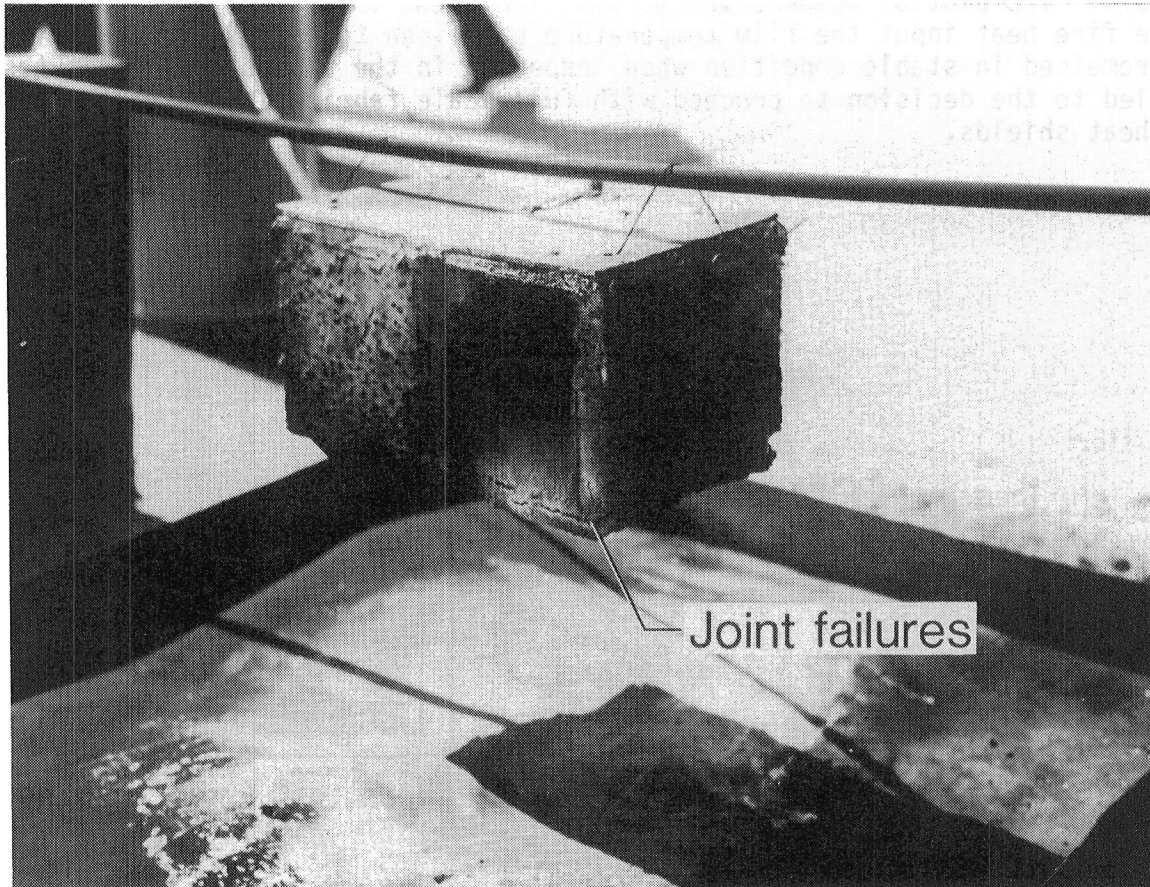
FIRE TEST - RESULTS

This initial fire test was not successful since the heat shield joints at the box corners opened and the flame entered to the metal dummy camera. All the inside thermocouples rapidly increased in only several minutes. The resulting temperatures would have destroyed any film inside the camera body.

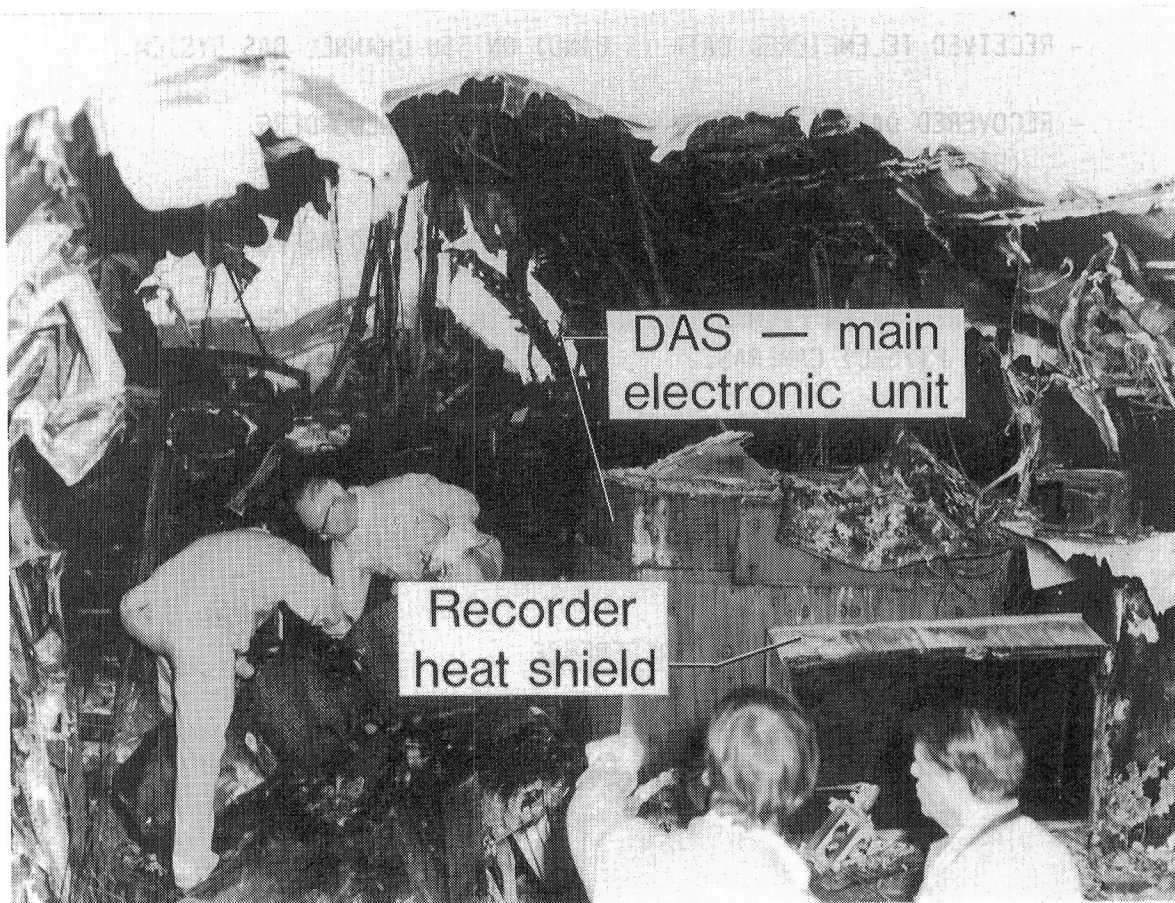
CID-720 POST-FIRE REMAINS

This photo shows the remains of the CID-720 test aircraft after the crash test with the subsequent intense fire. This is a view inside the fuselage looking forward. Shown standing rigidly in place is the DAS-main electronic unit with heat shields in place and molten aluminum metal deposited on its top from the melt down of the aircraft crown section. The DAS recorder heat shield is shown on its side after removal of the data tape from the recorder package. Both the heat shield and the data tape were in good condition. In the far right side of the photo can be seen a camera heat shield on its supporting aluminum mounting (partially melted) after removal of the 16 mm high speed camera and its spool of good film. The two technicians on the left side are inspecting the large chartek 59 heat shield that was still in excellent condition (less than 1/8 inch char layer) and the photographic power distribution system inside had performed its mission flawlessly.
