*Report to the President*

*By The*  
**PRESIDENTIAL  
COMMISSION**  
*on the Space Shuttle  
Challenger Accident*

June 6th, 1986  
Washington, D.C.

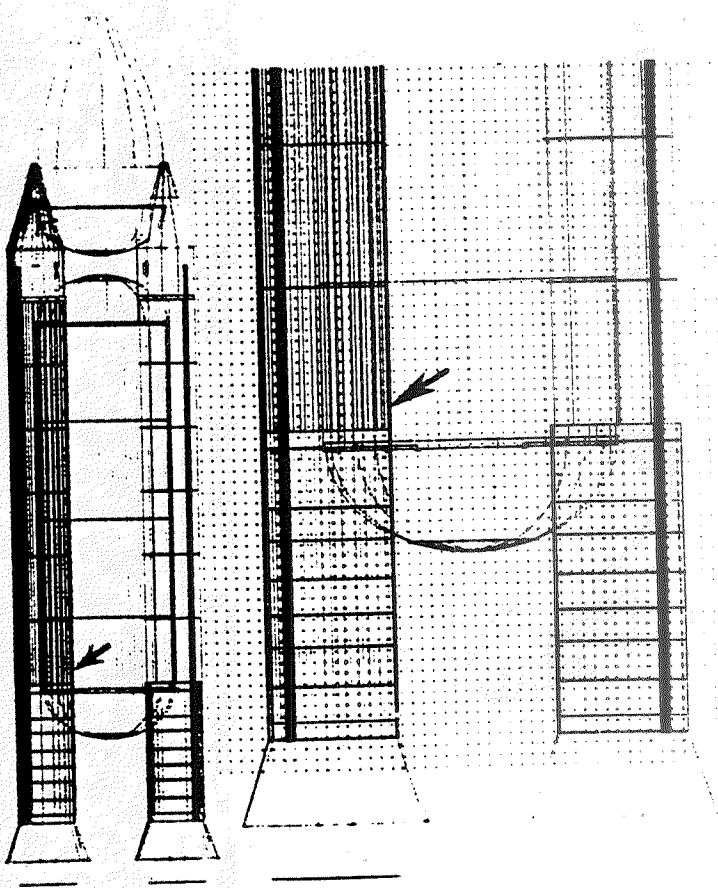
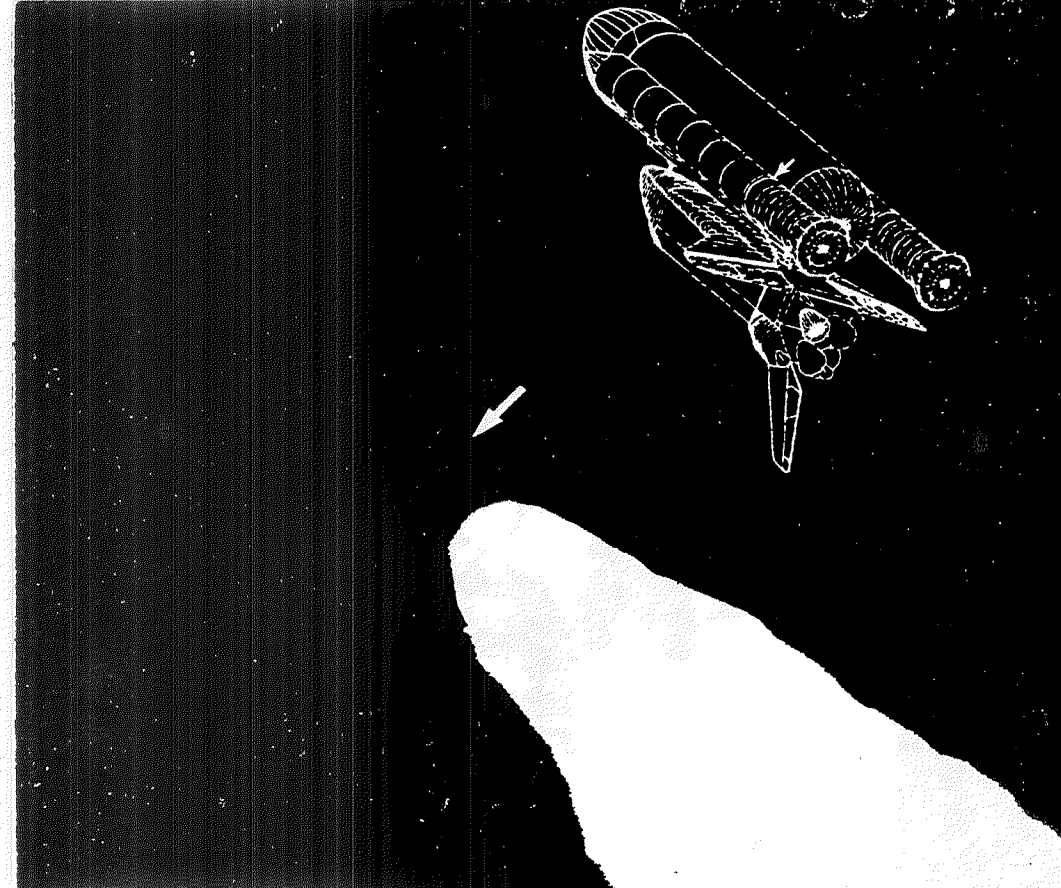
At 58.788 seconds, the first flicker of flame appeared. Barely visible above, it grew into a large plume and began to impinge on the External Tank at about 60 seconds. Flame is pinpointed in the computer drawing between the right booster and the tank, as in the case of earlier smoke puffs. At far right (arrow), vapor is seen escaping from the apparently breached External Tank.

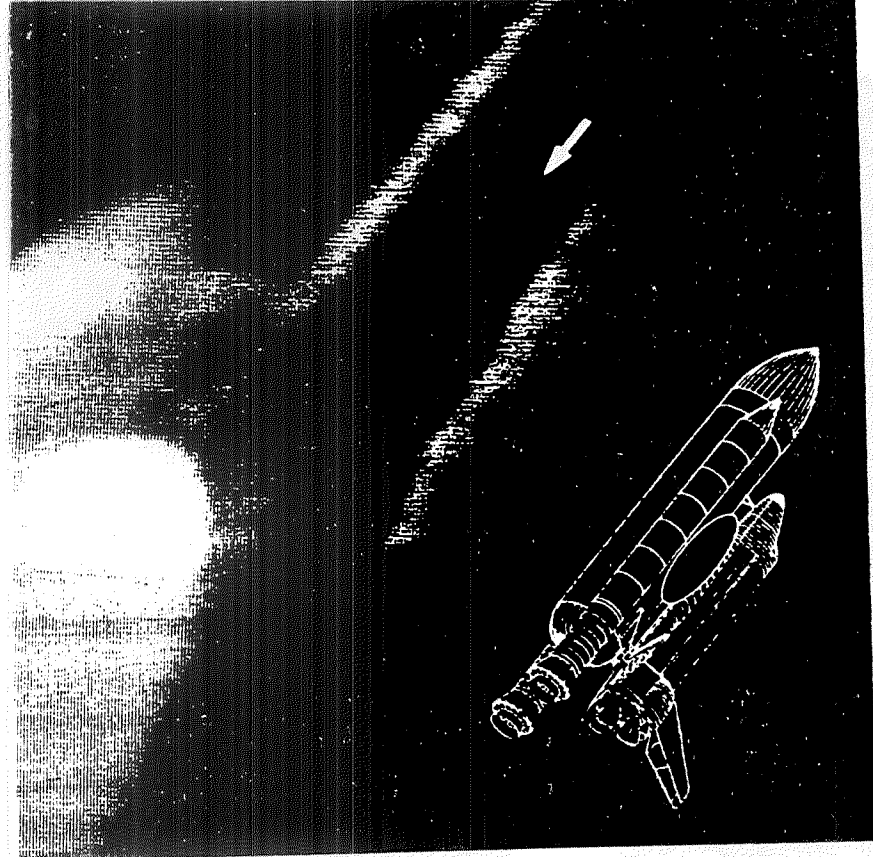
Camera views indicate the beginning of rupture of the liquid hydrogen and liquid oxygen tanks within the External Tank. A small flash (arrows above) intensified rapidly, then diminished. A second flash,

attributed to rupture of the liquid oxygen tank, occurred above the booster/tank forward attachment (below left) and grew in milliseconds to the maximum size indicated in the computer drawing.

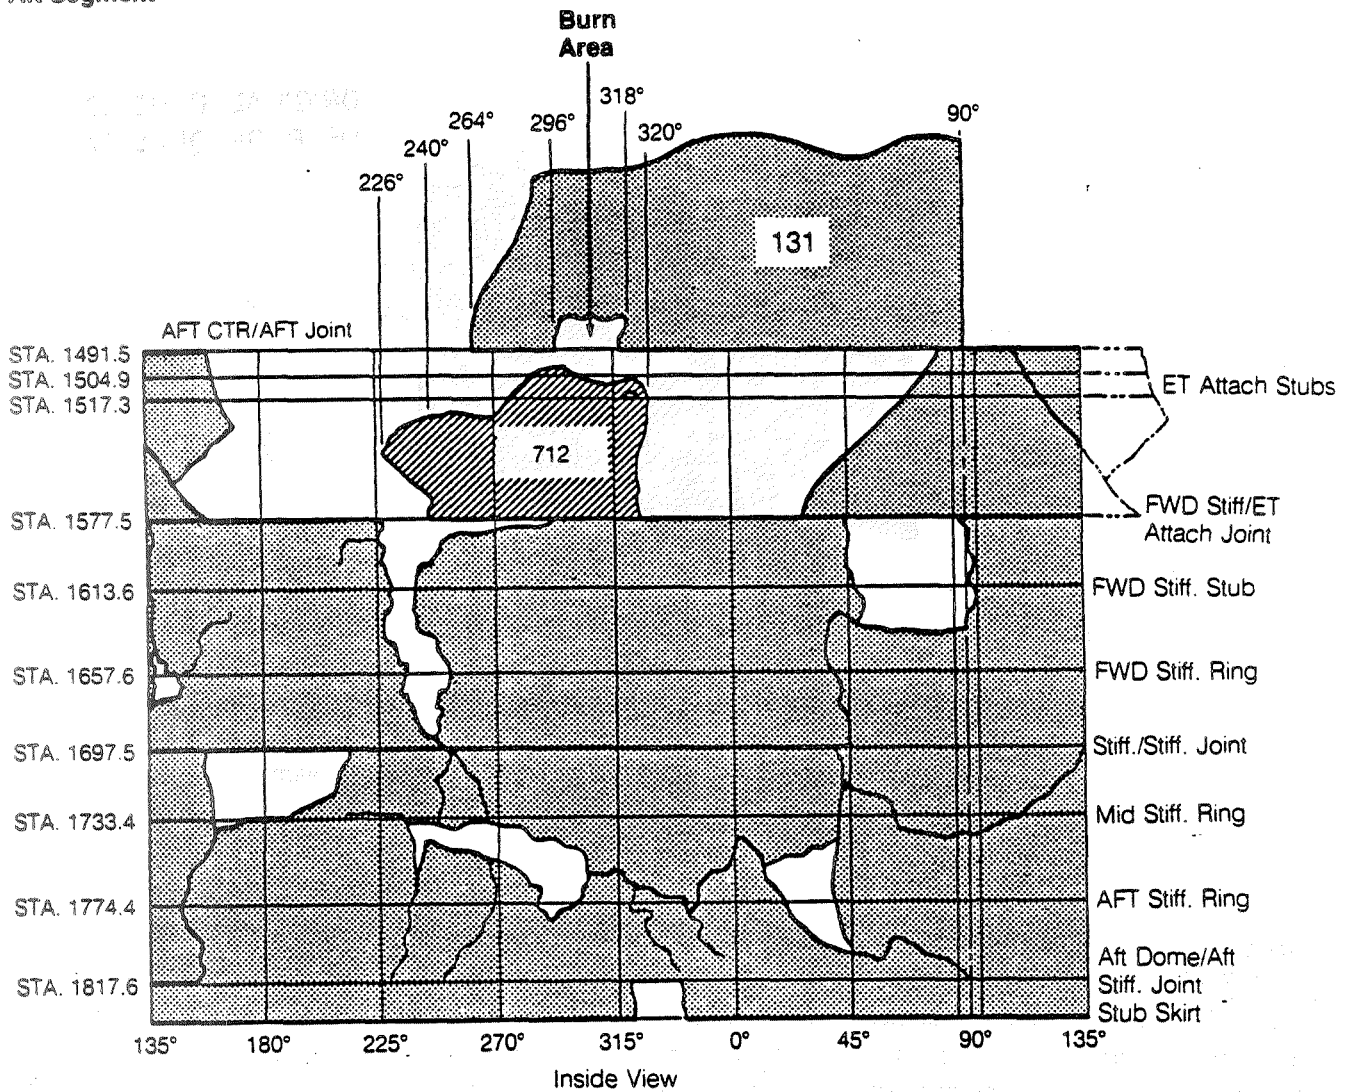
RH SRB Recovered Debris  
Aft Segment

Figure 25  
Drawing depicts pieces of right Solid Rocket Booster aft segment recovered. At top is piece of aft center segment.

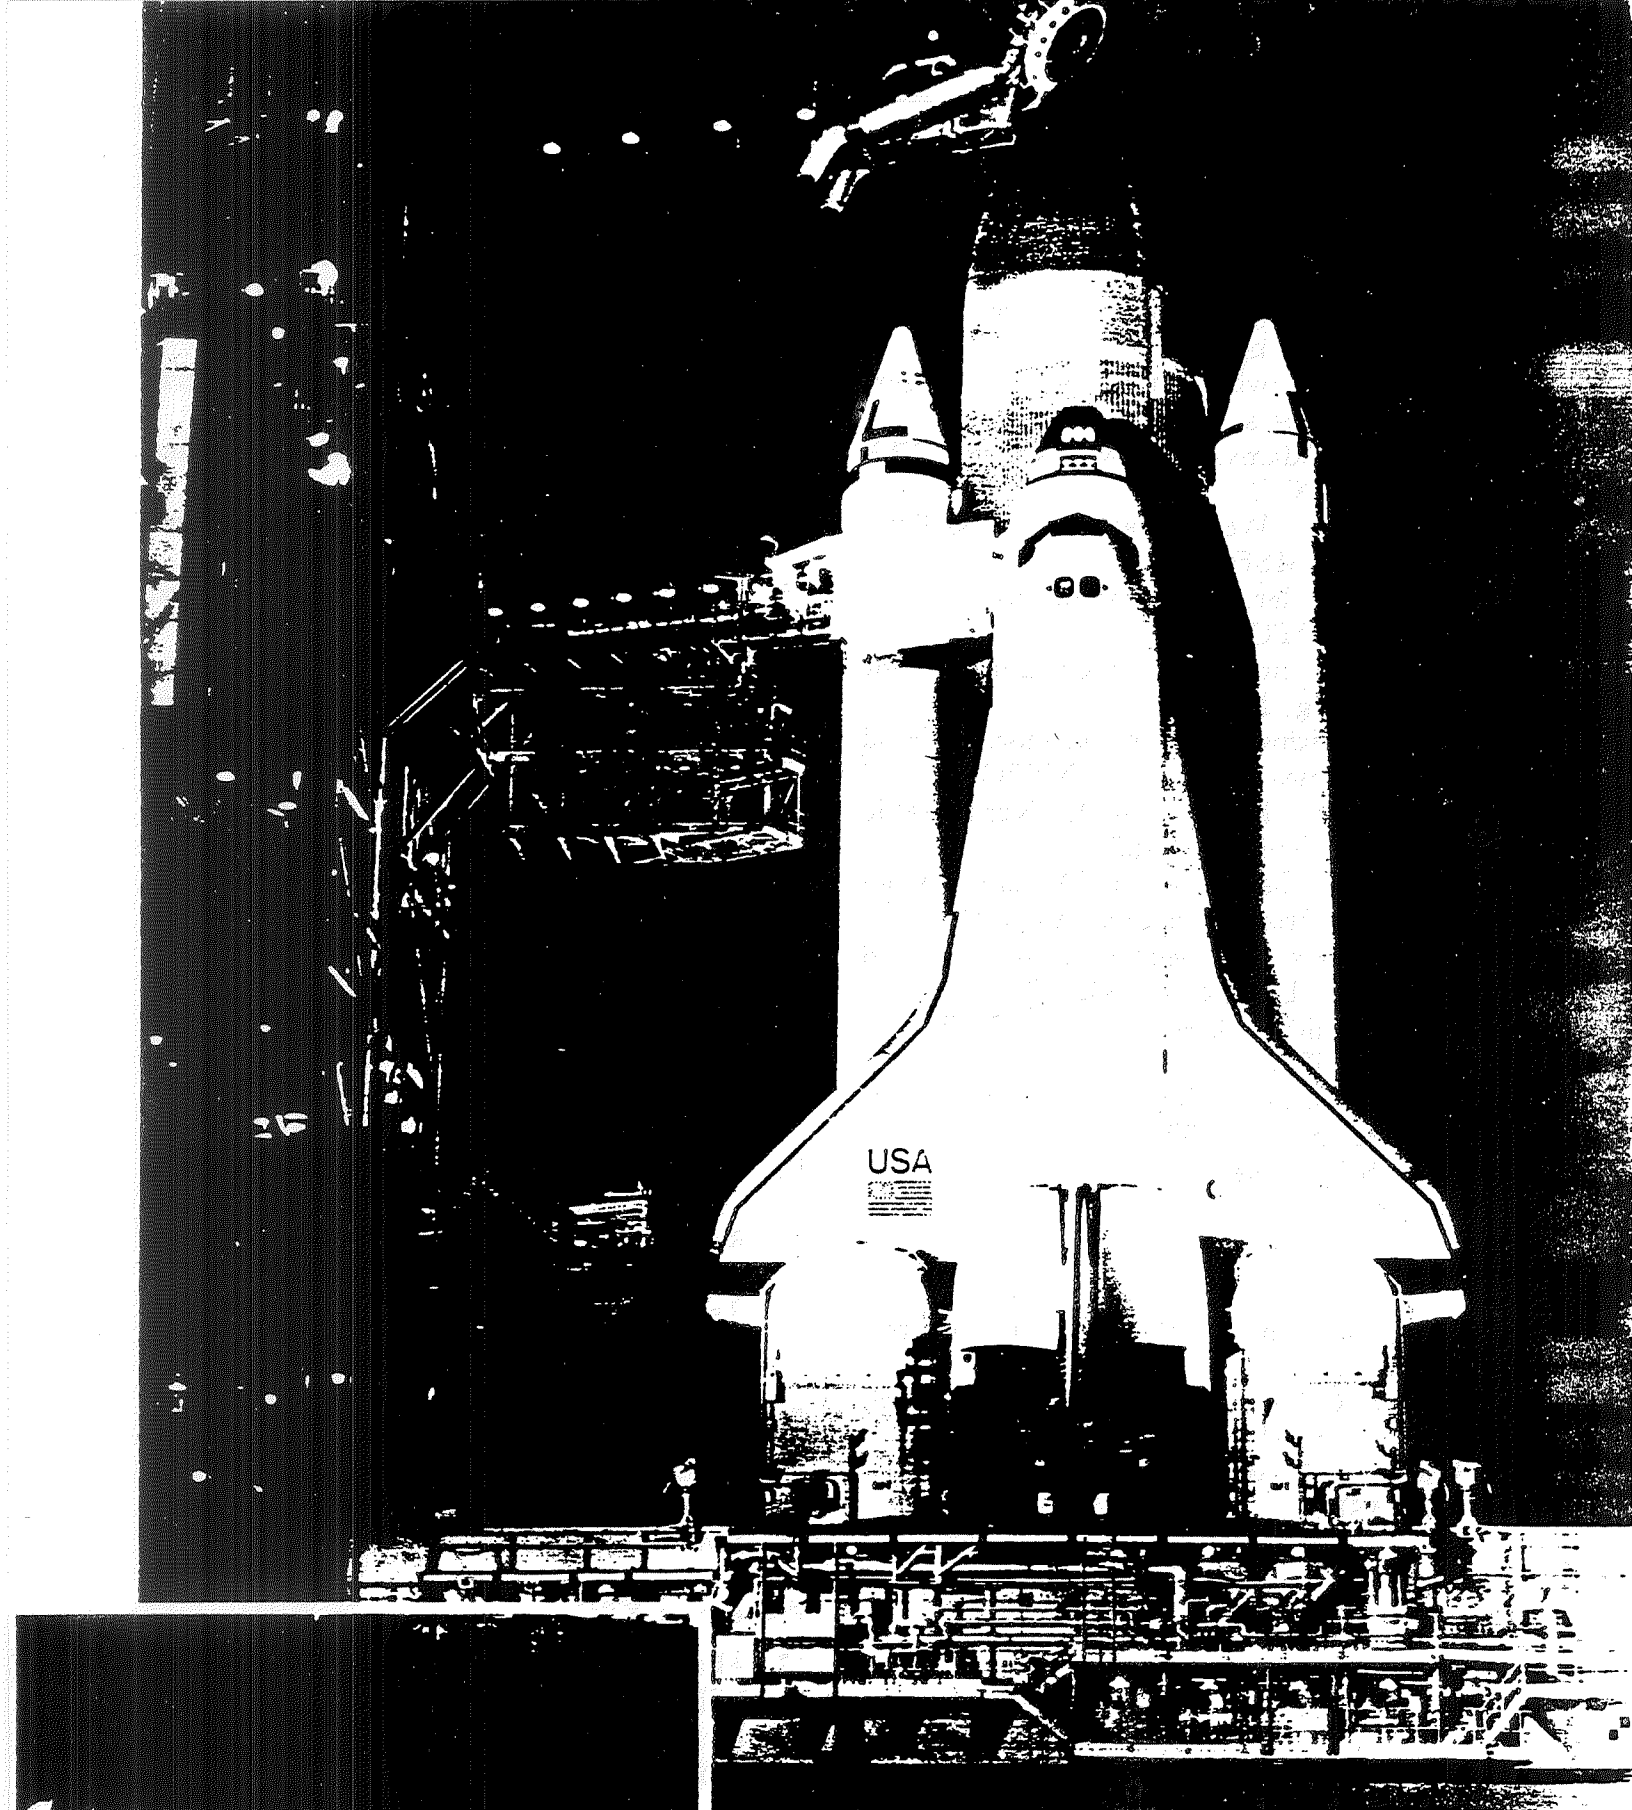
Above, Shuttle 51-L on Kennedy Space Center Pad 39B in the early morning of launch day. Temperatures were well below freezing, as indicated by the lower left photo, which shows thick ice in a water trough despite use of an anti-freeze solution.

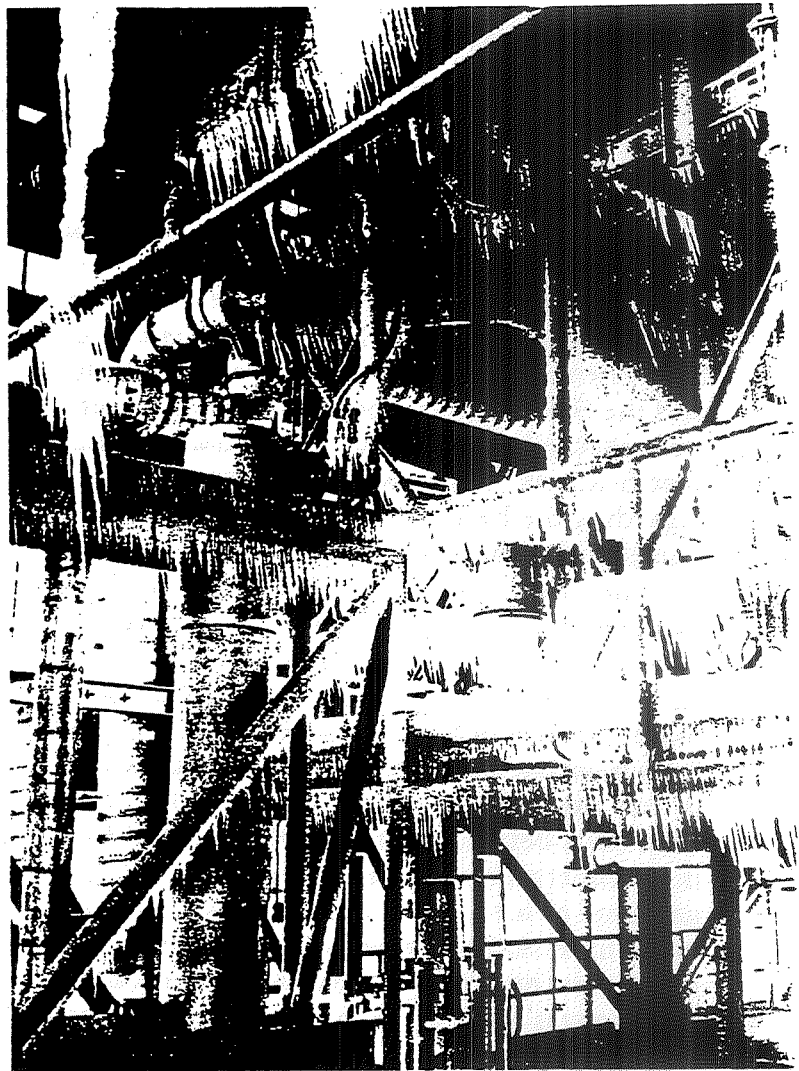
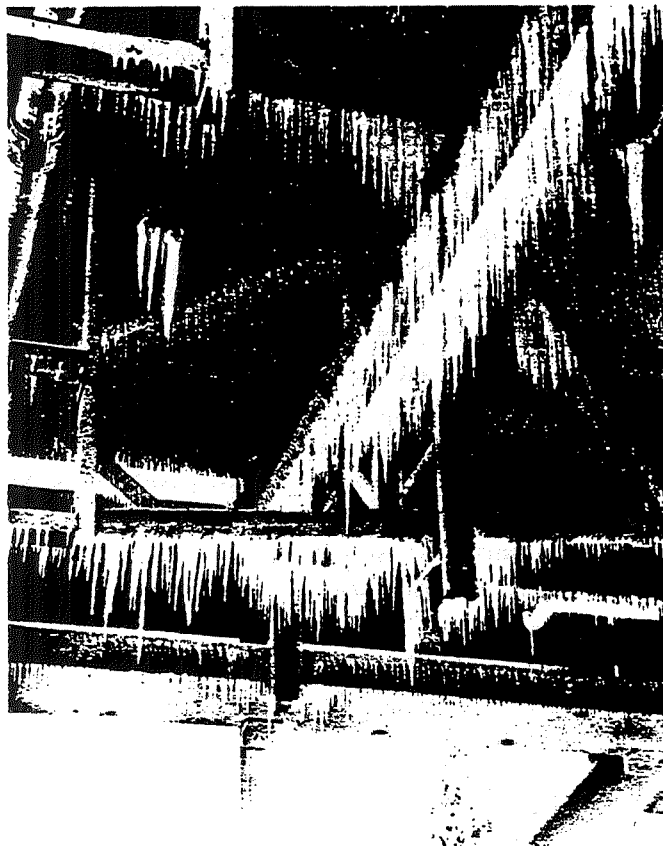
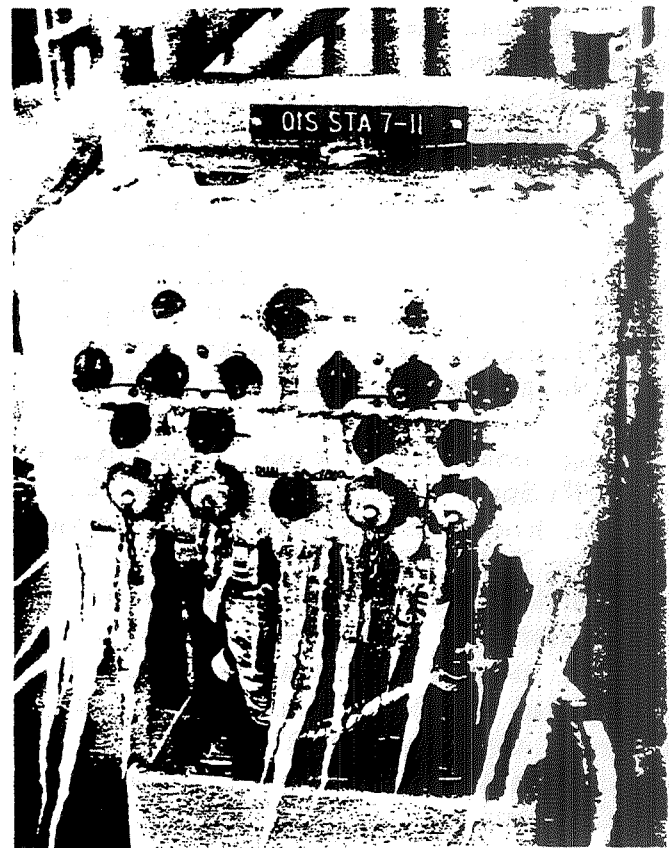
Above, foot long icicles on a lower level of the Fixed Service Structure frame the attachment point where the Orbiter is attached to the external tank (arrow). Icing was even more extensive at upper levels of the service structure (upper right and below). At right below is a ground communications box (not used during launch) rendered inoperable by heavy ice.
