Solar Thermal Power Systems Project
Parabolic Dish Systems Development

Bearing Development Program for a 25-kWe Solar-Powered Organic Rankine-Cycle Engine

September 15, 1985

JPL Publication 85-81

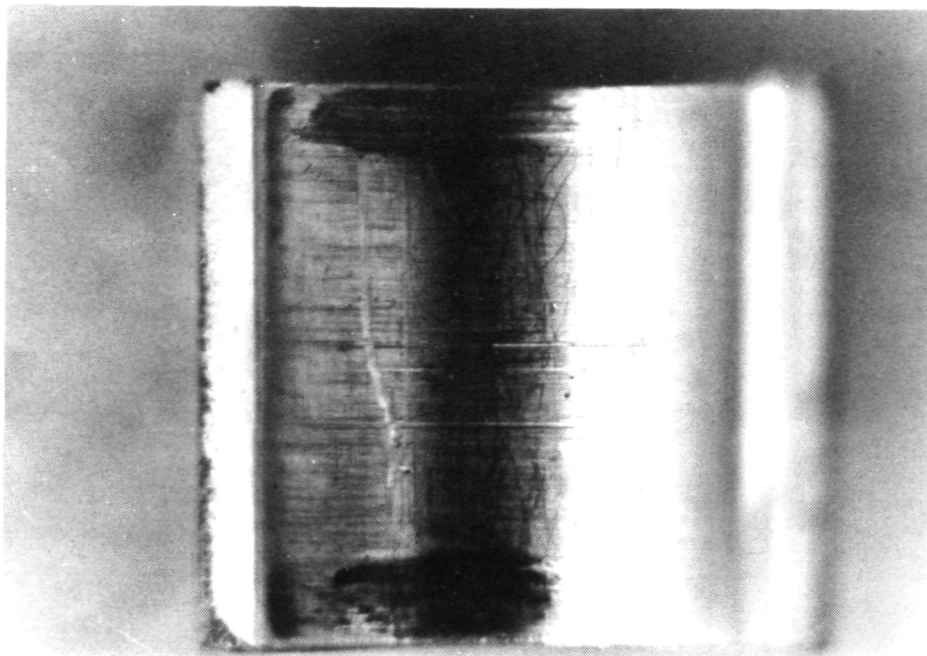
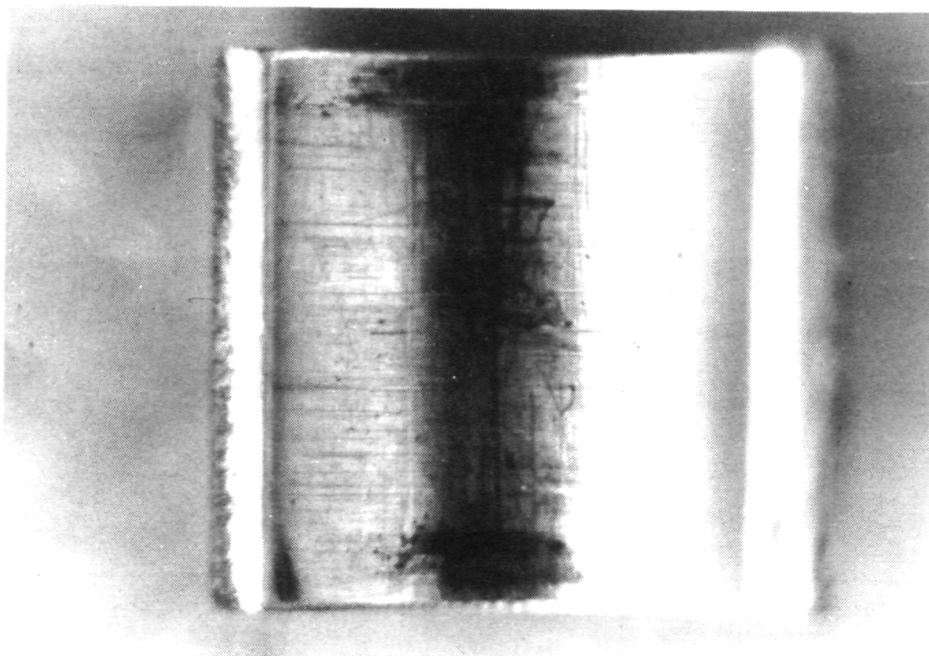
Figure 3-3. Edge Wear on Tilting Pads, Possibly Caused by Excessive Yaw Motion

Tin-antimony babbitt provided a more forgiving metal-to-metal contact surface than bronze for initial start-up and lift-off of the pads. The two most severe wear patterns on the turbine end thrust bearing coincided with the two gimbal pin locations on the bearing. This raised a suspicion that the thrust bearing was deflected under load at all locations except where supported by the gimbal pins. The locations of the thrust bearing gimbal pins were changed so that they would not coincide with the lubrication grooves in each thrust bearing. Because there was no measurable improvement in PCS performance in builds 4 or 5, the slinger ring was removed. Immediately upon reaching design speed for the first run of TAP build 6, the turbine wheel rubbed the turbine housing because of plastic deformation of the wheel at high speed. Apparently at high operating speeds the wheel plastically deformed and redistributed the mass of the wheel, thus continuously changing the rotor balance. The excessive imbalance caused severe bearing loads that resulted in pounded and worn journal bearings. Barber-Nichols followed the Inconel 718 supplier's recommendations by heat treating and brazing the turbine wheel and shroud in two separate consecutive processes; unfortunately, this technique resulted in excessive grain growth and an overall reduction in material strength. The process was corrected by simultaneously heat treating and brazing in a single process to minimize grain growth and increase material strength.

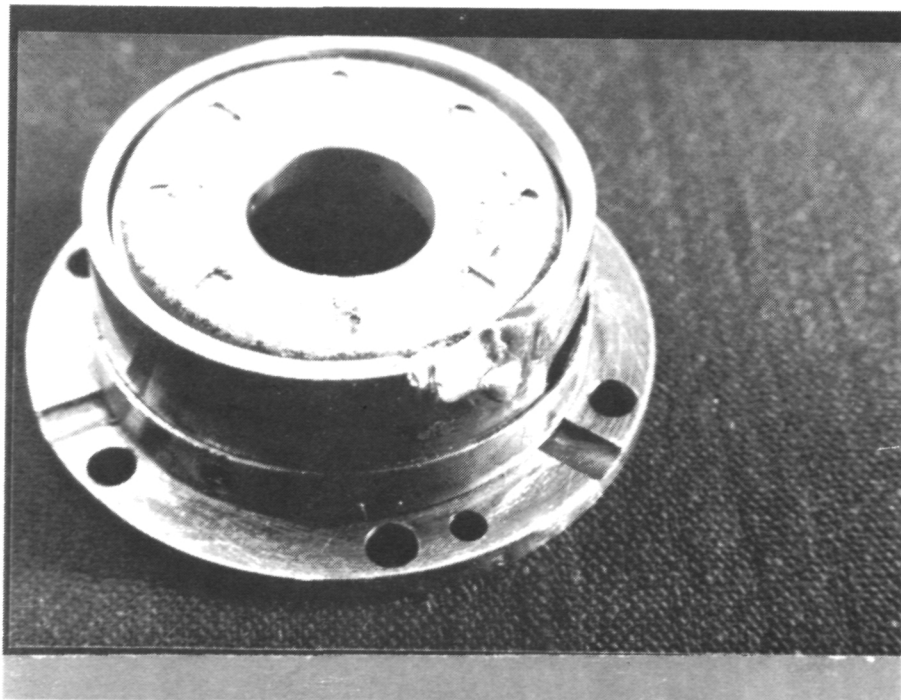
Inspection of TAP build 11 revealed severe electrical arcing between the PMA stator end turns and the outside diameter of the turbine end thrust bearing (Figure 5-6). The arcing was severe enough to melt and remove a section of the turbine end bearing carrier. The outer diameter surface of the thrust bearing was severely worn, and deep pits were observed in the center of

the radial bearing pads. The back of the feed pump impeller had rubbed against the TAP housing. Subsequent analysis of PCS performance indicated a substantially lower power output of the TAP compared to the predicted output at all thermal input levels.

Figure 5-6. Electrical Arcing Damage between (a) the PMA End Turns and (b) the Turbine End Thrust Bearing Carrier

A number of concurrent tasks were initiated to resolve the problems discovered in TAP build 11. A Rayleigh step thrust bearing was designed and installed on the turbine end for all future builds to replace the relatively lower load-carrying flat pad (Fogg) bearing currently used. A second-generation bearing test stand was fabricated to verify the maximum load-carrying capacity of both radial and thrust bearing designs with internal shaft-fed lubrication and with external flooded lubrication. The failed PMA stator was rewound with upgraded insulation wire, potted with insulating material, and finally encapsulated in an additional toluene-resistant black stycast 2850 material (Figure 5-7). The unused spare PMA stator was only encapsulated in stycast material for future use. A TAP test stand was developed that could measure the applied torque on the tap, which in turn could be used to derive the efficiency of each tap component as it is added or removed to determine the cause of the lower-than-predicted performance. The feed pump was to be performance-tested with various back clearances to determine the effect of increased clearance on pump efficiency. It was hoped that the larger feed pump impeller back clearance would reduce the probability of contacting the TAP housing without significantly reducing the pump efficiency.

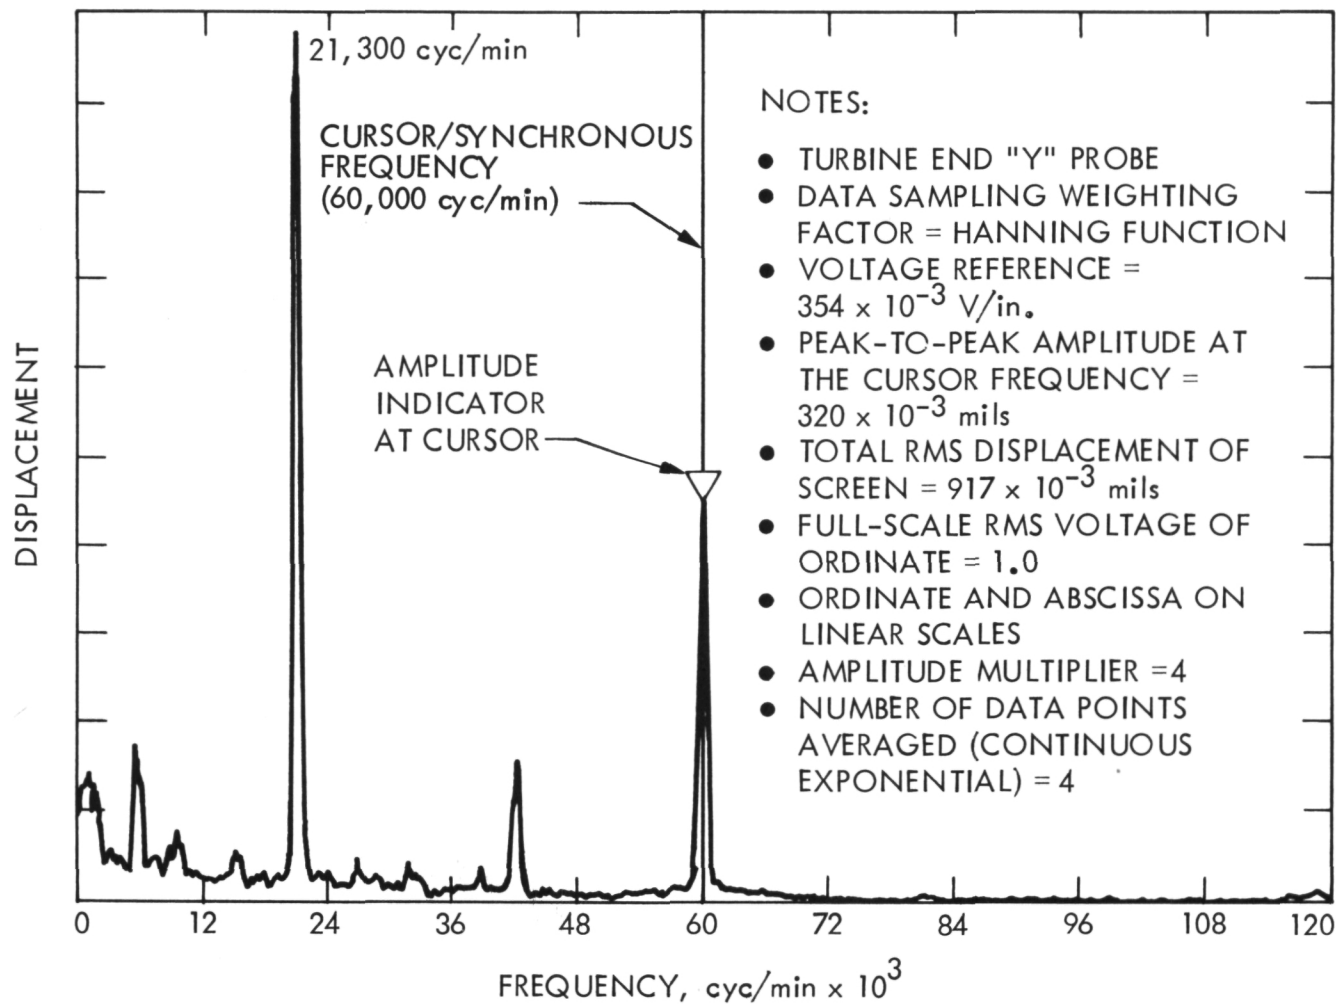
During operation of TAP build 14, the proximity probe data indicated a serious subsynchronous rotordynamic instability. Figure 7-3 gives the spectrum plot from a TAP optical proximity probe showing this effect. Disassembly and inspection revealed wear on the trailing edge of each tilting pad and polishing on the turbine end thrust bearing.

Figure 7-3. Spectrum Plot from Tests of a Barber-Nichols Three-Pad Tilting-Pad Bearing

After extensive analysis of the proximity probe data, three concurrent courses of action were initiated in an attempt to resolve the rotordynamic instability problem. The squeeze-film-damped journal bearings (designed, installed, and tested by B-N) were the first to be tested because they had the shortest lead time (Figure 7-4). It was thought that by providing the proper amount of external damping to a simple journal bearing, the rotor bearing system could be stabilized. This was considered to be only a temporary fix to continue testing because vertical operation eventually would be required, and the journal bearing would probably be unstable in that position. The second parallel approach was a fully flooded five-pad tilting-pad journal bearing (from Waukesha Bearings Corporation) that was lubricated by externally supplied fluid from a dedicated bearing lube pump. This more conventional approach would eliminate all bearing and shaft dynamic uncertainties introduced by the lubrication system. A final backup approach was for Mechanical Technology, Inc. (MTI) to analyze and design a four-pad tilting-pad bearing and deliver drawings to Centritek for fabrication if the first two approaches failed.

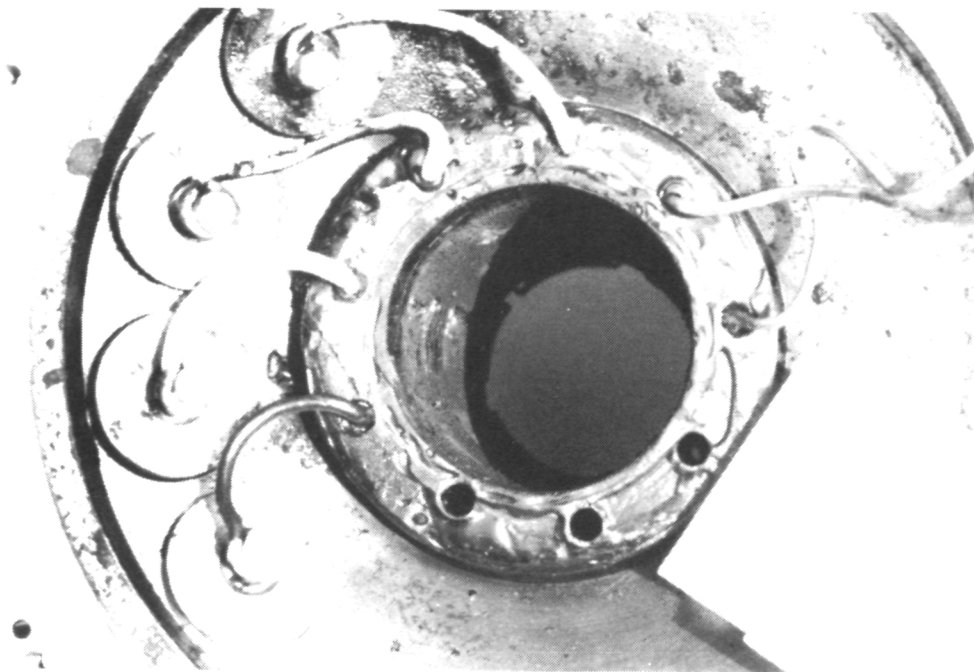
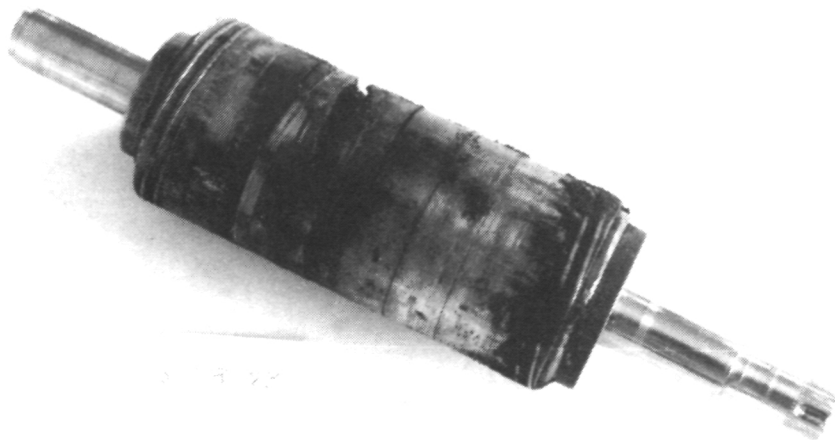
Figure 7-7. Permanent Magnet Alternator Failure Caused by Arcing between Adjacent Stator Coils

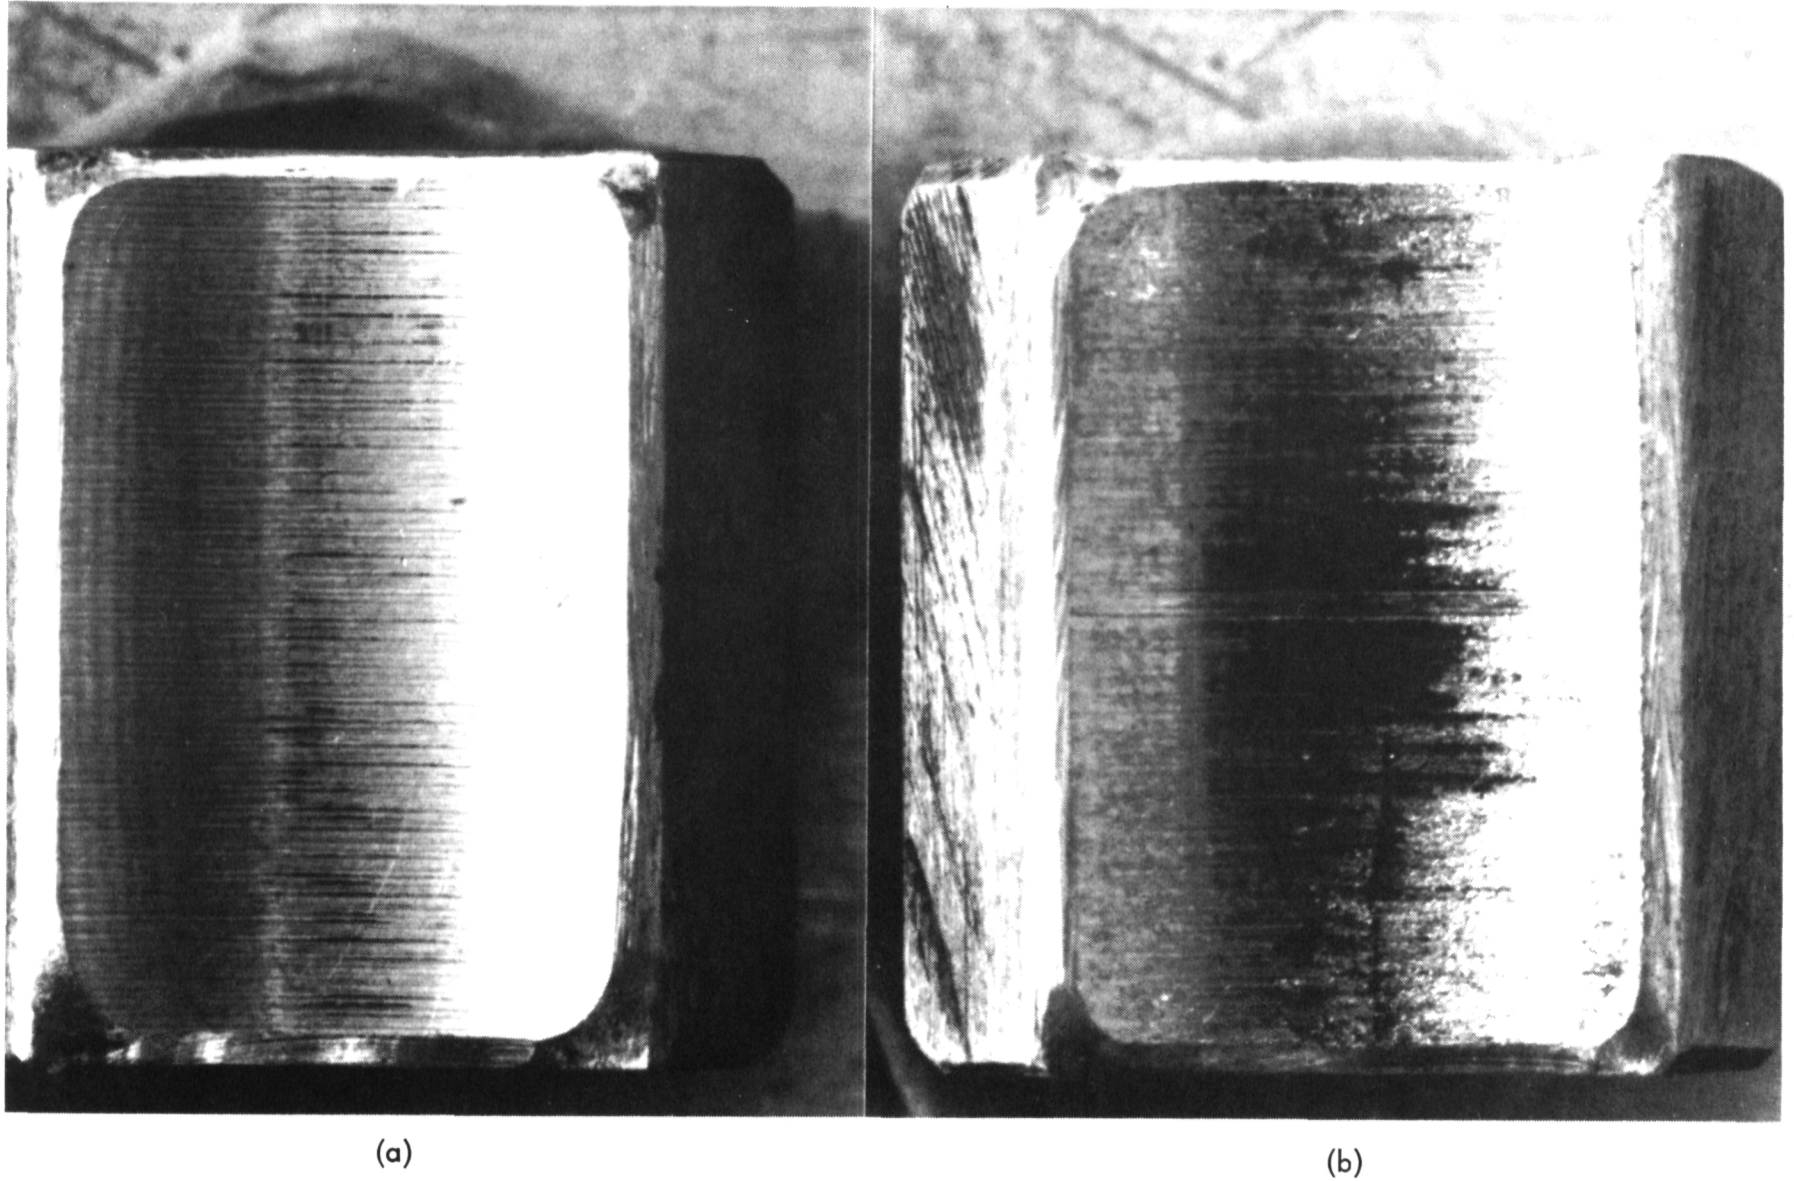
Figure 7-11. Waukesha Journal Bearing Pad (a) Before and (b) After Testing

An extensive analysis of the build 21 damaged bearing surfaces was conducted by FACC using an electron beam microscope. The damaged surface on each pad had a frosted appearance, which was determined to be a number of separate but closely packed pits. Figures 7-12 and 7-13 show various magnifications of the pitted surfaces and compare them to unpitted zones. A chemical analysis inside the pits revealed high concentrations of zinc and chlorine, which were not present in the virgin babbitt or bearing material. This change is shown in Figure 7-14 where the virgin material analysis and an analysis inside a single pit are compared on one plot.

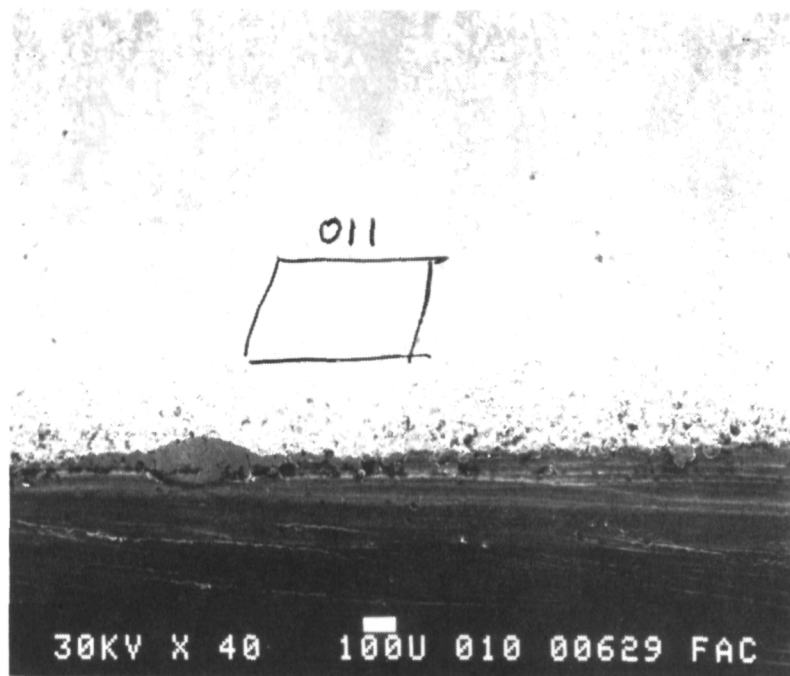
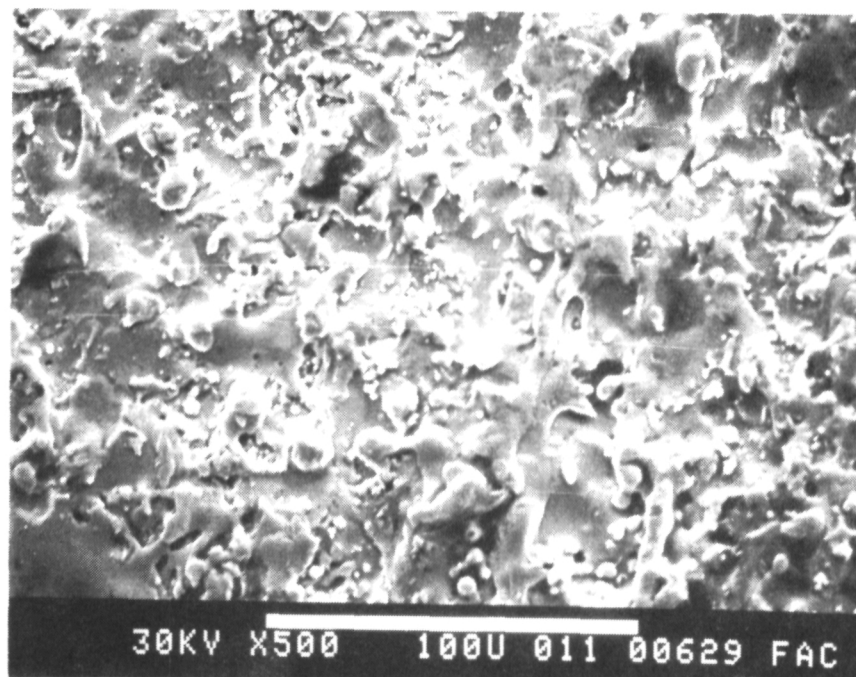
Determining the source and mechanism of transferring zinc to the bearing surface became the primary concern (a grounding strap was placed on the shaft turbine end center line prior to TAP build 2, and it remained intact for all PCS tests). Similarly, all test stand testing required an external drive shaft, which was grounded to the test stand. These two facts were the primary reasons for dismissing electrical discharge as a failure mechanism in earlier TAP builds. It also seemed apparent that the subsynchronous whirl and subsequent bearing wear may have destroyed most of the evidence of the frosted and pitted surface. The evidence was overwhelming, pointing to some form of electrical discharge as the mechanism of zinc transfer and the source of the material seemed to be the brass end seals. These seals maintained the lubricant around the bearings and operated in close proximity to the rotating shaft and the non-rotating bearings. Further analysis indicated that the grounded shaft would prevent electrostatic buildup and discharge but would not necessarily prevent electrodynamic discharges generated by the PMA. It was suspected that the PMA was generating and circulating stray current around a closed loop from the PMA stator to one set of bearings, to the shaft (or ground) to the other set of bearings, then back to the PMA stator.

Figure 7-12. Trailing Edge Surface of a Waukesha Pad with Electrical Discharge Pitting

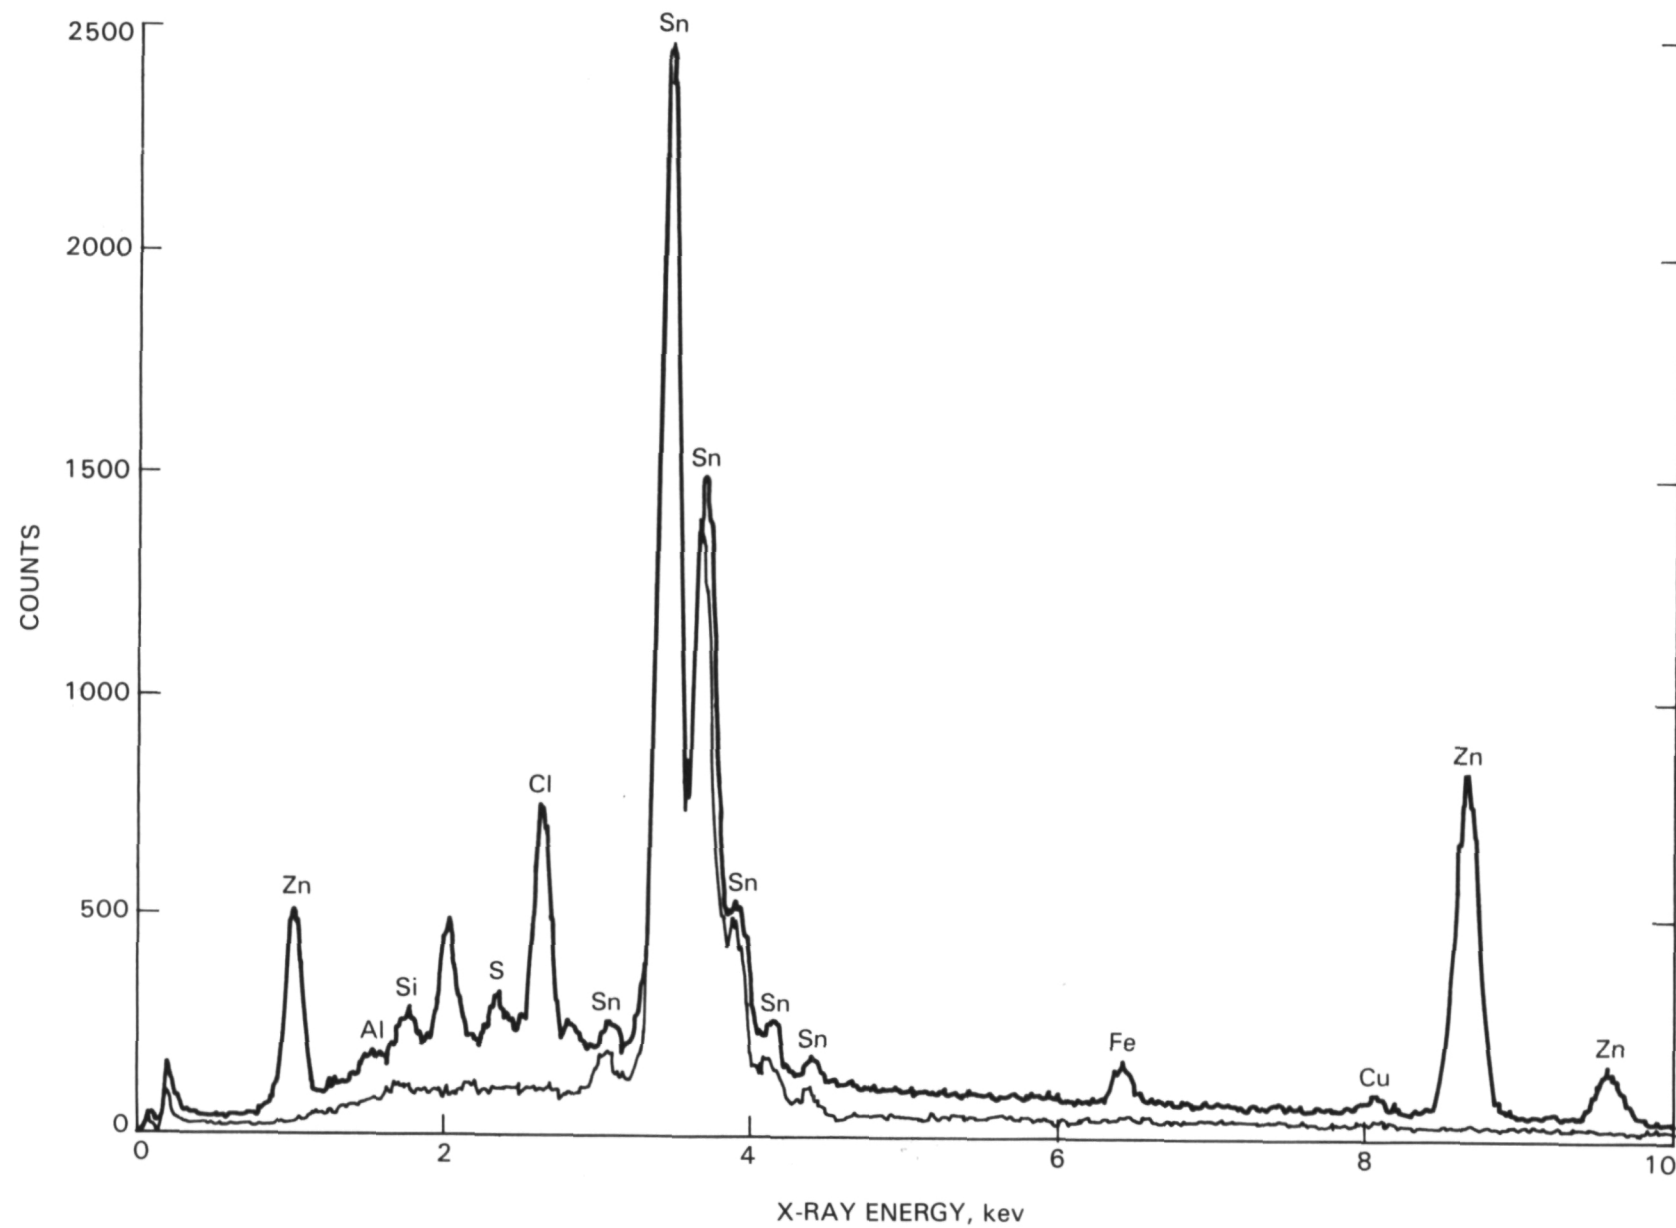
Figure 7-14. Comparison of Pitted (upper line) and Up-pitted (lower line) Surface X-ray Spectrums from a Scanning Electron Microscope in Spot Mode. Note the Higher Zn and Cl Concentration in Pitted Surface

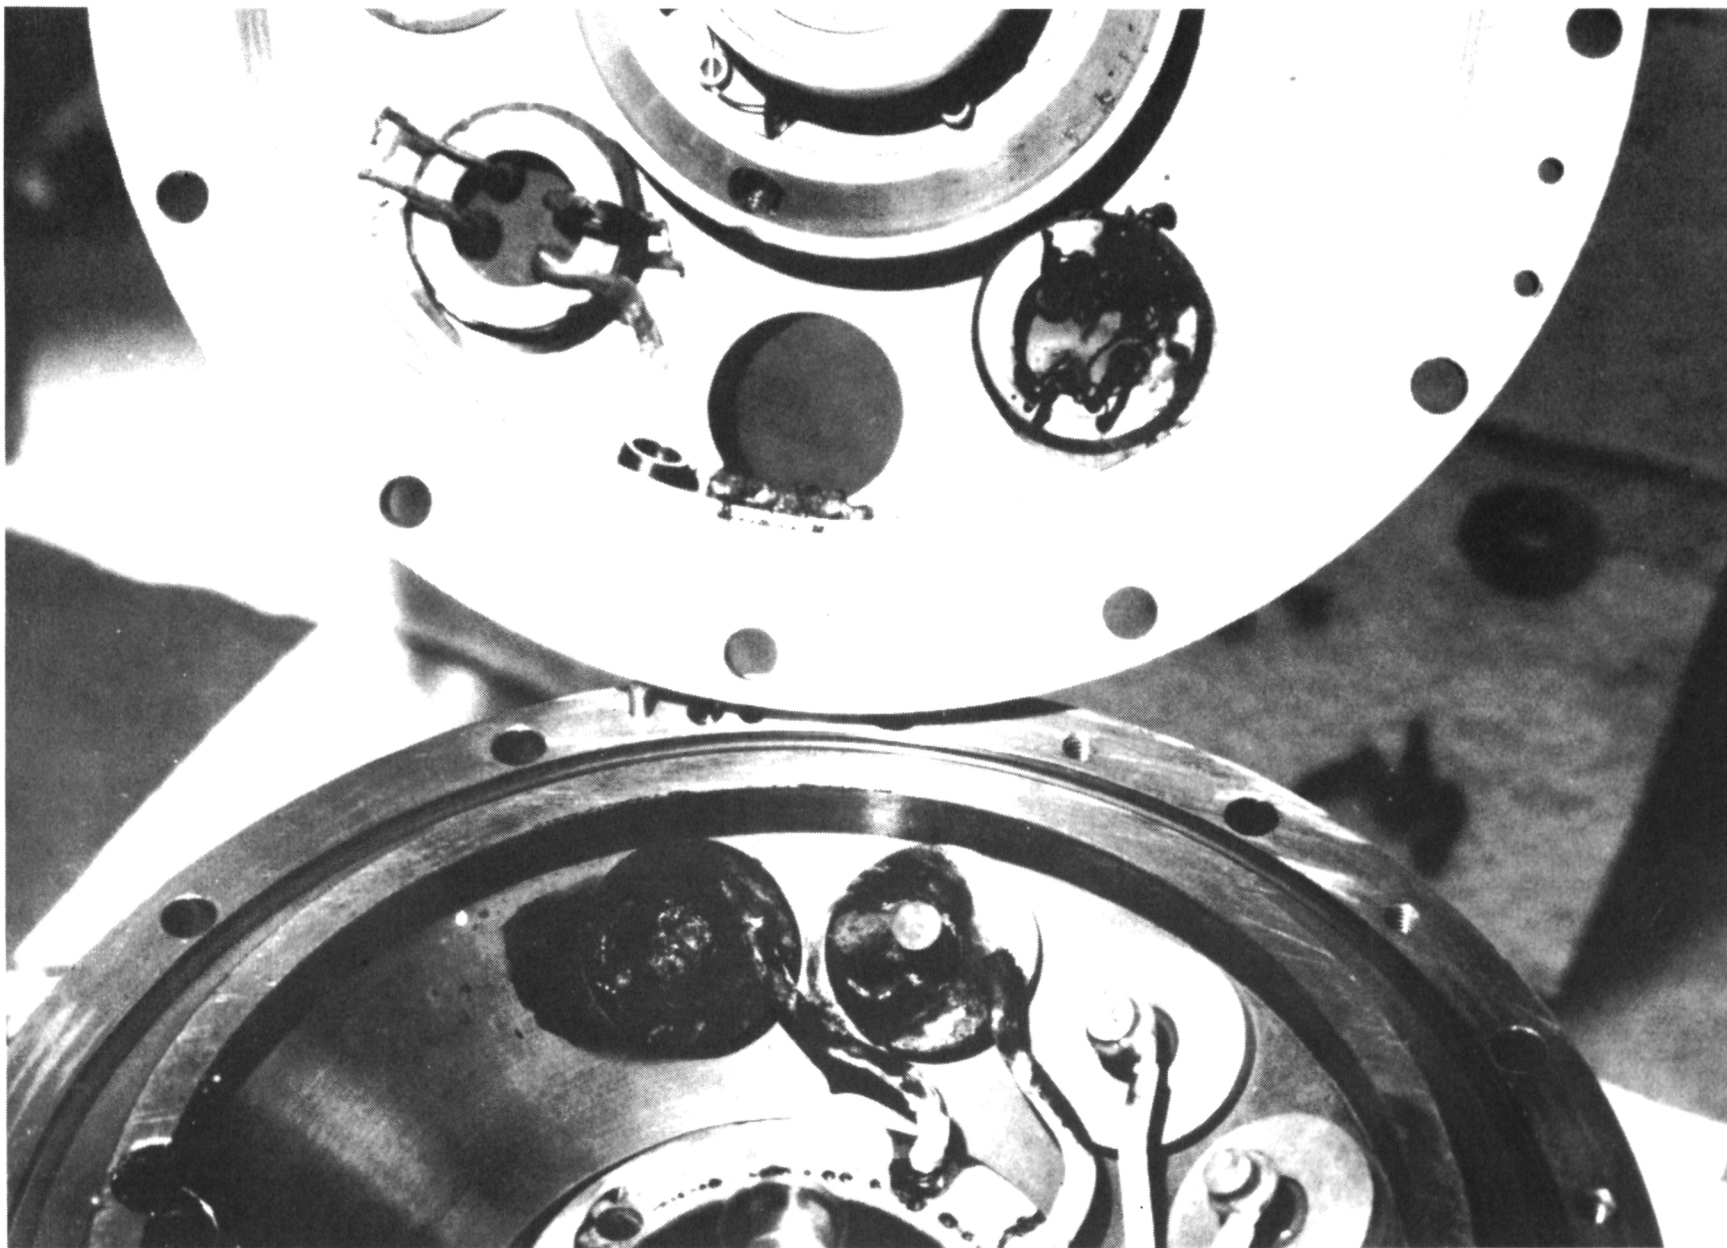
Figure 7-15. TAP Build 23 Electrical Feed-Through Failures of the Neutral and One of Three Phases from the Permanent Magnet Alternator

power phase may have dripped material onto the neutral, causing a simultaneous failure. Unfortunately, the failure damaged the bearings and invalidated the test to determine if and in what manner the magnetic rotor effected bearing wear.

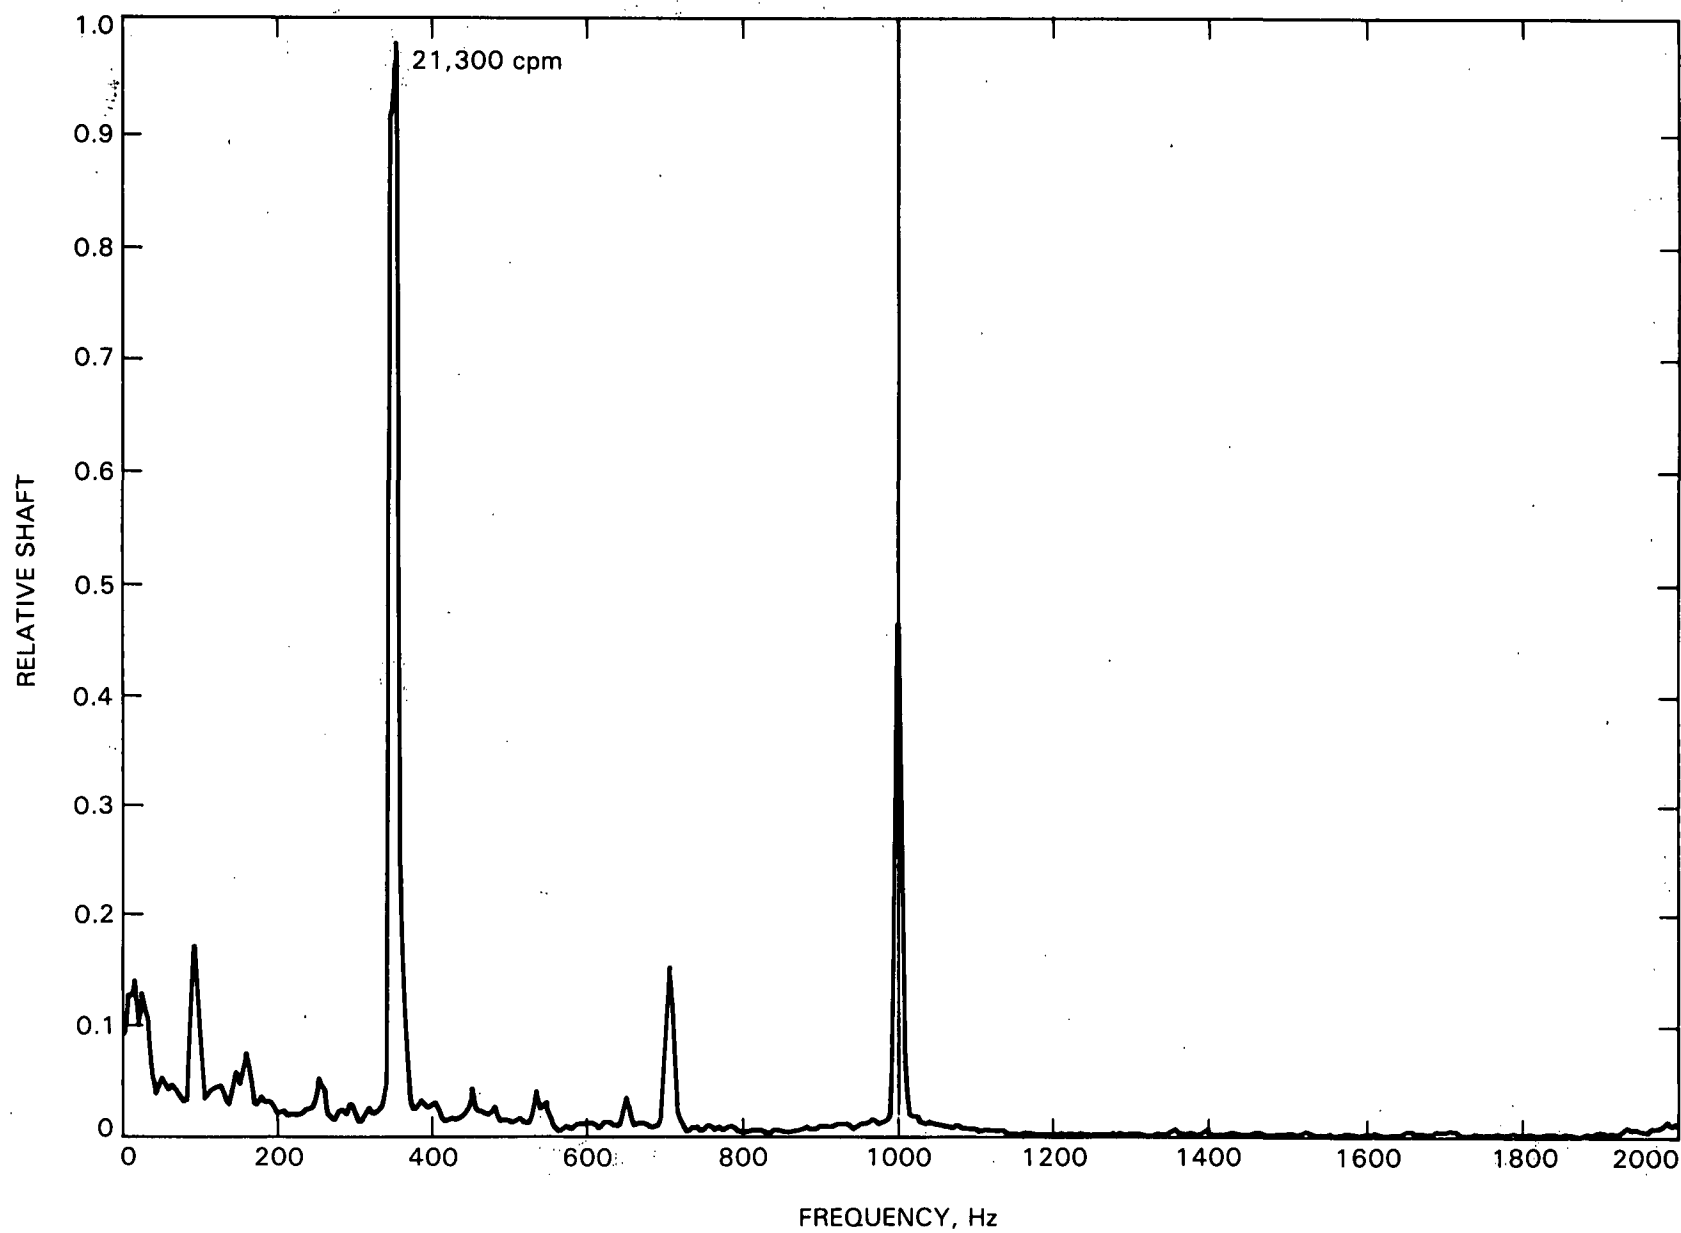
Figure 9-1. Typical Shaft Displacement Spectrum of Barber-Nichols Three-Pad Bearings, December 1982 (Turbine End "Y" Probe, TAP Build 14)
