ROTOR-TO-STATOR RUB VIBRATION IN CENTRIFUGAL COMPRESSOR

Gao Jin Ji and Qi Qi Min
Liaoyang Petrochemical Fiber Company
Liaoning, The People's Republic of China

This paper discusses one example of excessive vibration encountered during loading of a centrifugal compressor train (H type compressor with HP casing).

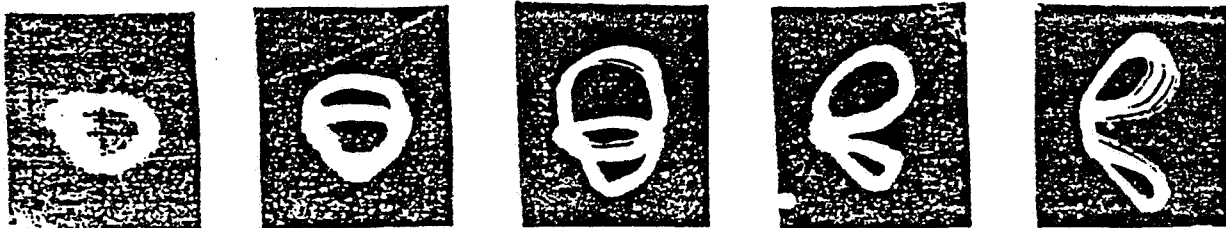
At the moment of passing through the critical speed on the threshold load, $1\times$ rpm high vibration occurred and soon dropped, but in the malfunction condition, excessive vibration did not drop even if passed through the threshold load. As shown in the Fig. 7 (A), the rotor motion orbit plot was elliptical with one fixed bright spot. During dismantling the machine, some wearing plots were discovered in the exact same direction on the #3 bearing. And at the moment when the excessive $1\times$ rpm vibration was dropping, the change of 720° in phase angle had been recorded by chance (see Fig. 8). It shows the excessive vibration was reverse precession due to full rub, because high friction forces may cause a dramatic change of the precession direction from forward to continuous backward whirl (Ref. 3). This is self-excited vibration. If harmful energy accumulates long enough, the orbit plots will diffuse (see Fig. 7 (A)). At this moment the machine must be shut down immediately.

Rotor rub against the bearing generates very complex rotor vibration. Rubs are created in machines by introducing a contact between the rotor and the bearing. The contact may be initiated by displacement of rotor center to stator center, which is caused by misalignment, foundation deformation, unparallel between gear shafts and eccentricity of the bearings. Displacement is prerequisite to introduction of rubs. That is why the machine may be put into operation by chance after remounting the bearings and exact alignment even in the oversize bearing condition. But in most cases, full rubs or partial rubs in the oversize bearing frequently occur due to rotor center displacement.

(a) Full-rub, reverse-precession vibration.

(1) The top clearances of both #3, #4 bearings were reduced from 0.48 mm to 0.31 mm on November 2, 1984.

(2) To increase oil viscosity the PRESLIA 20 type lub oil was replaced by PRESLIA 30 and oil temperature was reduced from 42°C to 28-30°C on November 3, 1984.

(3) The gear coupling was replaced by a new one and exact alignment was taken in December 1984.
