CRACKED SHAFT DETECTION ON LARGE VERTICAL NUCLEAR REACTOR COOLANT PUMP

L. Stanley Jenkins
Westinghouse Electric Corporation
Cheswick, Pennsylvania 15024

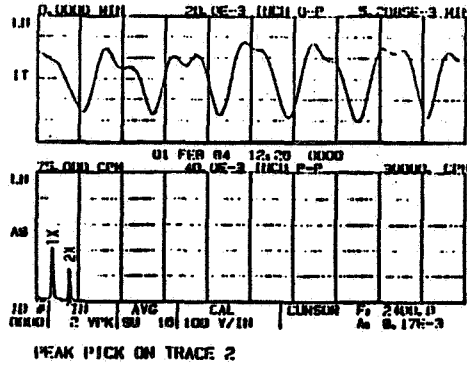
Figure 3. - Sample of waveform and spectral data taken on B RCP: February 1, 1984 (original data).

1. Comparison of vibration levels between pumps indicated nothing unusual. However, B RCP contained a large amount of 2X vibration component not present to any significant degree in the other RCP's. Table 2 shows the vibration level and frequency content comparison.
2. A reduction in 1X (running speed = 20 Hz) motion due to the addition of weight to a pump coupling bolt had no impact on the 2X component. Table 3 shows the results of this test. Response to the weight was normal (approximately 3.5 grams/micron, 40° lag).
3. During no-load motor operation, all 2X components disappeared from frame and shaft (motor) data (a probe had been mounted to read motor shaft motion specifically for this one test).

Figures 2 through 6 are samples of the waveform and spectral data taken during the above tests on B RCP.

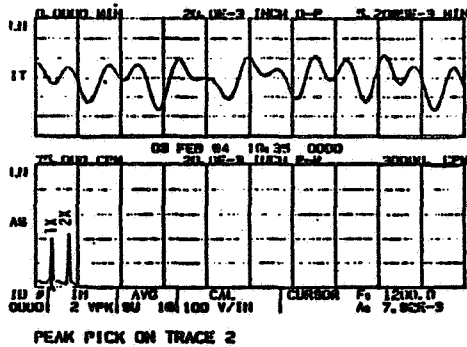
Figure 4. - Sample of waveform and spectral data taken on B RCP: February 3, 1984 (after balance).

The rationale for showing that the observed motion is predictable is more difficult. First of all, it is logical to place the crack below the pump bearing. (The presence of a fixed radial load in the casing, and the observation that balance weight response was normal suggest a crack below the pump bearing.) Then, by utilizing a simplified model of the pump shaft and taking the motor shaft between bearings as a "built-in beam," it is possible to relate a dynamic motion observed at the pump coupling to a stationary -- fixed in the casing -- hydraulic load at the impeller. The end result of this analytical exercise (using the principal of superposition of loadings and deflections to establish the proper phasing of the motions at the impeller and coupling) is shown in Figures 9 and 10. This effect was successful in not only predicting the observed 2X motion qualitatively but also, when the 1X motion is added in (generated by the "hinging" action of the impeller mass below the crack) the observed composite waveform was predicted. Compare Figure 10 with Figure 4 where 1X and 2X amplitudes are nearly equal.

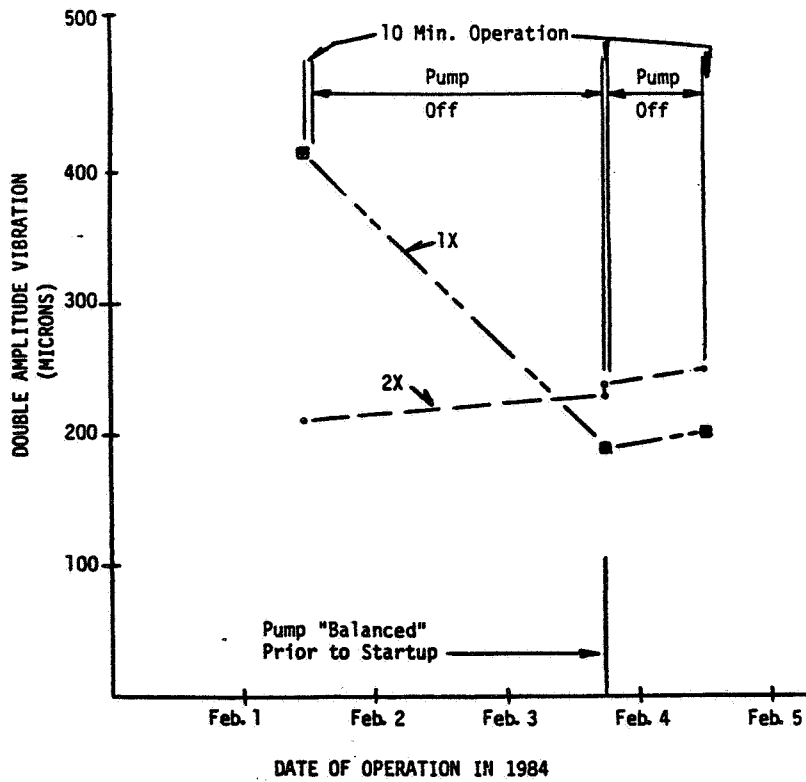
Figure 7. - Trend plot for 1X and 2X vibration levels for B RCP shaft.

1. The 2X vibration level would "ratchet" up on each start of the coupled pump assembly (see Figure 7).
2. The pump and motor were found to be 812 microns (32 mils) out of alignment, laterally (centerline to centerline shift). The effect of this is depicted in Figure 8.

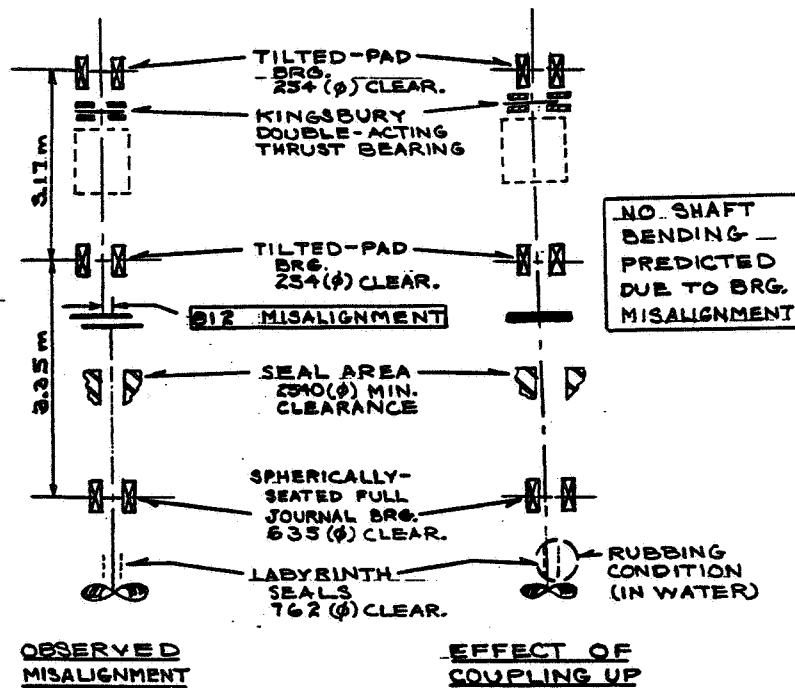
Figure 8. - Effect of 0.032-inch-bearing centerline offsets on shaft bending.

The rationale for elimination of misalignment induced 2X is based on bearing clearances in the pump and motor plus the beneficial effect of long distances between bearings. Again, referring to Figure 8 it is easy to see that a minimum of 457 microns (18 mils) centerline shift, without any tilting of the rotor on the Kingsbury thrust bearing, is possible without incurring any bending of the rotor. Furthermore, the long distance between bearings will permit additional tilting of the motor rotor (the Kingsbury thrust bearing can accommodate this easily as will the spherically seated pump bearing) to accommodate the measured 812 micron shaft lateral misalignment with introduction of some edge loading of the motor radial tilted pad bearings. Hence, it is highly unlikely that 2X would be generated by bearing misalignment. Note that labyrinth rubbing (which was predicted on the basis of a separate evaluation of the direction of misalignment coupled with anticipated radial motion of the impeller under a fixed load in the casing) does not produce shaft bending since rubs in water wear out in a relatively short time.

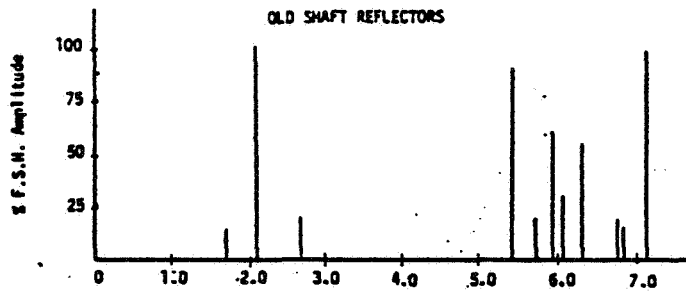
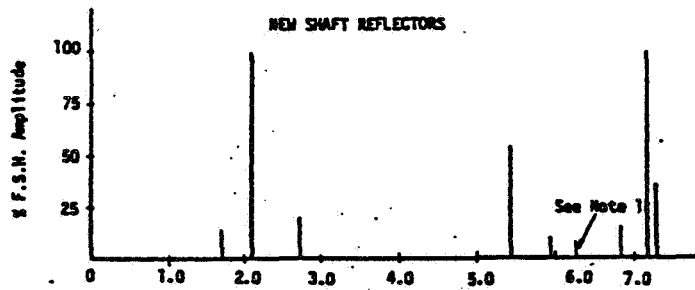
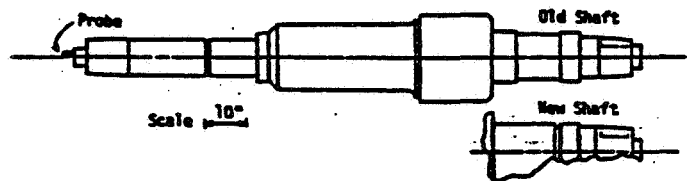
Figure 11. - Comparison of old shaft and new shaft UT reflectors.

For obvious reasons, there was an extreme reluctance to accept that the difficult to access pump shaft was cracked. Hence, another independent method of crack verification was desired. An Ultrasonic Test (UT) of the 3.3 m long pump shaft was attempted from the accessible coupling end. Data obtained was compared to another survey on a new pump shaft on site. The best available comparison of data (actually obtained after removal of the pump shaft) is in Figure 11. During the investigative effort and afterwards as well, it was found to be nearly impossible to predict by UT, from the coupling end of the shaft, if a crack existed in the overhang and where in the overhang it was located.

It was noted, however, that once the impeller end of the shaft was exposed that a UT of this end of the shaft produced very strong evidence of a sizeable discontinuity. The axial location predicted and its orientation relative to the coupling keyway was very close to the predictions made on the basis of vibration analysis described in this paper. From the UT check of the impeller end, approximately 60% of the cross-section was estimated to be cracked through.

Note 1: Probably reflection from anti-rotation pins
