VERTICAL REACTOR COOLANT PUMP INSTABILITIES

Robert M. Jones
Tennessee Valley Authority
Soddy-Daisy, Tennessee 37379

This paper describes the investigation conducted at the Tennessee Valley Authority's Sequoyah Nuclear Power Plant to determine and correct increasing vibrations in the vertical reactor coolant pumps. Diagnostic procedures to determine the vibration causes and evaluate the corrective measures taken are described.

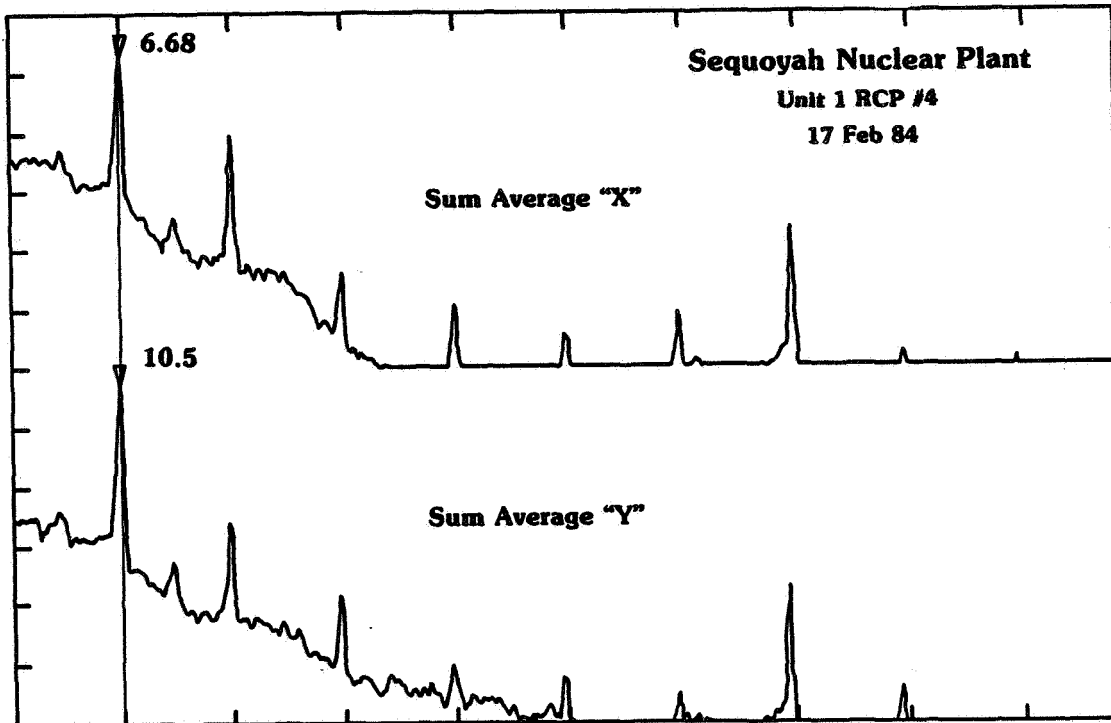
Figure 1

Our investigation began in the fall of 1983 when trend data began to show a gradual increase in vibrations from the desired level of 3-4 mils P-P displacement. At that time, vibration levels were indicating between 6 and 10 mils for no apparent reason. (Fig 1) Fig 2 illustrates a typical RCP with bearing locations and Fig 3 shows the Bently-Nevada proximity probe location on the pump shaft.

Frequency Analysis of Pump Vibrations

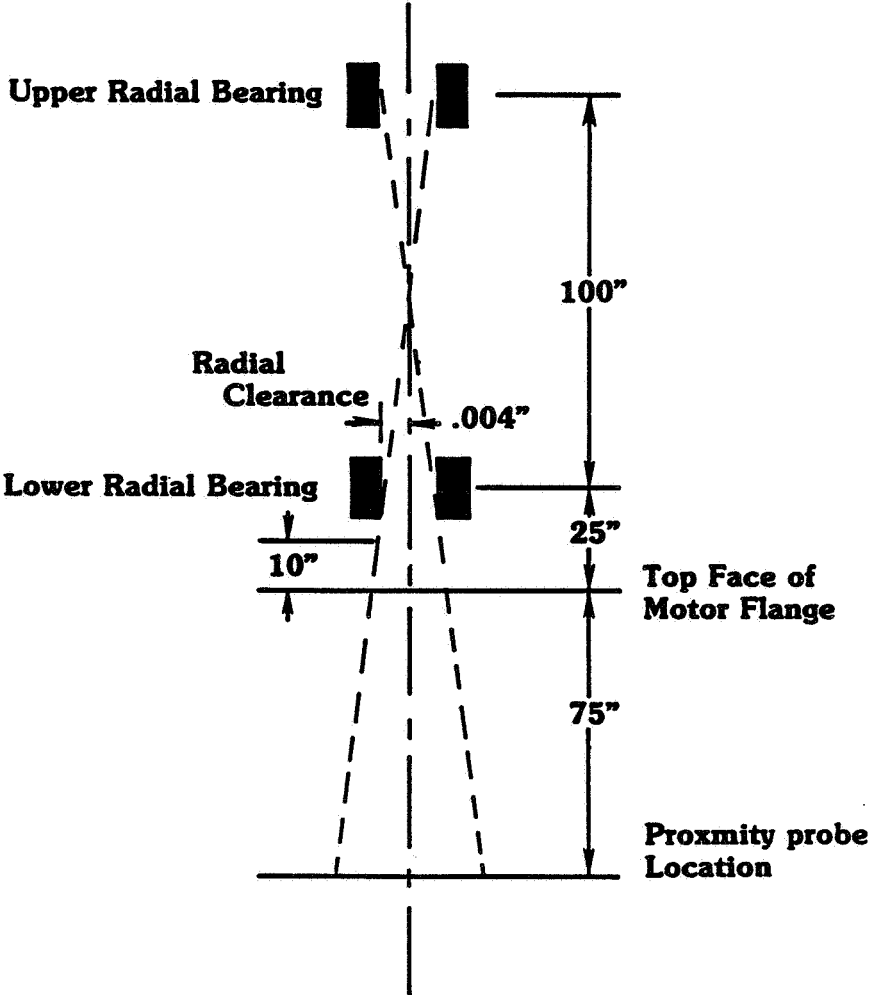
Figure 3

The geometric configuration of the pump results in shaft movement at the probe being 2X the movement at the bearing (Fig 3). Therefore the bearing clearance is .0085" and the excessive clearance at the bearing is .0025". (Assuming the shaft was rotating in the center of the bearing.) The accuracy of this analysis was confirmed later when a teardown revealed a bearing clearance of .008".

Sequoyah RCP's Physical Arrangement of Bearings and Displacement Probes

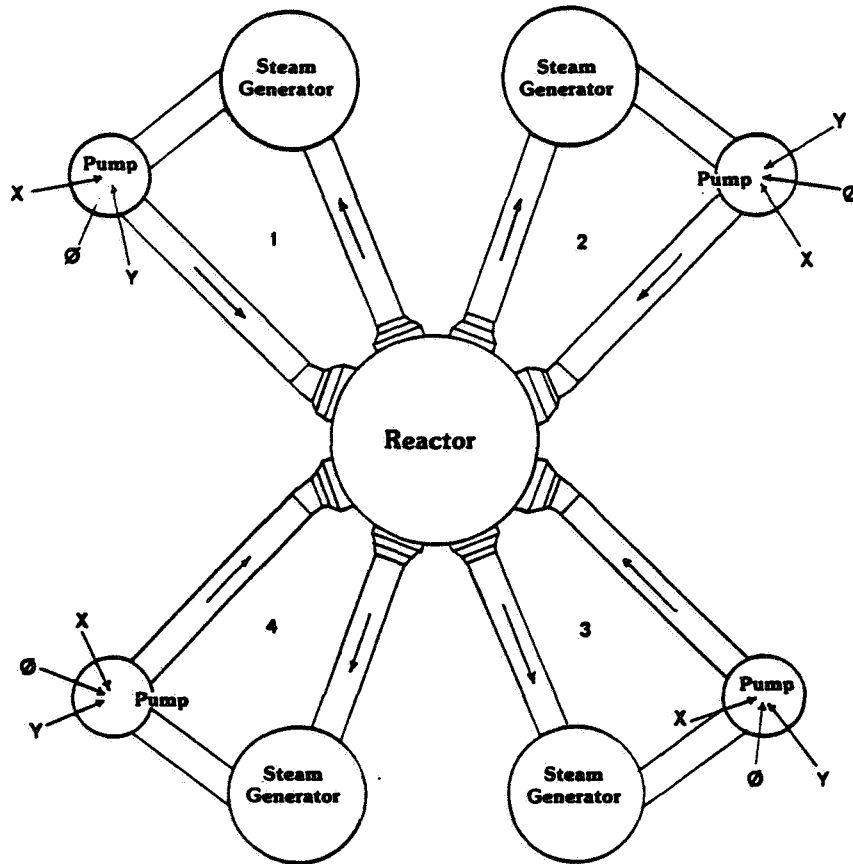
Figure 4

The installation location of the proximity probes and the geometry of the pump support structure (Fig 4) allowed us to make some judgements on bearing clearance without disassembly of the unit. The following procedure was used:

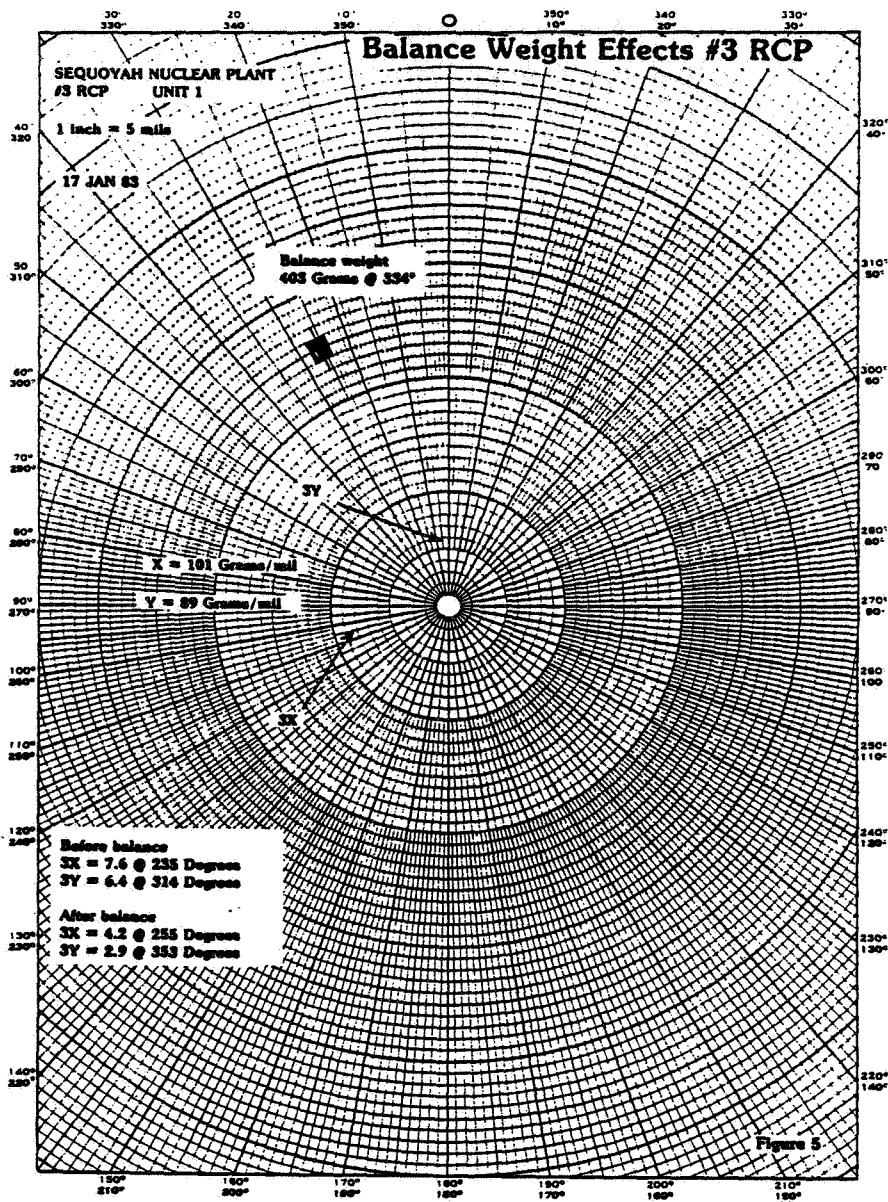
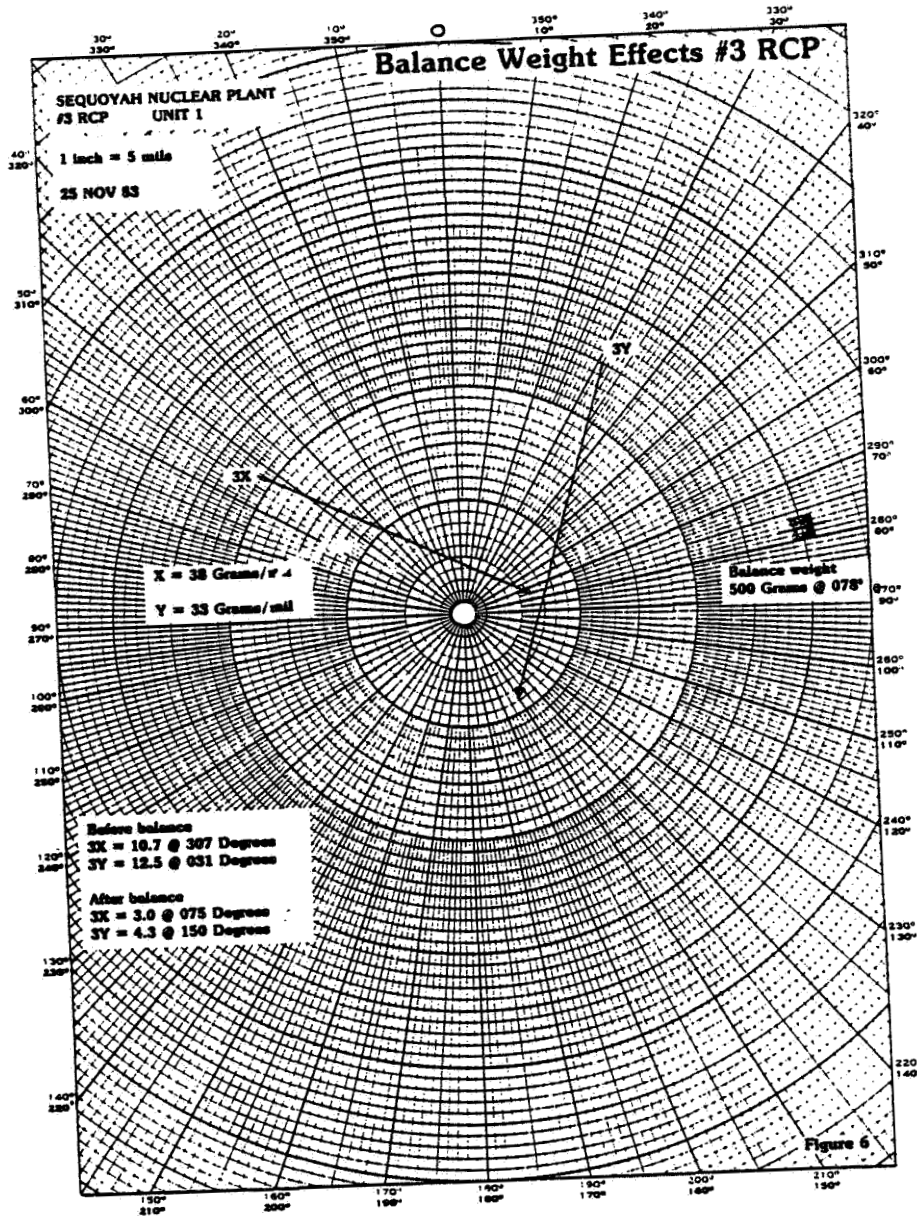
Balance--The second area of investigation was to determine the cause of the increased sensitivity to balance weights. During initial start-up, the observed sensitivity was in the range of 90-100 gm/mil. At the time of the investigation this sensitivity had changed to a range of 30-40 gm/mil (Fig 5,6). The first thought that this data suggests is an increased sensitivity due to reduced bearing support, i.e., excessive clearance in the motor bearings. In the arrangement of the bearings, the lower motor bearing "carries the load" and is the most susceptible to problems. One area that needs additional study under controlled conditions is the relationship between this increased sensitivity and

the critical speed of the pump. During normal operations the pump exhibits 3 critical speeds, 300, 800, and 1500 rpm. It appears that as the bearings provide less support, the third critical is moving down from 1500 rpm toward the operational speed of 1200 rpm.

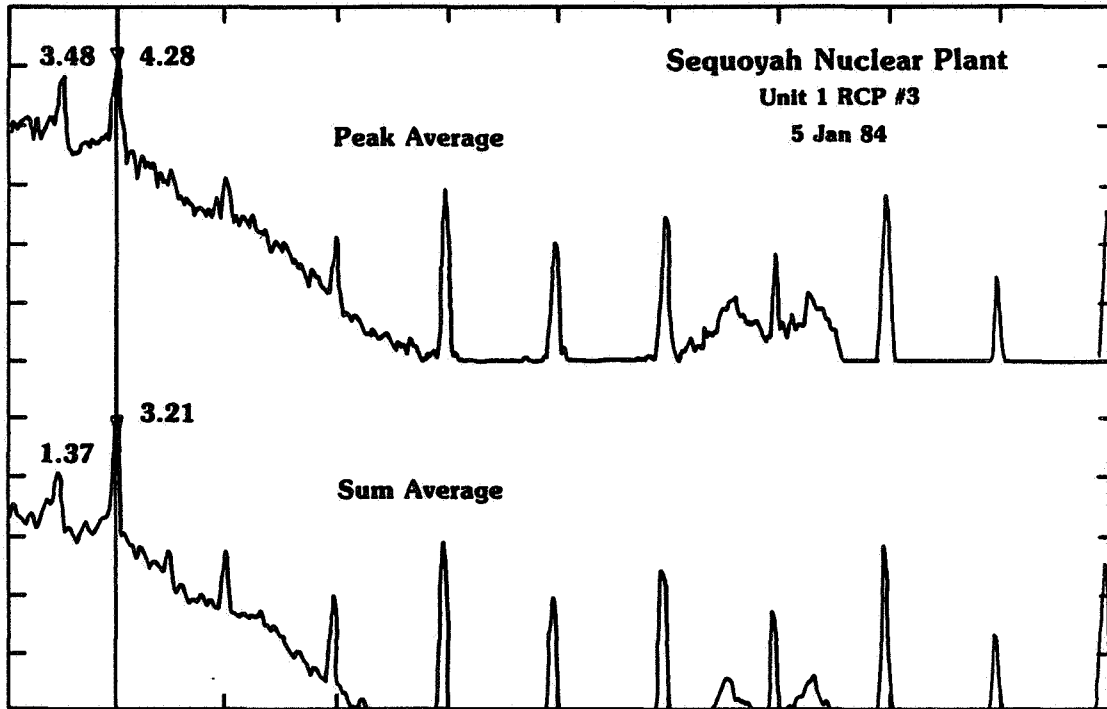
Figure 7

Spectral Analysis--The third area we examined was the spectrum analysis in the 0-200 Hz range. Two points of interest were observed. Although the lower motor bearing is a 7-shoe segmented bearing designed to reduce oil whip, a 1/2 harmonic of over 3 mils was observed on some pumps (Fig 7). In conversations with other utilities, an incident was discussed where the entire shoe support harness had become detached allowing excessive bearing clearance and a resulting 15 mil vibration at 1/2X. The other point noted was the variation in the 2X component, the usual interpretation being possible misalignment. During the maintenance teardown of this pump, the pump/motor misalignment was found to be .014".

Frequency Analysis During Operation

- 1) The motor shaft must be centered in the bearing. Swing check methods were refined to insure this point.
- 2) Seal clearances must be equal at all points on the shaft.
- 3) Only after the shaft is centered in the seal and centered in the bearing will the bearing shoes be gauged. Clearances are set at .005" and if there is any give, it is toward .004".
