AERODYNAMIC INSTABILITY: A CASE HISTORY

Robert C. Eisenmann
Machinery Diagnostics, Inc.
Minden, Nevada 89423

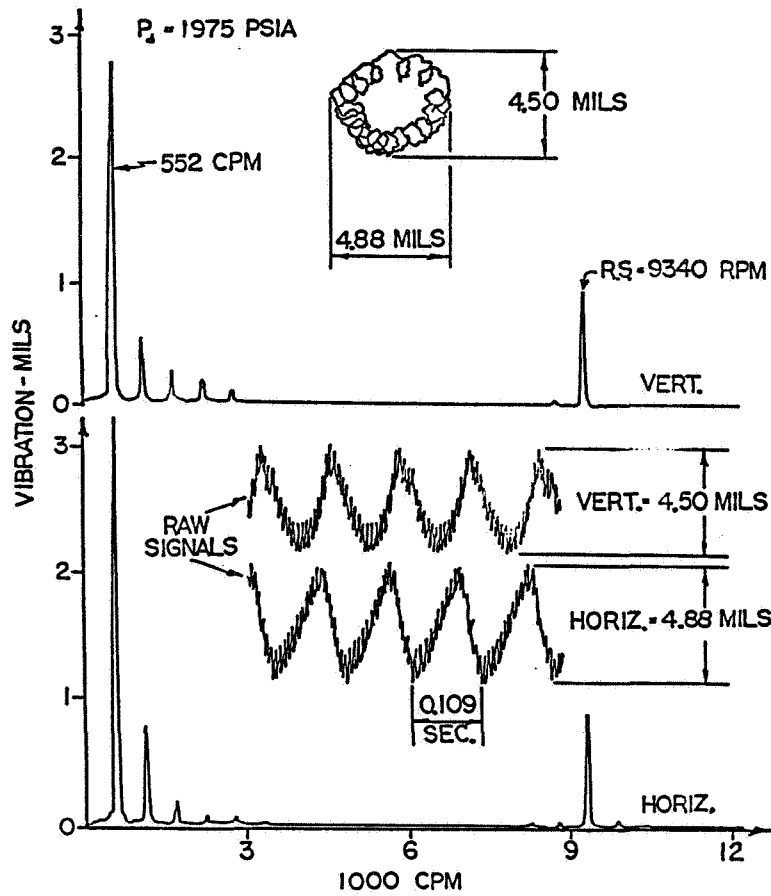
00108-0211
Typical shaft response for this unit is shown in figure 2. Vibration amplitudes at running speed were approximately 1 mil, and most of the motion occurred at a frequency of 552 cpm. This motion was strongest on the coupling end bearing and somewhat lower on the outboard bearing. The shaft orbit was nearly circular with predominant motion at 552 cpm and a series of inside loops at running frequency. Under this set of operating conditions the rotor made almost 17 revolutions for every 1 cycle of the low-frequency excitation. This low-frequency vibration was audible on the compressor deck and the associated piping. In fact, the machine sounded more like a reciprocating engine than a centrifugal compressor. One of the workers claimed that it sounded like there was an "armadillo" in the piping.

Figure 2. - Initial coupling-end shaft vibration.

During initial field startup with process gas the high-stage compressor wrecked. The general consensus of opinion was that the system was underdamped. To provide additional rotor damping, the original equipment manufacturer designed and retrofitted a set of squeeze-film damper bearings. This change proved successful, and the unit was easily brought up to normal operating speeds.

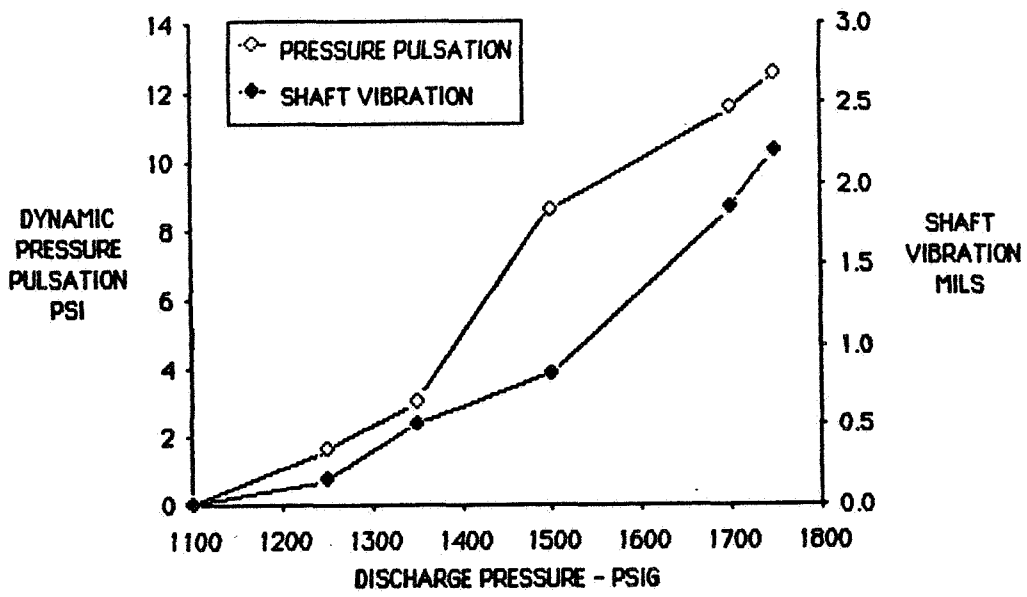
A second phase of field testing was then implemented. During these tests the shaft vibration was measured concurrently with the dynamic pressure pulsation at the fourth-stage discharge flange. The significant results of this test are summarized in figure 3. From these data it is apparent that a strong relationship must exist between low-frequency shaft vibration, dynamic pressure pulsation, and discharge conditions.

Figure 3. - Pressure pulsation and vibration versus discharge pressure.

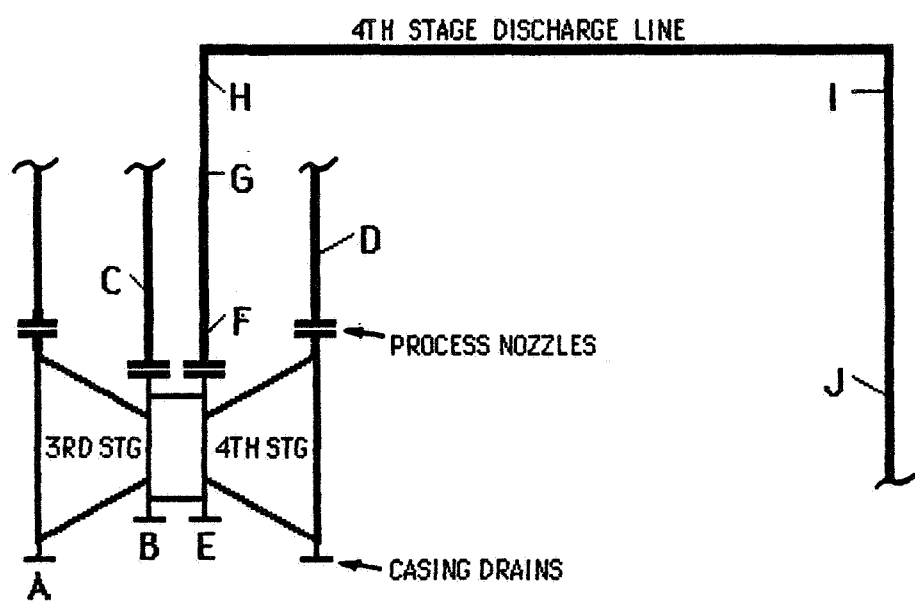
After following several other blind alleys, we established a test plan to make a series of dynamic pressure pulsation measurements throughout the high-stage piping system. Figure 4 shows the approximate location of available test points A to J, corresponding to the casing drain at the third-stage suction all the way through the fourth-stage discharge piping. During this test the compressor exhibited a low-frequency vibration at 558 cpm (fig. 5). The measurements revealed that under this condition the third stage (points A, B, and C) did not exhibit the low-frequency activity, and neither did the suction of the fourth stage (point D). However, the fourth-stage casing drain (point E) and the fourth-stage discharge piping (points F to J) did reveal a definite pressure pulsation at 558 cpm.

Figure 4. - Location of pressure pulsation transducers.

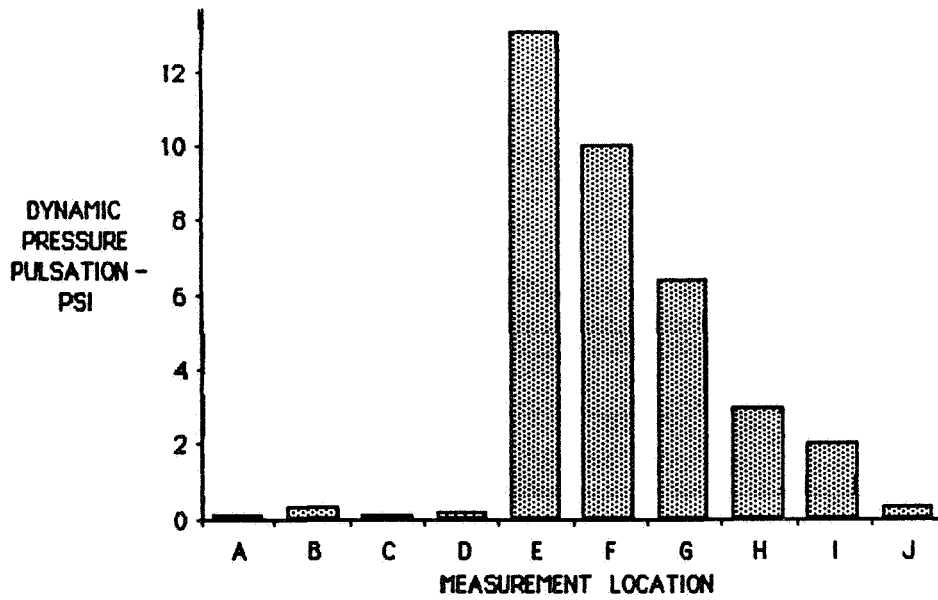
Figure 5. - Dynamic pressure pulsation at 558 cpm.

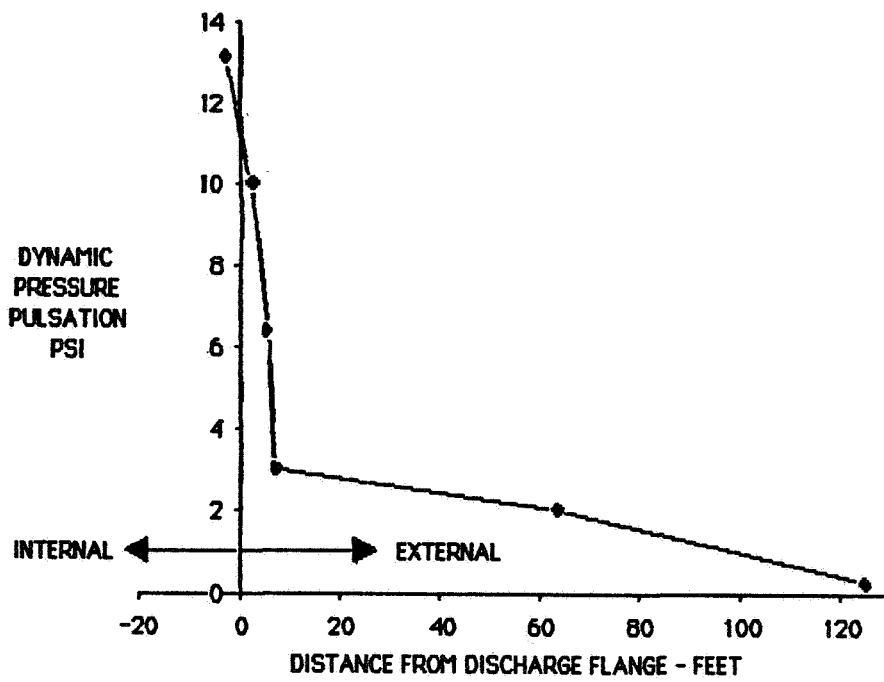
These same data were observed in another manner (fig. 6) by plotting dynamic pressure pulsation amplitudes versus distance from the fourth-stage discharge flange. This showed that the magnitude of the pressure pulsation decayed rapidly as a function of discharge pipe length. Since the low-frequency excitation did not appear on the suction nozzle to this stage, it was concluded that the exciting force was internal to the compressor and probably located between the fourth-stage suction and discharge flange.

Figure 6. - Pressure pulsation with respect to discharge pipe length.

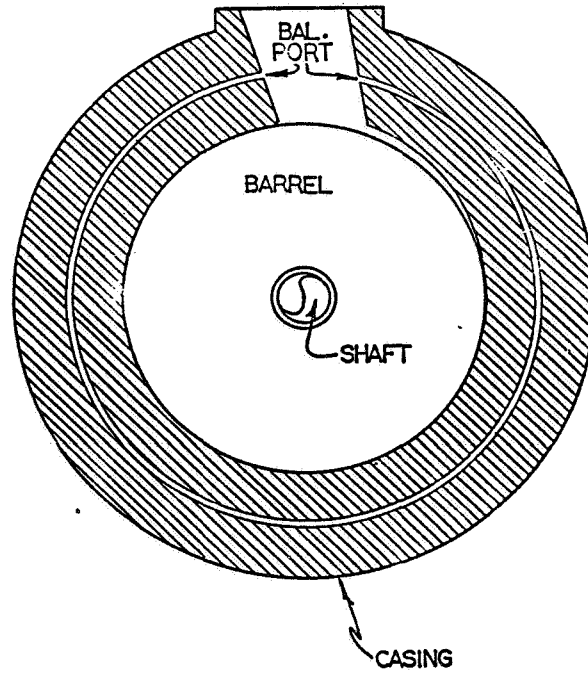
After many hours of discussion with the original equipment manufacturer it was generally agreed that the rotating assembly could not generate the type of frequency measured. Since everything on the rotor system appeared to be normal, the next step was to begin examining the entire machine drawing set for anything that was different from traditional design. During this review someone mentioned the balance port at both the third and fourth-stage discharge nozzles. This balance port consisted of a rectangular passage that connected one side of the discharge nozzle with the other side of the nozzle (fig. 7). The passage was an integral part of the casing and was intended as a means to pressure balance each discharge nozzle.

Sometime after the conclusion of this project one opinion was that the balance port passage acted as an acoustic resonator (open at both ends). On the basis of the passage length and the estimated sonic velocity, the fundamental acoustic resonant frequency was approximately related to the measured low-frequency excitation. Another opinion was that the measured frequency was related to a vortex shedding phenomenon as the discharge flow passed across the rectangular balance port passages. In either case a more rigorous examination of the specific flow characteristics would be required to gain a proper understanding of this fluid-related excitation.

Figure 7. - Cross section through discharge nozzle.

From this discussion it was decided (1) to plug both ends of each balance port, (2) to hand grind the surface in contour with the nozzle, and (3) to provide a drilled weep hole in one side. After return to the plant site it was confirmed that a balance port did exist. Running a piece of wire through the hole on one side confirmed that the balance port was a circumferential passage that connected both sides of each discharge nozzle.

This unusual problem was corrected by plugging the discharge nozzle balance ports. The low-frequency vibration and the pressure pulsation in the fourth-stage discharge were eliminated. However, it is difficult to verify the exact nature of the specific physical mechanism and the associated forcing function. This uncertainty is due to a lack of knowledge of the accurate fluid properties of the process gas stream plus insufficient documentation of flow characteristics during the execution of field tests.

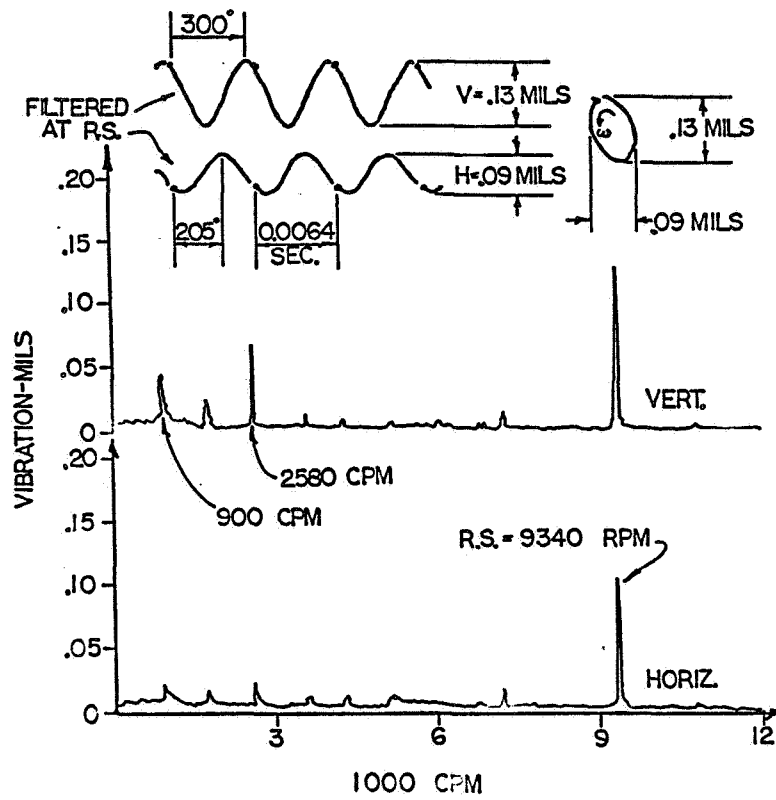
The unit came up smoothly through the first critical and reached normal operating speed without any problem. This time the machine came up to 1500 psi, then 1600 psi, without the low-frequency excitation. Finally the compressor was fully loaded, and the previously encountered vibration at 540 or 660 cpm did not appear. Figure 8 is representative of the final condition of this machine at 9340 rpm and a discharge pressure of 2150 psig.

Note that running speed motion was decreased to amplitudes of 0.13 mil vertically and 0.09 mil horizontally. This was due to refinement of compressor rotor balance during the course of this project. There are two minor components at 900 and 2580 cpm that appeared at amplitudes of 0.04 and 0.06 mil, respectively. These components were considered to be nondestructive and were later found to be associated with the stiffness of the O-rings installed with the squeeze-film dampers.

Figure 8. - Final coupling-end shaft vibration.

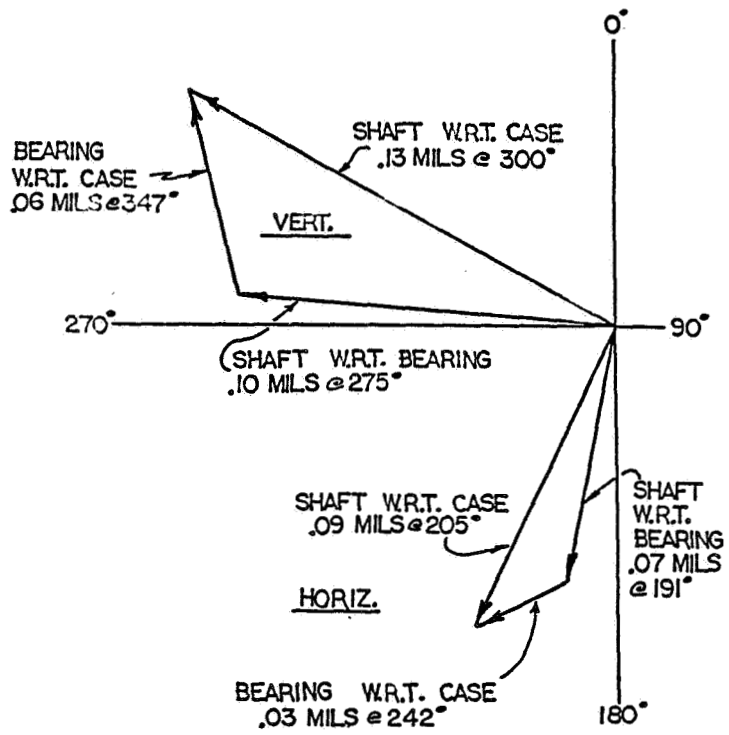
As part of the overall testing program X-Y shaft proximity probes were installed on the floating squeeze-film bearing housing to observe shaft motion relative to the housing. In addition, the standard X-Y shaft probes were mounted on the case and provided a measurement of shaft motion with respect to the case. The 1X vectors from both sets of probes are presented in figure 9.

From this plot of shaft motion with respect to the case and the bearing, the vector difference must be the motion of the squeeze-film bearing housing with respect to the case. Hence the squeeze-film housing was moving and providing the necessary additional system damping.

Figure 9. - Relative motion of coupling-end bearing.
