INVESTIGATION OF THE CHALLENGER
ACCIDENT

COMMITTEE ON
SCIENCE AND TECHNOLOGY
HOUSE OF REPRESENTATIVES

NINETY-NINTH CONGRESS
SECOND SESSION

**OCTOBER 29, 1986.—Committed to the Committee of the Whole House on
the State of the Union and ordered to be printed**

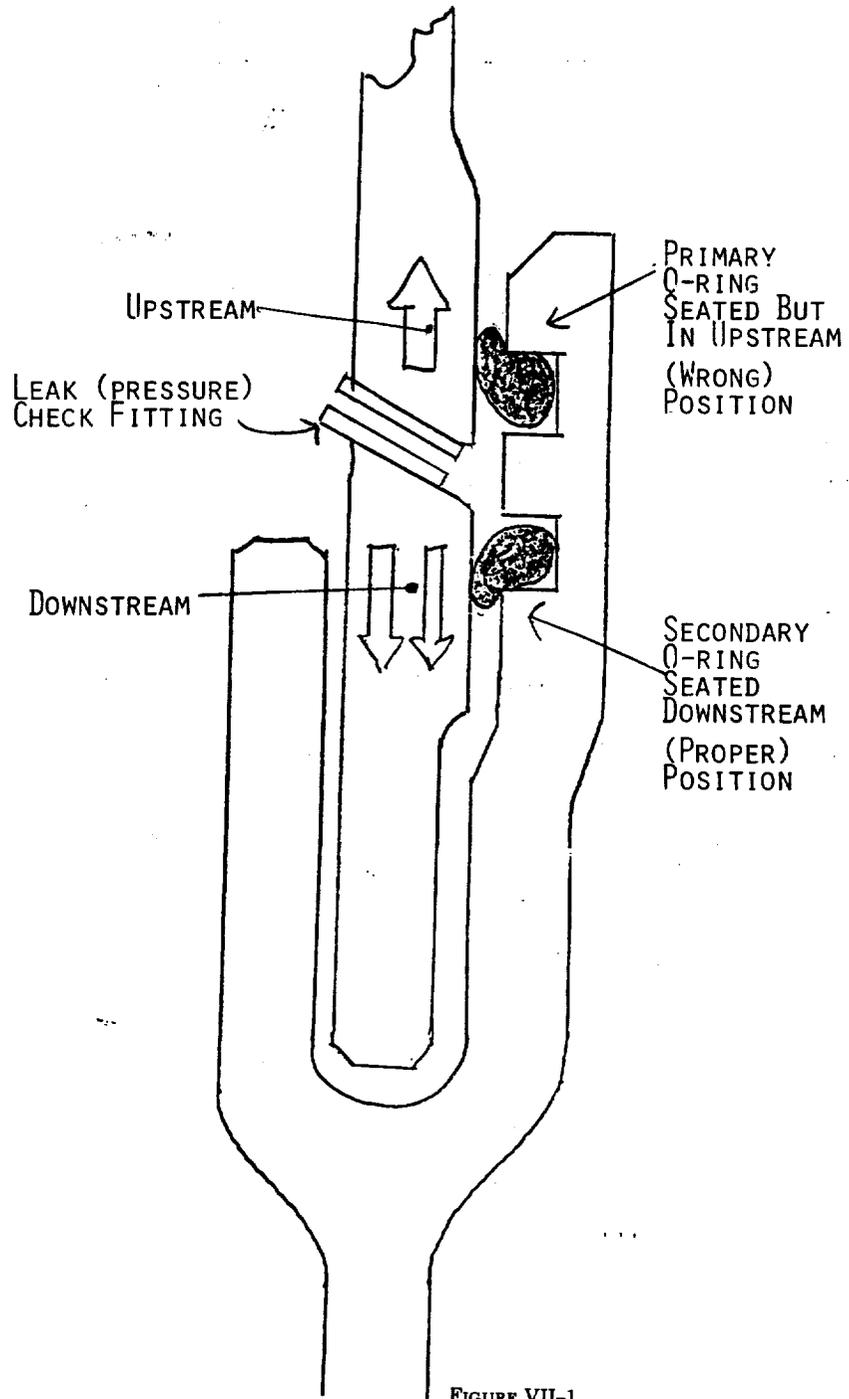
FIGURE VII-1

1. Both the primary O-ring and the secondary O-ring were seated when the steel casings were mated. The pressure check verified this fact. However, from experience, the primary O-ring was seated in the upstream position as had been previously recognized by NASA and Thiokol engineers. (See Figure VII-1.)

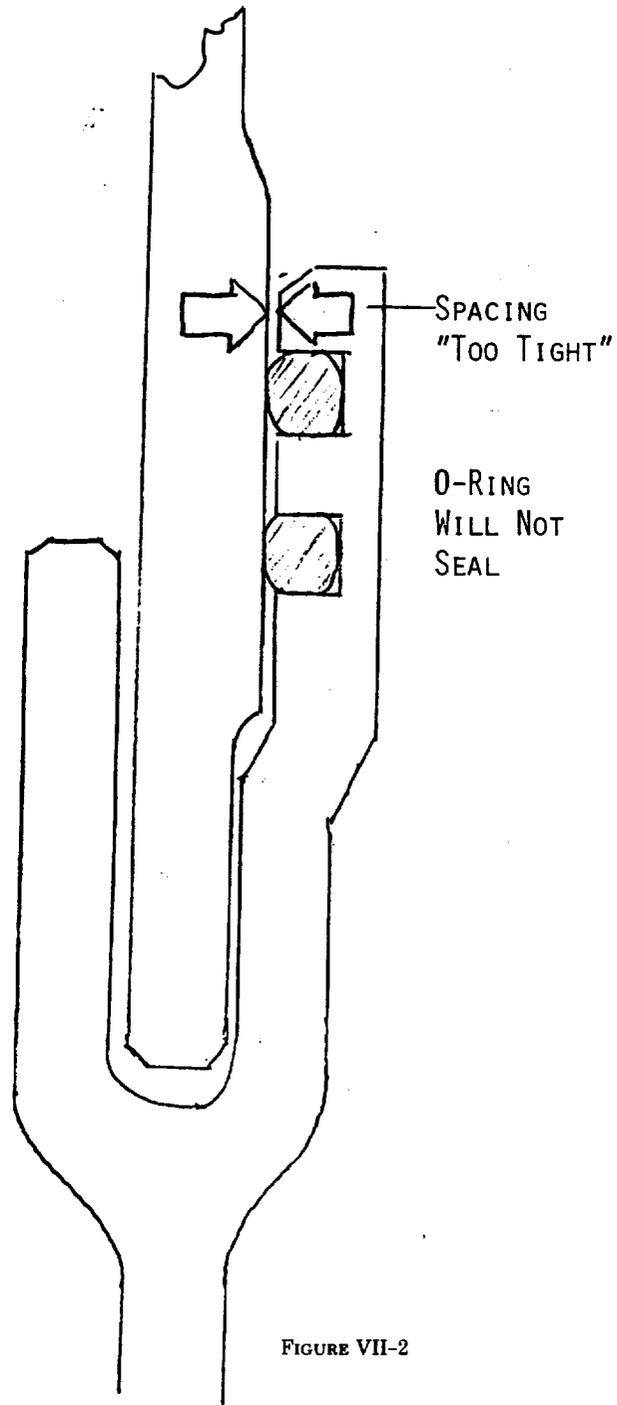
FIGURE VII-2

2. Upon ignition, the primary O-ring could not reseal at the 300 degree location in the downstream position, where it needed to be in time to prevent blowby. At this point there were too many deficiencies acting in unison which prevented the O-ring from reseating in that location. First, proper spacing between the inner face of the tang and the opposing face of the inner leg of the clevis approximately 0.020 inches, is critical. That spacing for Flight 51-L was too small, at the 300 degree location where the smoke was observed, to facilitate prompt reseating of the primary O-ring. Calculations of segment diameters indicate the gap spacing was only 0.004 inches, near metal-to-metal contact. The ignition gases passed the O-ring at this location (See Figure VII-2). This condition did not exist elsewhere in the joint around the casings since the primary O-ring was able to seat around the joint in other locations.

Second, the low temperature throughout the night prior to launch left the fluorocarbon elastomer primary O-ring stiff and lacking in ability to spring into the downstream (seated) position at the 300 degree location in time, relative to the buildup of motor pressure, to provide a tight seal. The temperature of the aft field joint at time of launch was calculated by Thiokol after the accident to be 16 degree F. Part of the reason for this low temperature was the heat transfer away from the joint, by conduction through the aft attachment strut. The conduction was driven by liquid hydrogen, which remained in the external tank overnight. The supercold fuel created a 430 degree temperature differential across the ship, drawing heat out of the joint and O-rings.

At ignition, blowby occurred, either with erosion of the primary O-ring or without erosion.

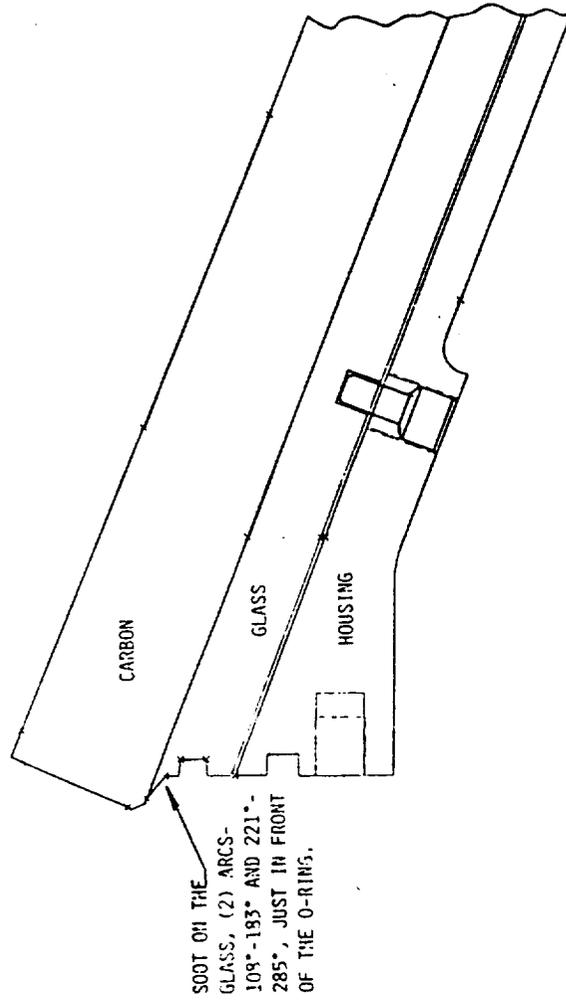
STS-61B (STS-31) (SRN-23) POST FLIGHT
(CHART NO. 3-2A)

SOOT ON THE
GLASS, (2) ARCS -
109°-193° AND 221°-
285°, JUST IN FRONT
OF THE O-RINGS.
