PROCEEDINGS
OF THE
SMRM DEGRADATION STUDY WORKSHOP

Organized by:
The Satellite Servicing Project
Goddard Space Flight Center

May 9-10, 1985

**SUMMARY OF THE SMRM DEGRADATION
STUDY WORKSHOP**

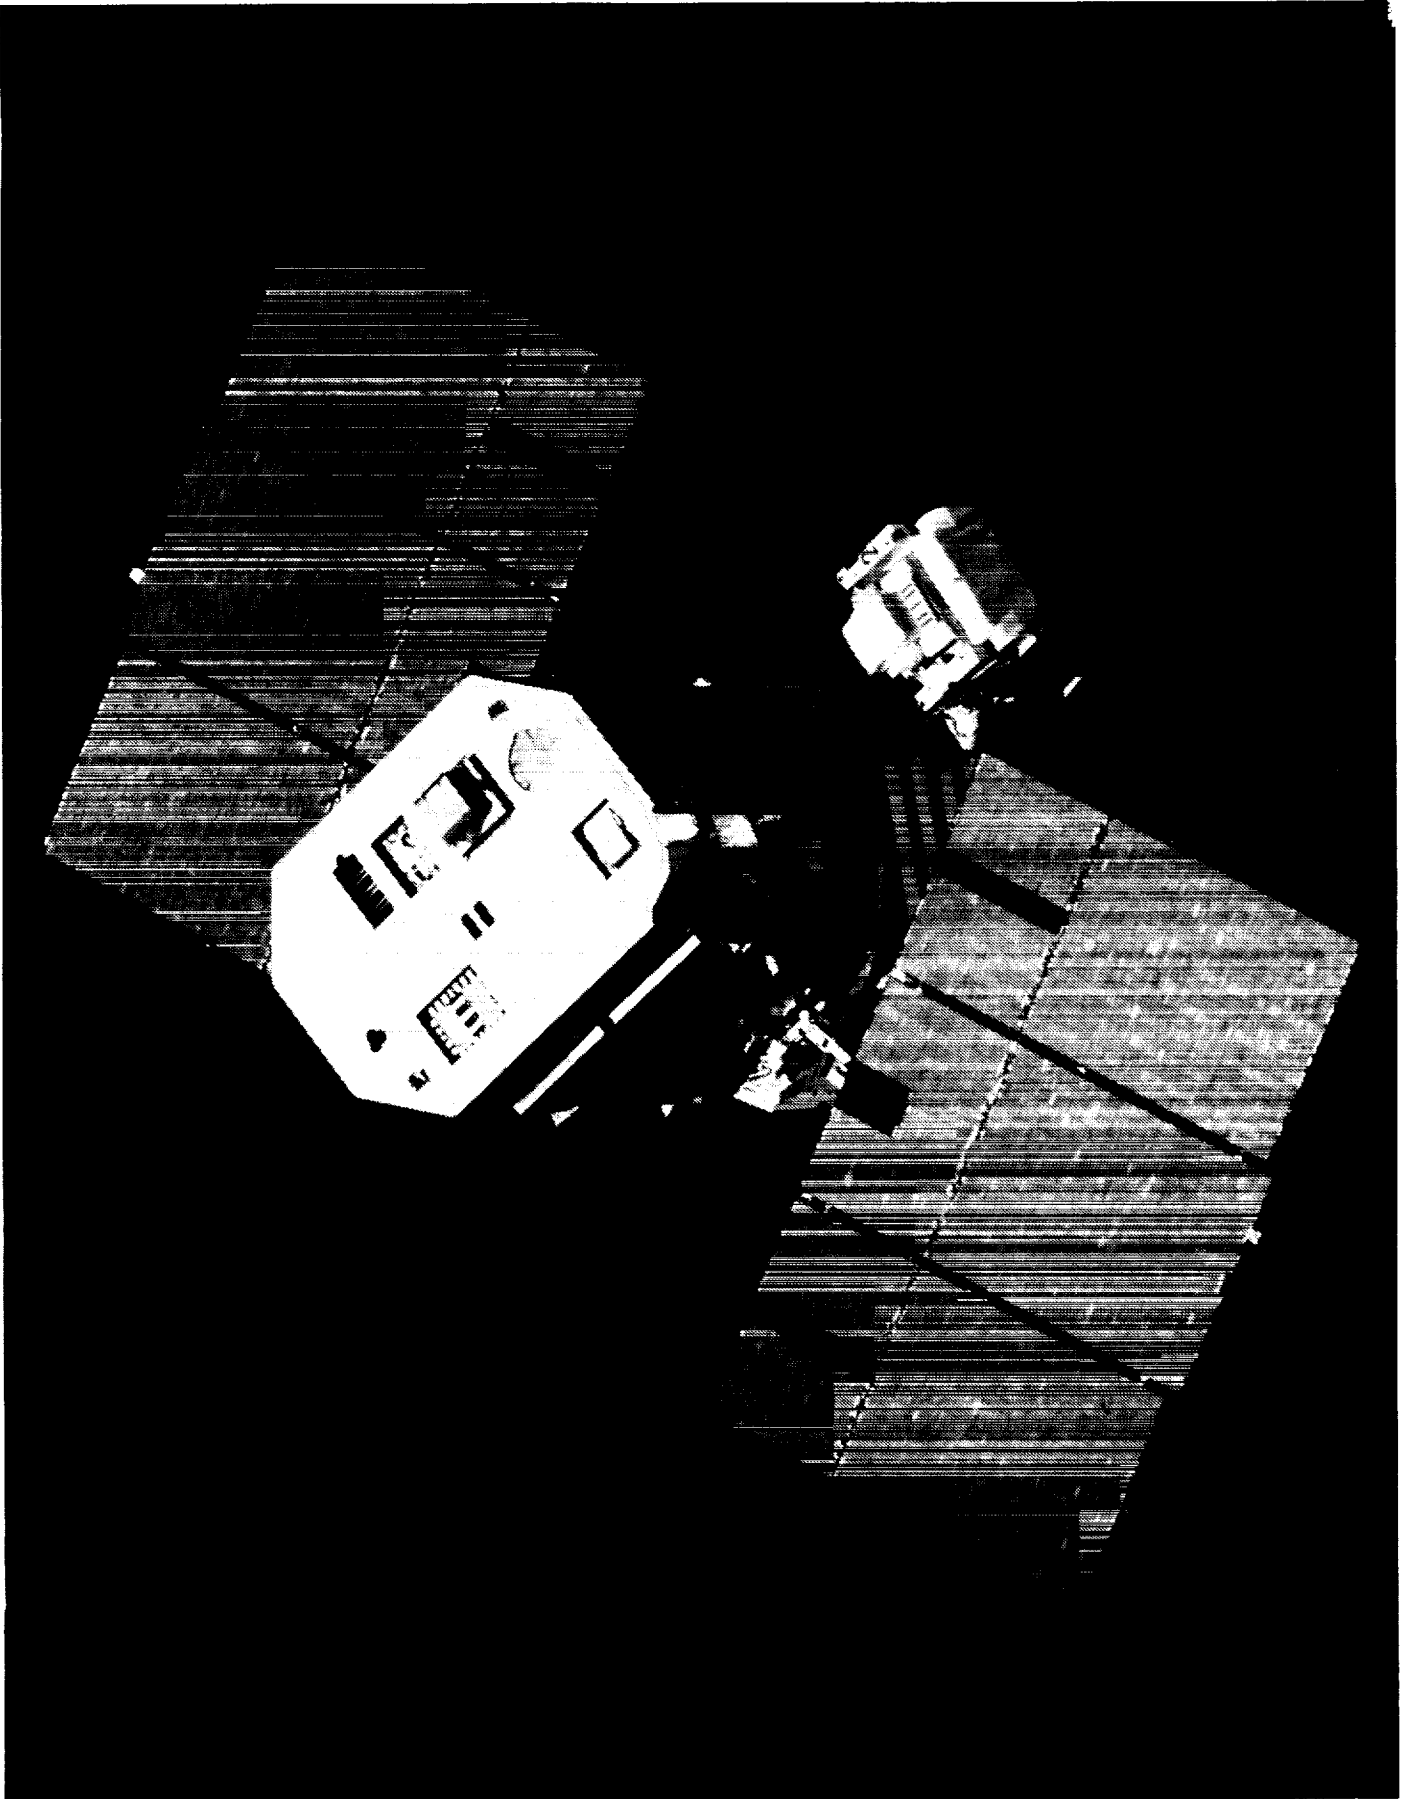
View of MACS module after unsuccessful dock attempt. Most louvers are closed. Degradation of bottom-facing louver trim can be seen.

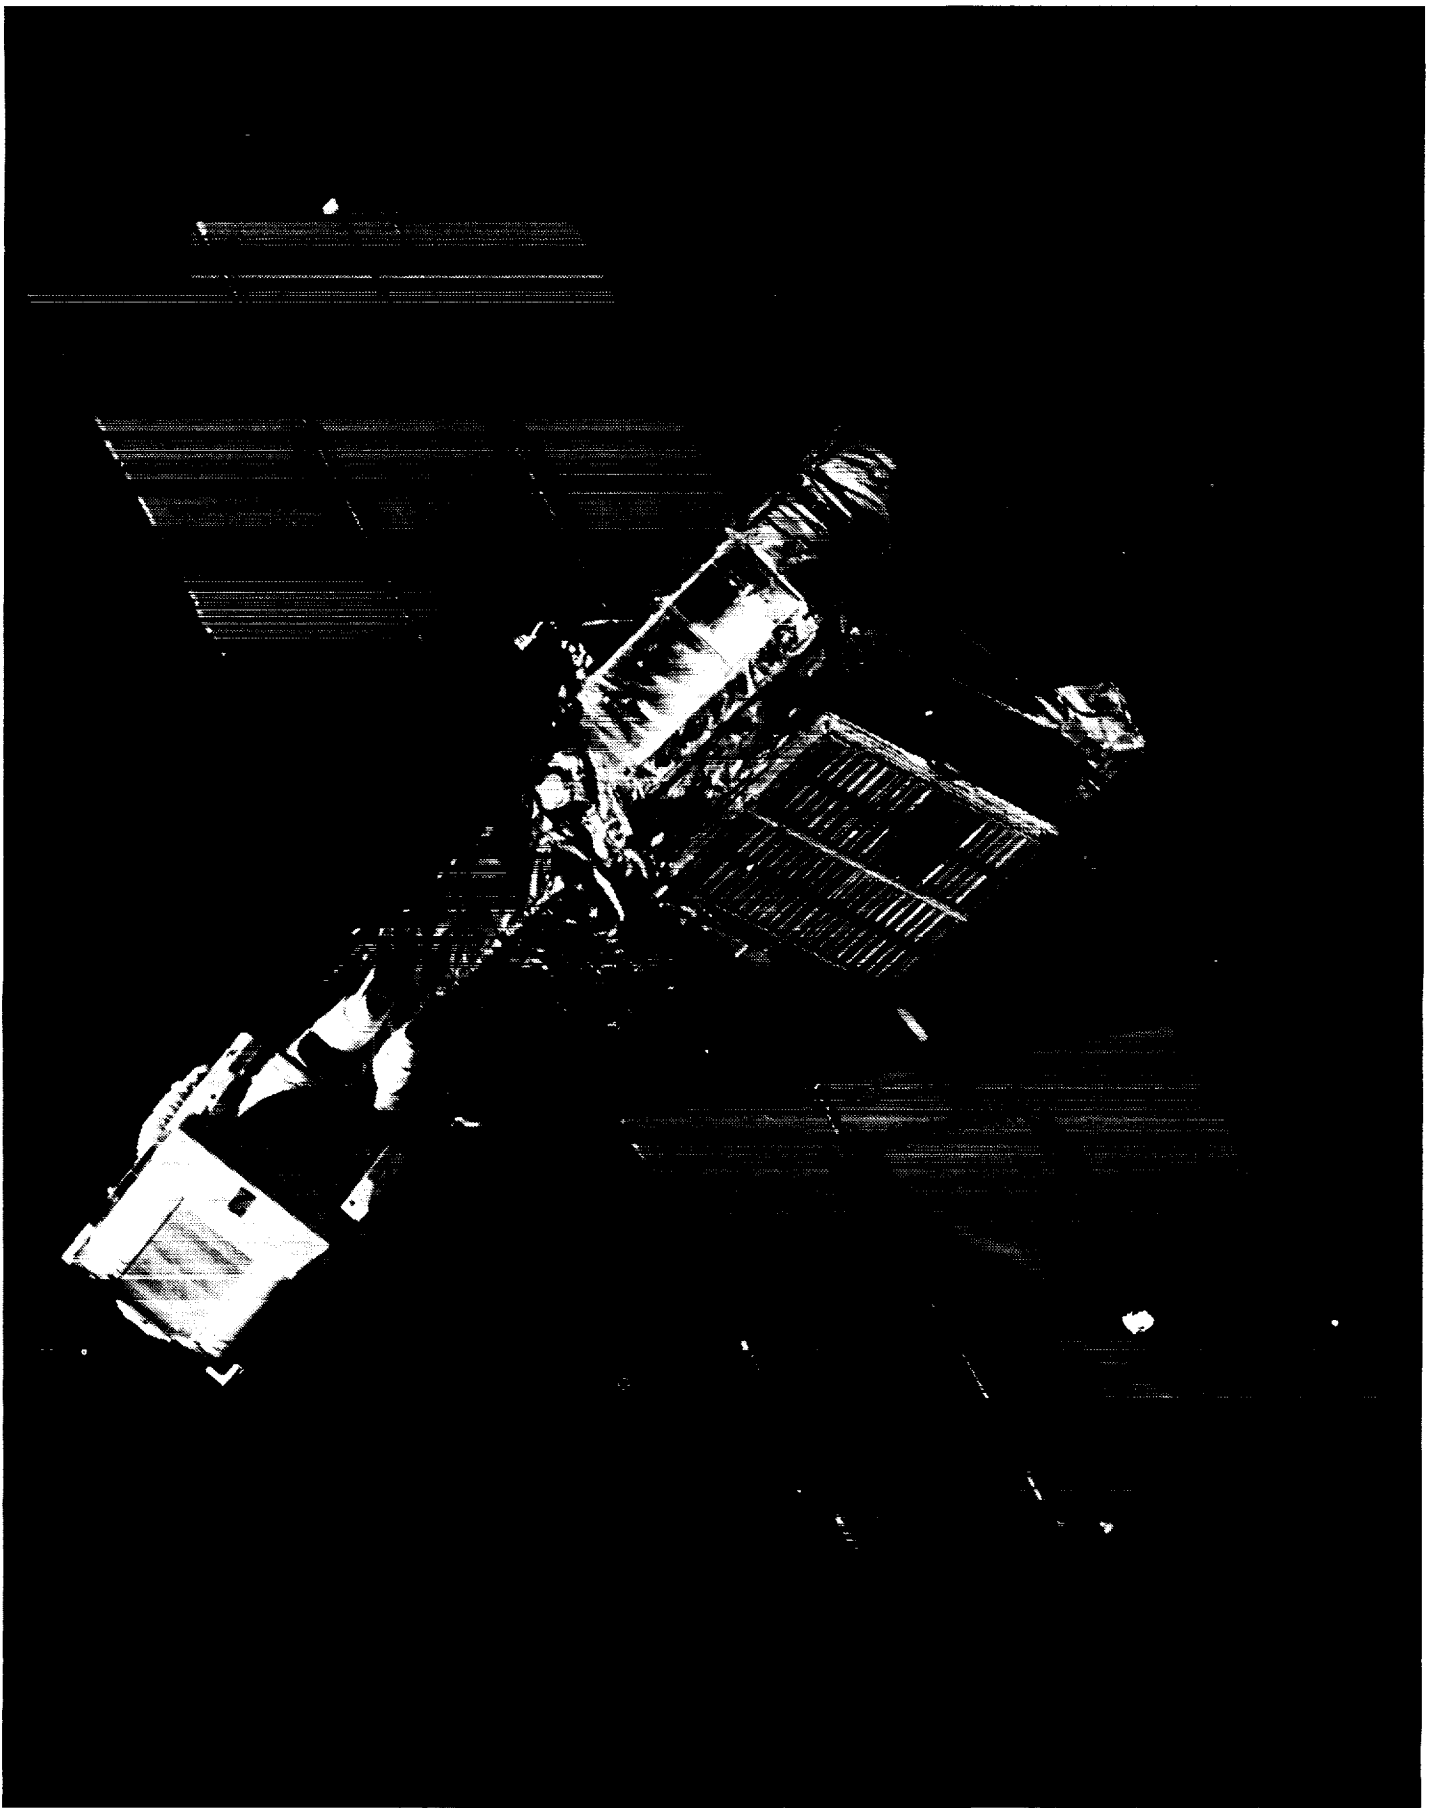
MACS Module Baseplate, after landing. Taken at KSC while still attached to FSS. Fading of black paint was caused by separation and "creep" of oil from thermal grease compound under (gold-colored) louver actuators. Louver blade sent by astronaut is also visible.

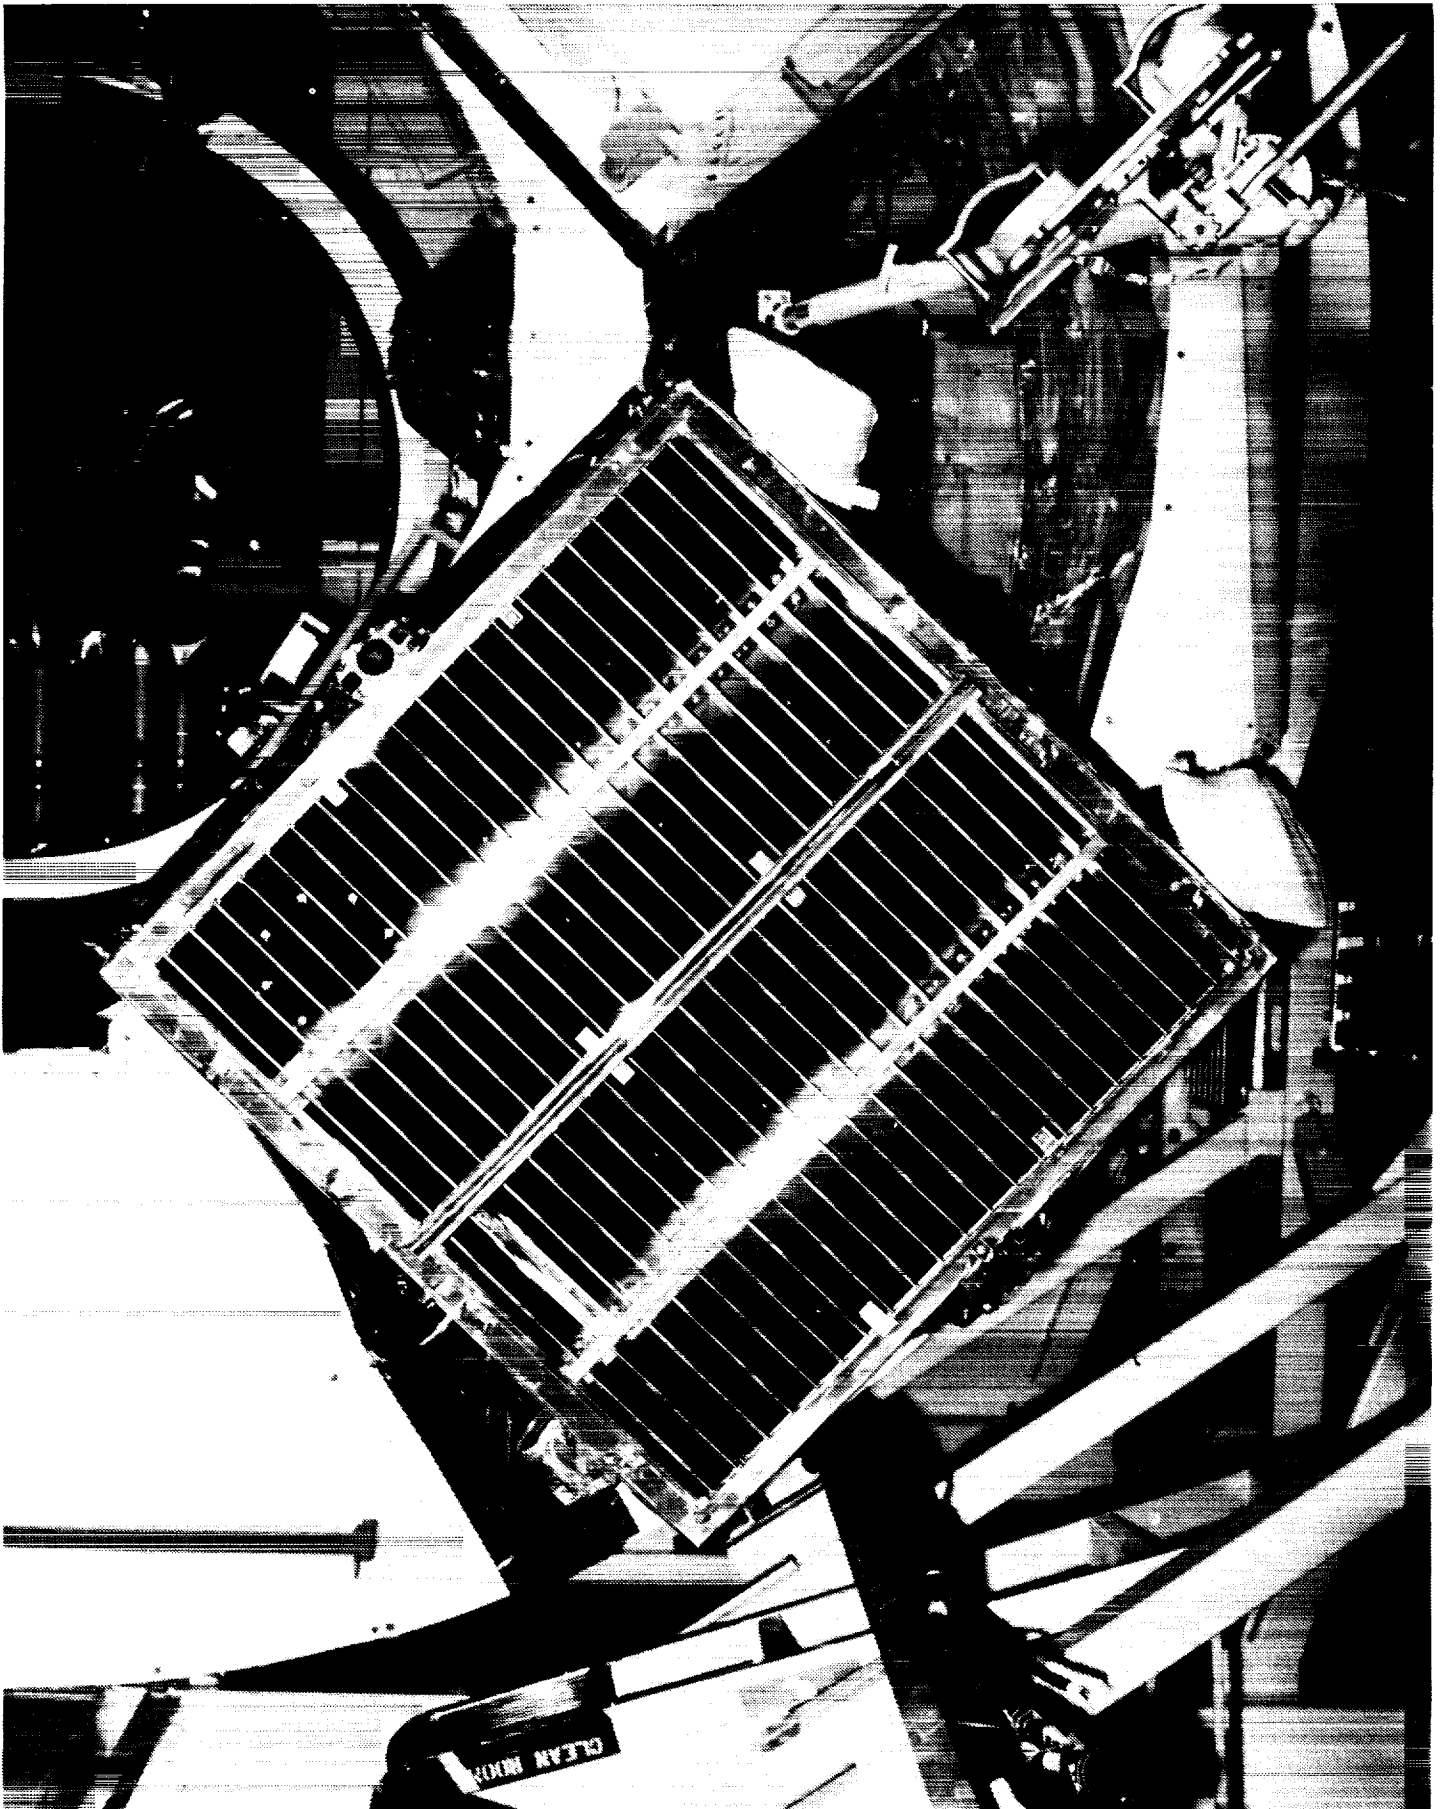
View of "top" (Sun-facing side) of MACS. Discoloration and tearing of silver Teflon, and fading of Kapton, are seen on the corner exposed to solar radiation.

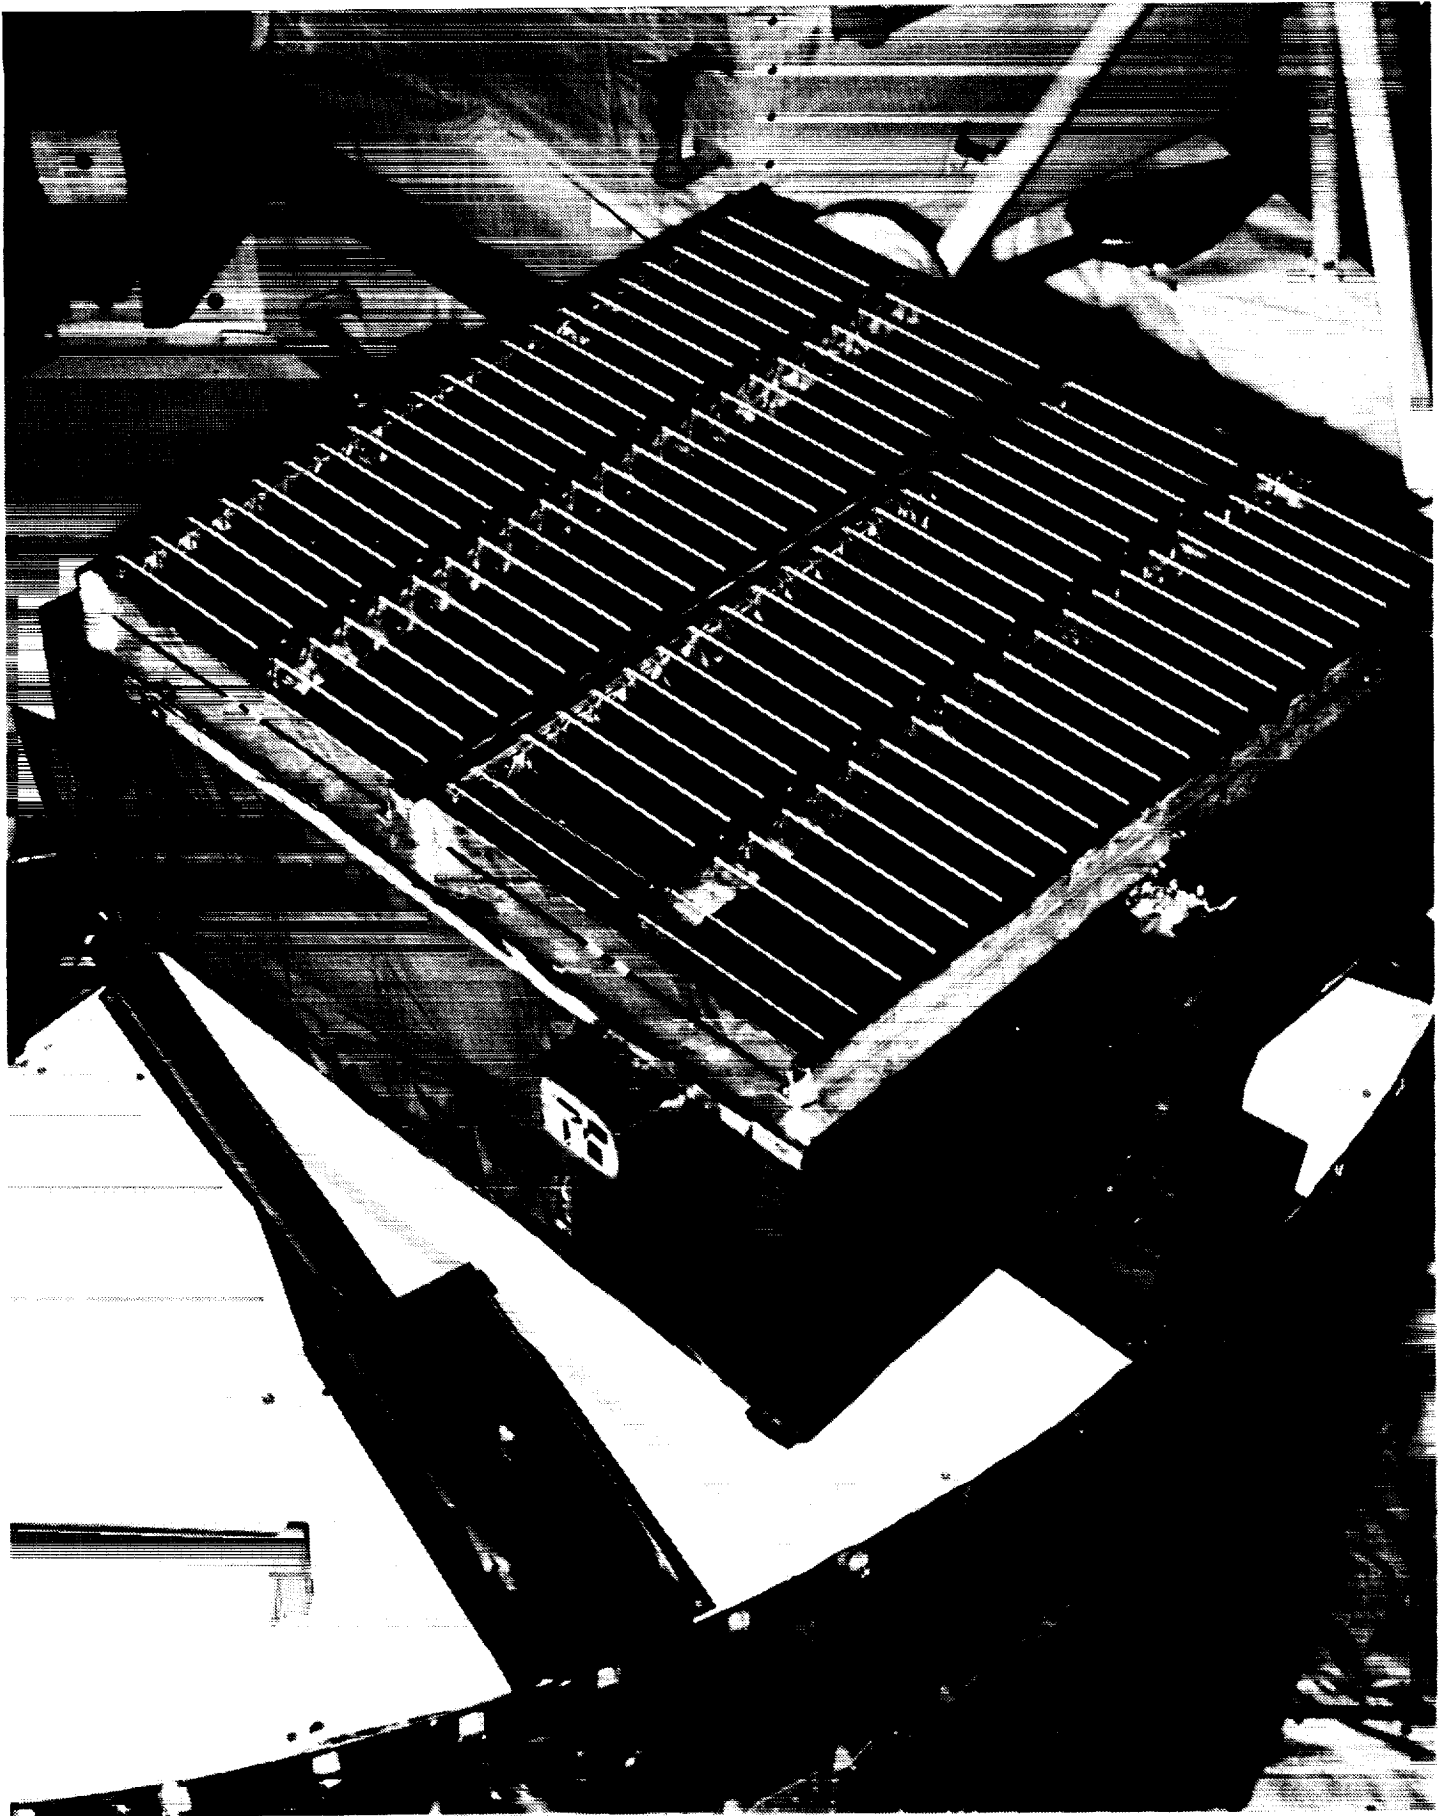
Close-up of the degraded silver Teflon louver trim, on the “bottom” side to solar radiation and the atomic oxygen fluence on the silver/Inconel side of the silver Teflon.

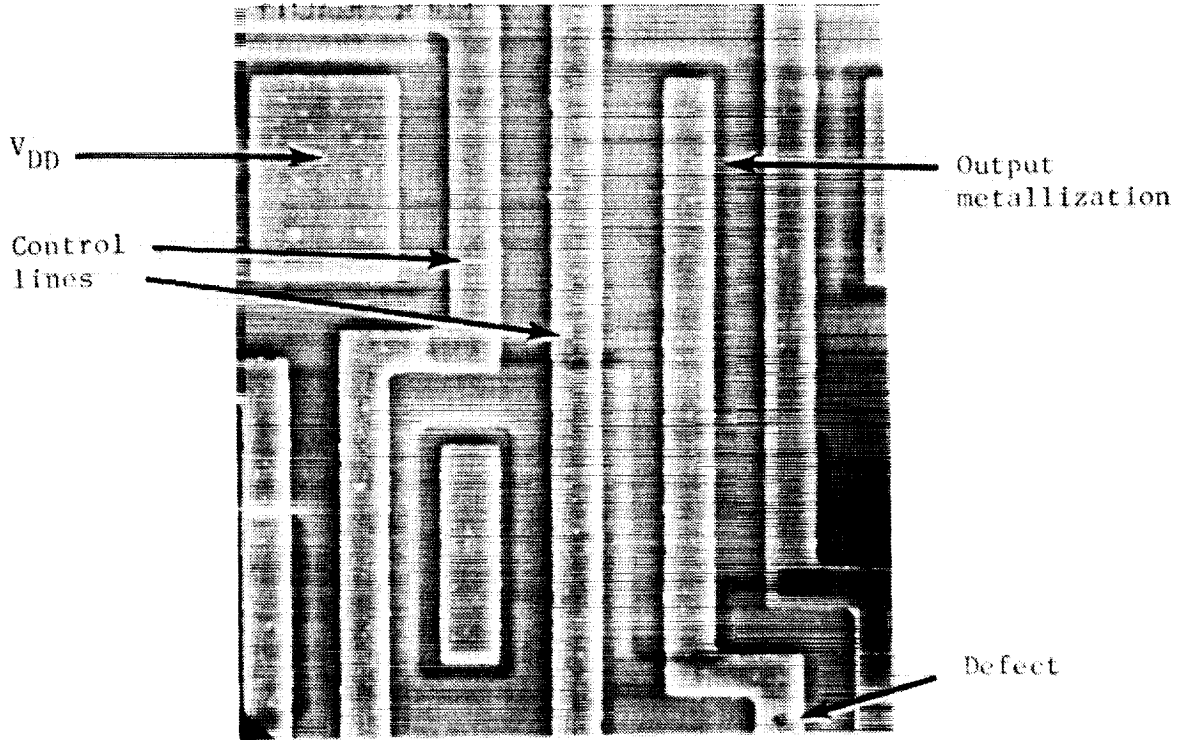
Figure 3. Photomicrograph of failed output stage. 800X

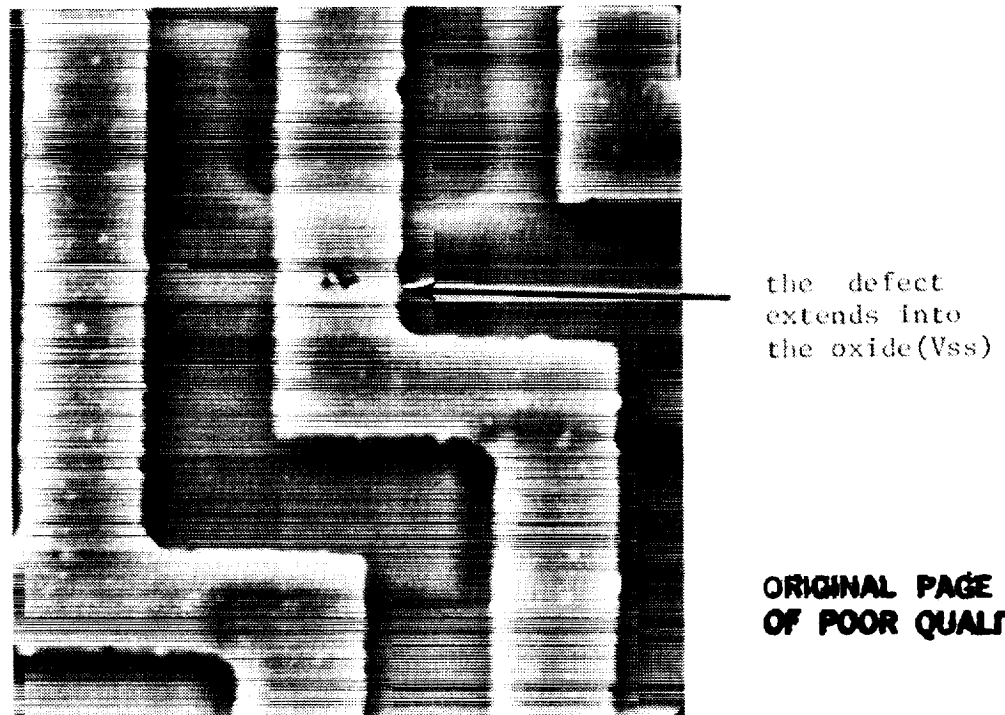
Figure 4. Photomicrograph of defect affecting output metallization. 2000X

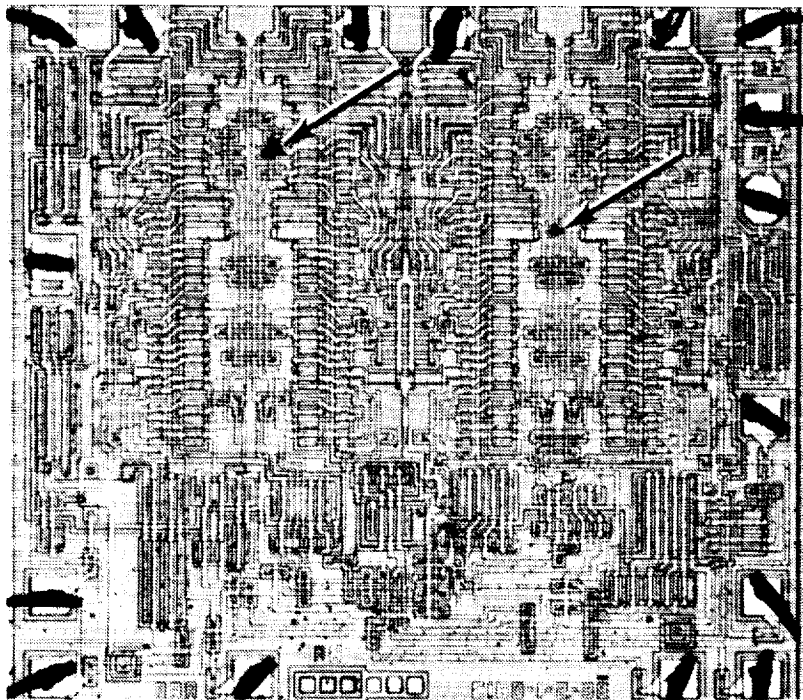
Fig. 1. Photomicrographs of die surface contamination (SN 139)

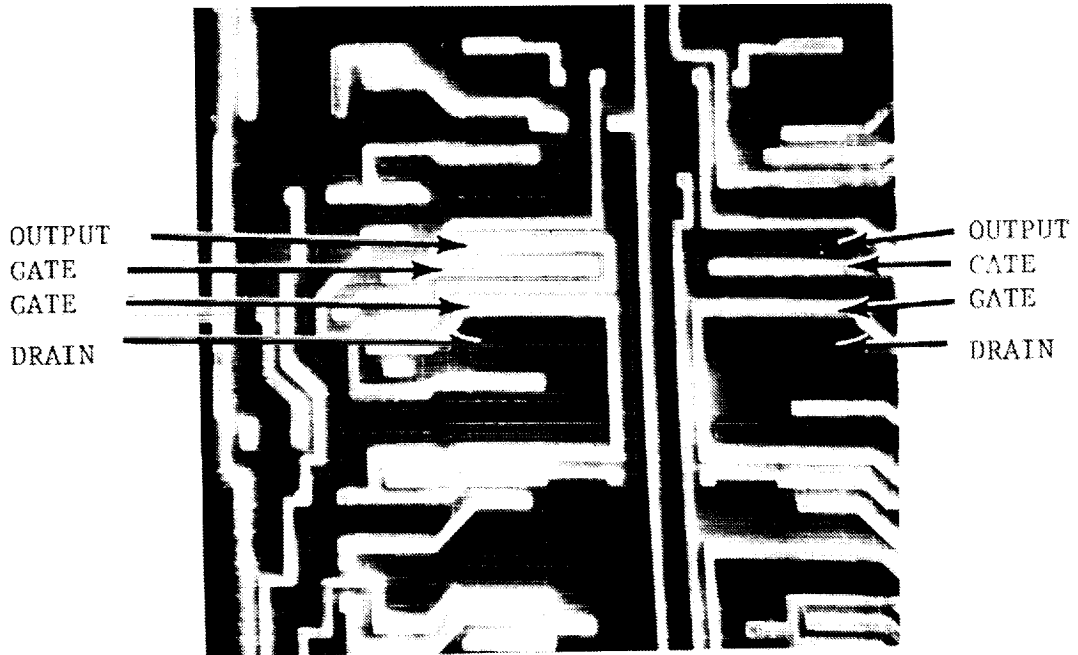
Fig. 2. SEM Micrograph of the failure utilizing Voltage Contrast. (SN 135) the A output stage (left) failed.

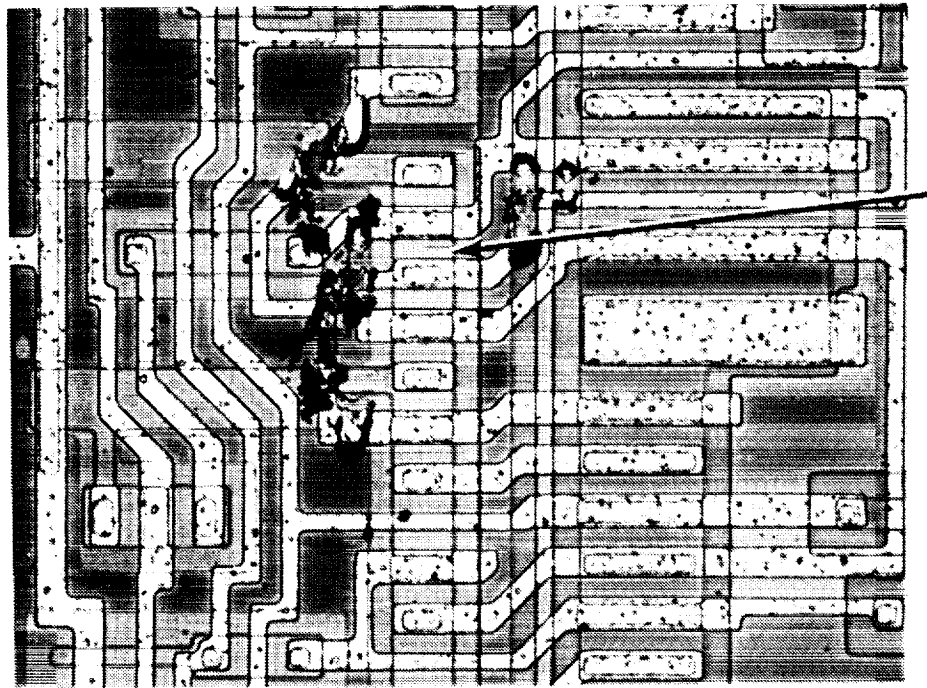
Fig. 3. Photomicrograph of the failure site isolated utilizing the microprobe station. (SN 135)

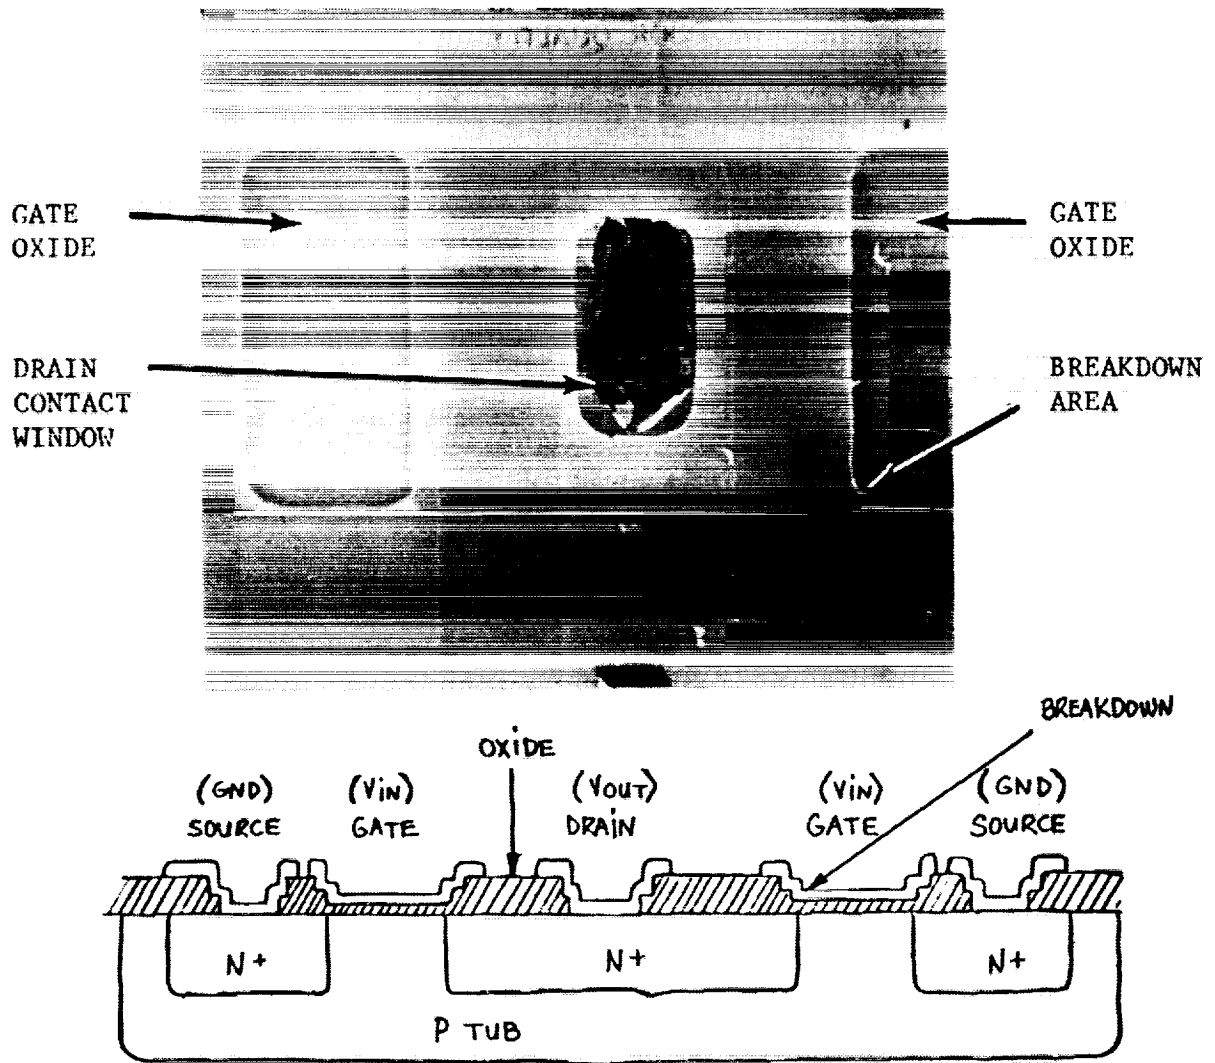
FIG 4. SEM Micrograph of the failed N-channel transistor. (SN 135)

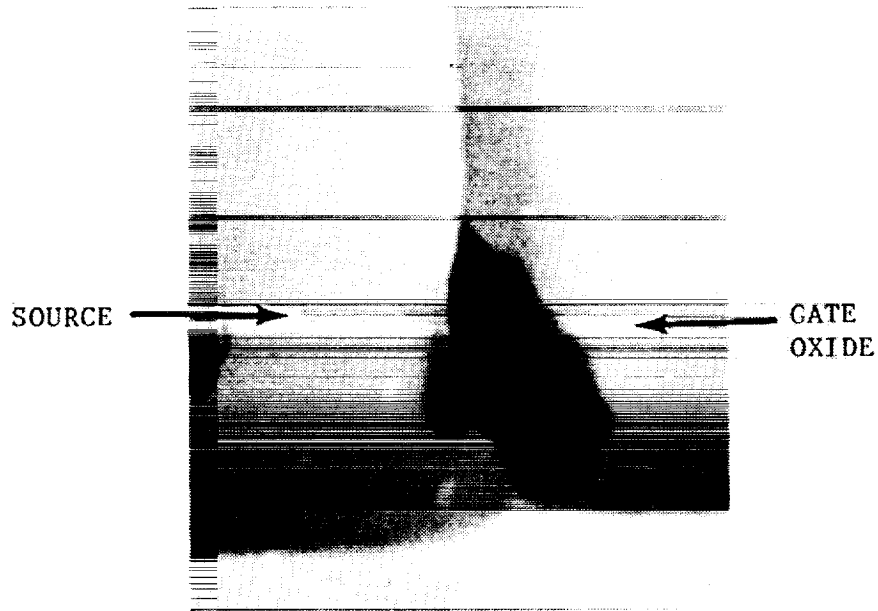
Fig. 5. Enlarged view of the breakdown area. (SN 135)

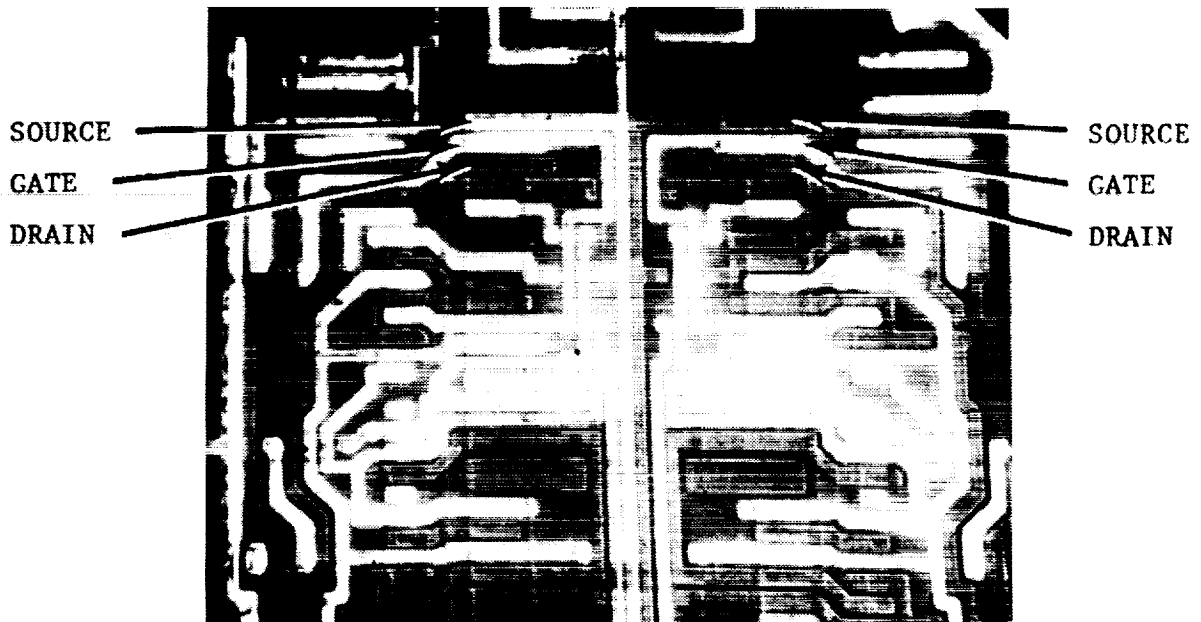
Fig. 6. SEM Micrograph of the failure utilizing Voltage Contrast. (SN 128) left is stage A (failed)

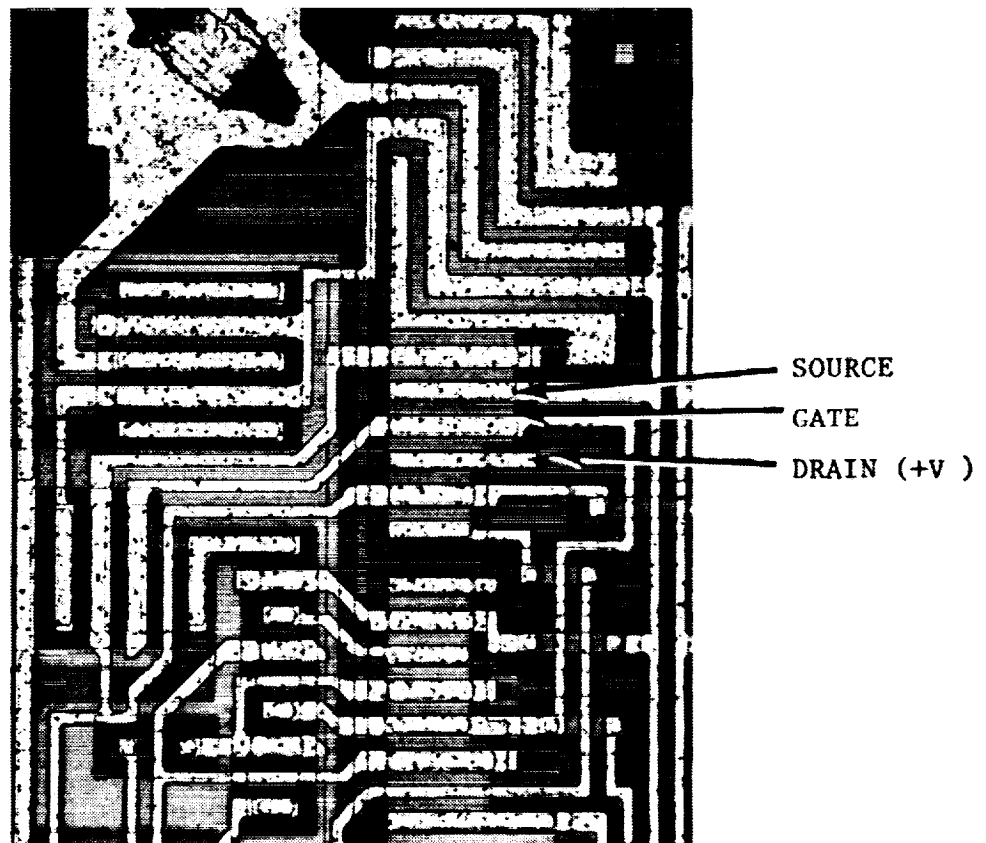
Fig. 7. Photomicrograph of the failed counter stage. (SN 128)

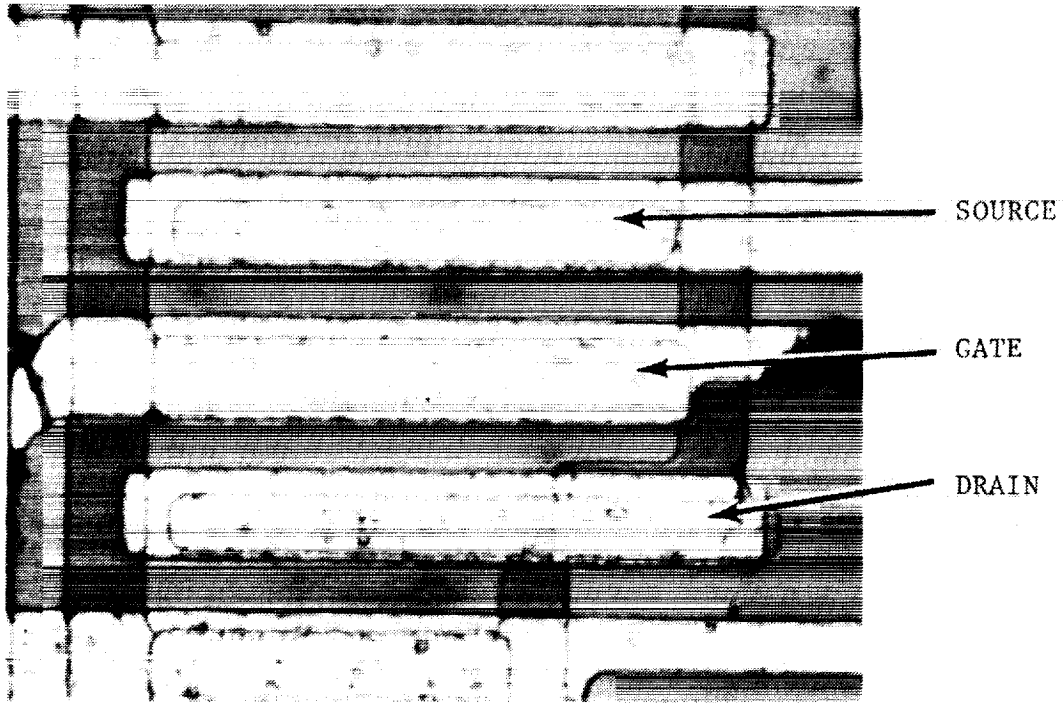
Fig. 8. Photomicrograph of the failed P-channel transistor. (SN 128)

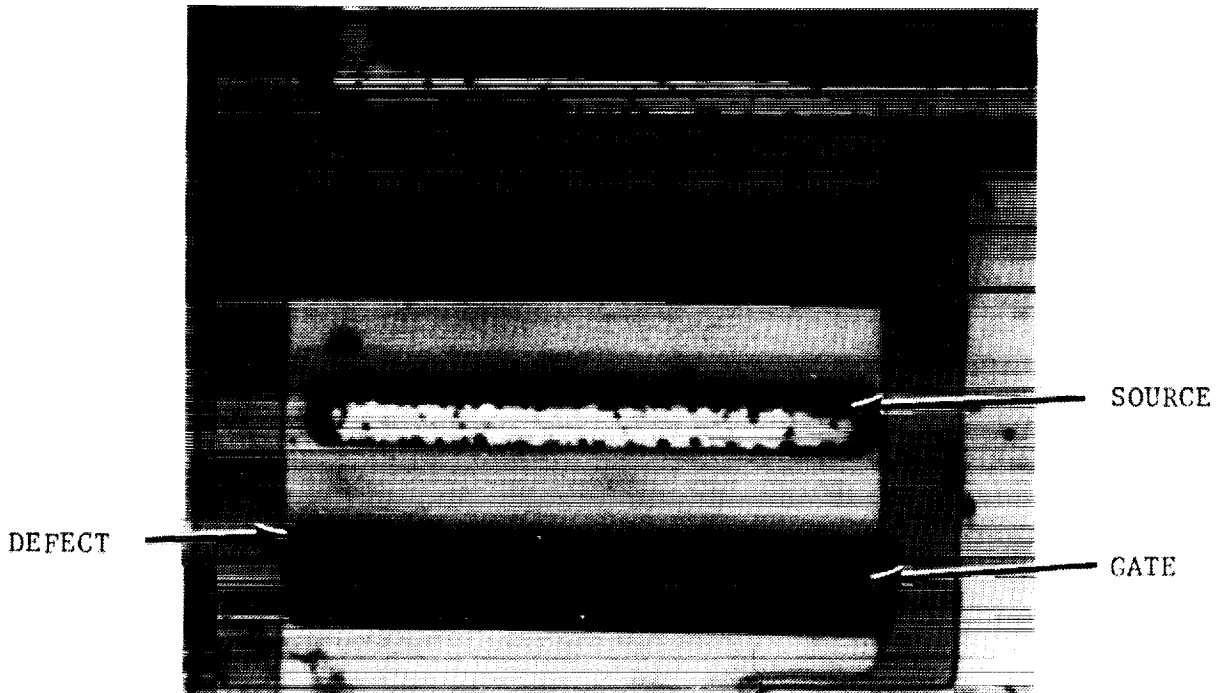
Fig. 9. SEM Micrograph of the failed area after an aluminum etch. (SN 128)

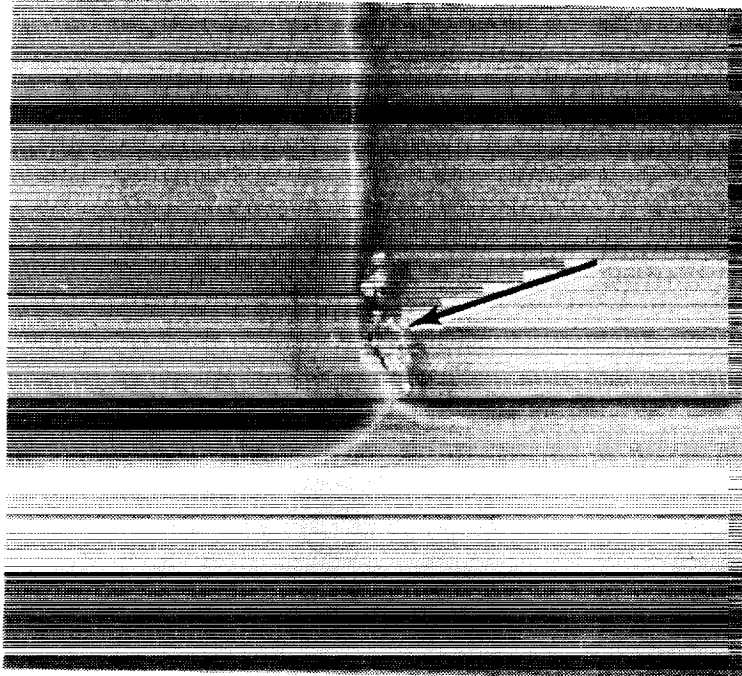
Fig. 10 SEM Micrograph of the defect in the gate oxide (SN 128)

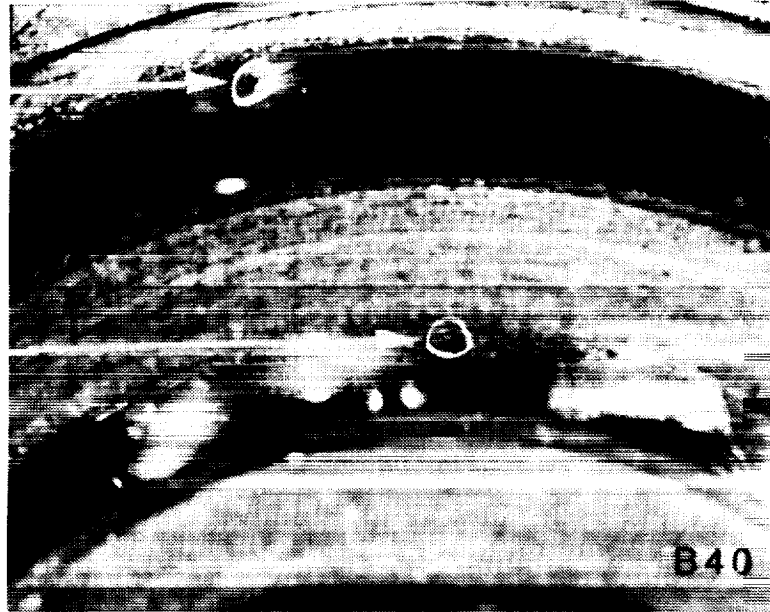
The bearings showed some wear in the form of tiny pits and scratch-line deformations. Numerous tiny particles were observed clinging to the bearing parts after the case and the hysteresis ring were removed. The particles had originated from the pits of the bearing races and the balls.

Figure 4. Typical particles observed clinging to B40 while still in gyroscope., 20x.

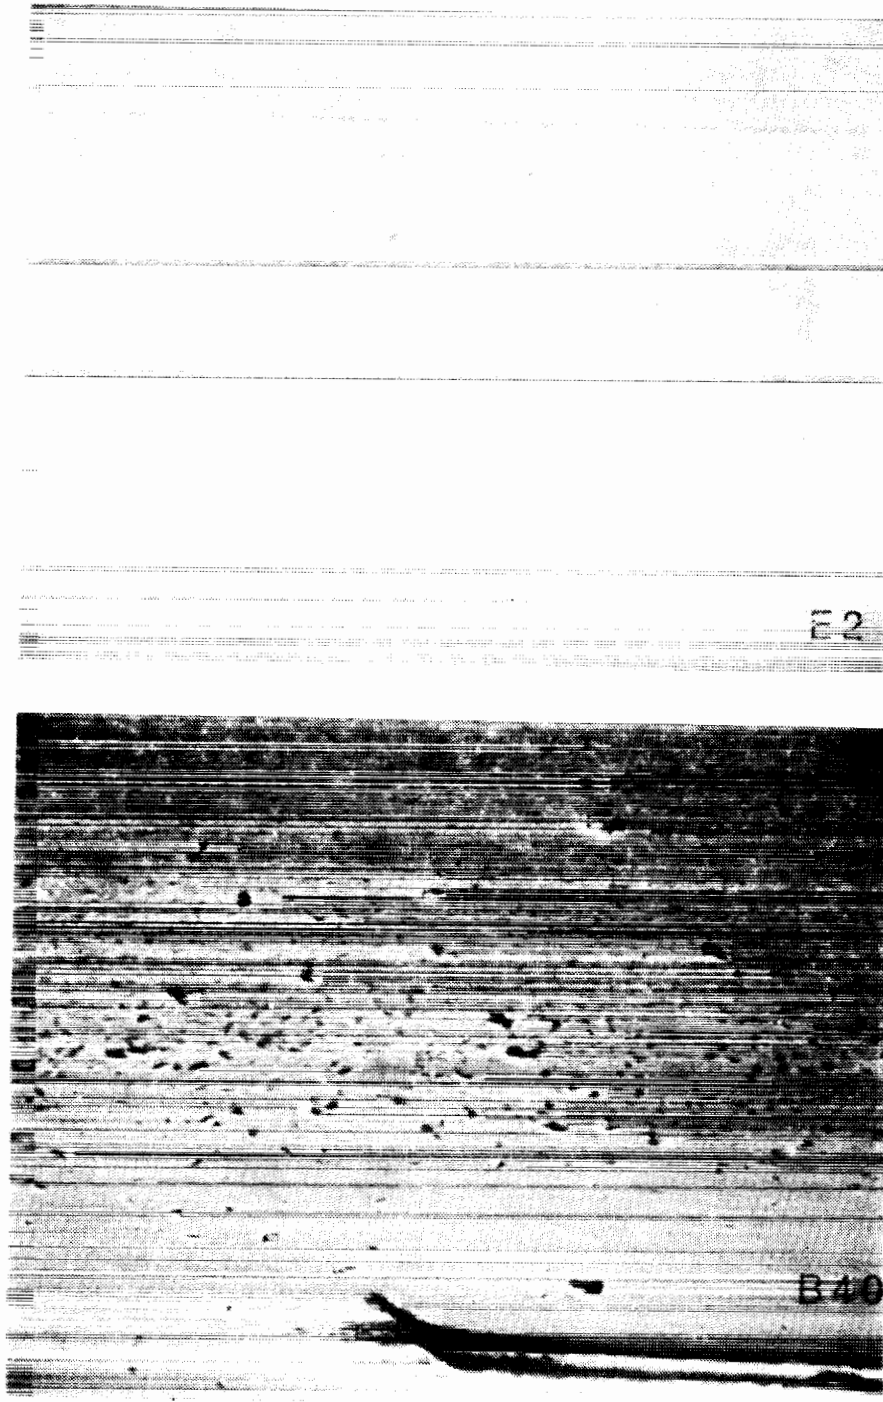
Figure 9. SEM photos of innter race of E2, top, and wear area of B40, bottom. 1250 \times .

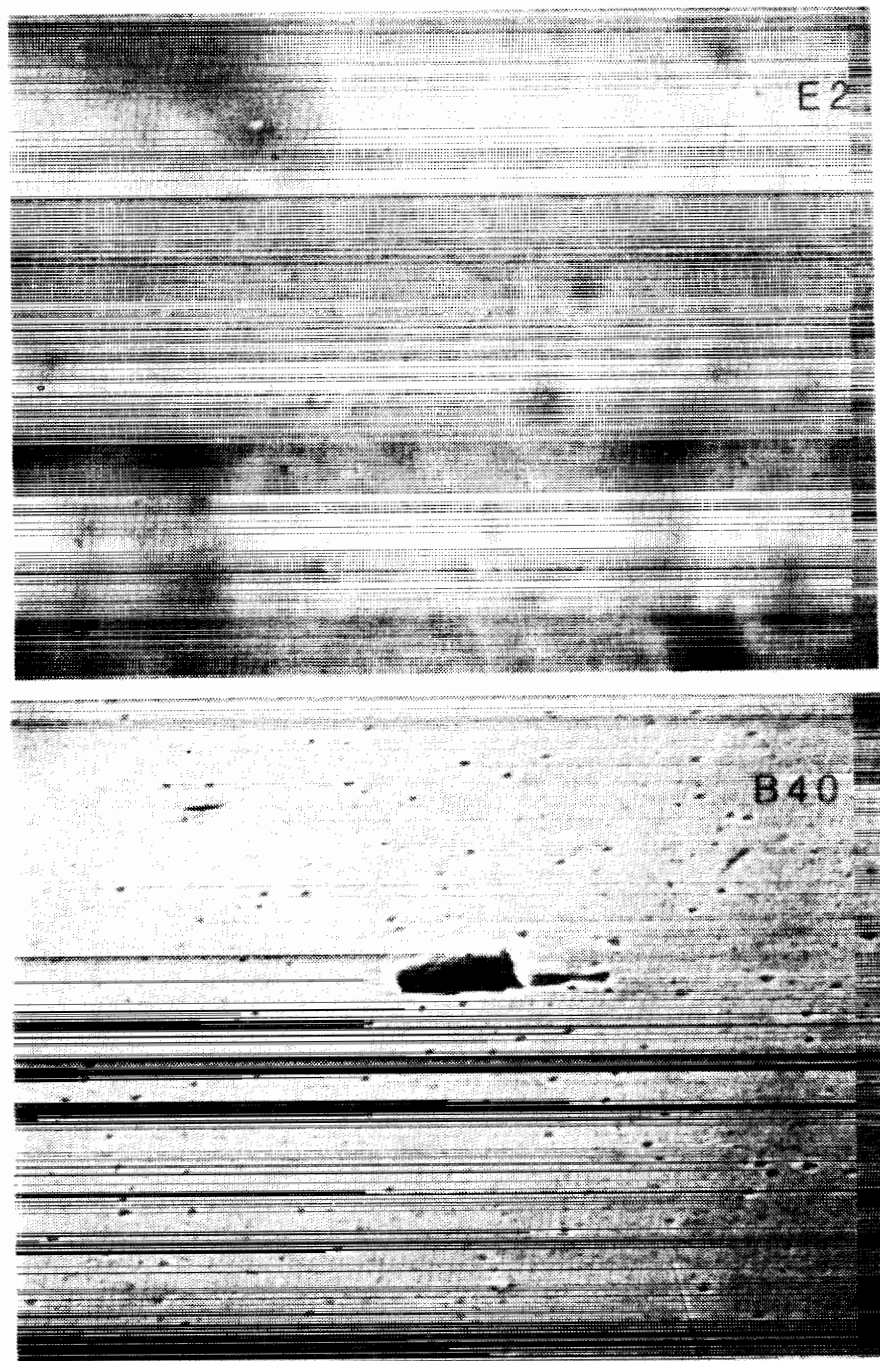
Figure 10. SEM photos of balls from E2, top, and B40, bottom. Note "large" pit is 115 square micrometers. 1250 \times .
