PROCEEDINGS
OF THE
SMRM DEGRADATION STUDY WORKSHOP

Organized by:
The Satellite Servicing Project
Goddard Space Flight Center

May 9-10, 1985

**SUMMARY OF THE SMRM DEGRADATION
STUDY WORKSHOP**

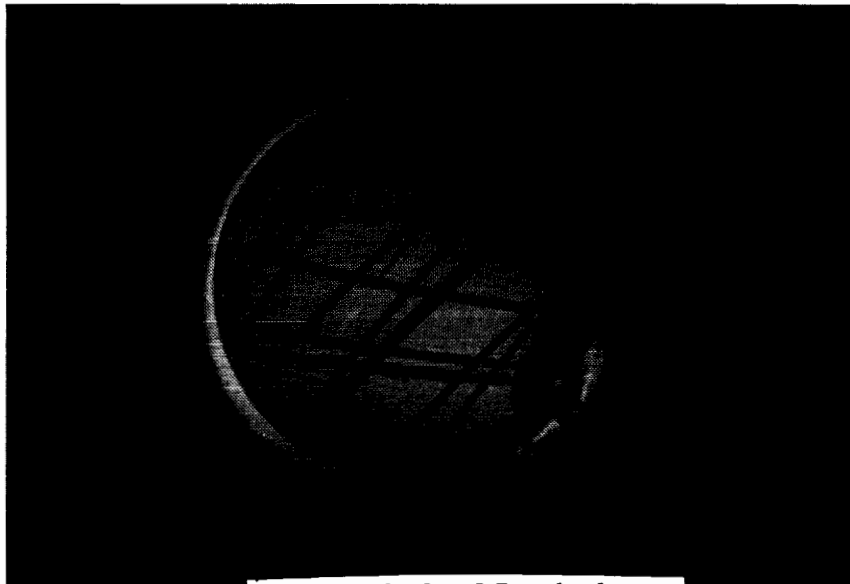
Photo cathode of Standard Star Tracker S/N 001 showing damage caused by the sun during SMM recovery. Lines are regions where heat from the solar image evaporated the cathode material resulting in regions of no sensitivity.

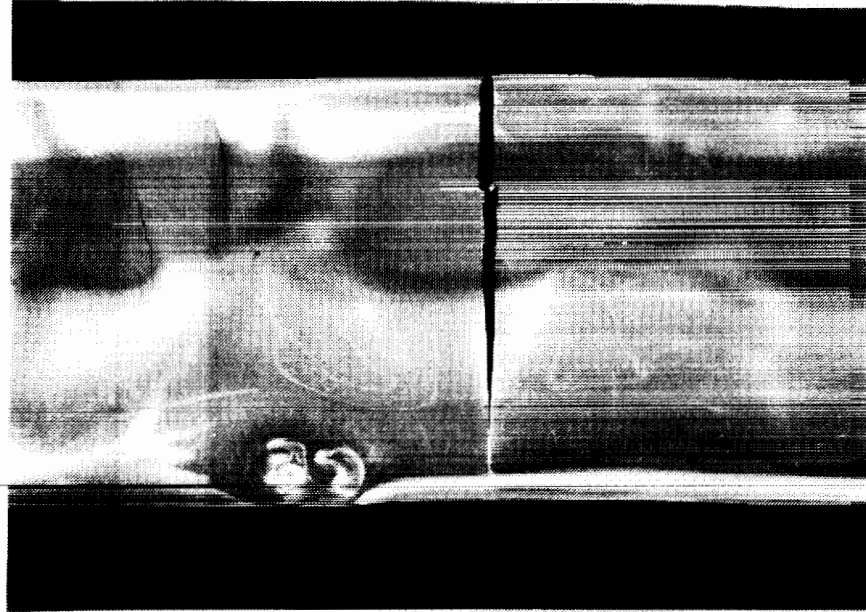
The result of exposing the Inconel in this way was the apparent removal of the vapor deposited metals (Figure 2) in a narrow strip of approximately 1/3 of the total width of deposited metal. The width of the total exposed surface was about 2-1/4 inches and the eroded surface, though non-uniform and irregular, was about 3/4 inch, or about 1/3 of the total exposed surface's width. In addition, the separations in the Teflon film ran essentially to the edges where the film was adhered to the U-channel which kept the film from coming loose.

Figure 2. Silver/Teflon film showing area having lost deposited metallic films, from bottom (B2) of ACS, with separation running across the short dimension of the film.

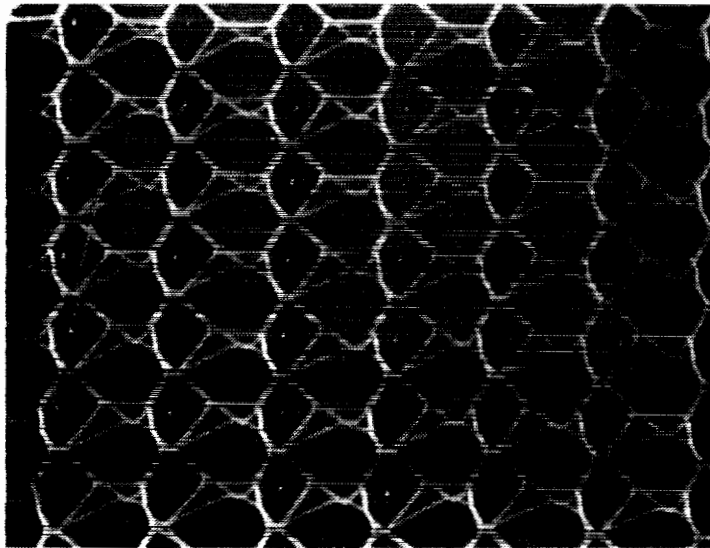
Another unusual feature of the MEB blanket was the appearance of what was an unusual pattern of light spots or reflections. Upon examining the back of the outer Kapton layer, it was noted that the aluminum deposit had been rubbed off, making it appear that there had been holes in the Kapton. By comparing the rubbed pattern with the knots (Figure 9) of the Dacron mesh in the thermal blanket, one can demonstrate how the pattern occurred.

Figure 9. Back-lighted MEB Kapton showing lighted areas adjacent to knots in the Dacron mesh, demonstrating how the deposited aluminum was removed.

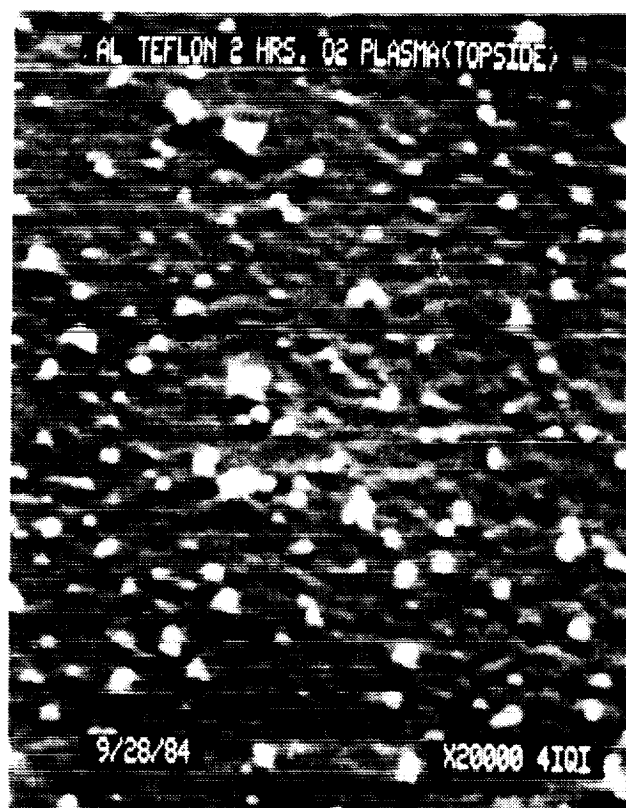
Figure 10 FEP Teflon After 2 Hours Plasma Exposure on the Ag/Inconel Surface. Growth of Ag along Grain Boundaries and Cracks in the Inconel Over Coat Has Occurred.

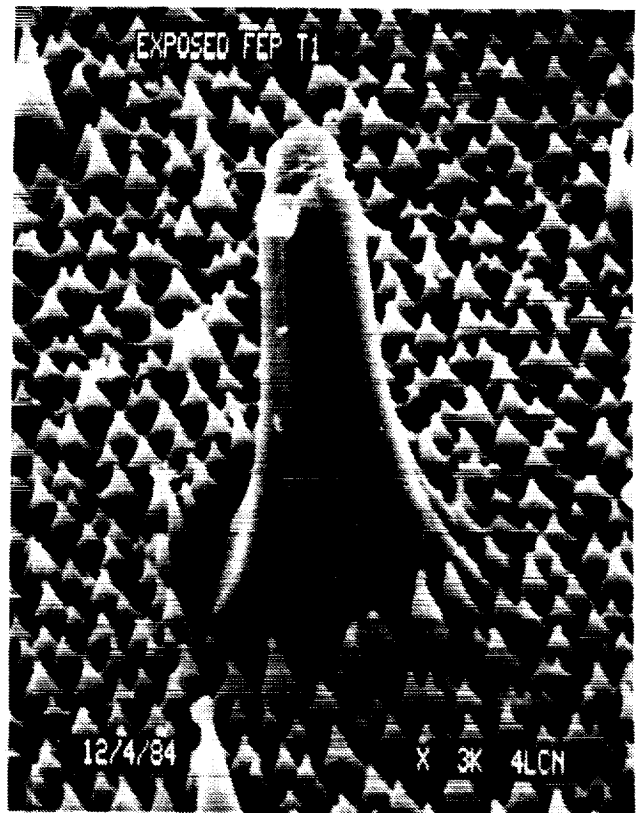
Figure 12 T1 FEP Teflon Exposed Ag/Inconel Side. The Morphology is Similar to that of the Laboratory Exposed Ag/Inconel with Ag Growing Through Cracks and Grain Boundaries in the Inconel Overcoat. At High Magnification it is Possible to Observe Regions in which the Ag/I has been Totally Removed and the FEP Teflon Textured Surface is Visible.
