Fatigue Failure of Regenerator Screens in a High Frequency Stirling Engine

David R. Hull, Donald L. Alger,
Thomas J. Moore, and Coulson M. Scheuermann
Lewis Research Center
Cleveland, Ohio

March 1987

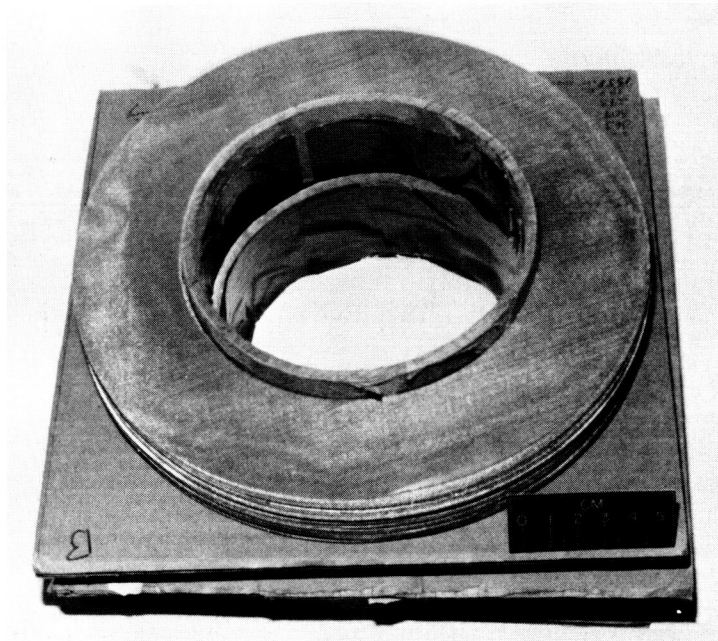
FIGURE 3. - STACK OF 350 TYPE 304 STAINLESS STEEL REGENERATOR SCREENS.

The regenerator matrix for each of the opposed engines of the SPDE is made up of a stack of 350 annular shaped, 200 mesh, woven screens with a wire thickness of 41 μm . A stack of new regenerator screens is shown in figure 3. The screens are pressed into the annular space at the base of the heater shown in figure 4, between the displacer cylinder and heater housing. The screens fill a regenerator length of about 2.54 cm.

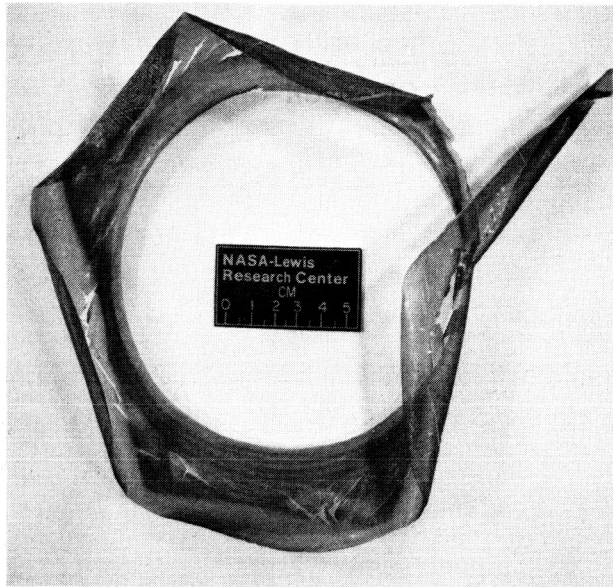
(A) TOP SCREEN (CLOSEST TO HEATER TUBES).

Figure 5 is a photograph of the top screen surface of the regenerator. Top screen refers to the regenerator screen surface that faces the heater tube sheet at the hot end of the regenerator. Figure 5(b) shows the surface of a screen that was deeper down in the regenerator stack- approximately two-thirds through the 350 screen stack. A higher magnification photograph of the top screen (fig. 6) shows more clearly the severe damage done to the screen and the presence of particles filling some of the screen openings. Specimens of these regenerator screens and the collected debris were prepared for metallurgical examination.

FIGURE 5. - REGENERATOR SCREENS AFTER 80 HOURS OF ENGINE OPERATION.
SUBSTANTIAL DAMAGE TO SCREENS IS EVIDENT.

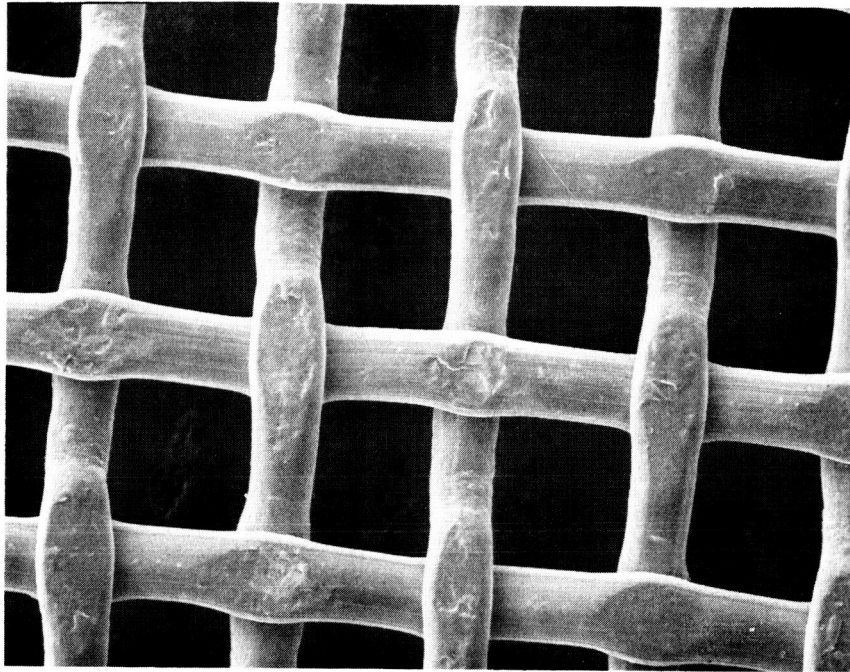
(A) AS-RECEIVED, DEFORMATION AT CROSSOVERS.

The scanning electron microscope (SEM) was used to examine the screens in three conditions; as-received, inside screen, and top screen (fig. 7). An as-received piece of screen is examined throughout the analysis to serve as a reference. Figure 7(a) shows the as-received screen to have flattened wires at crossovers due to the manufacturing process of the screens. After being run in the engine, a screen from inside the stack (fig. 7(b)) shows additional uniform damage (cratering) and "chips" of material on the wires. The top screen, closest to the heater tubes shows severe damage to the wires (fig. 7(c)), including fractures at crossovers, uniform cratering, pieces of wire missing, and wire debris filling screen openings. In looking at the fractured wires more closely there is evidence of fatigue striations (fig. 8(a) to (b)) and fatigue cracking at the saddle points of the crossover (fig. 8(c) to (d)).

It was later learned that the reduction in wire thickness occurred because the screen fabricator had subjected each screen to a light cold-roll process. The rolling process had reduced each screen thickness, at the crossovers, from the nominal 82 μm design thickness to about 65 μm . These dimensional changes were not detected prior to use of the screen, allowing the screens to move freely within the regenerator cavity.

FIGURE 7. - SCANNING ELECTRON MICROGRAPHS OF REGENERATOR SCREENS. SIGNIFICANT INCREASE IN DAMAGE TO THE WIRES FROM (A) TO (C). FAILURES AT WIRE CROSSOVERS, SMALL CHIPS AND A LARGE PARTICLE CAN BE SEEN IN (C).

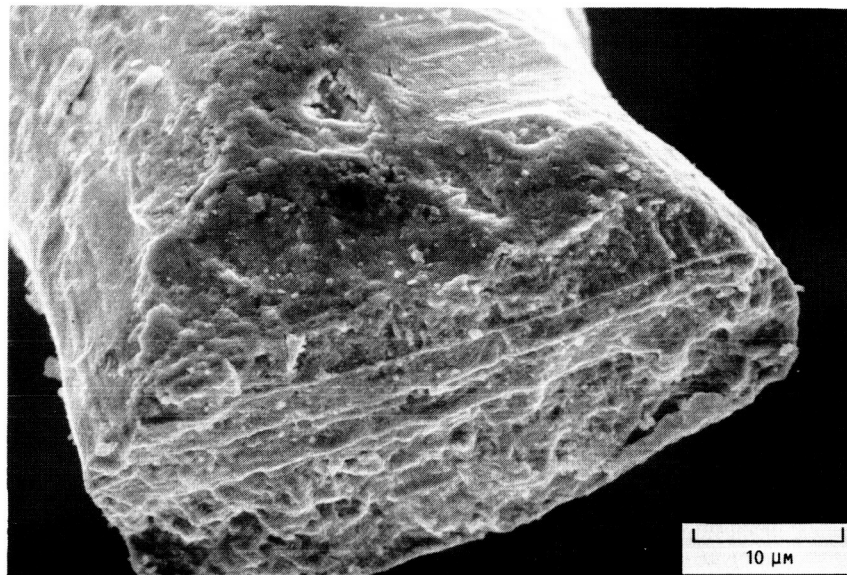
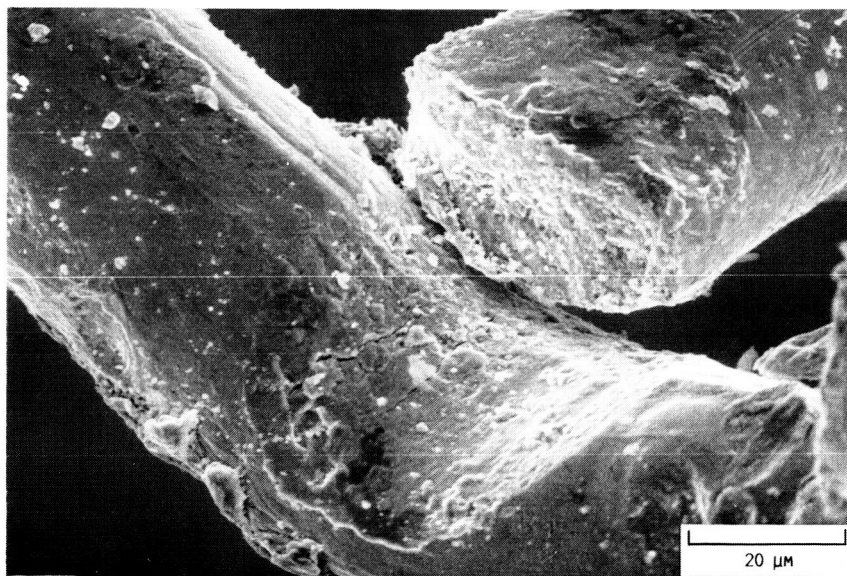
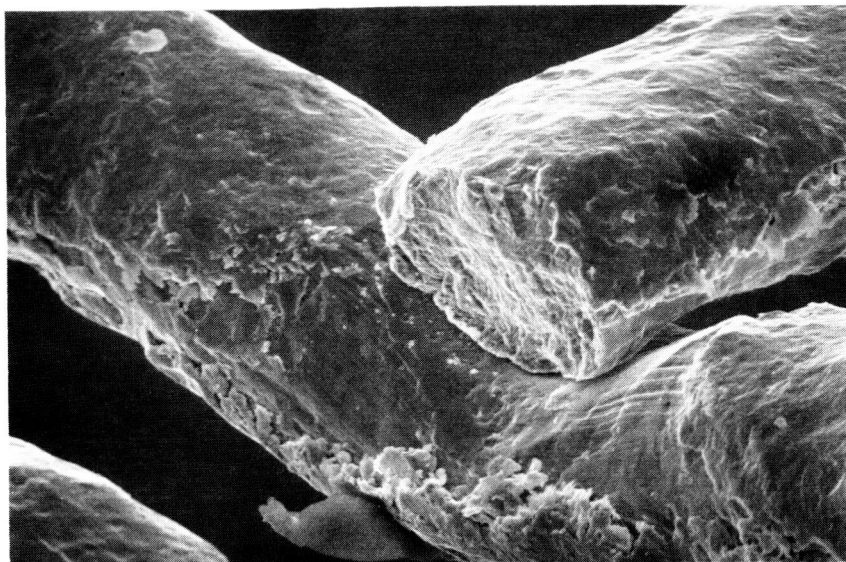
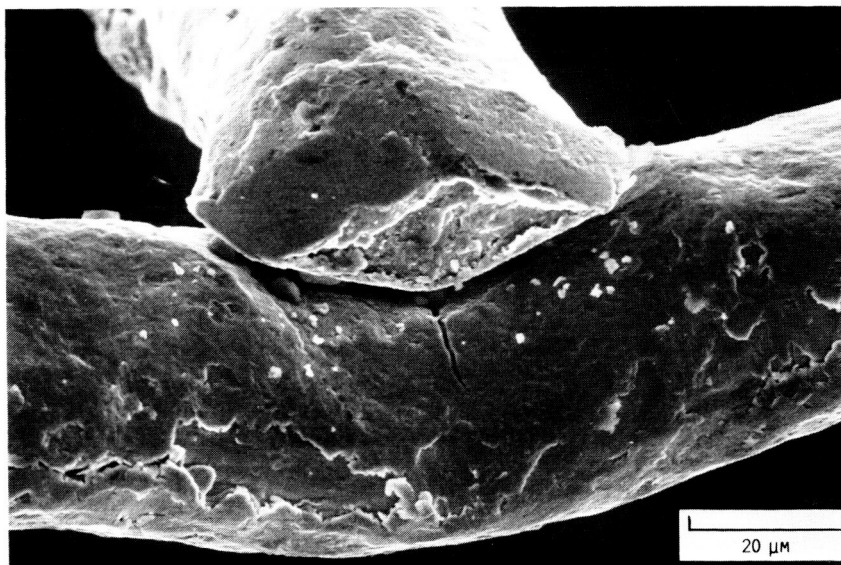
Several factors are believed to have contributed to the fatigue failures of the screen wires at crossovers. These factors include; reduction of wire thickness, stress concentration, and highly worked microstructure. The combination of the reduction in wire thickness and the ability of the individual screens to move, causes stress concentration at the wire crossovers. The highly worked microstructure was found to have a 65 percent increase in hardness (table I) hence, an easier location for crack initiation and subsequent fatigue failure.

FIGURE 8. - SEM MICROGRAPHS OF ENDS OF FAILED WIRES SHOWING OCCURRENCE OF FAILURE AND CRACKING AT WIRE CROSSOVERS AND FATIGUE STRIATIONS.

A new permanent design of the regenerator is now being fabricated with the same Type 304 stainless steel screens sintered together and brazed into a can for insertion into the regenerator cavity as a unit. This new design will prevent individual screen movement, reducing the stress concentration at crossovers. Originally, unsintered screens were chosen over sintered screens because of an expected improvement in performance. Experimental testing of regenerator screens in lower frequency Stirling engines has shown that unsintered screen has better heat transfer and fluid friction characteristics than sintered screen. However, as has been observed, if unsintered loose-screen is used in a regenerator matrix, the screens must be packed tightly together in the regenerator cavity in order to prevent any flexing of the individual screens by the oscillating gas flow.

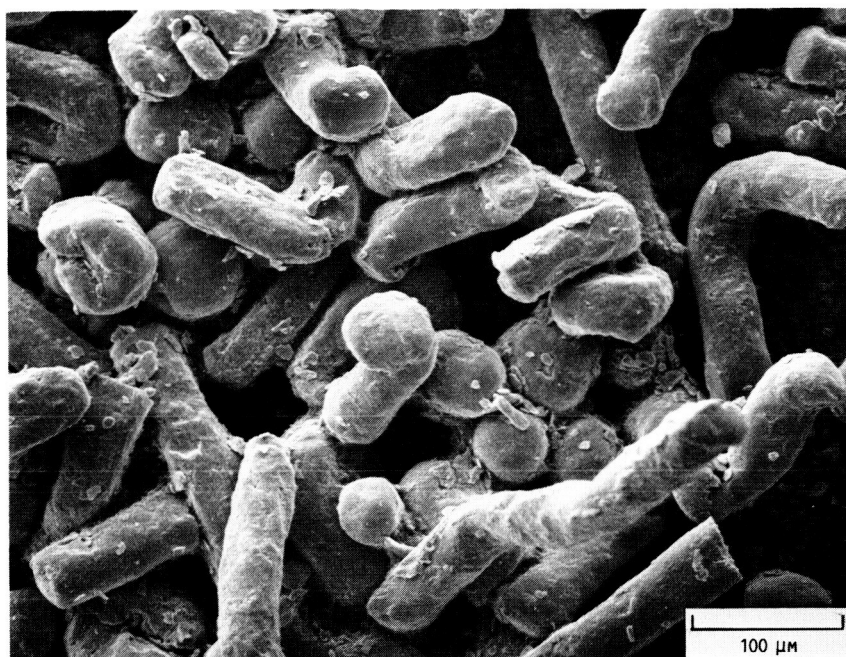
(A) COARSE DEBRIS FOUND BETWEEN SCREENS.

Debris found in the engine was examined by SEM and identified as Type 304 stainless steel by x-ray energy dispersive spectroscopy (XEDS). X-ray diffraction of the debris, as-run-in-engine screens, and as-received screens, were found to consist of both face-centered-cubic ($a = 0.3607 \text{ nm}$) and body-centered-cubic ($a = 0.287 \text{ nm}$) phases. The debris found in between the regenerator screens is shown to be pieces of screen (fig. 9(a) to (b)). The debris found outside the regenerator is made up of stainless steel "chips" less than $20 \mu\text{m}$ in size (fig. 9(c)). The "chips" arise from the deformation of the wire, a chip being fractured from a wire can be seen in figure 9(b). Due to their size they were able to pass through the screen openings and exit the regenerator.

FIGURE 9. - DEBRIS FOUND IN ENGINE. ALL PARTICLES WERE IDENTIFIED BY XEDS AS TYPE 304 STAINLESS STEEL. THE EXTENSIVE CRATERS IN (B) CORRESPOND WITH THE PARTICLES IN (C).

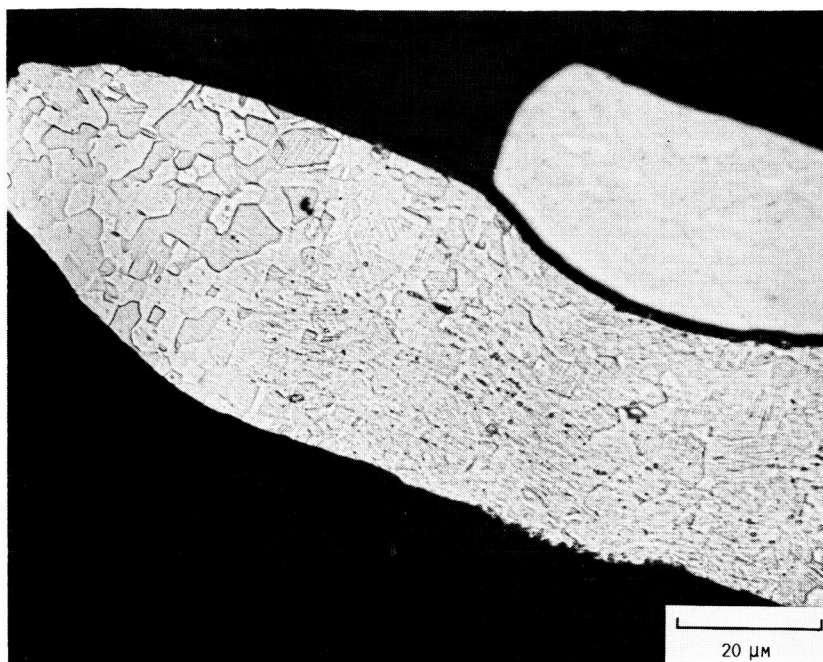
(A) LONGITUDINAL SECTION OF WIRE AT CROSSOVER.

Microstructures of the as-received and run-in-engine screens were examined by performing standard metallographic techniques. Optical micrographs show the wire crossovers to contain a highly worked microstructure, while away from the crossovers the microstructure consisted of equiaxed grains (fig. 10). Transverse sections of the wires showed the worked microstructure to exist across the full thickness of the wires at crossovers (fig. 10(c)). No variation in microstructure was observed between the as-received and run-in-engine screens.

Debris found in the engine was identified as pieces of the regenerator screens. The magnetic behavior of the debris is explained by the presence of a bcc phase identified by x ray diffraction. The bcc phase was also found in the as received screens. It has been shown by Manjoine (ref. 4) that the bcc phase may be present after plastic deformation by tensile or fatigue loading in Type 304 stainless steel. There is clearly evidence of deformation of the as-received screen at crossovers (fig. 10(a)), which can account for the bcc phase being present.

FIGURE 10. - OPTICAL METALLOGRAPHY OF SCREEN WIRES SHOW A HIGHLY WORKED STRUCTURE AT CROSSOVERS. ETCHED ELECTROLYTICALLY USING 8 VOLTS/1 AMPERE IN A SOLUTION OF 10 PERCENT CHROMIC ACID IN WATER.

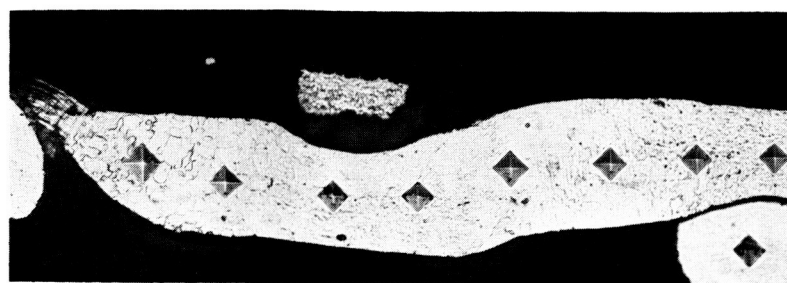
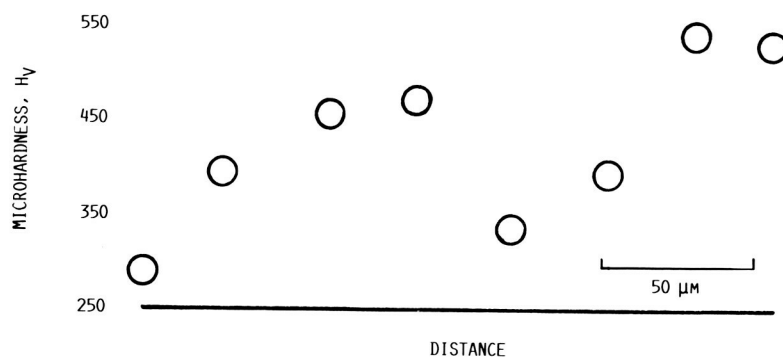
(A) MICROHARDNESS TRAVERSE THROUGH A WIRE CROSSOVER.

Microhardness measurements showed the highly worked microstructure at crossovers to be harder than the equiaxed structure between crossovers (fig. 11(a)). A comparison of hardnesses between as-received and run-in-engine is shown in table I. Hardness of the undeformed wire was the same for both conditions. The deformed wire in the run-in-engine sample showed a slight decrease in hardness when compared to the as-received sample. Microhardness measurements were made on transverse sections for the comparison to be sure that an adequate thickness of sample existed below the indentation for valid measurements (fig. 11(b)). Figure 11(b) also shows a 30 percent reduction of wire thickness from the undeformed wire to the deformed wire at crossover.

FIGURE 11. - OPTICAL MICROGRAPHS OF MICROHARDNESS INDENTATIONS SHOW VARIATION OF MICROHARDNESS.

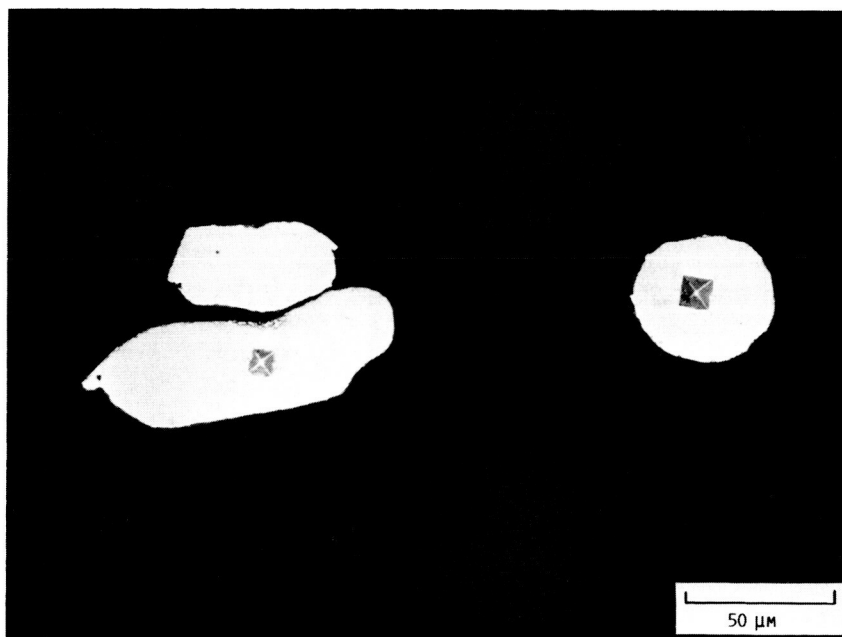
(B) MICROHARDNESS OF A DEFORMED WIRE (AT WIRE CROSSOVER) AND AN UNDEFORMED WIRE.

Undeformed	Deformed
As-received	^b 258±24	452±28
Run-in-engine	251±20	408±47
