Aircraft Accident Report

NASA 712, Convair 990, N712NA
March Air Force Base, California
July 17, 1985

Facts and Analysis

NASA Aircraft Accident Investigation Board
National Aeronautics and Space Administration
Washington, D.C. 20546

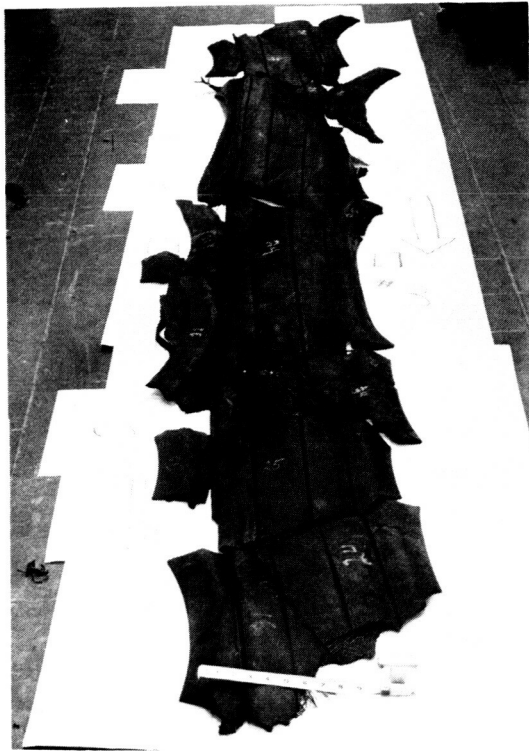
(a) Tire 3 - left front.

Figure 2. - Assembled fragments of right main gear tires from NASA 712, found on runway 32 at March Air Force Base, California.

The sequence of tire failures was established by the marks on the runway and analyses of the tire/wheel assembly fragments. Tire 3 was the first tire to begin fragmenting. Portions of the tread recovered from the runway still had casing attached, indicating that failure probably originated in the casing structure. Once portions of the tread were lost, the diameter of the tire was reduced, causing tire 4 to run in an overloaded condition. This resulted in excessive sidewall flexing and significant heat buildup. The heating reduced cord strength and raised internal tire pressure. When the tensile limits of the cord were exceeded, a catastrophic blowout occurred. Postaccident examination of tire 4 fragments revealed evidence of extreme heat buildup as well as the classic "X" rupture usually attributed to blowout failure. Tires 7 and 8 probably failed from overload caused by the failure of tires 3 and 4. Tires 7 and 8 may also have been punctured by wheel fragments from the two forward wheel assemblies.

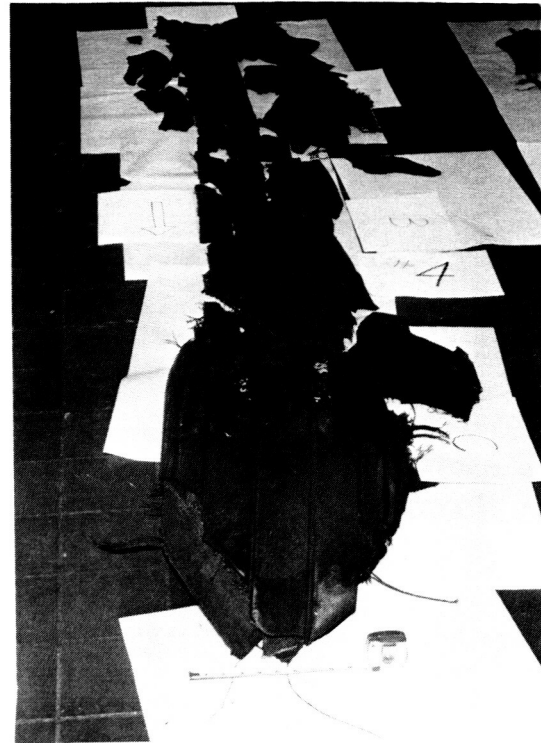
(b) Tire 4 - right front.

The evidence showed that the accident began with tread/carcass separation on tire 3, precipitating the overload failure of tire 4 since both tires were on the same axle. The analysis of tire and wheel marks on the runway indicated that the failure sequence began when the tread from the tire 3 started coming apart at about 1,400 feet. The failing tire 3 caused tire 4 to run in an overloaded condition. This continued until the 4,125-foot mark when tire 4 blew, followed 0.05 second later by the blowout of the tire 3 carcass at 4,138 feet. The postaccident examination of the tire fragments indicated that extreme heat had built up in tire 4, contributing to its failure.

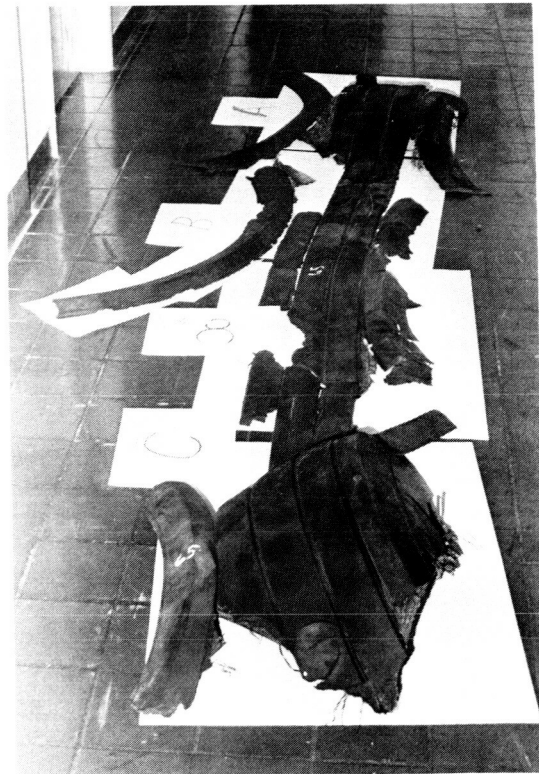
(d) Tire 8 - right rear.

16. A third tire failed at the no. 8 position at 6,190 feet, 2,065 feet after tire 4 failed. Tire 8 failed from overloading or damage from wheel debris.

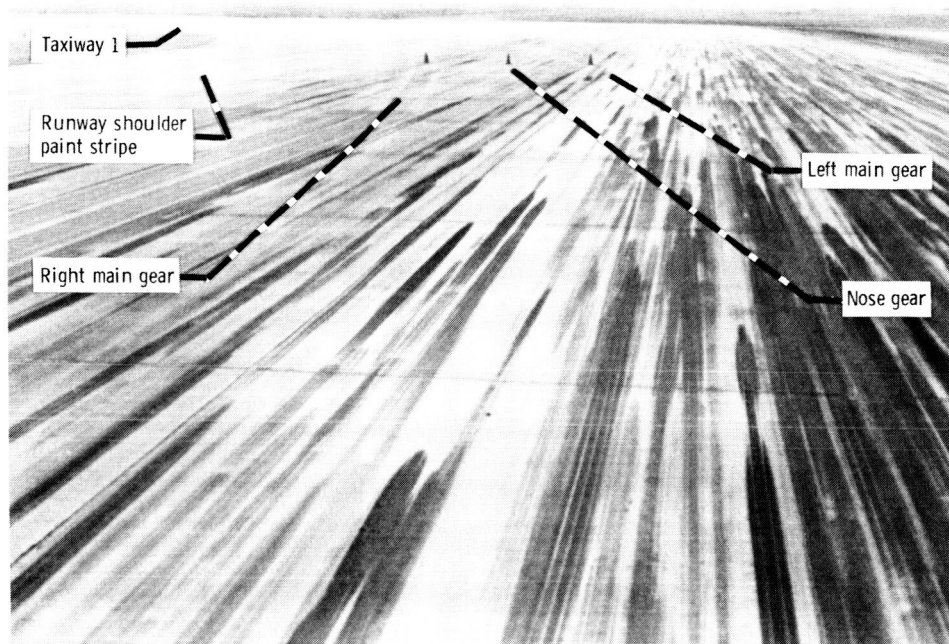
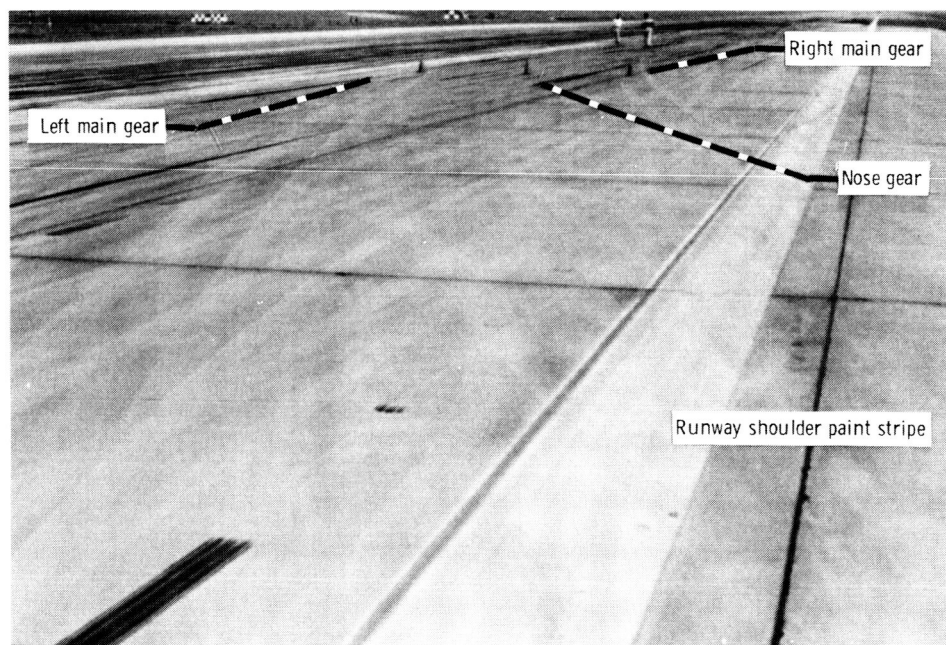
The first marks found were white tire scrub marks, caused by the heavy aircraft scrubbing black deposits off the PCC runway surface, tracking from taxiway 1 onto runway 32. The width of each mark and the spacing between the marks of each landing gear were the same as the dimensions of the CV-990 aircraft (fig. 7). These white tire marks faded away as the airplane entered the moderately to heavily rubber contaminated area near the runway centerline at about 700 feet.² The marks did not show evidence of dragging brakes or underinflated tires. The first tire rubber shards were found at about 1,400 feet on the right side of the centerline near the arresting gear cable (fig. 6(a)). At 2,200 feet and about 11 feet right of the centerline, fresh squiggly rubber marks were found on the rubber-coated PCC surface in line with the estimated position of tires 3 and 7. These wavy intermittent rubber marks, visible for about 400 feet (fig. 8), were later associated with tire 3 by tread debris found nearby. All of the tire fragments collected on the runway between 1,300 and 4,000 feet were later identified with tire 3. Rubber marks were found on the runway surface at 4,125 and 4,138 feet, indicating where tire 4 and then tire 3 blew out. Visible score marks (fig. 9), starting at about 4,175 feet, showed where the wheel flange rims of wheels 3 and 4 contacted the PCC surface. Fragments from the remainder of tire 3 and from tire 4 were scattered over a large portion of the runway surface between 4,000 and 5,200 feet.

Figure 7. - Suspected white tire scrub marks produced during turn onto runway 32 at taxiway 1.

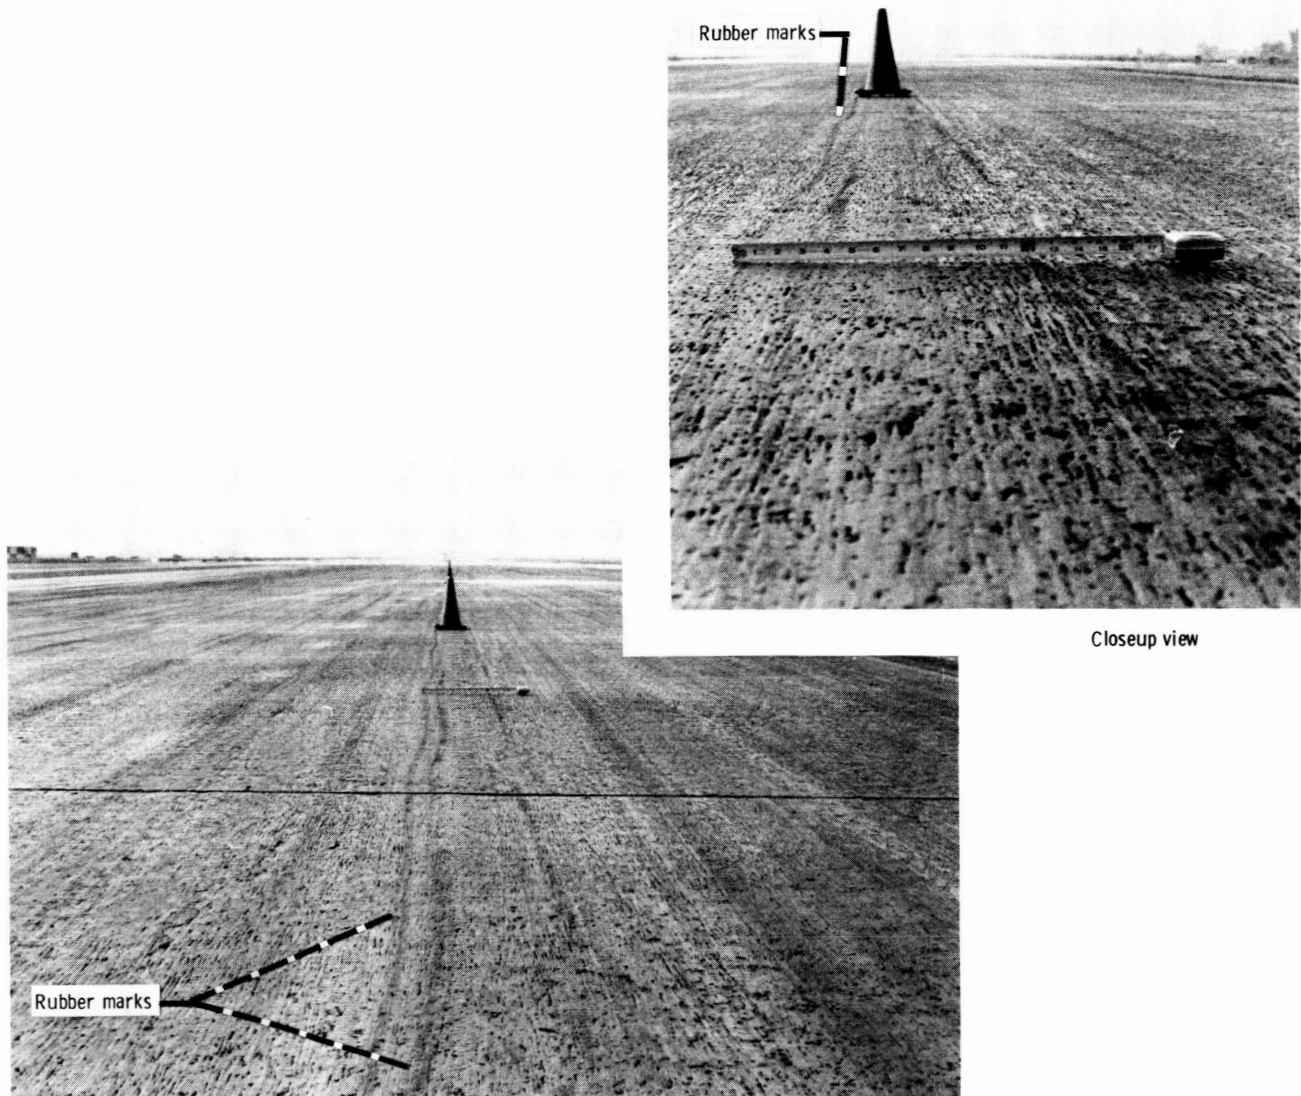
Figure 8. - Tire 3 rubber marks found on surface 2,200 ft from threshold of runway 32.

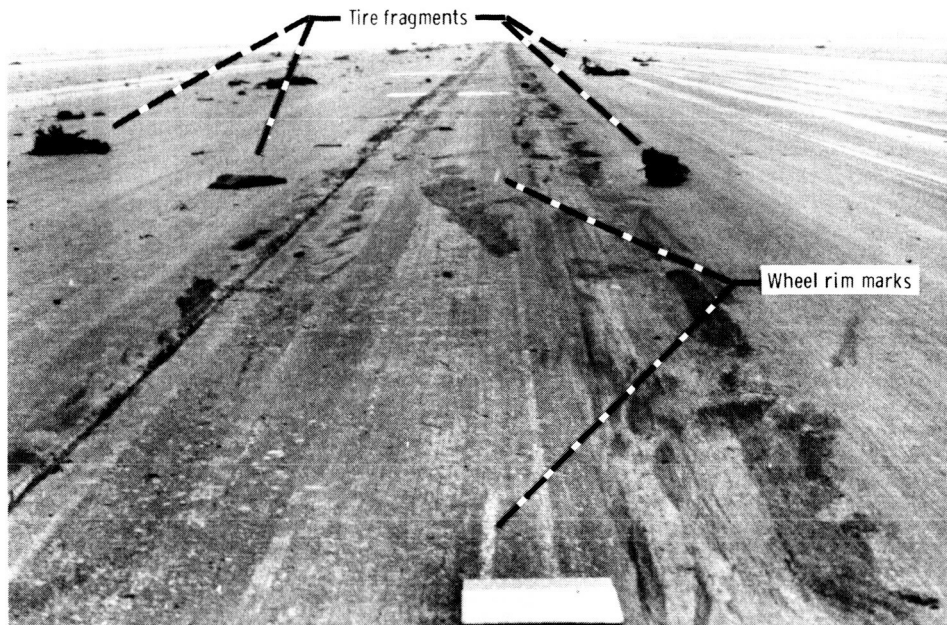
Figure 9. - Wheel flange rim marks and debris from tires 3 and 4 at approximately 4,188 ft from runway 32 threshold.

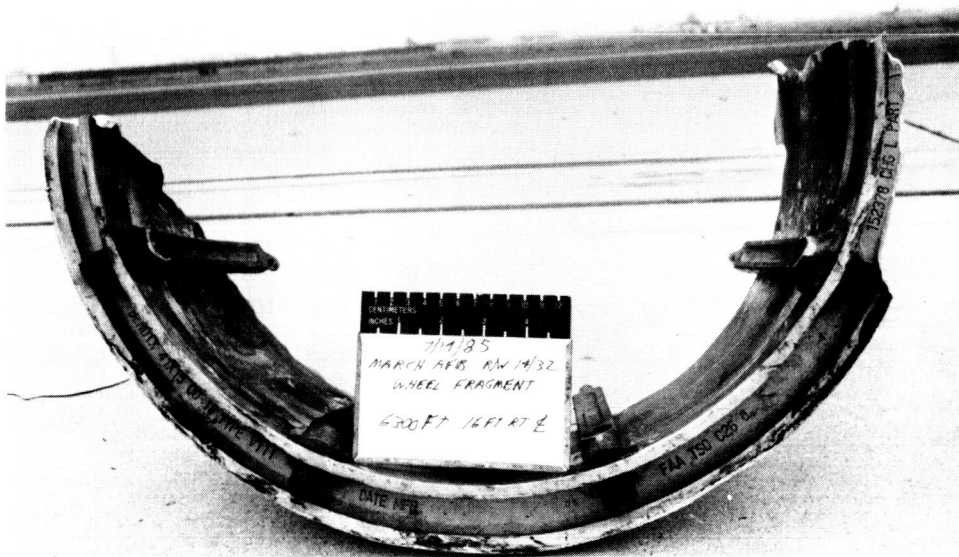
Figure 10. - Fragment of wheel 4 found 6,300 ft from runway 32 threshold.

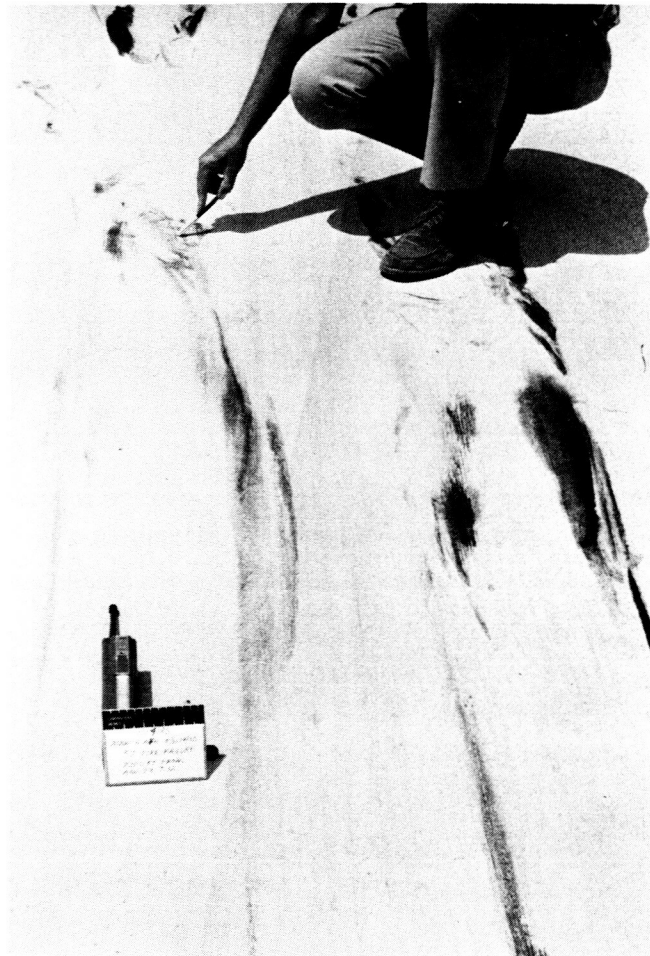
Figure 11. - Runway surface rubber marks from blowout of tire 7.

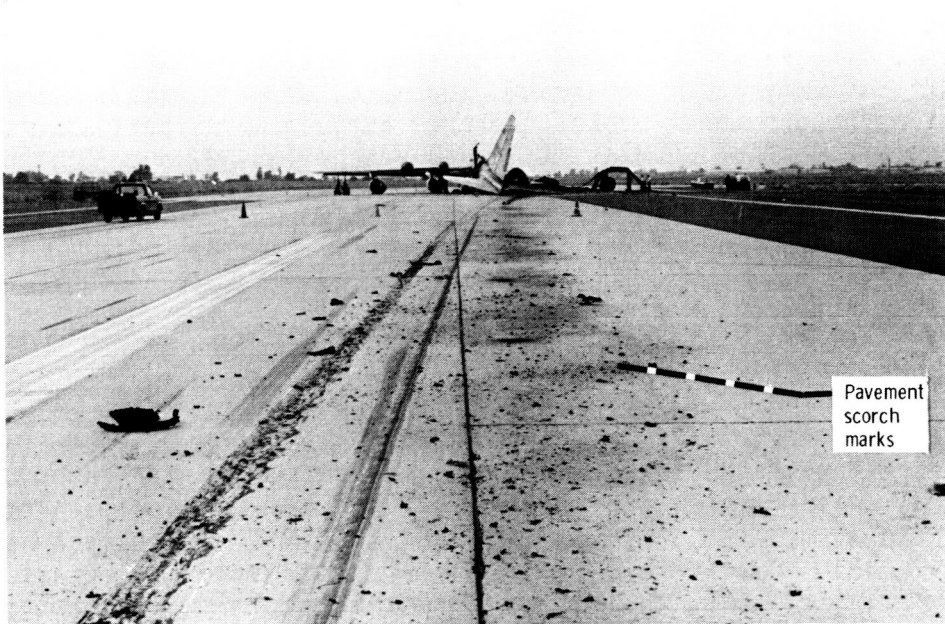
Figure 12. - Runway surface scorch marks and tire rubber debris from right main gear at about 11,950 ft down runway 32.

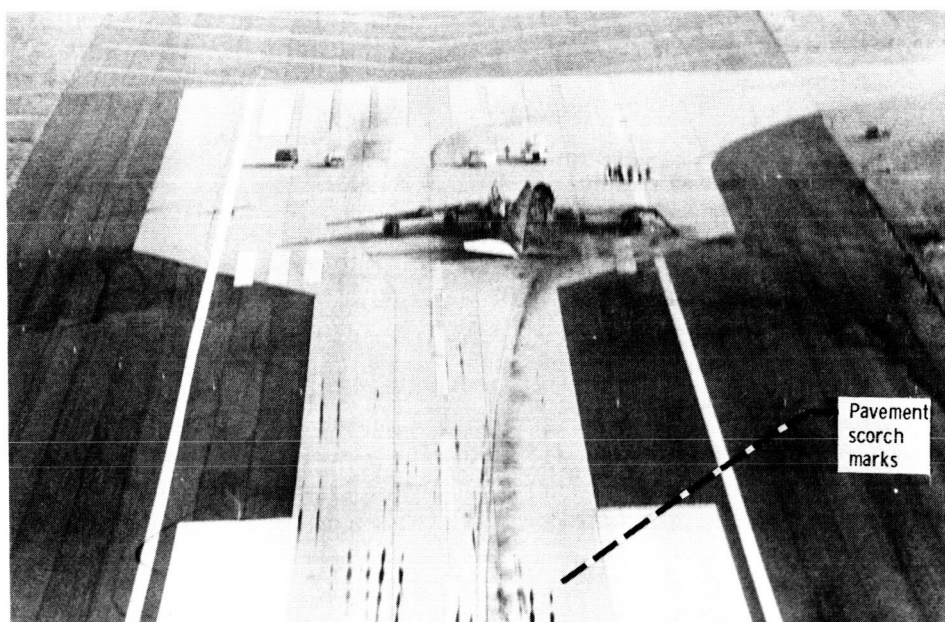
Figure 13. - Aerial view of fire-damaged NASA 712 at stop point, 12,660 ft down runway 32.

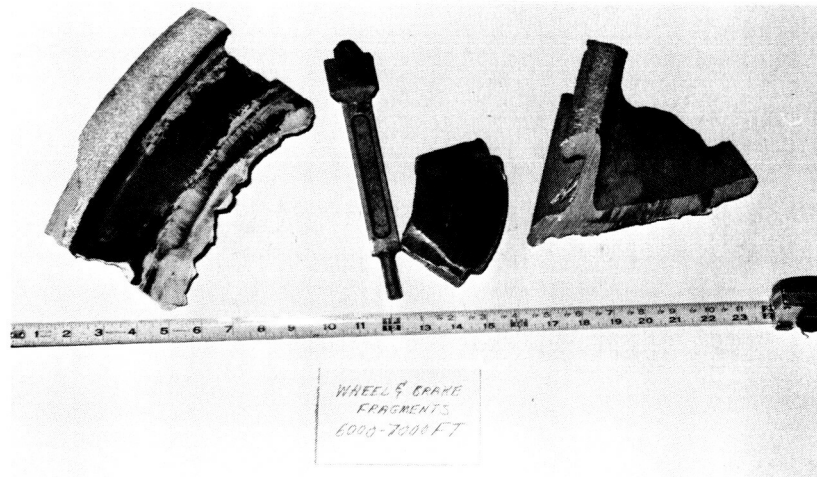
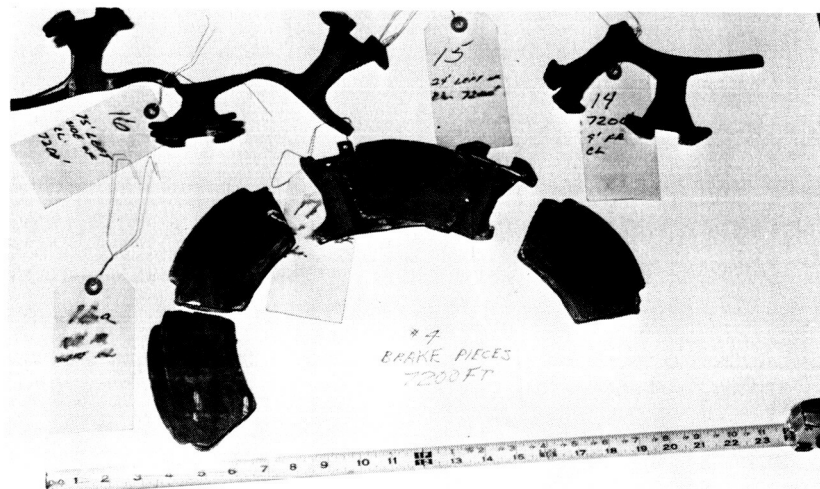
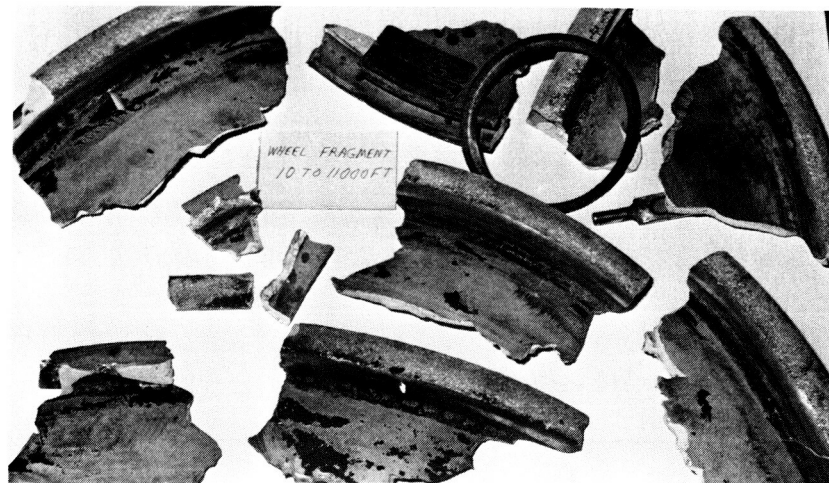
Figure 14. - Some additional fragments of right main gear wheel/brake assembly found at various locations on runway.

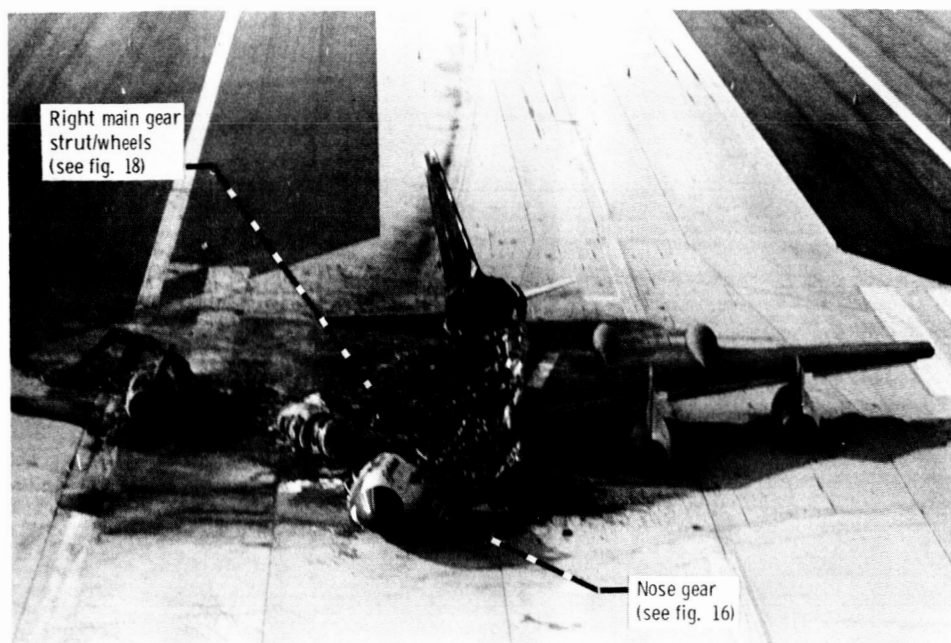
Figure 15. - Aerial view of fire-damaged NASA 712 taken at front of wreckage.

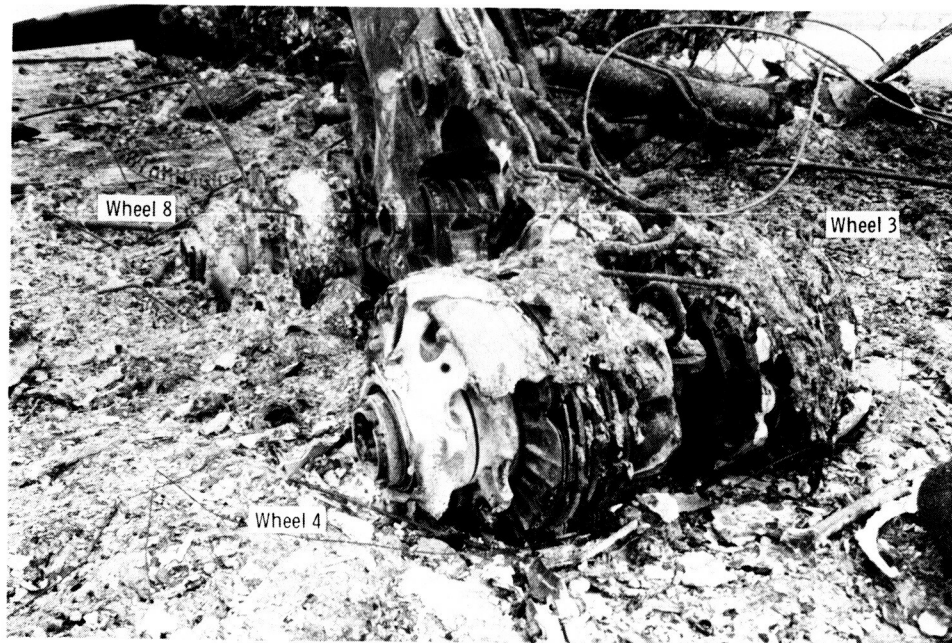
Figure 18. - Closeup view of right main gear wheels after fire.

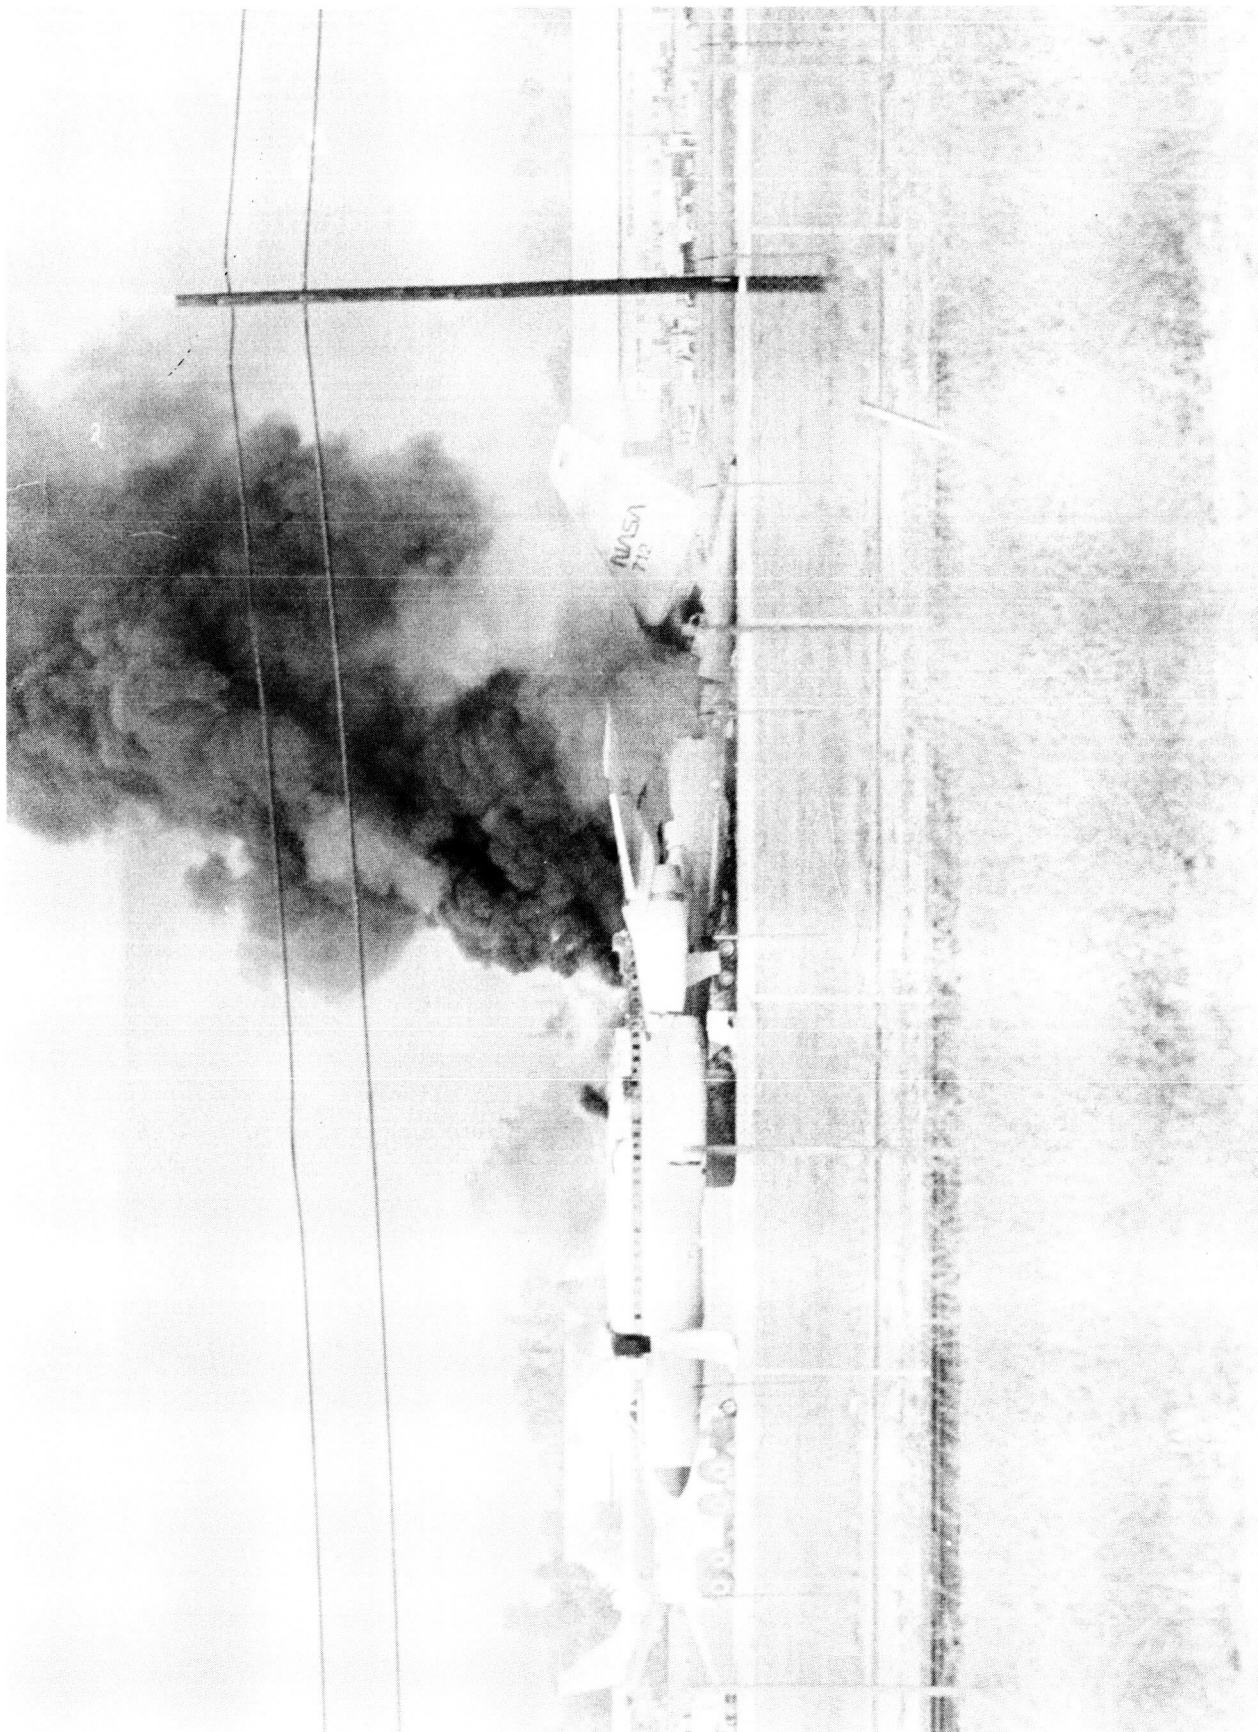
The fire became more intense after the aircraft came to a stop and the fuel column became involved. The fire rapidly spread to the right inboard engine, to the right-wing root, and then rearward along the right fuselage, engulfing the right side of the aircraft in flames (figs. 19 and 20).

Figure 19. - NASA 712 on fire at end of runway 32.

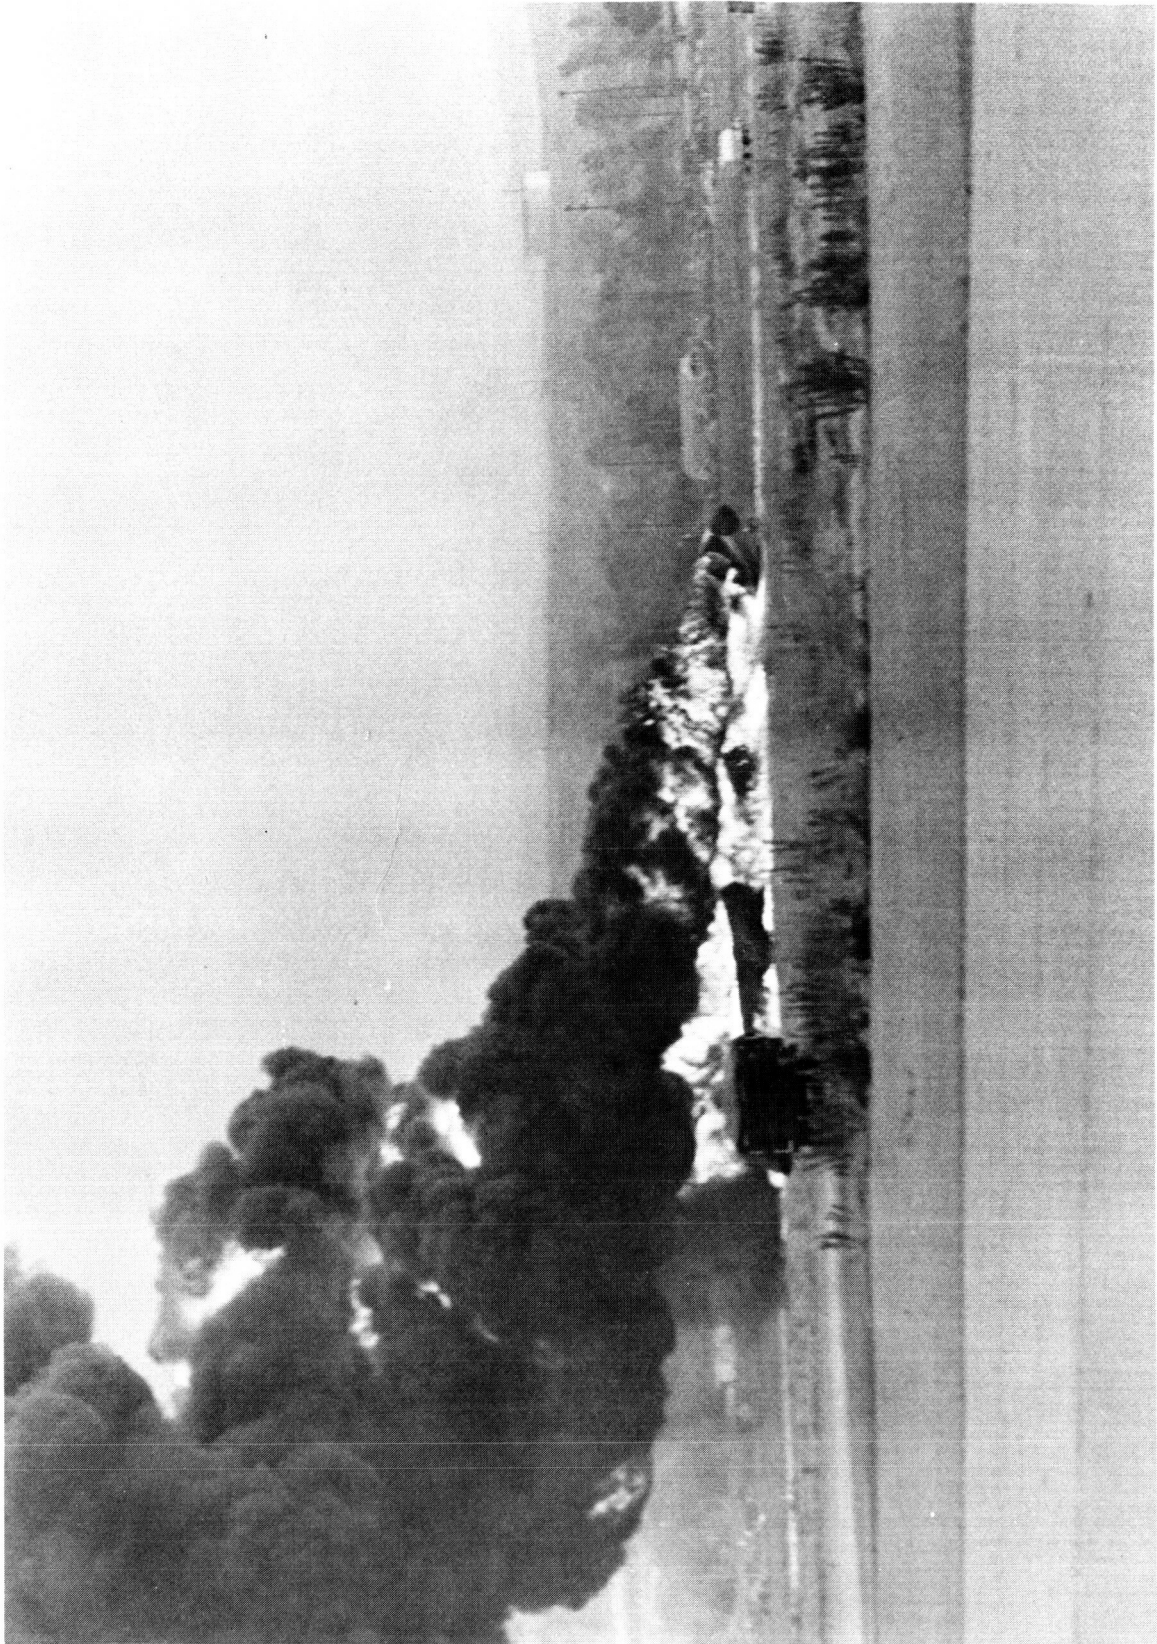
Figure 20. - NASA 712 engulfed in flames.
