NASA Technical Memorandum 100189

Analysis of Convair 990 Rejected-Takeoff Accident With Emphasis on Decision Making, Training, and Procedures

Byron E. Batthauer
Lewis Research Center
Cleveland, Ohio

Prepared for the
40th International Air Safety Seminar
sponsored by the Flight Safety Foundation, Inc.
Tokyo, Japan, October 26-29, 1987

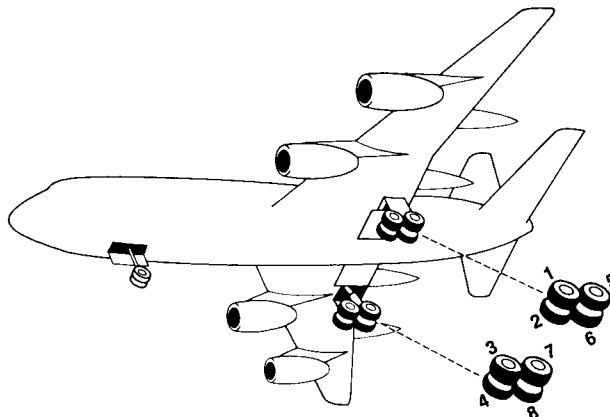
The flightcrew stated that everything was normal in the cockpit during the first part of the takeoff roll. However, the occupants of the cabin and several witnesses outside the aircraft noted abnormalities. A technician, watching a television monitor linked to a camera focused on tire 3 (fig. 1), noticed deformation of the tire early in the takeoff roll before the tire blew out. Another technician occupying a right-side cabin seat aft of the wing had a fleeting perception of a "black object flying over the wing." An outside witness made a similar comment. Other witnesses, who were positioned about 2 miles from the aircraft, noticed white smoke coming from the aircraft underside early in the takeoff roll. There was no indication of these abnormalities in the cockpit, nor did the cabin occupants relay their observations to the flightcrew.

Figure 1. - Positions of tire and wheel assemblies on CV-990 main landing gear.

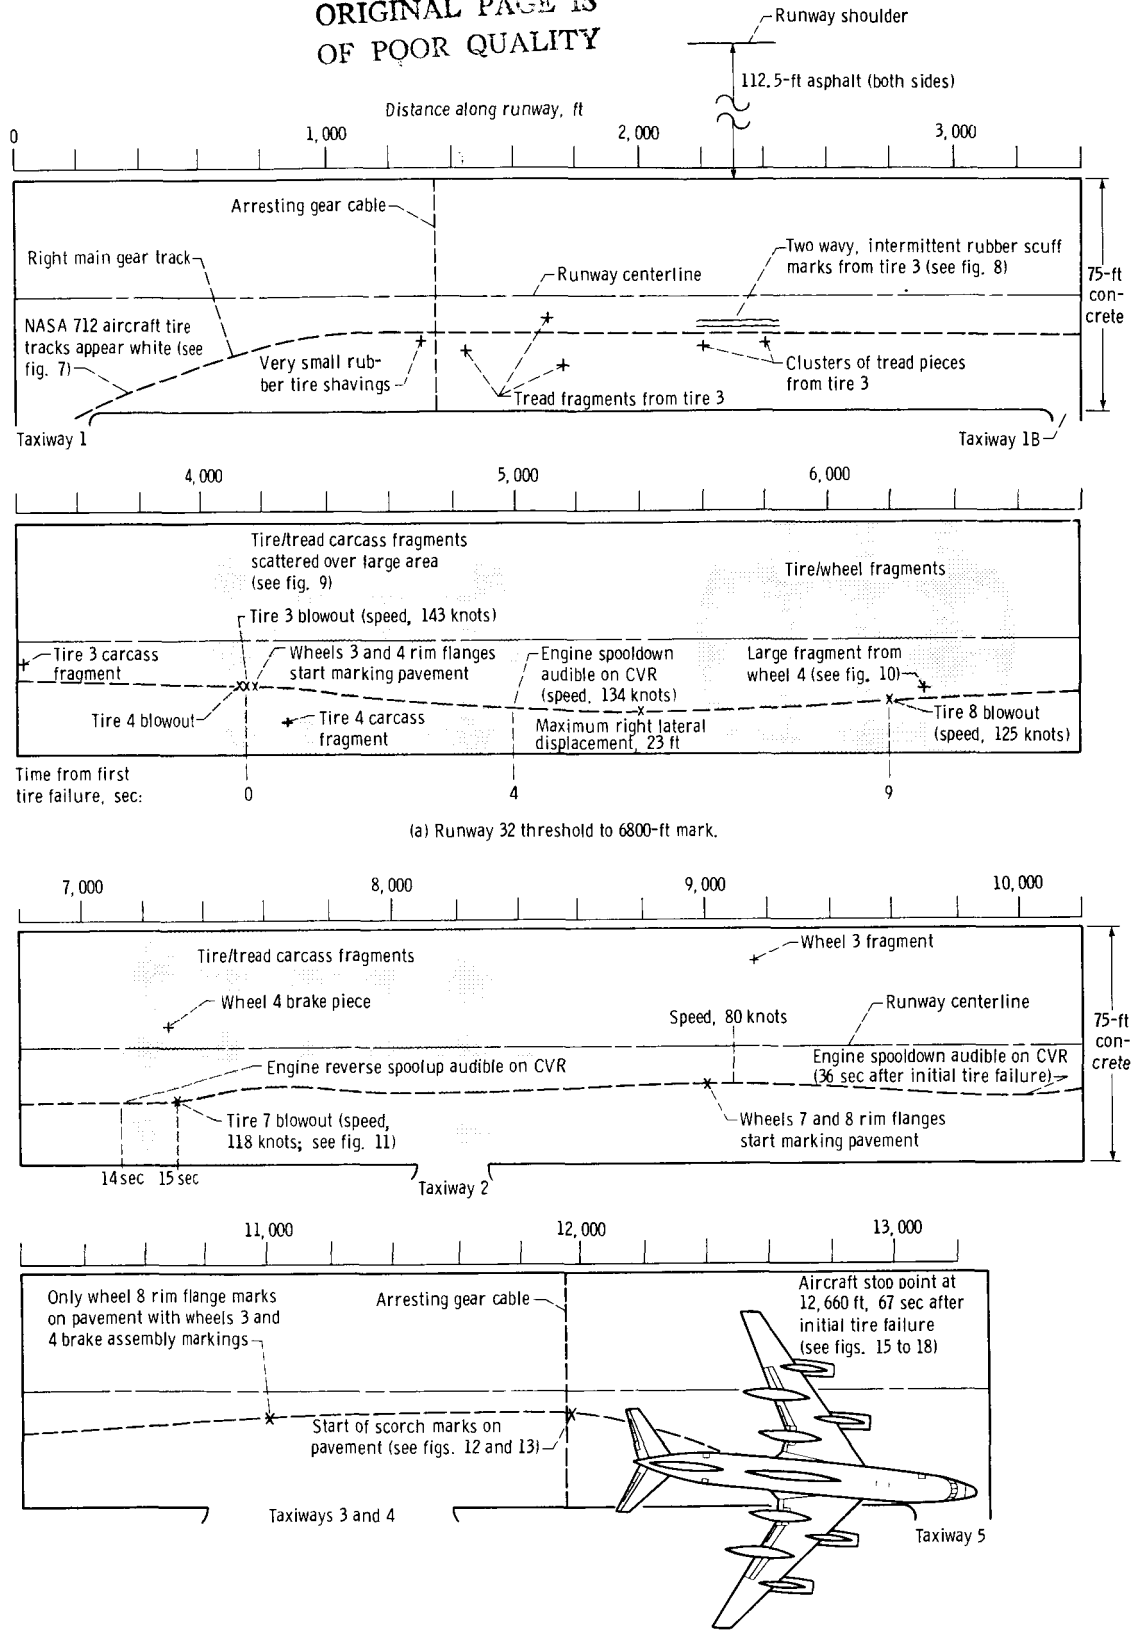
To assist the Accident Board in analyzing the sequence of the aircraft accident events, a runway event reconstruction was diagrammed (fig. 2). This was accomplished by identifying the debris and its location on the runway, along with marks made on the runway surface primarily by the tire and wheel assemblies of the right main landing gear. From this and other factual data, the following accident sequence analysis was made.

Figure 2. - Reconstruction of NASA 712 accident. Total runway width, 300 ft with 75-ft concrete surface in center and 112.5-ft asphalt on both sides.

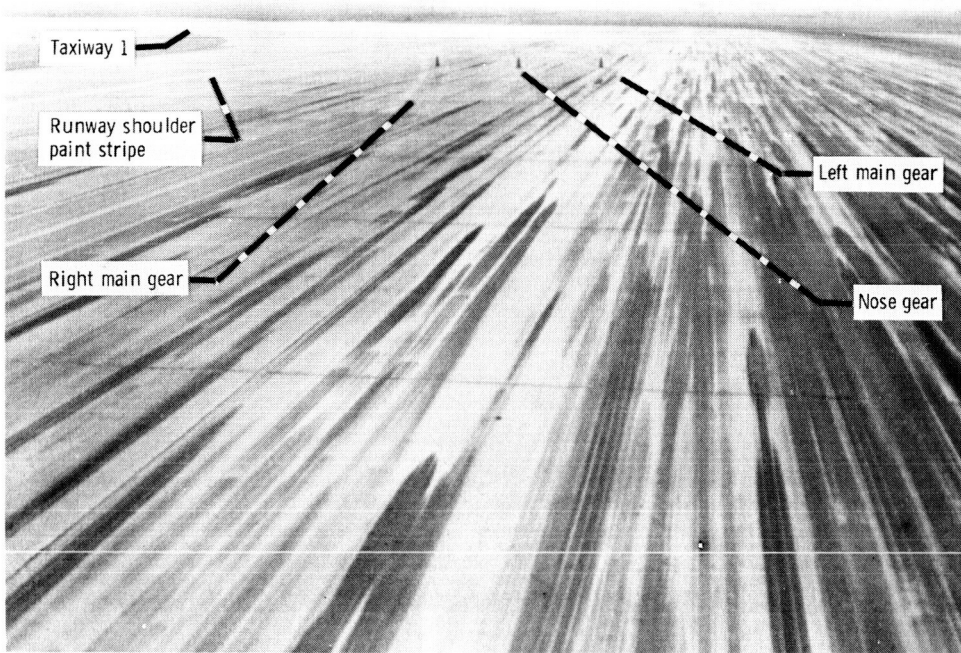
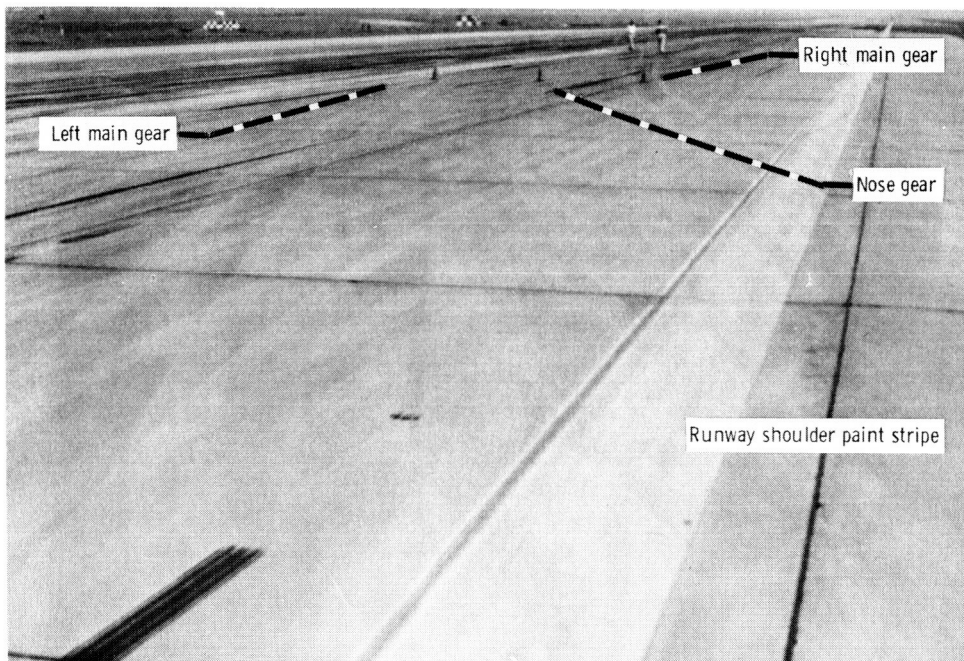
As the aircraft taxied onto runway 32, it left a distinctive white track (fig. 3). The aircraft tires scrubbed black jet engine exhaust deposits off the concrete runway surface during the turn onto the runway. These white tire marks faded away as the aircraft entered the moderate-to-heavy rubber-contaminated area near the runway centerline at about 700 feet.² The width of the individual tire tread was uniform, showing no evidence of lost inflation pressure or other tire abnormality. Light or even moderate brake drag probably would not be detected on the runway or taxiway surface, but subsequent heat effects would have occurred in the tire body. The first tire rubber shards were found at about 1,400 feet on the right side of the centerline near the arresting gear cable. At 2,200 feet and about 11 feet right of the centerline, fresh squiggly rubber marks were found on the rubber-coated concrete surface in line with the estimated position of tires 3 and 7 (fig. 1). These wavy intermittent rubber marks, visible for about 400 feet (fig. 4), were later associated with tire 3 by tread debris found nearby. All of the tire fragments collected on the runway between 1,300 and 4,000 feet were later identified with tire 3. The tire 3 retread cap (fig. 5), most of which was recovered, showed no heat effects. Inspection of the wheel bearings on the right main landing gear, with particular emphasis on bearings 3 and 4, revealed no abnormalities. An inspection of the brakes, although not conclusive because of fire damage, showed no evidence of dragging. Therefore it was concluded that the main gear tires were properly inflated and that the brake systems were normal during the initial takeoff acceleration roll.

Figure 3. - Suspected white tire scrub marks produced during turn onto runway 32 at taxiway 1.

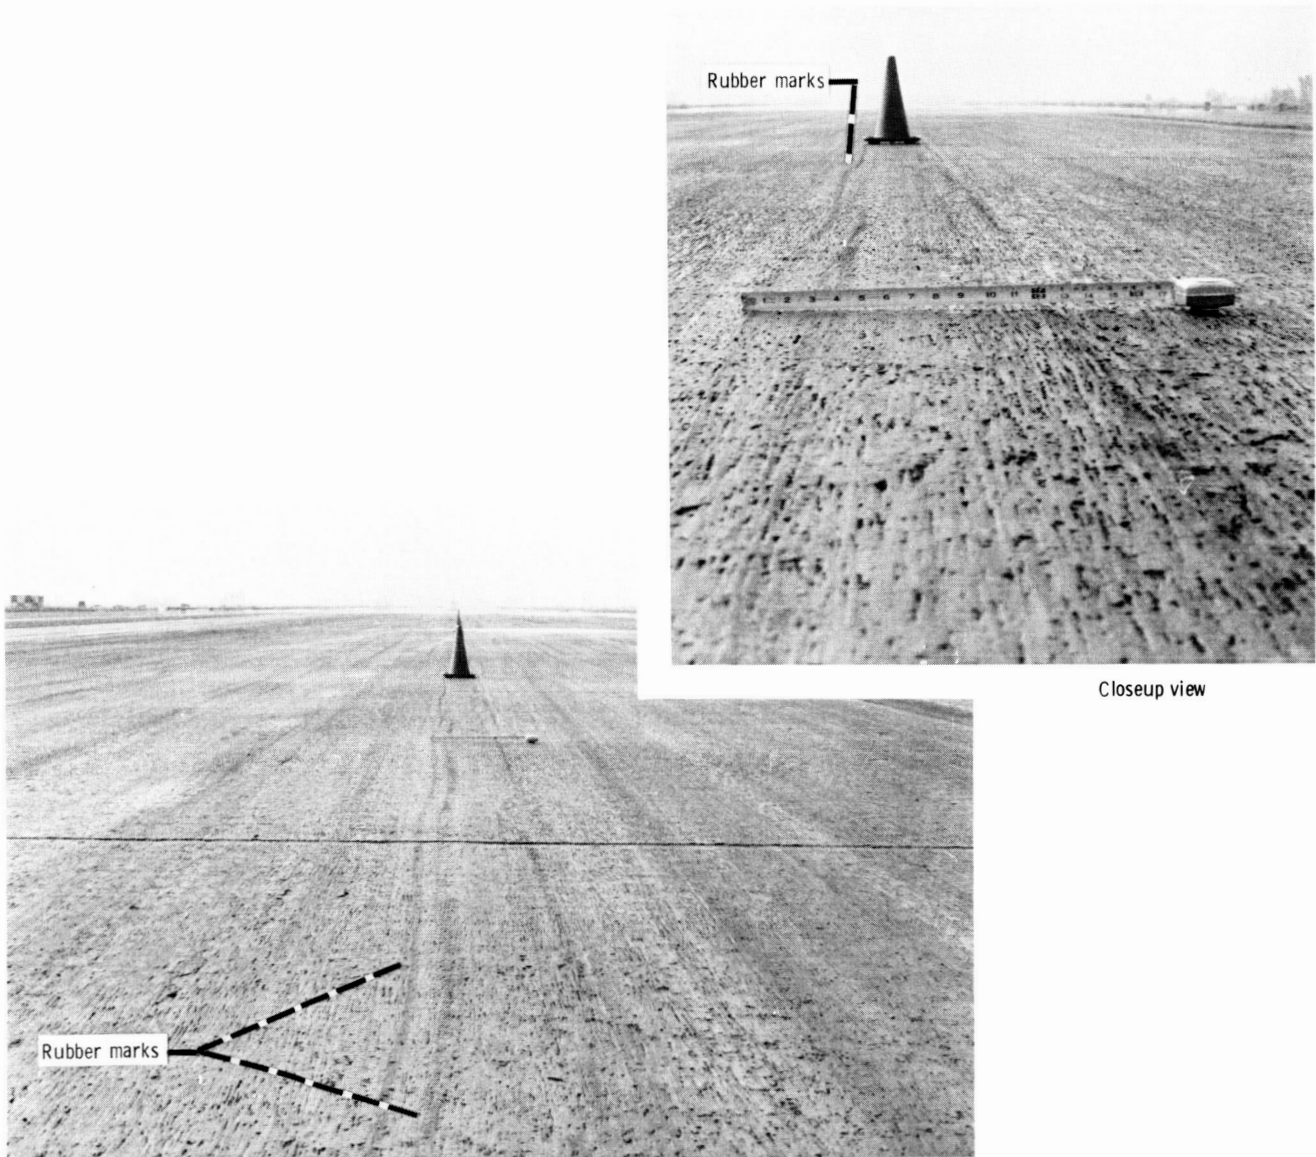
The analysis of tire and wheel marks on the runway indicated that the failure sequence began when the tread from the tire 3 started coming apart at about 1,400 feet. The failing tire 3 caused tire 4 (both on the same axle) to run in an overloaded condition. This continued until the 4,125-foot mark, when tire 4 blew, followed 0.05 second later by the blowout of the tire 3 carcass at 4,138 feet. The postaccident examination of the tire fragments indicated that extreme heat had built up in tire 4, contributing to its failure. Fragments of tires 3 and 4 were scattered over a large portion of the runway surface between 4,000 and 5,200 feet. The drag resulting from the tire failures caused the aircraft to swerve slightly to the right. Marks on the runway indicated that the swerve began within 300 feet (less than 2 seconds) of the first two tire blowouts. There were no visible indications of left main gear wheel braking to correct for this swerve and, in fact, the pilot stated that he was "going to stay off the brakes." The actions taken by the pilot, after the first tire blowouts, were to close the throttles (the CVR indicated that the throttles were closed within 4 seconds of these blowouts), to deploy the spoilers, and to correct for a slight right swerve. There was no runway evidence of wheel braking from either the fully operational left main gear or the failing right main gear during the entire rollout.

Figure 4. - Tire 3 rubber marks found on surface 2, 200 ft from threshold of runway 32.

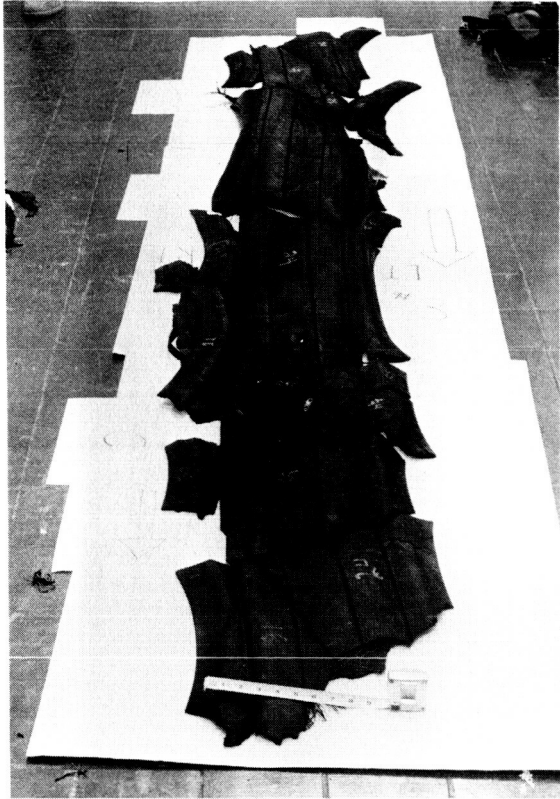
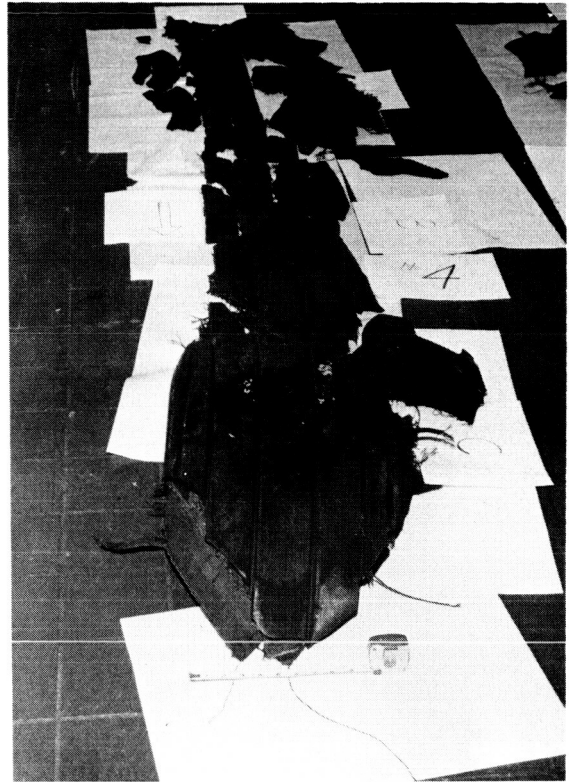
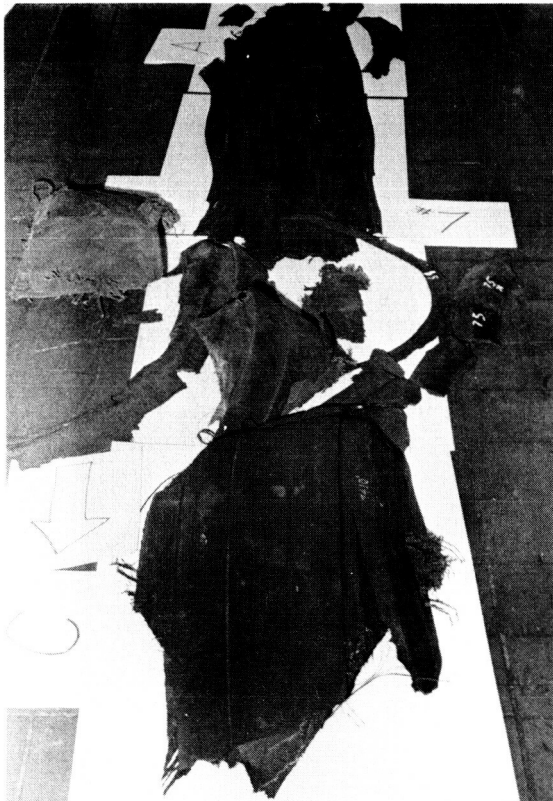
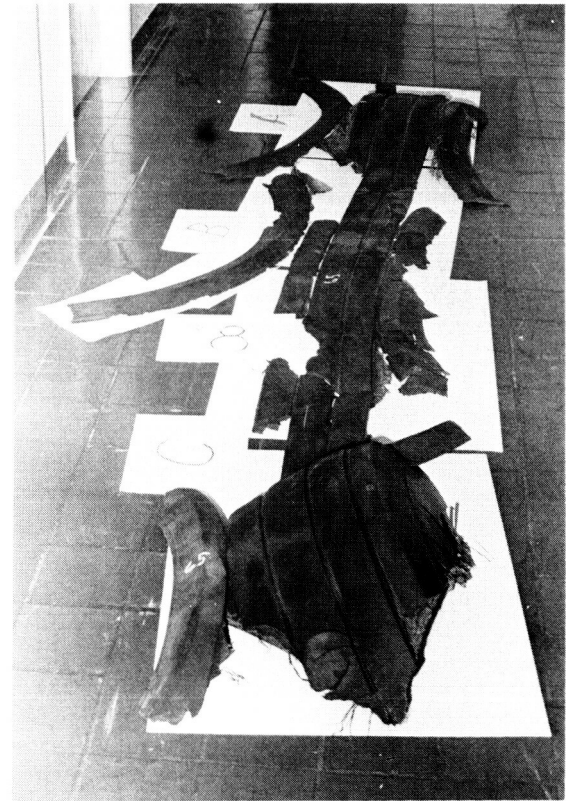
Figure 5. - Assembled fragments of right main gear tires from NASA 712, found on runway 32 at March Air Force Base, California.

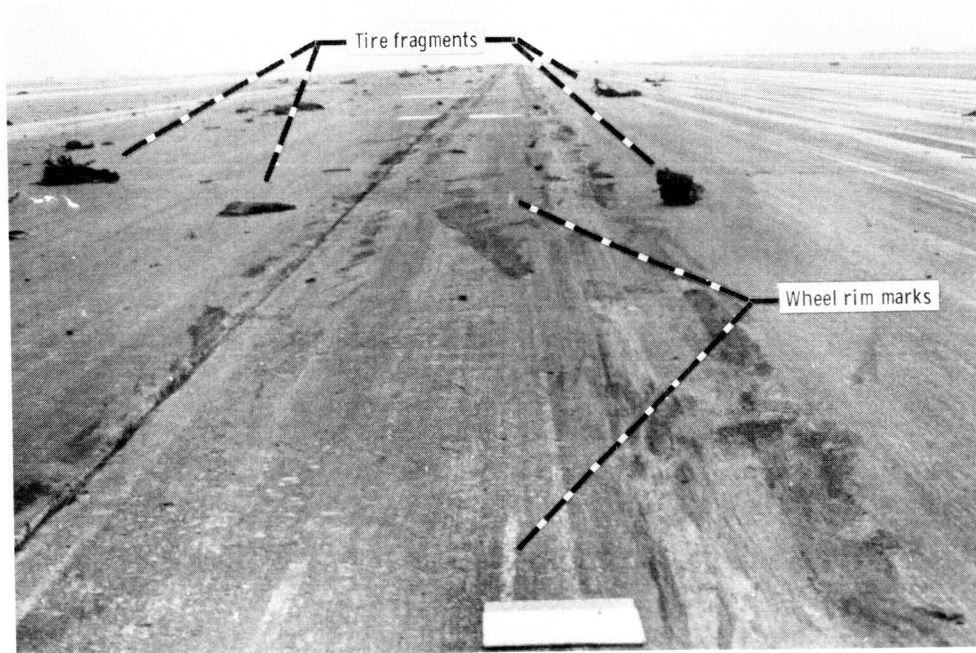
With the failure of tires 3 and 4 on the right truck, visible score marks (fig. 6), starting at about 4,175 feet, showed where the number 3 and 4 frangible aluminum wheels contacted the runway. The right side of the aircraft was now supported by tires 7 and 8 and wheel rims 3 and 4. The aircraft began riding intermittently on wheel rims 3 and 4 from the 4,175-foot point, since most of the rubber of tires 3 and 4 (except for the bead bundles) quickly abraded. Wheel fragments from wheels 3 and 4 were found on the runway starting at about 5,600 feet, the point at which the rims started breaking up, scattering fragments in all directions. A fragment from wheel 4 is shown in figure 7. These fragments may have contributed to the failure of the two rear tires. Rubber marks on the runway surface at 6,190 feet indicated where tire 8 blew out. From CVR information this occurred 9 seconds after tire 4 blew out. The flightcrew perceived this as the second tire failure. Scuff marks on the runway surface at 7,300 feet (fig. 8) indicated where tire 7 blew out, and the sound was recorded on the CVR. However, the flightcrew stated that they did not hear the blowout as it was masked by the sounds of engine spoolup as reverse thrust was being applied 12 seconds after the "abort" callout. A large number of tire rubber and wheel fragments were found scattered over the runway from 7,100 to 8,400 feet (fig. 9).

Figure 6. - Wheel flange rim marks and debris from tires 3 and 4 at approximately 4,188 ft from runway 32 threshold.

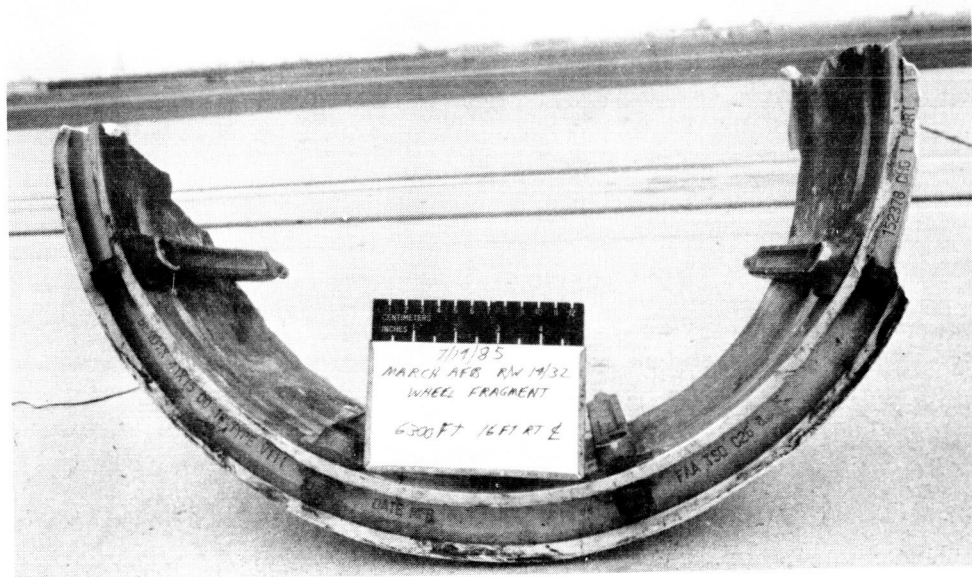
Figure 7. - Fragment of wheel 4 found 6,300 ft from runway 32 threshold.

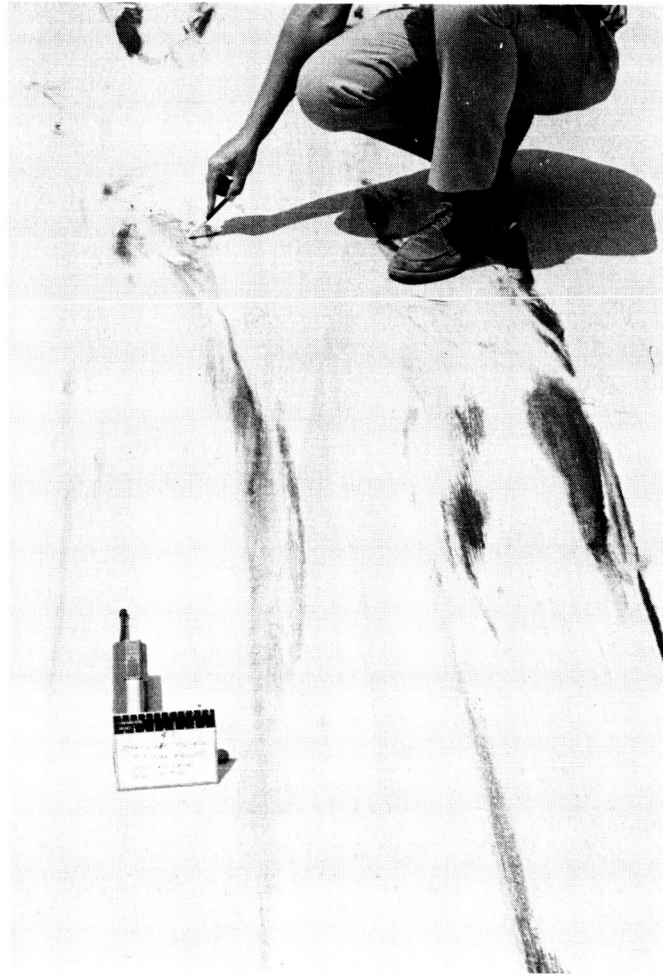
Figure 8. - Runway surface rubber marks from blowout of tire 7.

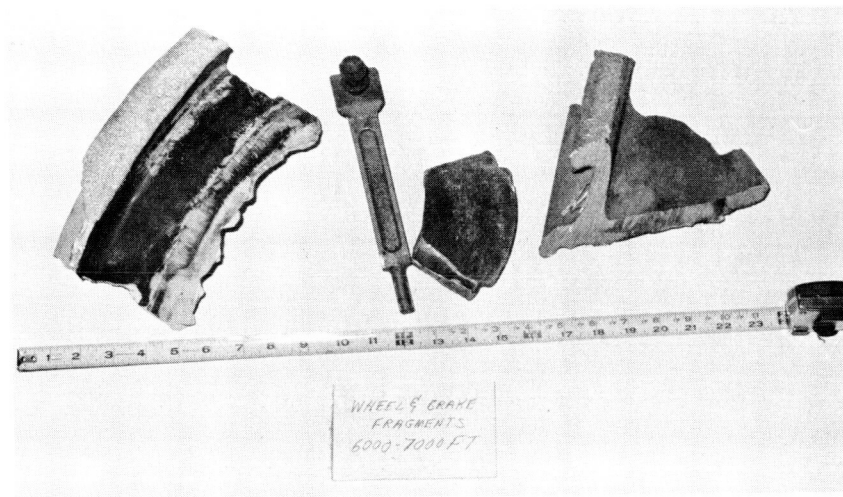
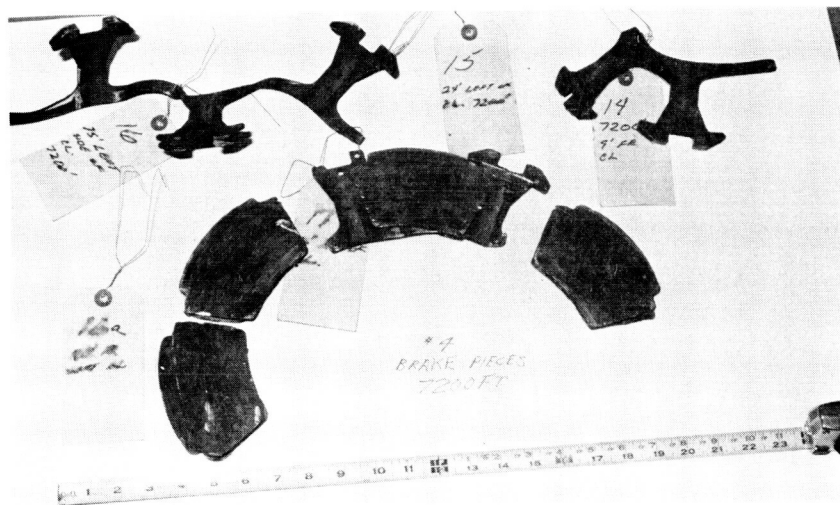
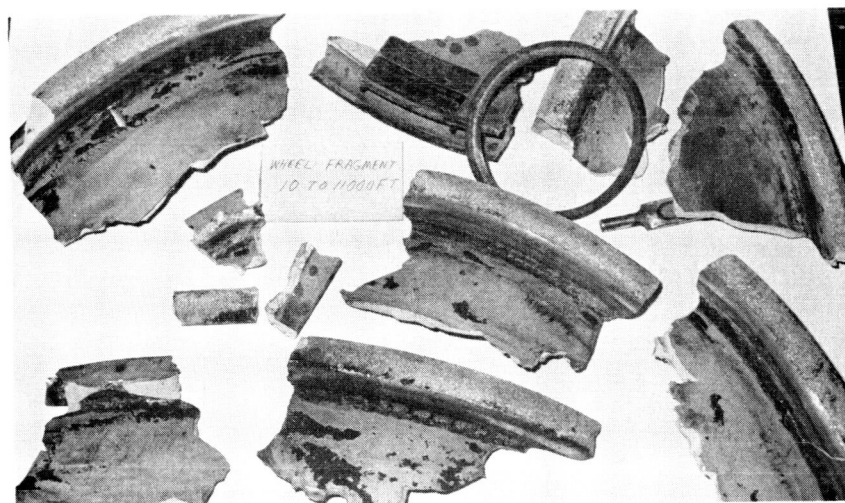
Figure 9. - Some additional fragments of right main gear wheel/brake assembly found at various locations on runway.

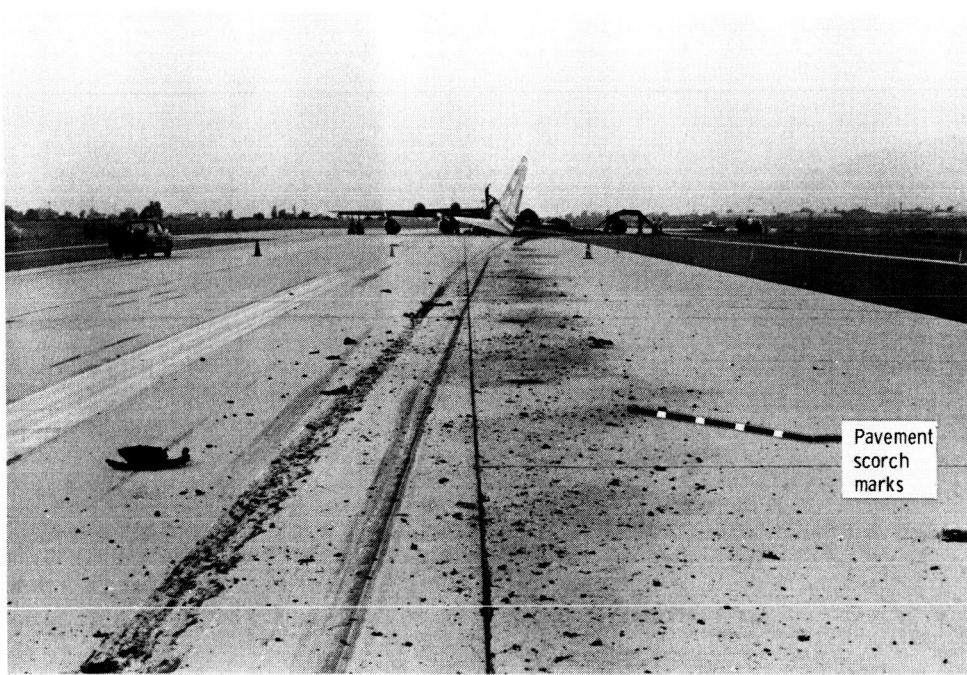
From witness testimony it is suspected that the wing was punctured after failure of the number 3 and 4 rim and wheel assemblies, somewhere between 6,000 and 7,000 feet from the takeoff end of the runway. Wheel scuff marks on the runway surface at 8,000 feet indicated that wheels 3 and 4 were worn down to the hub (wide marks) but that wheels 7 and 8 were still rolling on the rims (two narrow marks for each wheel). The scuffing on the runway of the tire remnants and bead bundles and the failure of tires 7 and 8 probably caused an almost continuous trail of white smoke to be emitted from the underside of the aircraft. However, it was not until after 7,000 feet that outside witnesses described intermittent flashes of fire around the right main gear. Inside witnesses saw flames coming from under the right wing flaps at 10,000 feet and passed this information to the flightcrew. The first evidence of fire on the runway - scorched, discolored concrete surface - was at 11,950 feet. The marks were in line with the tracks of the right main gear wheels. The scorched surface marks persisted down the runway to the aircraft stop point at 12,660 feet

Figure 10. - Runway surface scorch marks and tire rubber debris from right main gear at about 11,950 ft down runway 32.

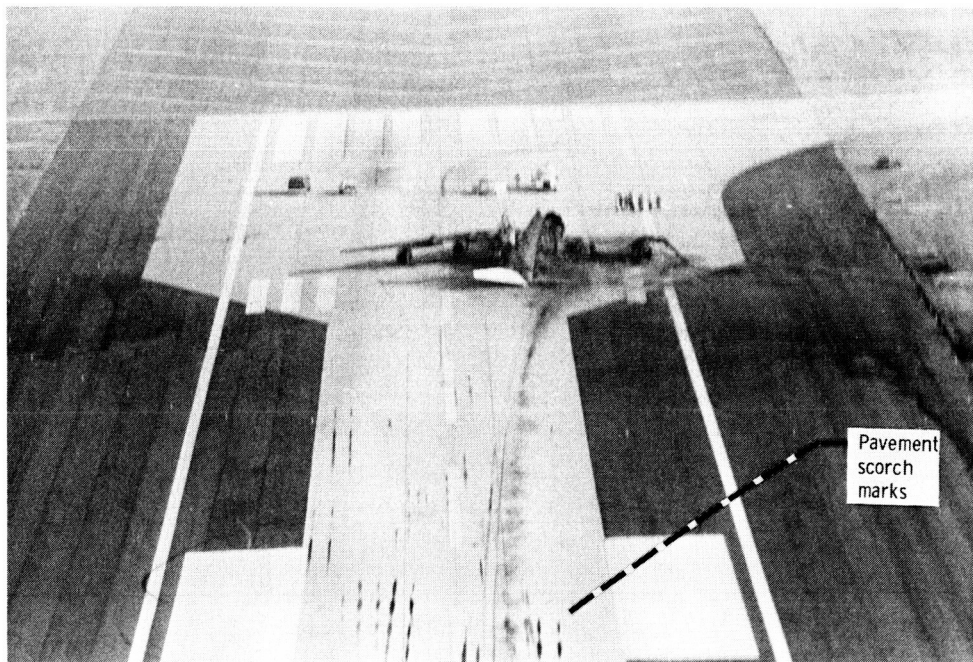
Figure 11. - Aerial view of fire-damaged NASA 712 at stop point, 12,660 ft down runway 32.

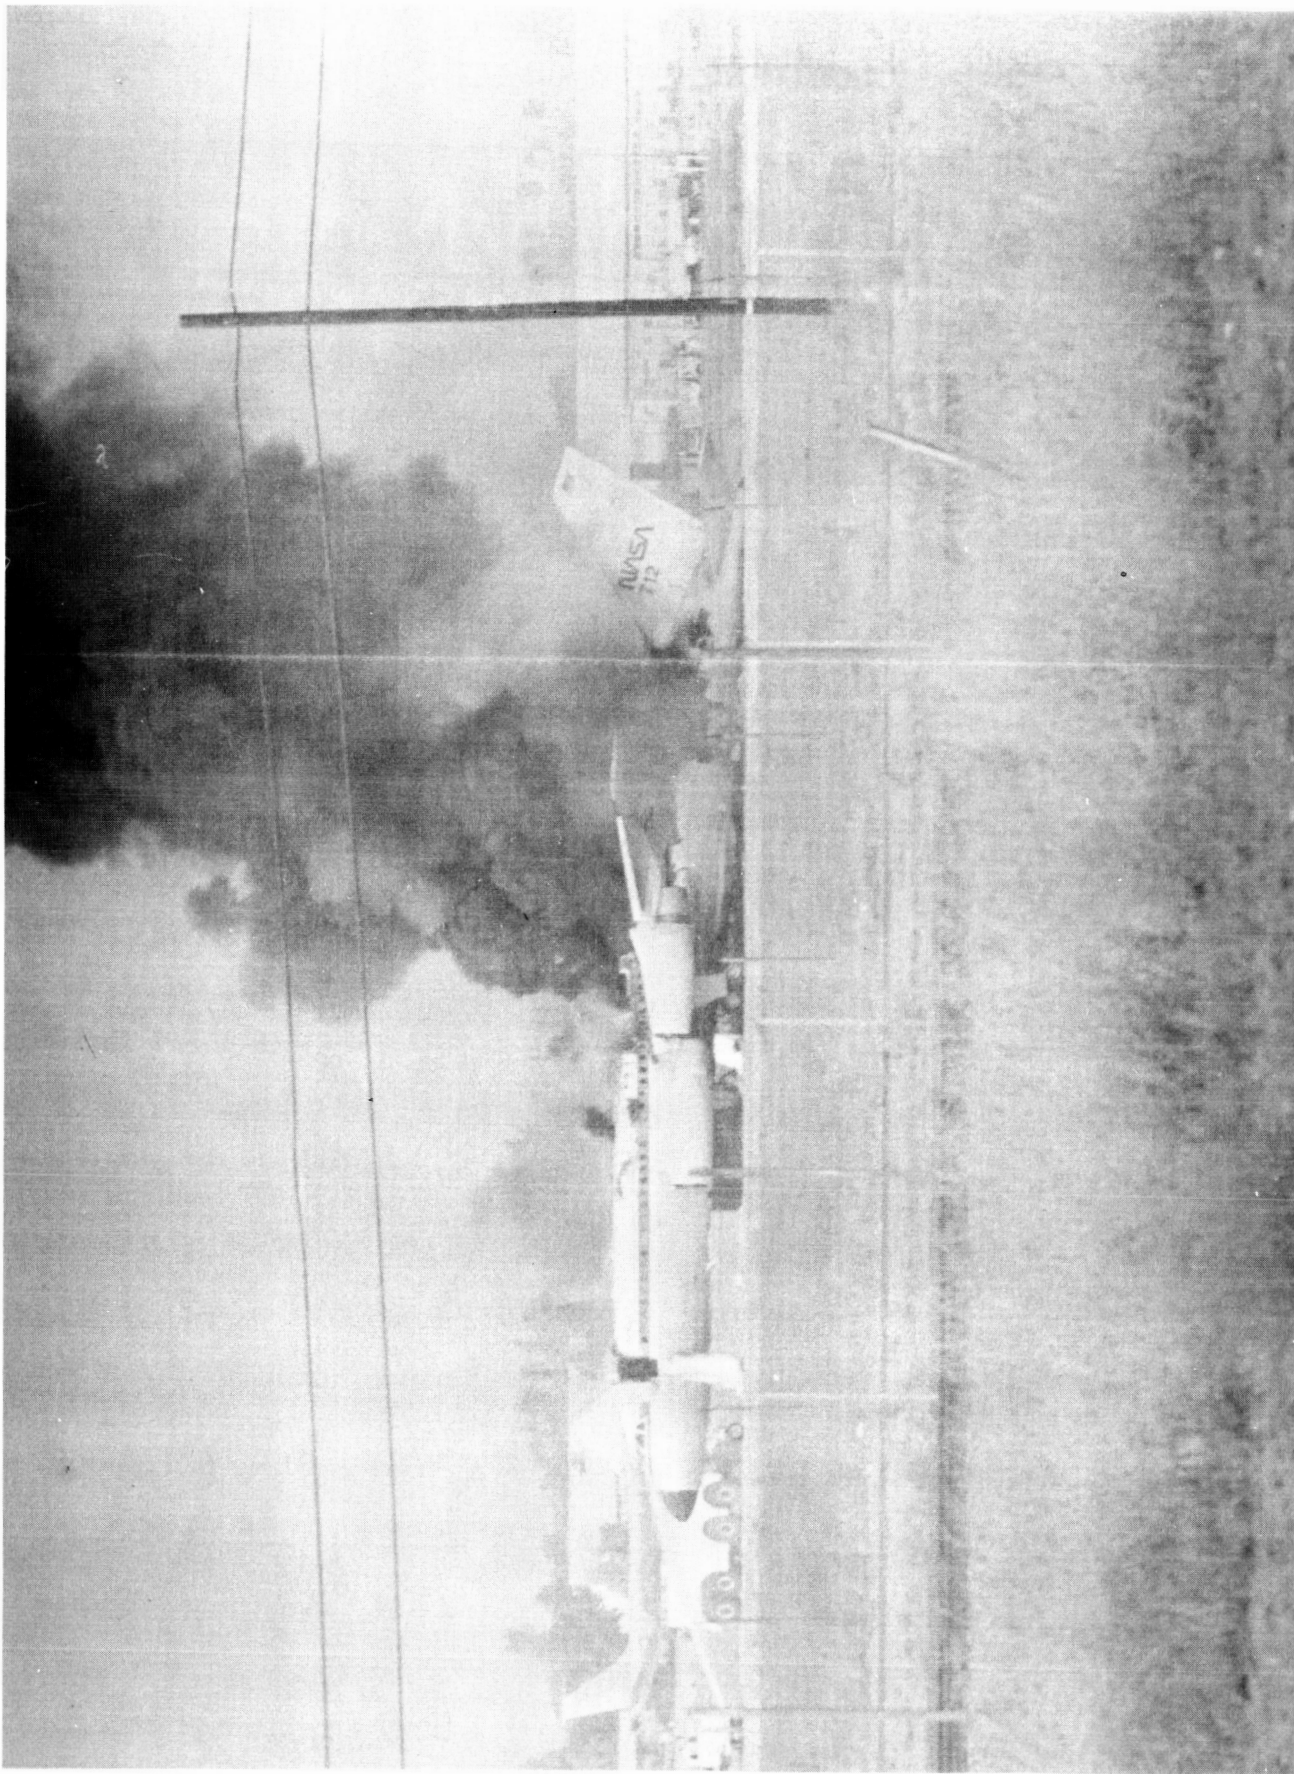
(figs. 10 and 11). The aircraft was immediately evacuated after it was brought to a stop. Shortly thereafter the aircraft was engulfed in flames (figs. 12 and 13). The aircraft wreckage on the runway was photographed from a helicopter (fig. 14) and at various ground locations (figs. 15 and 16).

Figure 12. - NASA 712 on fire at end of runway 32.

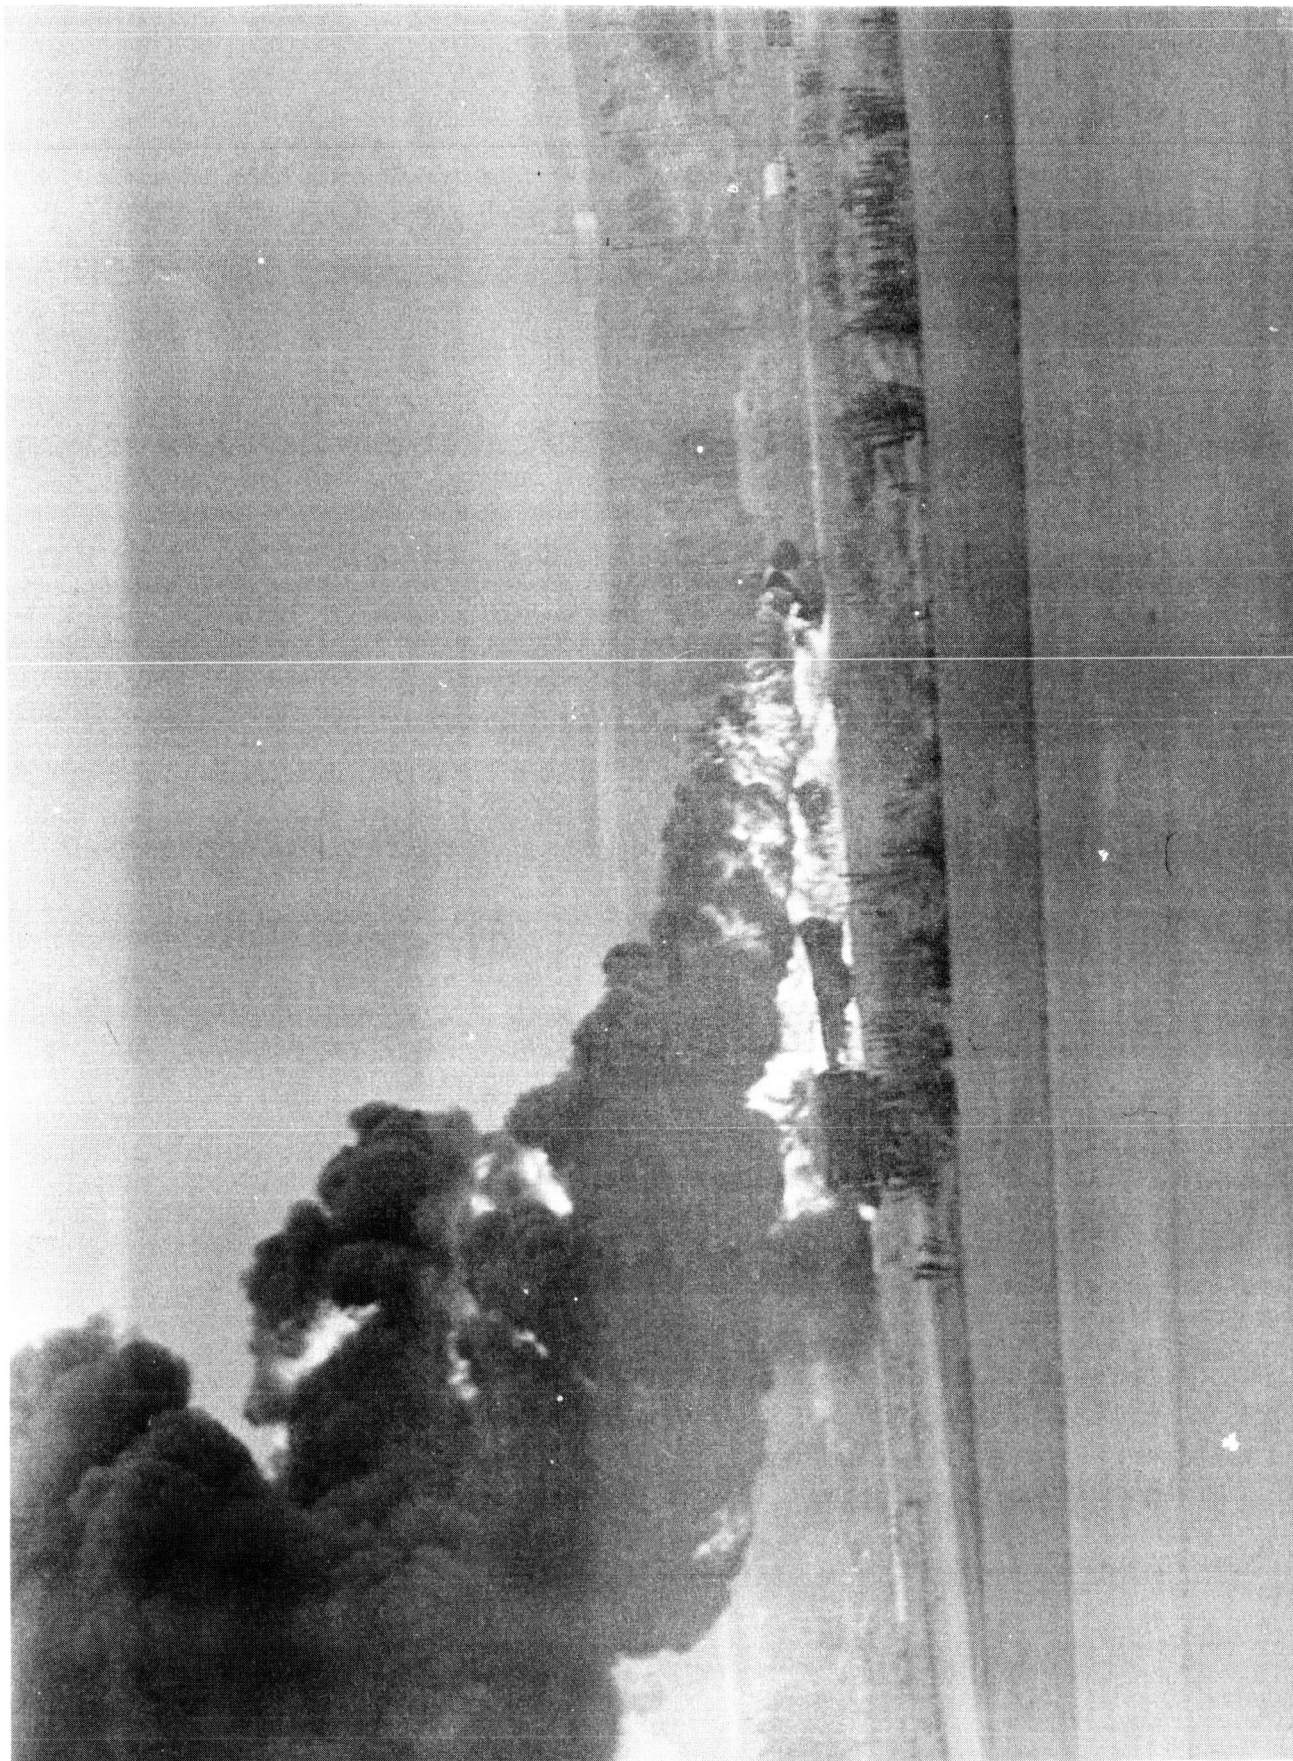
Figure 13. - NASA 712 engulfed in flames.

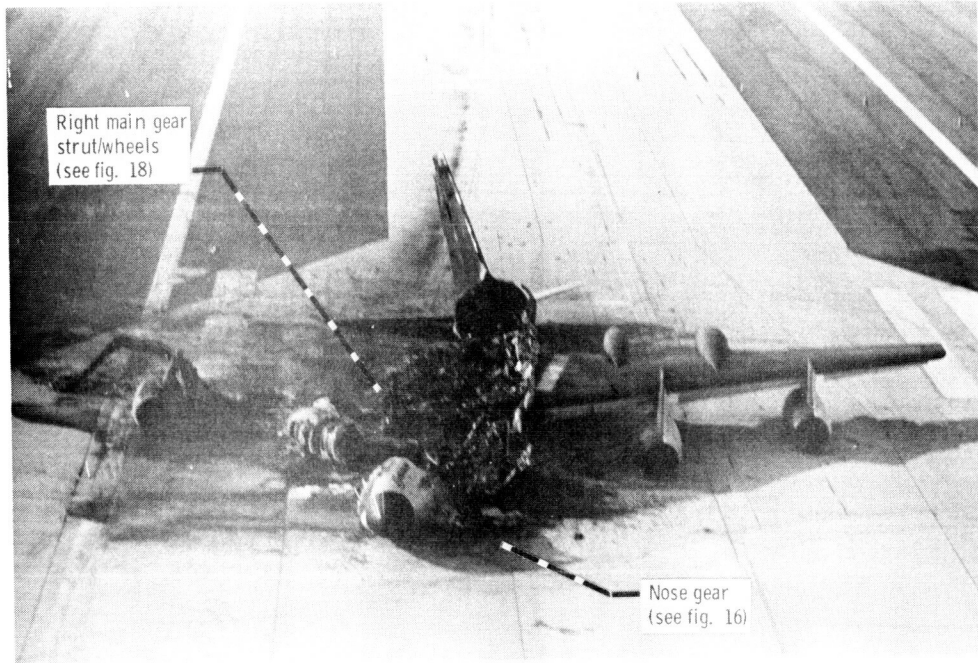
Figure 14. - Aerial view of fire-damaged NASA 712 taken at front of wreckage.

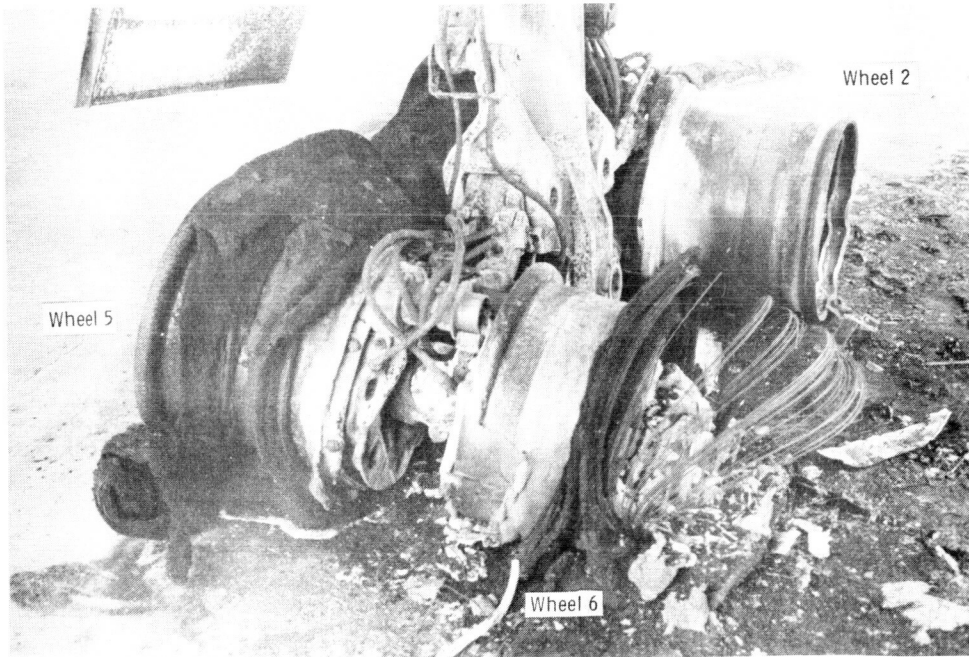
Figure 15. - Closeup view of left main gear wheels.

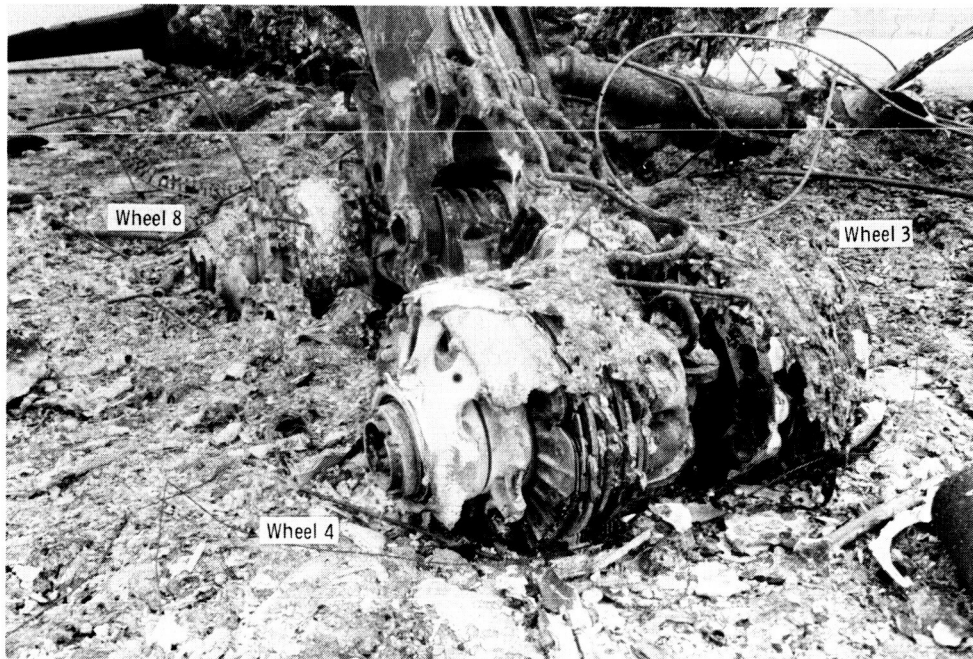
Figure 16. - Closeup view of right main gear wheels after fire.
