ANATOMY OF A BEARING TORQUE PROBLEM

Damon D. Phinney*

In the early 1970s, Ball Aerospace Systems Division developed an antenna despinn drive for the Messerschmitt Boelkow Blohm (MBB) solar science satellite HELIOS. This paper discusses a problem with high bearing drag torque that was encountered on the two flight models of this drive, after successful tests were completed on twelve bearings, an engineering model, and the qualification unit.

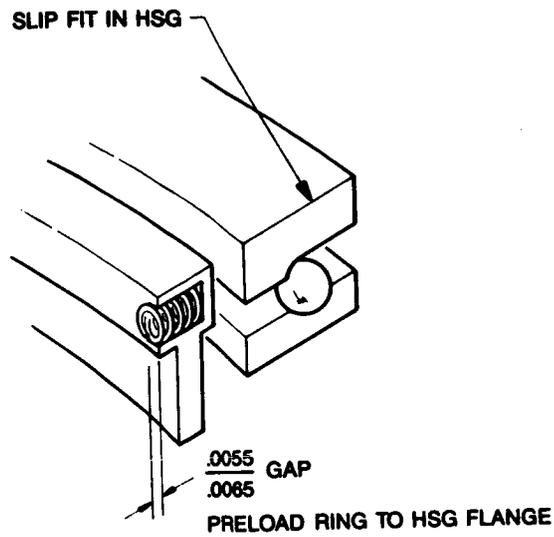
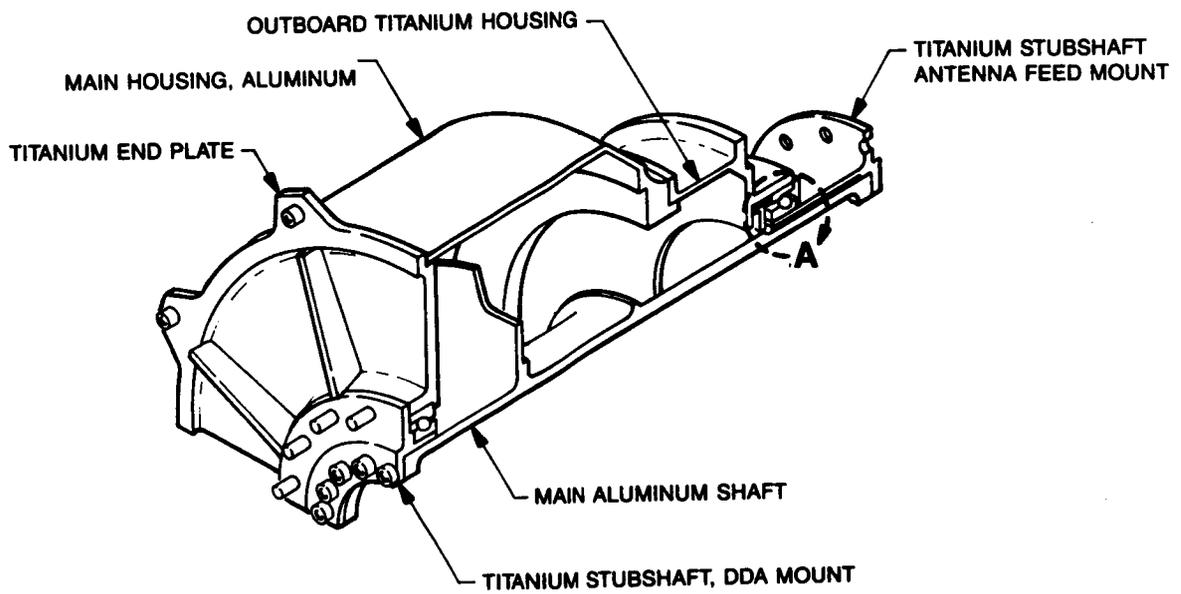
Figure 3 Bearing installations

- A three-piece shaft assembly, consisting of a 7075-T652 aluminum tube 7.8 in. long with 6Al-4V titanium stubshafts at each end. Bearing journals were on the stubshafts, whose function was to isolate the bearings from the high expansion rate of the aluminum tube. The stubshaft at the left end of Figure 3 has 16 studs on a flange outside the bearing, by which the DDA was mounted on the spacecraft.
- A three-piece housing assembly. The main housing was aluminum, with an 8-in. ribbed titanium plate at one end, and a short cylindrical titanium member at the other. The titanium pieces carried the bearing outer rings, isolating them from the aluminum member.

- Two angular contact ball bearings were spaced 6.4 in. apart with outer race thrust shoulders facing each other. All bearing rings were slight interference fits except for the outer race of the right hand bearing. This was slip-fitted and acted on by a set of coil springs with a force of 5 lb. The springs were in a carrier machined to length at assembly to produce an end play of 0.0055/0.0065 in. Because of the mix of aluminum and titanium pieces in the shaft and housing, the end play would be reduced by 4 mils at -50°C.

- The 440C bearings were lubricated with a thin film of MoS₂ approximately 1/4 micron thick, and had inner-land-riding Rulon-A separators with full cylindrical pockets. The normal ball complement was reduced from 42 to 38 to provide additional separator material between pockets and increased dimensional stability.

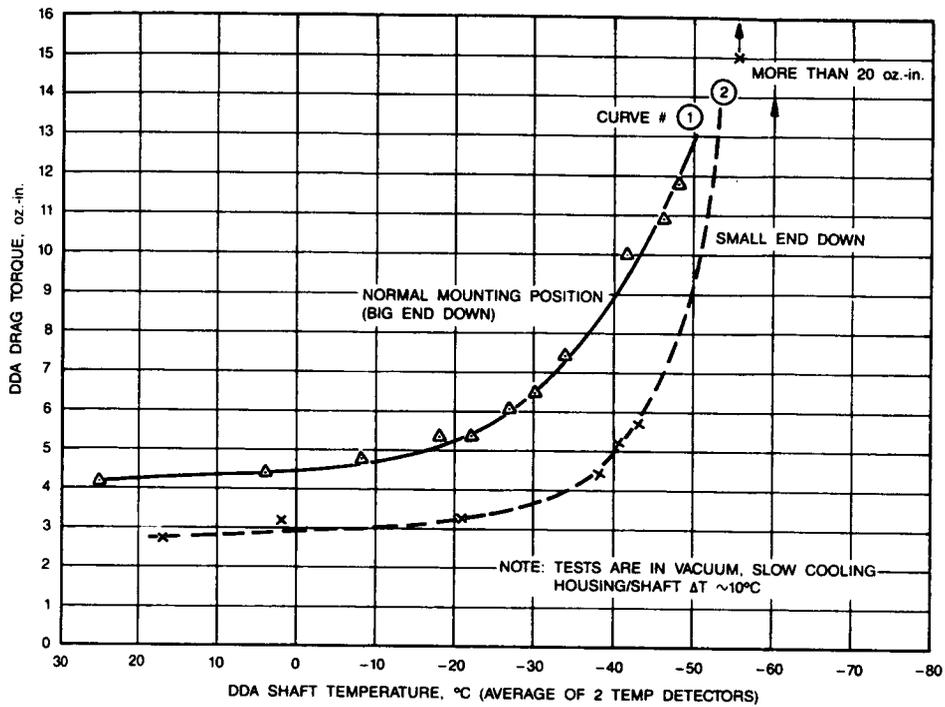
Figure 4 Torque vs. temperature, 1st flight DDA in thermal vacuum chamber

Curve 1 on Figure 4 shows results with the DDA in its normal mounting position, shaft vertical and big end down. In this position, the lower bearing carries the weight of the drive housing (several lb) and also the bearing preload force of 5 lb. Although this test indicates a peak torque of only 13 oz-in. at -50°C , and suggests that limiting the housing-to-shaft temperature gradient was helpful, it clearly shows a problem.

Curve 2 on Figure 4 gives results with the drive inverted. Torque exceeded 20 oz-in. at -56°C . In this position, the bearing now on top is essentially unloaded and the bottom bearing is subject to the preload force only, with the housing weight close to the preload spring force. This removes approximately 10 lb of total bearing load and explains the reduction in drag torque at room temperature, correlating well with results of bearing torque vs. preload tests. The shift in the knee of the torque curve to a lower temperature is not explained. As will be seen, our corrective actions were taken at the big end of the drive where it was usually attached to the mount, which was also a cooling plate. With the sensitive end of the shaft no longer attached to the cooling plate, it may not be surprising that response to low temperature is somewhat different.

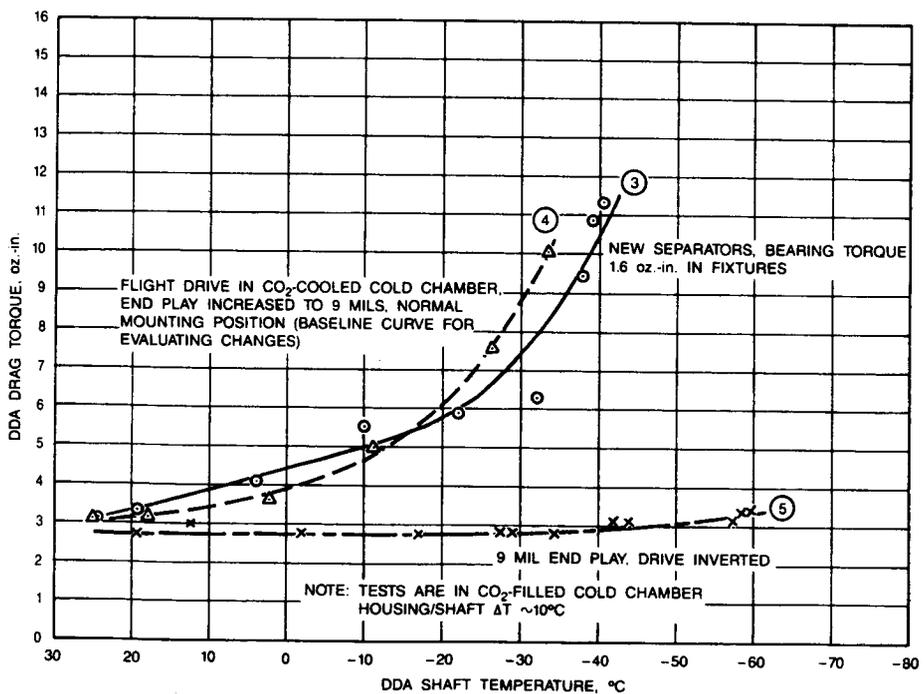
Figure 5 Cold chamber test results with new bearing separators and increased end play

This test indicated high torque again (Curve 3 on Figure 5) and proved that there was a problem other than in the bearings.

Nevertheless, a simple fixture was made with which we could manually feel end play with the drive stopped. In the first test, we could no longer detect any play at -25°C and torque was up to 8 oz-in. A new preload ring giving 9 mils of end play was installed. Now some play was still detectable at -33°C but torque had reached 10 oz-in. (see Curve 4, Figure 5). Since all subsequent tests will be run with increased end play, Curve 4 will be used as a baseline for evaluating effects of changes.

end play. Torque was only 3.5 oz-in. at -50°C (see Curve 5, Figure 5). Comparing results with Curve 2, Figure 4, when the drive was upside down in a thermal vacuum test, it appears that increased end play and/or the difference in cooling method caused a major improvement. We did not determine the reasons for this improvement.

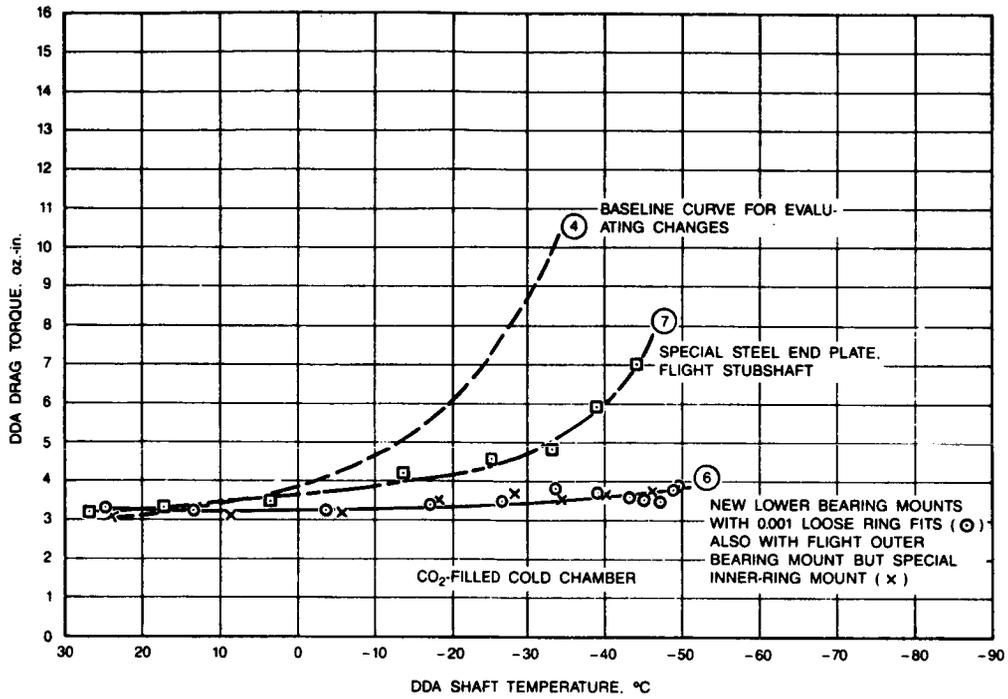
Figure 6 Performance with new lower bearing mounts

Because we now suspected the lower bearing mounting hardware, a new, simple outer ring mounting plate (end plate) was made from mild steel, and a spare engineering model stubshaft was located. Both bearing ring fits were made nominally 0.001 in. loose instead of line-to-line to tight, as on the flight hardware, and end play was adjusted to 9 mils. As shown by Curve 6 in Figure 6, these changes were magic! Torque was below 4 oz-in. at -50°C with the DDA right side up. We now had to discover why.

The next experiment was to try the new stubshaft by itself, with the flight end plate. Again torque stayed low, perfectly duplicating results of the previous test with both lower bearing mounts changed. Data points from this test (x's) mingle with the ones of the previous test (o's) on Curve 6.

Going back to both flight bearings, we tried the flight stubshaft with the special steel end plate. We had already shown that the combination of flight end plate and special stubshaft was just as good as the special end plate and special stubshaft, so we might have expected that the new configuration would bring us all the way back to our original high torque curve. This did not occur. The special end plate used with the regular stubshaft somehow significantly reduced the adverse effect of the flight stubshaft (see Curve 7, Figure 6). We then rotated the special end plate 90 degrees and found that this greatly reduced the improvement (8.1 oz-in. at -36°C). Returning it to its original position resulted in repetition of Curve 7 results.

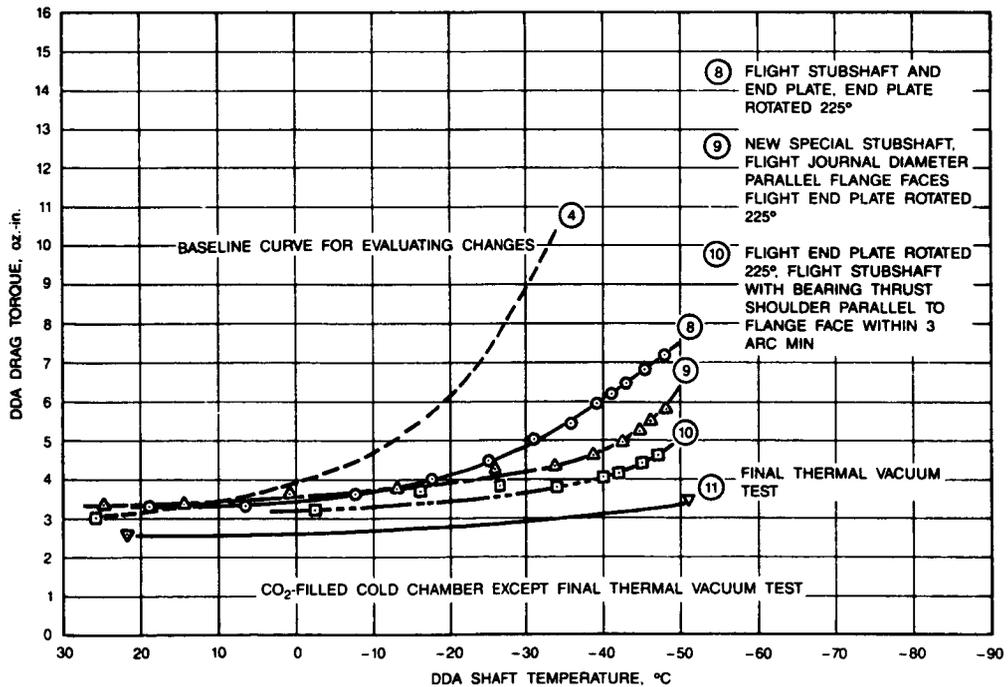
Figure 7 Performance with bearing mount changes that corrected the problem

With this new knowledge, a series of tests with the flight end plate in different angular positions was conducted. We discovered that flight end plate position did indeed affect low temperature torque, and that results at any position were quite repeatable. Furthermore, the position for the as-built DDA was the worst one - somebody's law at work! In its most favorable position, the drag torque was as shown by Curve 8, Figure 7. Instead of over 20 oz-in. at -50°C , we had only 7.5 oz-in., and the sharp knee in the curve was gone. Compare Curve 8 with baseline Curve 4, which has been repeated in Figure 7, for reference.

with the new steel stubshaft, illustrated by Curve 10, Figure 7, after being cleaned up and made ready to repeat some of the formal acceptance tests. At -50°C , torque was 5 oz-in., just meeting the original specification requirement.

During acceptance tests, drag torque was measured in vacuum at 22°C and -51°C , where it was 2.6 and 3.4 oz-in. Curve 11 on Figure 7 shows these final results.

With this finding, we had the flight stubshaft thrust face trued up on a jig grinder (measured parallel to the shaft flange within 0.3 arcminute) while removing 0.0005 in. from the journal. The DDA now tested even better than

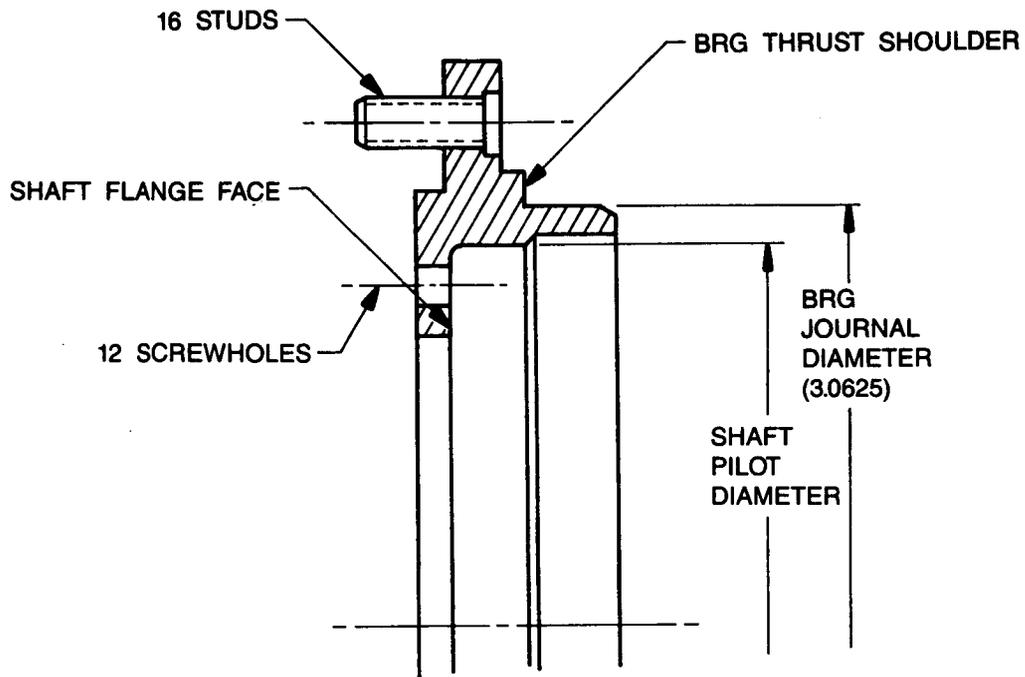
Figure 8 Lower stubshaft configuration

- Axial distortion between shaft flange and bearing thrust shoulder as temperature was reduced to -50°C . On the flight part, we found 0.0001 in. and 0.0002 in. change in two locations, while the engineering model stubshaft was worse (0.0004 in.).

- Changes in two bearing journal diameters, 90 degrees apart, between room temperature and -50°C . Both diameters on both parts changed the same amount (-0.0016 and -0.0017 in.).

- Roundness of bearing journals. The flight journal was round within 0.0001 in. while the engineering model part was off as much as 0.0004 in. Since the latter journal was intentionally undersize and a loose fit, any effect of the poor journal roundness would have been suppressed. Excellent roundness of the flight journal indicated that it could not be a problem.

- Concentricity between bearing journal and pilot diameter. Flight part concentricity was within 0.0003 in. while the engineering model part showed 0.0001 in. This difference seemed negligible.

- The flight journal was larger than the engineering model journal, and was also 0.4 mil over the drawing dimension. This diametral difference had already been discounted by test results.

- Parallelism between the shaft flange face and the bearing thrust shoulder. The engineering model stubshaft showed essential parallelism, but the flight part was off 0.0007 in. For the 3.2 in. diameter of the thrust shoulder, this corresponds to an angular deviation of 0.8 arcminute.

The only significant difference that was worse on the flight stubshaft was the seemingly insignificant reduced parallelism between flange and bearing thrust shoulder. With the bearing ring slightly tight on the journal, so that it should only bottom out on the high point of the shoulder, it hardly seemed possible that this could make any functional difference. Nevertheless, we promptly made a mild steel stubshaft, duplicating the flight bearing journal diameter with its tight fit to the flight bearing, but holding parallelism of the two critical surfaces within 0.0001 in. When this part was tried out in the DDA, Curve 9, Figure 7, we had found another piece in the puzzle. The new stubshaft was noticeably better, bringing -50°C torque down to the 6-7 oz-in. range.
