FAILURE ANALYSIS OF A 3.5 INCH, 50 AMPERE-HOUR
NICKEL-HYDROGEN CELL

KENNETH H. FUHR
MARTIN MARIETTA DENVER AEROSPACE
DENVER, COLORADO

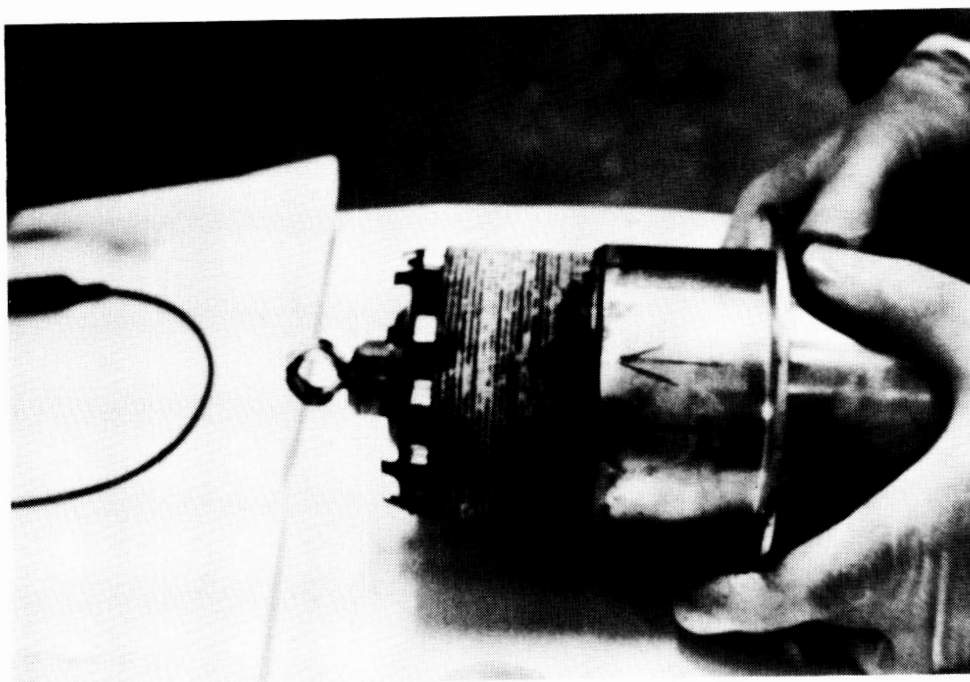
Figure 1.

Upon removal of the plate stack from the pressure vessel, a large dark area was clearly visible (Figure 1) beginning at positive plate (counting from positive terminal end) number 15 and continuing to approximately positive plate number 38 with the major damaged area occurring from plate 15 to plate 31 (Figure 2). Detailed examination of the plate stack assembly revealed the complete absence of separator material. Active material was noted to be missing from both the positive and negative substrate (Figures 3 & 4). Shorting of adjacent positive and negative plates was found in these areas. Portions of the gas screens from this area were found to be missing and the edges of the missing area appeared to be burned or fused together (Figure 5). Examination of the separator material also revealed portions of it to be missing, (Figure 6).
