NASA Technical Memorandum 100987

Ice/Frost/Debris Assessment For Space Shuttle Mission STS-26R

November 7, 1988

Charles G. Stevenson
Gregory N. Katnik
Scott A. Higginbotham
The John F. Kennedy Space Center, NASA

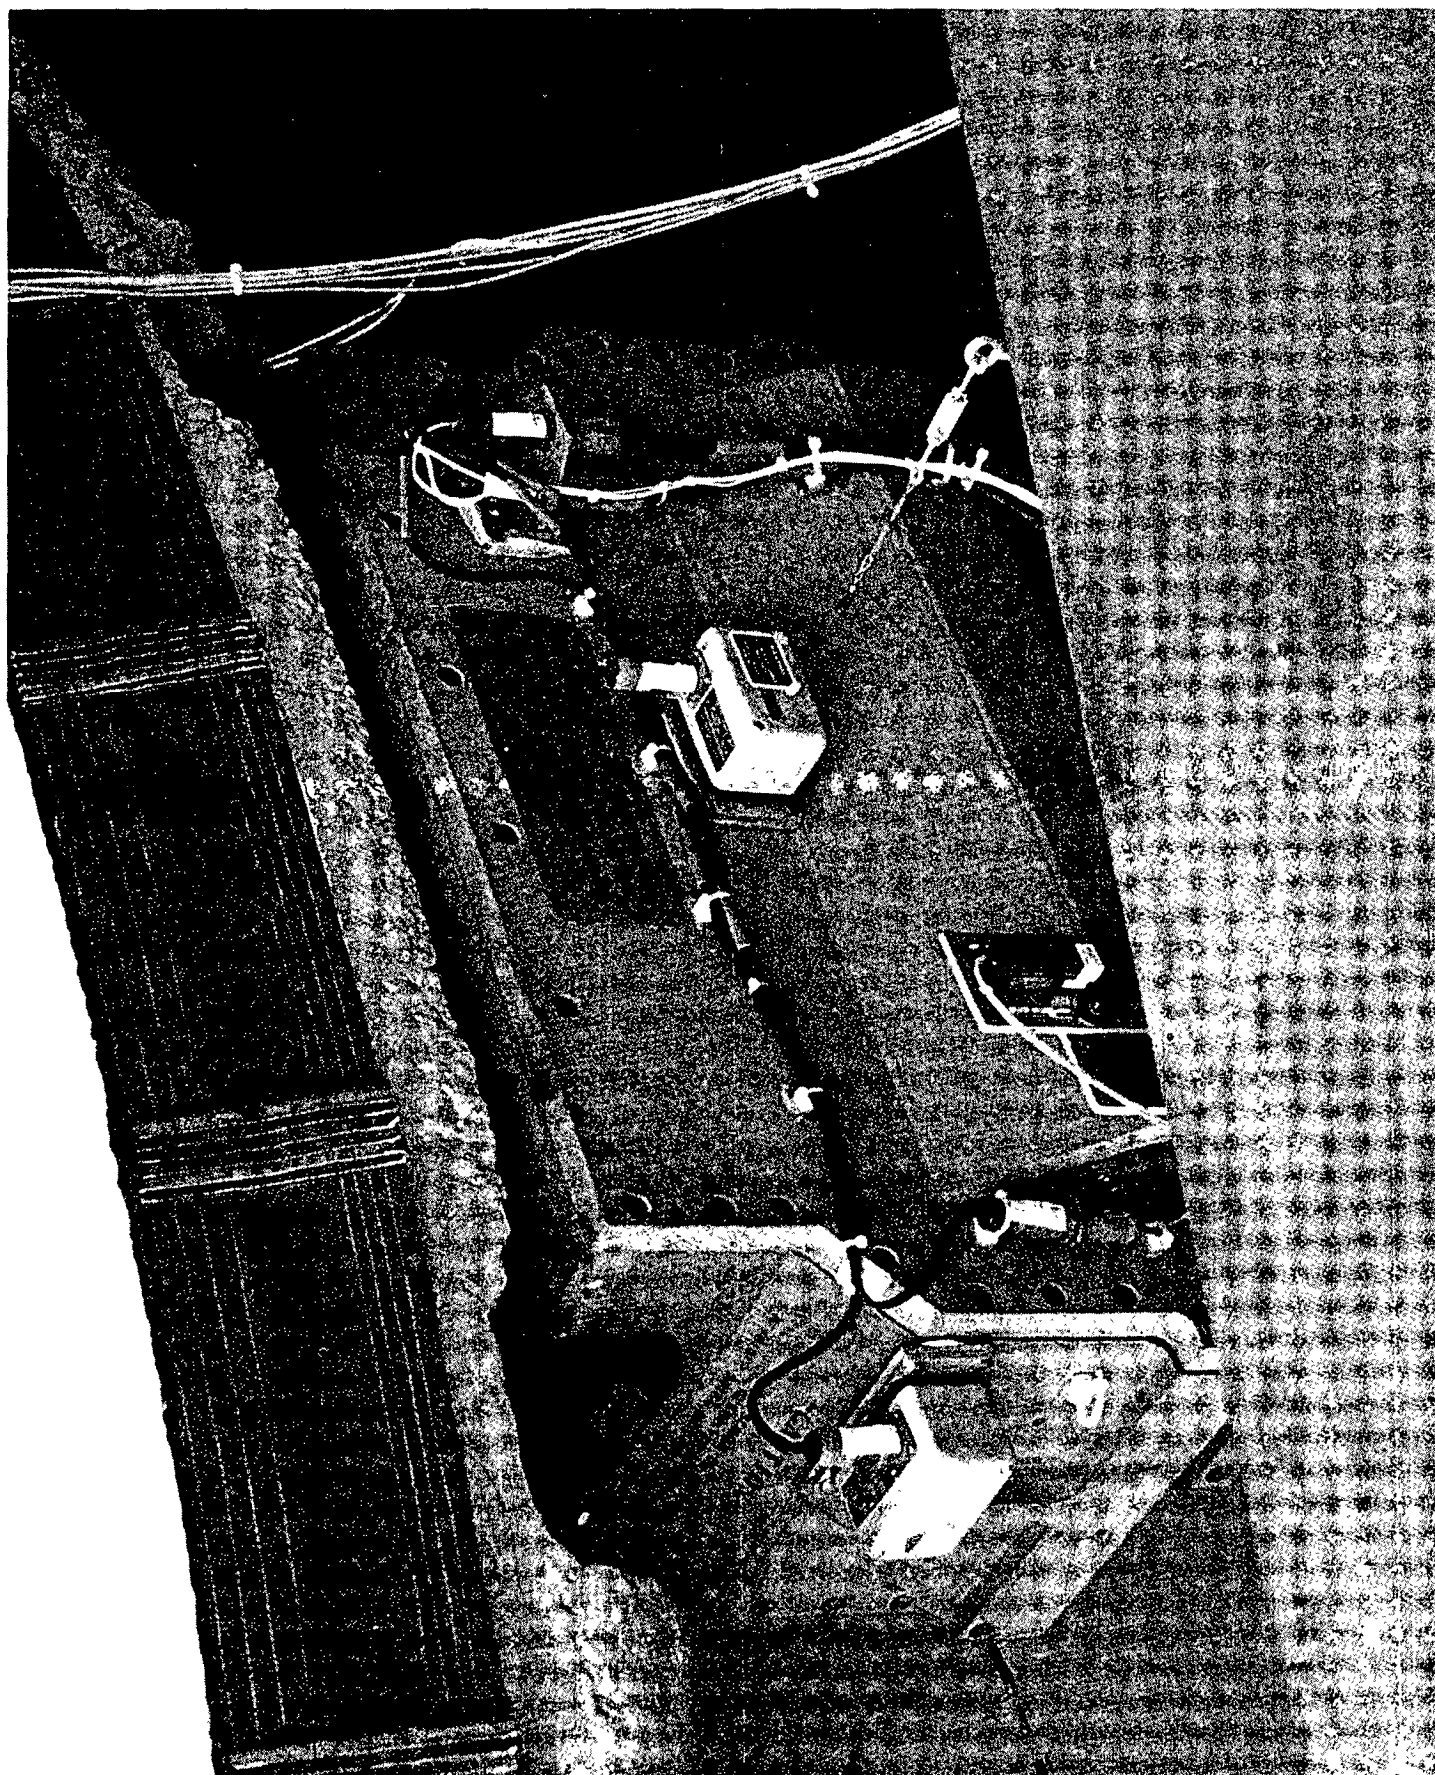
SRB JOINT HEATER UMBILICAL. RED CLAMP AND INSTRUMENTATION
CABLES ARE FOR FRF ONLY AND ARE REMOVED BEFORE FLIGHT.

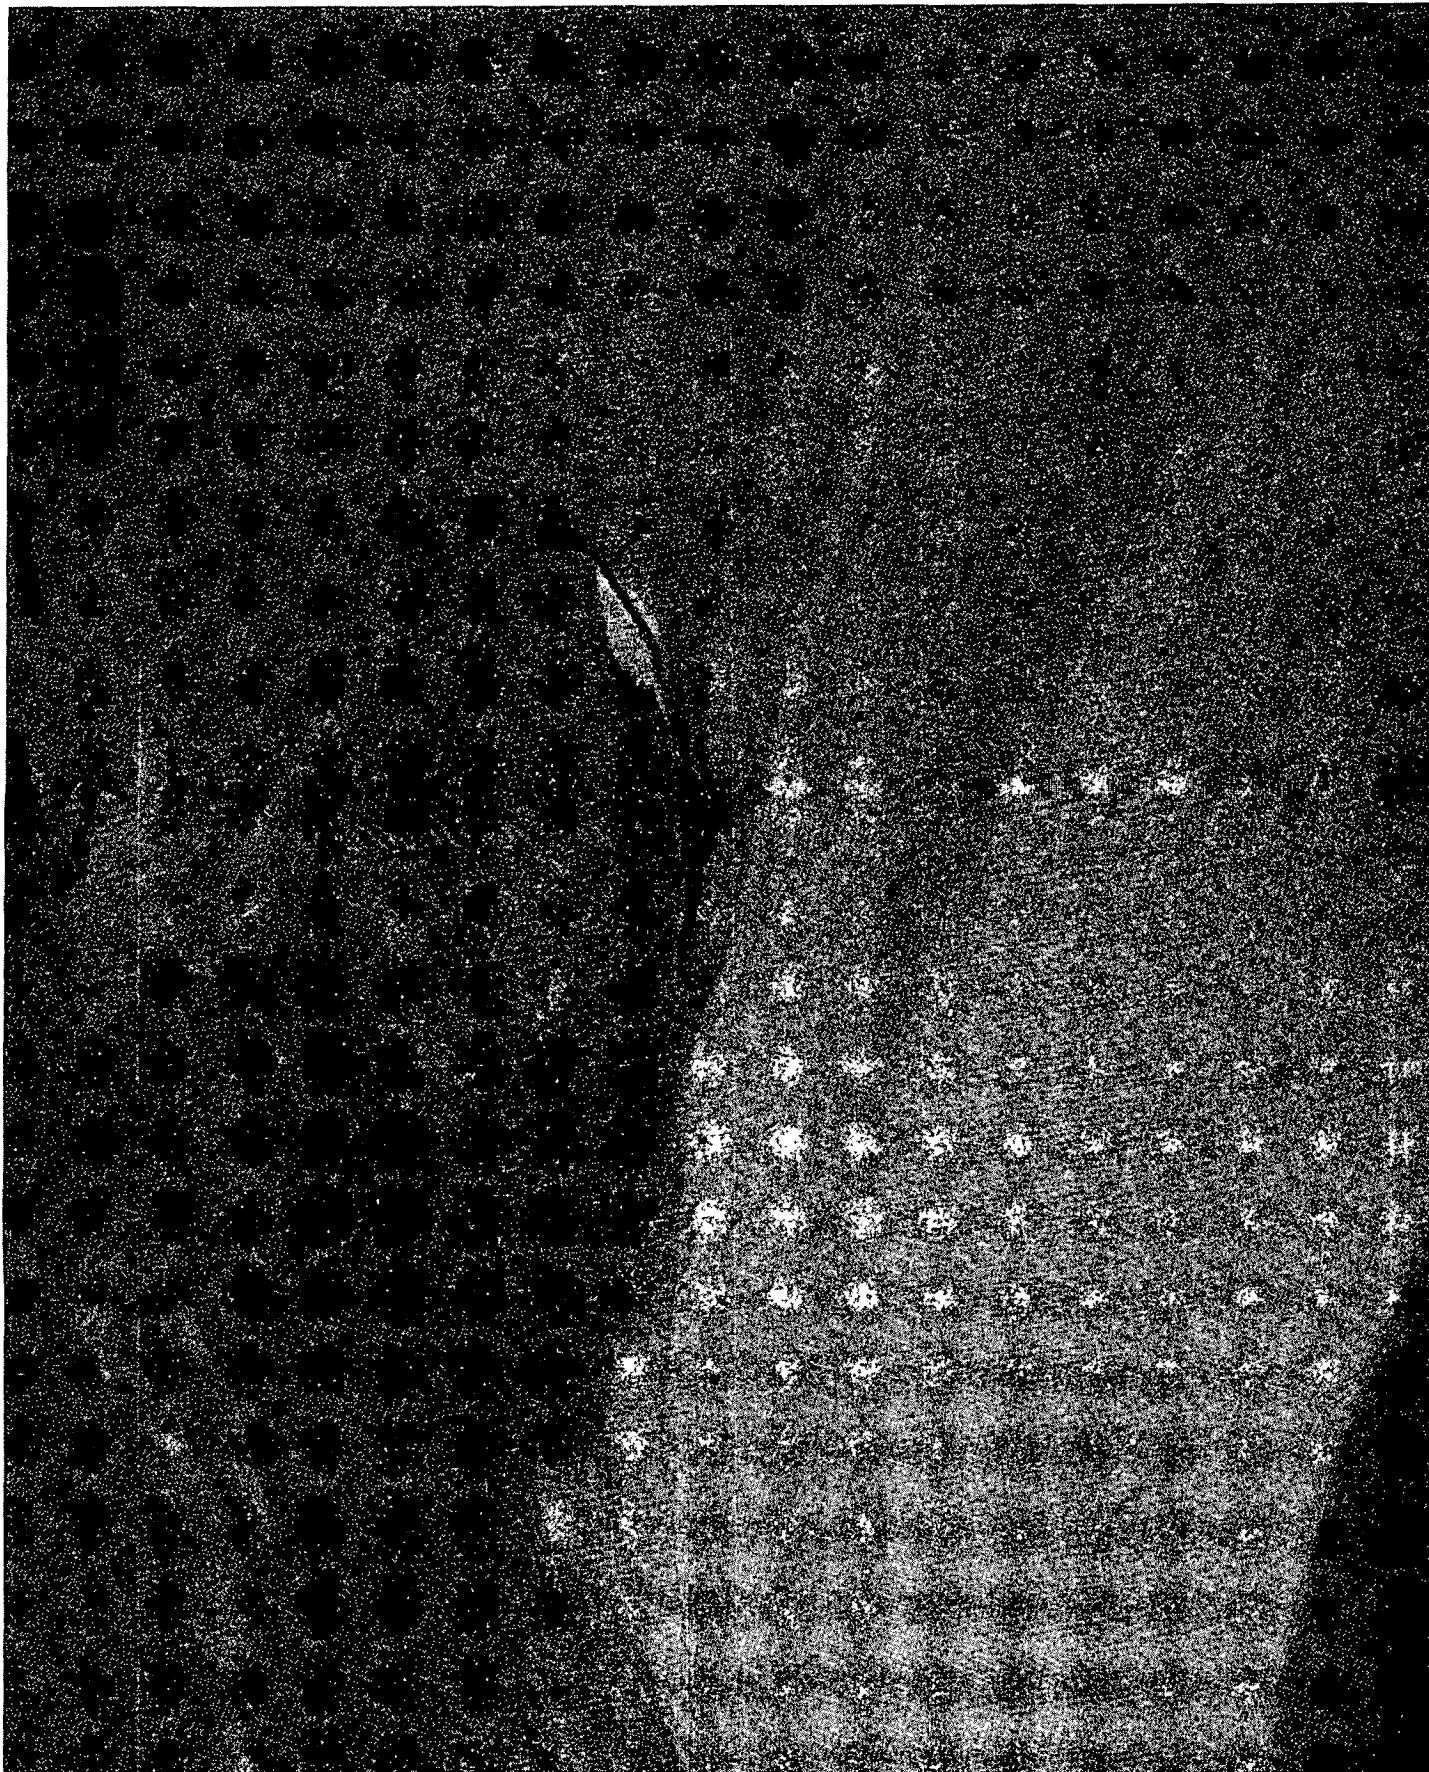
A previous PDL foam repair on the ET LH2 aft dome apex area had a broken bondline for approximately 40 percent of the circumference and the PDL foam was protruding above the adjacent foam about 1/8 inch. An air pocket was the cause of the debond. This area of damaged foam was repaired.

ET LH2 TANK AFT DOME APEX DIVOT

A foam repair on the LH2 aft dome apex exhibited a broken bond line and was protruding above the adjacent surface (Anomaly 003). This area of foam was removed and repaired with PDL per PR ET-28-TS-0205.

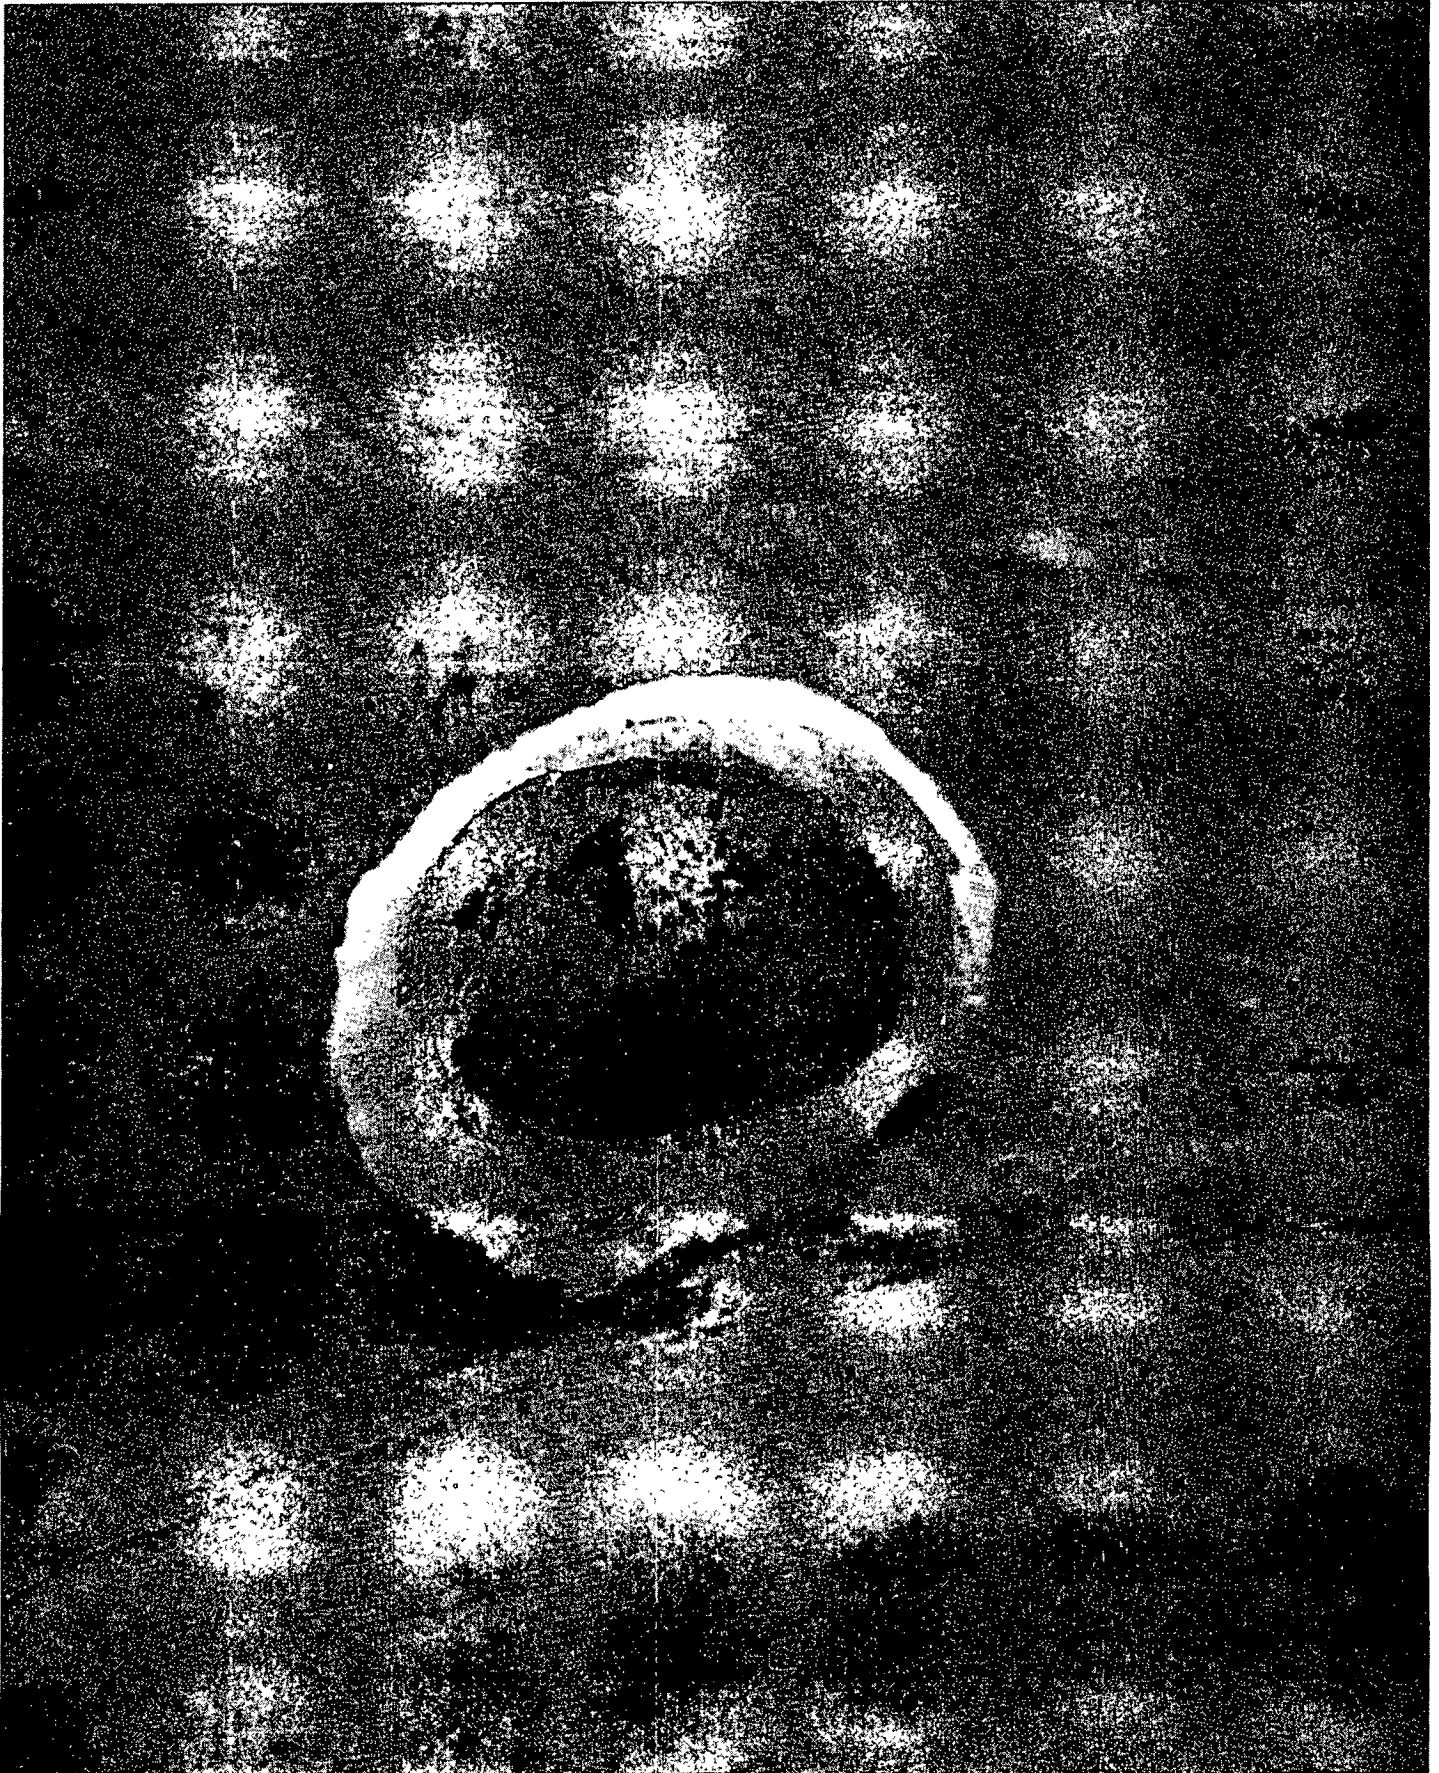
ET LH2 TANK AFT DOME APEX DIVOT TRIMMED FOR PDL REPAIR

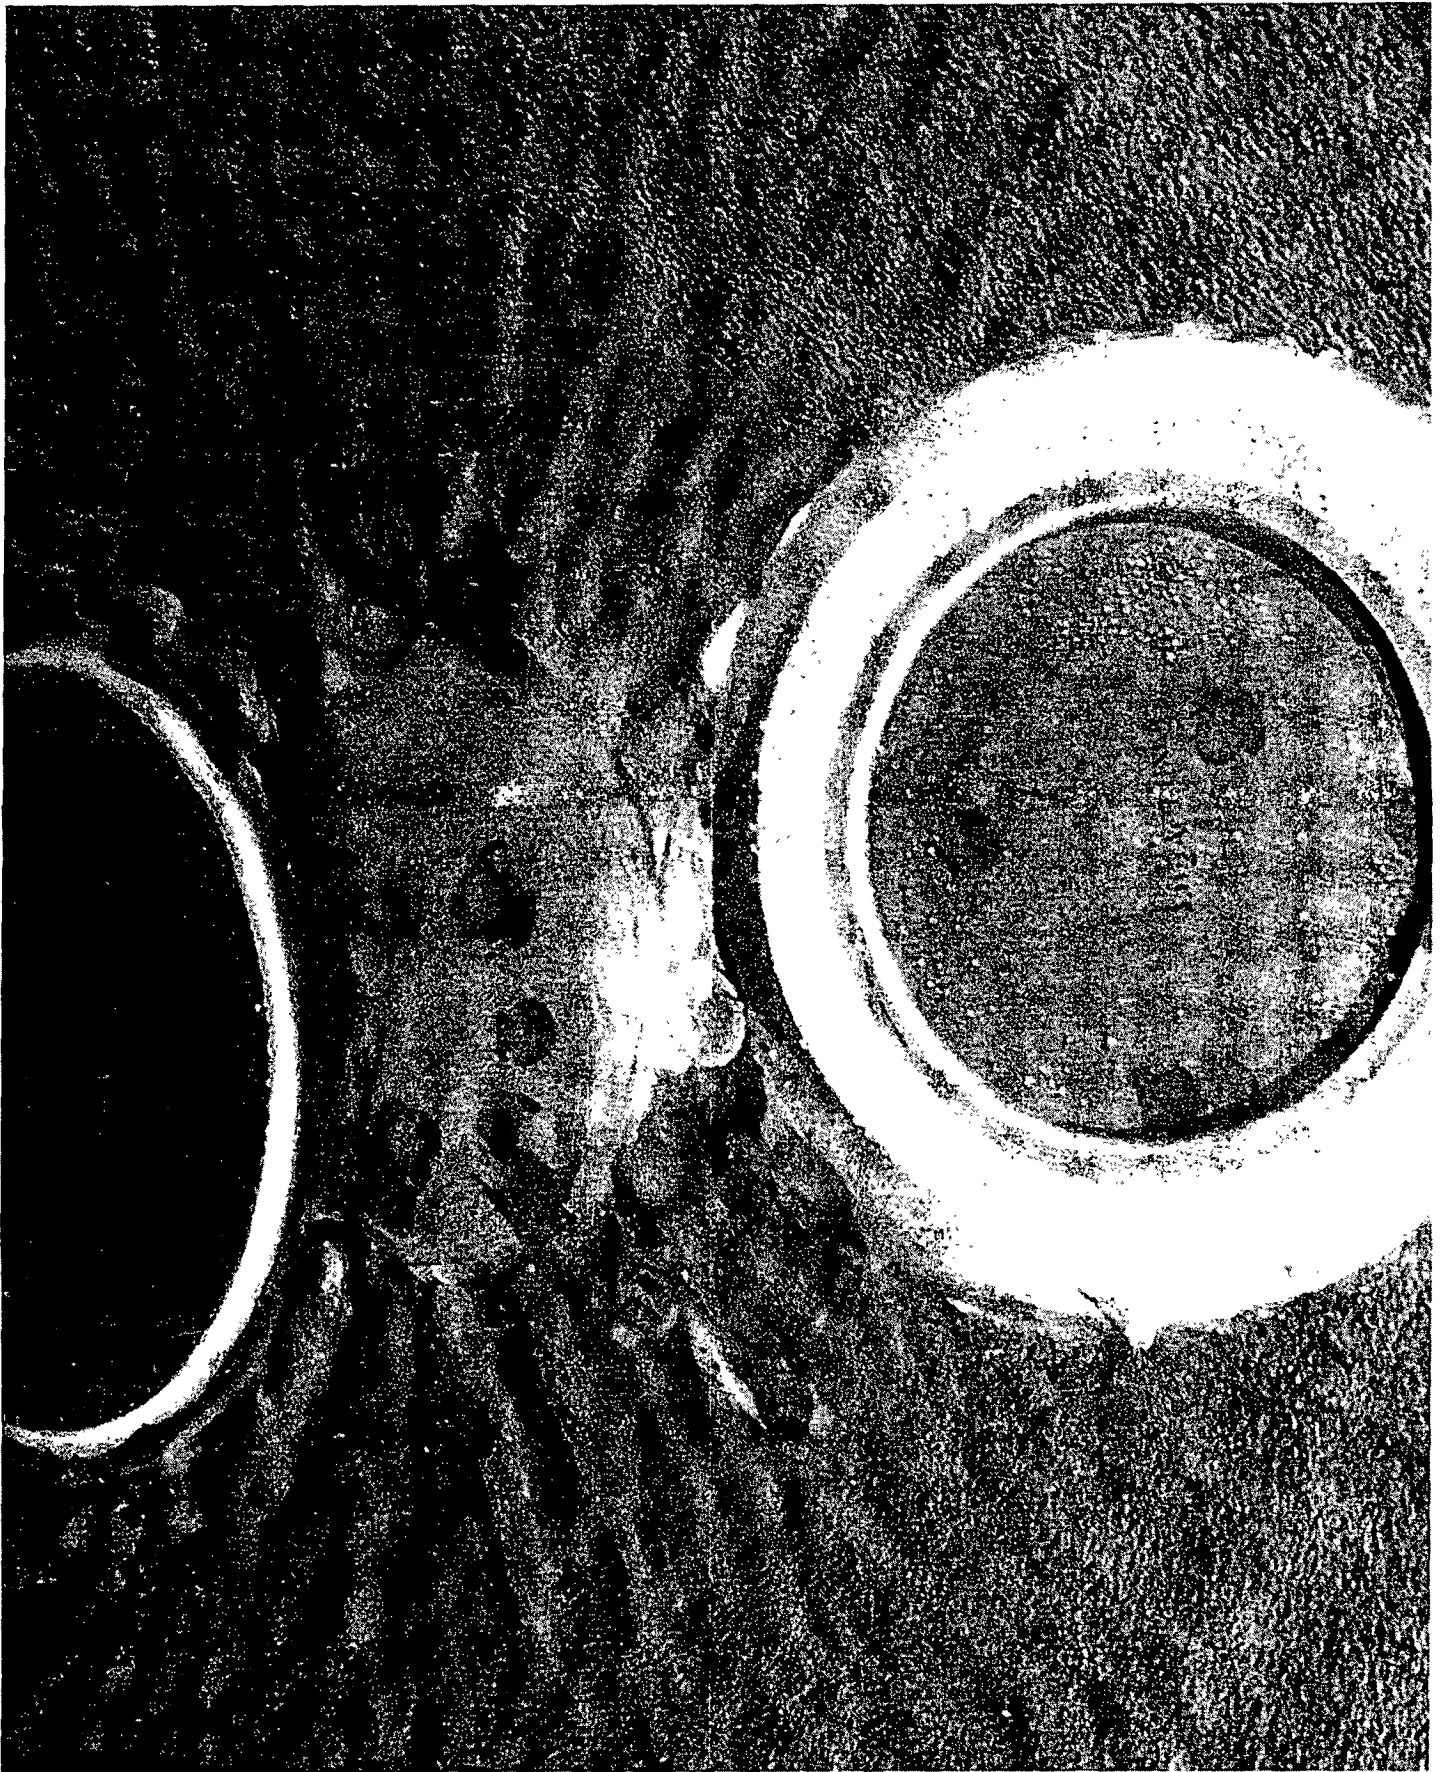
A frost line on an LH2 aft dome apex foam repair was observed during the ice inspection (Anomaly 005) and accepted per the criteria in NSTS-08303.

CONDENSATE AND FROST LINES ON LH2 TANK AFT DOME APEX

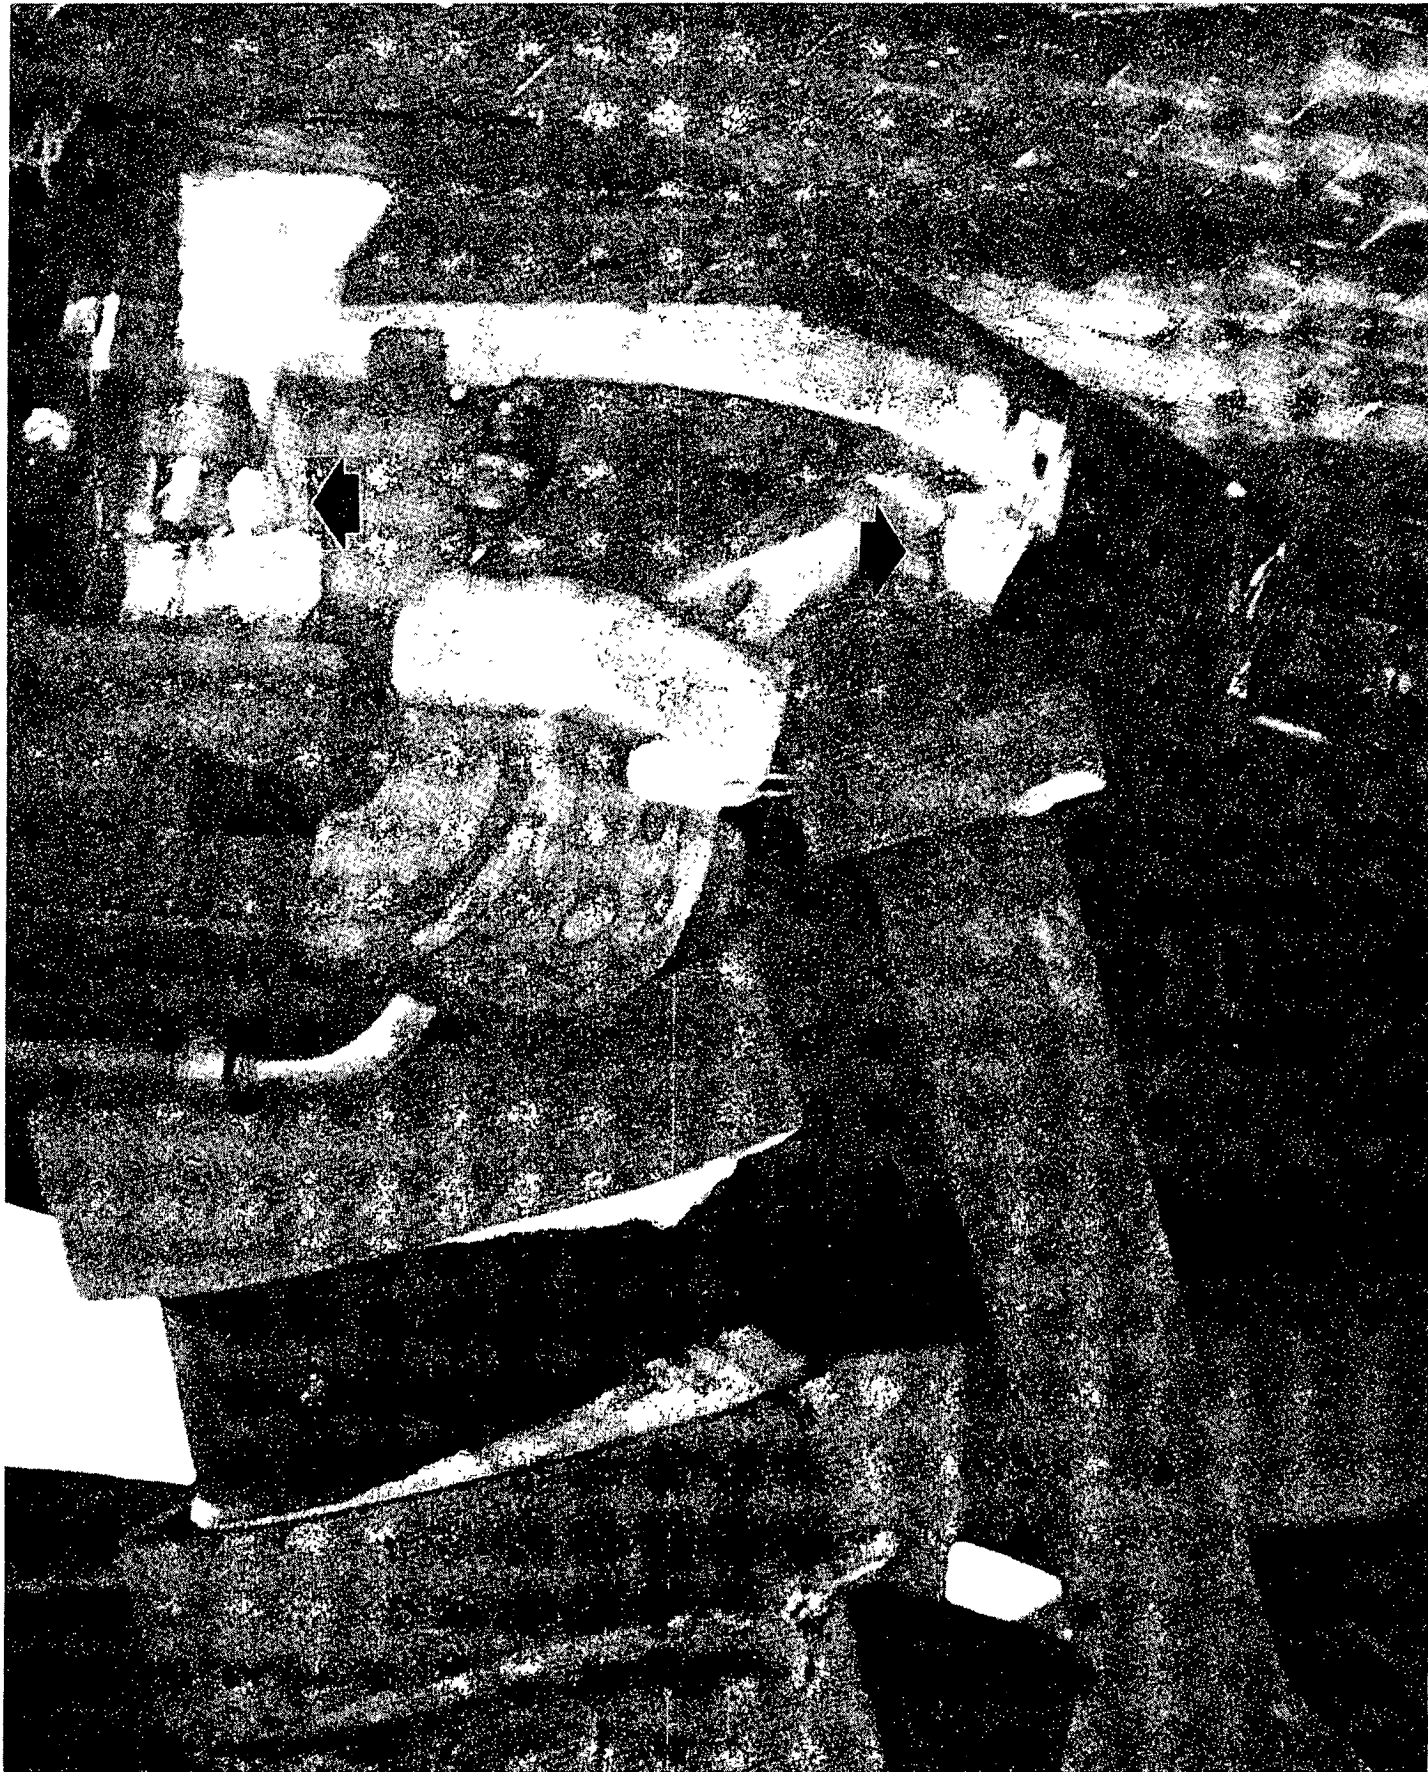
ET/ORB LH2 UMBILICAL. GAS ANALYZERS AND INSTRUMENTATION
ORIGINAL PAGE IS CABLES INSTALLED FOR FRF ONLY.
OF POOR QUALITY

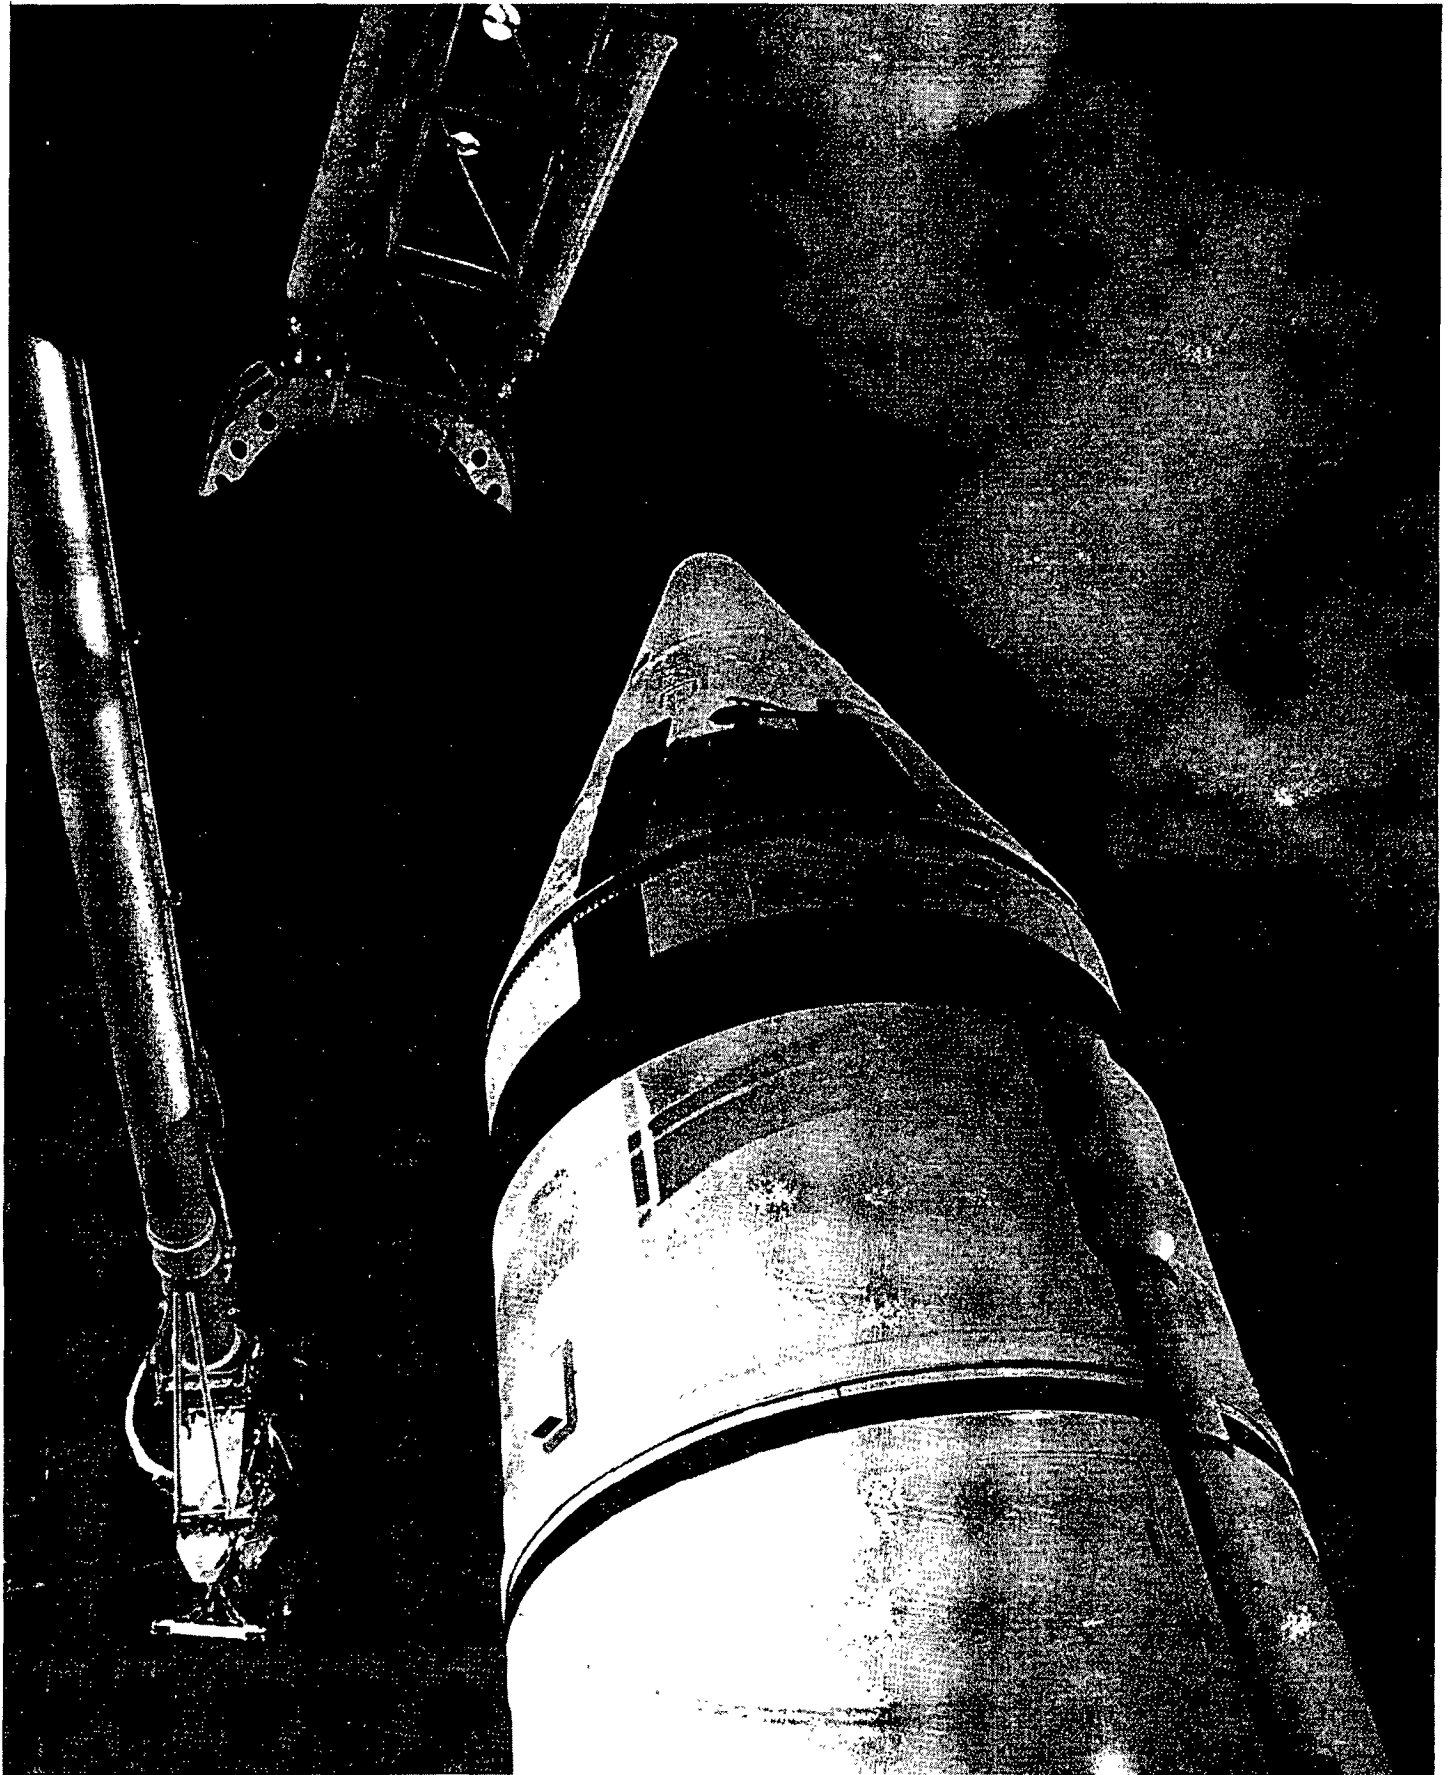
GH2 VENT LINE WITH INSULATION MOD TO PREVENT FORMATION OF ICE

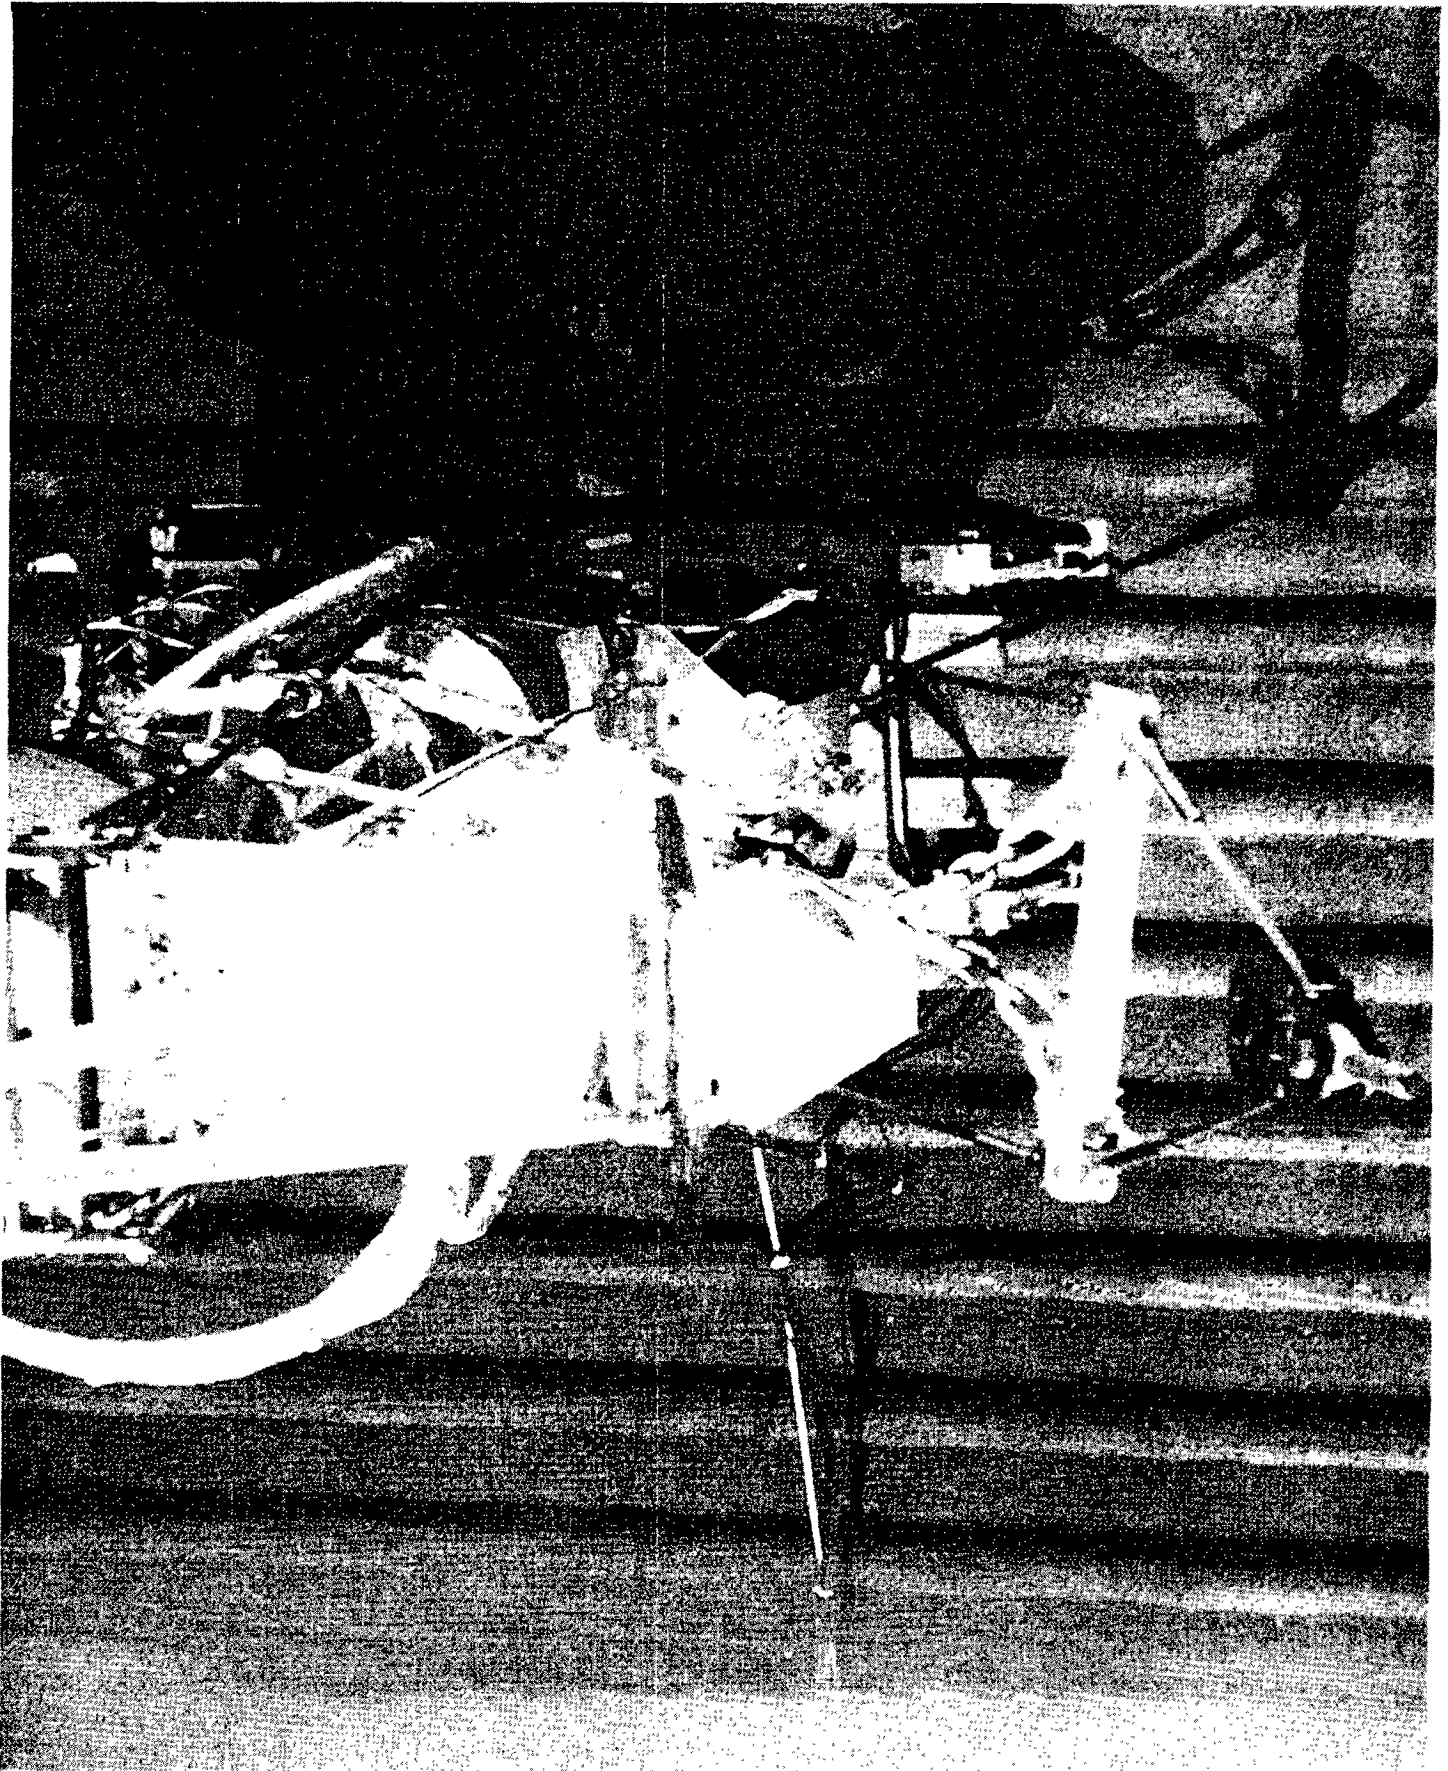
ORIGINAL PAGE IS OF POOR QUALITY NO ICE/FROST FORMATION ON GUCP OR GH2 VENT LINE. RED FRF CABLES REMOVED BEFORE LAUNCH

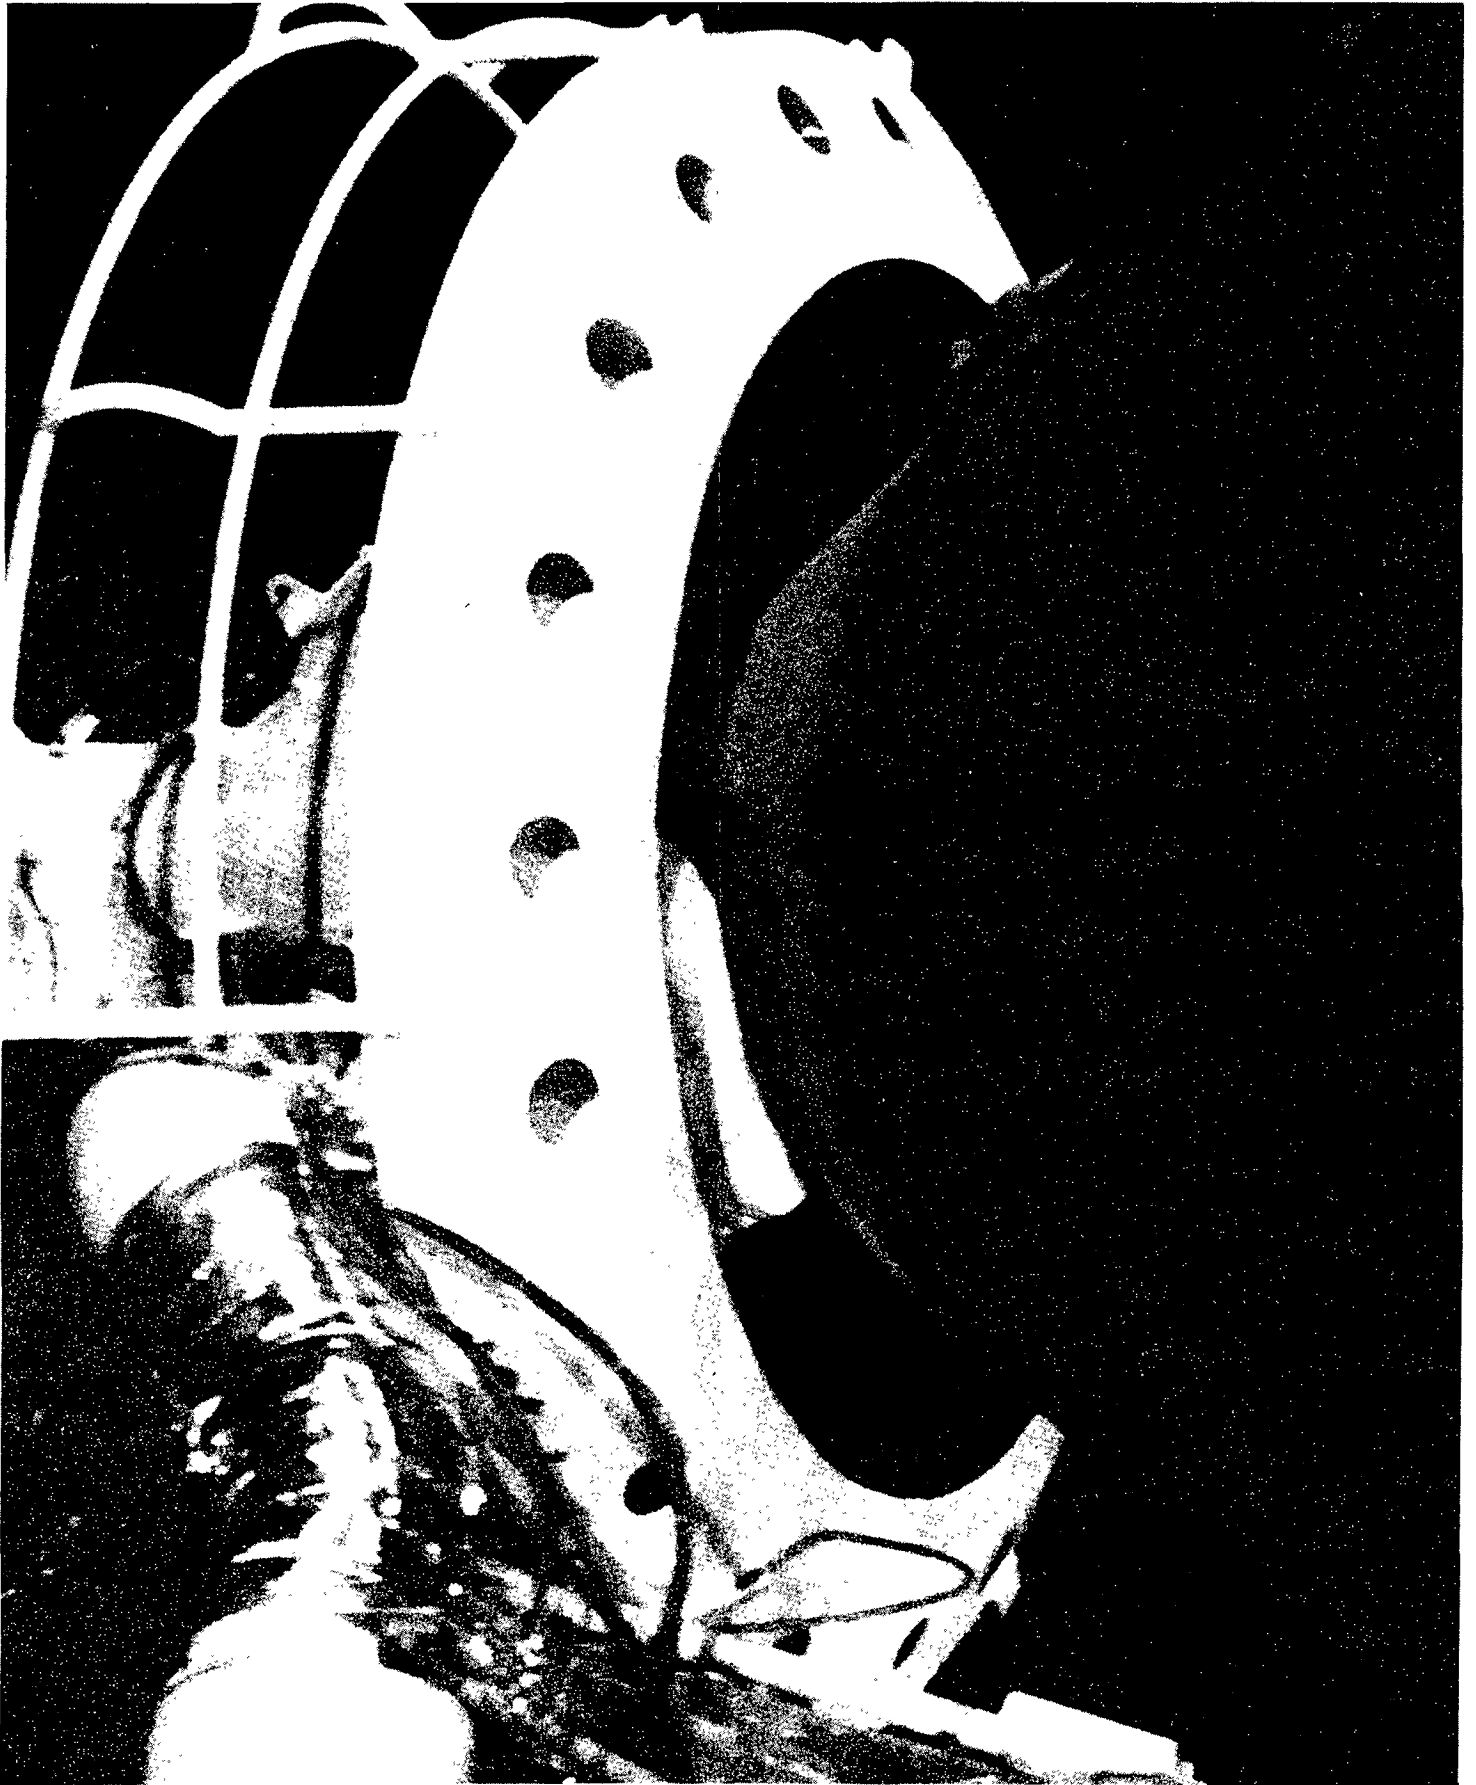
Anomaly 004 documented a leak from the -Y GOX vent seal. CMEC took a PR to remove and replace the seal.

DISCREPANT SOUTHWEST SEAL OF GOX VENT HOOD IS POSITIONED HIGH
ON FOOTPRINT AREA AND RESULTING LEAK CAUSES SLIGHT EROSION
