NASA Technical Memorandum 100987

Ice/Frost/Debris Assessment For Space Shuttle Mission STS-26R

November 7, 1988

Charles G. Stevenson
Gregory N. Katnik
Scott A. Higginbotham
The John F. Kennedy Space Center, NASA

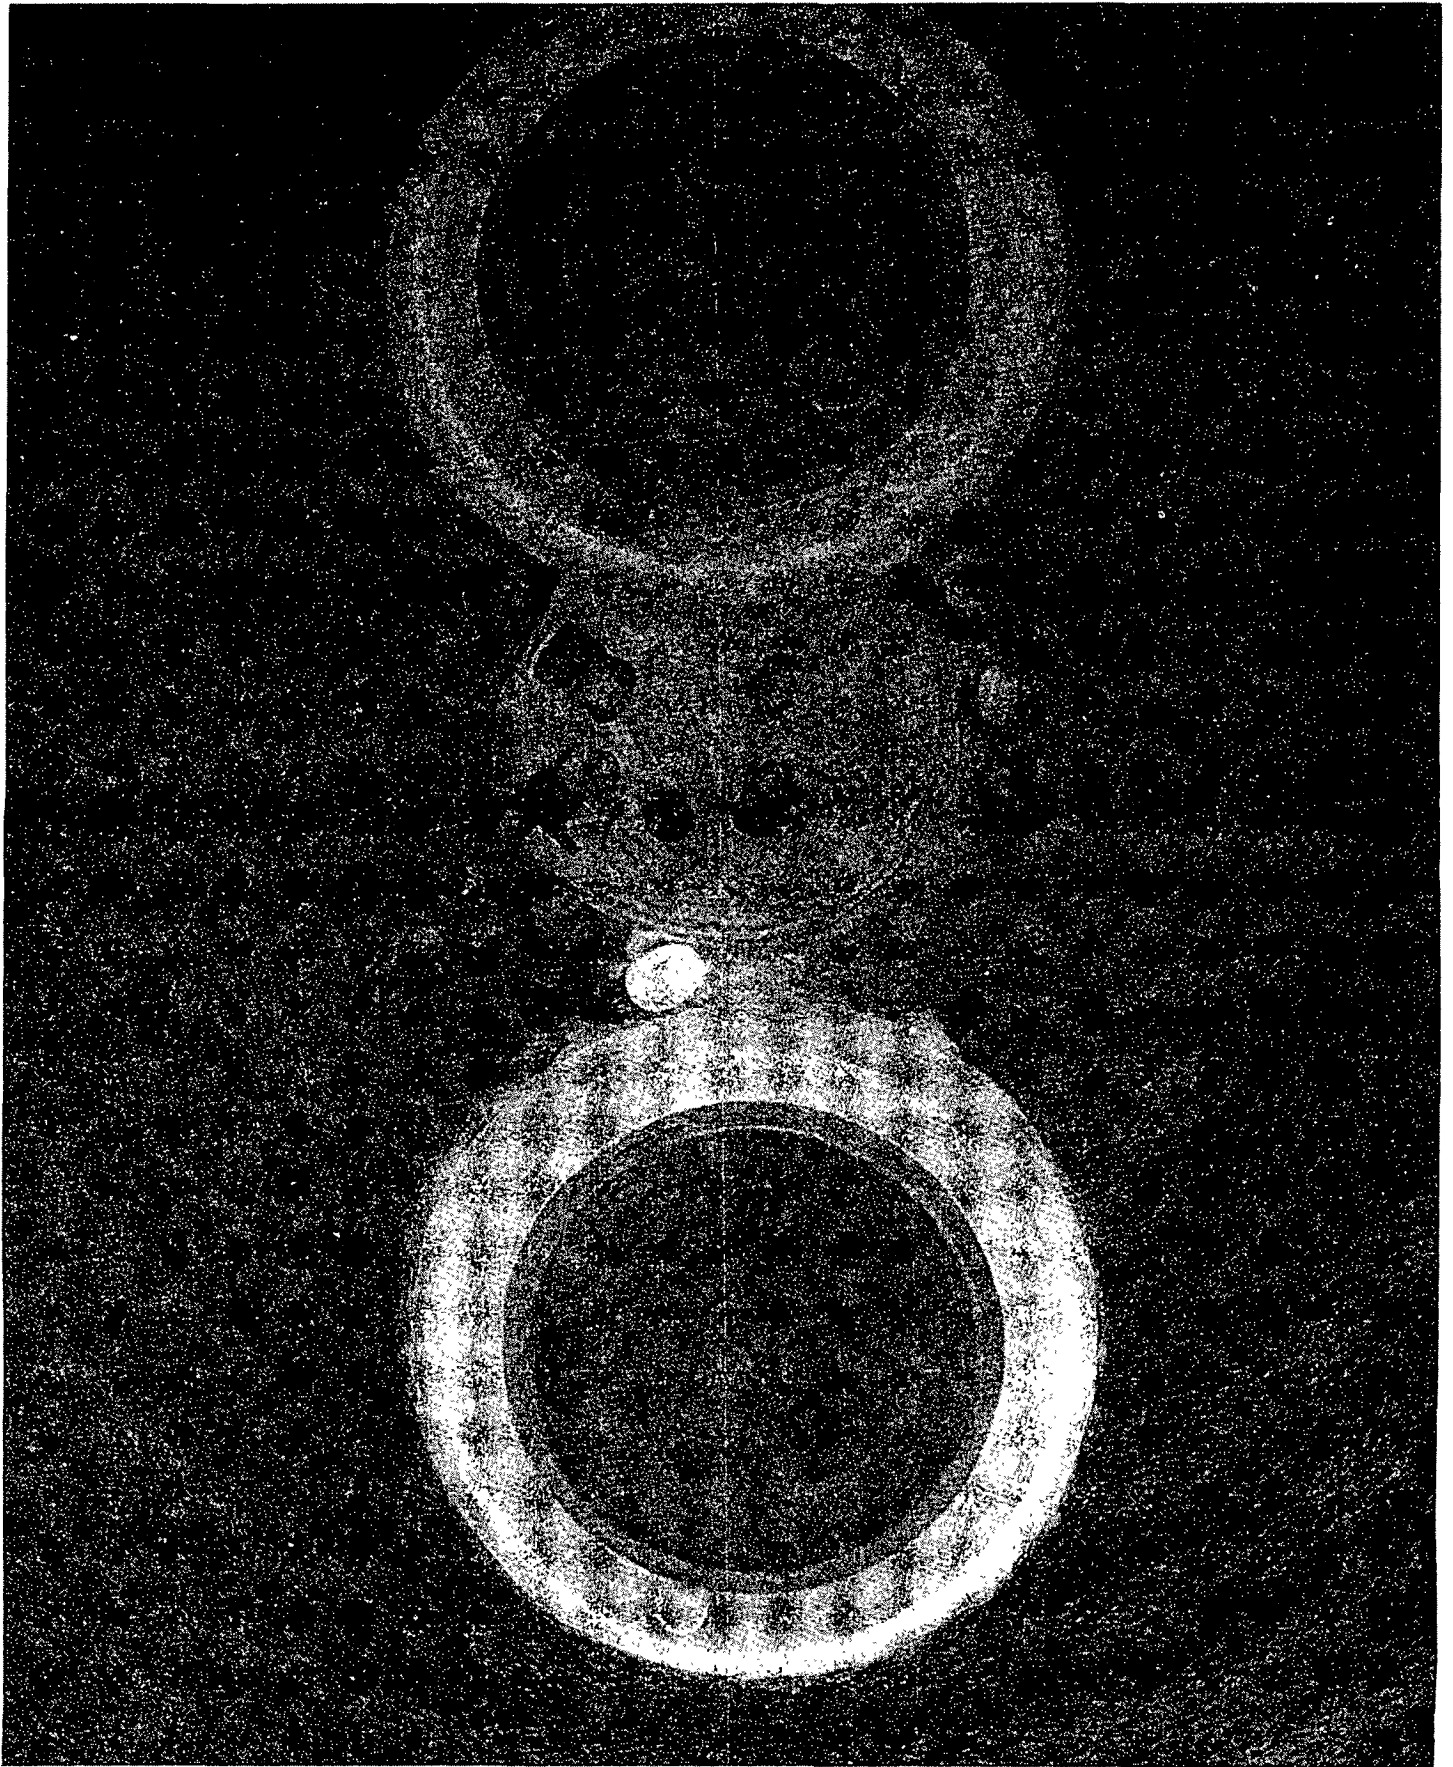
REPAIRS TO DIVOTS ON ET LH2 TANK AFT DOME APEX

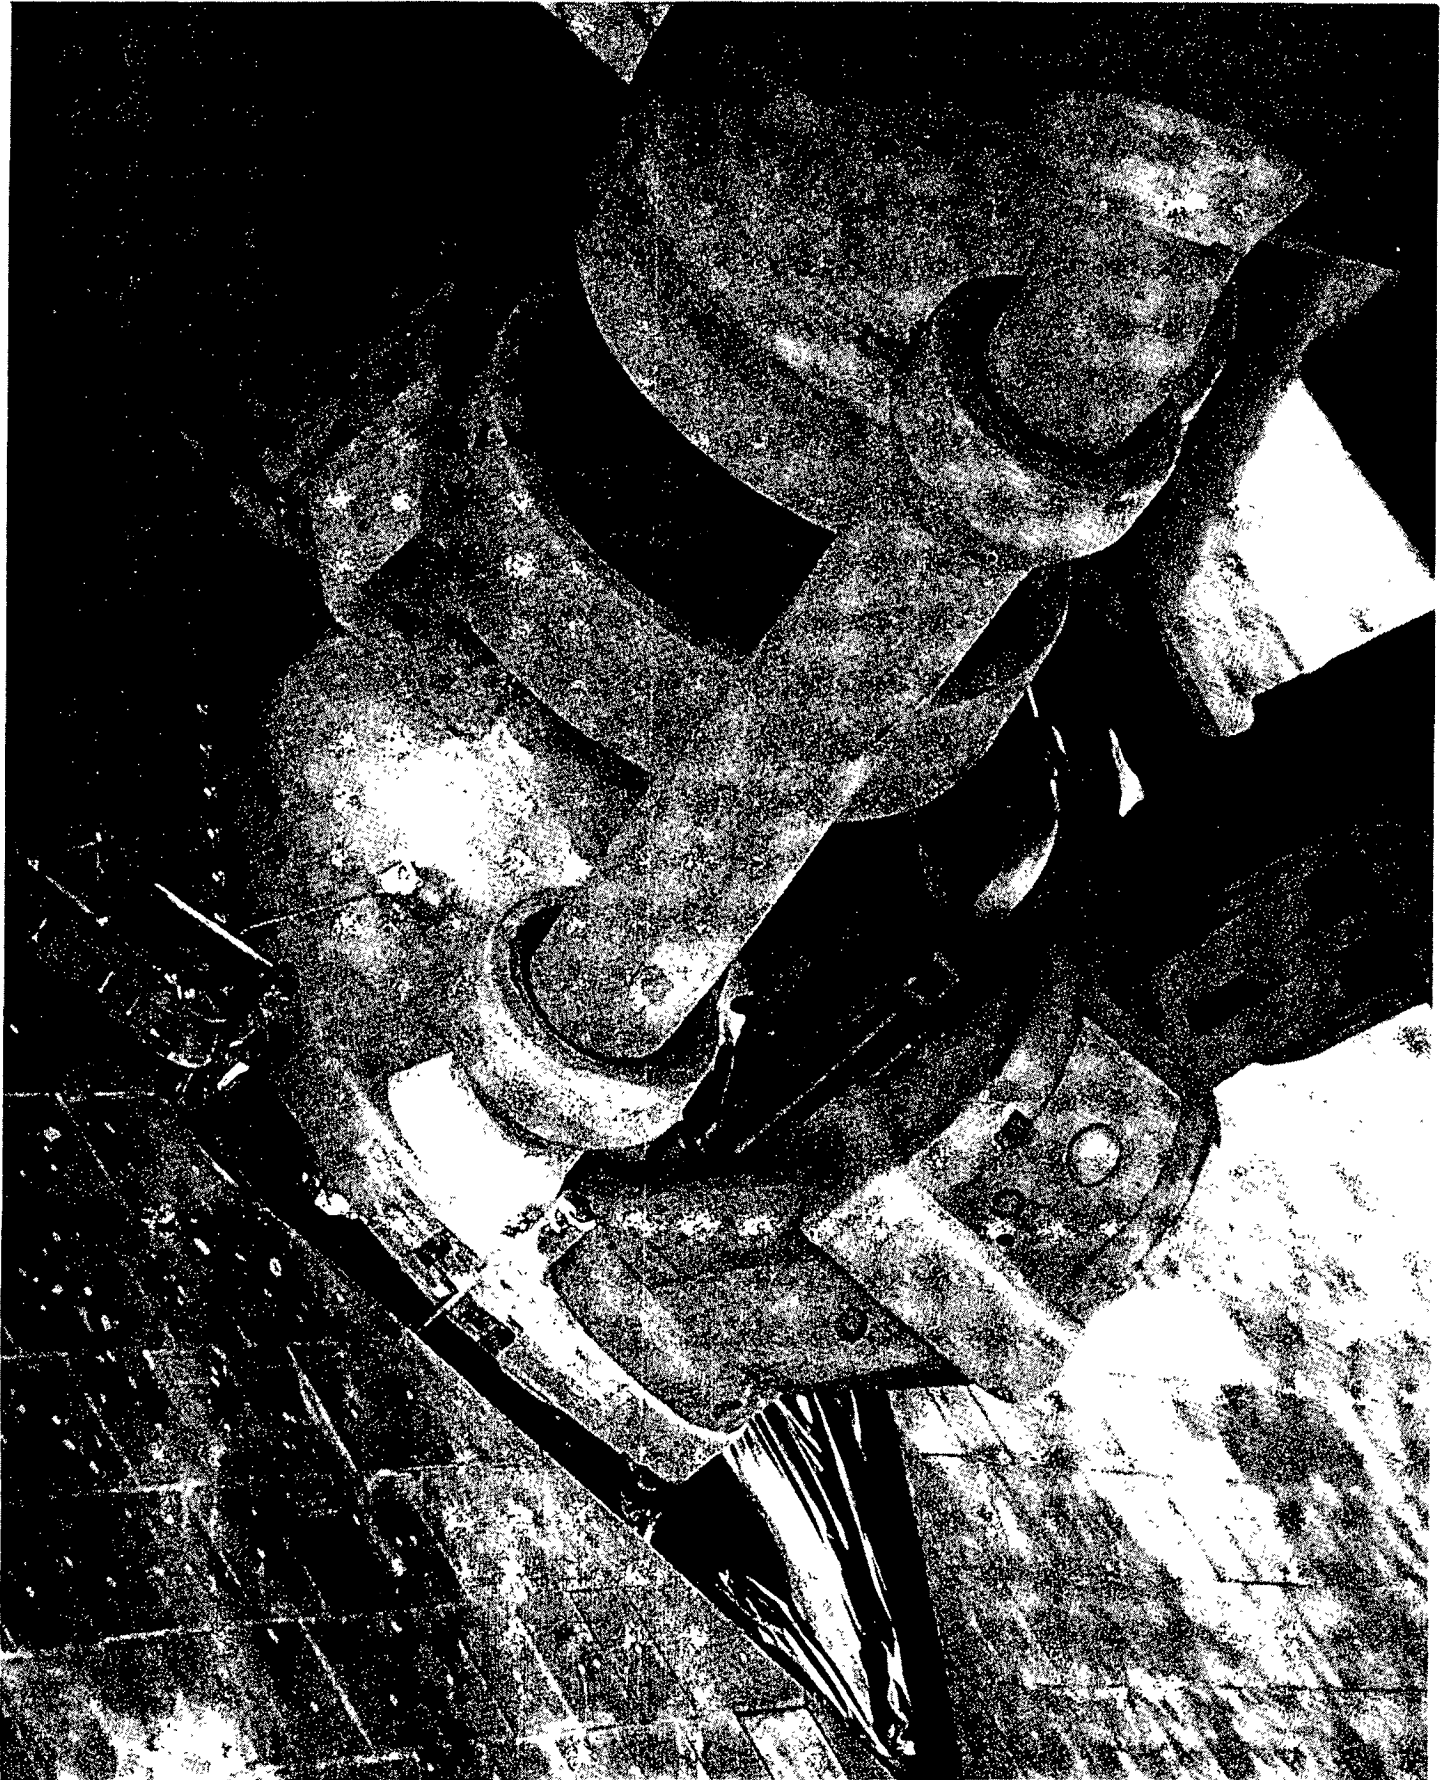
GAS ANALYZER INSTALLATION ON ET/ORB LH2 UMBILICAL

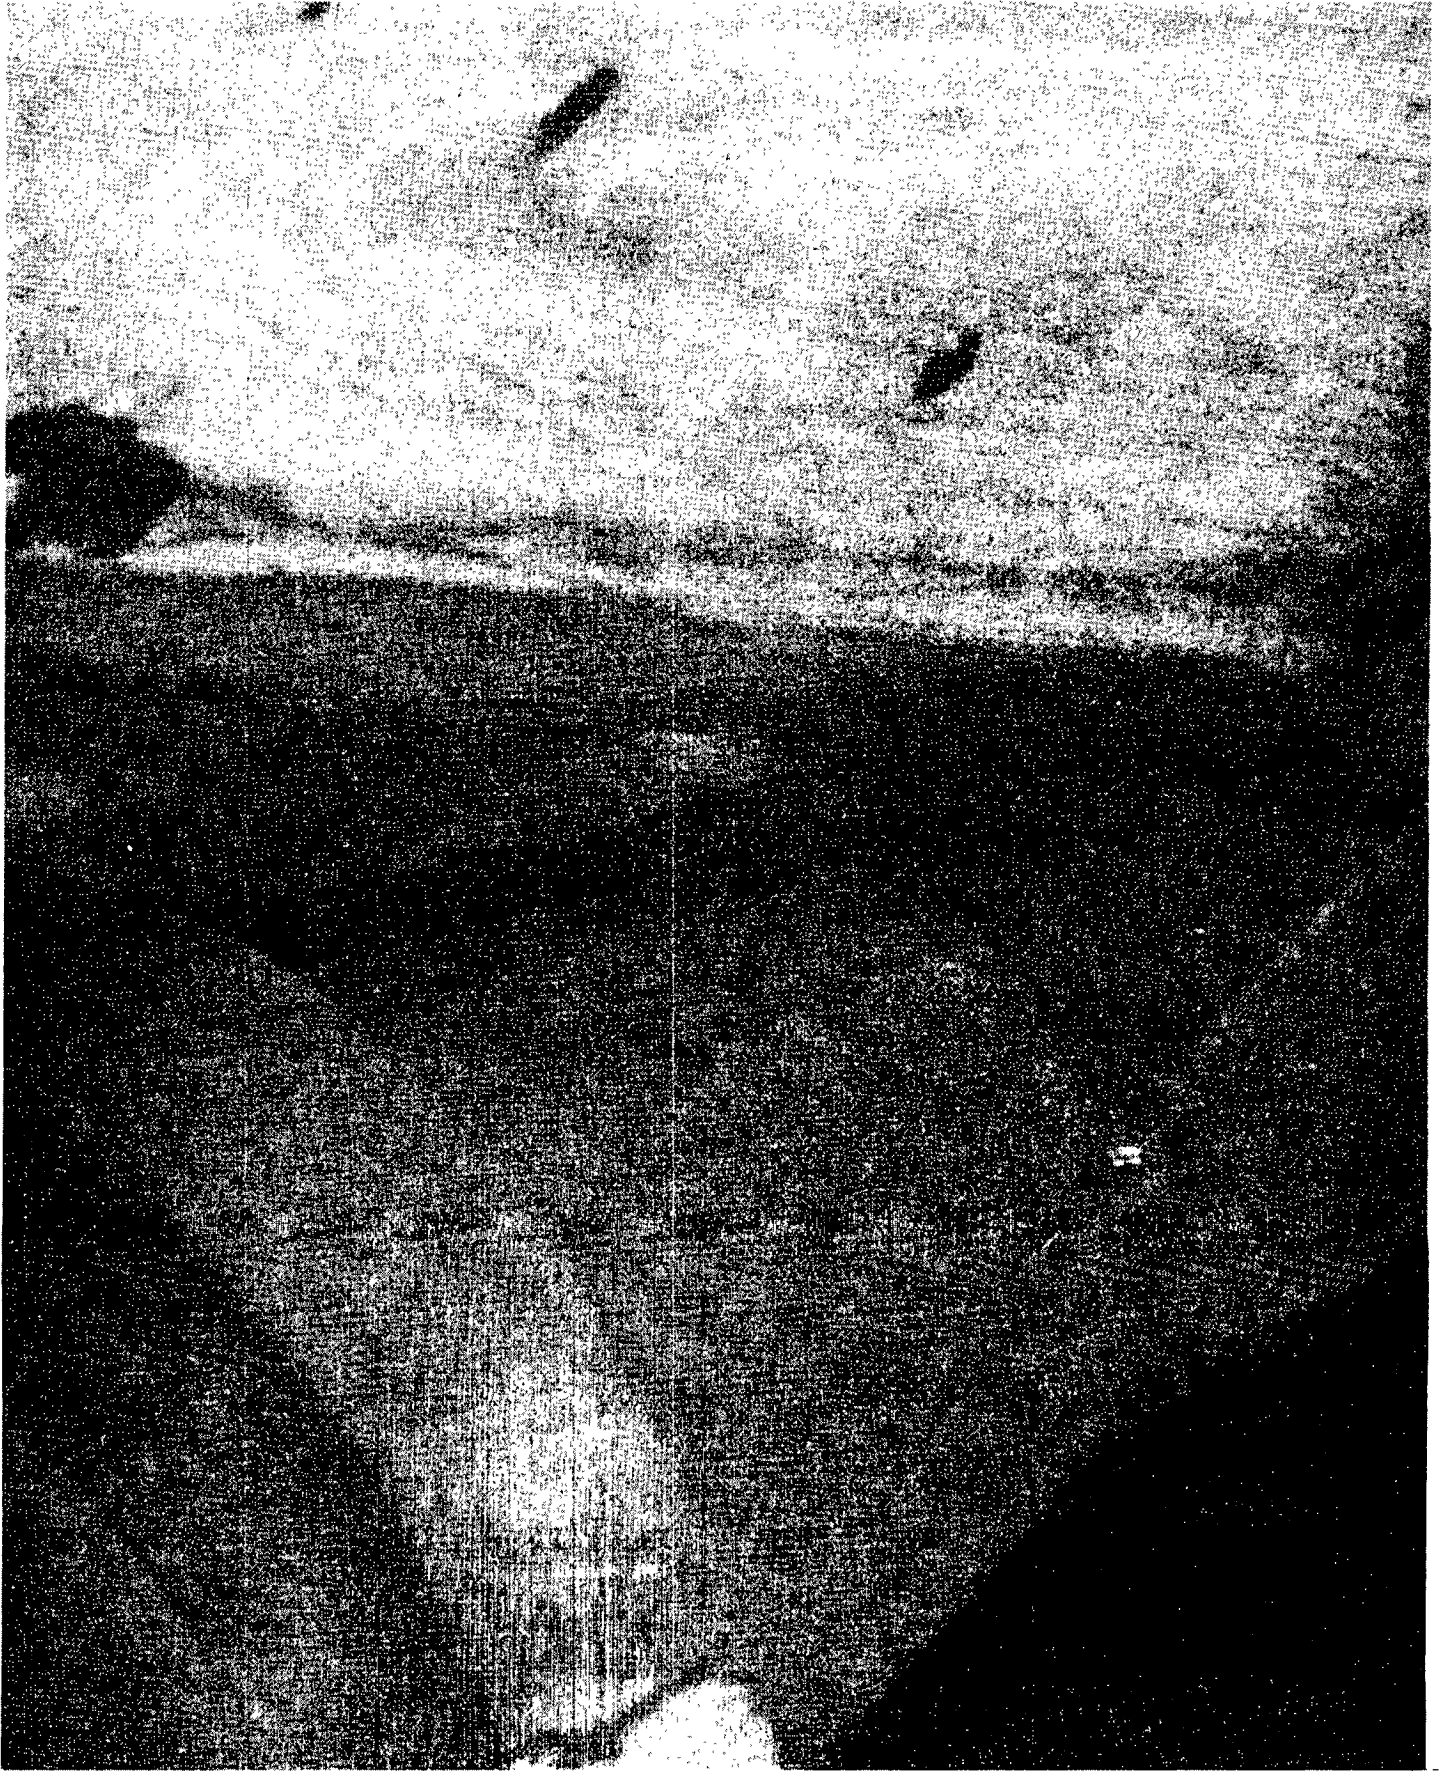
A crack had formed in the SOFI where the ball-fitting joint of the thrust strut interfaces with the longeron (both +Y/-Y sides). These cracks were considered acceptable per the NSTS-08303 criteria.

CRACK IN TPS AT THRUST STRUT TO LONGERON INTERFACE

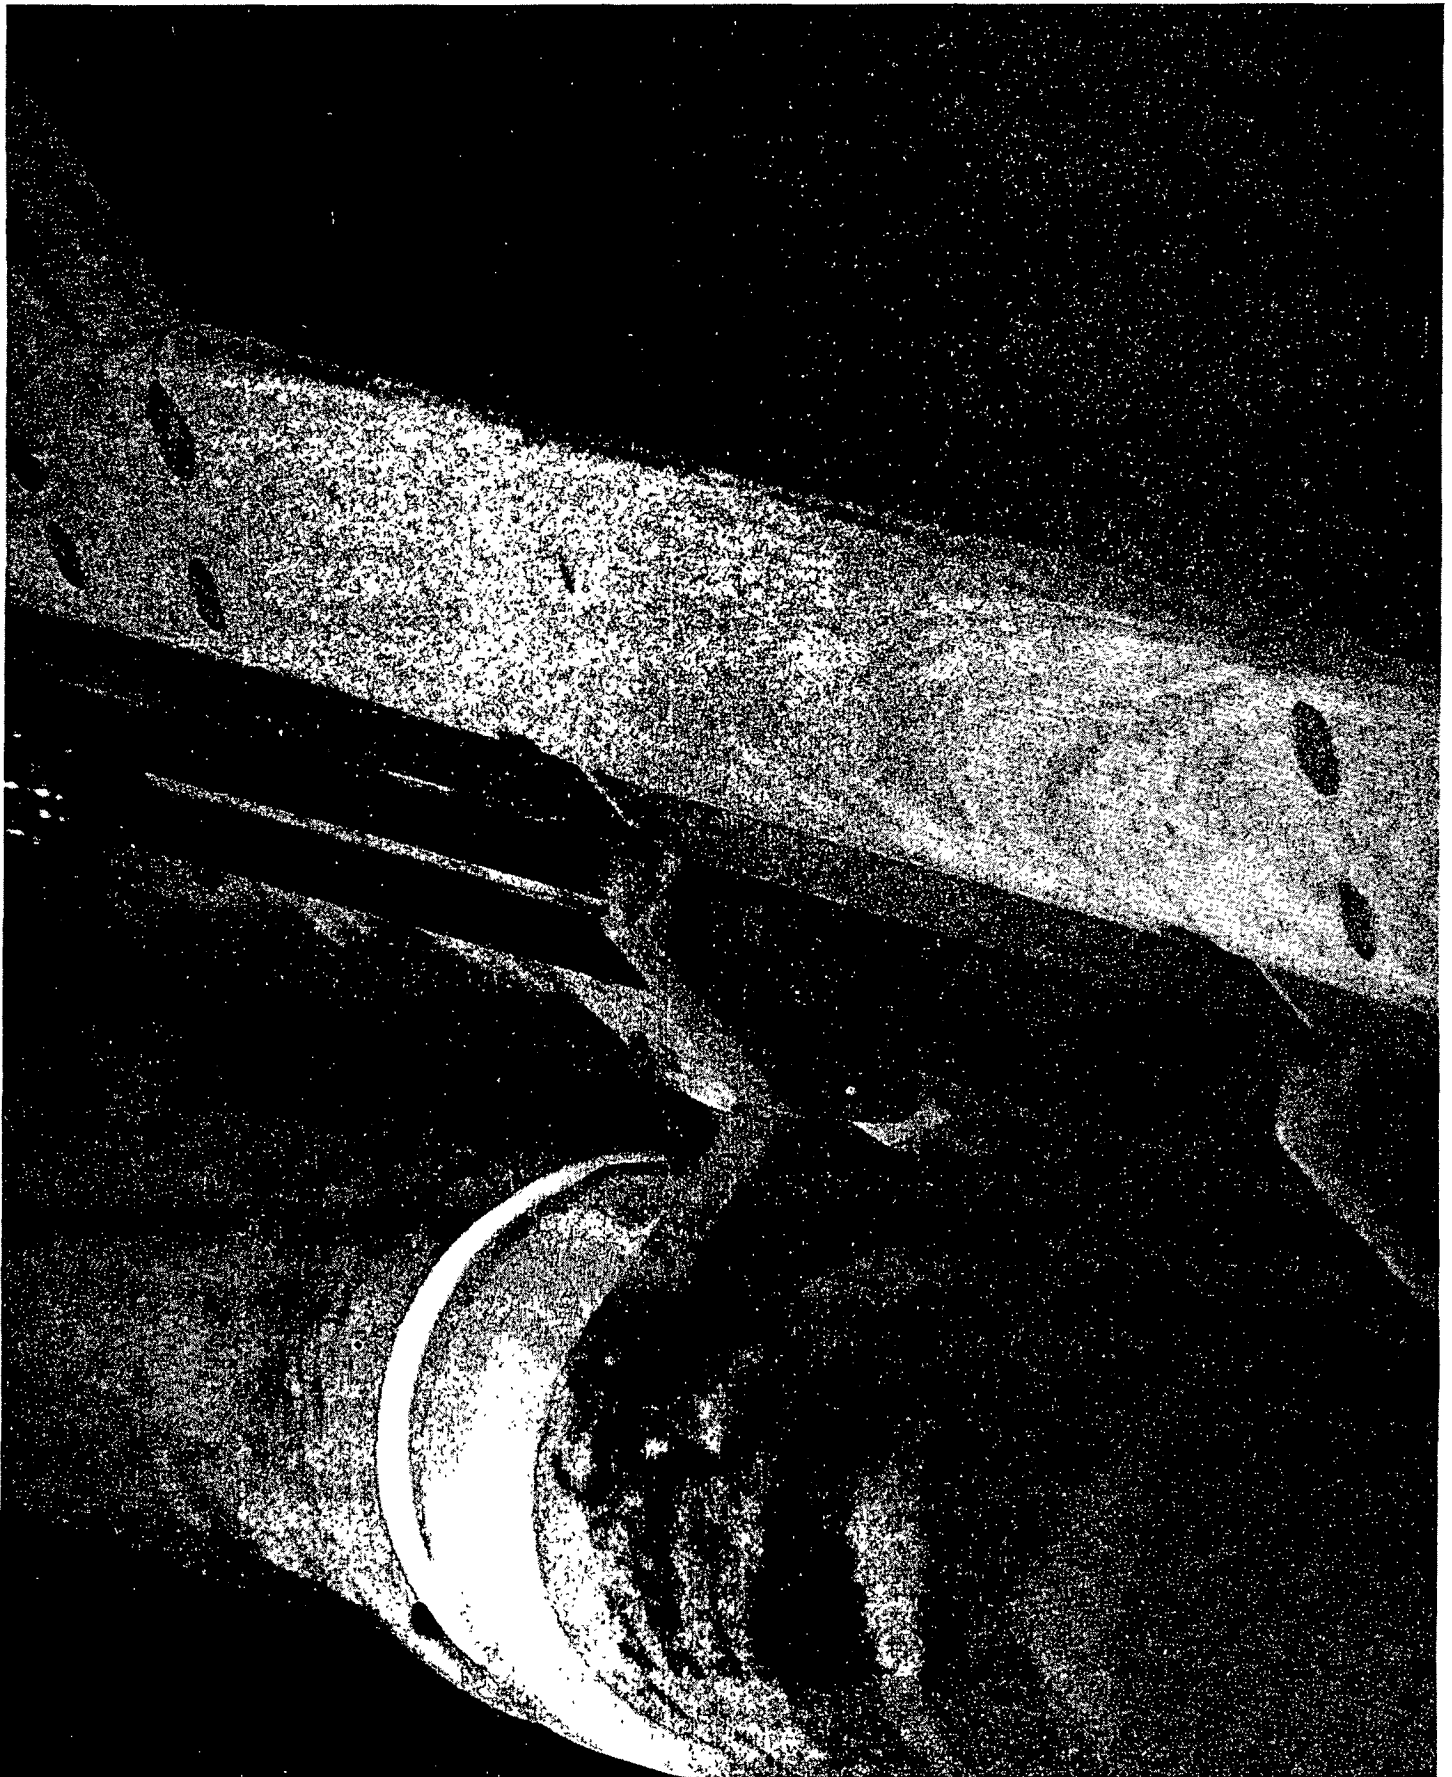
TYPICAL ICE/FROST ACCUMULATION IN ET LO2 FEEDLINE BELLOWS AND
SUPPORT BRACKET. FROST SPOT ON AFT SIDE OF PRESS LINE RAMP.

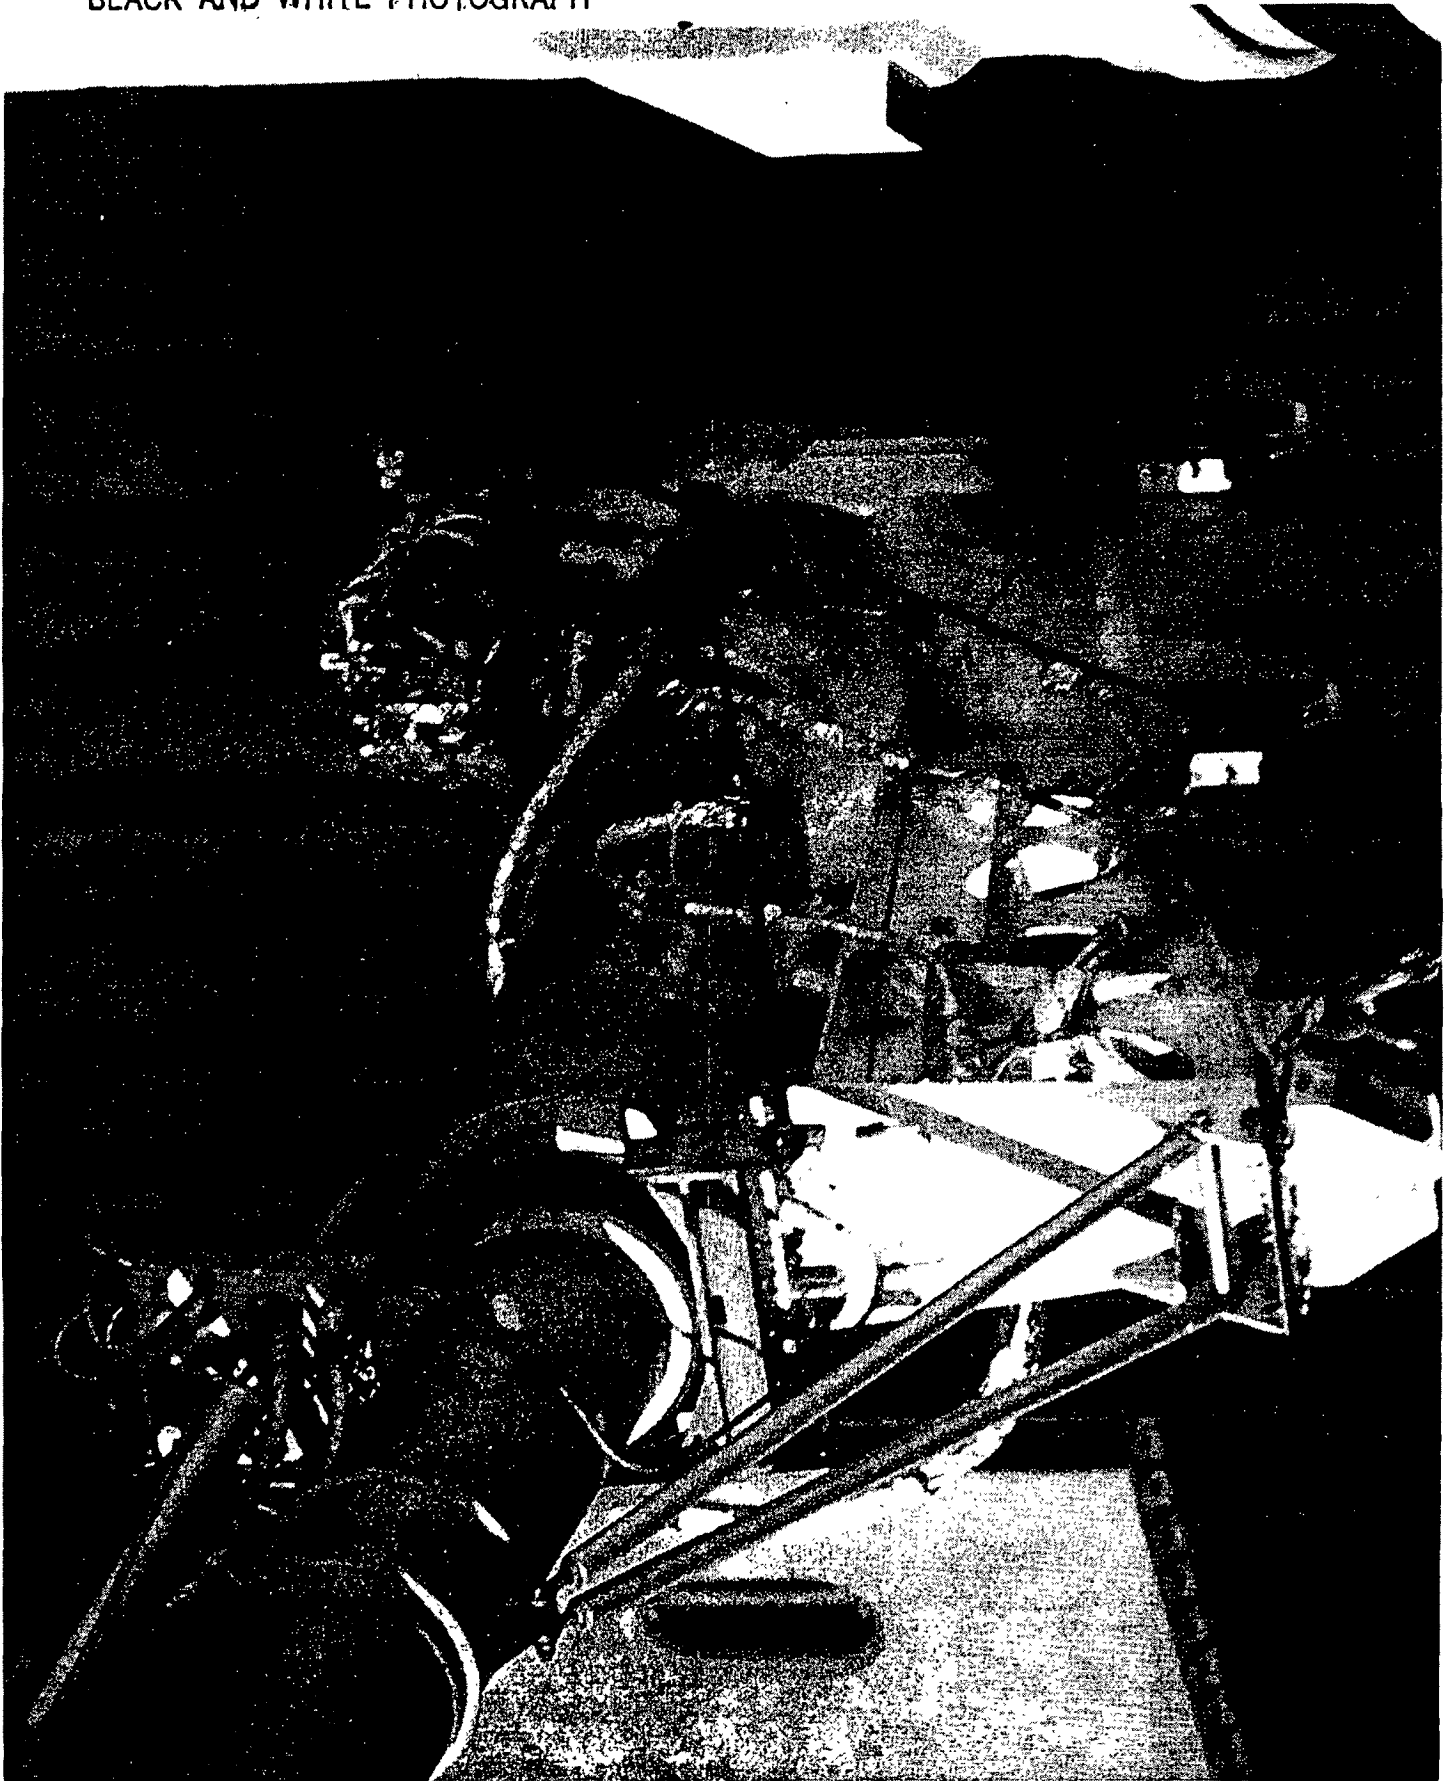
GH2 VENT ARM MODIFICATION PREVENTS ICE/FROST FORMATION
ON THE LINE. LIGHT FROST HAS FORMED ON +Z SIDE OF GUCP.

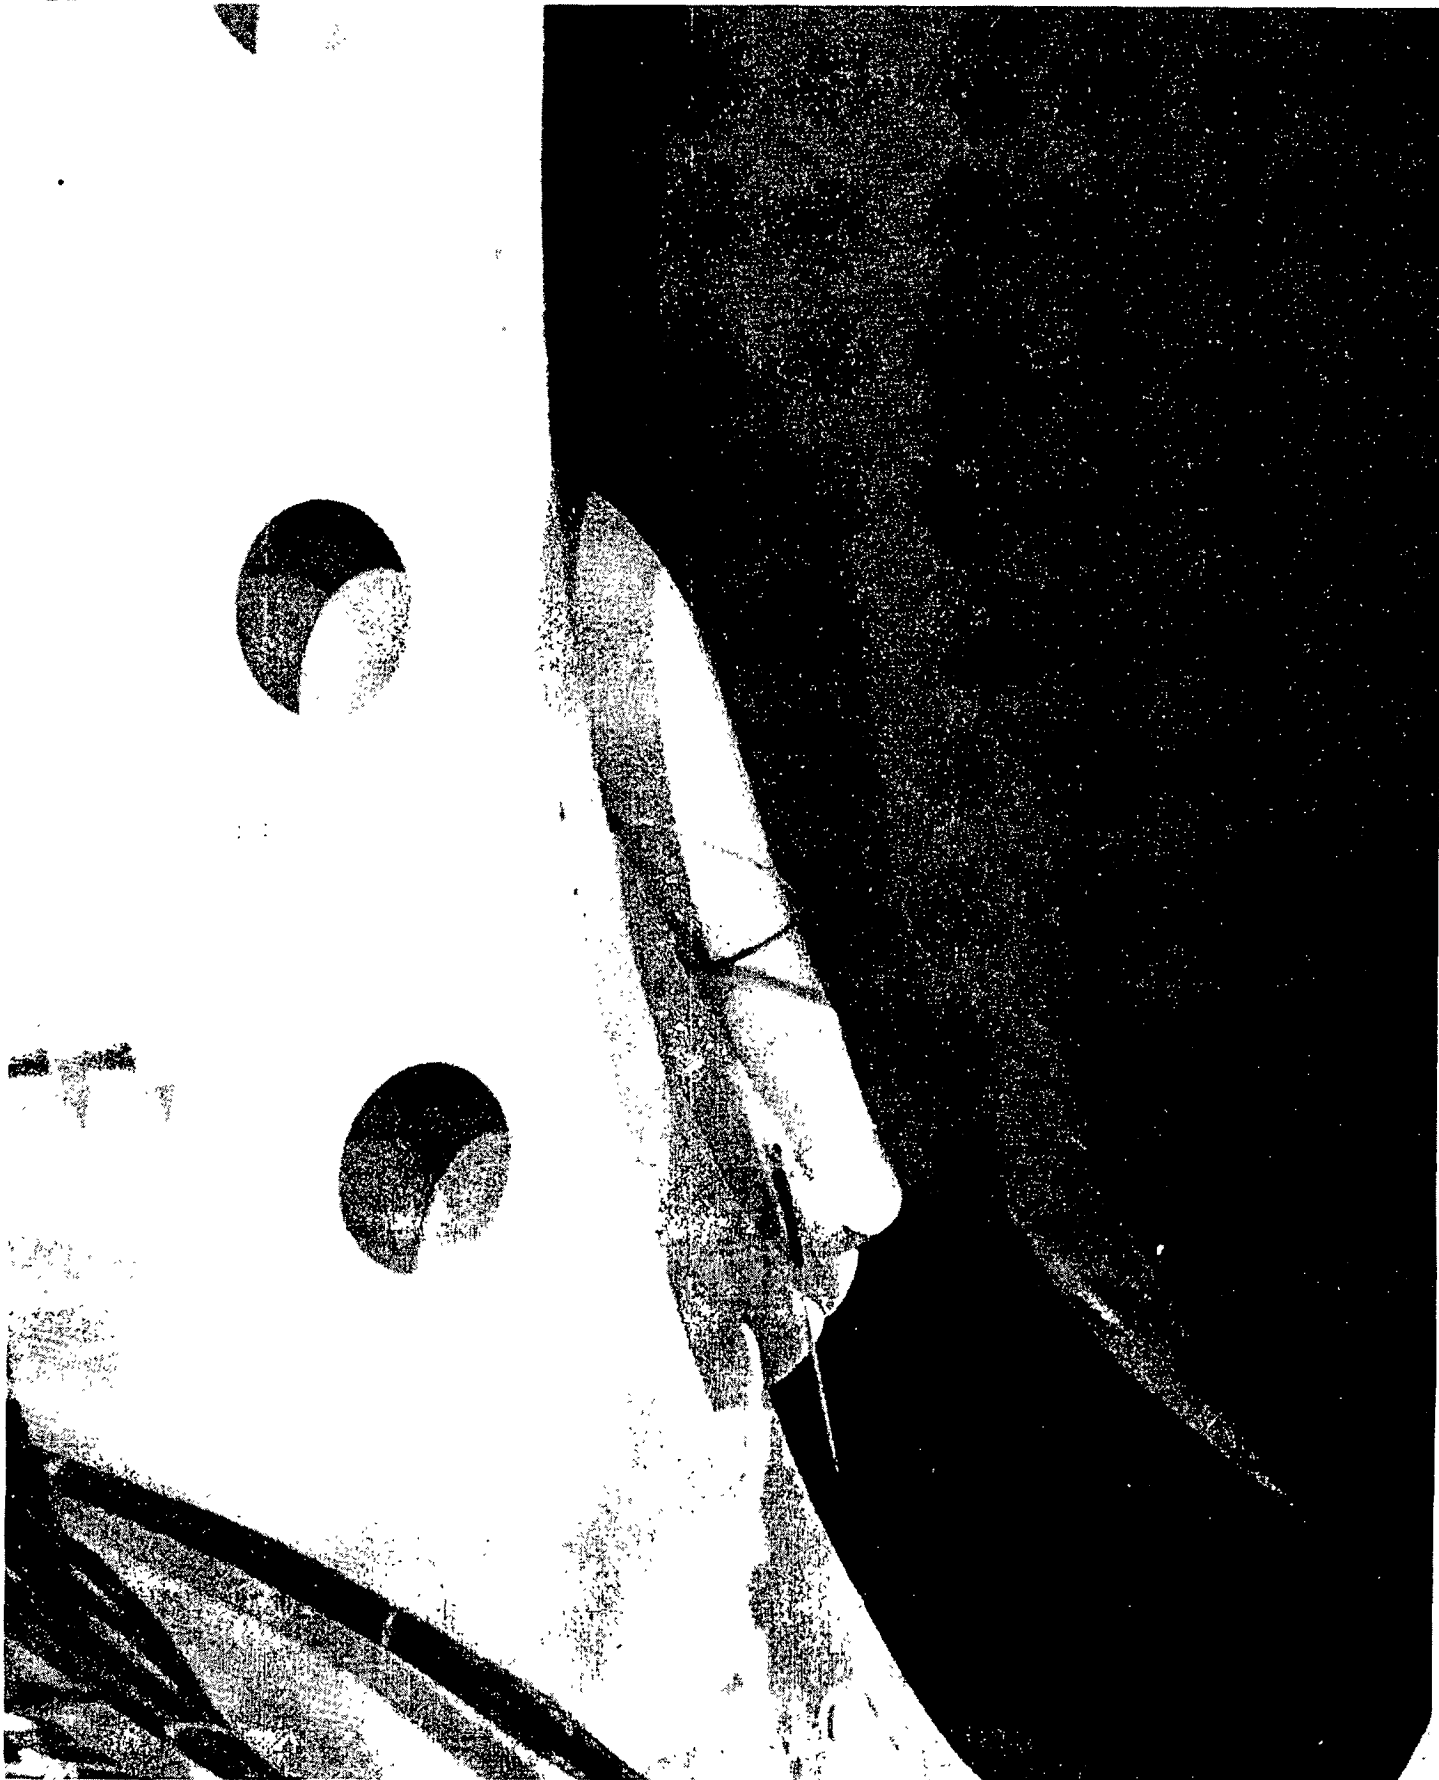
SOUTHWEST GOX VENT SEAL IS PROPERLY POSITIONED
OVER ET FOOTPRINT AND DID NOT LEAK

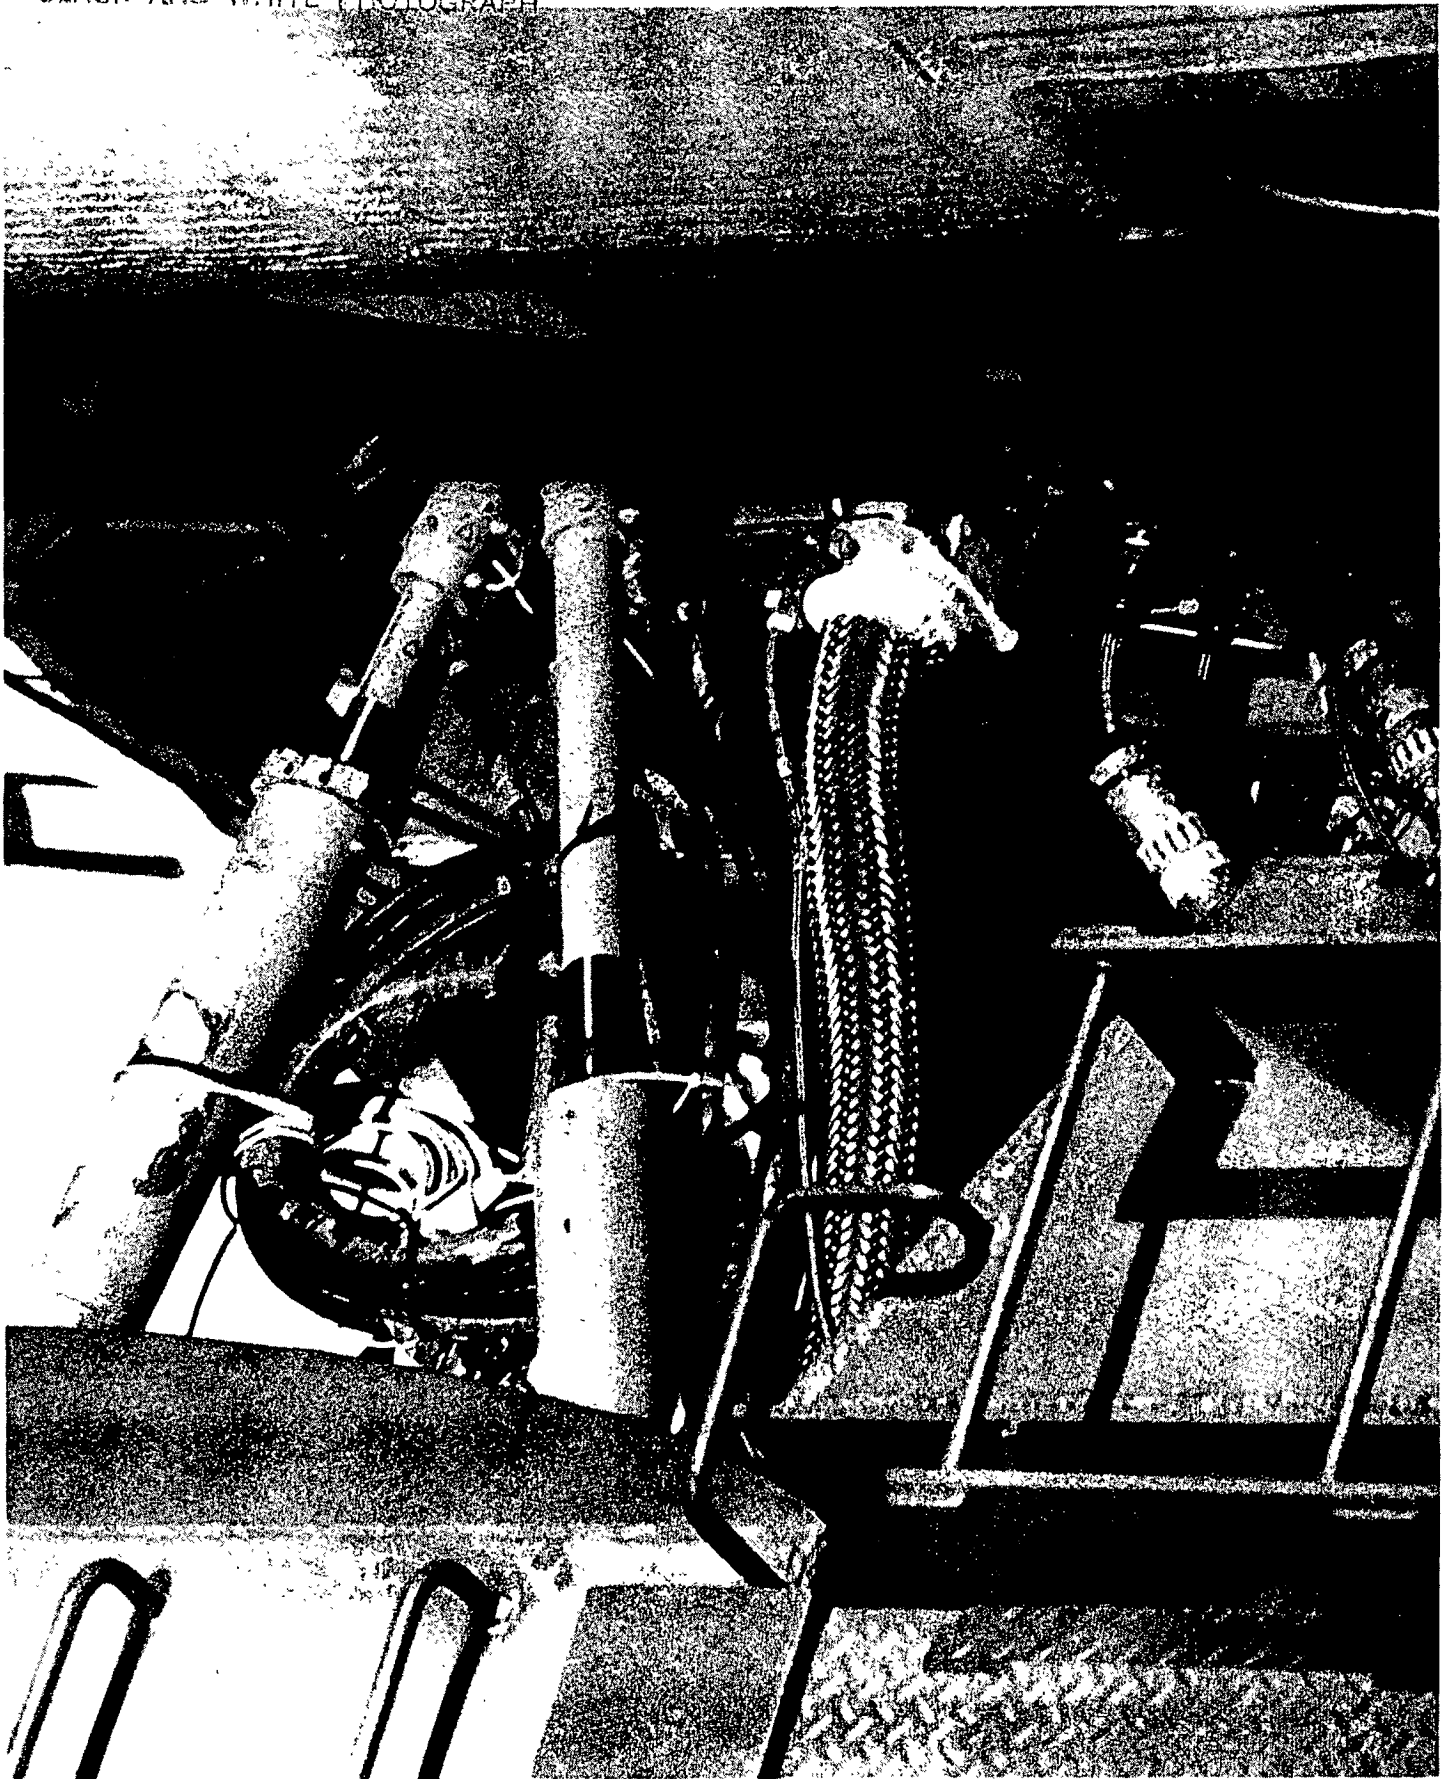
NO LEAK ON ORBITER LH2 T-0 UMBILICAL

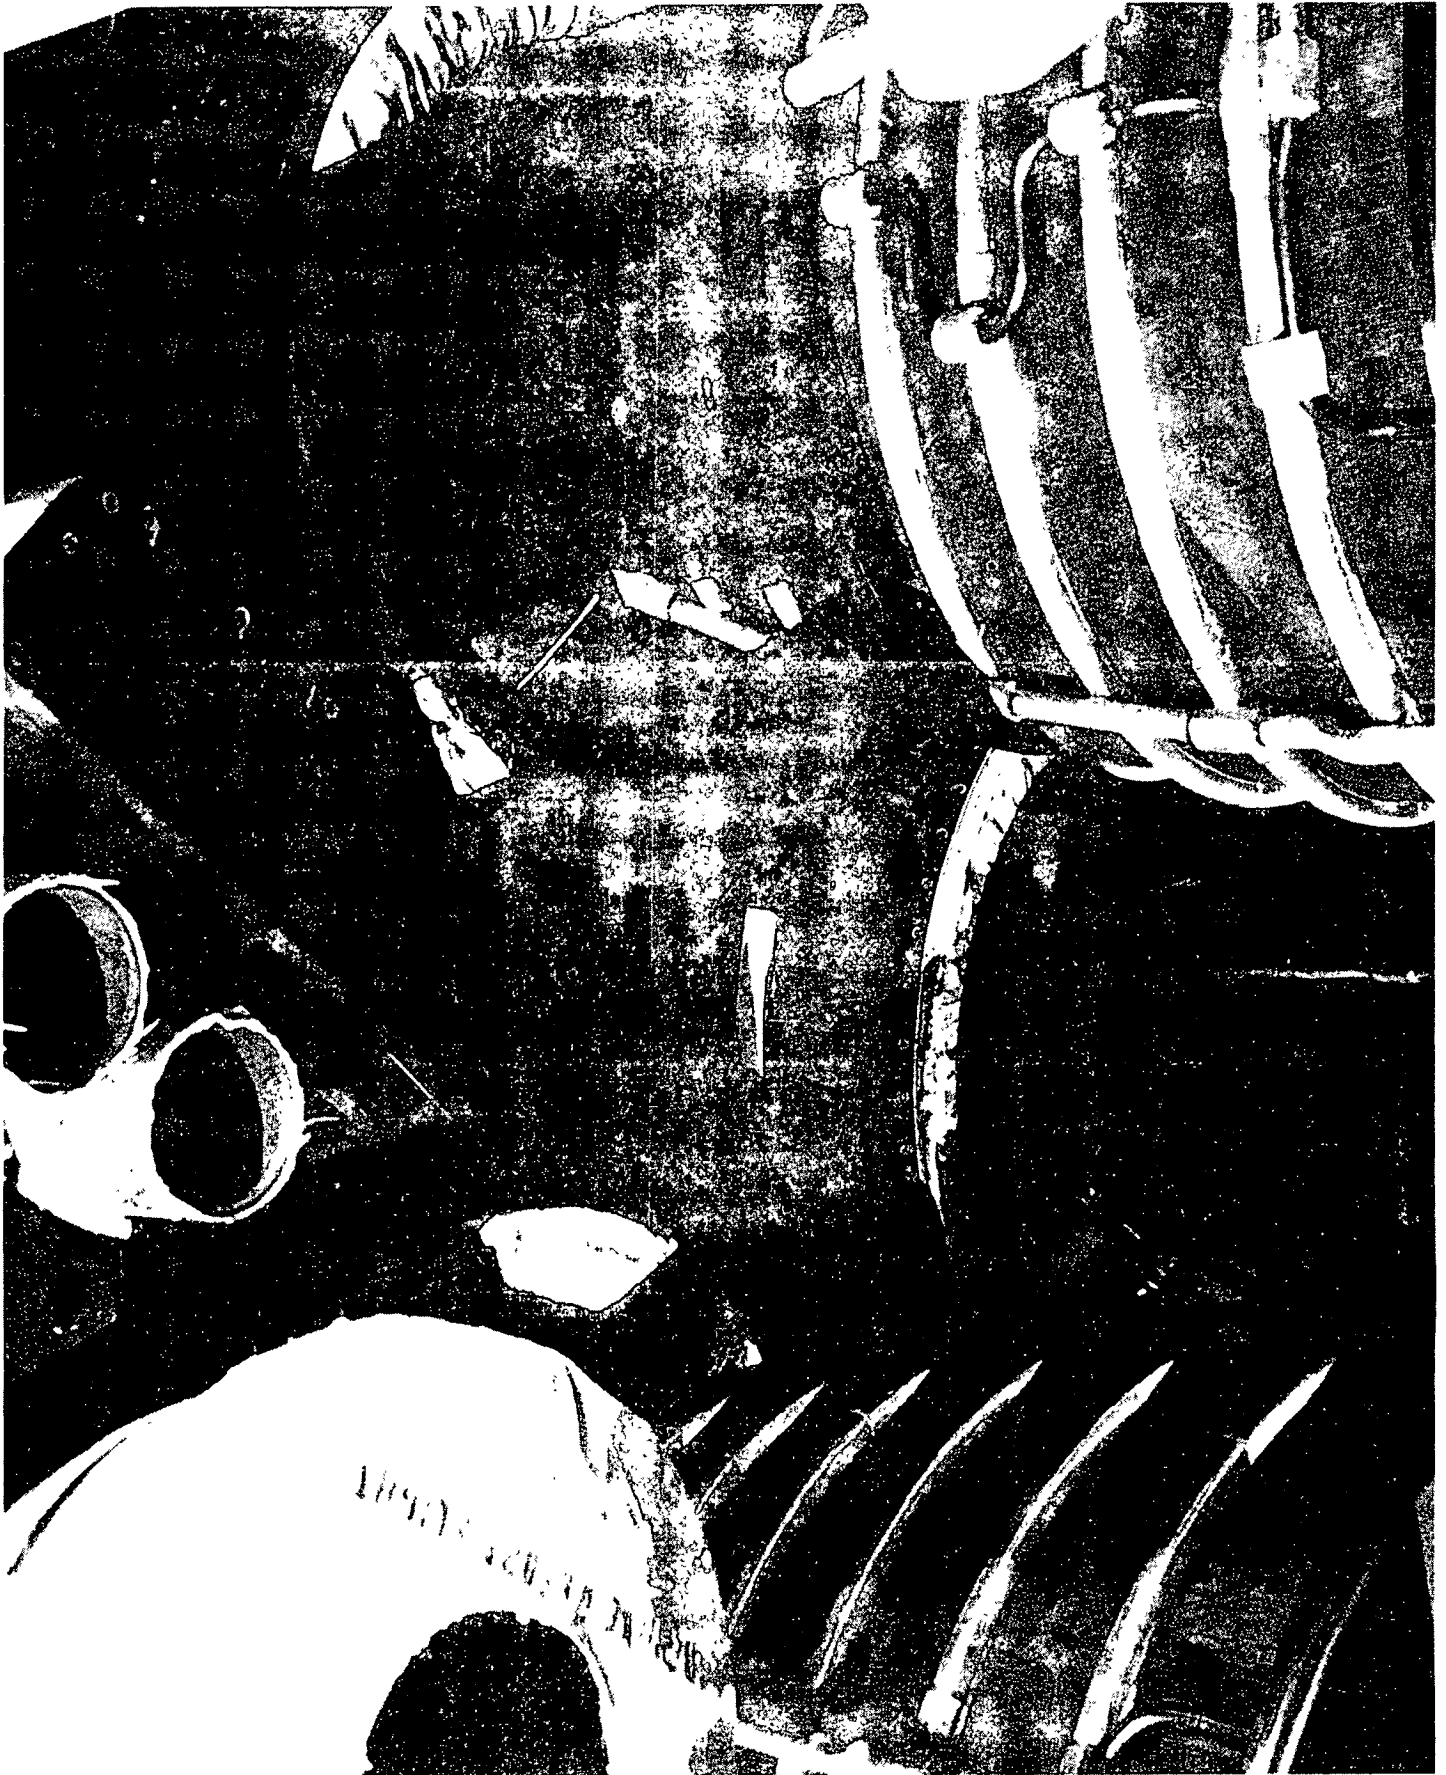
TILE CARRIER PANEL ON ORBITER AFT HEAT SHIELD NOT
YET INSTALLED TO ACCOMMODATE FRF INSTRUMENTATION

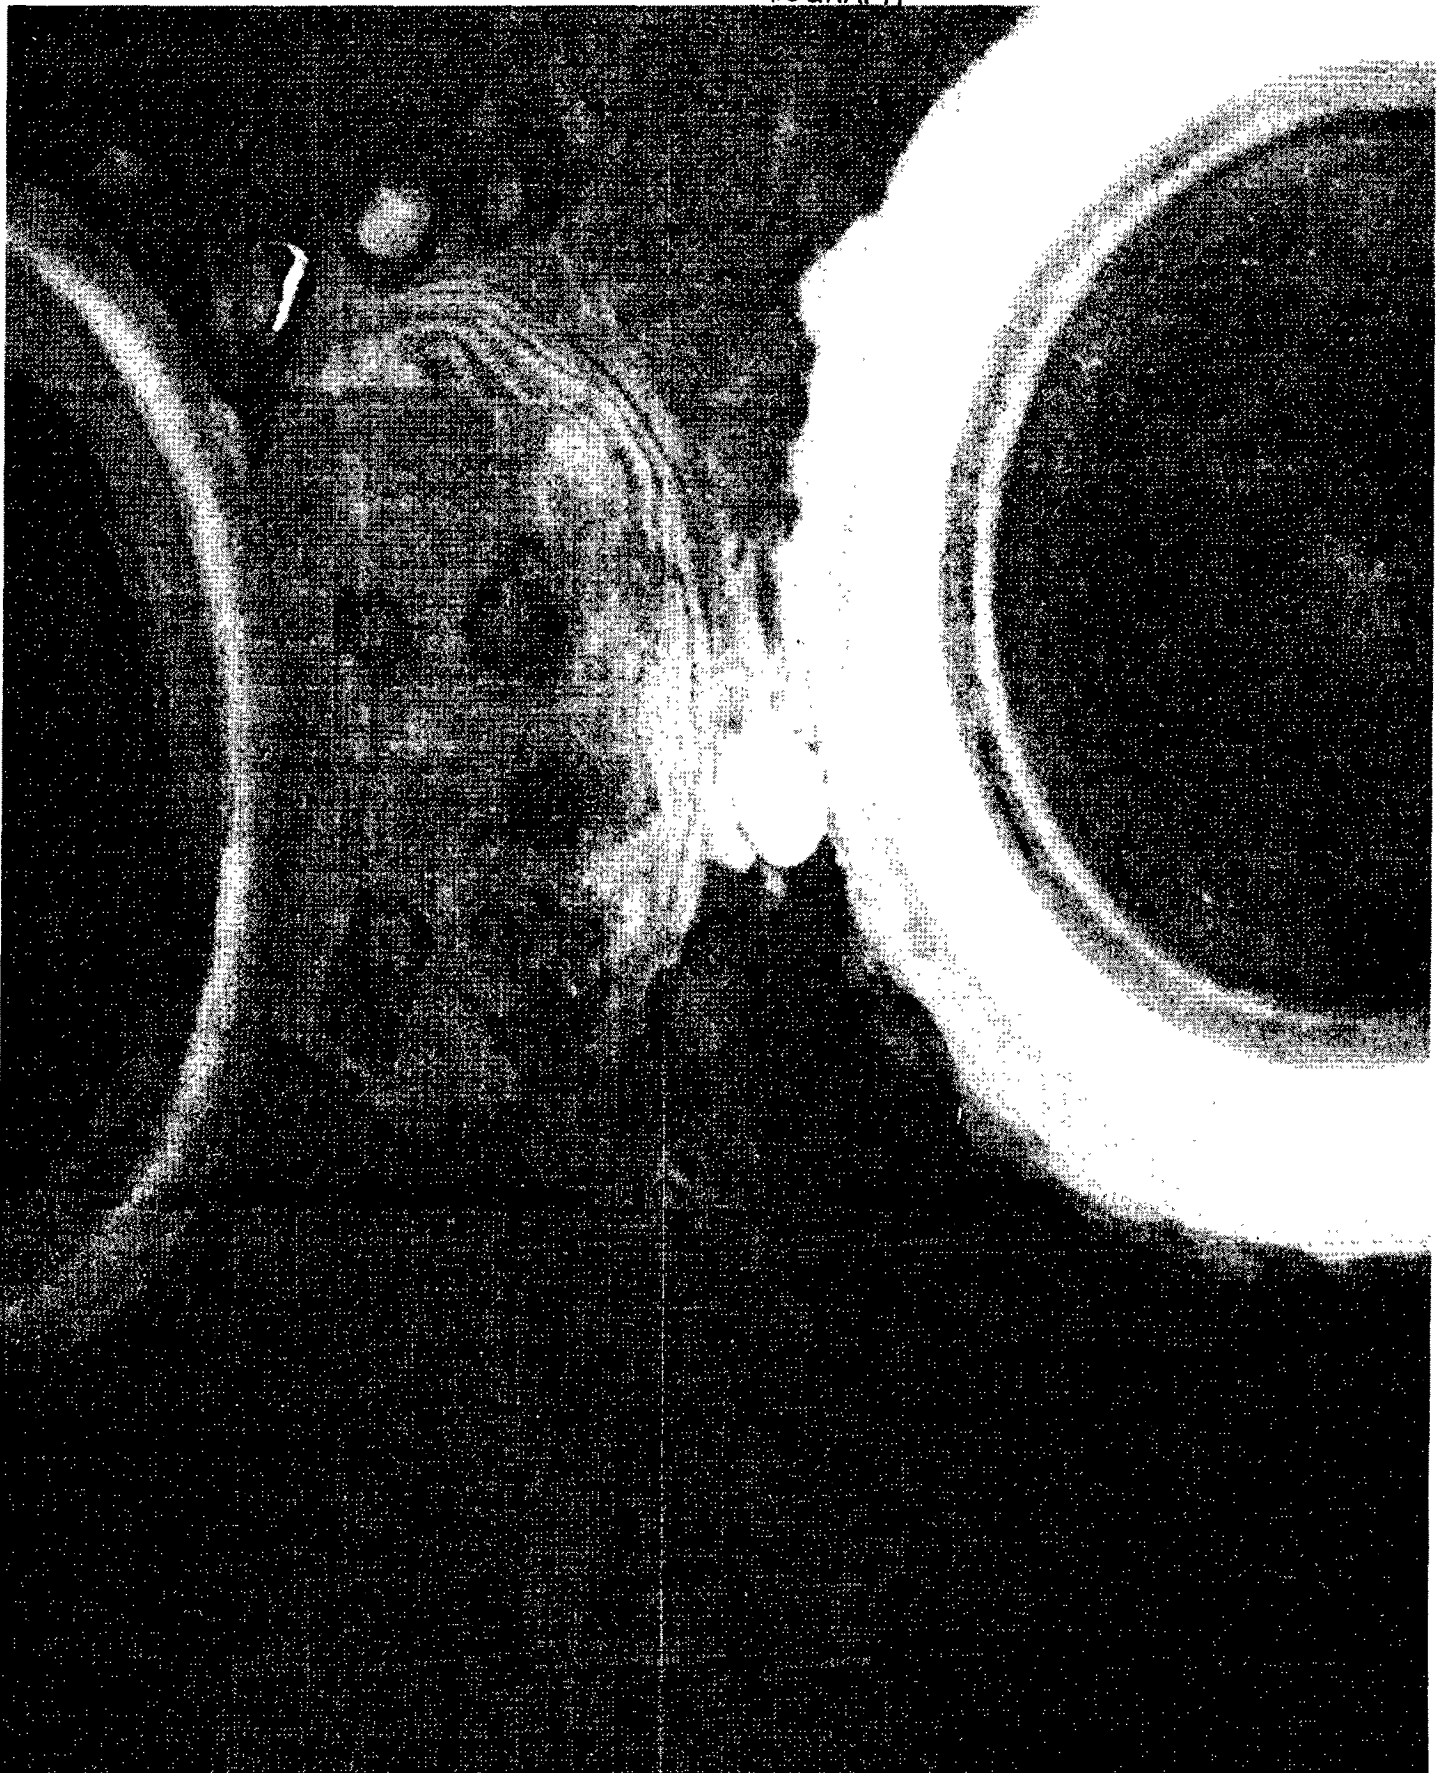
DIVOT ON ET LH2 TANK AFT DOME APEX
