NASA Technical Memorandum 100987

Ice/Frost/Debris Assessment For Space Shuttle Mission STS-26R

November 7, 1988

Charles G. Stevenson
Gregory N. Katnik
Scott A. Higginbotham
The John F. Kennedy Space Center, NASA

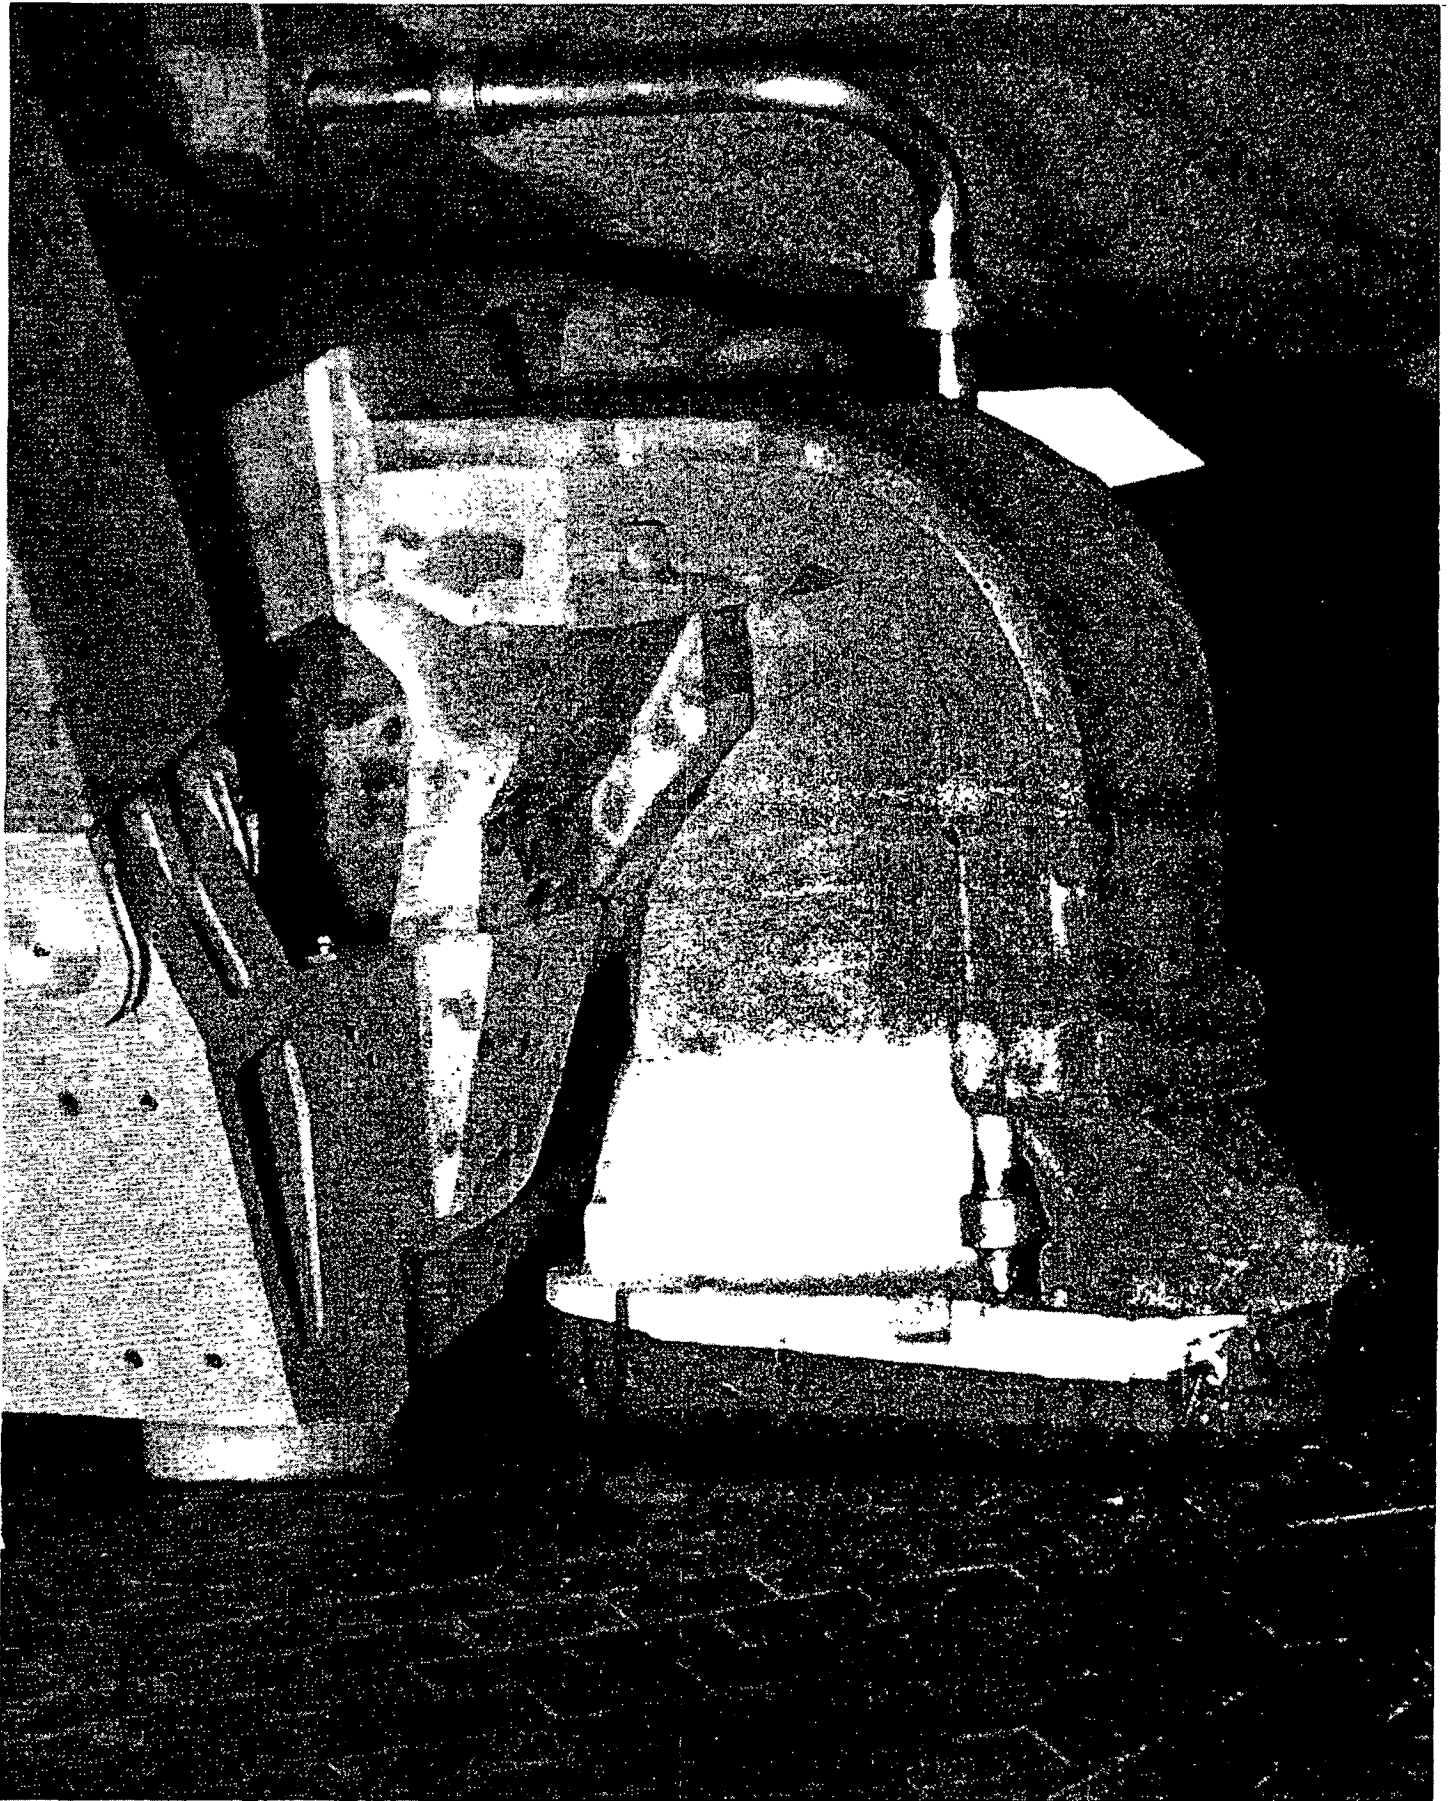
ET/ORB LO2 UMBILICAL WITH FROST FINGER ON PURGE VENT.

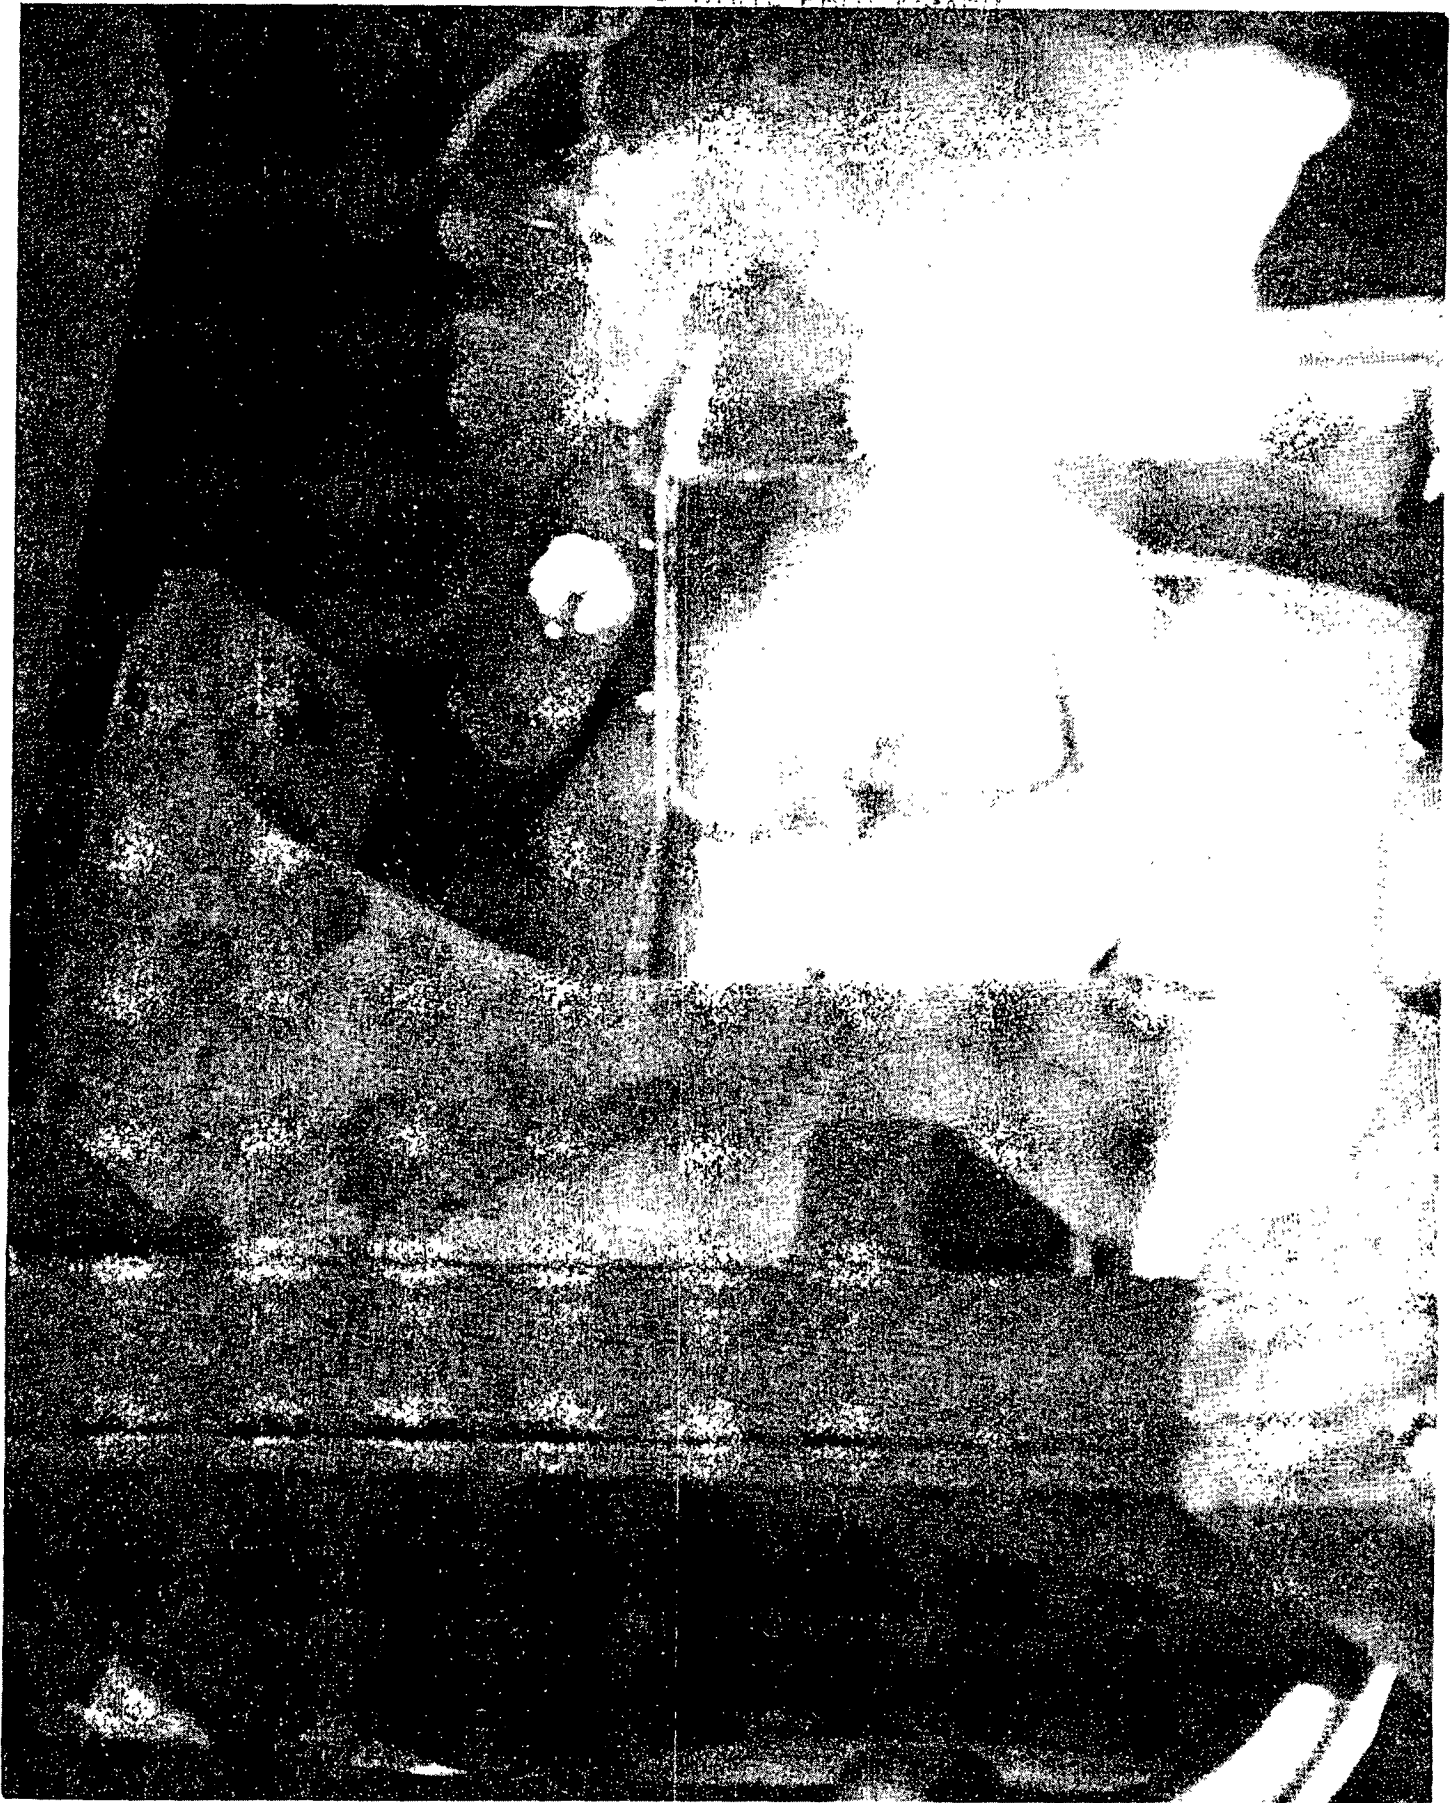
ICE/FRST ACCUMULATION ON LH2 UMBILICAL BAGGIE. GAS ANALYZERS
AND INSTRUMENTATION AND CABLES HAVE BEEN INSTALLED FOR FRF.

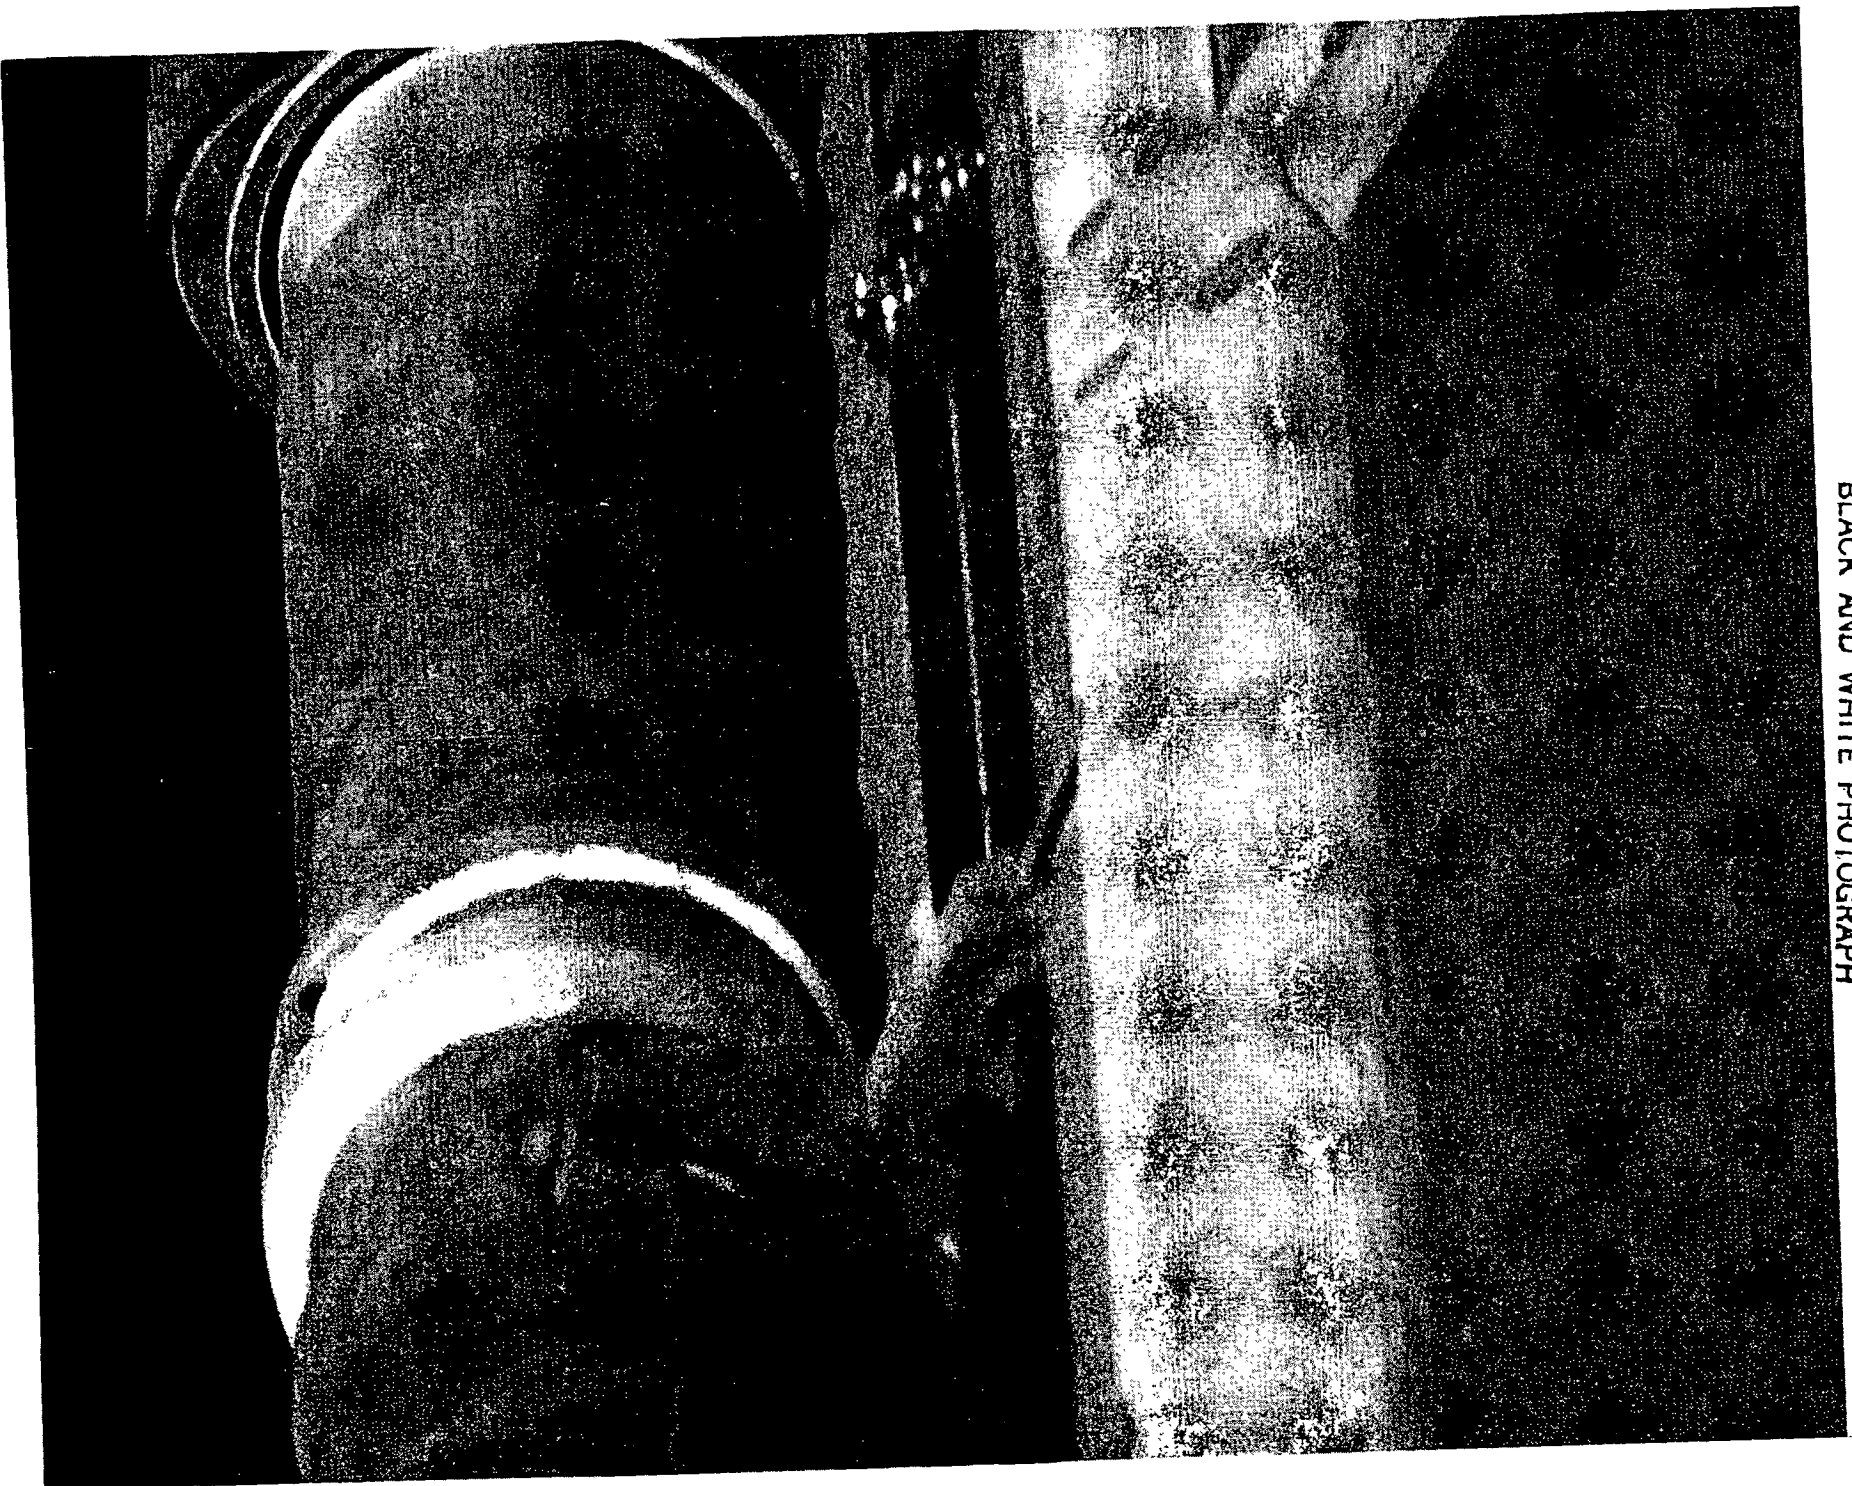
ICE/FROST ACCUMULATION IN LO2 FEEDLINE BELLOWS/SUPPORT BRACKET

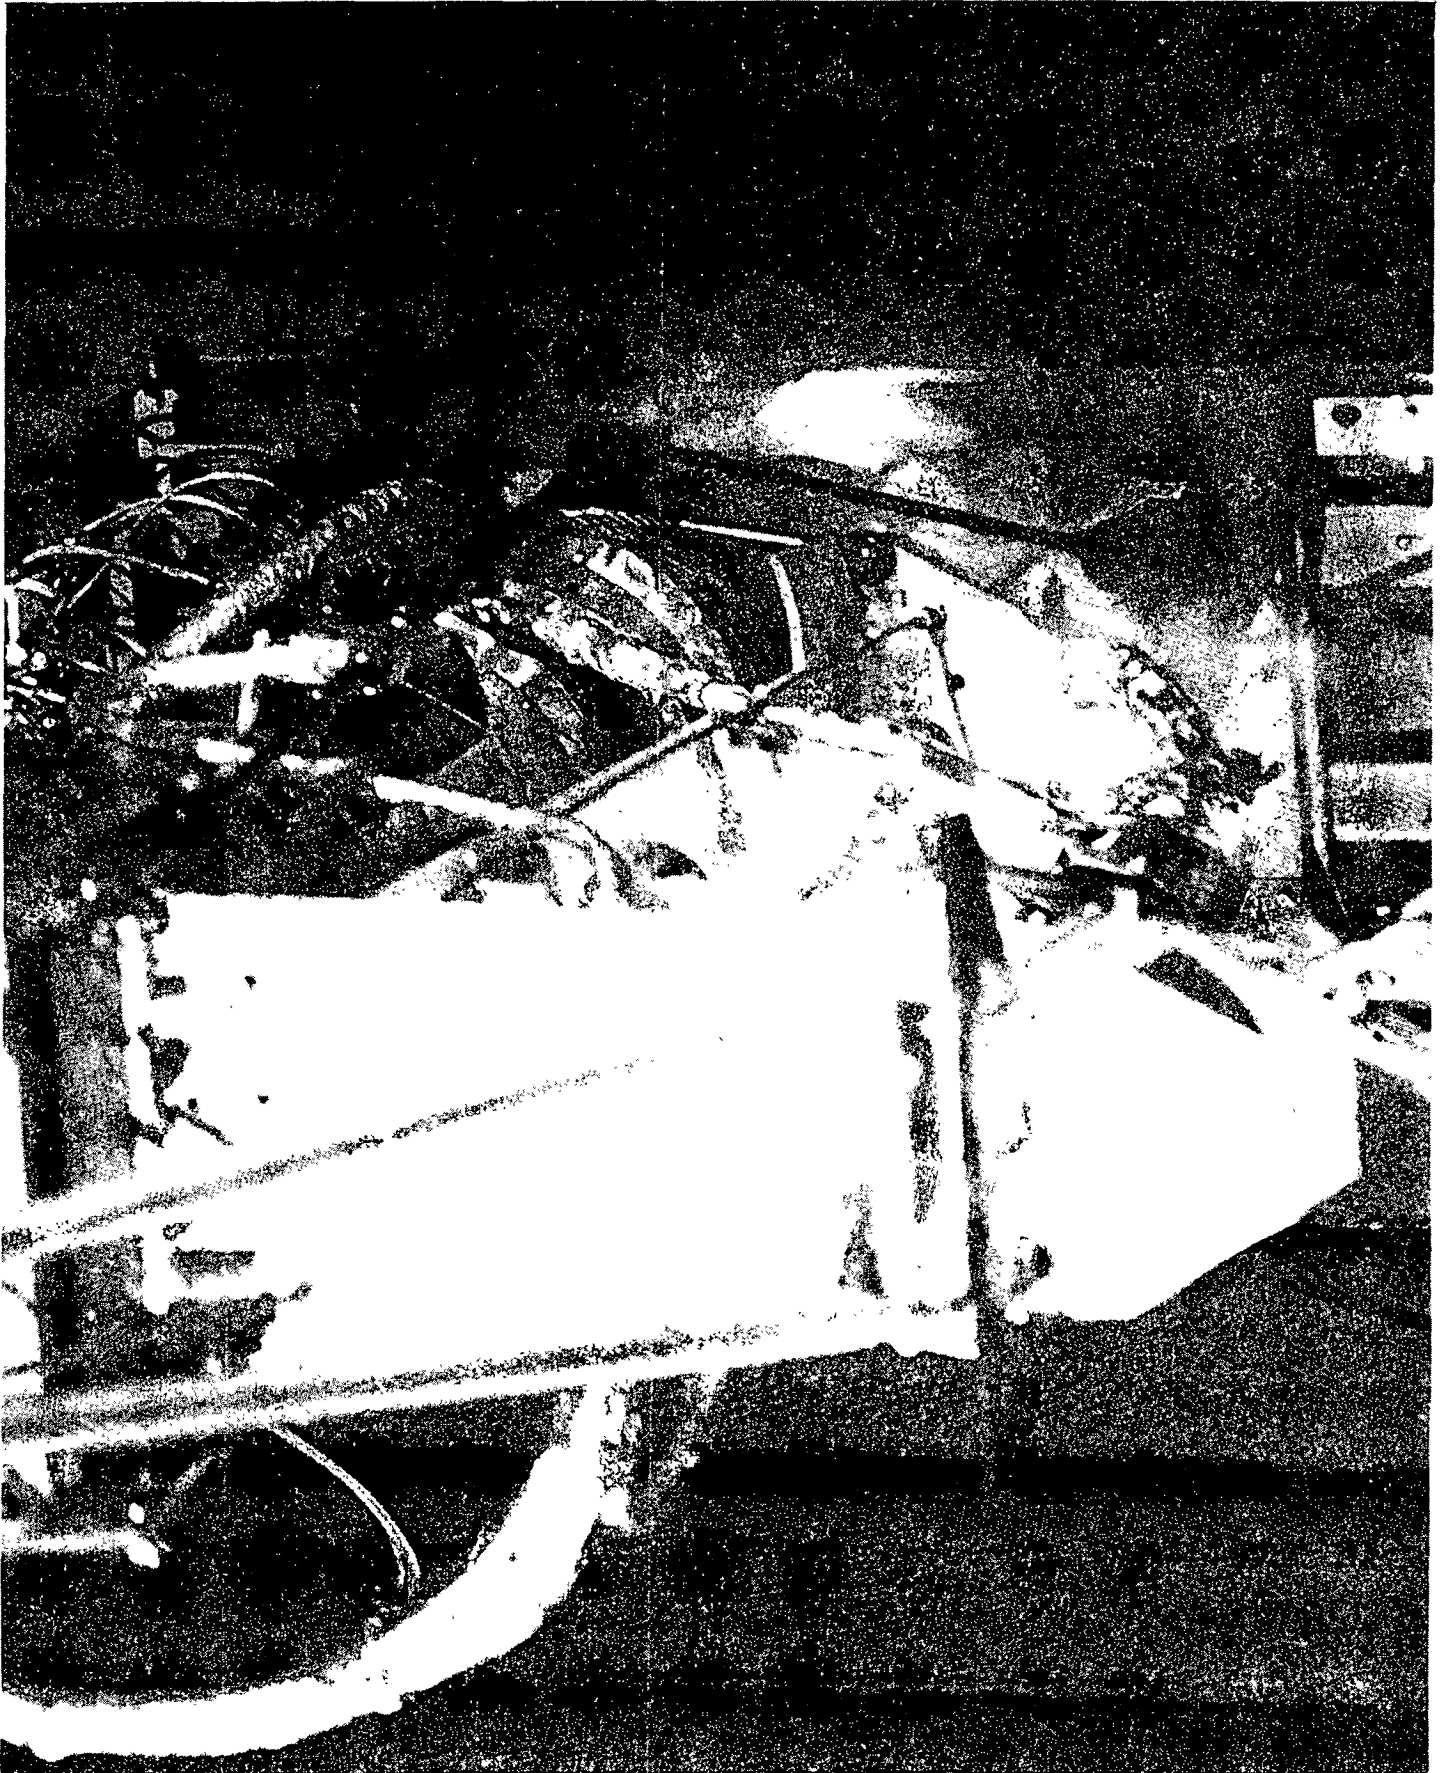
LIGHT FROST ACCUMULATION ON +Z SIDE OF GUCP

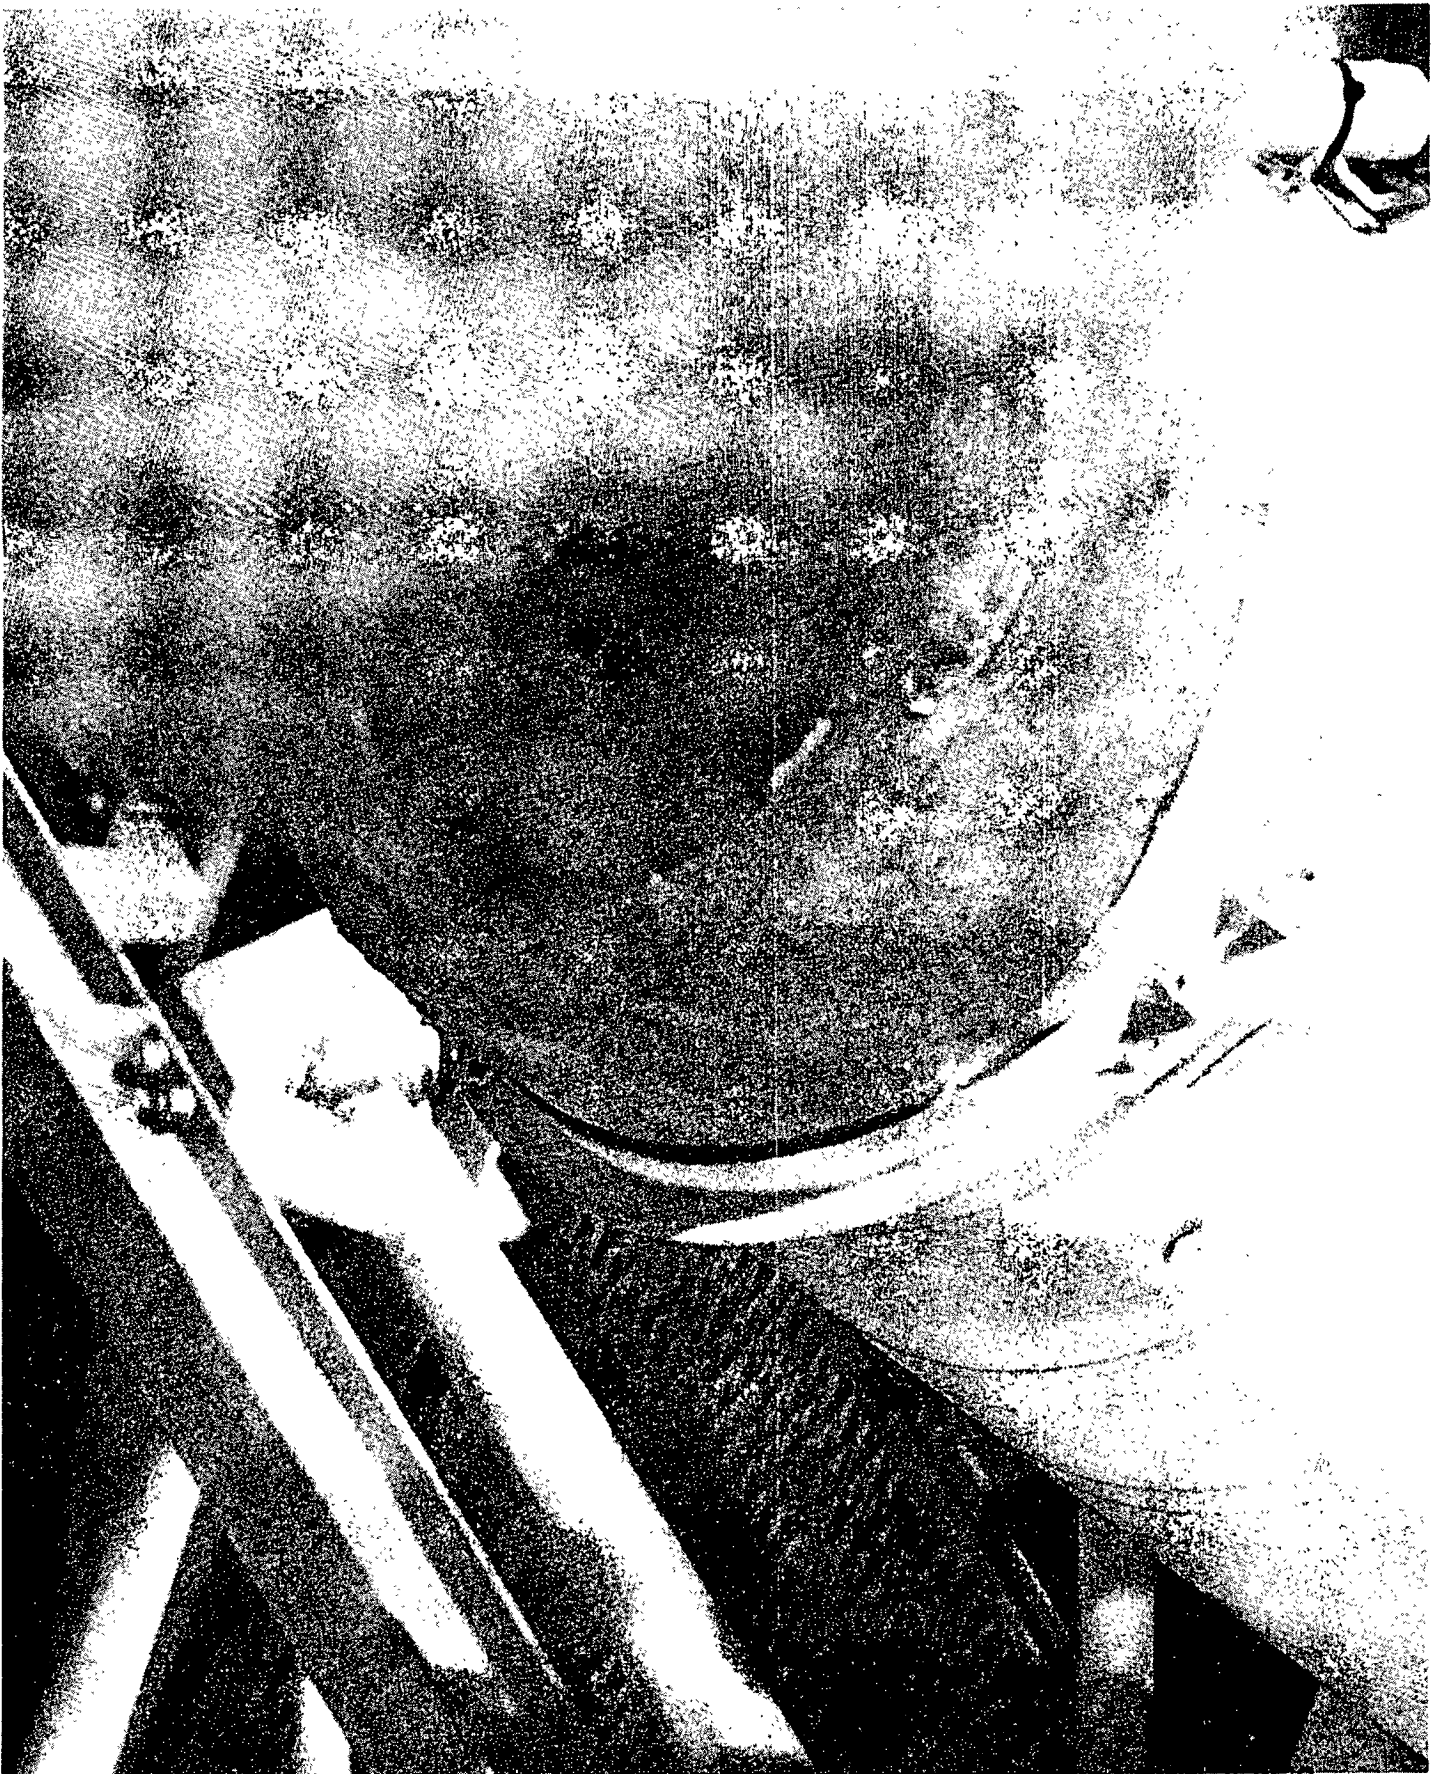
SMALL ICICLES AND FROST FINGERS ON COX VENT EXHAUST DUCT

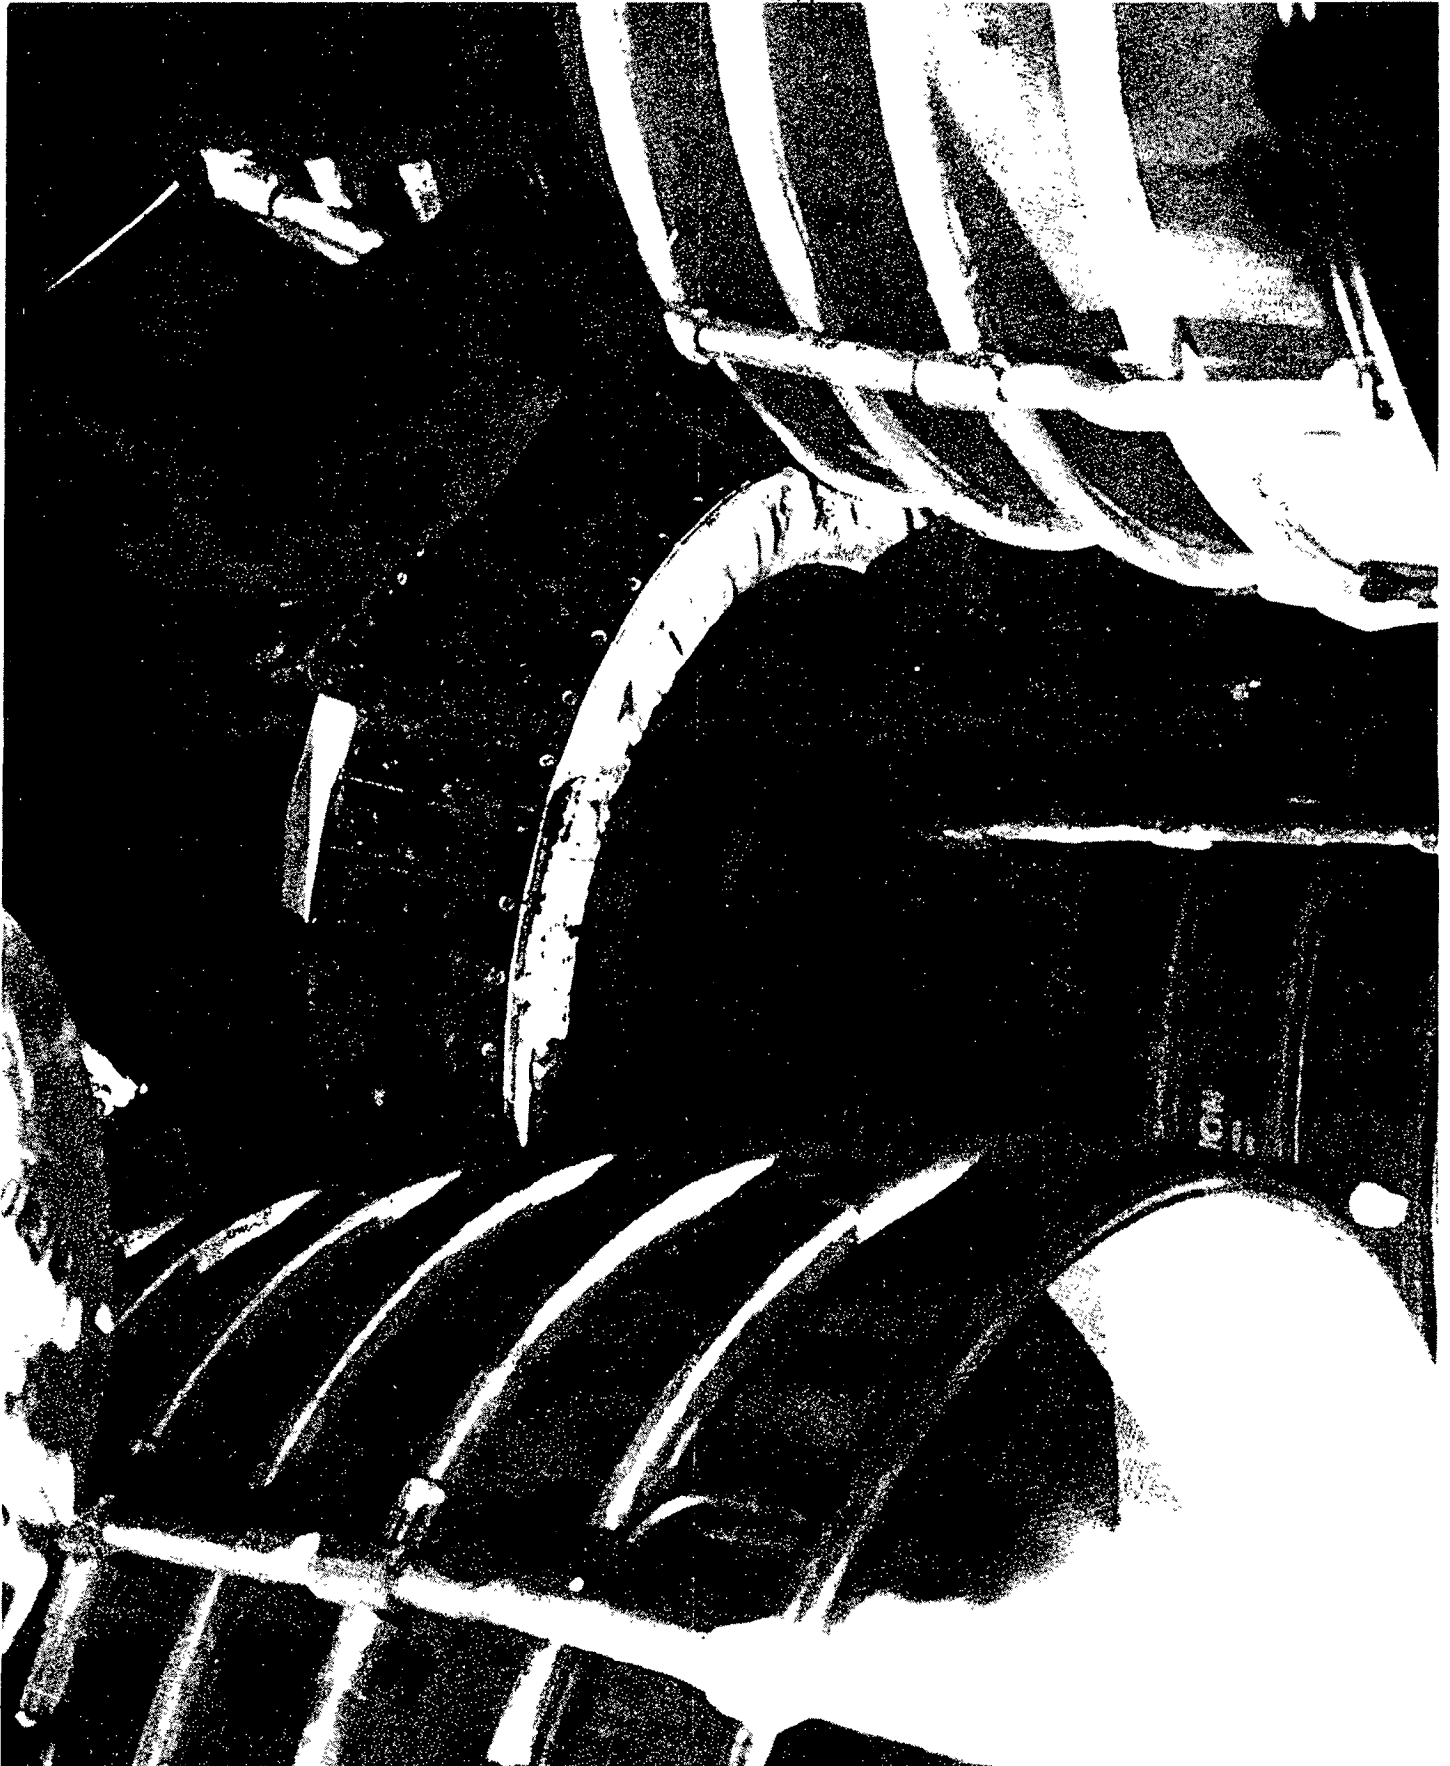
FROST ACCUMULATION ON SSME#2 ENGINE MOUNTED HEAT SHIELD. TILE
CARRIER PANEL REMOVED TO ACCOMMODATE FRF INSTRUMENTATION.

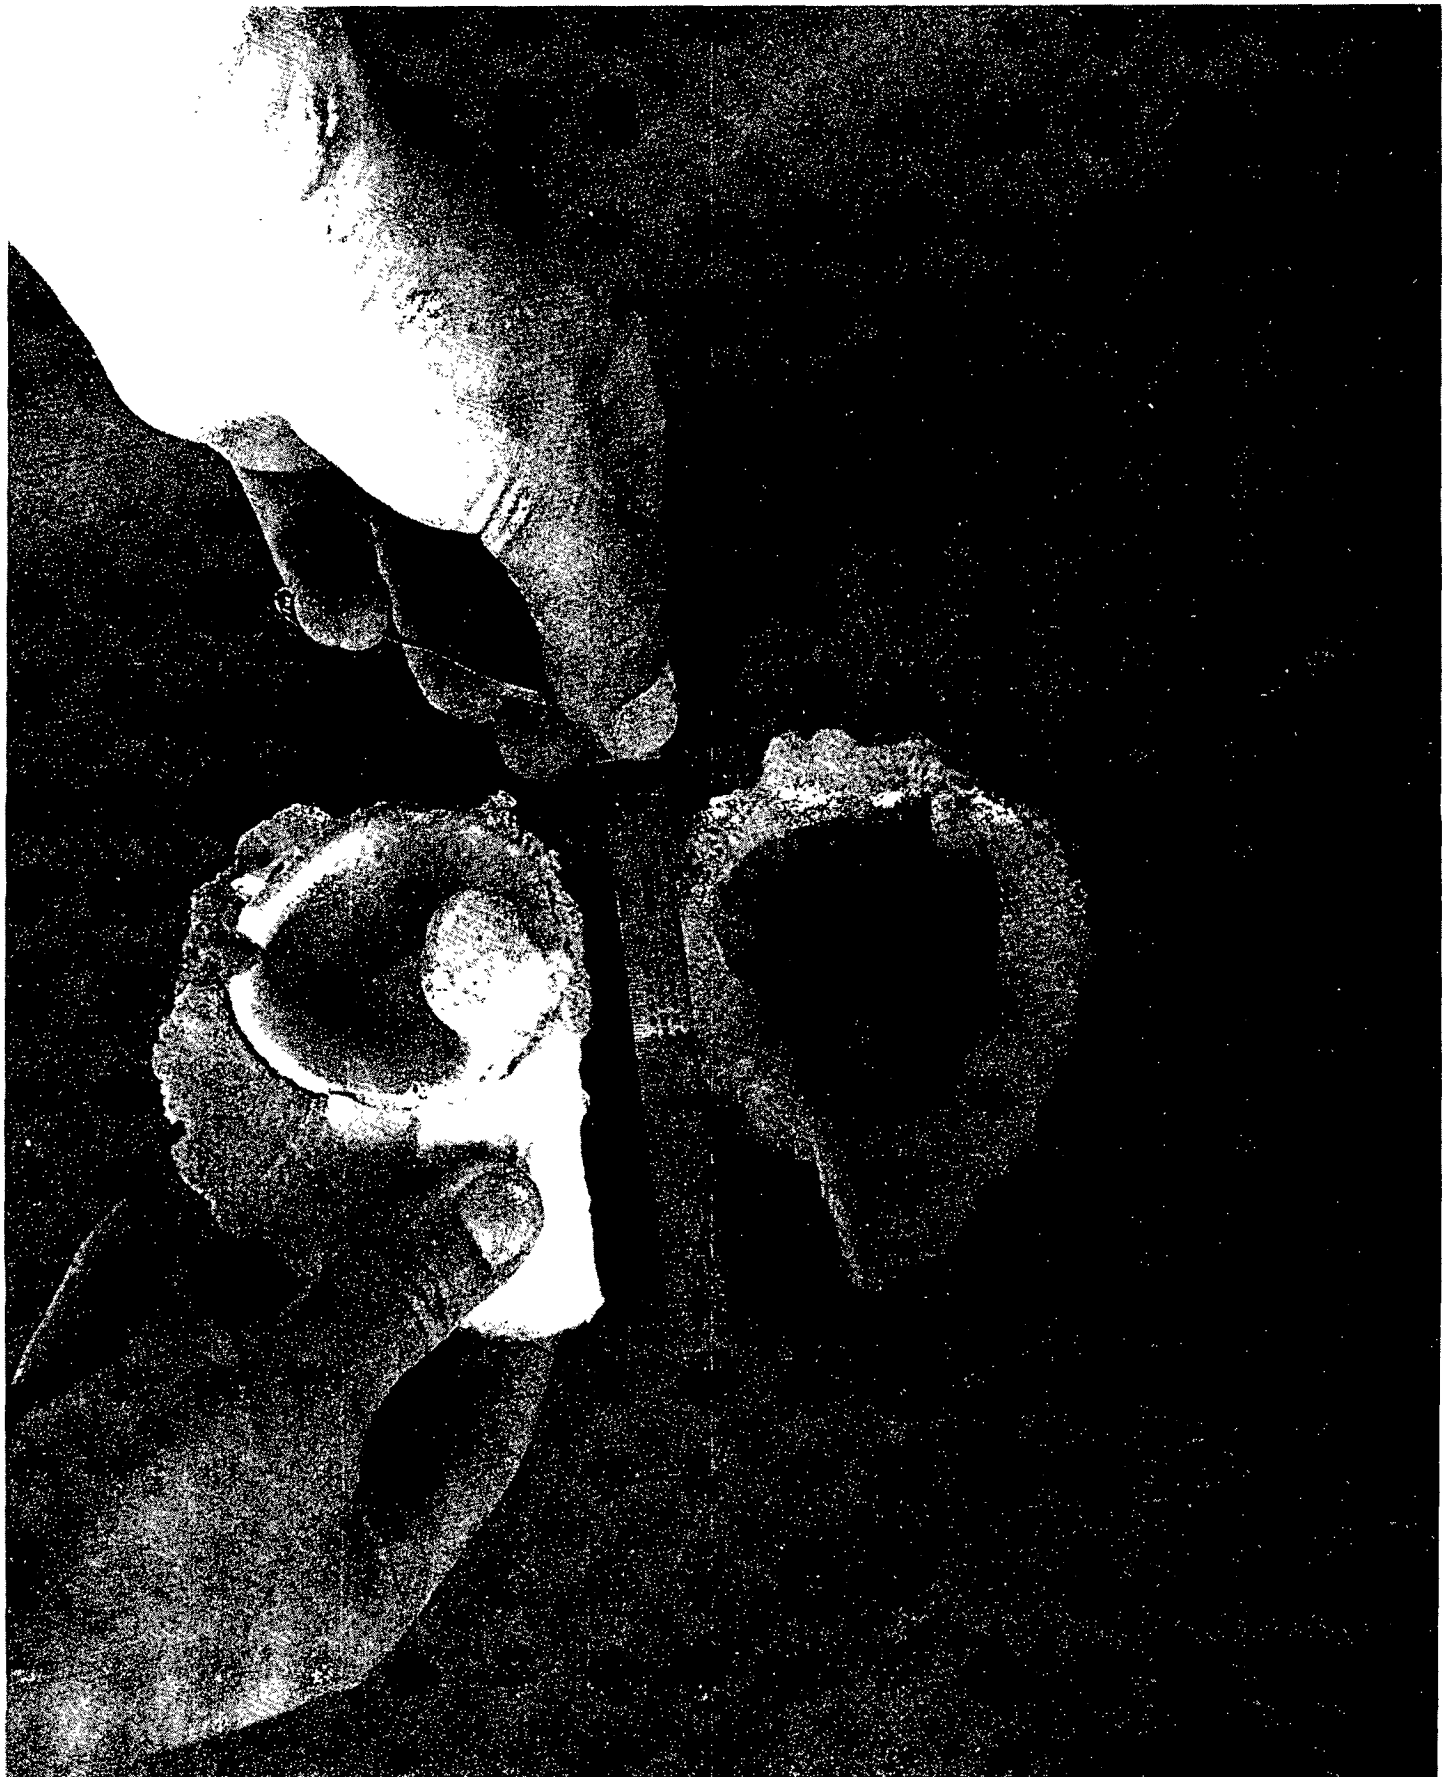
AIR POCKET WAS ENTRAPPED DURING REPAIR AND PDL FOAM
DID NOT ADHERE TO SLA SUBSTRATE OR ISOHEM BONDLINE

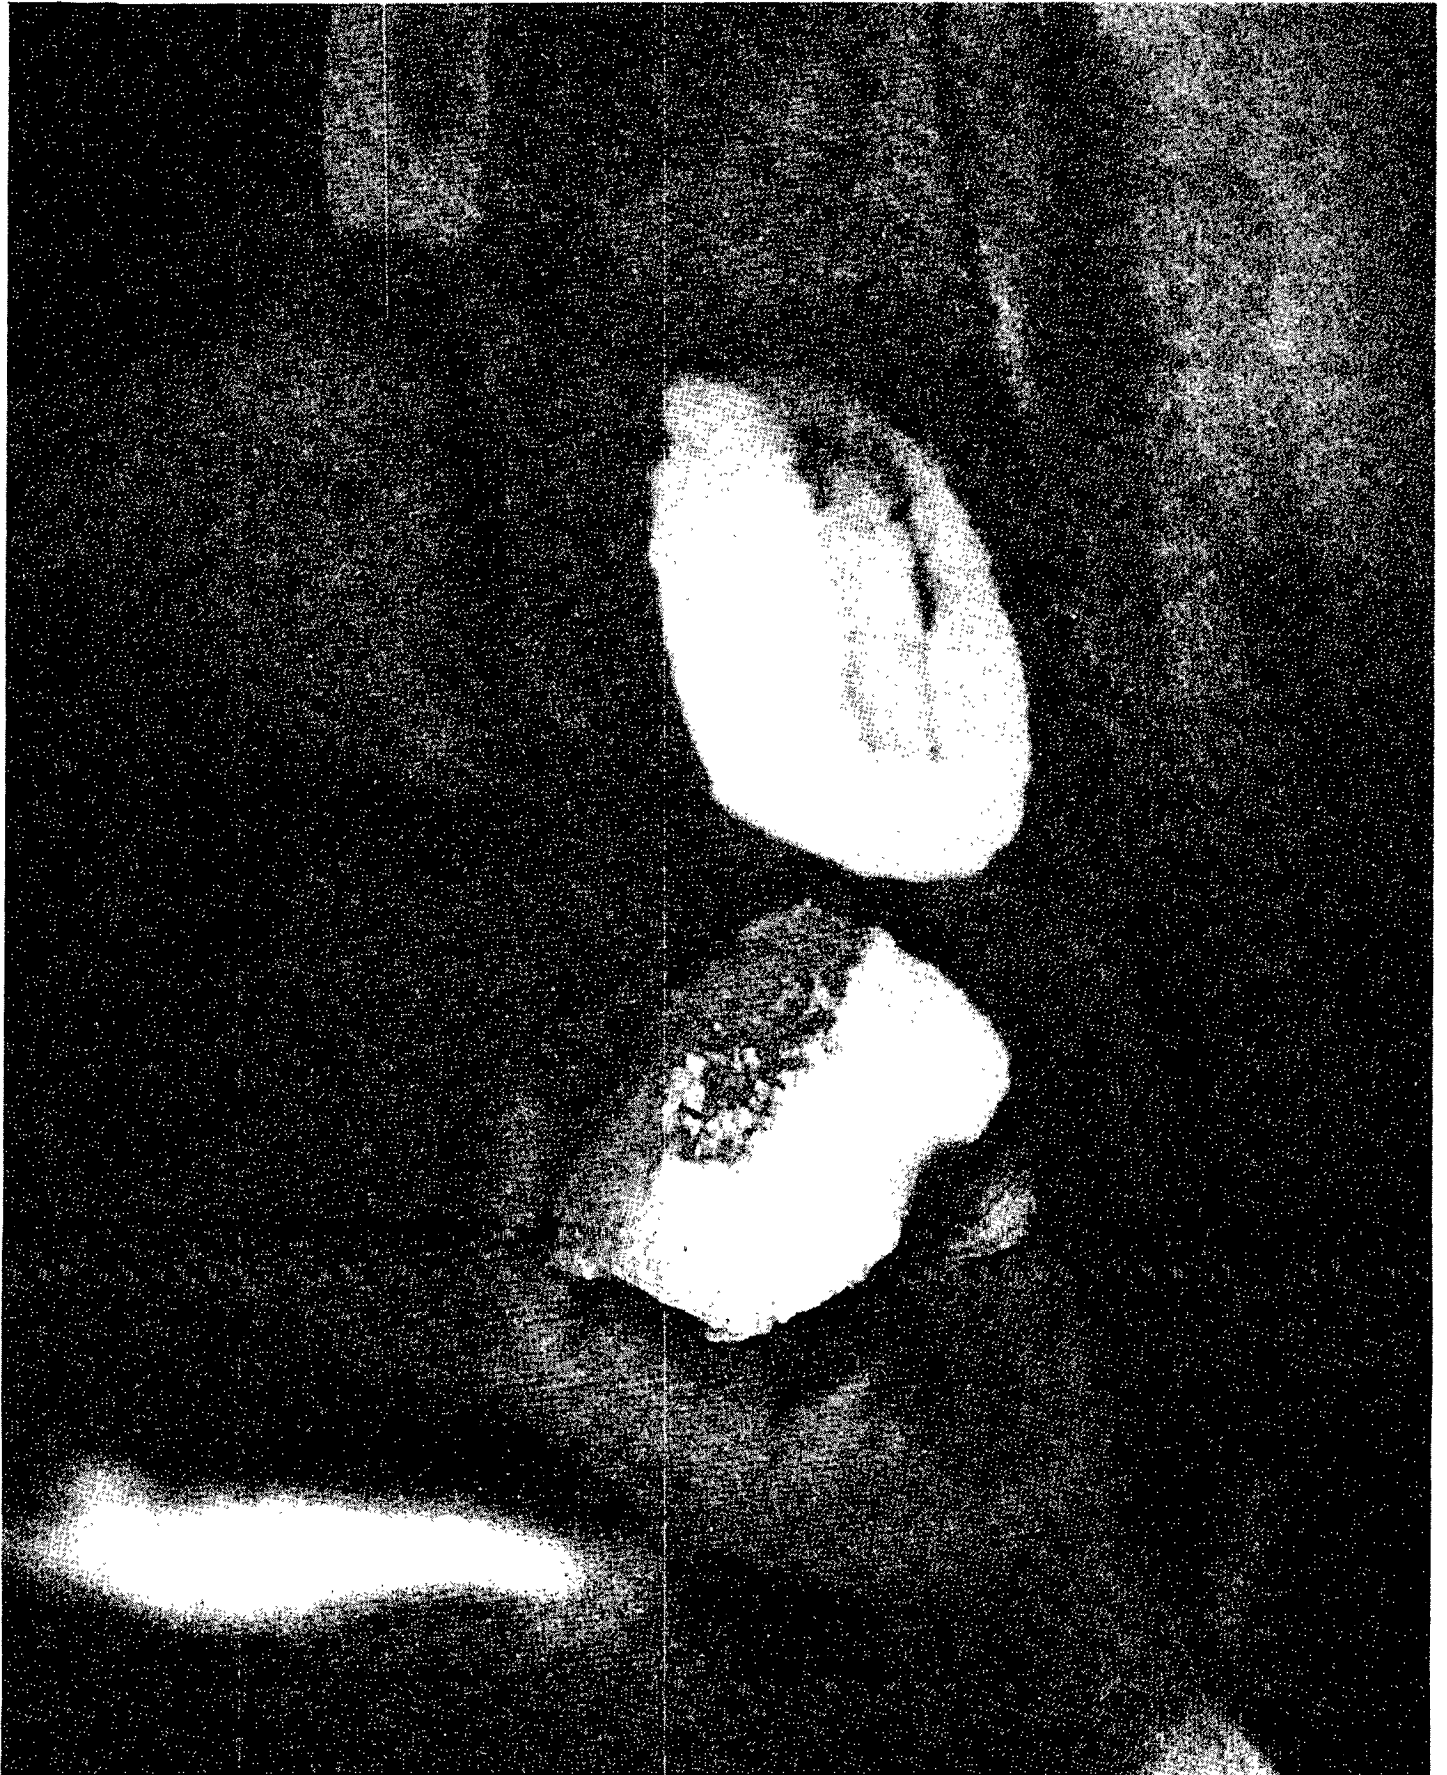
- o The 3-1/4" x 2-3/8" divot on -Y side of LO2 Feedline XT-1623 was investigated for a suspected leak at the ECO leak check port, but no leak was found during mass spec evaluation. The divot was caused by an air pocket
- o The 2-inch crack previously observed on X/Y thrust strut knuckle crotch area was found to be acceptable for flight
- o The 4-inch crack along -Y edge of BX-250 closeout on -Z side of siphon manhole (LH2 aft dome) was found to be a bondline and not in violation of the acceptance criteria
- o Topcoat was missing from the alignment grid on -Y nose cone footprint area
- o The second loose LH2 aft dome PDL repair was removed. Three other PDL repairs were included in the same rework job and were also removed.

LO2 FEEDLINE ACREAGE DIVOT XT-1629 CAUSED BY ENTRAPPED AIR
