NASA Technical Memorandum 100987

Ice/Frost/Debris Assessment For Space Shuttle Mission STS-26R

November 7, 1988

Charles G. Stevenson
Gregory N. Katnik
Scott A. Higginbotham
The John F. Kennedy Space Center, NASA

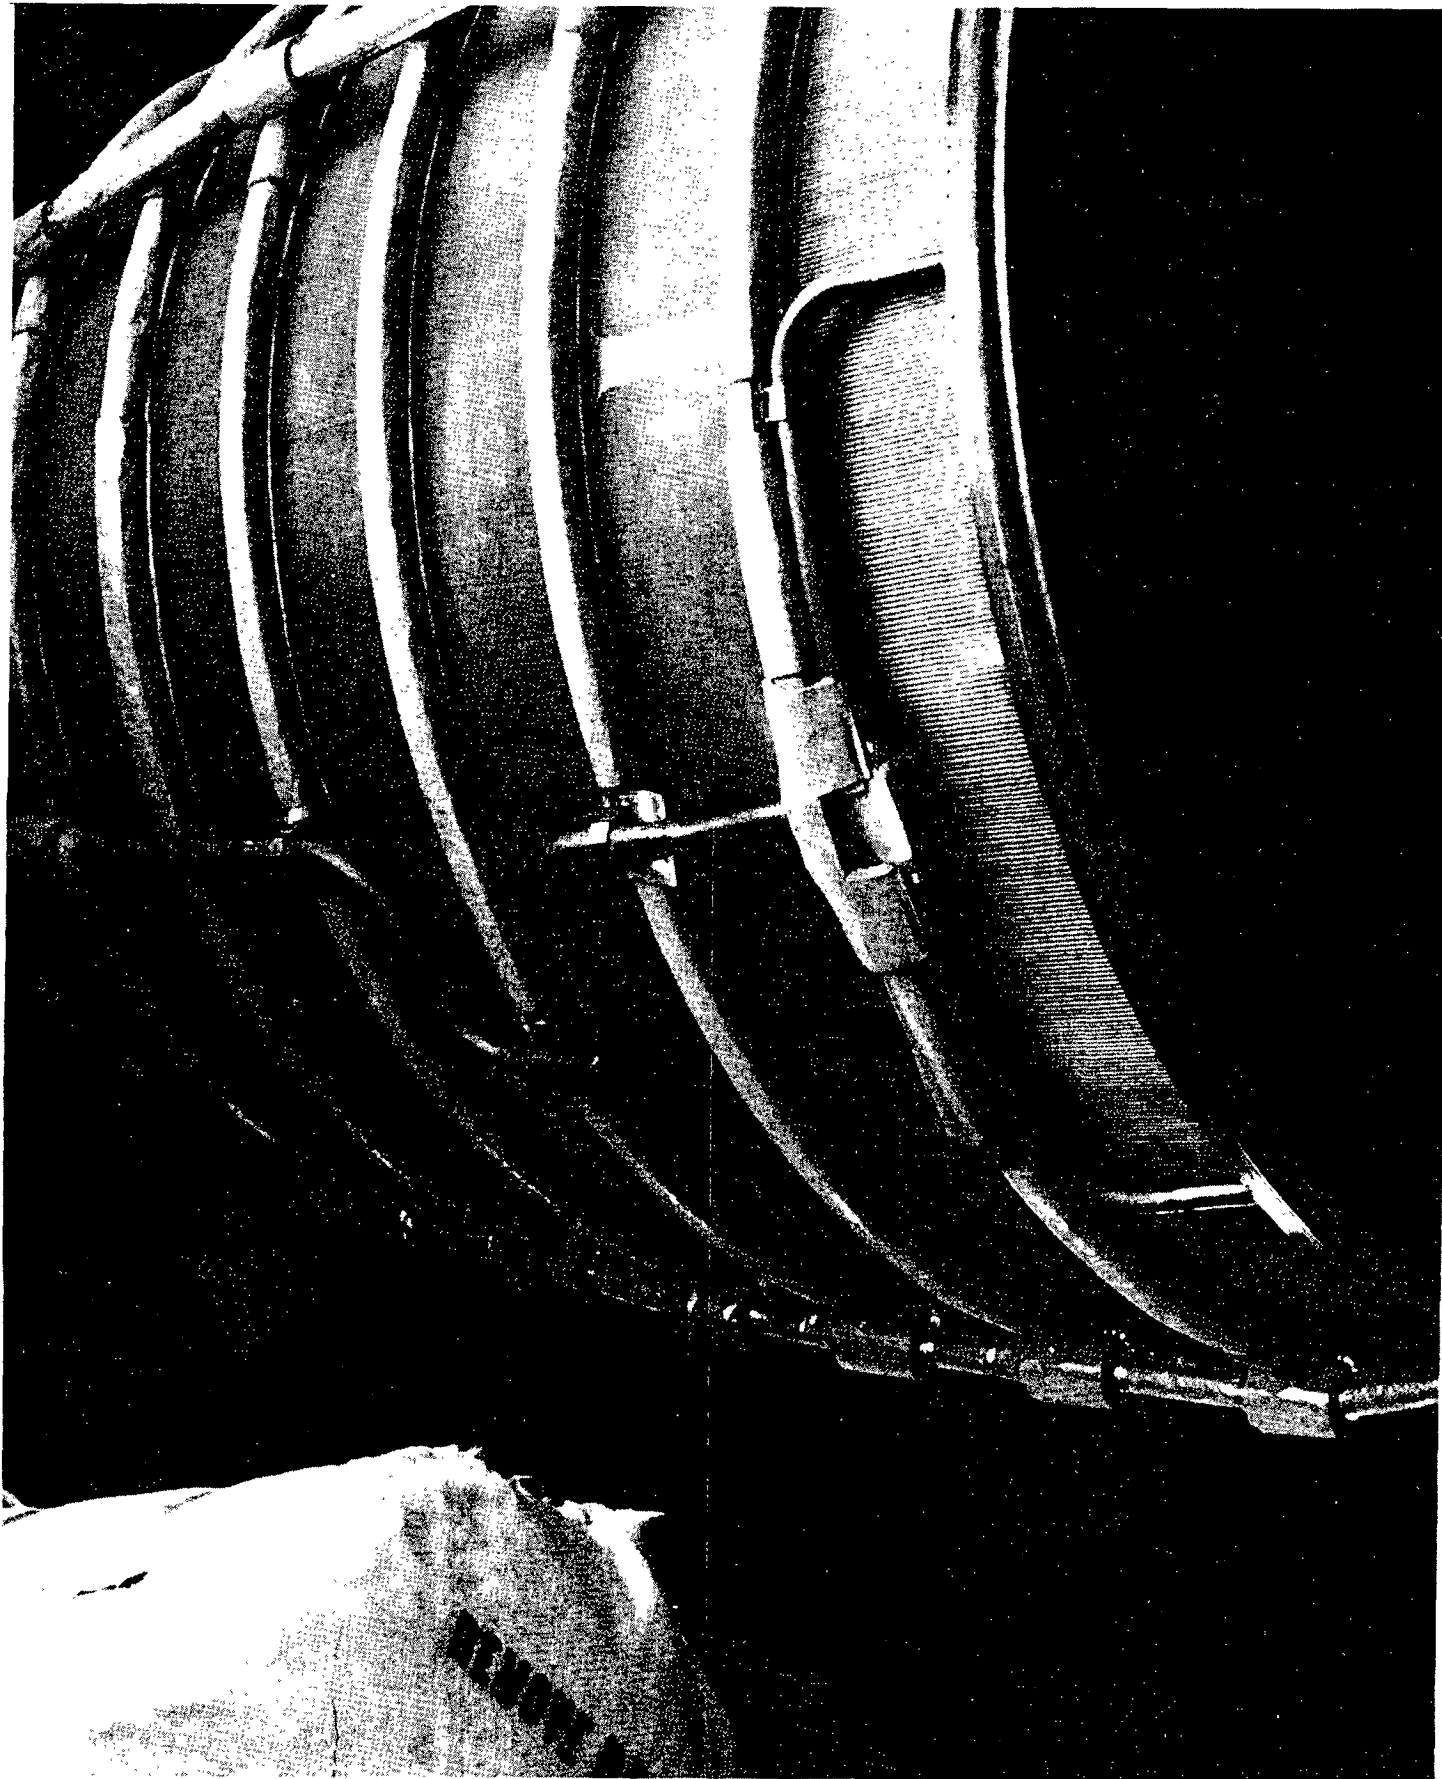
LOOSE FOIL THERMAL INSULATION BLANKET ON SSME #1 NOZZLE

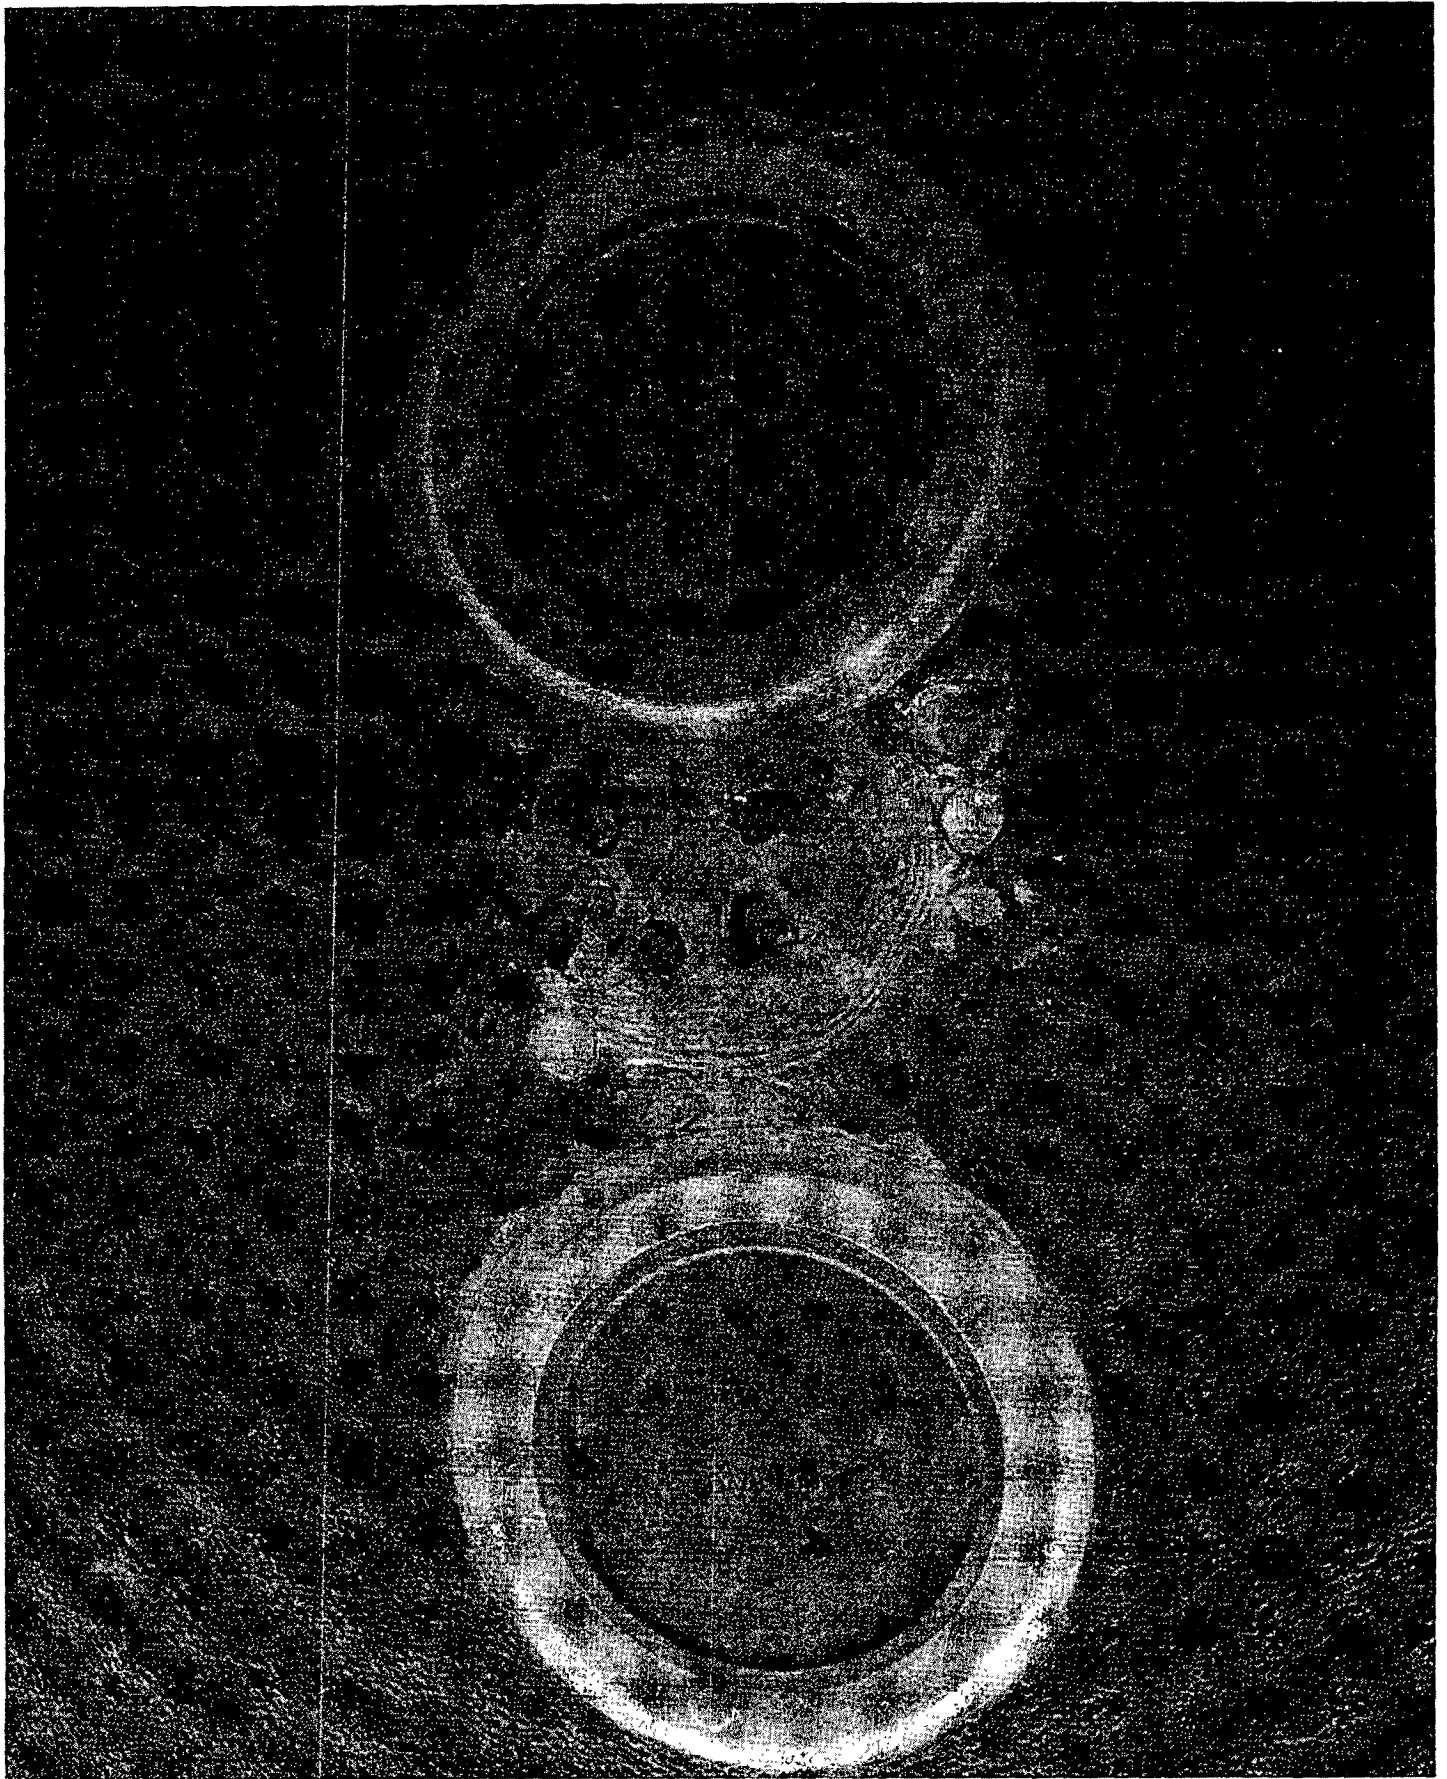
PDL REPAIRS TO DIVOTS ON ET LH2 TANK AFT DOME APEX

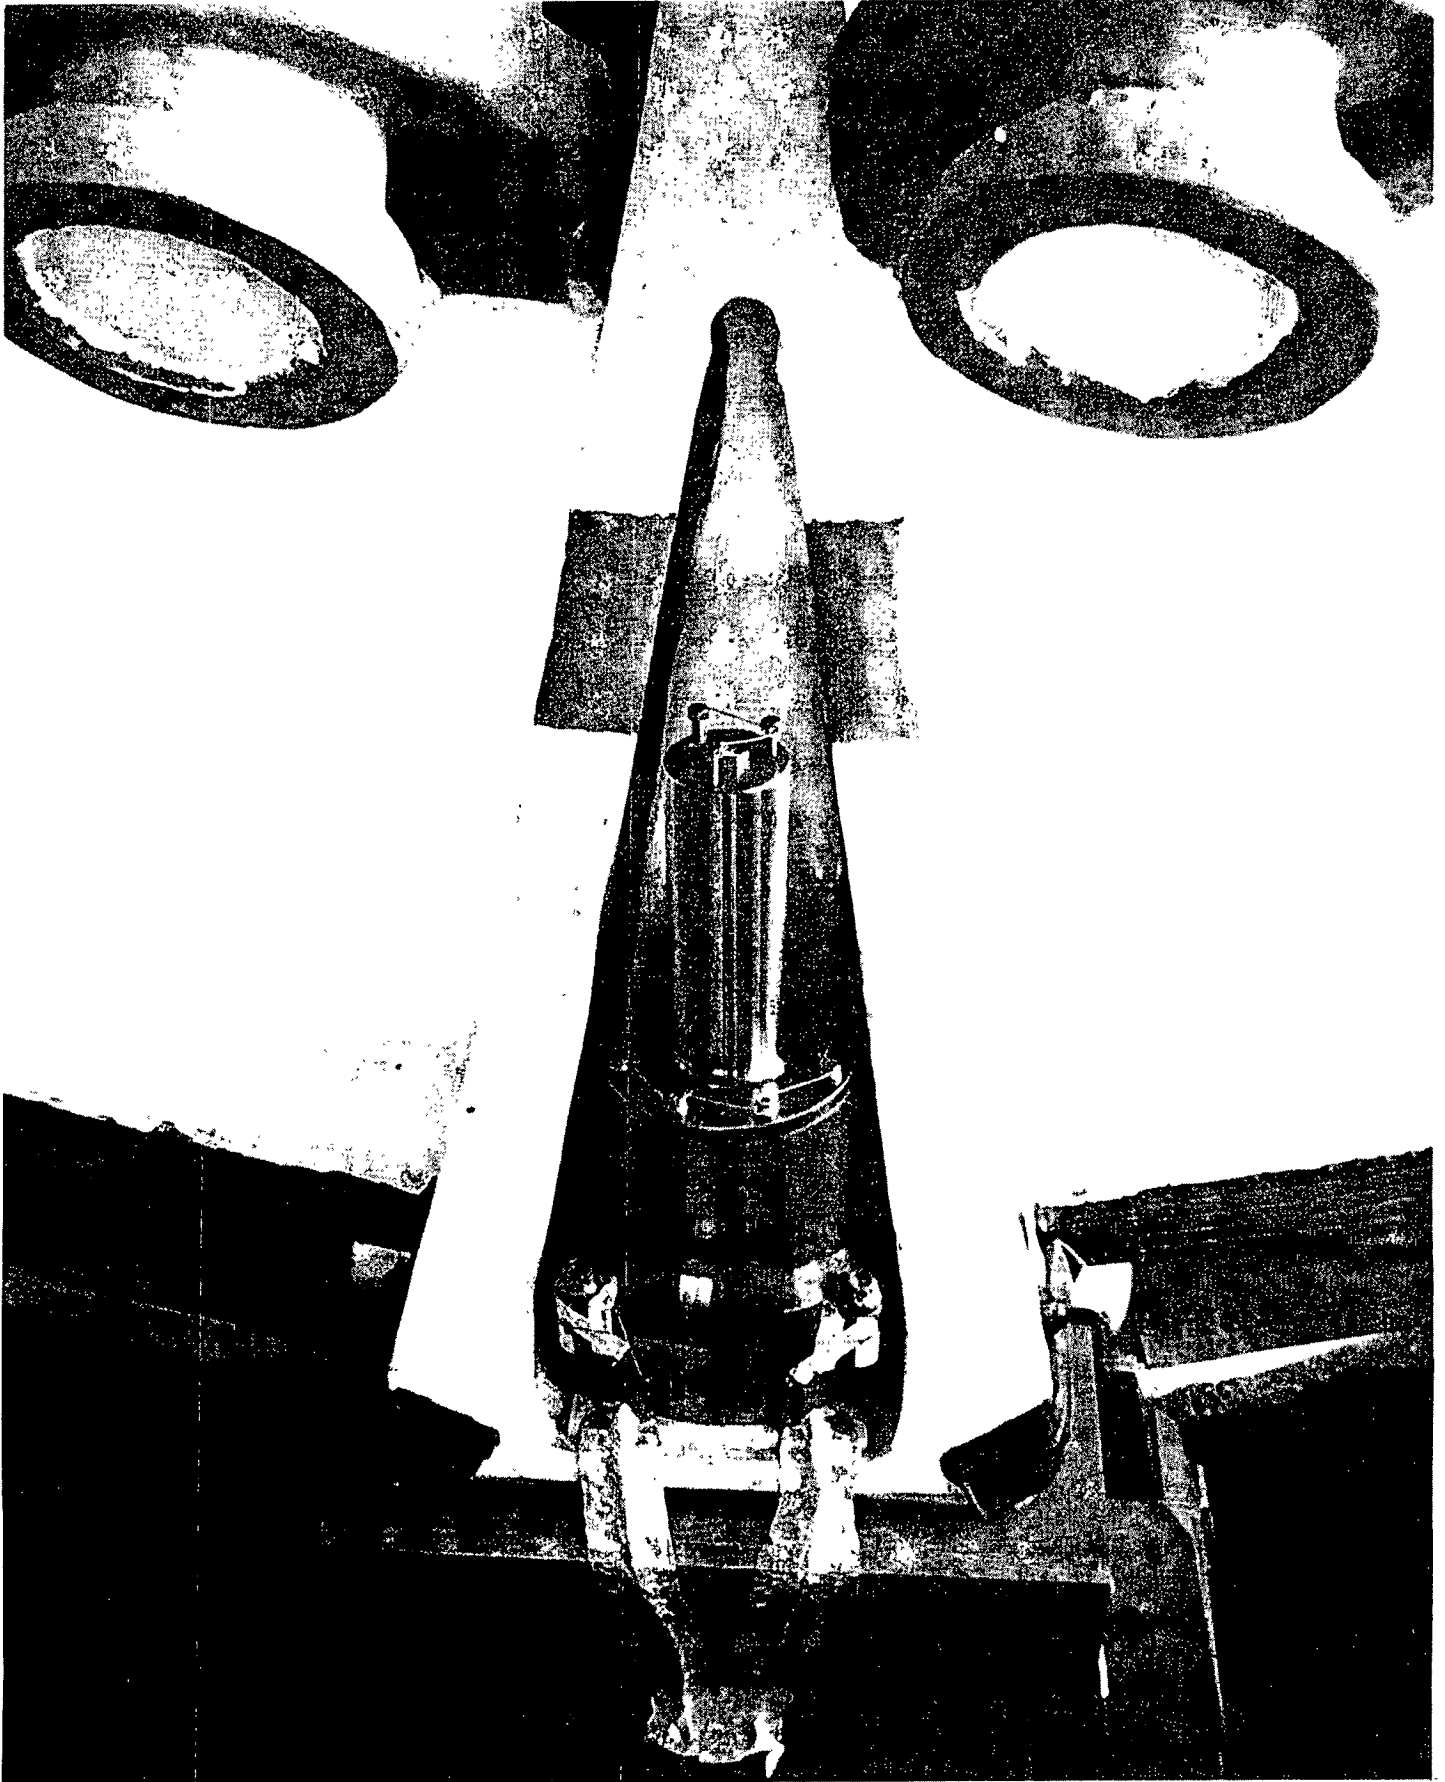
REDESIGNED HDP DEBRIS CONTAINER WITH INTERNAL PLUNGER TO PLUG
HOLE IN AFT SKIRT FOOT. CHAMFERED SHOE PROTECTS FIRING CABLES

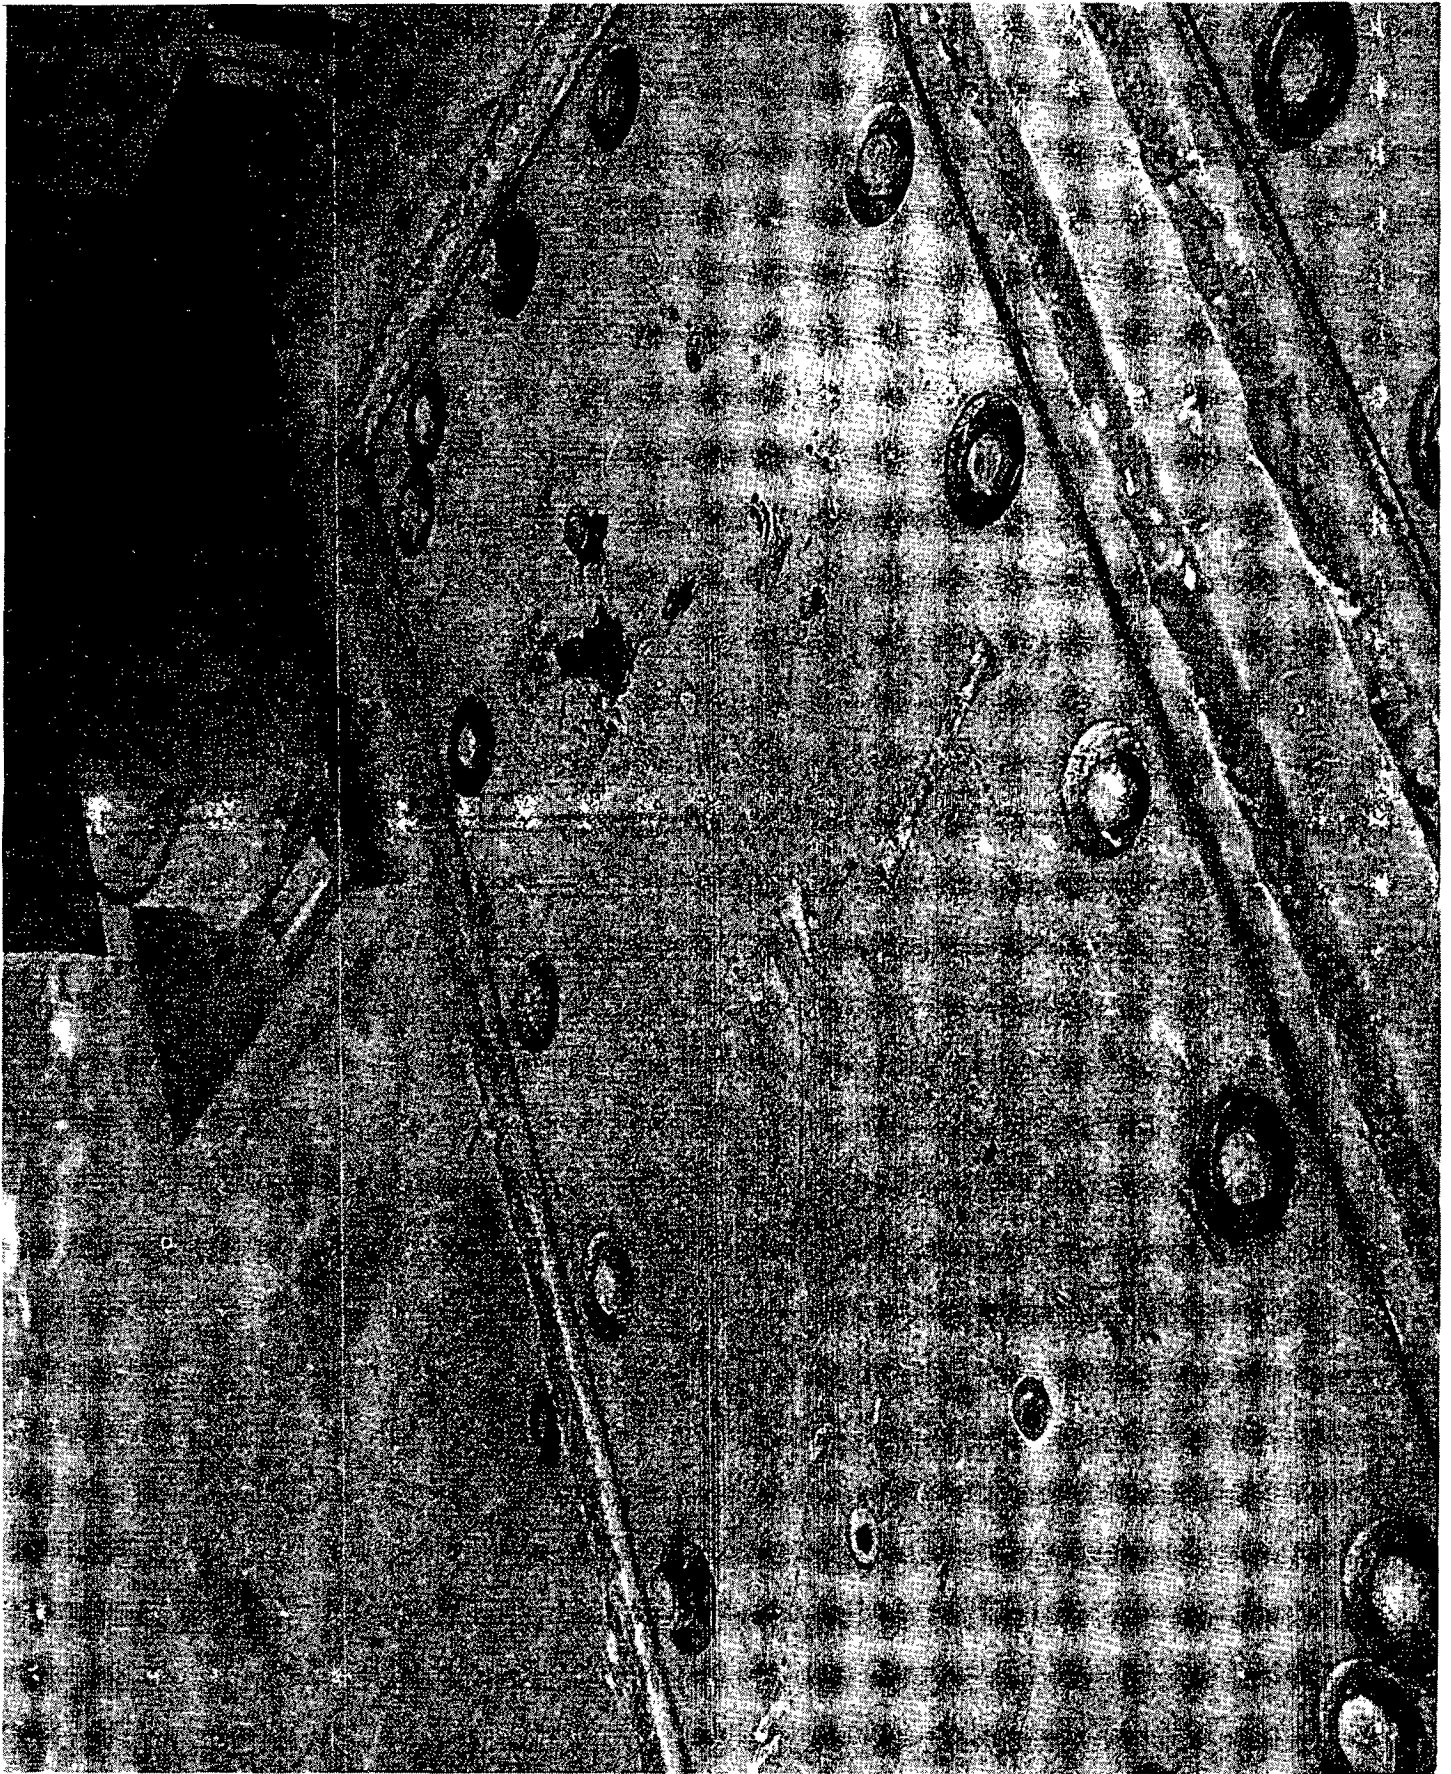
LOOSE ONE-INCH DECK PLATE BOLTS ON EAST SIDE OF MLP

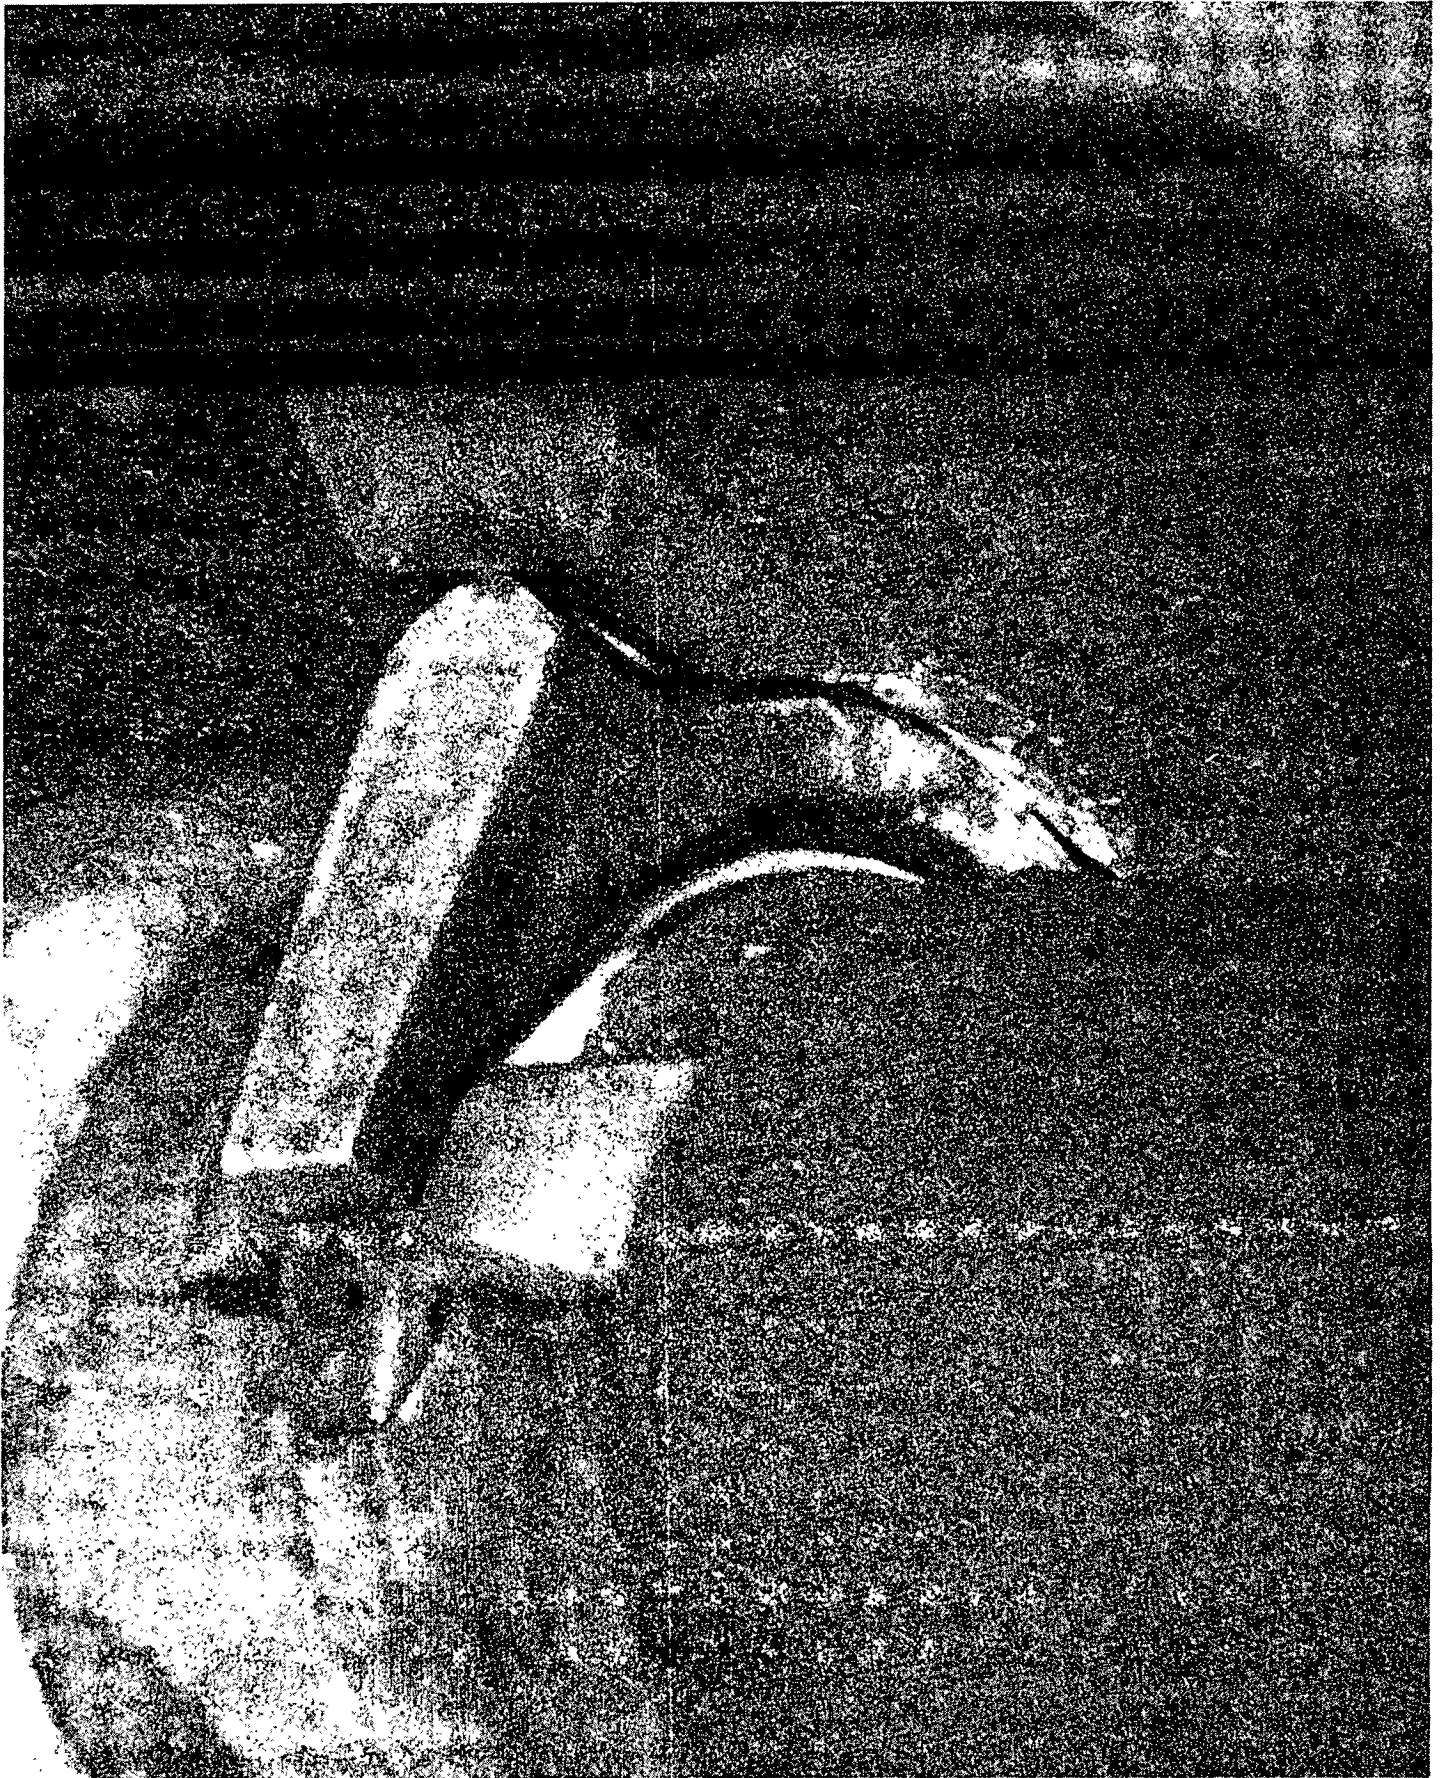
ICE/FROST ACCUMULATION IN LO2 FEEDLINE SUPPORT BRACKET

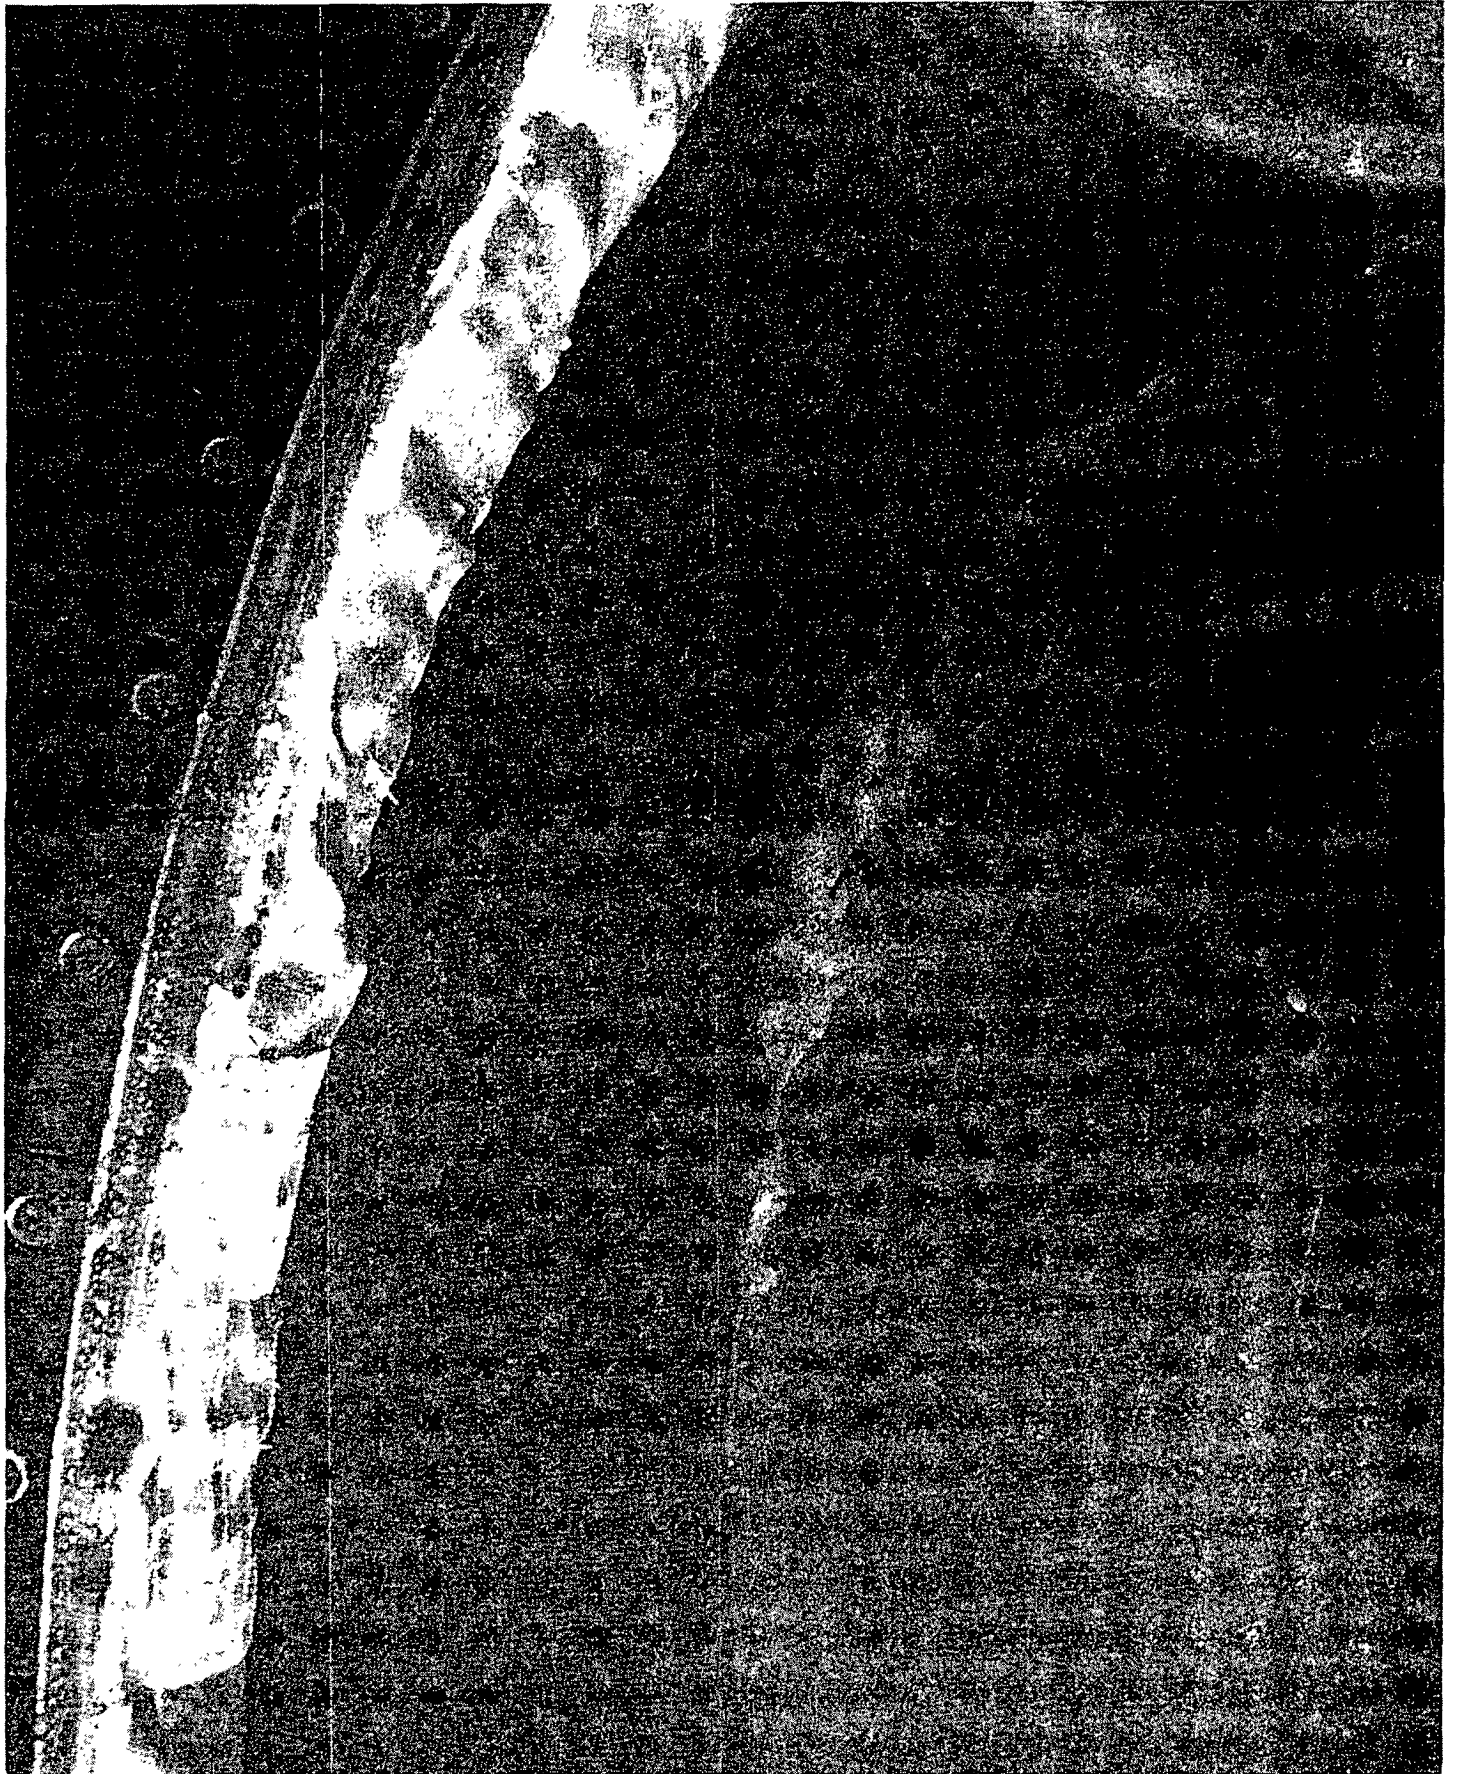
FROST ACCUMULATION ON SSME ENGINE MOUNTED HEAT SHIELD

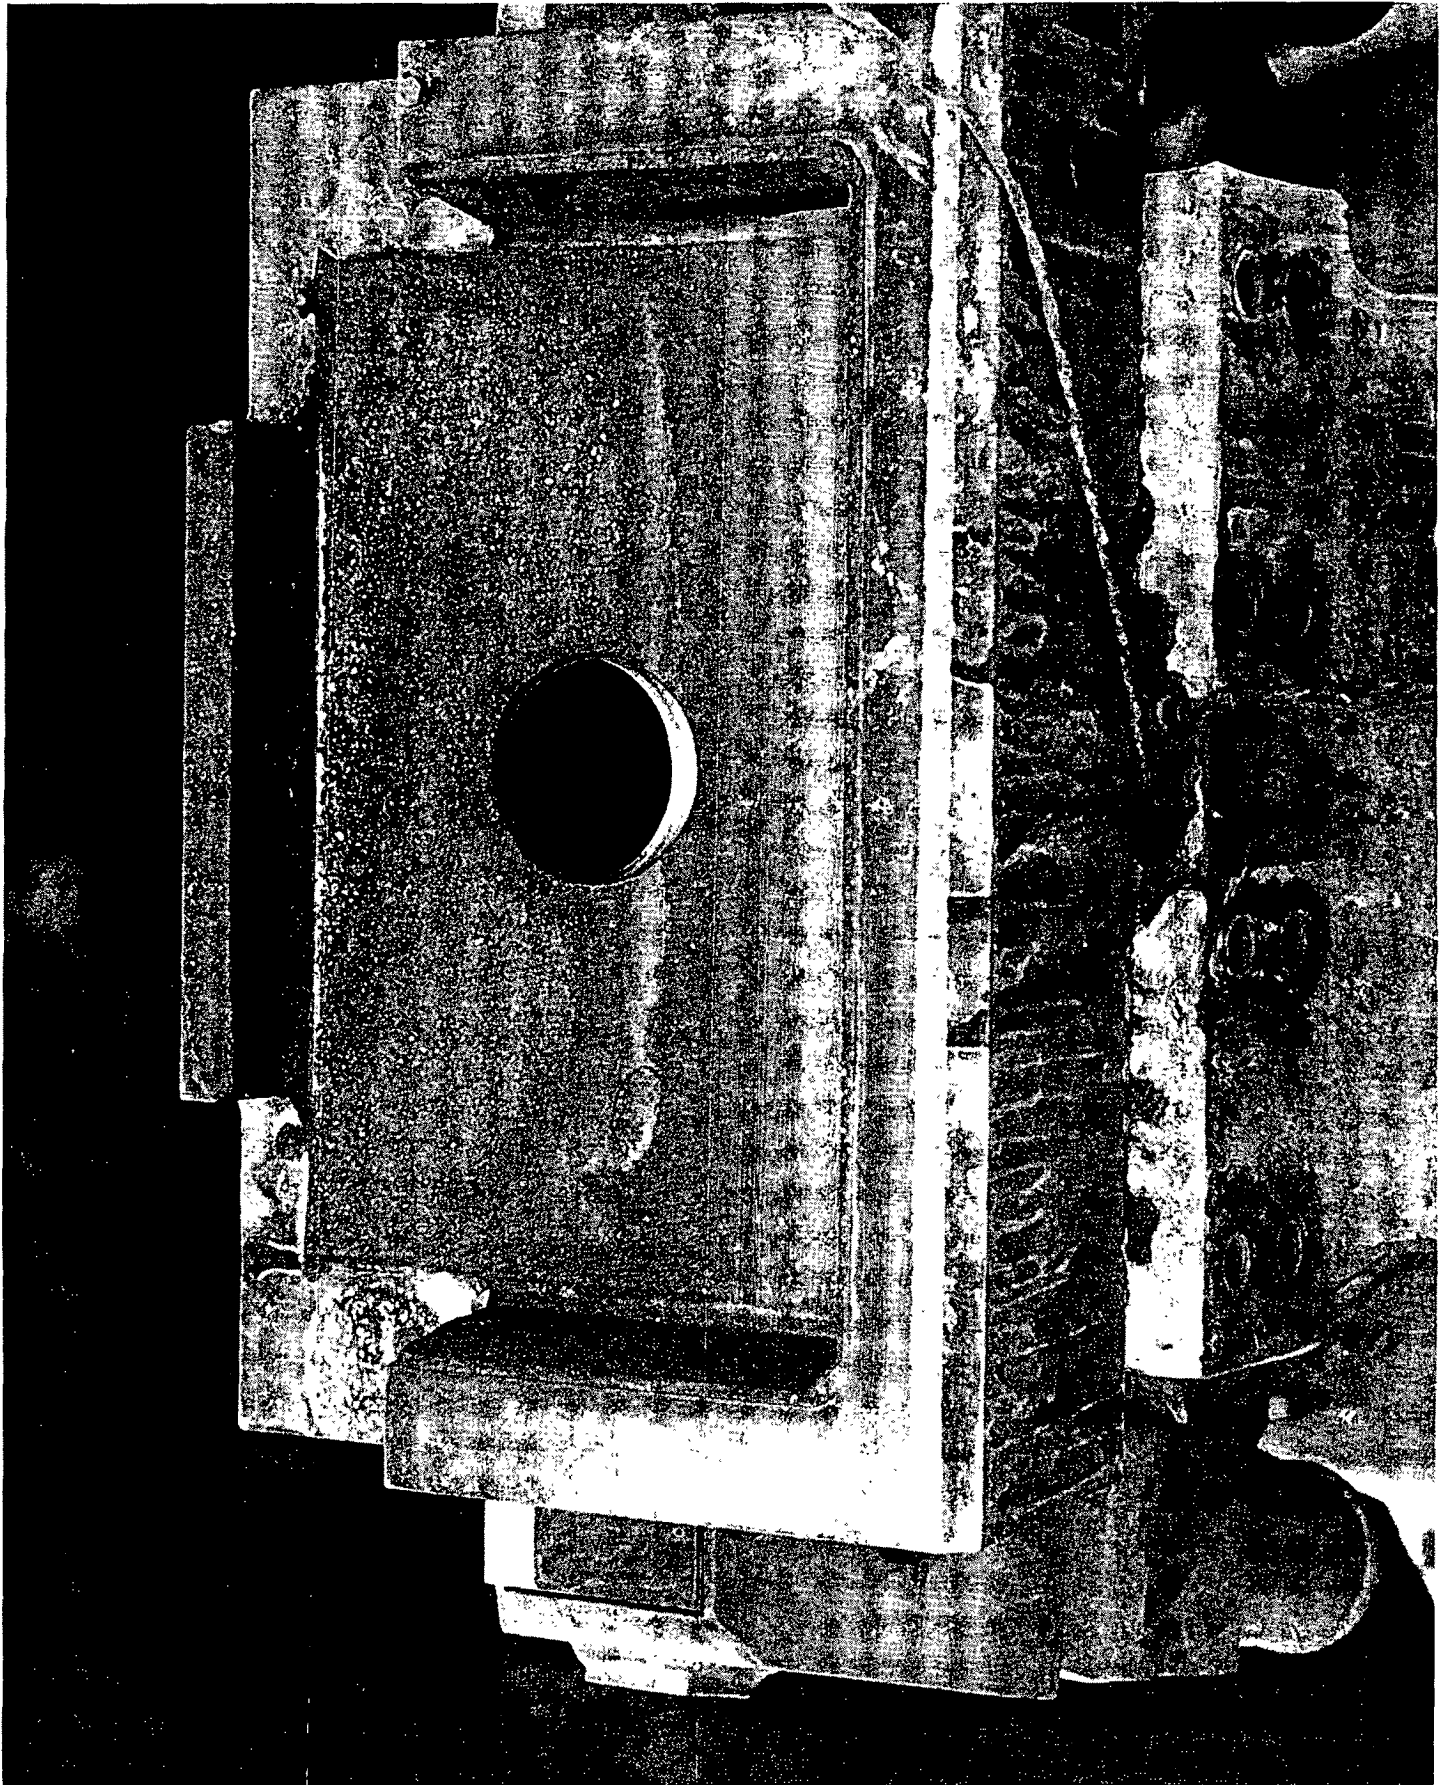
NO POST LAUNCH DAMAGE TO SOUTH HOLDDOWN POST
SHOE. SHIM AND SIDEWALL MATERIAL IS INTACT.

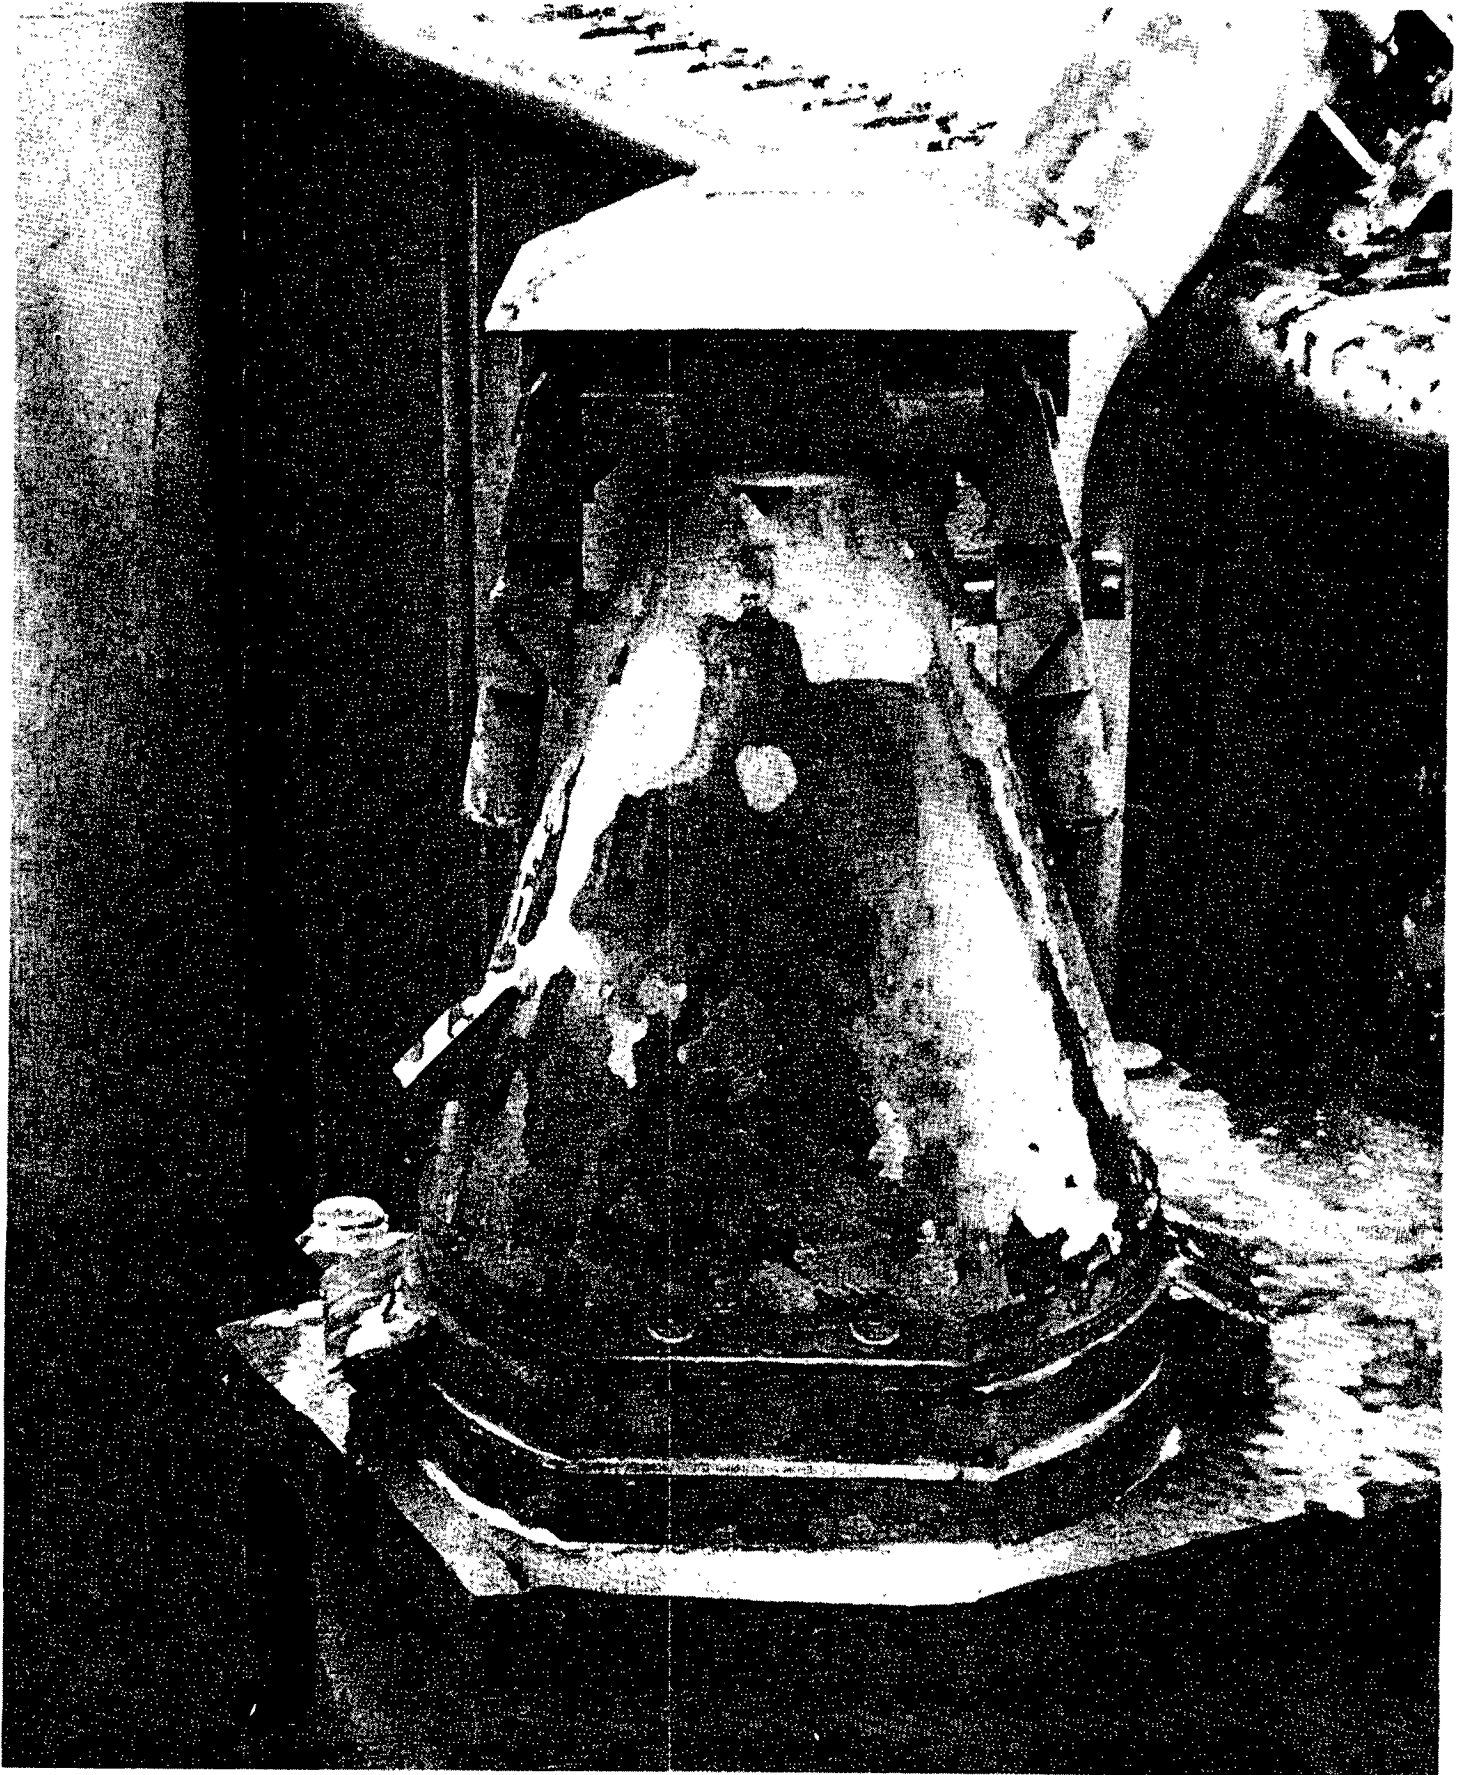
NORTH HOLDDOWN POST SUSTAINED MINIMAL DAMAGE.
DOGHOUSE BLAST COVER CLOSED NOMINALLY.

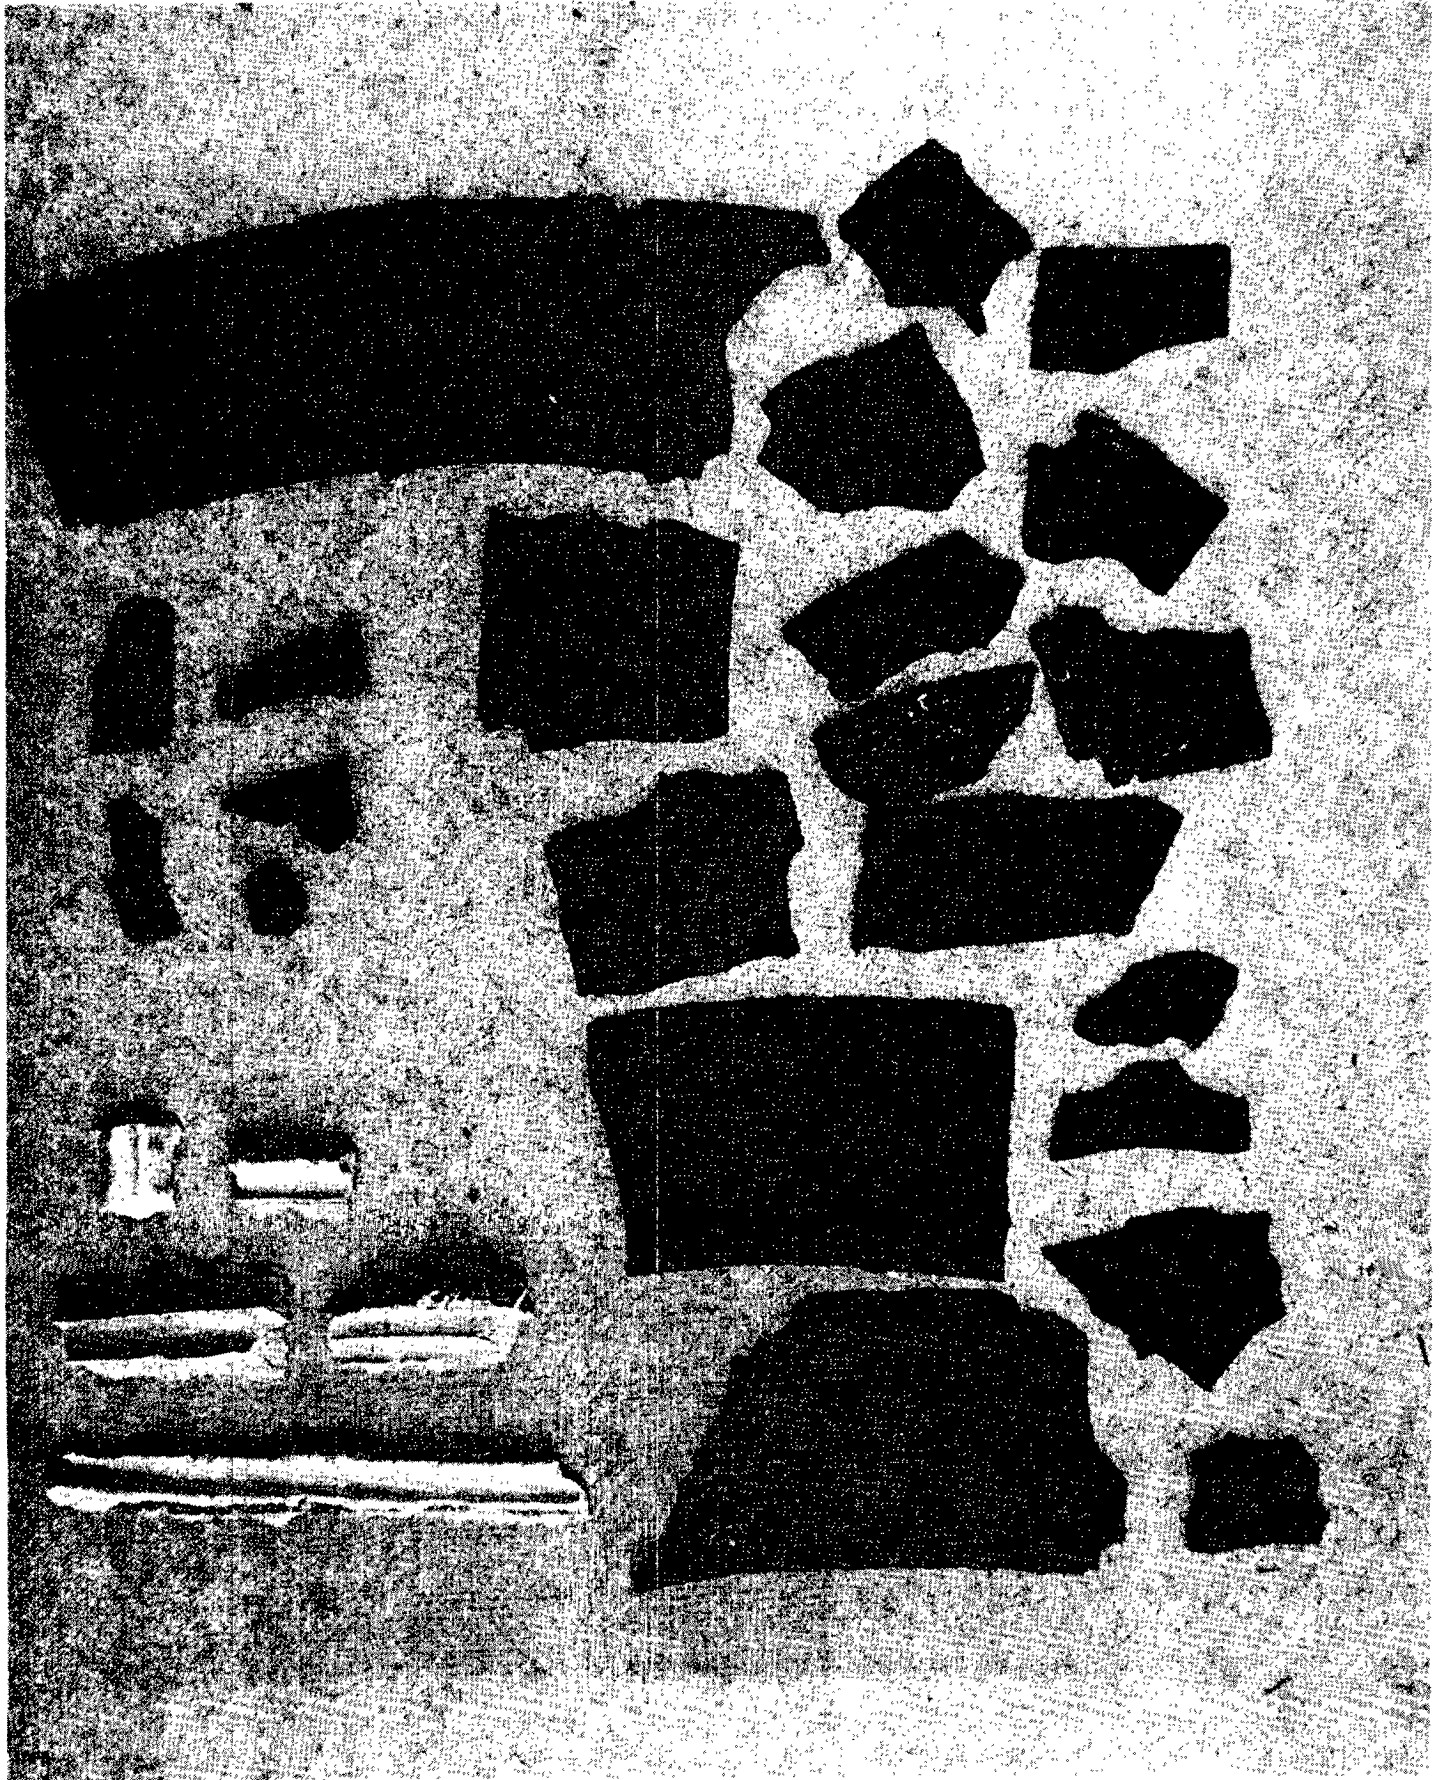
SAMPLES OF RED/BLACK SRB THROAT PLUG
MATERIAL AND WHITE FACILITY RTV
