NASA Technical Memorandum 100987

Ice/Frost/Debris Assessment For Space Shuttle Mission STS-26R

November 7, 1988

Charles G. Stevenson
Gregory N. Katnik
Scott A. Higginbotham
The John F. Kennedy Space Center, NASA

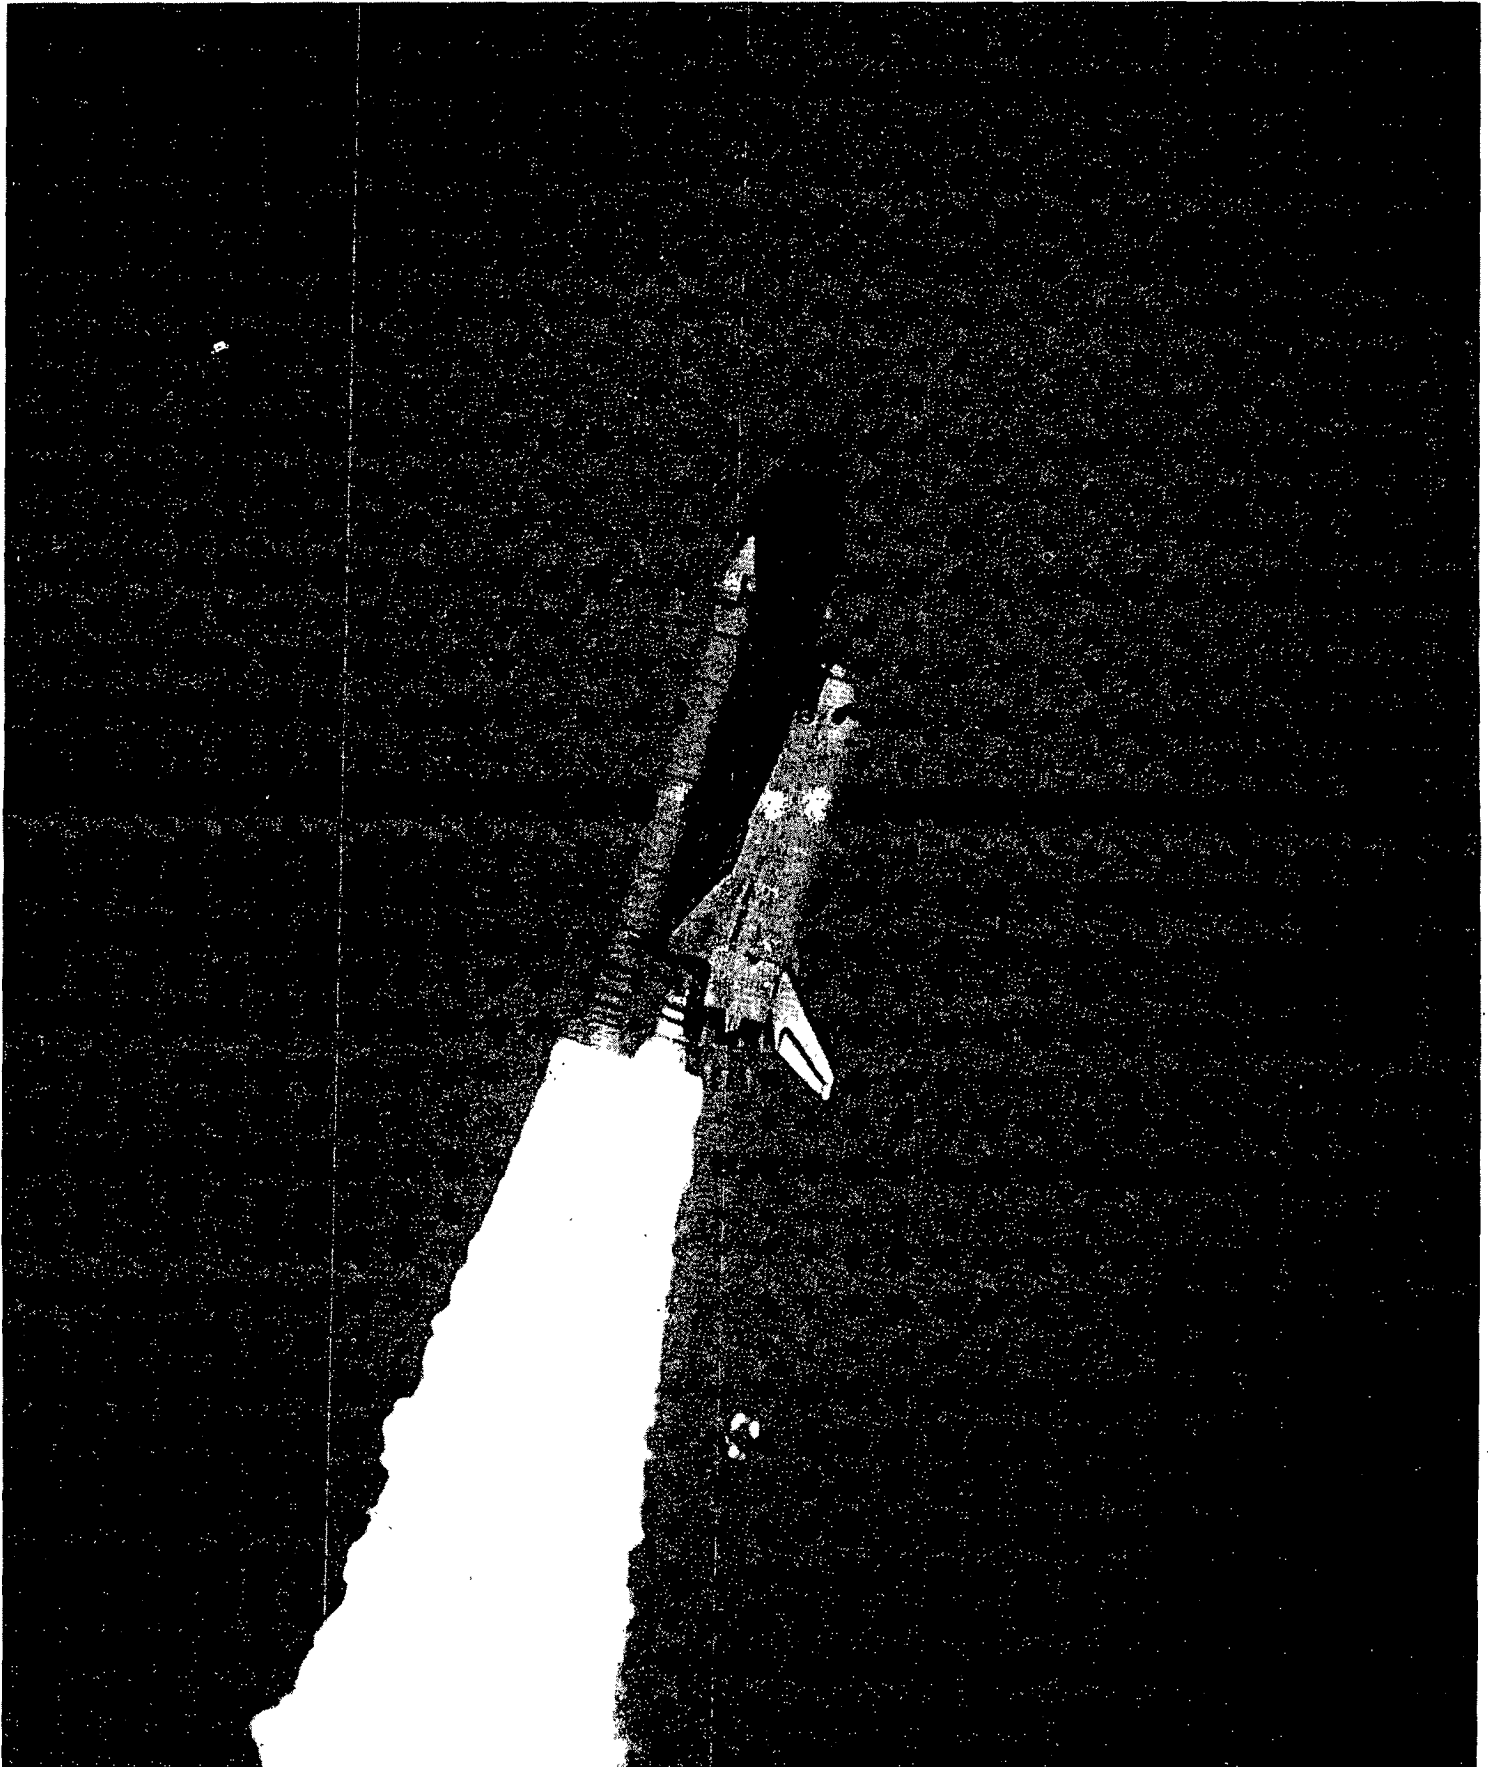
FLASH OF VAPORIZING HYDROGEN IN SSME #1 PLUME AT T+13
SECONDS CAUSED BY MAIN COMBUSTION CHAMBER FAILURE

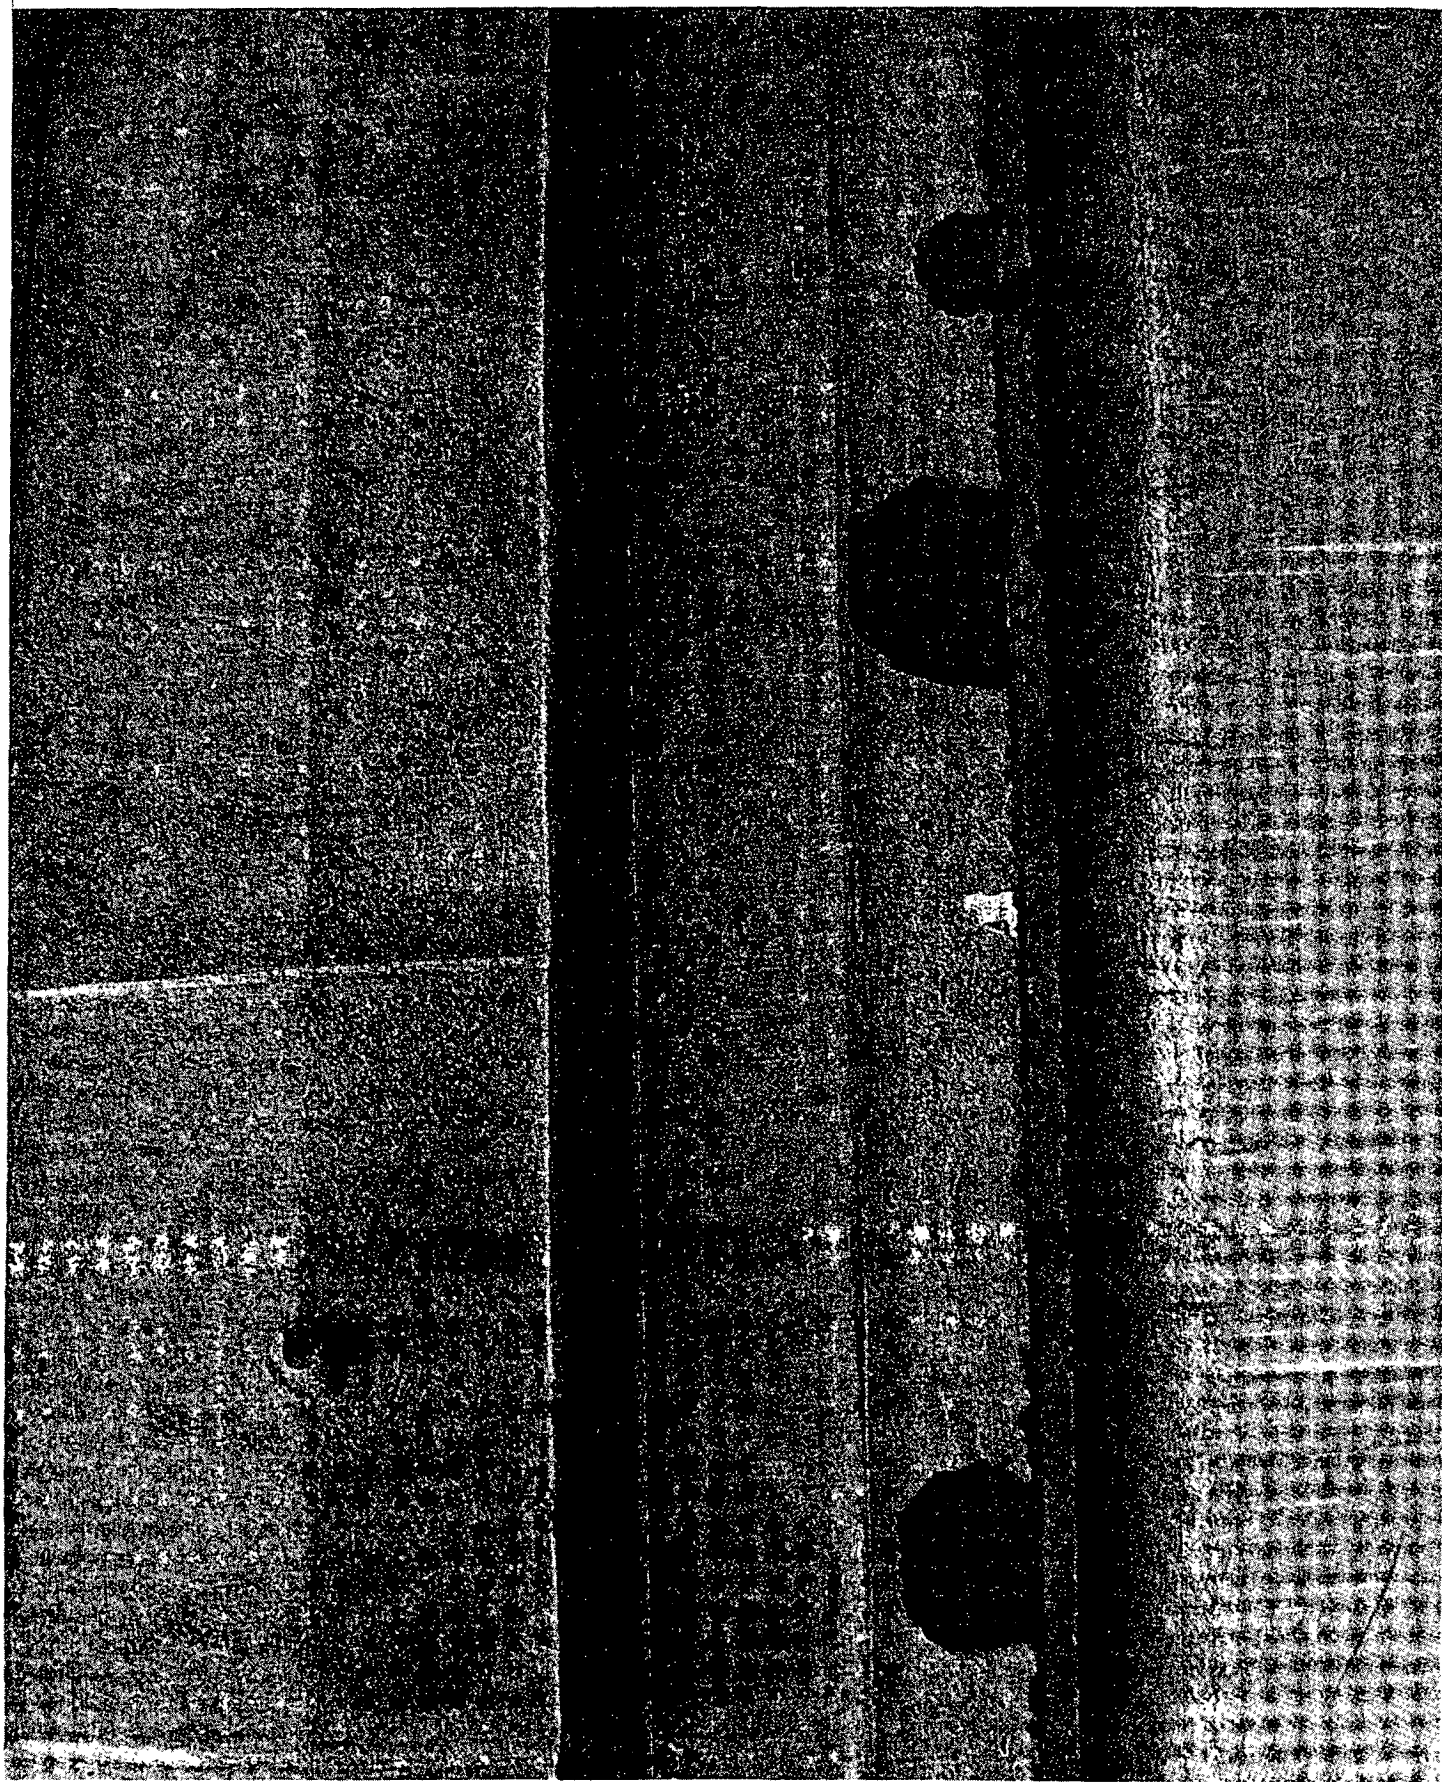
MISSING CORK FROM GIRTH INSTRUMENTATION BAND

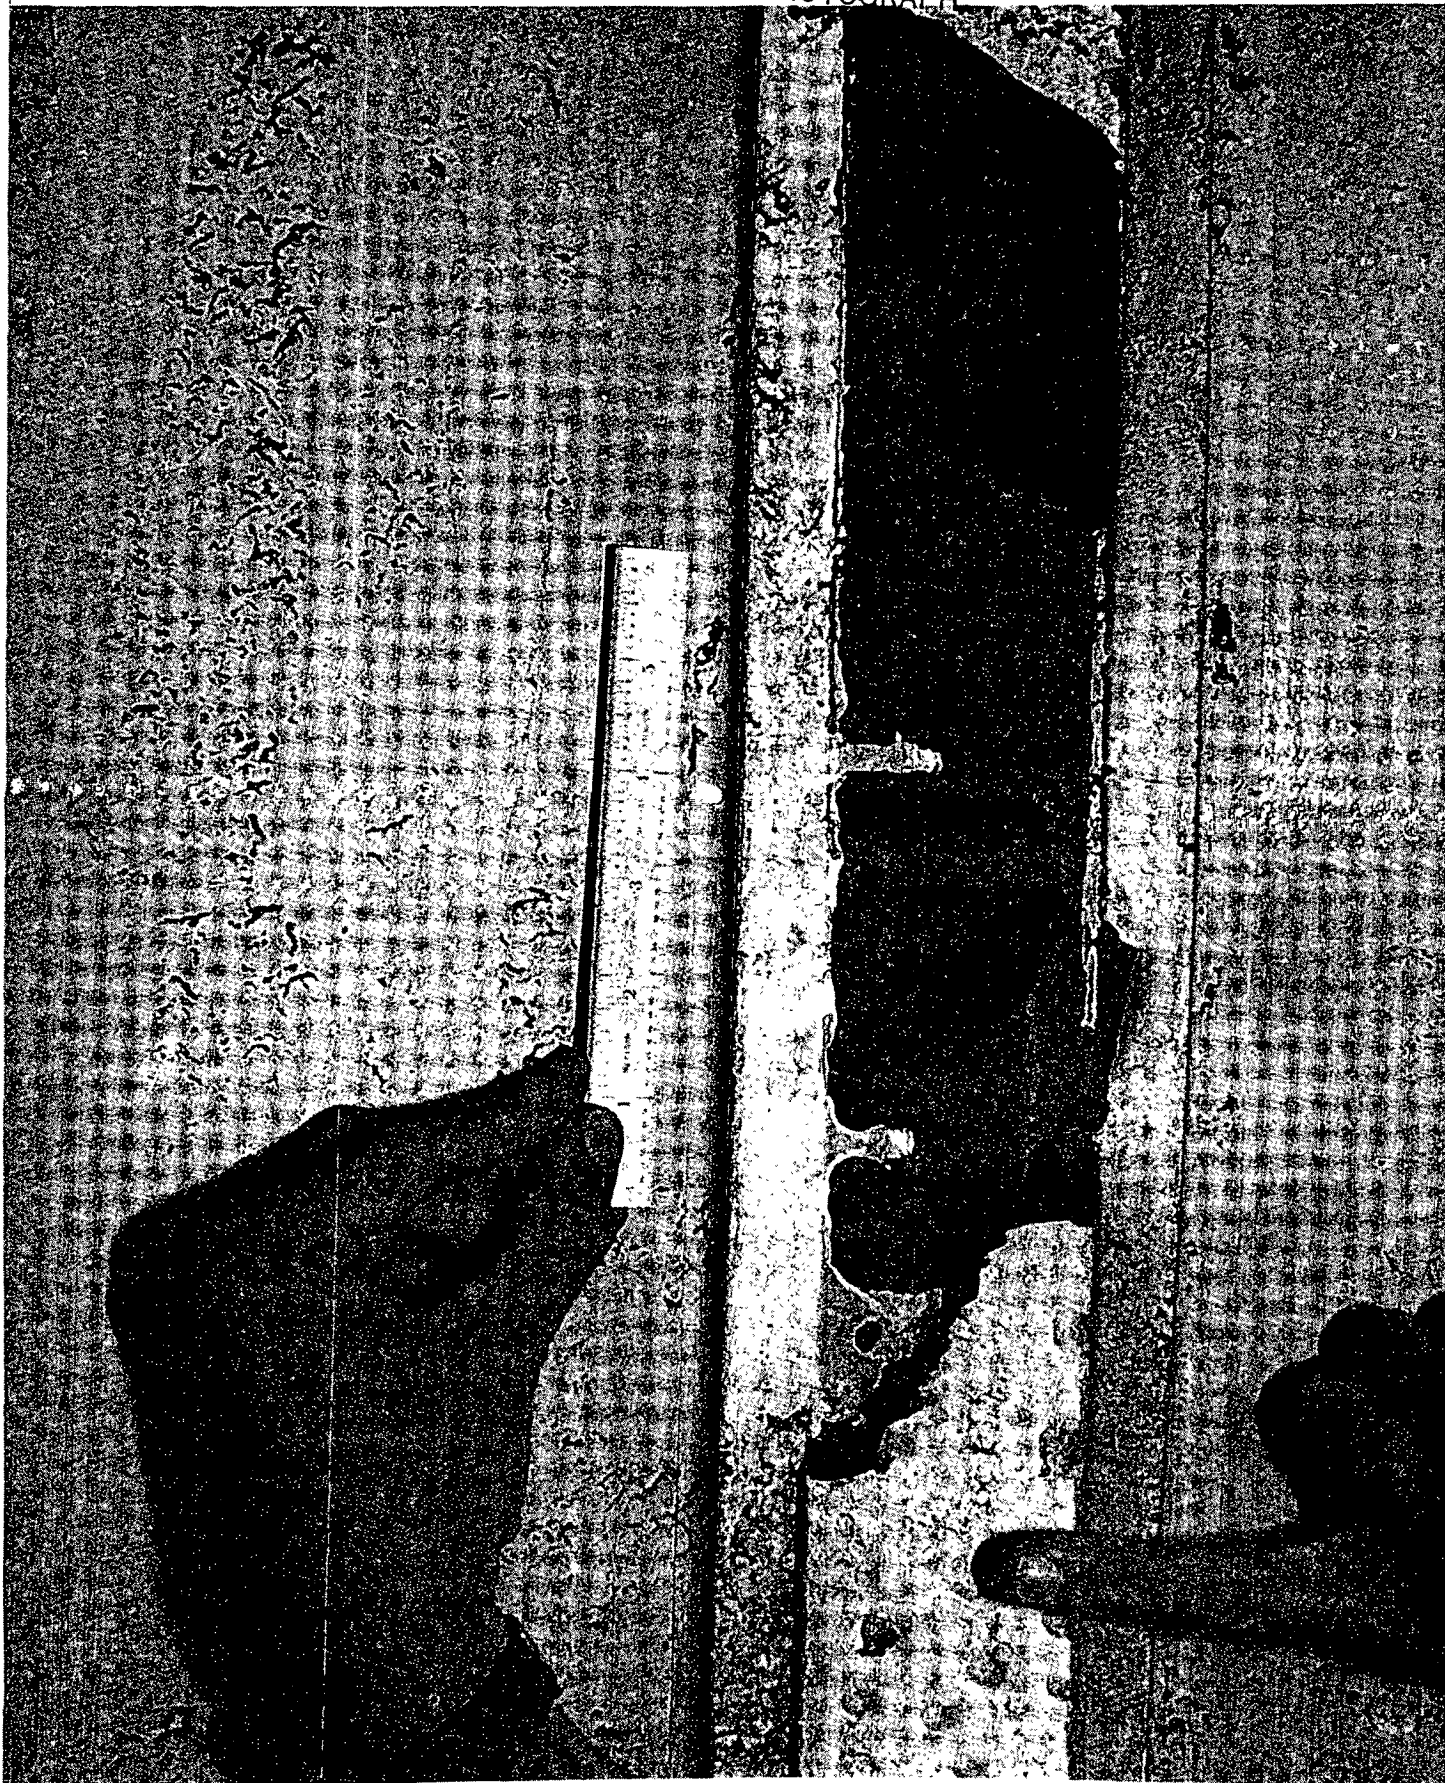
MISSING CORK FROM DFI CLOSEOUT ON RH SRB XB-939, 190 DEGREES.
DEBOND IS EVIDENT BY PAINT DRIPS ON SUBSTRATE

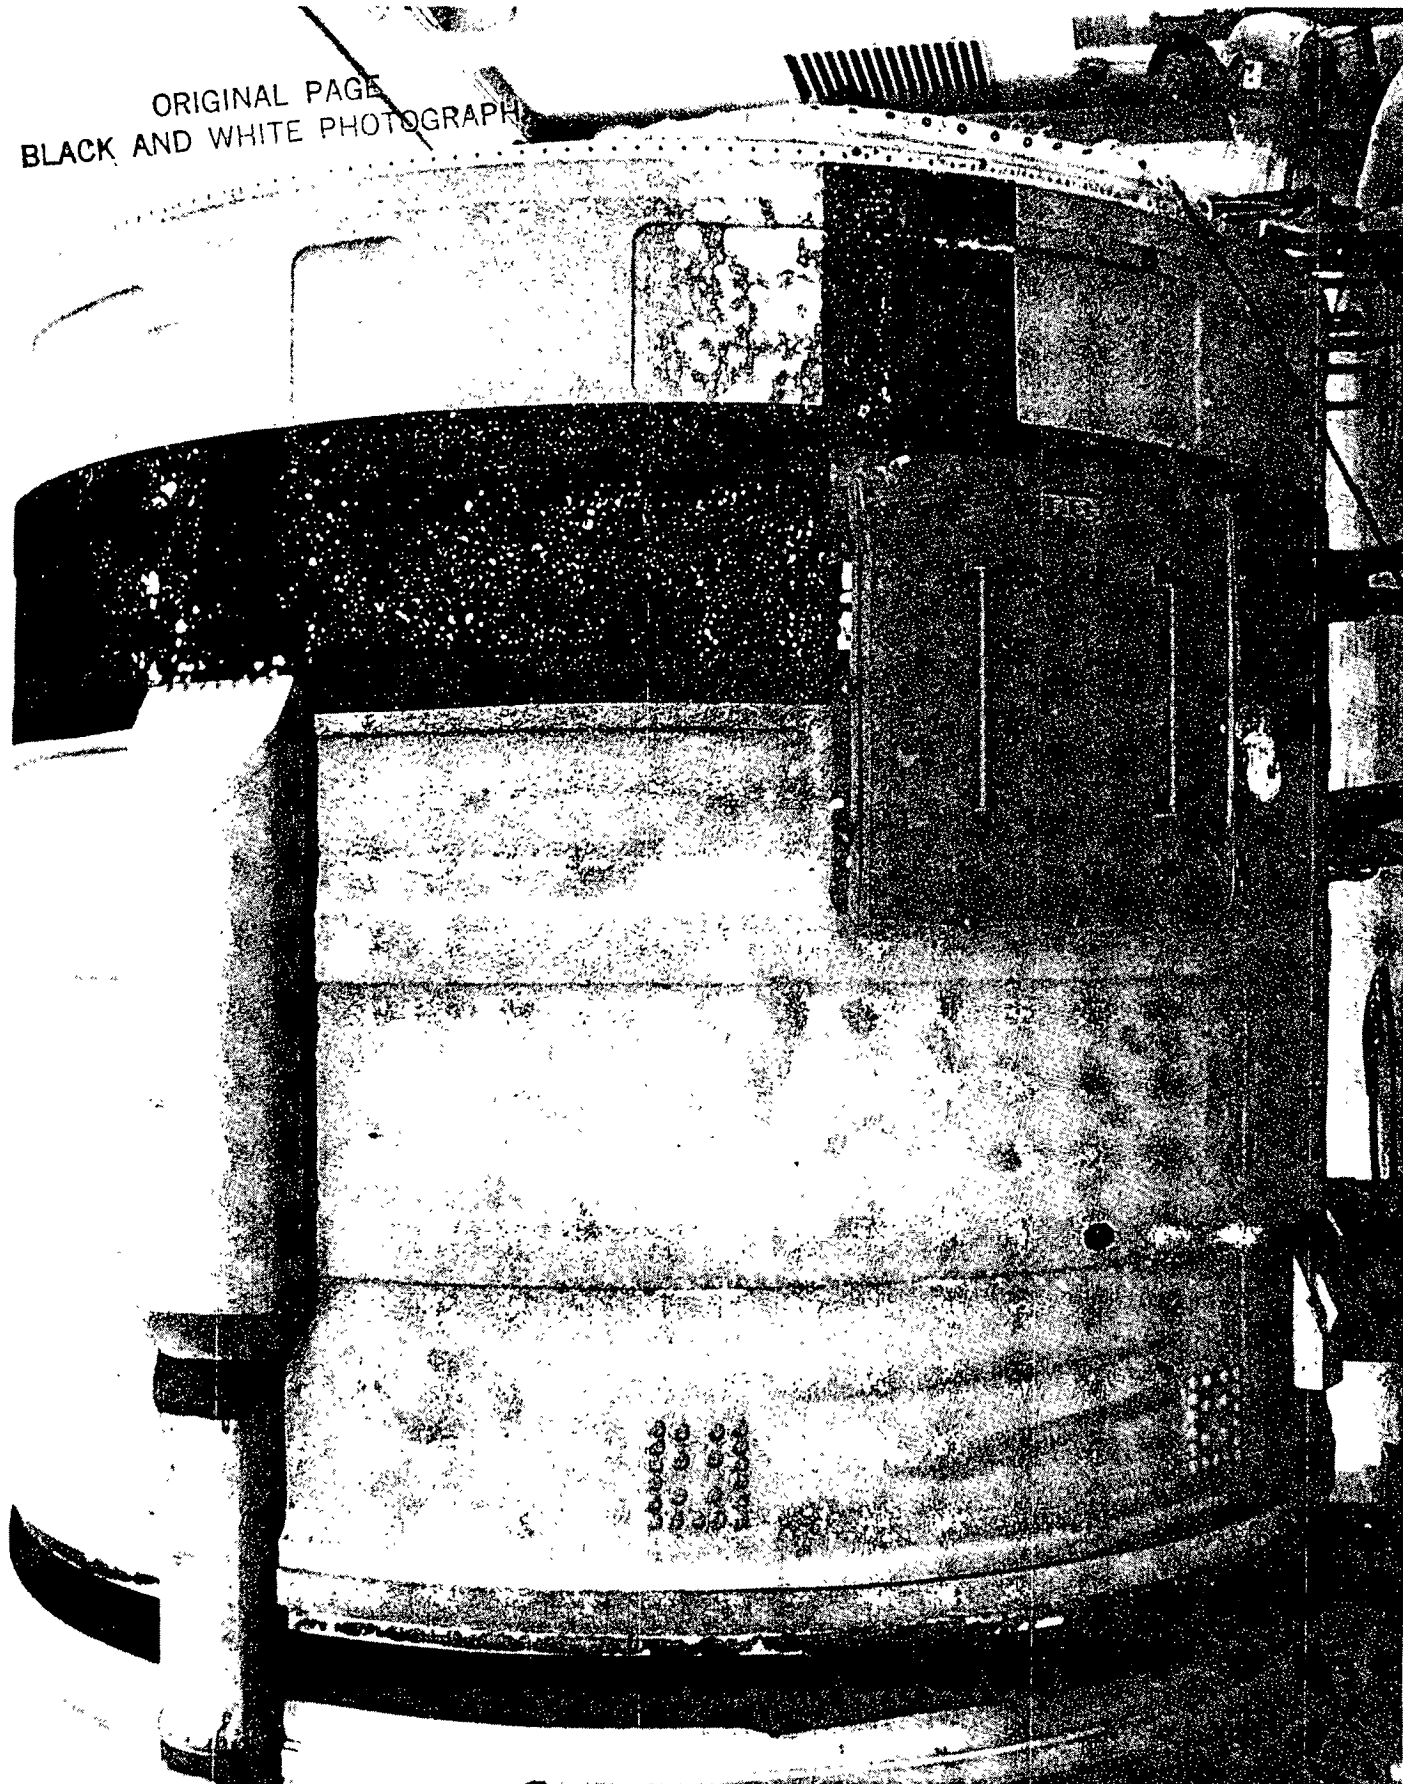
LEFT SRB FORWARD SKIRT EXHIBITS BLISTERING OF HYPALON PAINT

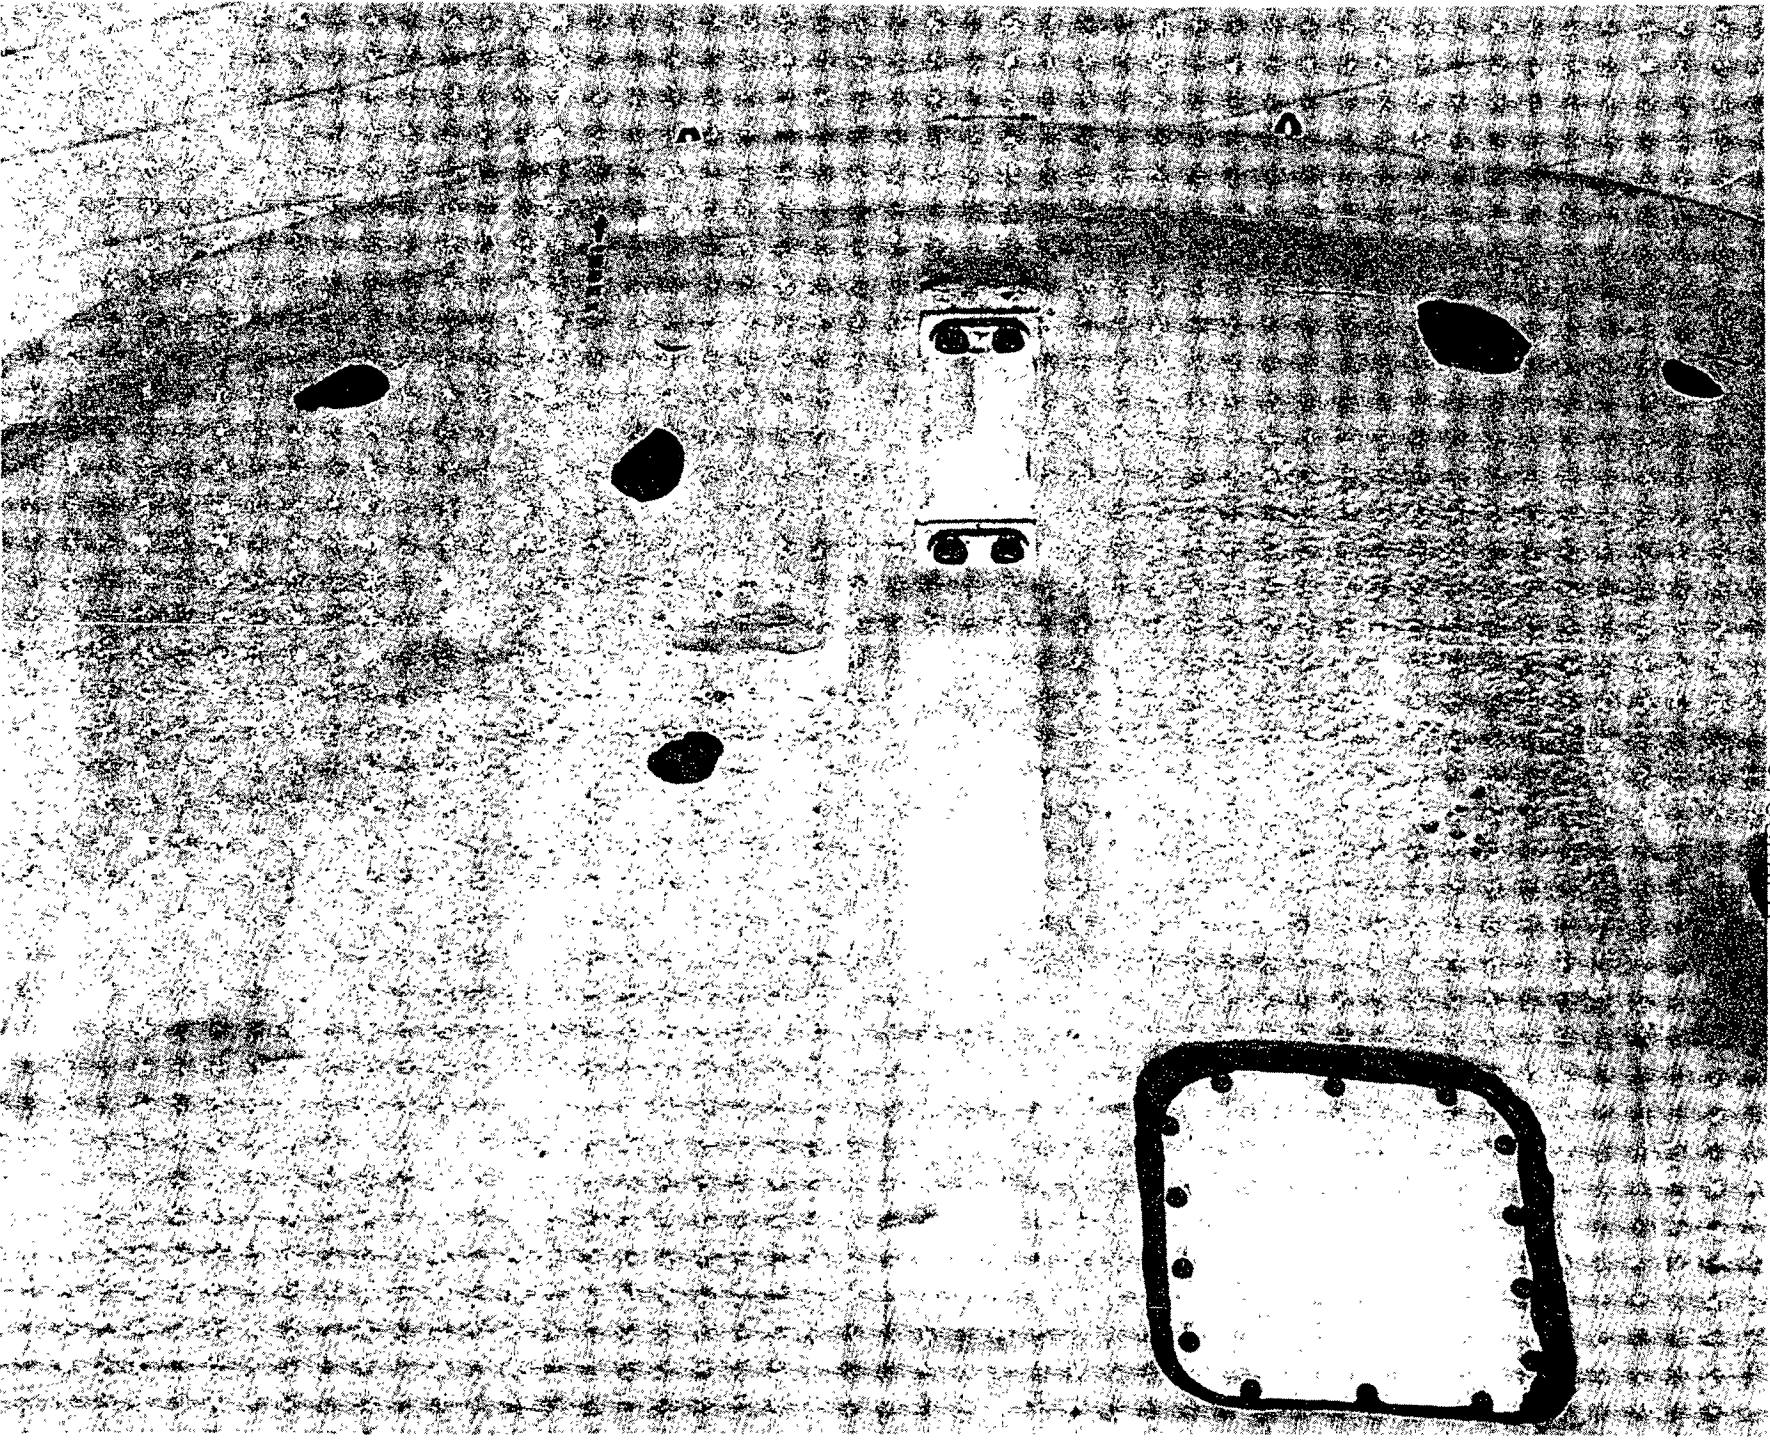
MISSING ABLATOR AND DIVOTS FROM RIGHT SRB FRUSTUM

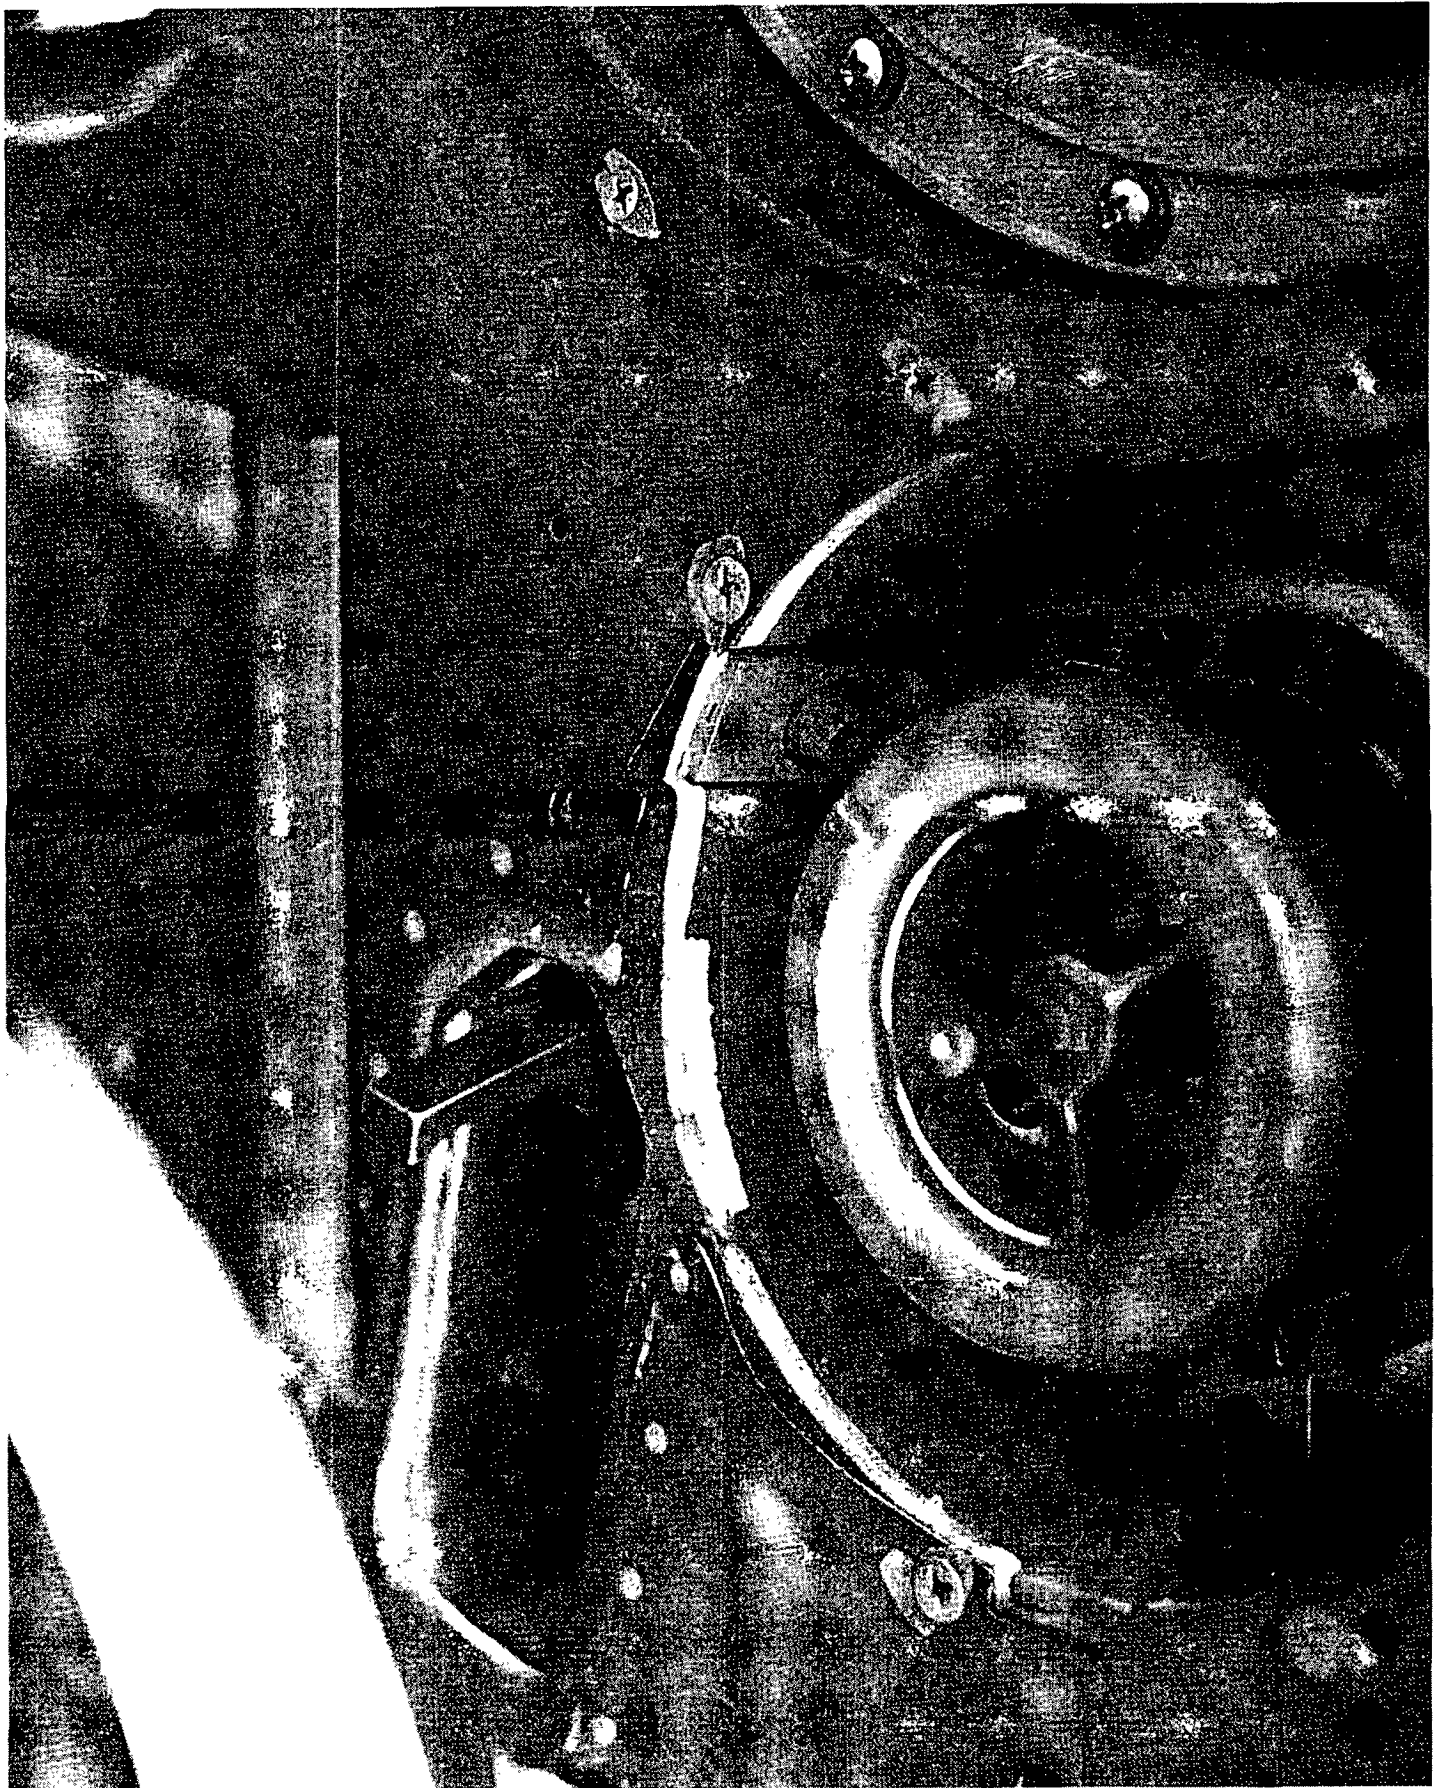
ET/ORB LO2 UMBILICAL FACE SHEET DAMAGE
IN AREA OF DISCONNECT MECHANISM

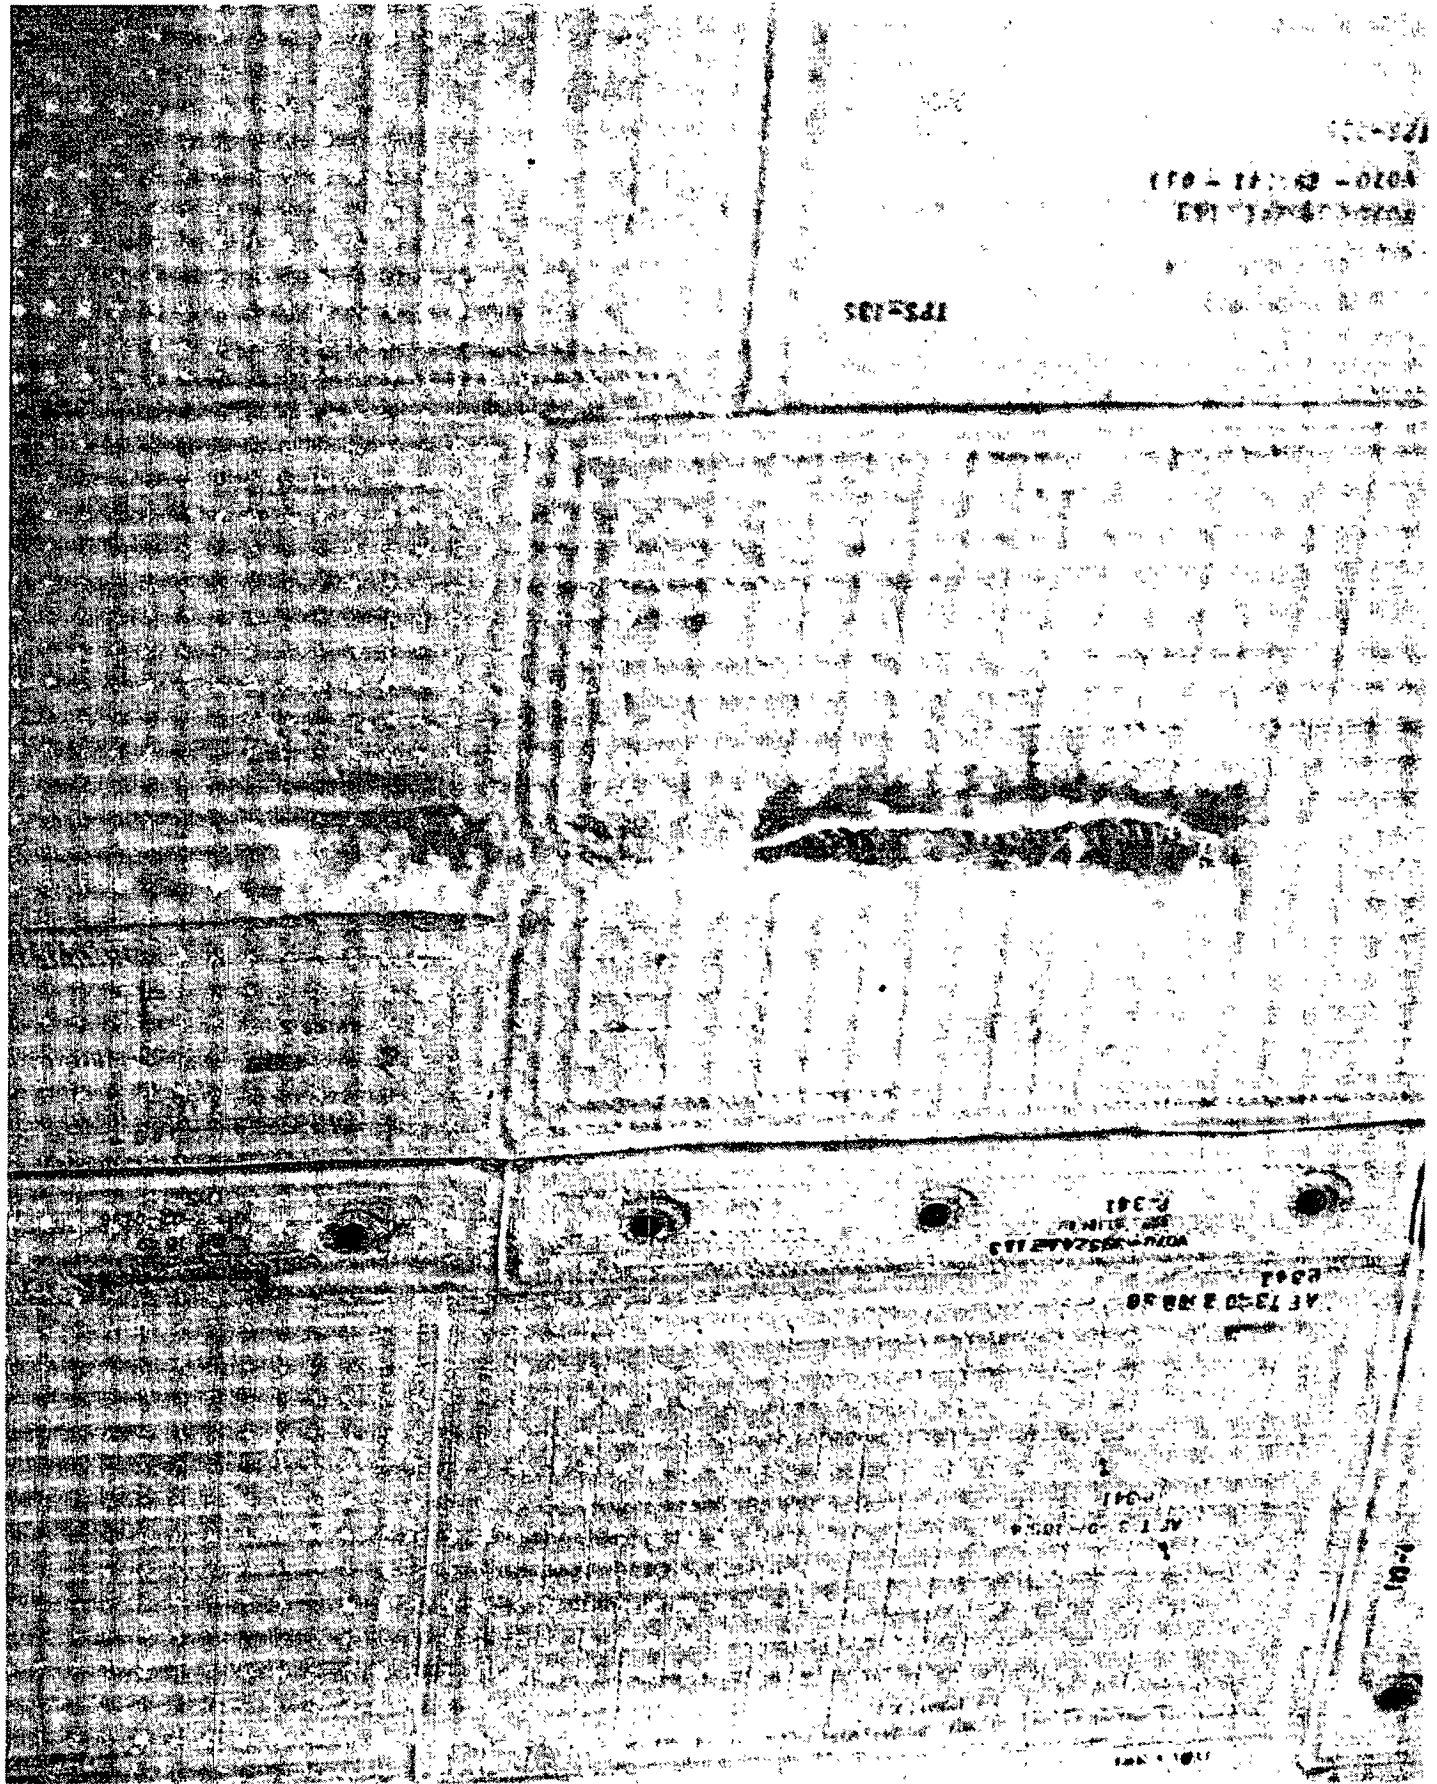
AFRSI BLANKET DAMAGE NEAR LEFT VENT DOOR #9

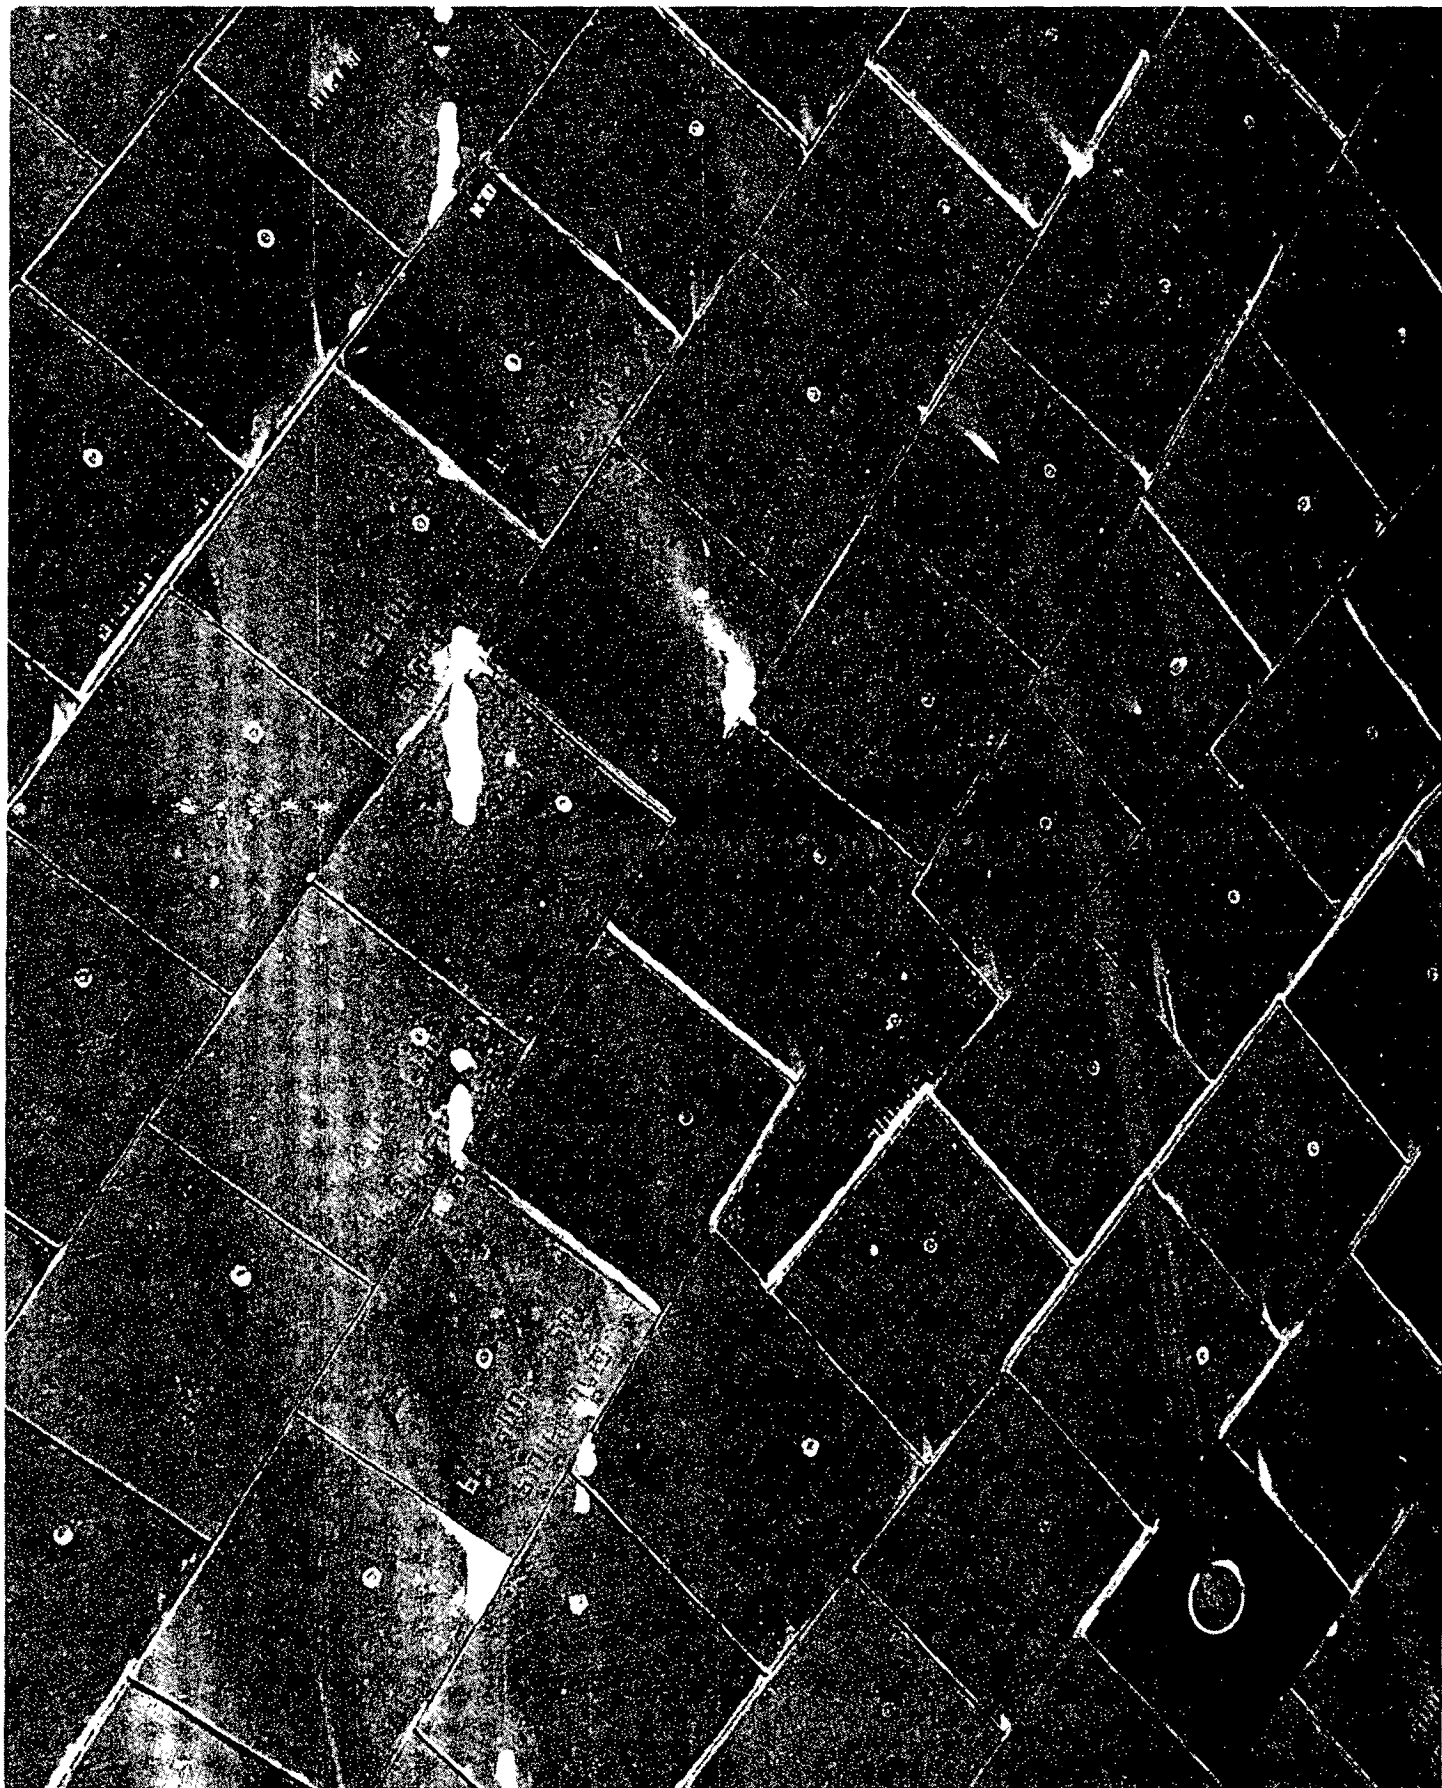
LINEAR STREAK OF TILE DAMAGE ON RIGHT WING LOWER SURFACE

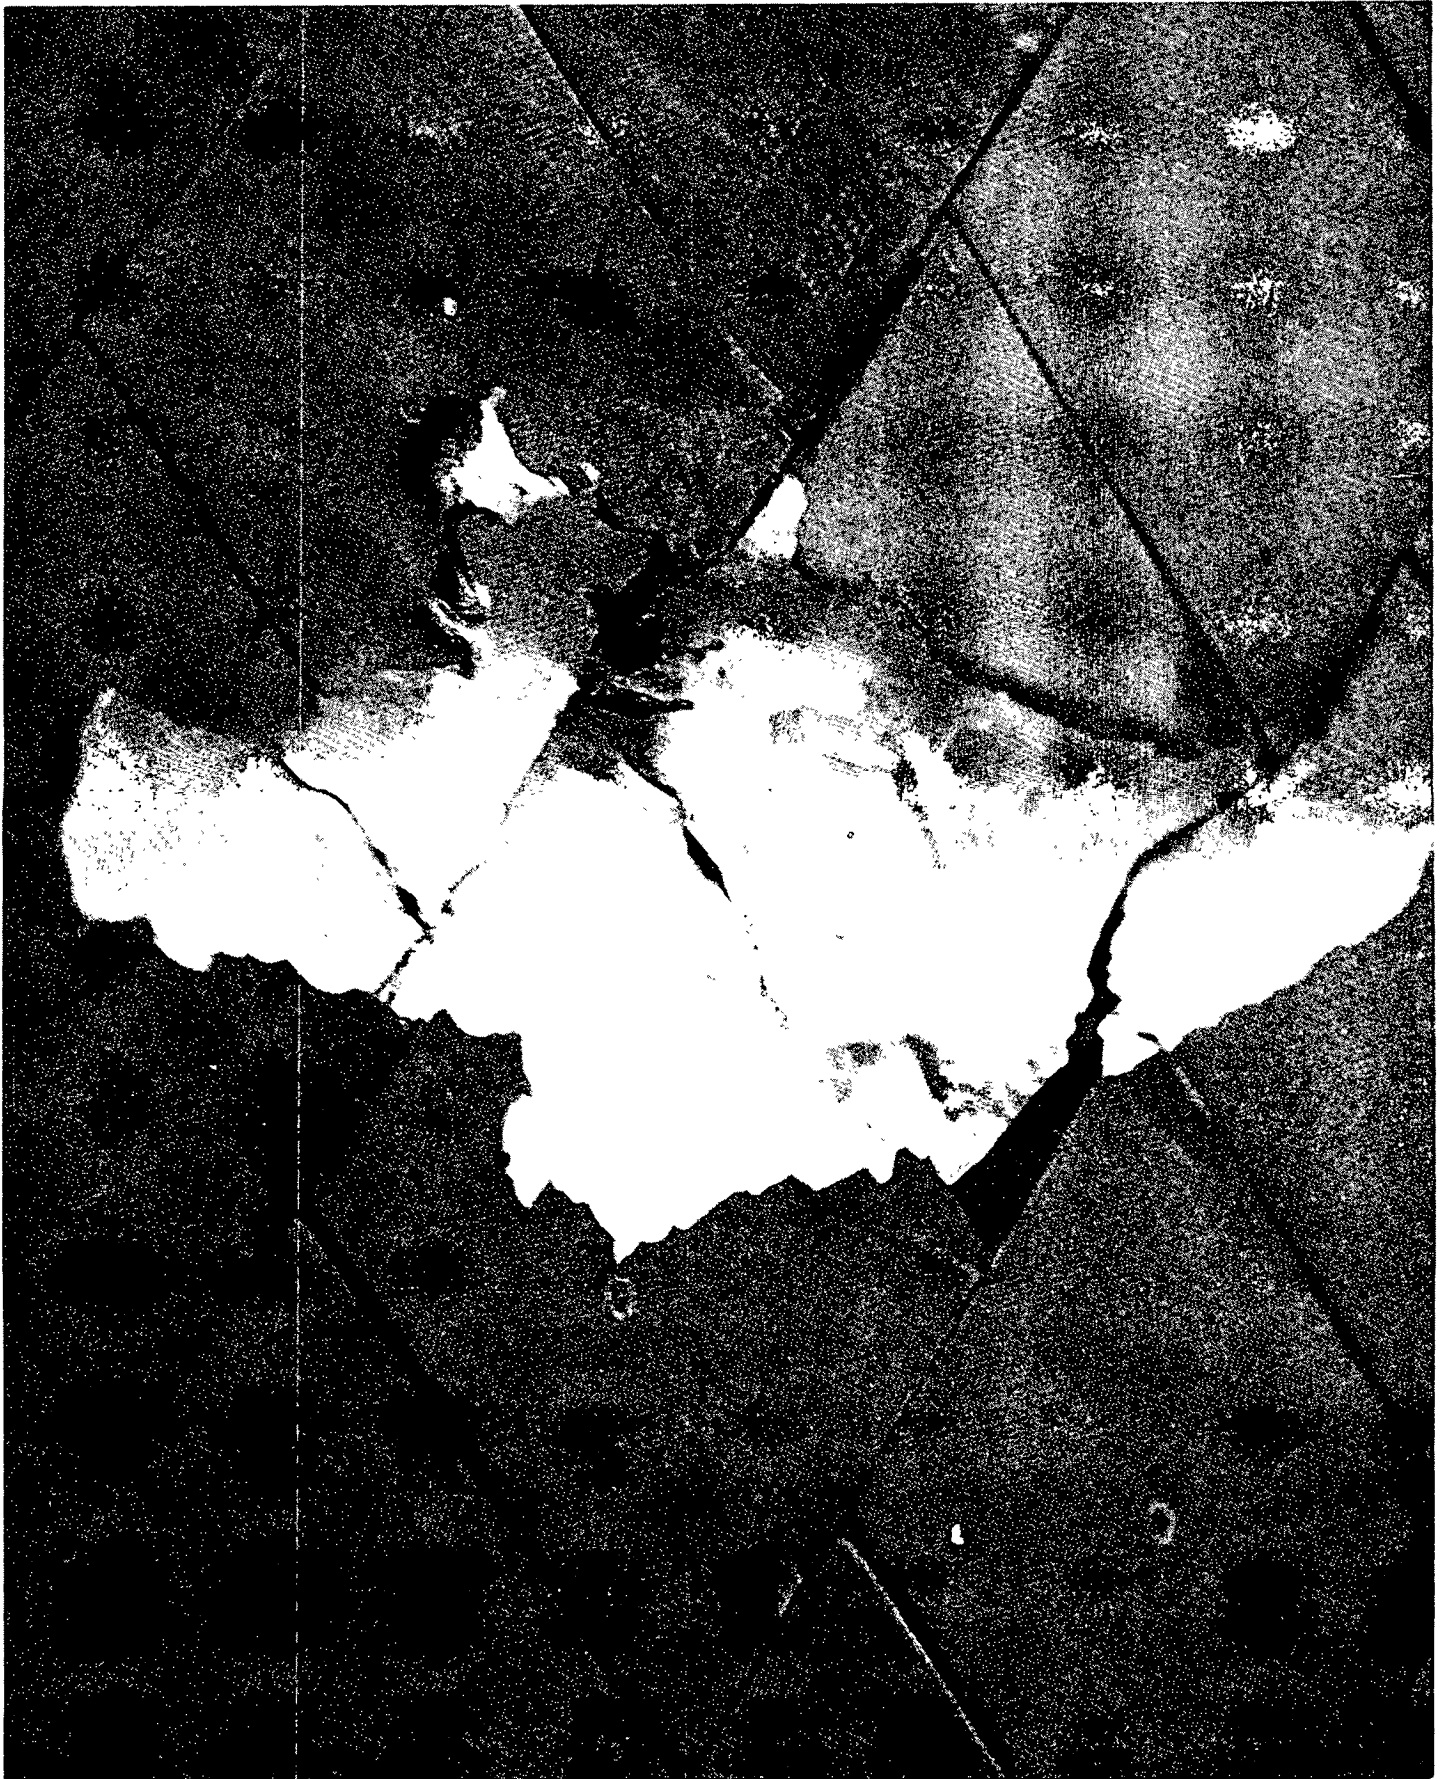
SIX TILES ARE DAMAGED BY INITIAL DEBRIS IMPACT
