NASA Technical Memorandum 100987

Ice/Frost/Debris Assessment For Space Shuttle Mission STS-26R

November 7, 1988

Charles G. Stevenson
Gregory N. Katnik
Scott A. Higginbotham
The John F. Kennedy Space Center, NASA

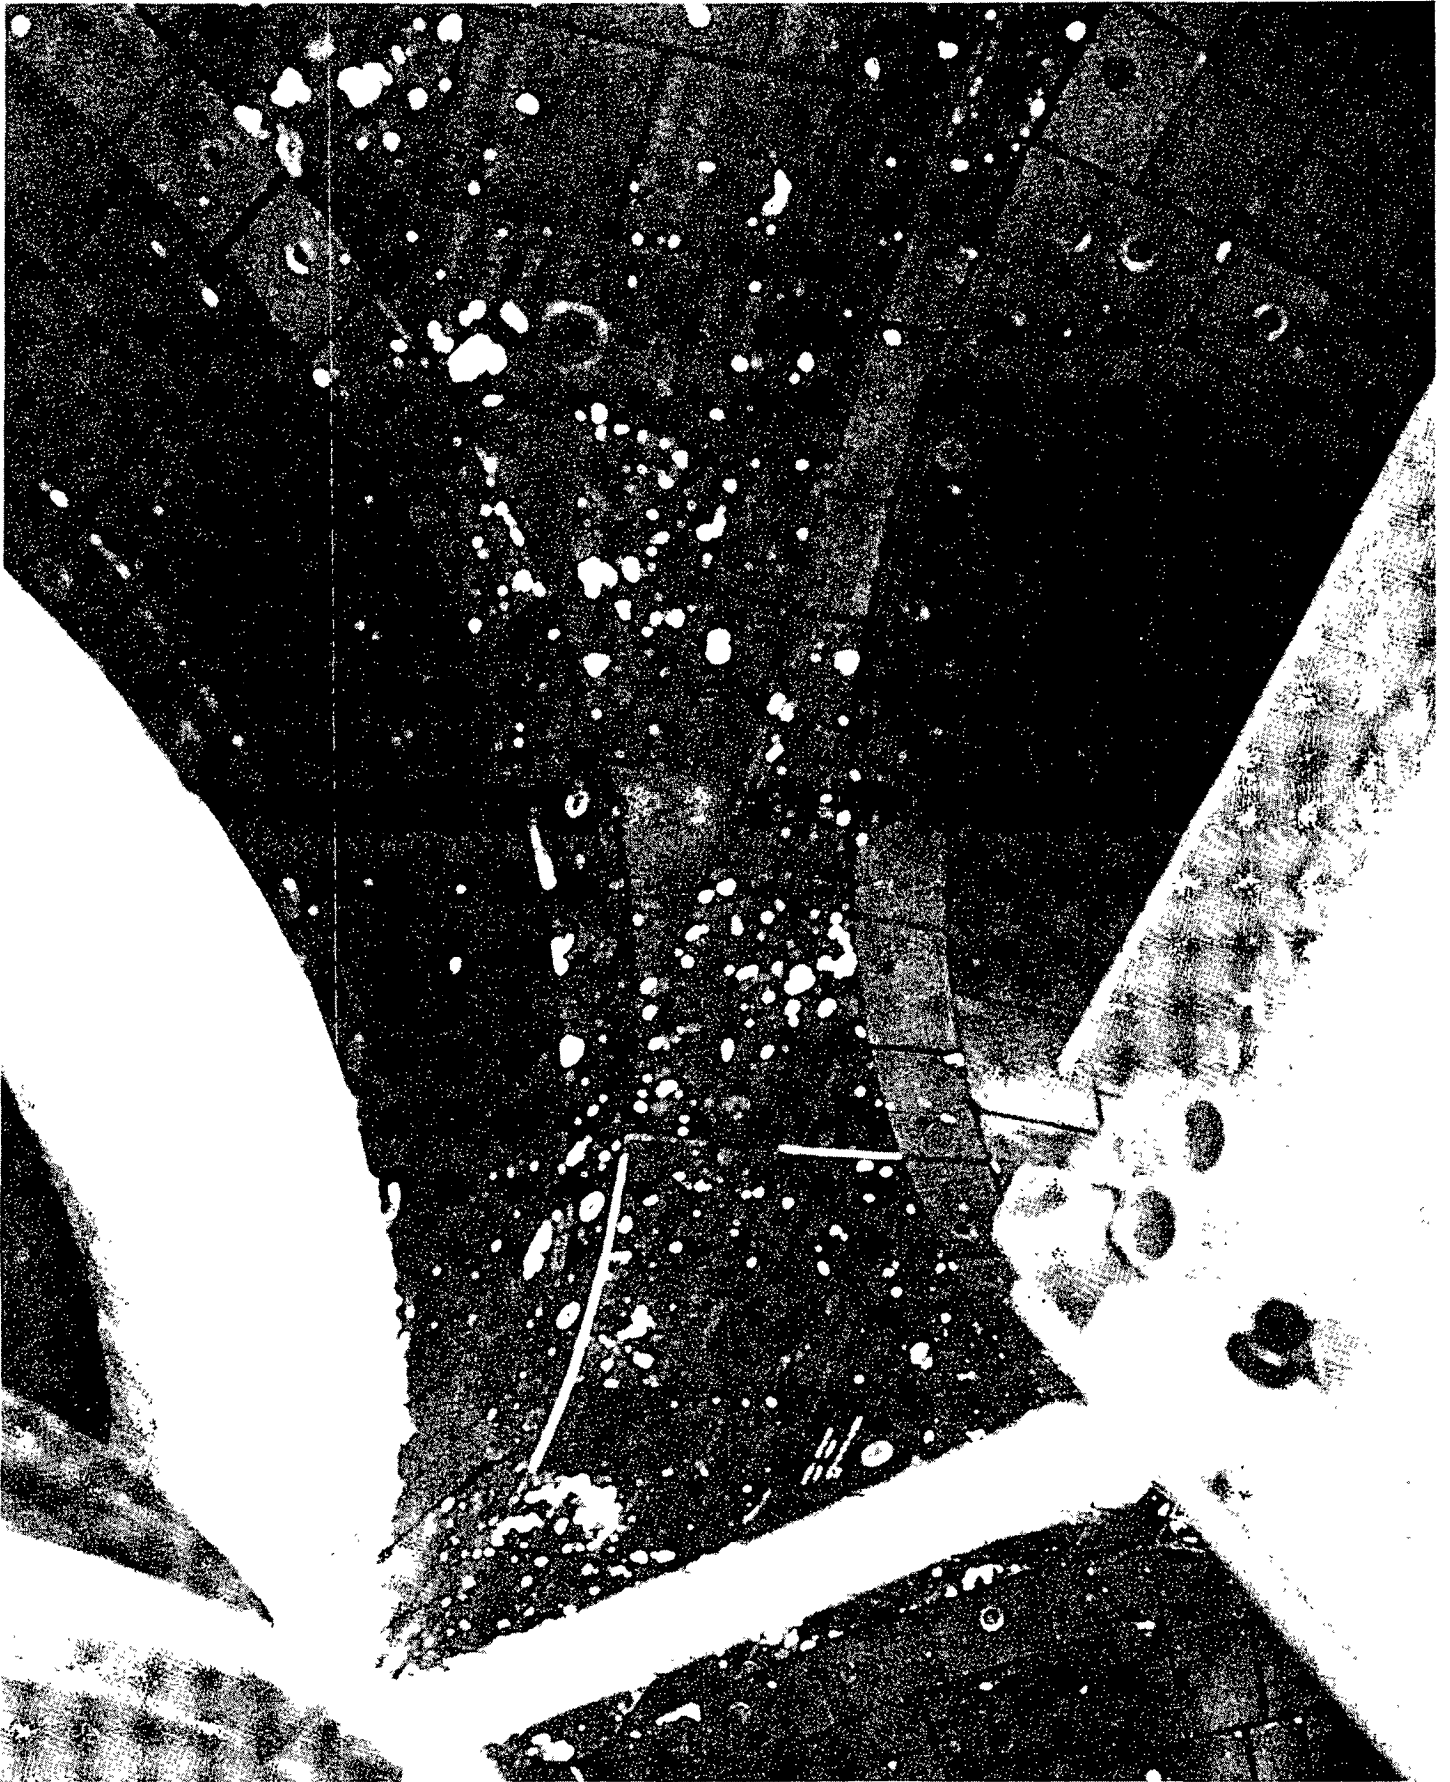
TYPICAL DAMAGE TO TILES ON ORBITER AFT HEAT SHIELD

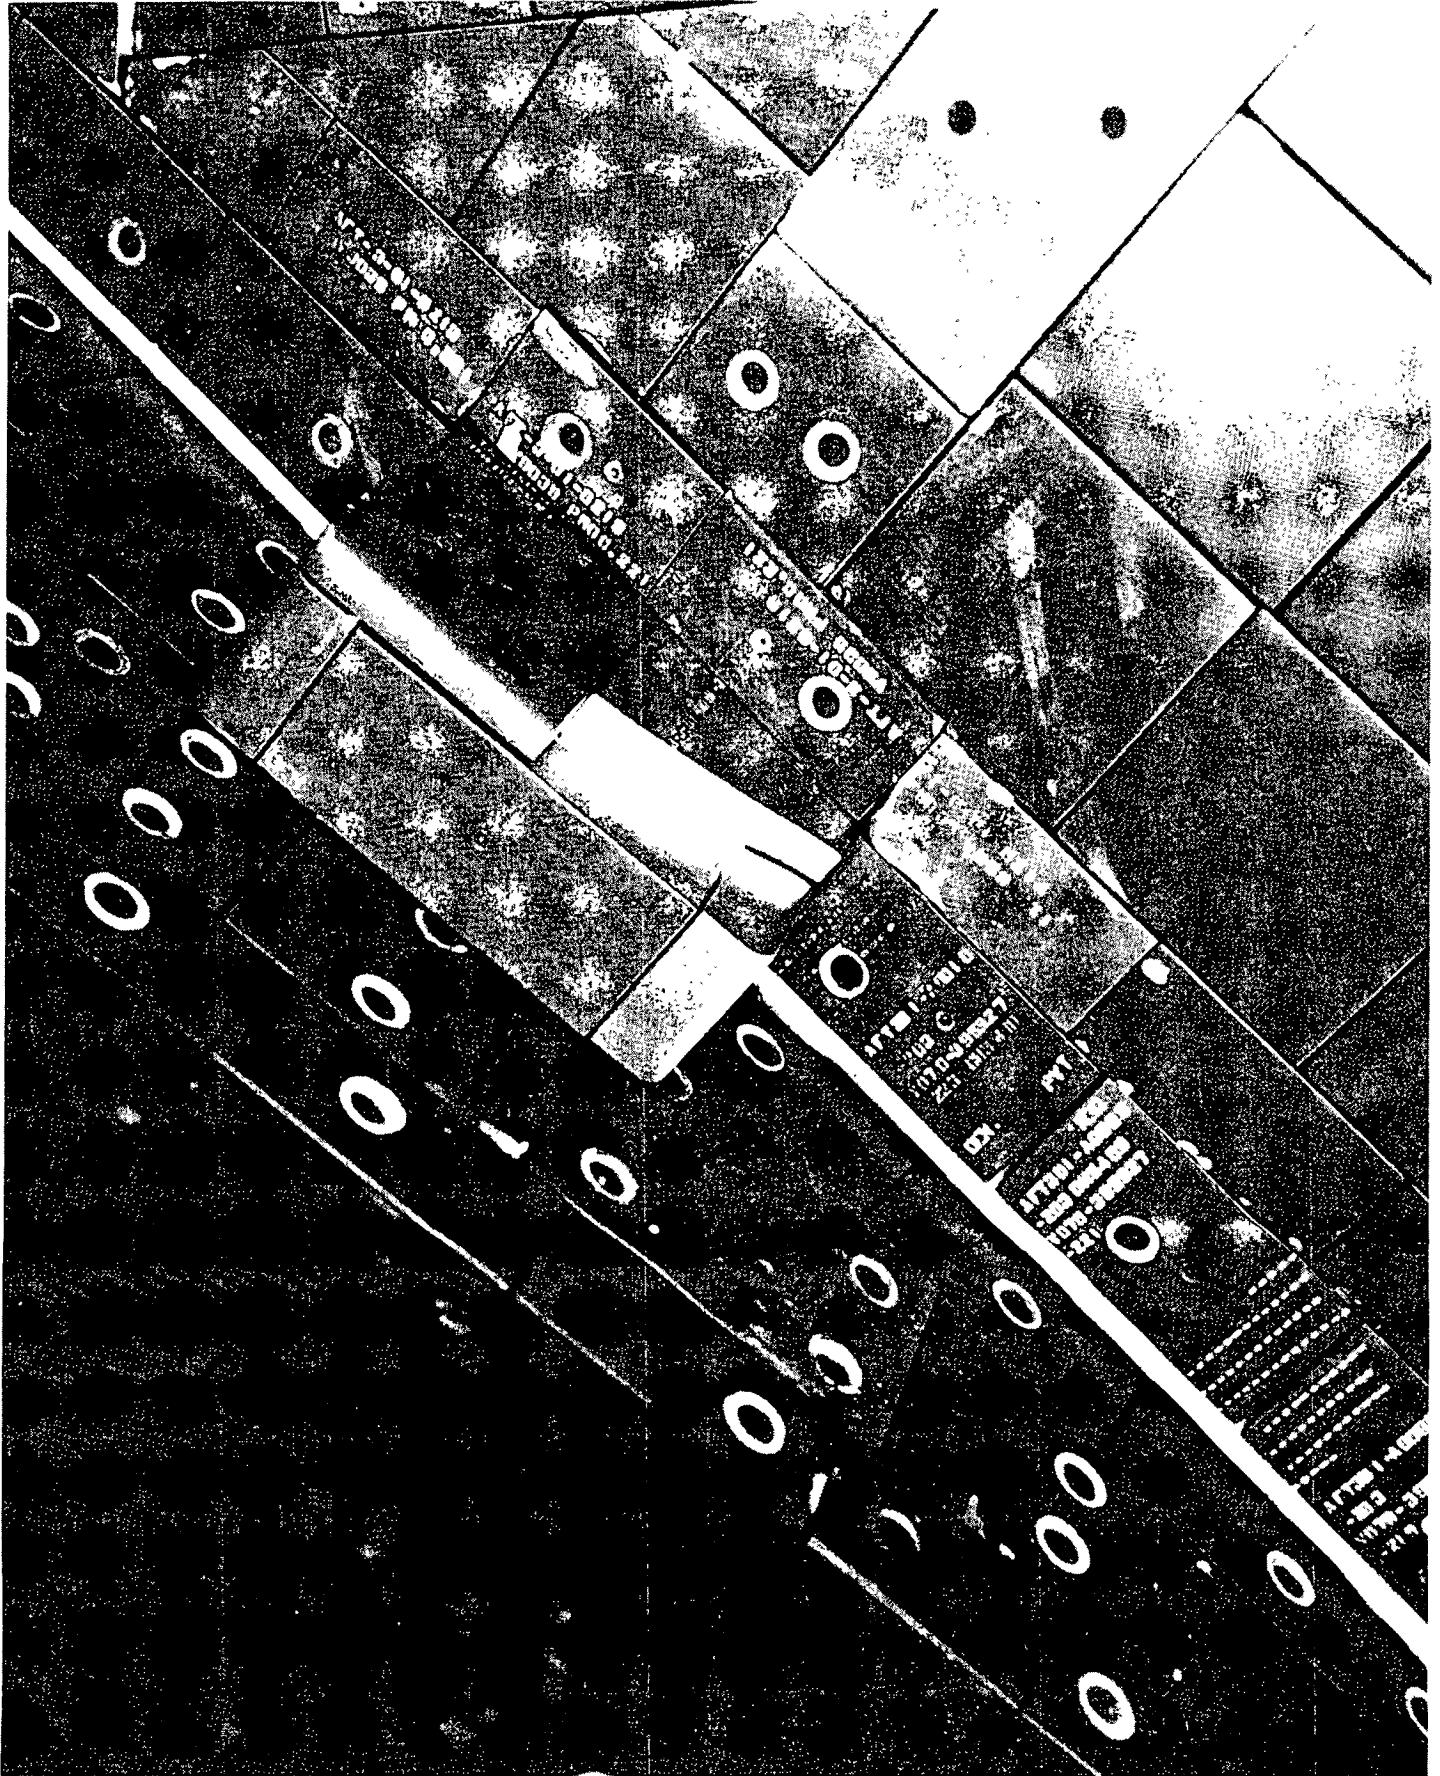
MISSING TILE FRAGMENT FROM LEFT OMS POD MOUNTING
BRACKET BROKE LOOSE AT SSME IGNITION
