NASA Technical Memorandum 101418

Failure Analysis of a Stirling Engine Heat Pipe

Thomas J. Moore and James E. Cairelli
Lewis Research Center
Cleveland, Ohio

March 1989

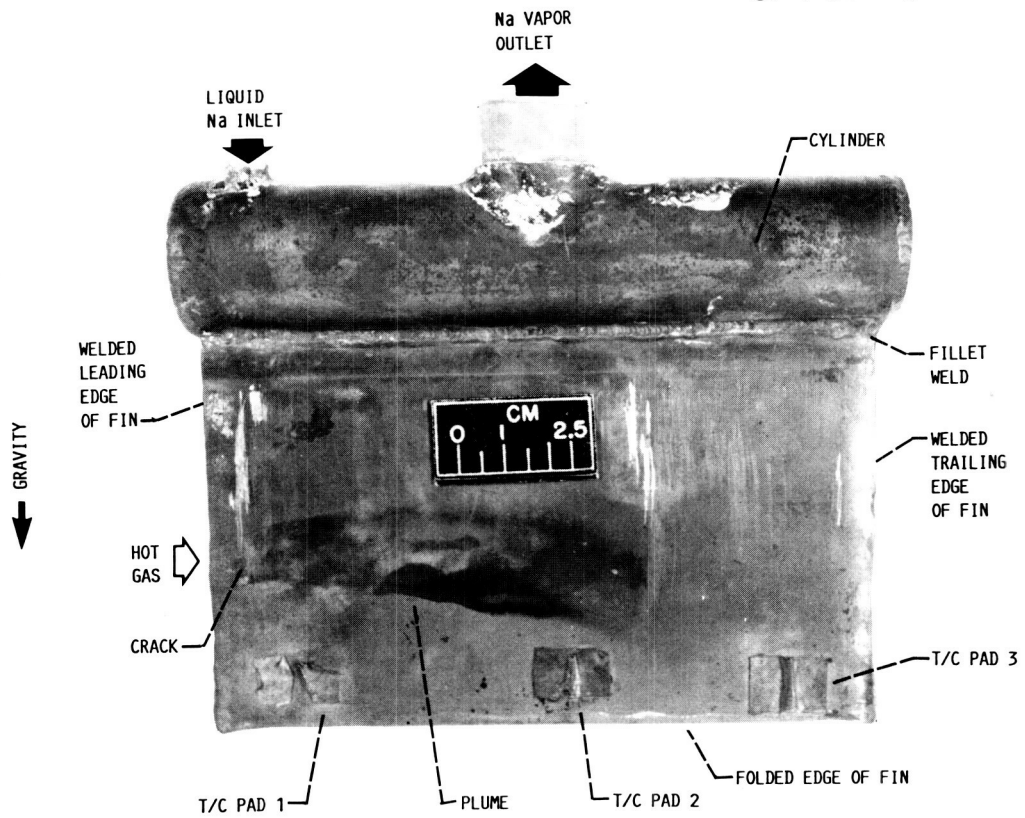
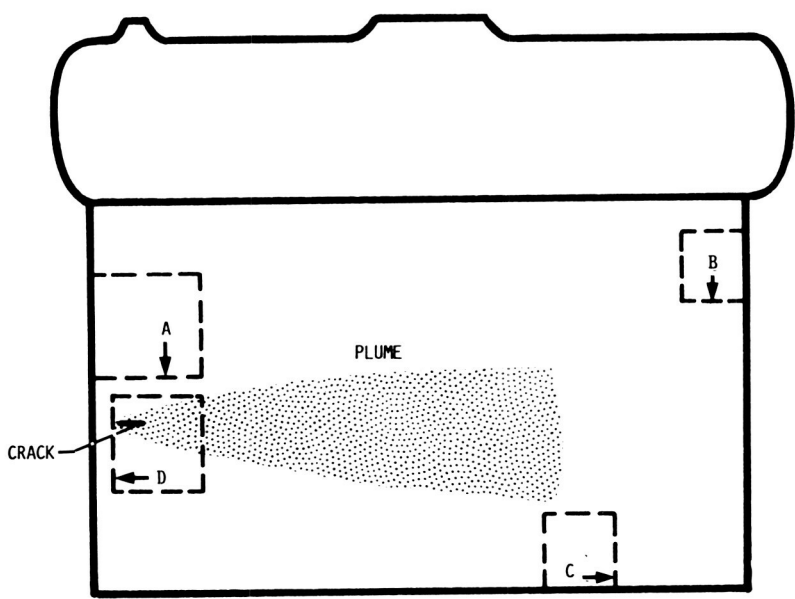
In operation, the axis of the cylinder was in a horizontal position, as shown in figure 1. The fin was located in flue gas heated with a natural gas flame with 20 percent excess air. On the basis of calculations, the temperature of the gas impinging on the leading edge of the fin was about 1820 K. During the run, the temperatures measured at pads 1, 2, and 3 (1076, 1065, and 1065 K, respectively) were very close to the 1073 K design temperature. A bright glow confined to the leading edge, however, indicated localized gross overheating to perhaps 1350 K. Estimated internal pressure within the heat pipe was about one half of atmospheric pressure (55.2 kPa). The power output during the run was between 2.0 and 2.2 kW and the heat flux at leading edge of the fin was in the range of 500 to 600 kW/m². Under the conditions described above the heat pipe system failed after only 2 hr due to a through-the-wall crack near the leading edge of the evaporator fin.

FIGURE 1. - EVAPORATOR PORTION OF A FINNED CYLINDER HEAT PIPE SHOWING CRACK LOCATION WHERE THE Na WORKING FLUID LEAKED TO THE ATMOSPHERE. LOCATIONS AND VIEWING DIRECTIONS FOR METALLOGRAPHIC EXAMINATION ARE SHOWN ON THE SKETCH.

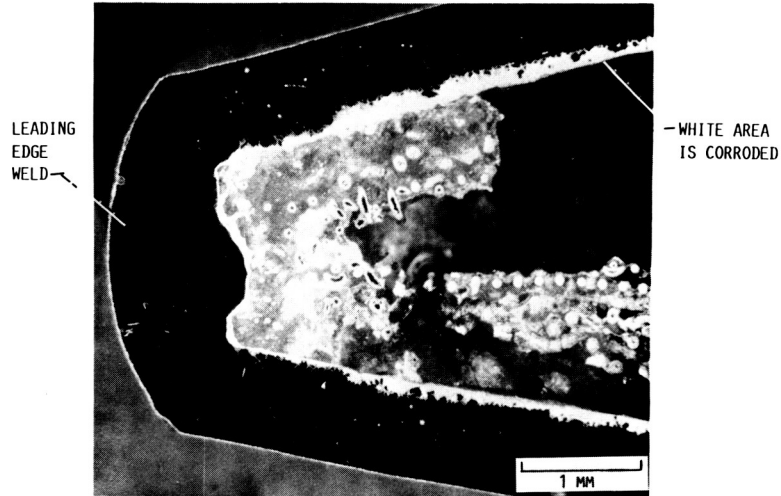
An examination of cross sections of the fin revealed that, at the overheated leading edge, the wick material was disintegrated by corrosion and the interior wall of the fin was also severely corroded. At location A in figure 2, areas of the fin wall that appear white are corroded. The maximum penetration of this general corrosion was about 360 μm near the through-the-wall crack which was parallel to this cross section. The severity of the corrosion progressively decreased as the distance from the leading edge increased. At a distance of 10 mm from the leading edge no macro-evidence of corrosion was observed.

LOCATION A. LEADING EDGE OF FIN NEAR THROUGH-THE-WALL CRACK REGION WHICH WAS PARALLEL TO THIS CROSS SECTION. CORROSION HAS OCCURRED HERE AT THE INNER SURFACE OF THE FIN AND IN THE WICK MATERIAL.

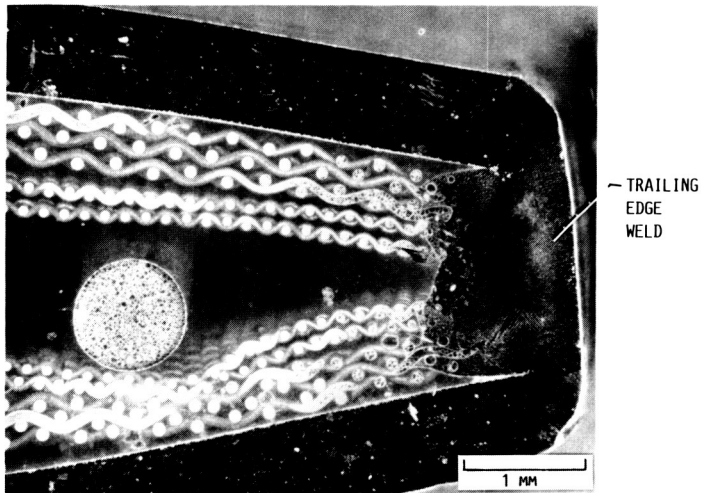
At the trailing edge, location B in figure 2, no corrosion of the wick or fin was evident. Thus, the wick exhibits an as-fabricated appearance. As shown at location C in figure 2, continuity of the wick at the folded edge of the fin permitted complete access of the Na coolant to this region of the fin. No corrosion was evident at location C.

LOCATION B. TRAILING EDGE SHOWING WELD PENETRATION INTO WICK AREA.

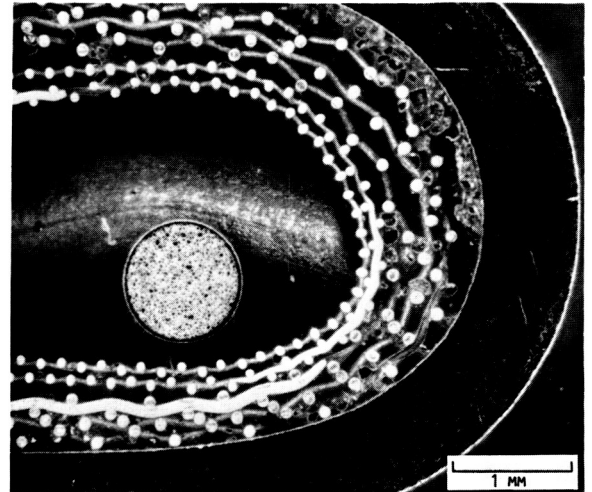
LOCATION C. FOLDED EDGE SHOWING CONTINUOUS CONTACT OF WICK WITH FIN SURFACE.

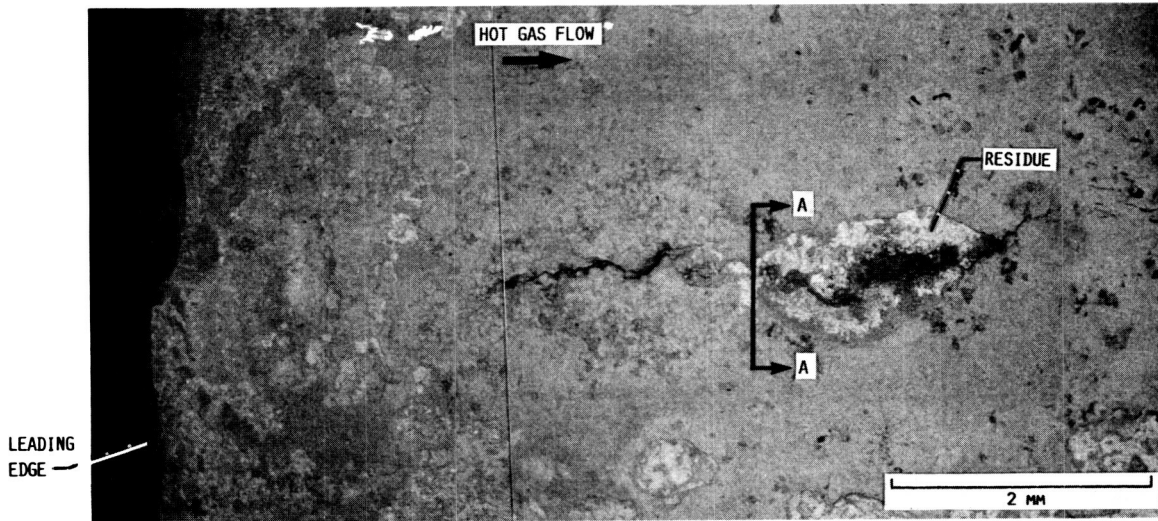
A photograph of the outer surface of the through-the-wall crack (from fig. 1) is shown in figure 3(a). Cracking, which initiated at the inner surface, extended through the thickness to the outer surface about 2.3 mm from the leading edge. The total length of the crack at the outer surface was about 4.3 mm. At cross-section A-A (fig. 3(b)), the crack does not quite extend to the outer surface. But, a little further back from the leading edge it did reach the outer surface and permitted air to enter the heat pipe. The air-contaminated Na coolant and corrosion products leaked to the outer surface and deposited a residue there (fig. 3(b)).

(a) EXTERNAL SURFACE OF THE FIN WITH CRACK NORMAL TO THE WELDED LEADING EDGE.

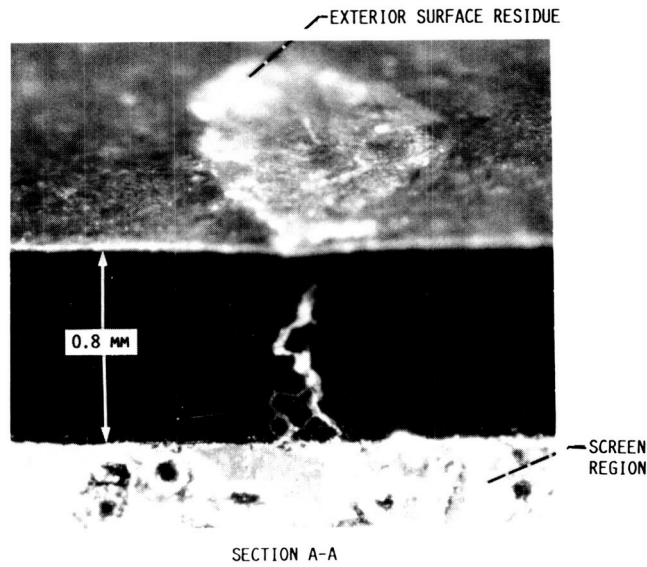
(b) AT THIS LOCATION, THE CRACK, WHICH STARTED AT THE INNER SURFACE EXTENDS ALMOST TO THE OUTER SURFACE OF THE FIN.

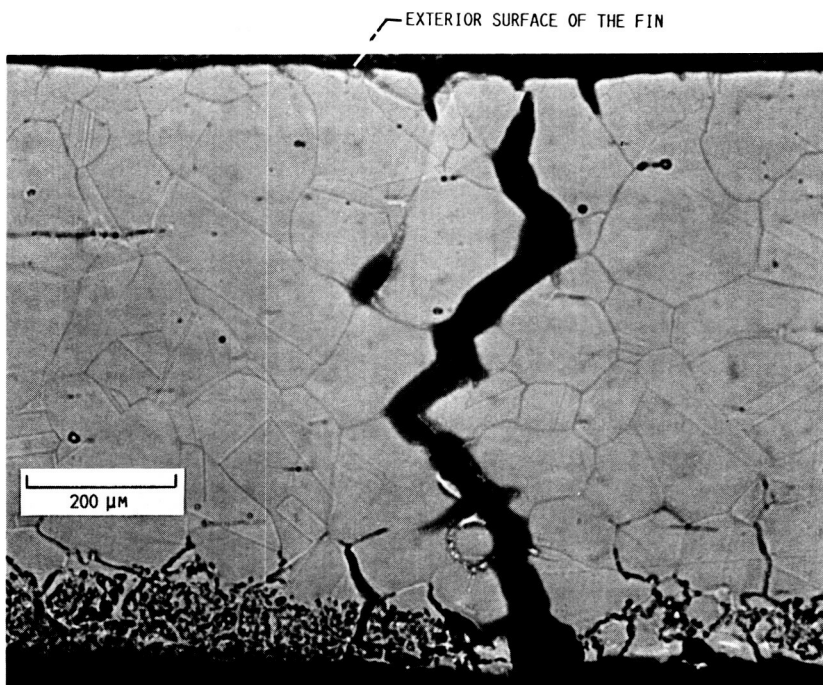
The intergranular nature of the corrosion cracking is evident in figure 4. The crack developed in the area of general corrosion at the inner surface of the fin and proceeded to the outer surface. Since the pressure within the fin was below atmospheric pressure, a slight tensile stress would be produced at the inner surface and it would contribute to a stress corrosion effect. Severe corrosion of the Type 316 wick materials also occurred near the overheated leading edge of the fin. At location A, shown in figure 5, the intergranular attack resulted in disintegration of the wire screen. It was not surprising to find the severe corrosion of fin and wick materials since the localized area at the leading edge of the fin was estimated to have been operating at about 1350 K. Under these conditions the Na was in the gaseous rather than the liquid state. At much lower temperatures in pumped Na loops, Devan (ref. 1)

(a) CROSS SECTION OF THROUGH-THE-WALL INTERGRANULAR CRACK IN THE FIN.

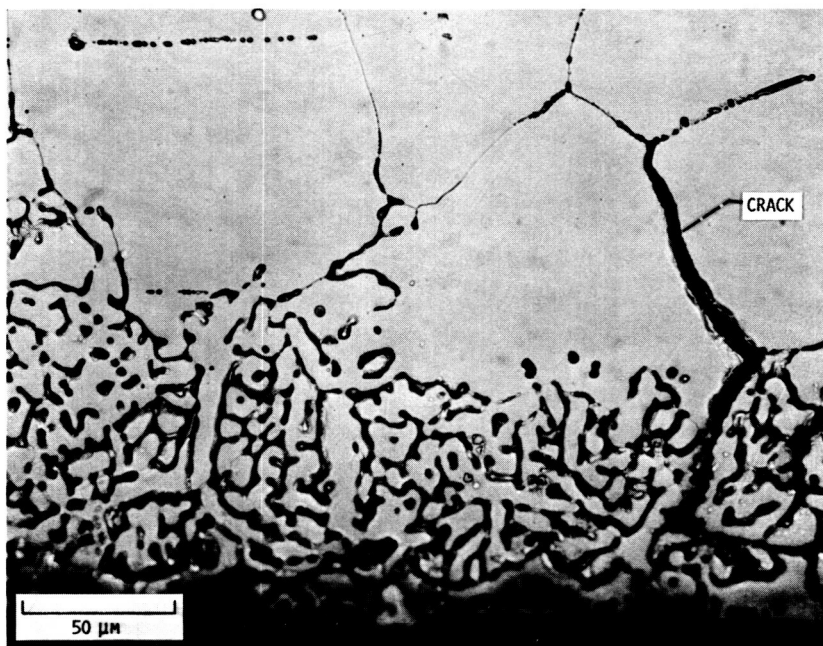
(b) CORRODED AREA AND INTERGRANULAR CRACKING AT INNER SURFACE OF THE FIN.

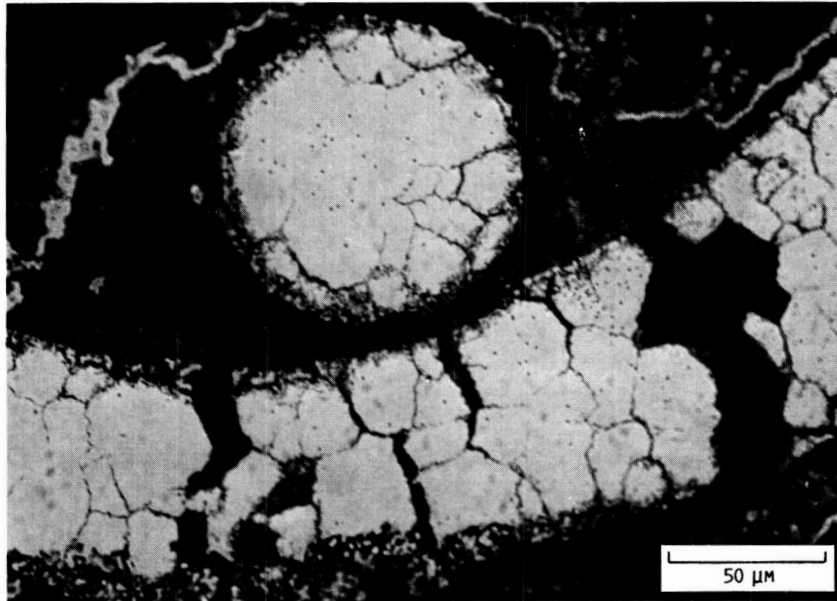
LOCATION A. SEVERE INTERGRANULAR CORROSION AND DISINTEGRATION OF THE TYPE 316 STAINLESS STEEL SCREEN NEAR THE LEADING EDGE OF THE FIN.

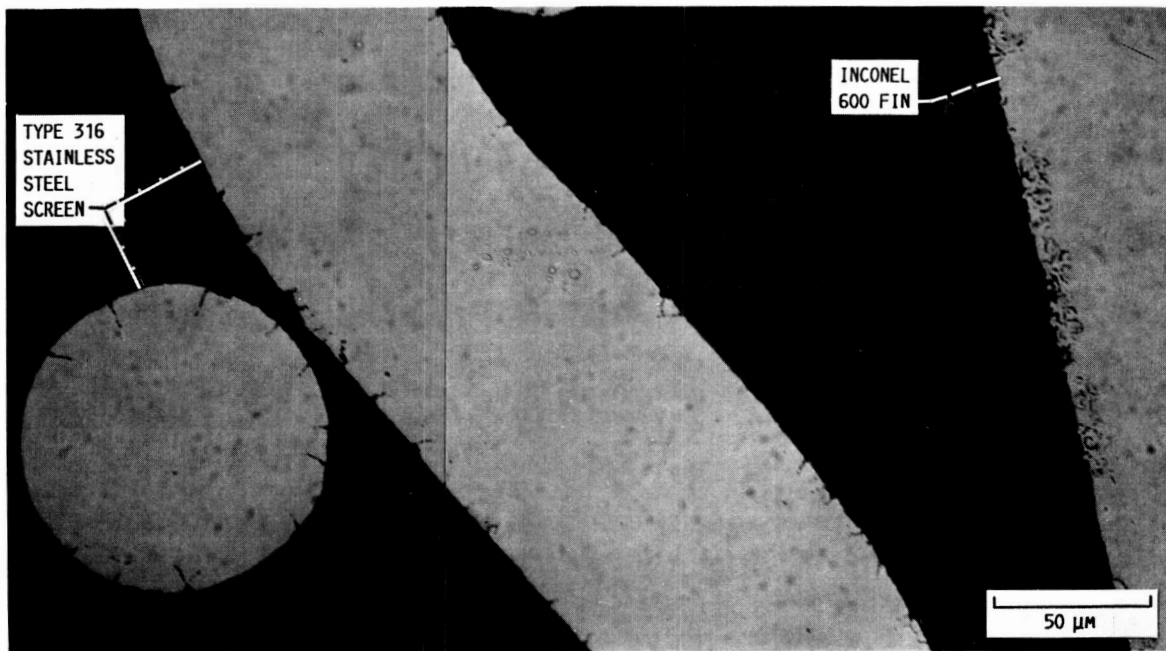
At location B (fig. 5) at the trailing edge, intergranular corrosion also occurred, but only to a depth of 10 μm in both the Type 316 wire screen and in the Inconel 600 fin. A lesser degree of attack (5 μm deep) took place at the folded side of the fin (see location C in fig. 5). Even though the extent of corrosion is very slight these results show that Inconel 600 and Type 316 stainless steel are susceptible to corrosive attack at the 1073 K design temperature.

LOCATION B. SLIGHT INTERGRANULAR CORROSION IN THE SCREEN AND FIN MATERIAL. THE DEPTH OF INTERGRANULAR ATTACK IS ABOUT 10 μm.

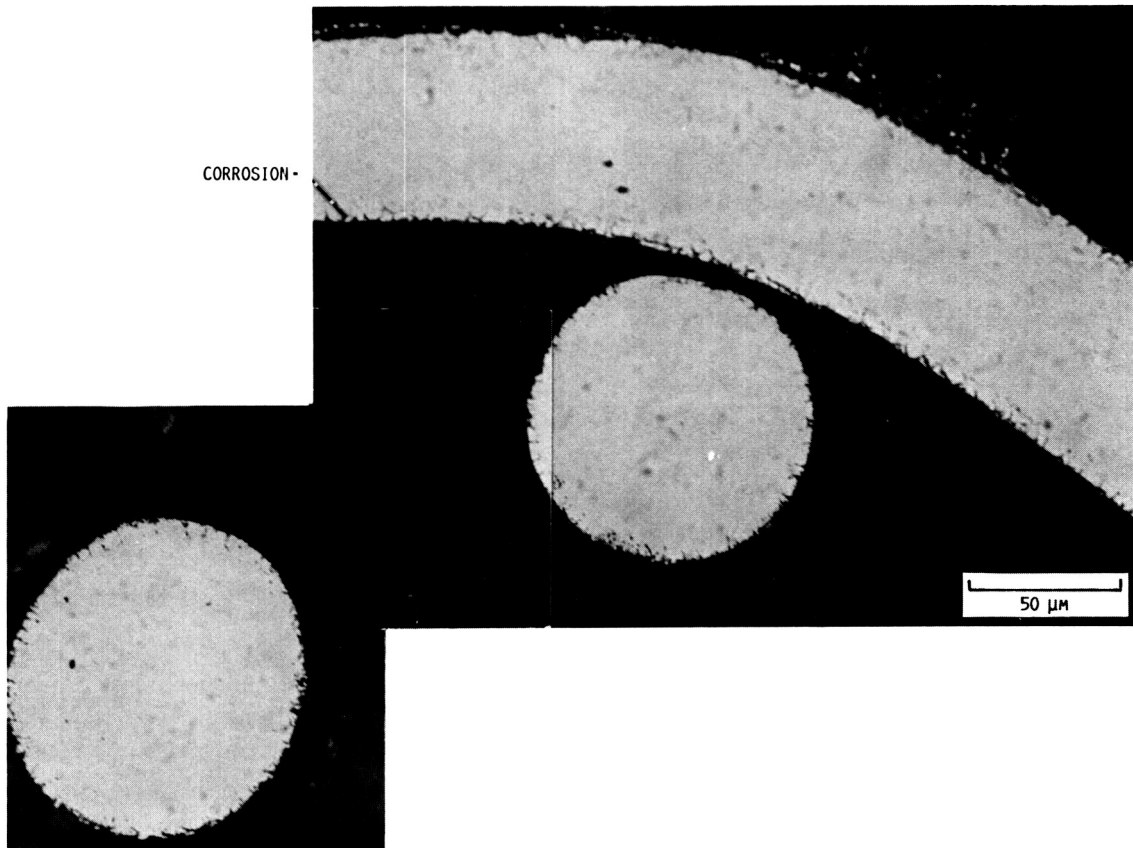
LOCATION C. INTERGRANULAR CORROSION TO A DEPTH OF ONLY 5 μm IN THE TYPE 316 STAINLESS STEEL SCREEN LOCATED AT THE FOLDED SIDE OF THE FIN.
