Structural Fatigue in the 34-Meter HA-Dec Antennas

R. A. Van Hek and B. P. Saldua
Ground Antenna and Facilities Engineering Section

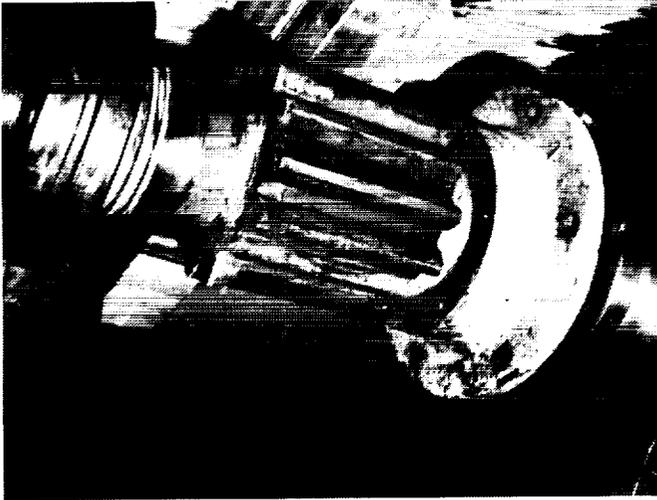
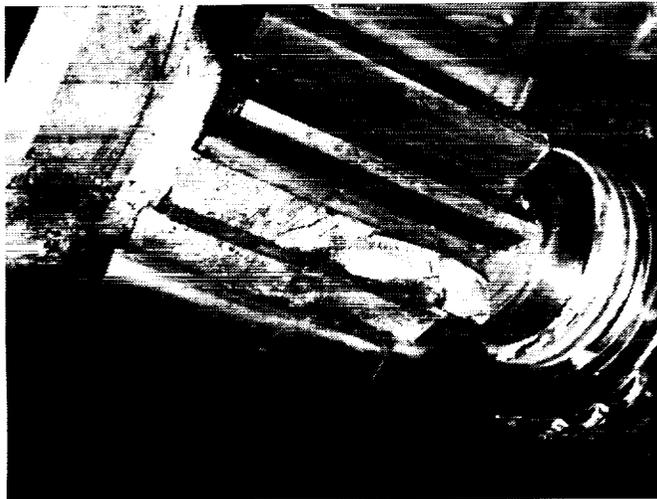
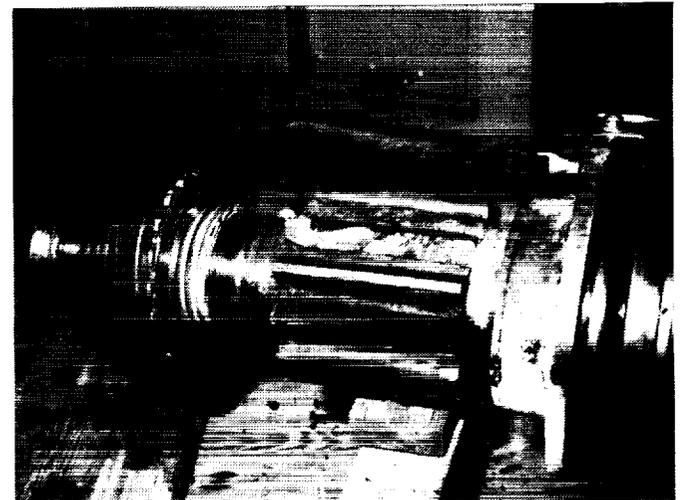
One of the most serious problems with the antenna is the excessive declination-axis bullgear-to-pinion separation that occurs as the antenna is moved from the east to the west horizon. The gear mesh separates when the reflector points to the horizon because the counterweight bends the rim and gear downward, causing a large deflection of the declination wheel. This reduced gear-mesh engagement has twice sheared off the pinion teeth at the DSS 12 antenna and three times at the DSS 42 and 61 antennas (Figs. 1 and 2). The gear-mesh separation increases during high winds, so the antennas are currently stowed before the wind reaches 45 mph.

Fig. 1. Broken pinion teeth of declination wheel drives, DSSs 42 and 61.

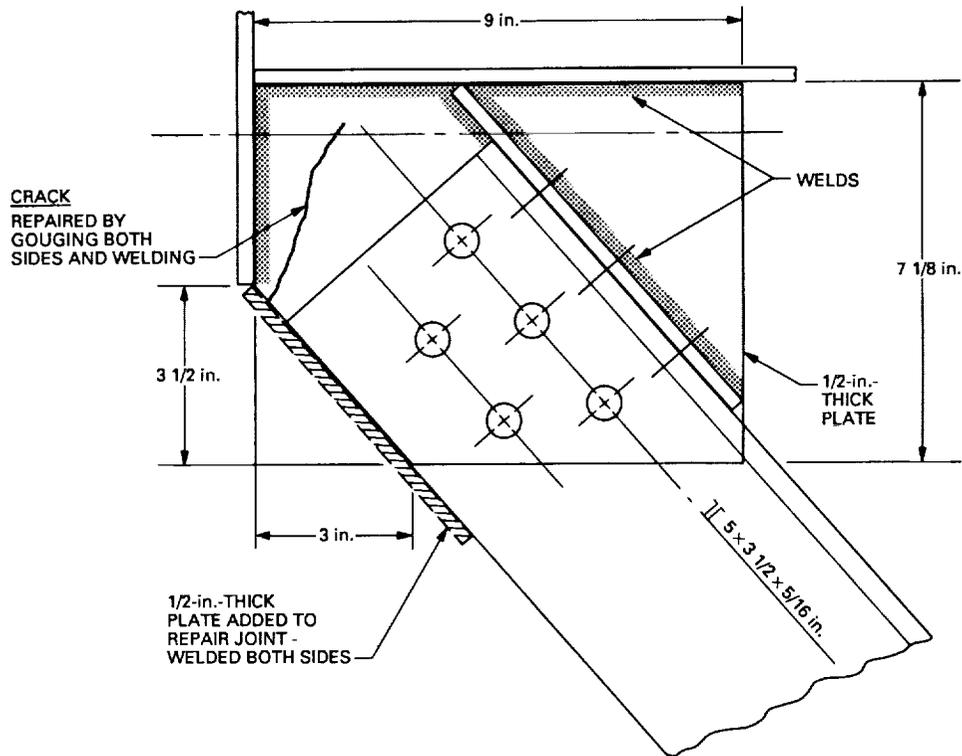
On the day of the annual inspection, May 25, 1989, a major failure was discovered at DSS 12; it must have occurred between April and May 25. The failure occurred in a gusset plate near the declination bearing. There are four such plates, and a crack developed in three of the four plates. The gusset plates connect primary members from the wheel rim to the bearings; these members support the weight of the counterweight and the dec house when the antenna is looking east or west (Figs. 4 and 5). The longest crack was 4 in. long (Figs. 6 and 7), while the two other cracks were only 0.5 in. long. All the cracks looked recent. (Note that the cracks were very similar to the gusset plate crack that caused the NRAO 300-ft antenna to collapse.)

Fig. 6. Failed joint detail drawing, DSS 12.

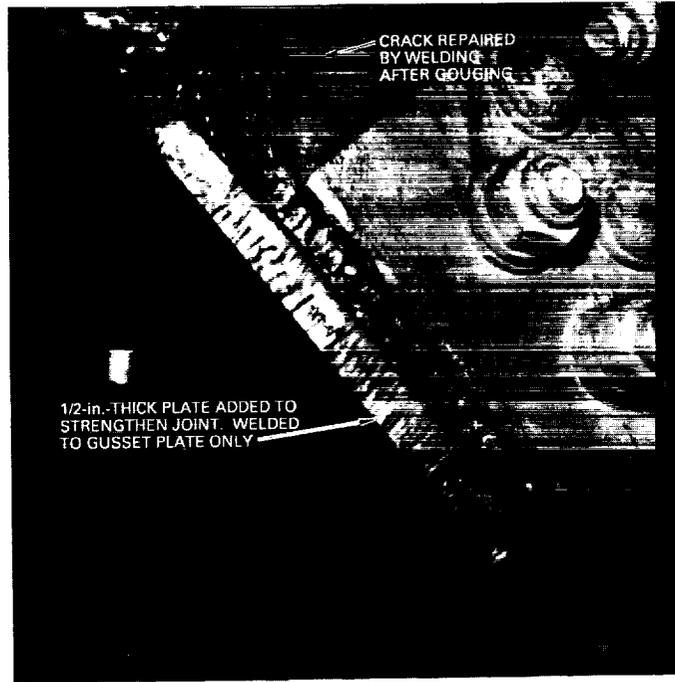
Fig. 8. Repair of failed joint, DSS 12.

Immediate action was taken to repair the gussets and reinforce the structural connections (Fig. 8). All minor repairs were also made at this time.

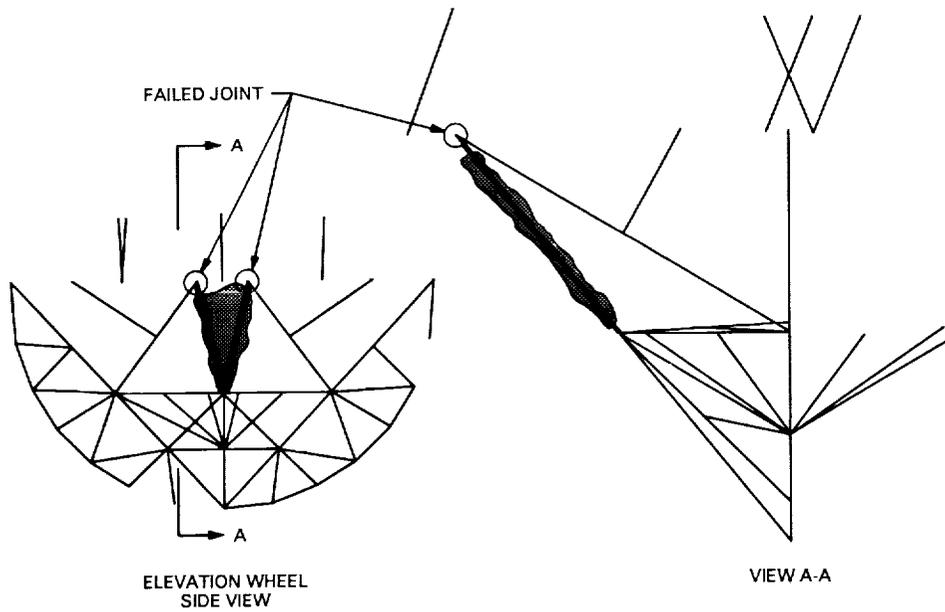
Fig. 9. Computer model of declination wheel.

The worst stresses occurred in loading condition (2) because a reversal of loads at the east or west position caused a reversal of stress in the members and their connections, which are the gusset plates. Thus the gusset plates are subject to stress reversals from (1) combined compressive stress plus bending stress due to eccentricity and (2) combined tensile stress plus bending due to eccentricity.
