TWR-17270 VOL. VI

QM-6 FINAL PERFORMANCE EVALUATION REPORT  
IGNITER

JULY 1990

TWR-17270  
QM-6 FINAL PERFORMANCE EVALUATION REPORT  
IGNITER

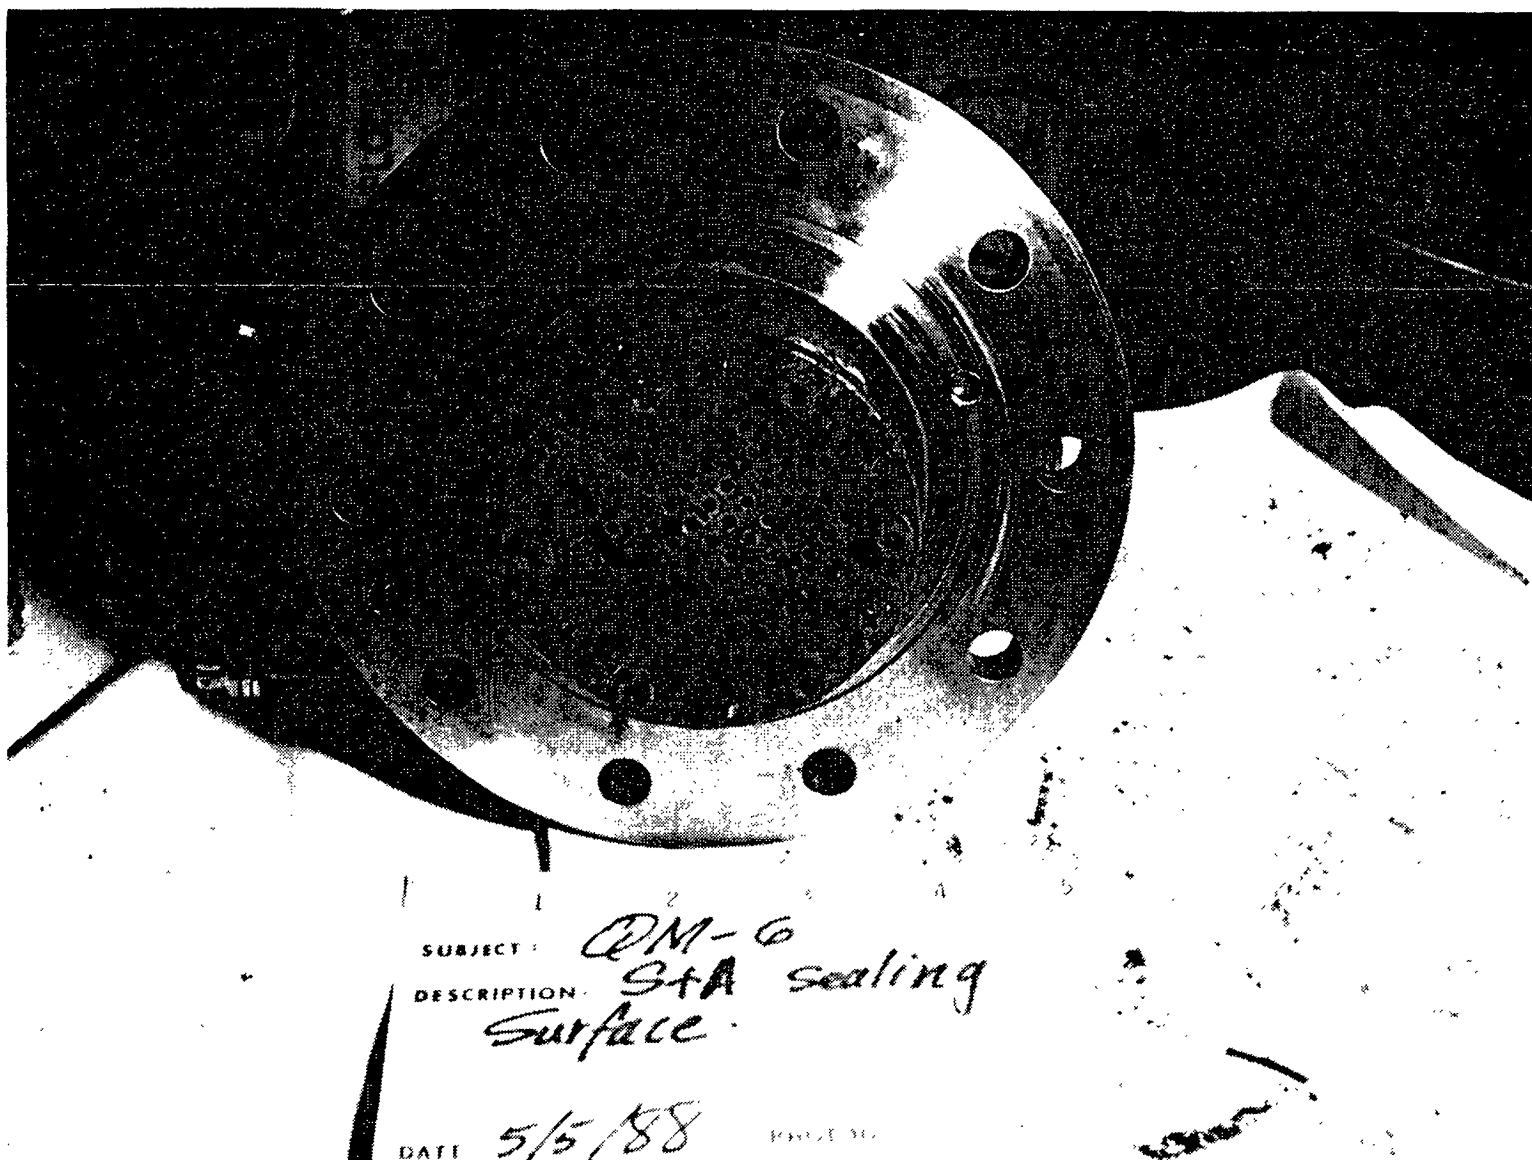
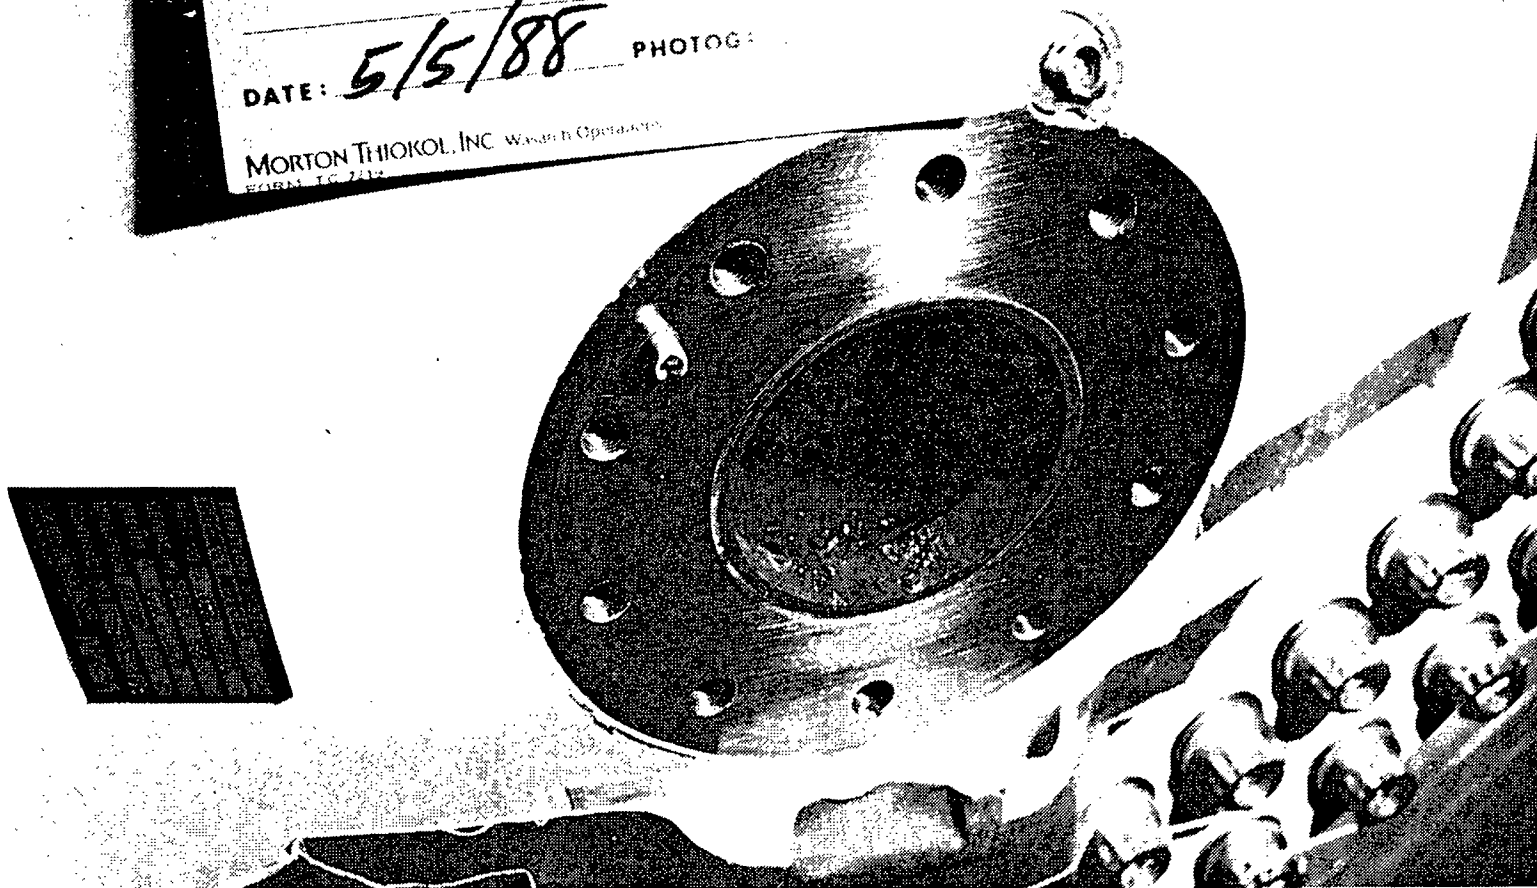
The Safe and Arm-to-igniter joint was disassembled on 5 May 1988. The S&A gasket and both S&A and igniter adapter sealing surfaces were thoroughly inspected, revealing no damage, erosion, or heat effect (see Figures 3 and 4). There was no soot to, or past the primary seal. The sealing surfaces of the joint were in excellent condition (see page A-1).

At 225 degrees, a depression of approximately 0.25 in. long, and 0.015 in. deep was found in the crown of the primary seal of the S&A gasket (see pages A-3 through A-5). Thiokol laboratory analysis showed that a combination of mold defect and gas entrapment were the cause of the depression.

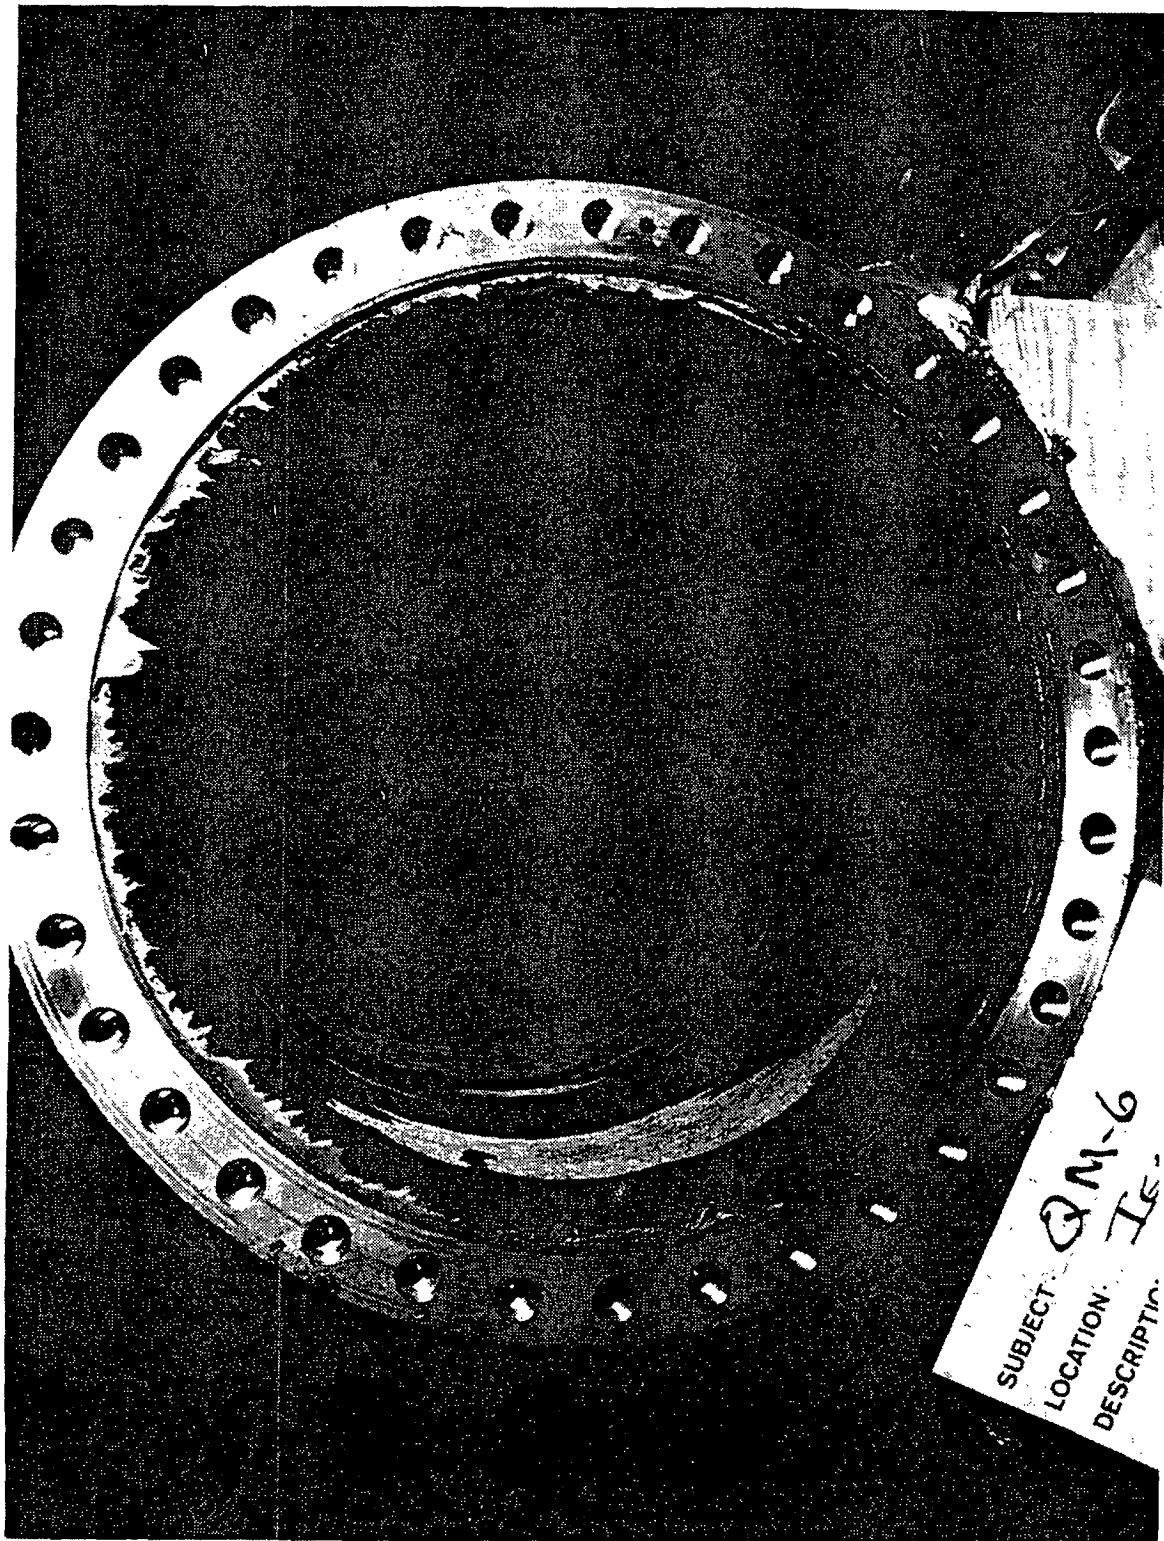
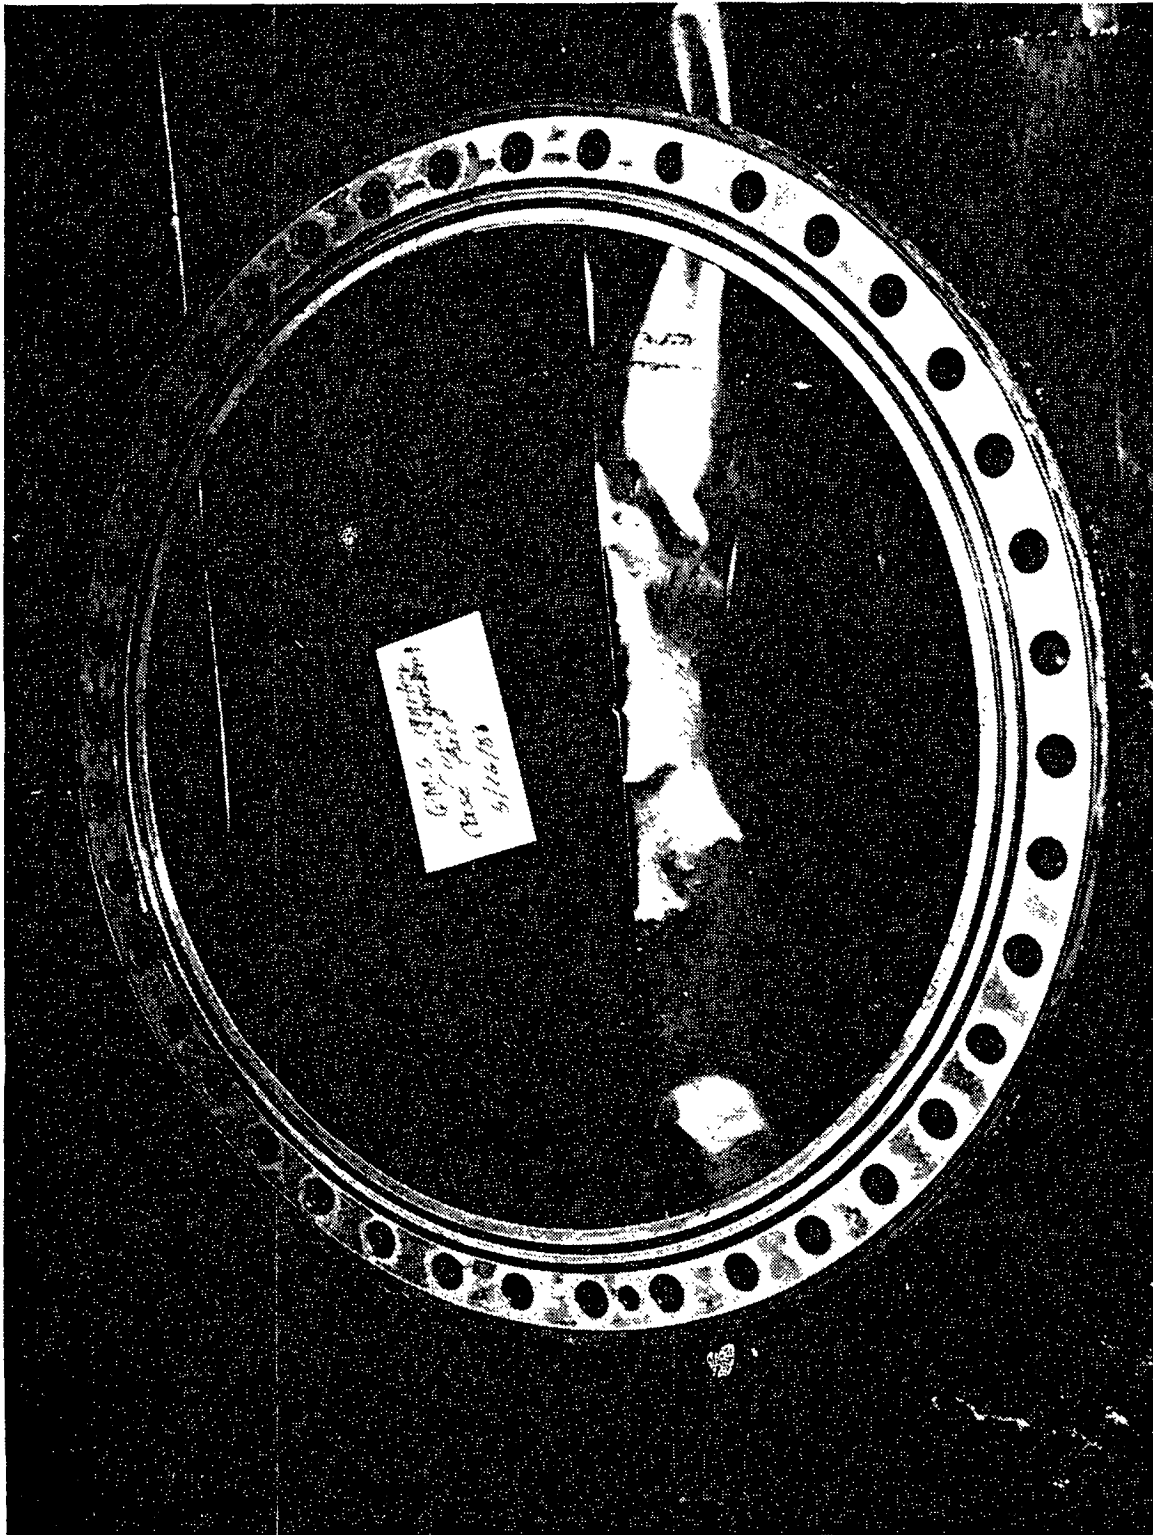
The igniter adapter-to-chamber joint was disassembled on 3 June 1988. Inspection of the inner gasket revealed no damage, heat effect, or soot to or past the primary seal (see Figures 5 and 6). Light soot was found on the outside edge of the gasket, covering the entire circumference. The sealing surfaces were free of soot and in excellent condition (see pages A-6 through A-11).

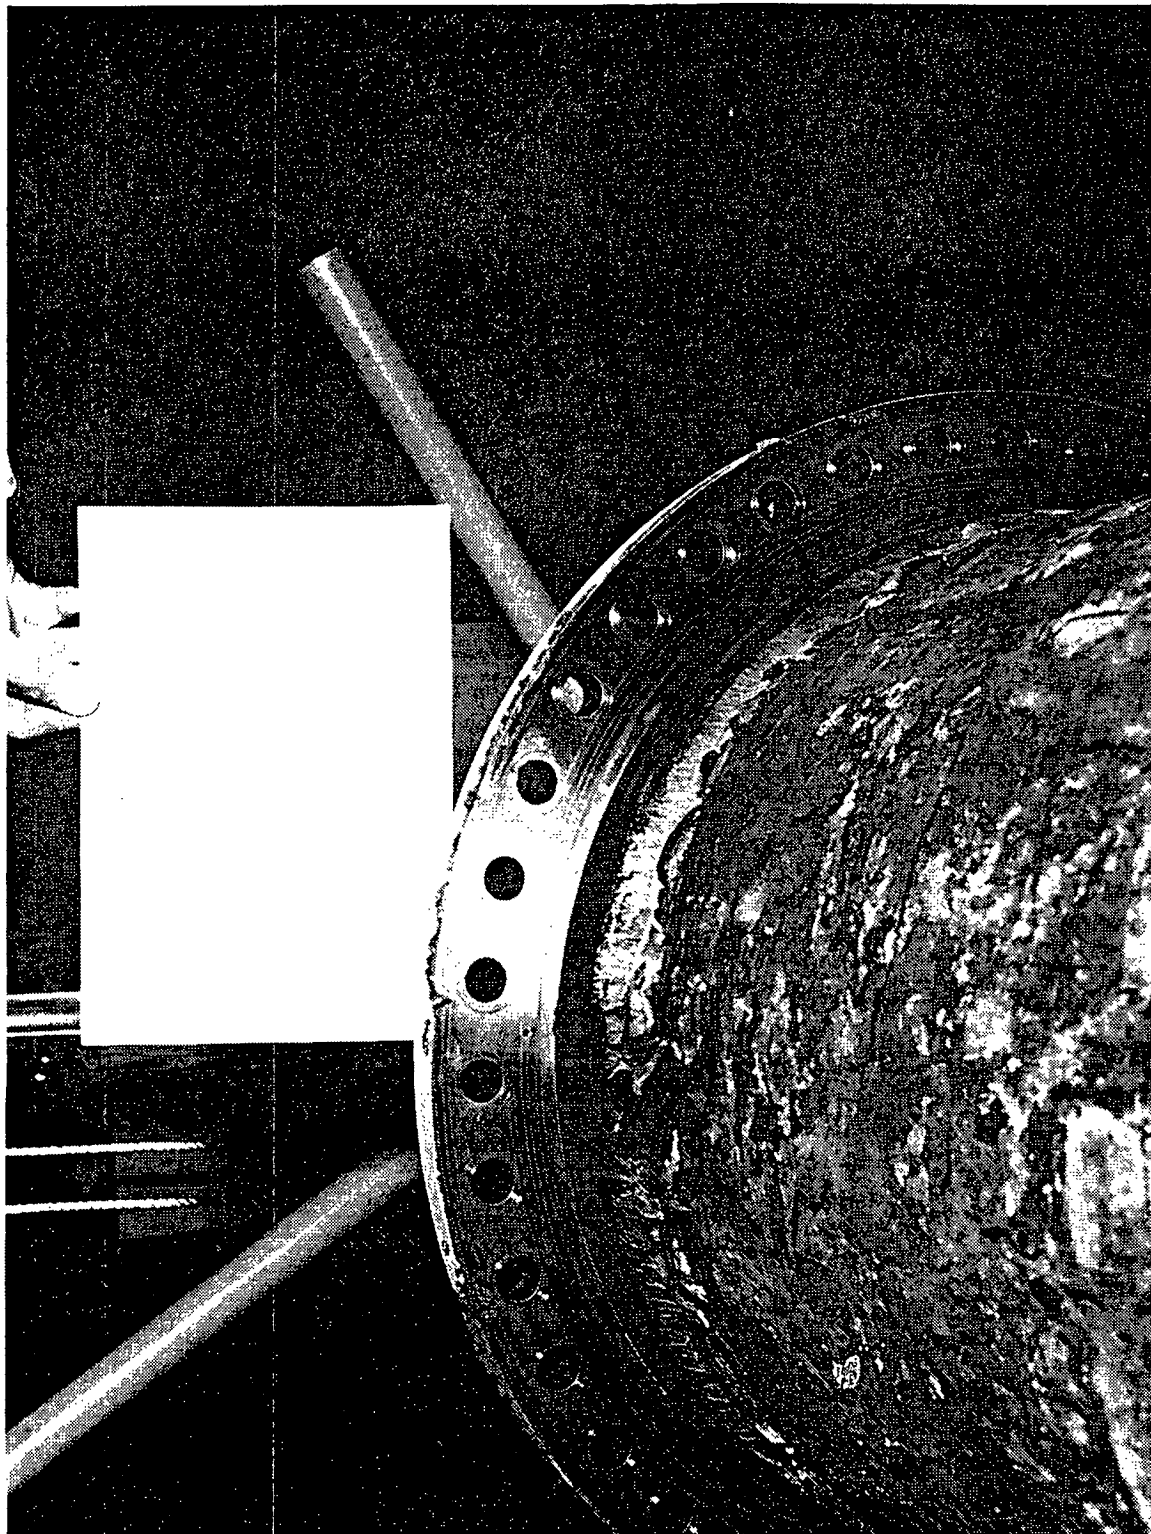
FIGURE 10. IGNITER ADAPTER SEALING SURFACE

No structural damage or heat affect was noted on any metal components. Light corrosion was found on the adapter sealing surface. No bolts showed signs of yielding or damage. Figures 5 and 10 are pictures of the igniter case after disassembly (see page A-21).

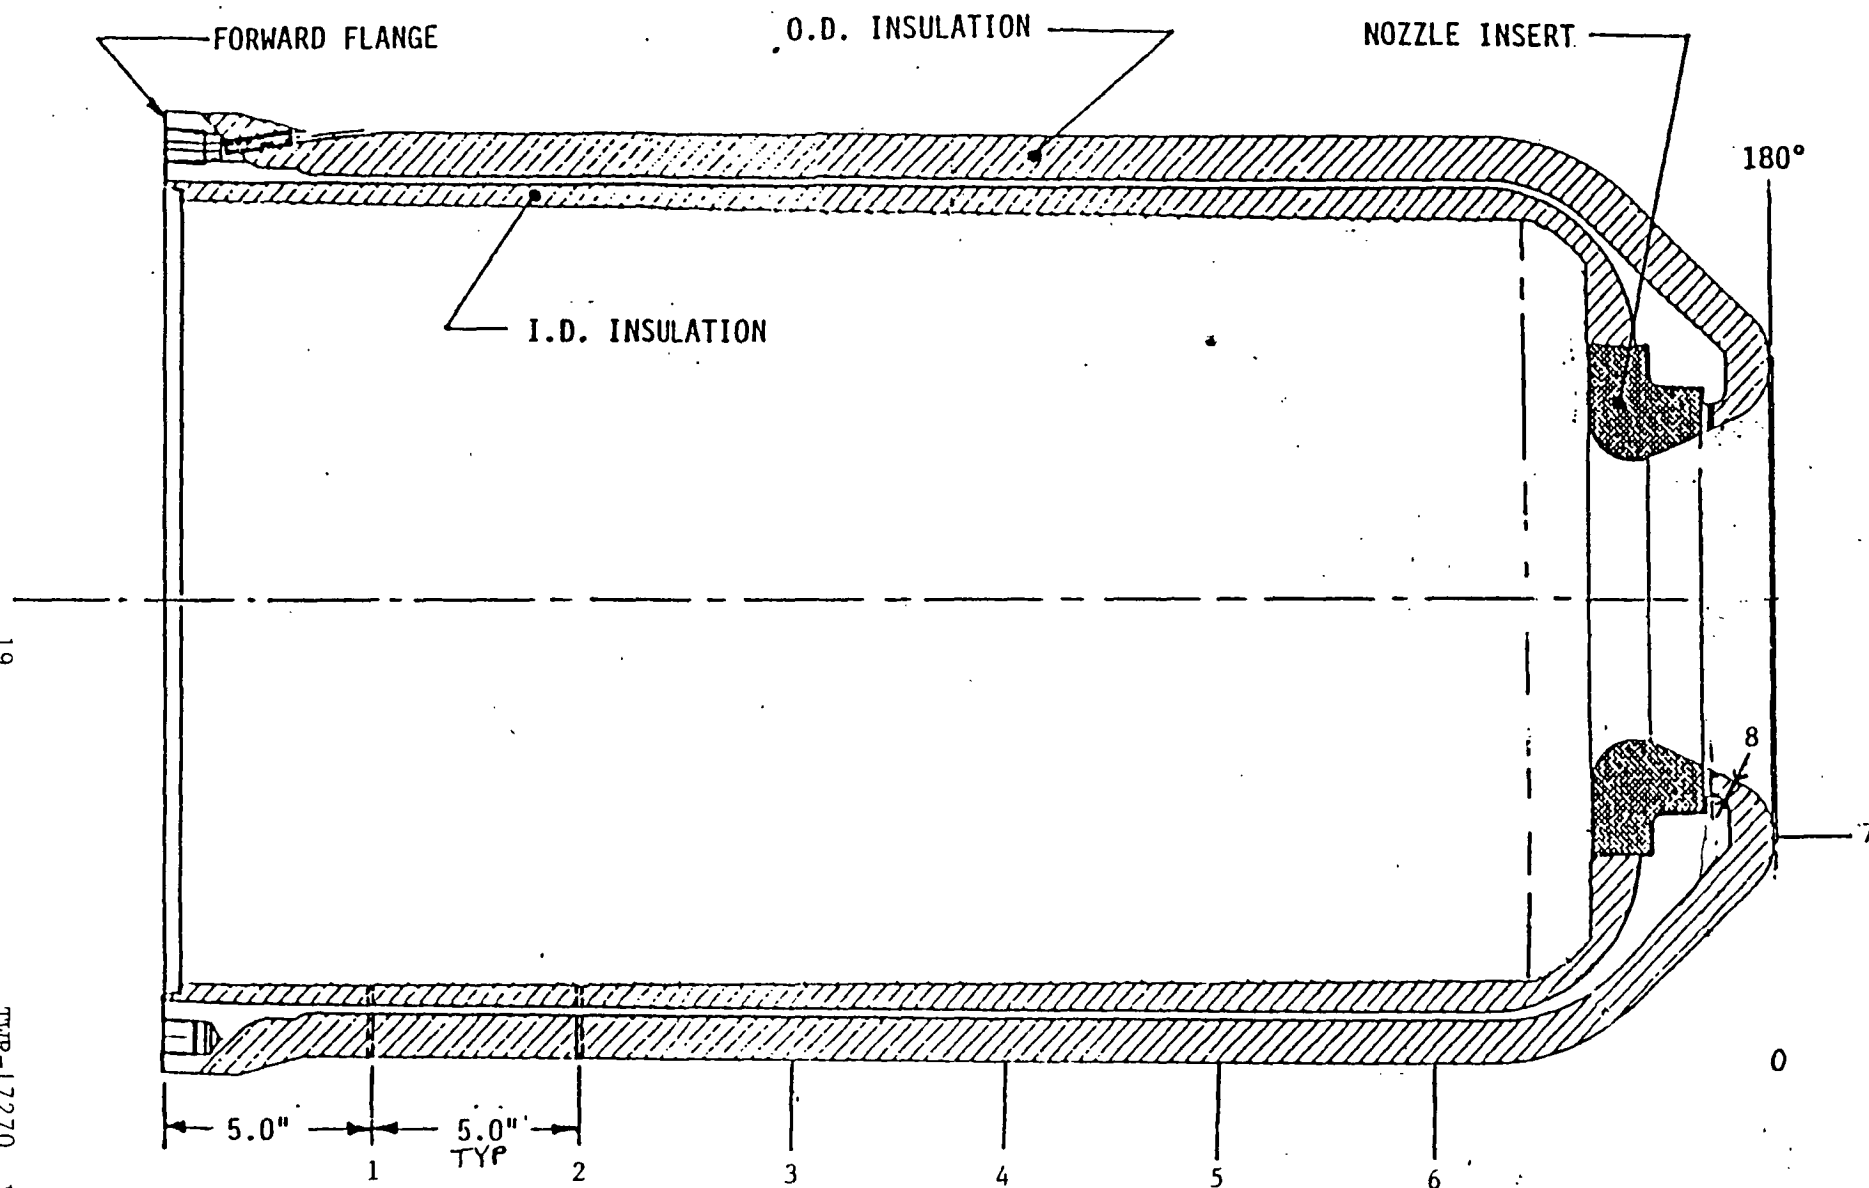
FIGURE 12

Post Test Plug Positioning For Insulation Measurements

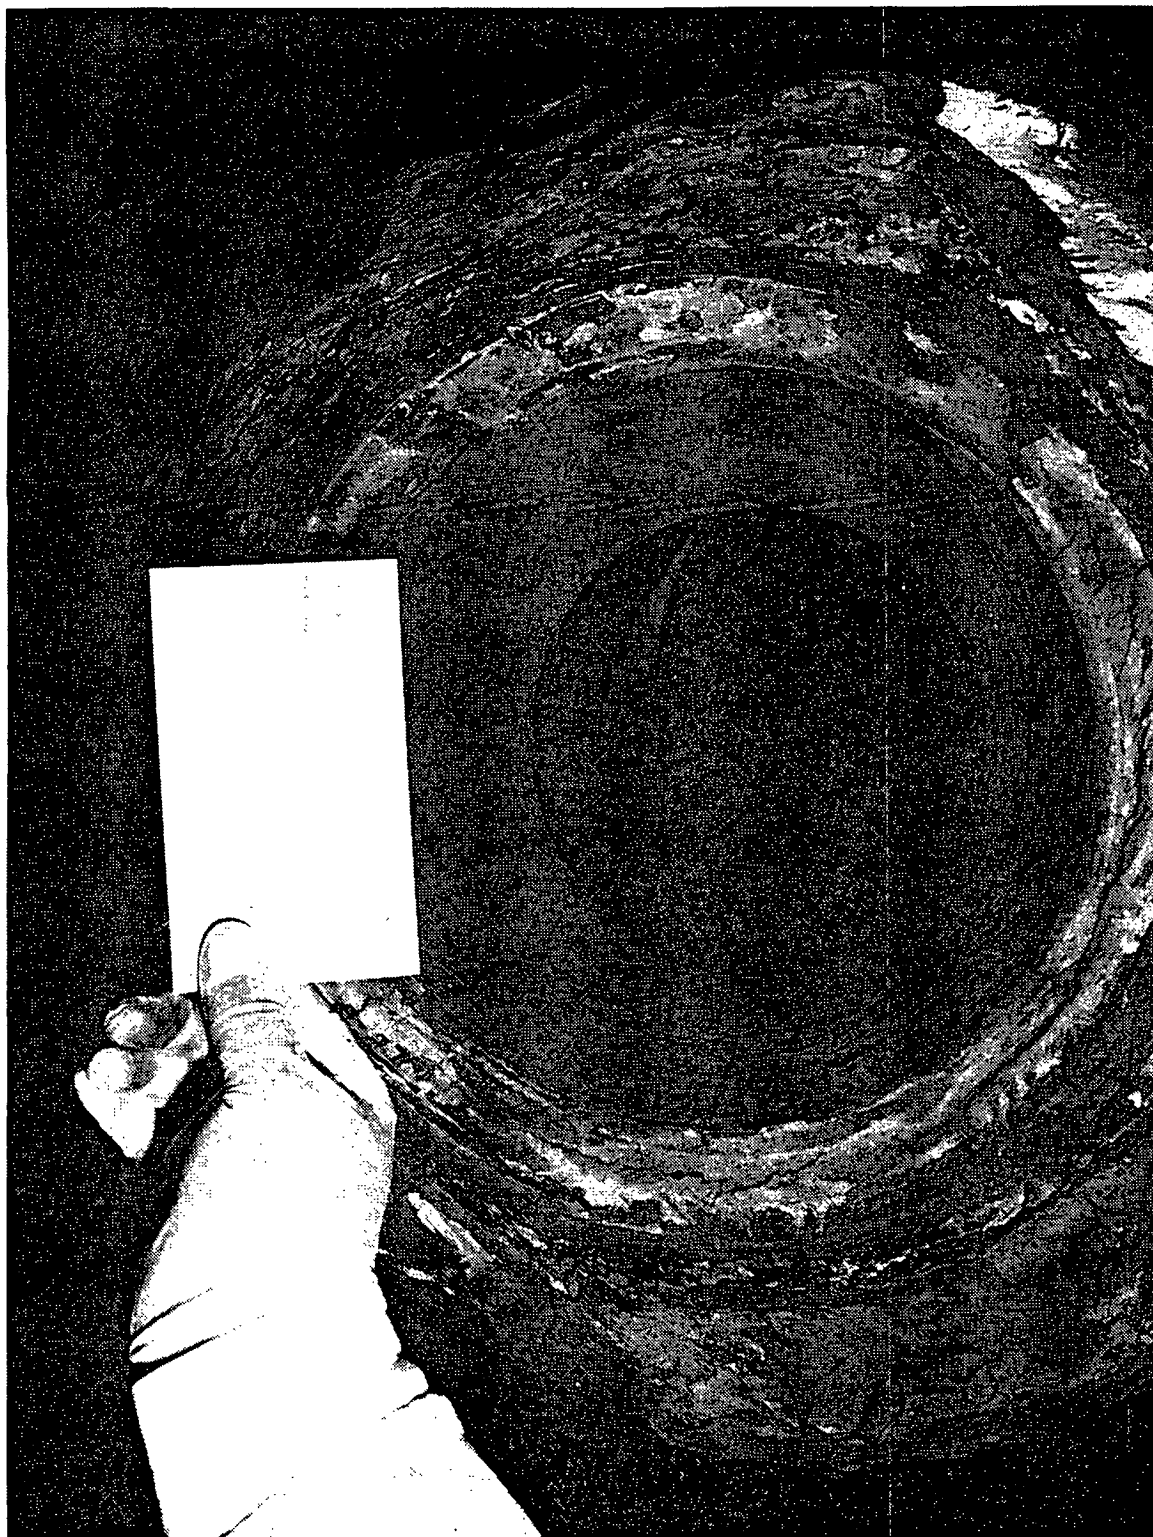
FIGURE 13. NOZZLE INSERT

| Notes / Comments<br><u>cracks in the char layer. NO</u><br><u>apparent damage to the insert.</u> | | | | |
