NASA
Technical Memorandum 4195

Evaluation of Composite Components on the Bell 206L and Sikorsky S-76 Helicopters

Donald J. Baker

AUGUST 1990

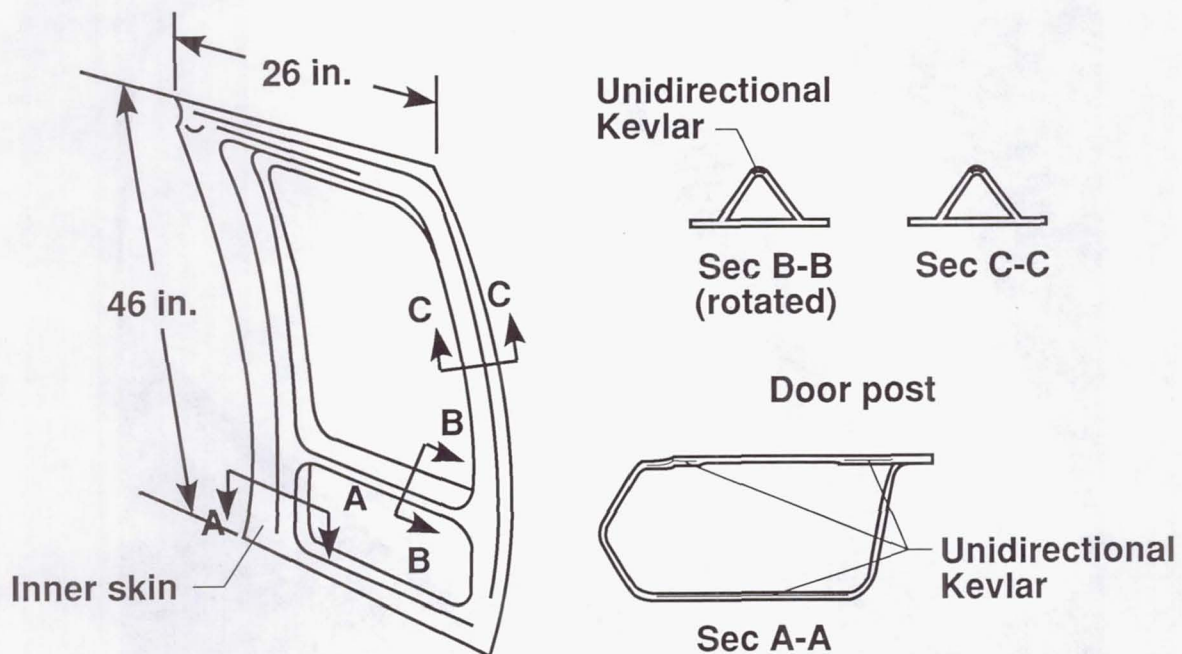
The litter door has had very few problems with the composite material skins. However, a major problem occurred with the metal hinges that are used to hold the cabin door. The hinges were under-designed and failed in service when someone pushed the cabin door open too far. New high-strength hinges have been installed and the litter doors are back in service.

Buckling occurred in the outer skin of the litter door on four helicopters parked in the Southwest United States desert during the summer. The probable cause of buckling is the thermal mismatch between the Kevlar-49/epoxy skins and the plexiglass window. This window was bonded to the exterior skin. The coefficient of thermal expansion of the plexiglass window is 4.5×10^{-6} in/in/°F, and the coefficient of thermal expansion for the Kevlar/epoxy

skin is near zero. Personnel at this desert facility have taken surface-temperature measurements on aluminum helicopter structures with the same external paint scheme as the composite skins, and their results show that the temperatures typically reach 200°F to 225°F during the summer. The bond between the door structure and window was broken near the buckle on the four doors. The doors were modified and a rubber seal was bonded between the door structure and window to permit relative thermal expansion. Other normal service problems have occurred such as broken windows, bumps, and scratches, all of which were repaired at the operator's repair facilities according to repair instructions received with the kits.

Figure 2. Bell 206L Kevlar/epoxy litter door.

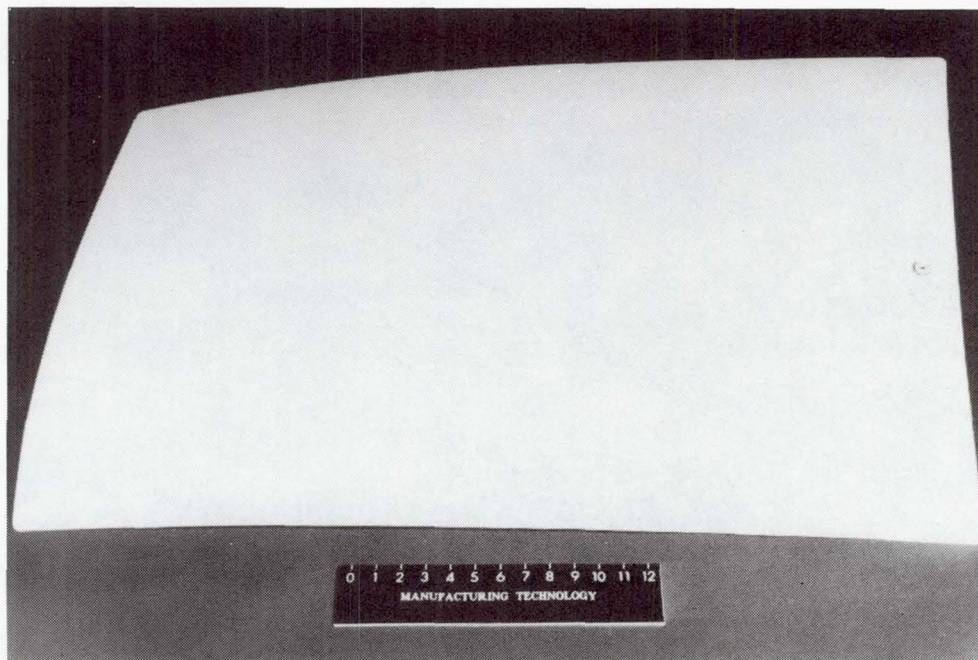
L-90-32

Another service problem with the baggage door is cracking of the unsupported corners. This corner cracking of the baggage doors is caused by people accidentally hitting the corners of the door with baggage and other gear to be stowed in the baggage compartment. This is an aesthetic problem rather than a functional problem but it does distract from the appearance of a commercial vehicle. The door and some of the adjacent structure would have to be redesigned to eliminate this corner cracking.

Figure 3. Bell 206L Kevlar/epoxy baggage door.

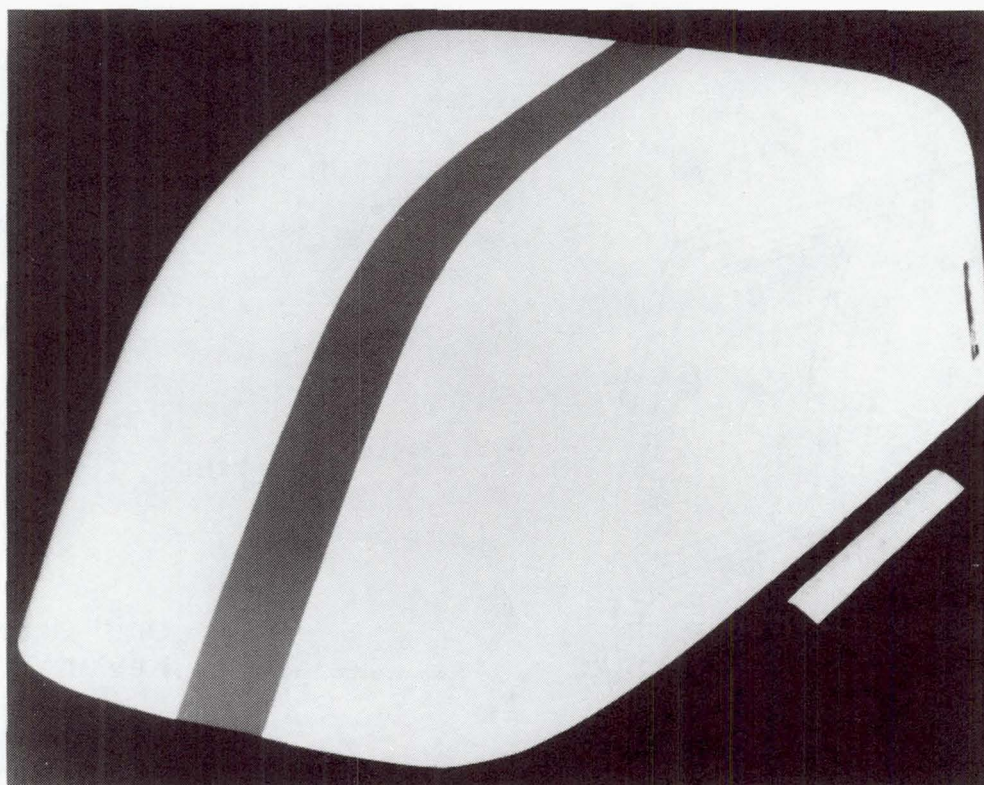
L-90-33

The forward fairing has had the fewest service problems. Until the 1985 inspection, the only service-related problem was associated with the use of the fairing as an antenna base. Field operators use the flat upper surface of the fairing to mount their communications antennas and they had to bond a metal plate to the underside of the fairing for grounding. The 1985 field inspection revealed that two helicopters operating in the Gulf Coast area had developed cracks on the inside surface near each latch. Both aircraft have been in service since 1981 and have flown 4193 hr and 5409 hr, respectively. The fairings were repaired with fiberglass, according to maintenance instructions, at the operator's repair facility.

Figure 4. Bell 206L Kevlar/epoxy forward fairing.

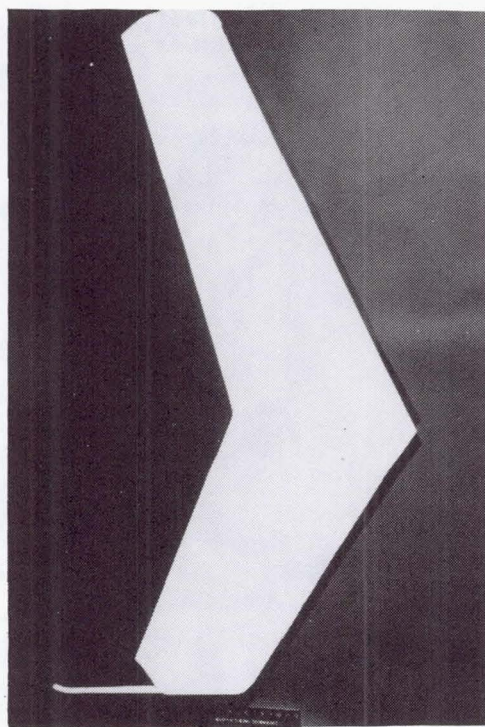
L-90-34

The graphite/epoxy vertical fin has an excellent service record. Its only problem has been the cracking of paint on the 2-ply Kevlar unsupported leading edge. This cracked paint was caused by field personnel using the fin as a handhold in ground han-

dling. Two fins have been struck by lightning and one fin was repaired and returned to service. The other fin was returned to Bell for analysis and residual strength testing.

Figure 5. Bell 206L graphite/epoxy vertical fin.

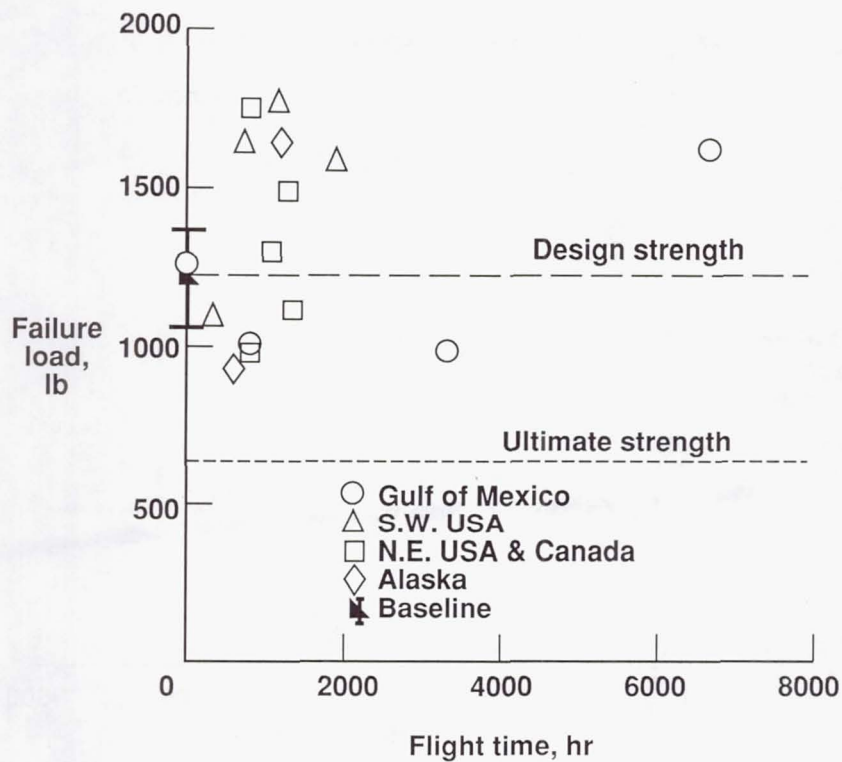
Failure loads (table 1) for 15 litter doors vary from 901 to 1768 lb. These failure loads are the total loads on the door including the hinge reaction from the cabin door. Failure loads as a function of flight hours are shown in figure 9. Each open symbol represents the failure load for a different exposure area. Also shown in figure 9 are two strength requirements, ultimate strength and design strength. The ultimate strength is the usual strength that an aircraft component must meet or exceed at all times. The design strength shown is the strength that an unconditioned component (as-fabricated) must meet or exceed. The design strength is intentionally greater than the ultimate strength and is the product of the ultimate strength and the environmental factor determined from the environmentally conditioned material coupon specimens (ref. 2). This strength is shown for reference only since the components tested are between as-fabricated and fully conditioned. The solid symbol represents the average baseline failure load (reported in ref. 2), which is the average of five components selected at random from the production lot of 45 components. The range of failure loads for the baseline tests is also shown in the figure. All litter doors had failure loads that exceeded the ultimate strength requirement of 635 lb (ref. 2), and nine of the doors had failure loads that exceeded the design strength of 1229 lb. It is acceptable for the failure load of doors that have been environmentally exposed to be below the design strength as long as the load is higher than the ultimate strength. Failure loads do not appear to be a function of exposure time. Initially in the postservice testing (ref. 3),

Figure 9. Failure load of litter doors after exposure.

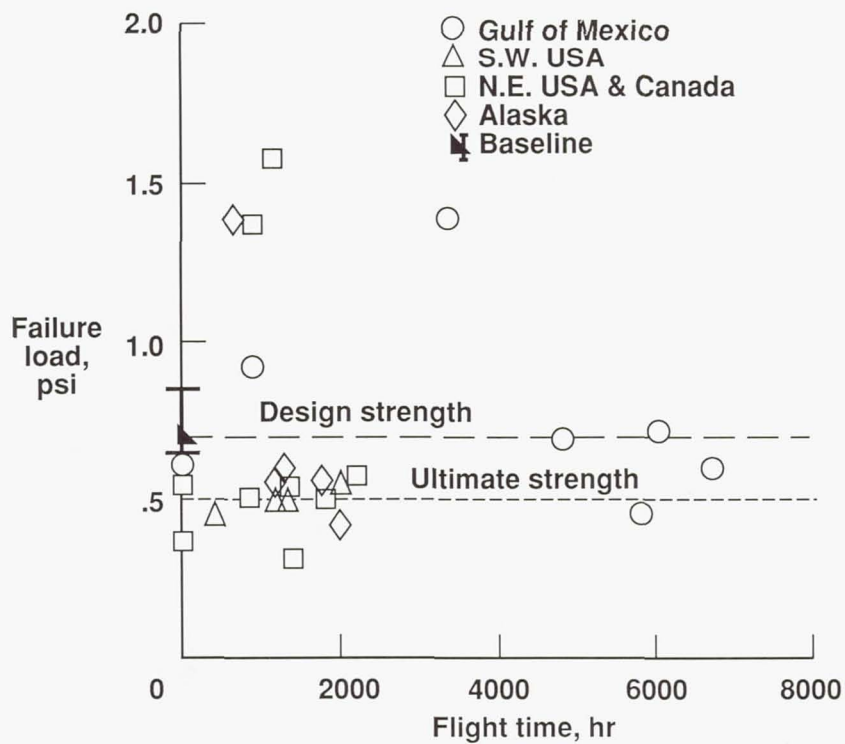
Failure loads (table 2) for 26 baggage doors vary from 0.32 to 1.57 psi, and service times for the doors vary from 386 to 6750 hours. Failure loads as a function of flight hours are shown in figure 11. Each open symbol represents the failure load for a different exposure area. The solid symbol represents the average baseline strength. These baggage doors are the components that developed large disbonds and have been removed from service. Most of the test points represent baggage doors that have some disbond between the core and the outer skin. Twenty-one of the doors had failure loads that were below the design strength of 0.70 psi, and nine doors had failure loads that were below the ultimate strength requirement of 0.50 psi (ref. 2). The stiffness of the baggage door as a function of the flight hours is shown in figure 12. The stiffness was determined by measuring the deflection at the center of the door as the loads were applied. The disbonds do not appear to affect the stiffness as much as the strength. The baggage doors that have been tested have accumulated a total of 51 798 hr of flight service.

Figure 11. Failure load of baggage doors after exposure.

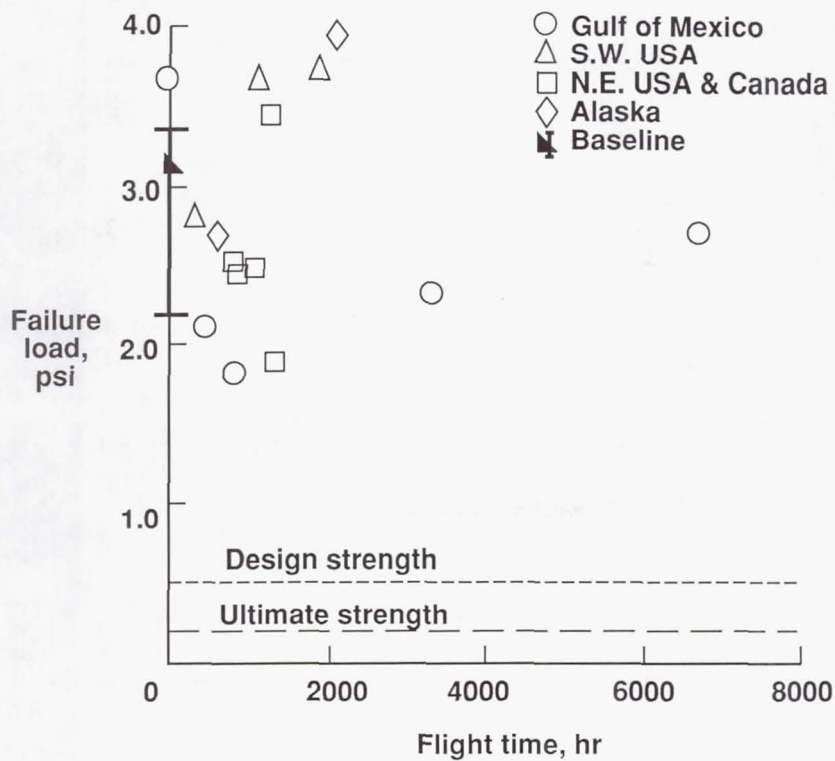
Failure loads (table 3) for 15 forward fairings vary from 1.80 to 3.93 psi, and service times for these components vary from 386 to 6750 hr. Failure loads as a function of flight hours are shown in figure 13. Each open symbol represents the failure load for

a different exposure area. Failure loads vary from 1.80 to 3.93 psi and exceed the design strength of 0.49 psi (ref. 2) by more than a factor of 3. Failure loads for forward fairings tested to determine the baseline strength (ref. 2) varied from 2.2 to 3.4 psi. Failure loads for 8 of the 15 forward fairings tested are between 2.2 and 3.4 psi. The large scatter in the failure load could be the result of variations in the fabrication process. Considerable variation could result from putting down the single ply of Kevlar fabric (style 281) on a compound contoured surface. The lay-up requires cutting and overlapping the fabric at many places to prevent wrinkling on the surface. The stiffness of the forward fairing as a function of the flight hours is shown in figure 14. The stiffness was calculated using measurements for the deflection of the upper surface at a point 14.5 in. from the aft end as the load was applied. The stiffness of all fairings, except one, exceeded the stiffness of the certification fairings. The fairings that have been tested accumulated a total of 23 730 hr of flight time.

Figure 13. Failure load of forward fairings after exposure.

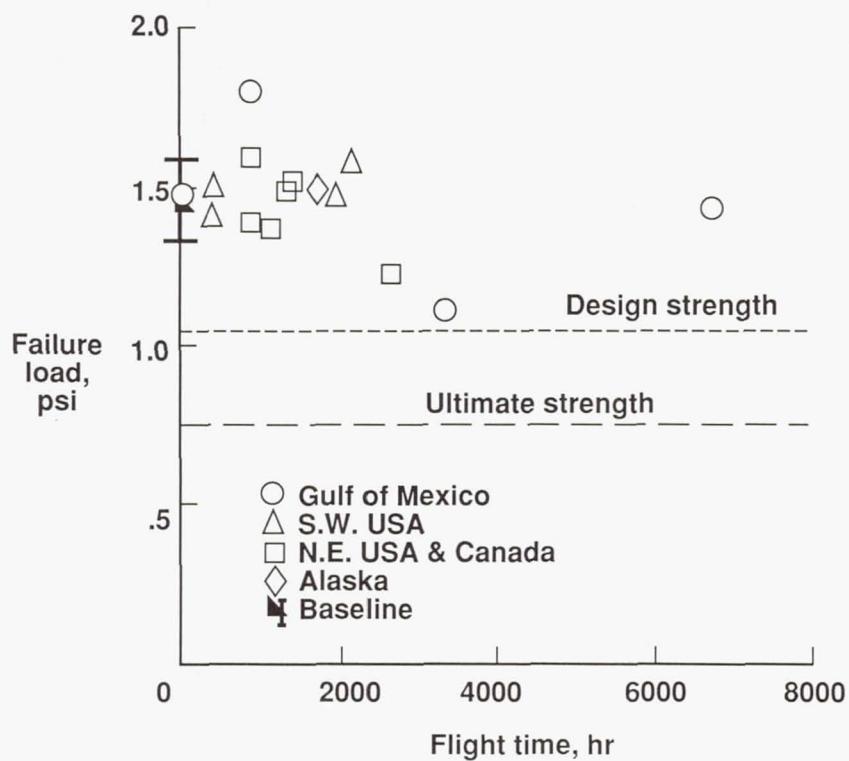
Failure loads (table 4) for 15 vertical fins vary from 1.12 to 1.80 psi, and service times for these fins vary from 385 to 6750 hr. Failure loads as a function of flight hours are shown in figure 15. All fins exceed the design strength of 1.05 psi. Failure loads for 12 of the 15 fins are between 1.35 and 1.57 psi, which is the range of failure loads for the baseline tests (ref. 2). One fin that was struck by lightning is identified in table 4. The fin was damaged at the top with no damage in the structural box. This fin failed at 1.23 psi with no apparent effect from the lightning strike. The environment does not appear to affect the failure load of the vertical fins. The stiffness of the vertical fin as a function of flight time is shown in figure 16. Stiffness was calculated using measurements for the tip deflection as the simulated aerodynamic load was applied. The certification deflection data for the fin are not available. The vertical fins that have been tested have accumulated 26 139 flight hours.

Figure 15. Failure load of vertical fins after exposure.

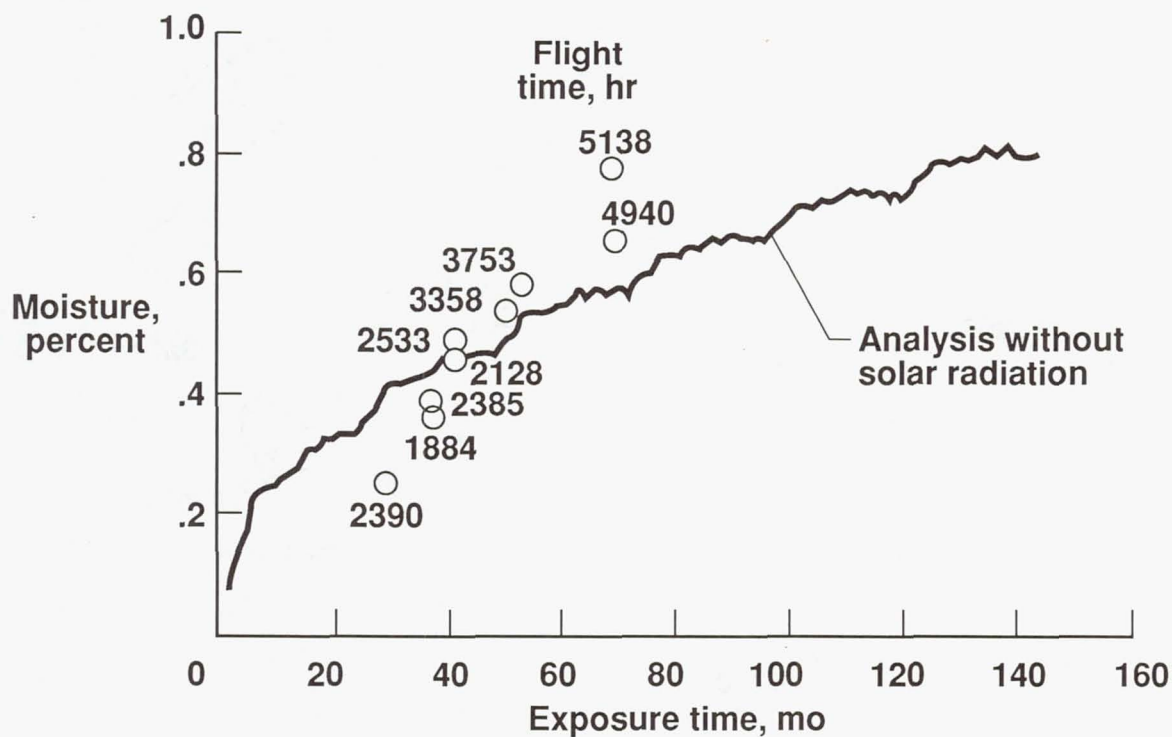
A predicted moisture-time profile (ref. 6) for the tail rotor spars (ref. 5) operating in the Louisiana Gulf Coast region is shown in figure 31. Weather data from Lake Charles, Louisiana, were used in predicting the absorbed moisture. Measured moisture values (table 7) are shown in figure 31 on a plot of percent moisture as a function of exposure time. As can be seen in figure 31, the measured moisture values are below the predicted moisture values for the low exposure time (30–40 months), whereas the measured moisture values are for an exposure time of 70 months higher than the predicted values.

Figure 31. Measured and predicted moisture content for S-76 tail rotor spars exposed at Lake Charles, Louisiana.
