The Hubble Space Telescope Optical Systems Failure Report

November 1990

NASA

EXECUTIVE SUMMARY

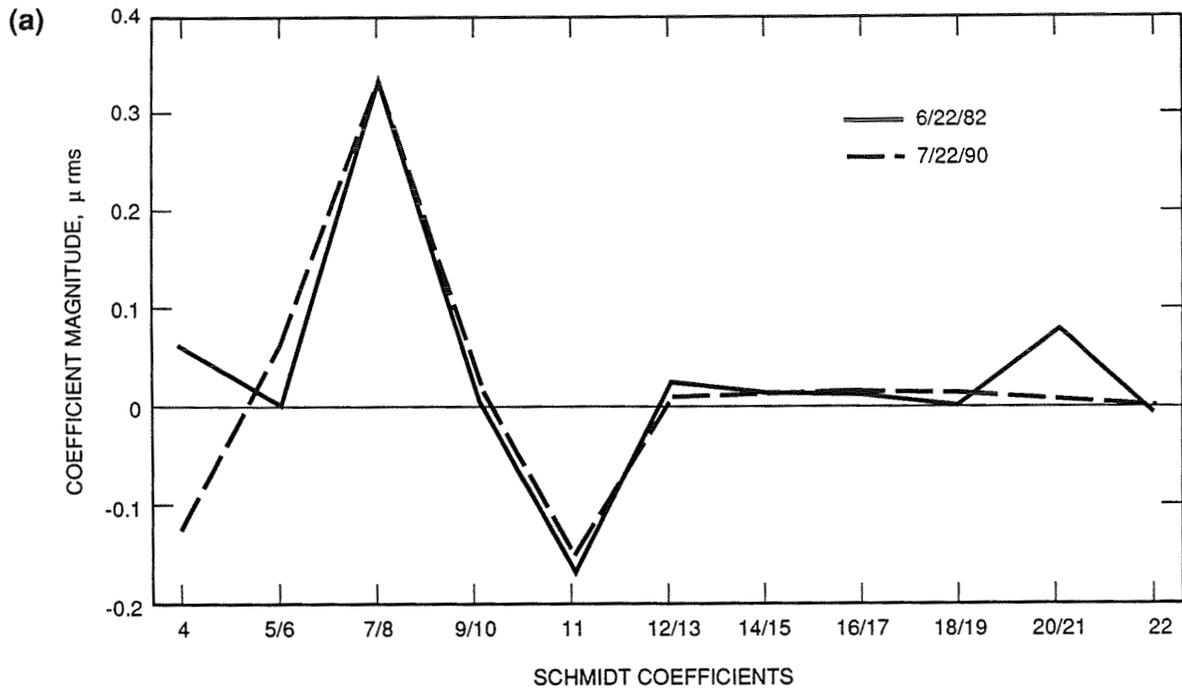
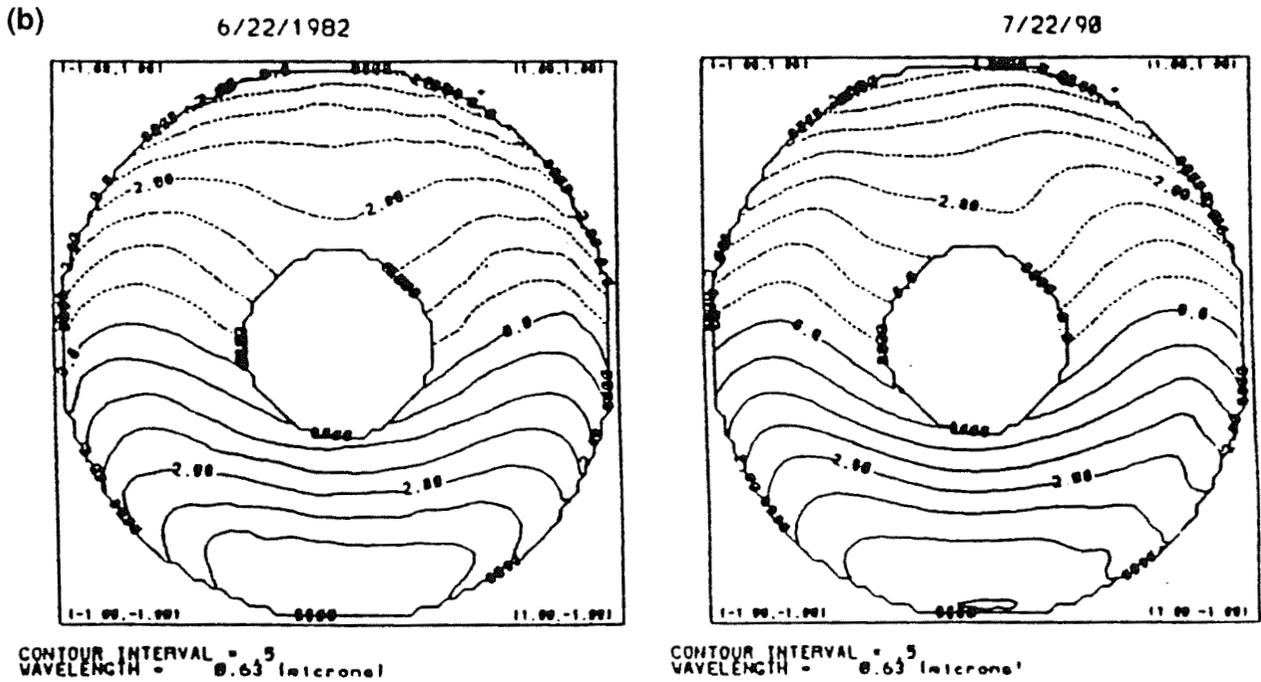
The first test performed on the RNC was to insert the INC and take an interferogram on July 22, 1990. This interferogram was analyzed and compared with a previous interferogram taken with the INC in place. (This latter interferogram was found in a notebook of a P-E employee and was dated June 22, 1982.) Comparison of these two interferograms (Figure 6-2) shows virtually identical results, clearly indicating the existence of spherical aberration. These INC interferograms are corroborated by the RvNC interferograms, which also show spherical aberration (as discussed in Appendix D, Figure D-2). The combination of these interferograms led the Board to conclude that the CORI/RNC assembly is now essentially in the same state of operation as it was at the time the final measurements were made on the primary mirror.

Unverifiable testimony raised the possibility of a waiver having been granted for an optical spacing error in the INC. During the current investigation, an error in the design calculations was discovered that produced a small amount of spherical aberration in the INC. An analysis of the "as-built" INC conducted for the investigation showed that the instrument had an accuracy to better than 0.14 wave.

Figure 6-2. Comparison of 1982 and 1990 inverse null corrector data. (a) The coefficients which define the magnitude of various distortions to the wavefront were measured by the INC when it was inserted in front of the RNC in 1982 and in 1990. (b) The coefficient data were extracted from these plots of the interferograms.

The amount of spherical aberration introduced by the INC error is only a small amount compared to the amount of spherical aberration actually measured.

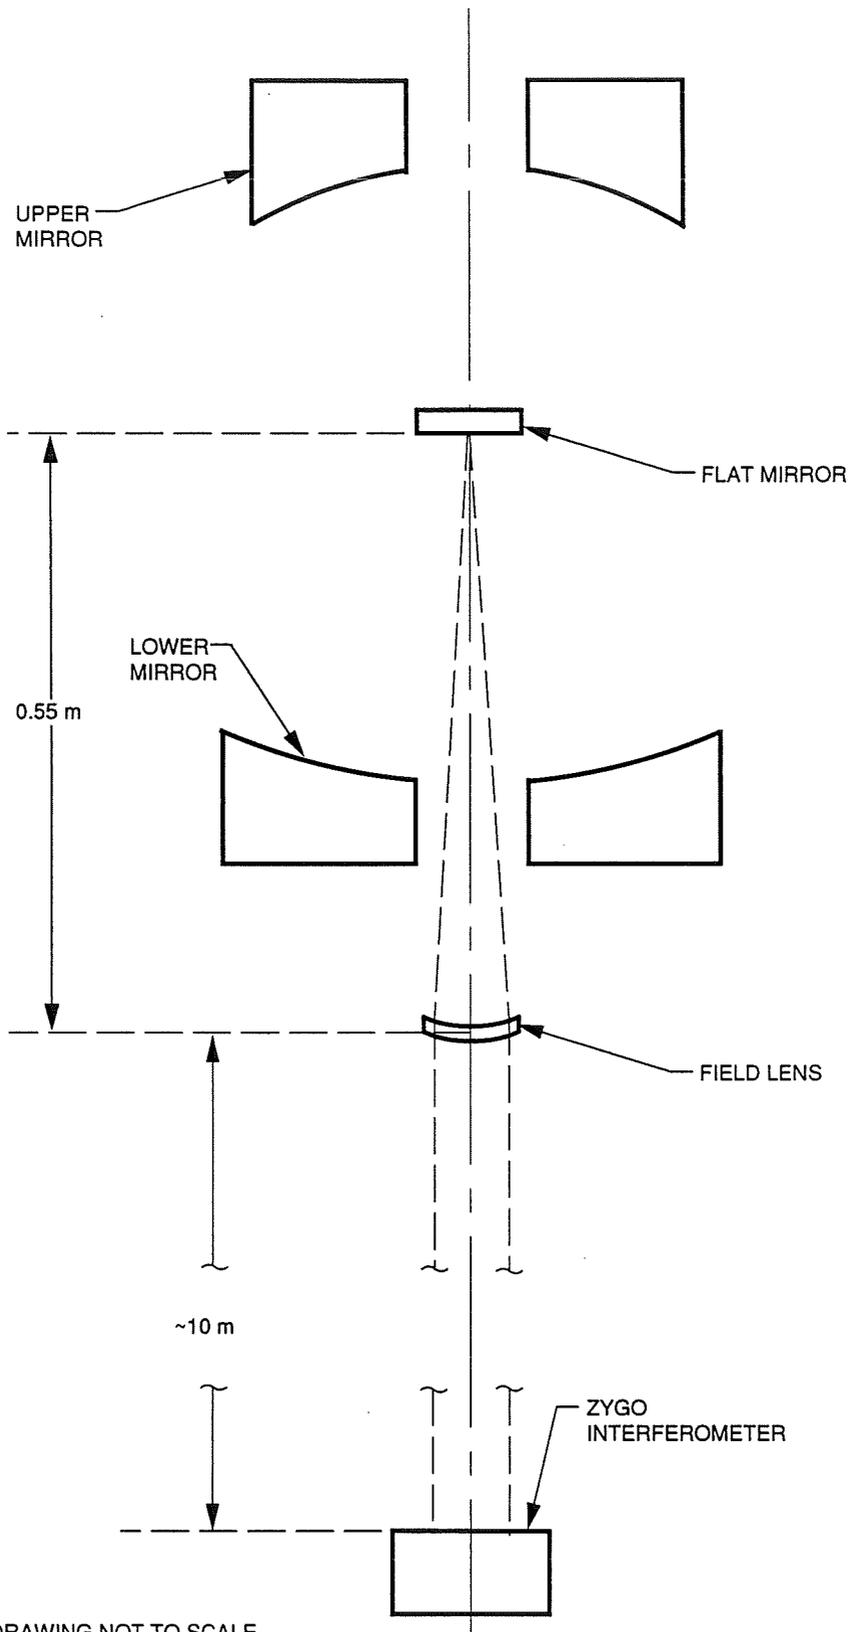
The optical element spacing was measured in 1990 by shining collimated light up through the field lens using a Zygo interferometer as the source, and by placing a flat mirror at the focus of the field lens (a distance of about 0.55 m above the lens). The correct position of the mirror was determined by using the interferometer to find the best focus (Figure 6-3). The distance from the flat mirror was then measured down to the vertex of the lower mirror using a fixture in the mirror hole for a reference. This measurement showed that the field lens was about 1.3 mm too far from the lower mirror. Both the direction and the magnitude of the spacing error correctly explained the spherical aberration observed in the HST image data. The spacings of the other optical elements in the RNC were measured and were found to be correct.

Figure 6-3. The 1990 spacing measurement between the field lens and the lower mirror of the reflective null corrector, using an optical test.

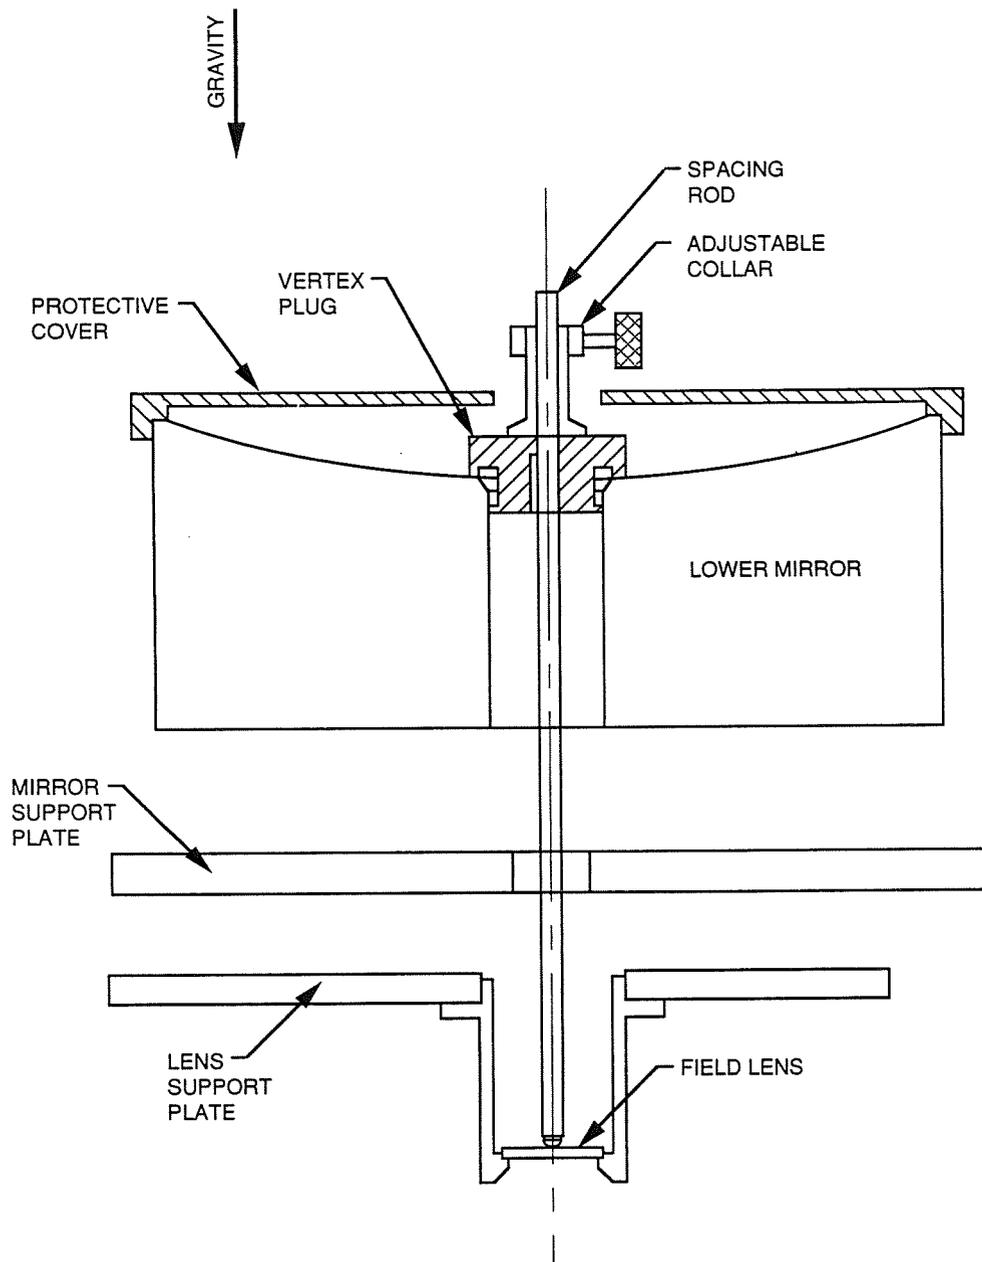
In addition to the optical test used to detect the field-lens spacing error, a direct physical measurement was made from the field lens to the vertex of the lower mirror (Figure 6-4). A lightweight spacing rod and a new vertex plug were made. The results verified the previously measured spacing error to ± 0.1 mm. More accurate measurements of the displacement error will be done at a later time, as this information is necessary for an accurate determination of a prescription for the recovery optics.

When the field lens position error (FLPE) is taken into account and applied in correcting the data taken with the RNC, it results in a mirror shape that would account for most of the error observed in the HST images. Also, the interferograms taken with the RvNC were reprocessed and corrected for the as-built data available for the RvNC. This independent set of data yields a mirror shape very close in value to the RNC/FLPE data. These data led the Board to conclude that the predominant source of error had been found and was caused by the field lens position error. (See Appendix E for the HST performance based on the as-built data.)

Figure 6-4. The 1990 spacing measurement between the lower mirror vertex and the field lens of the reflective null corrector, using a mechanical technique.

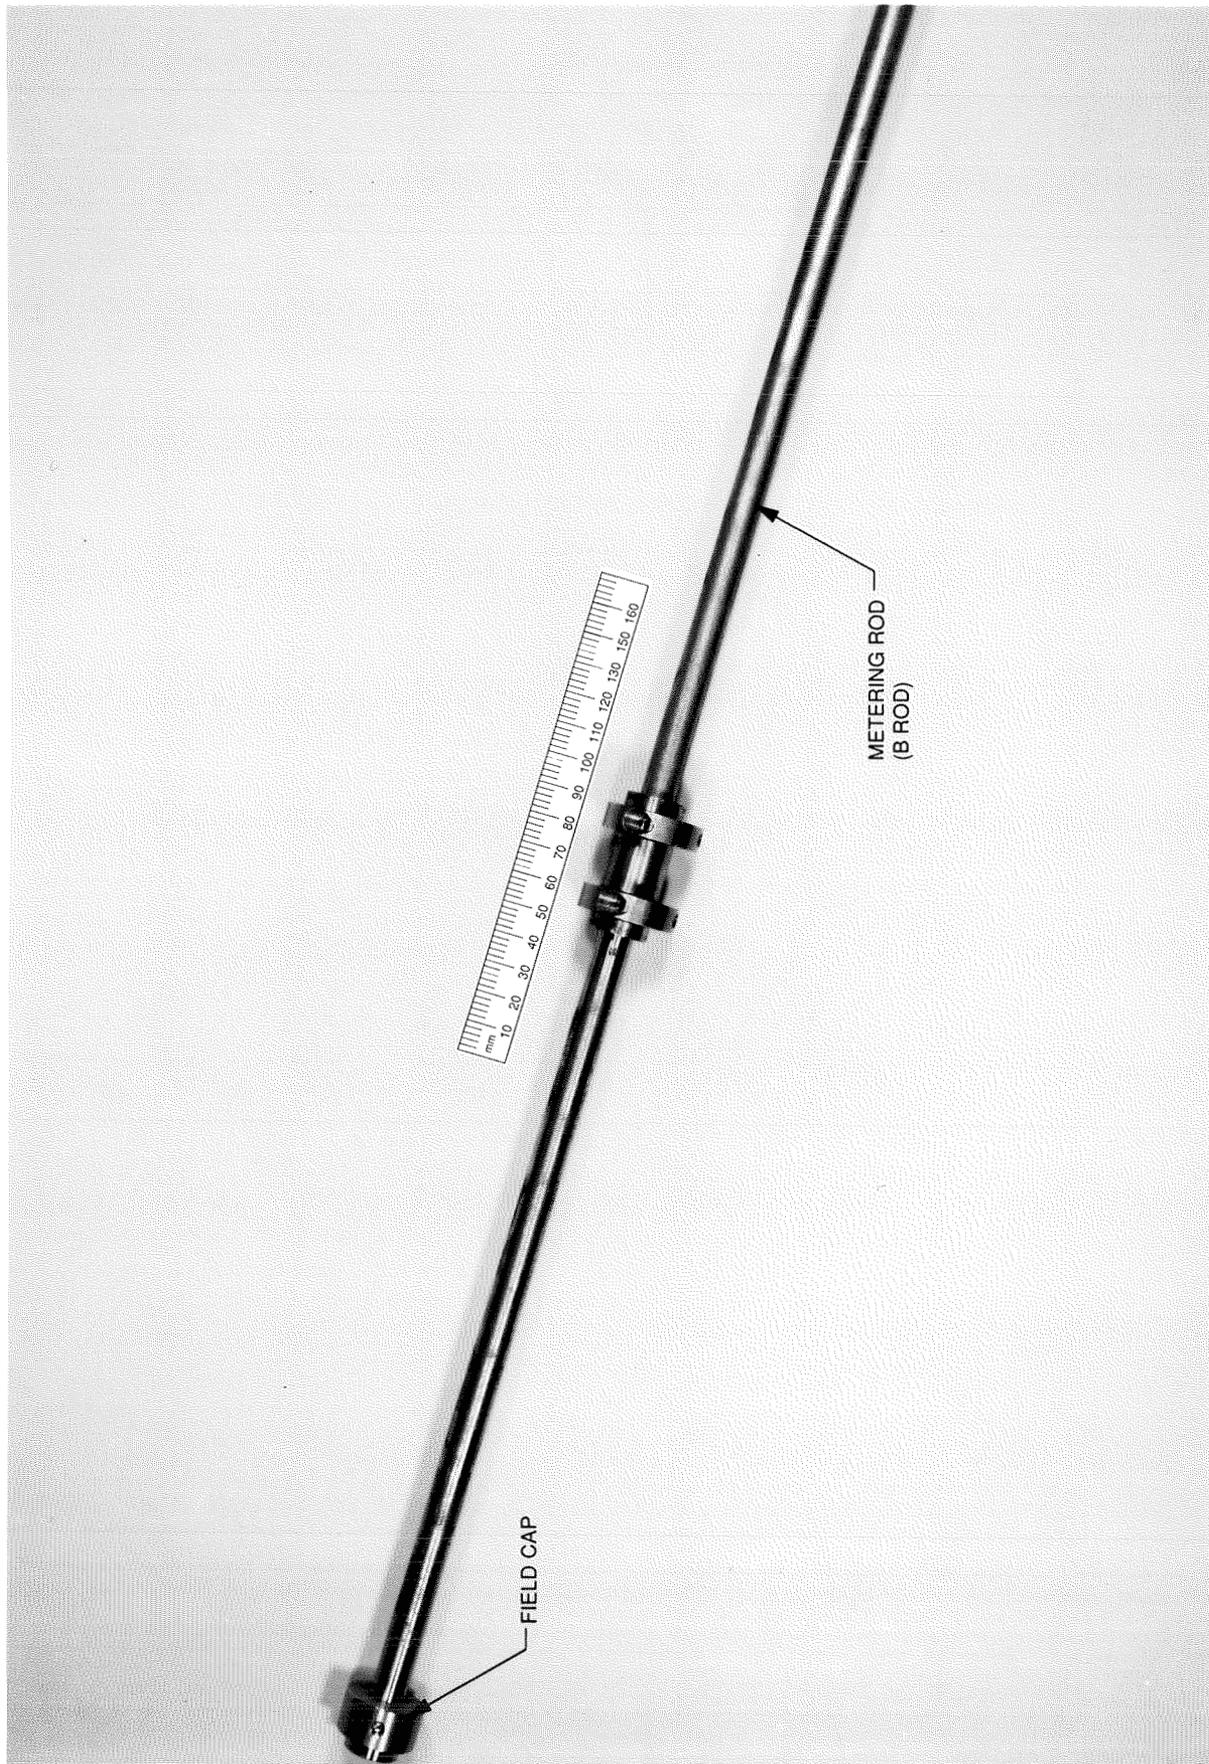
Figure 7-2. Metering rod (B rod) used to space the field lens and the center of curvature of the lower mirror in the reflective null corrector.

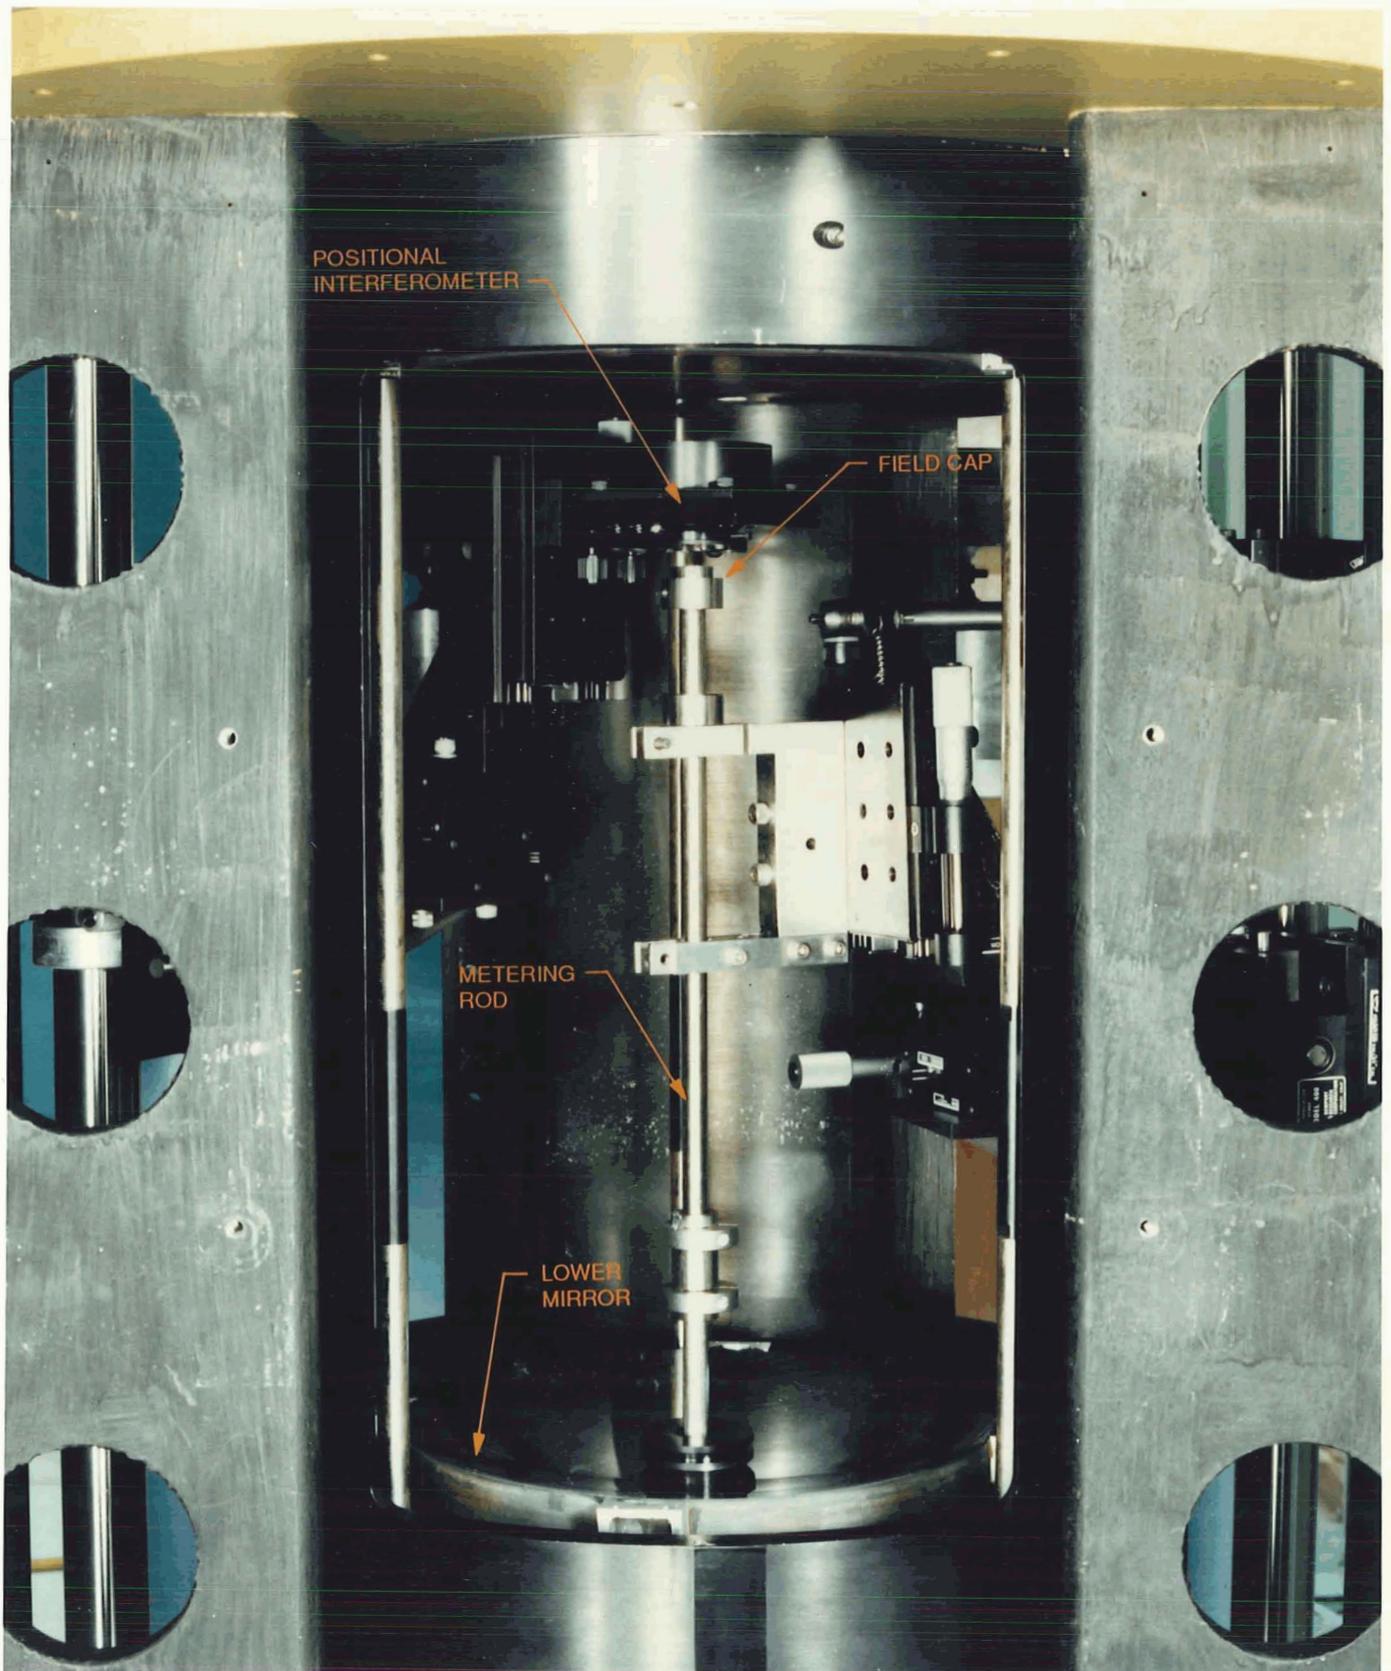
Figure 7-3. Metering rod in position between the field lens and the center of curvature of the lower mirror in the reflective null corrector.

With one end of the metering rod presumably located at the center of curvature of the lower RNC mirror, the field lens was then brought up to the end of rod B, but there was no adjustment left in the screws used for this positioning. More adjustment room was made by inserting spacers between the field lens and the lower mirror mounting plate. The adjustment mechanism was found not to be staked. Staking, i.e., securing the mechanism to prevent inadvertent movement, was a specified procedure. The final location of the field lens was then set with the addition of the spacers. As a result, the field lens was about 1.3 mm too far from its correct position relative to the lower mirror.

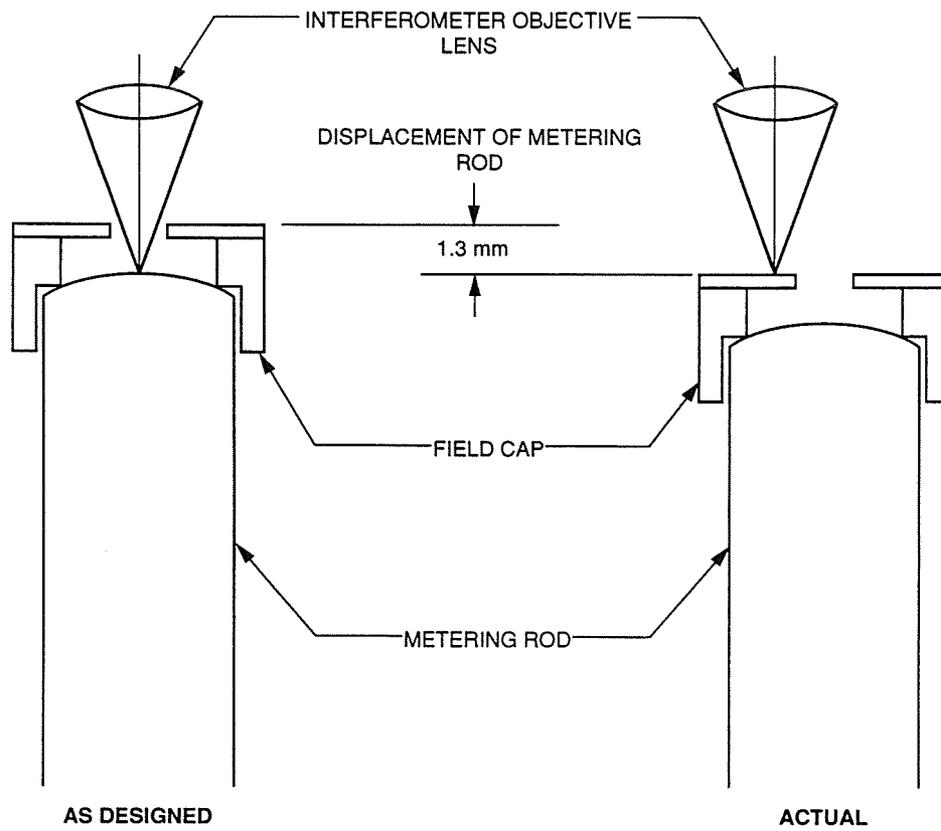
Figure 7-4. Displacement due to the interferometer focusing on the field cap instead of the metering rod.

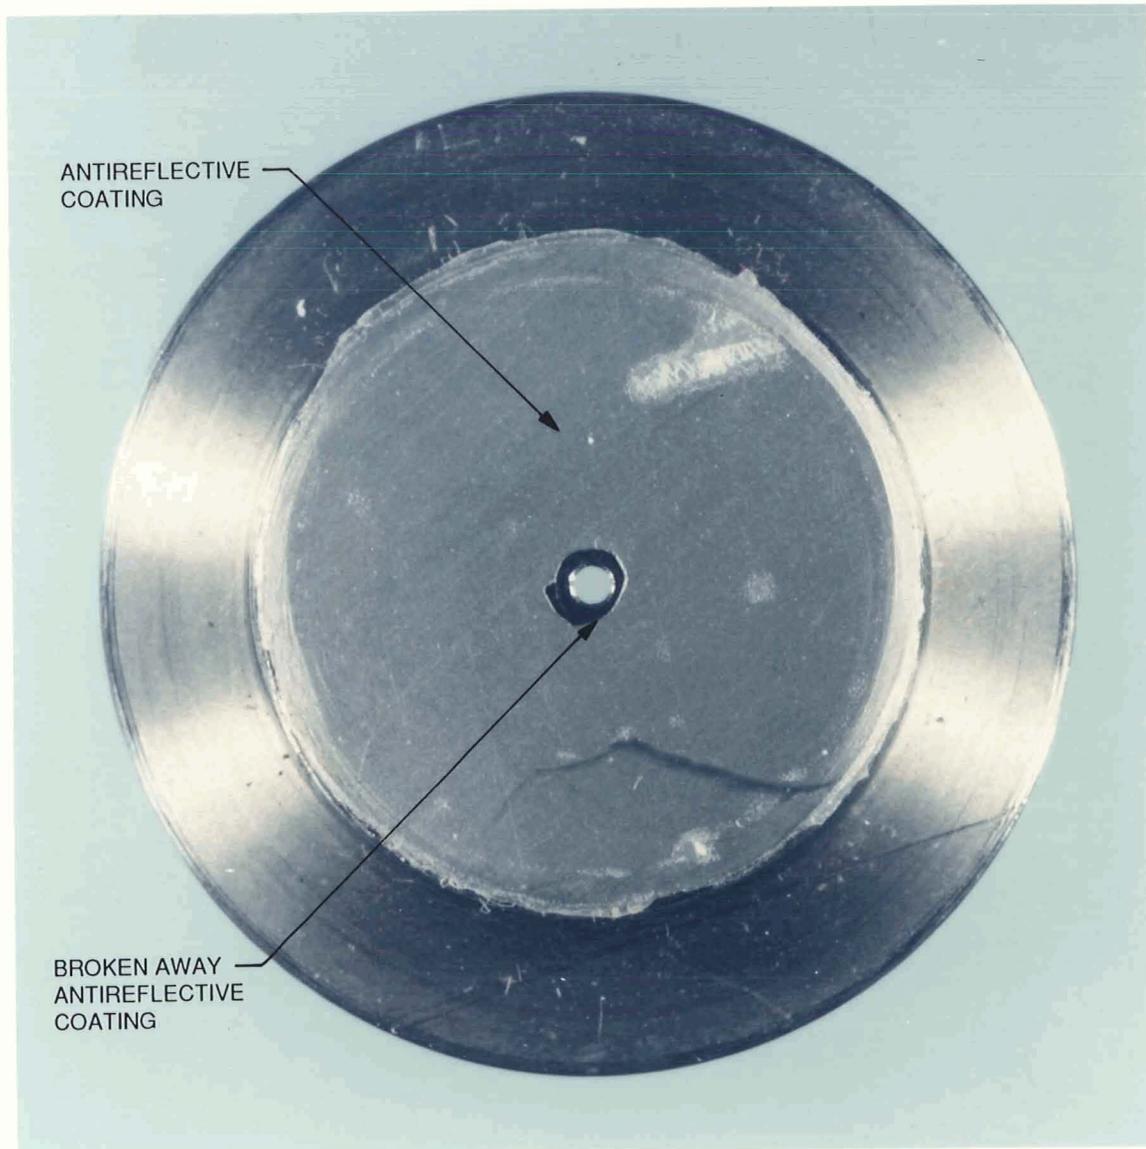
The top surface of the field cap was covered with nonreflecting material; however, some of this material had, apparently inadvertently, broken away from a small area around the field cap aperture. It appears that the operator obtained reflection from the field cap where the nonreflecting material was absent, rather than the rod end, causing the 1.3-mm misspacing. A test performed in 1990 with the equipment showed that it was quite easy, even probable, to make this error with the configuration used. Figure 7-4 indicates how the displacement error occurred by reflecting light off the field cap, rather than the rod end, as designed. Figure 7-5 is a photograph of the field cap and shows the specular region around the aperture. (In this photograph, the broken-away coating appears darker than the surrounding region.)

Figure 7-5. Top view of the field cap, showing the aperture and the area where the antireflective coating had broken away.

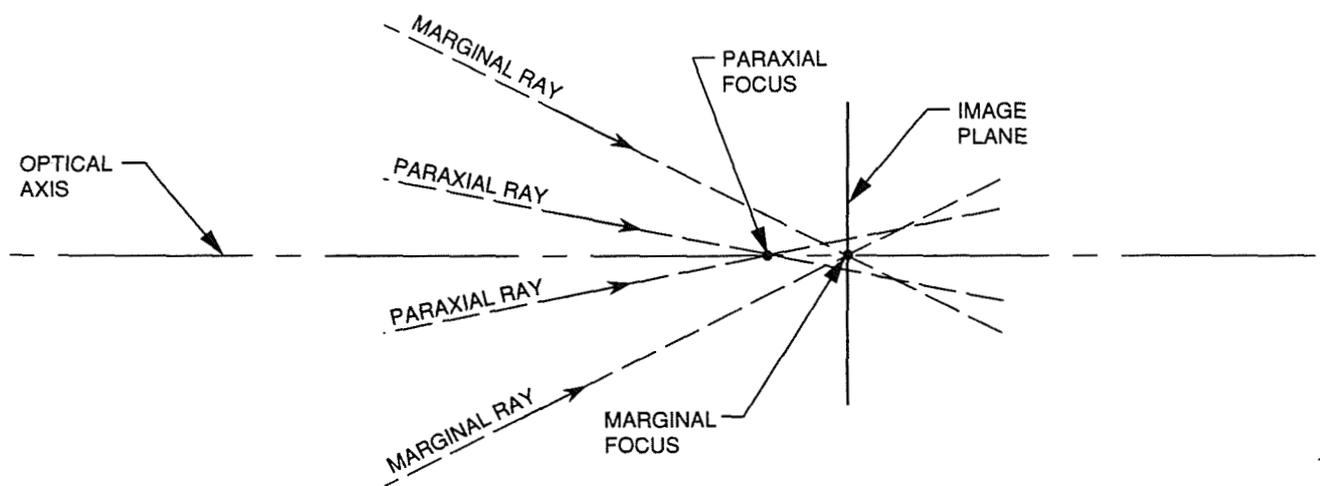
In the case of the HST, the "template" (the reflective null corrector) used to provide the reference surface for figuring the primary mirror, was not correct. In Figure C-4, we show an enlarged view of the marginal and paraxial rays as they converge in the vicinity of the vertex of the HST. Figure C-1 was used to show how the marginal focus could be superimposed on the paraxial focus by removing material. In the HST, too much material was removed from the outer edges of the primary mirror, and the marginal focus was moved to the right, past the paraxial focus. Since the marginal focus is to the right of the paraxial focus, the sign on the error is negative. Since more material than necessary was removed, the opticians call this situation "overcorrected" spherical aberration.

Figure C-4. Image-plane enlargement of the HST Ritchey-Chretien optical system. In the HST, too much material from the edges of the primary mirror was removed, and the marginal focus was moved past the paraxial focus. This is characteristic of an optical system overcorrected for spherical aberration.

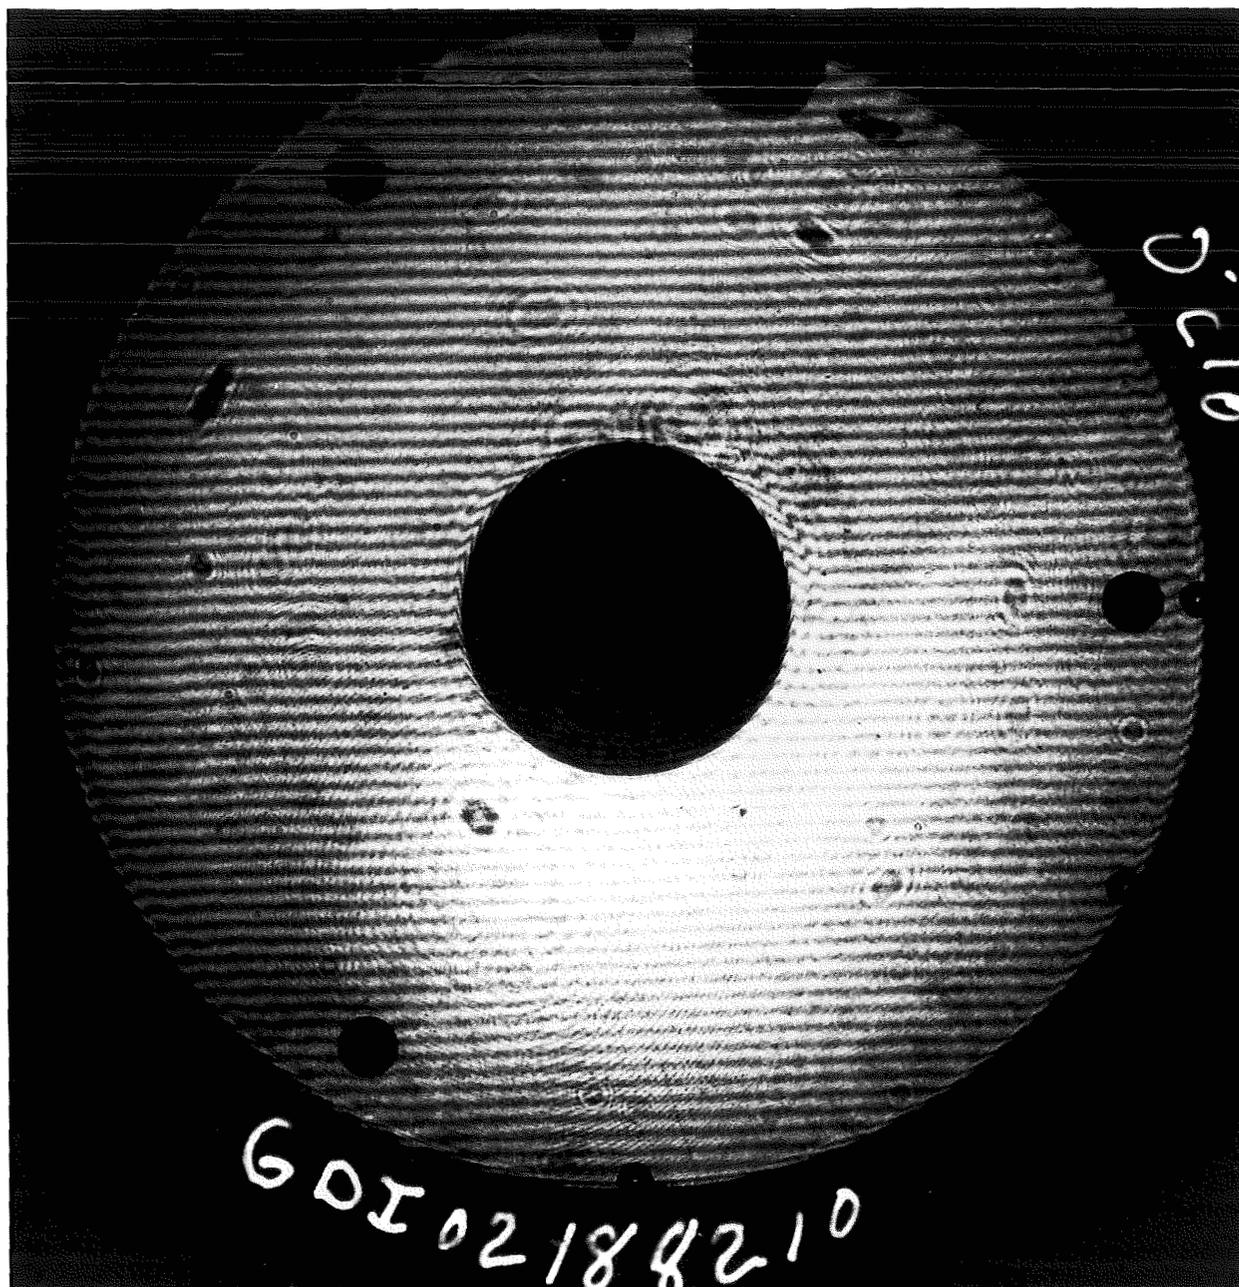
Figure D-1. RNC interferogram of the primary mirror, taken in February 1982.

During this test, the primary mirror was resting on a flotation mount designed to provide an artificial "zero-gravity" condition by supporting the mirror uniformly on 128 mechanically loaded support points. The process of testing required that the primary mirror be adjusted upward toward the RNC until straight fringes could be observed. In the test procedure used, the focus of the system was adjusted during the process by changing the location of the primary, while the components of the RNC and interferometer were held fixed. The lengthy distance from the RNC to the mirror was not precisely measured.

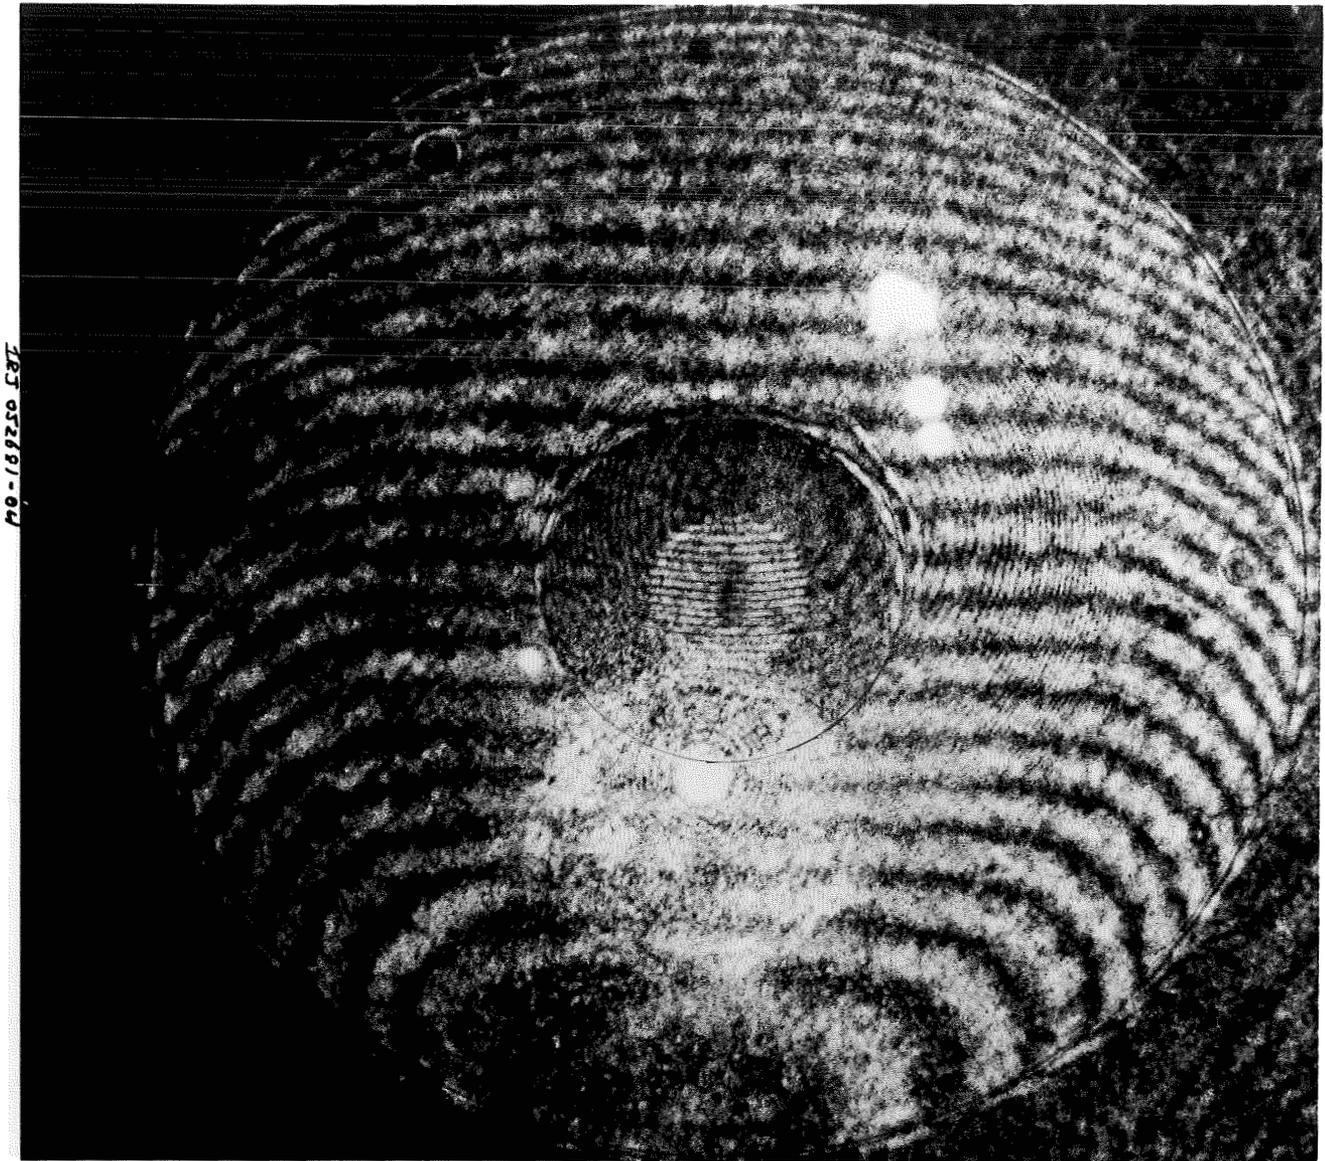
Figure D-2. RvNC interferogram of the primary mirror, taken in May 1981.

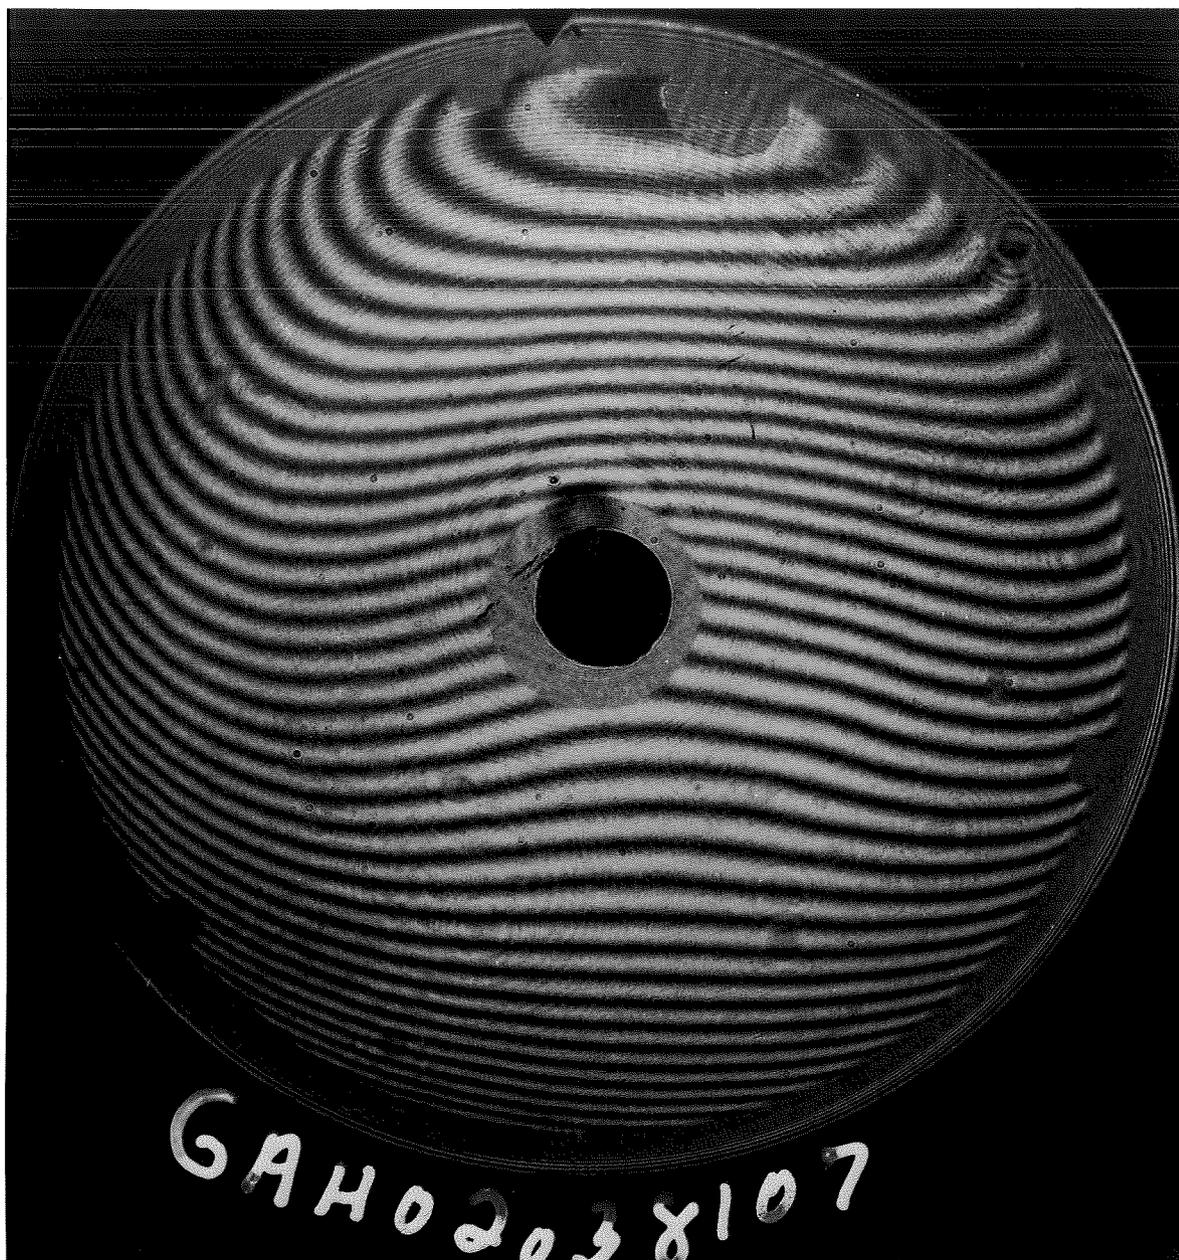
Figure D-3. INC interferogram of the reflective null corrector, taken in February 1981.

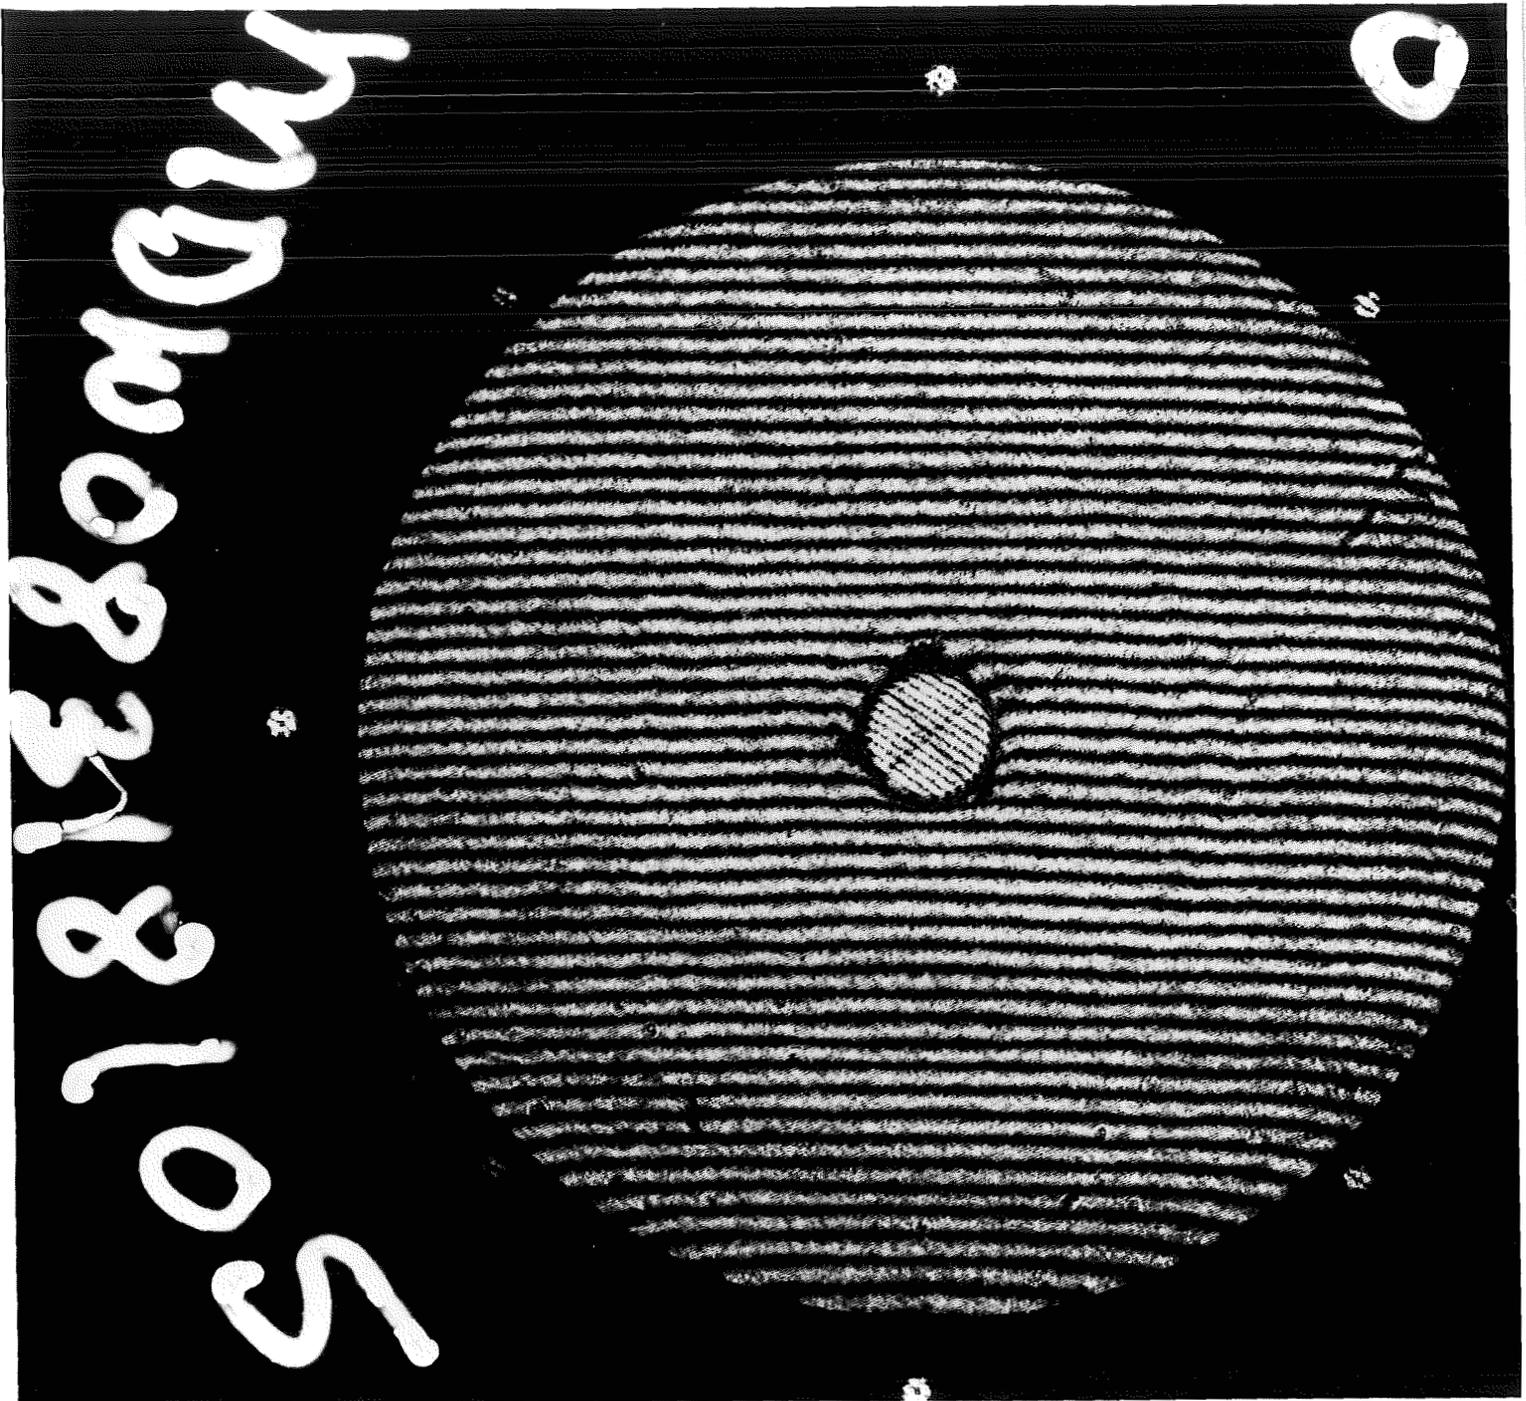
Figure D-4 is one of a set of interference fringes obtained from the flight secondary mirror at the completion of fabrication. A Hindle Shell test, which uses a double bounce off the surface of the secondary mirror, produced a distance between fringes corresponding to a surface-height variation of 0.25 wave. The secondary mirror is quite smooth, with an rms surface error of 0.012 wave. The small circular zones have an error of about 0.018 wave peak-to-valley at 632.8 nm. Because of the double bounce, the appearance of the fringes doubles the effective wavefront error that this component introduces into the system.

Analysis of this interferogram in 1990 supports, with only minor differences, the predicted quality of the surface shape.

Figure D-4. Hindle Shell interferogram of the secondary mirror, taken August 31, 1981.
