Tiltrotor Research Aircraft Composite Blade Repairs— Lessons Learned

Paul S. Espinosa and David R. Groepler

December 1991

Paul S. Espinosa and David R. Groepler, Ames Research Center, Moffett Field, California

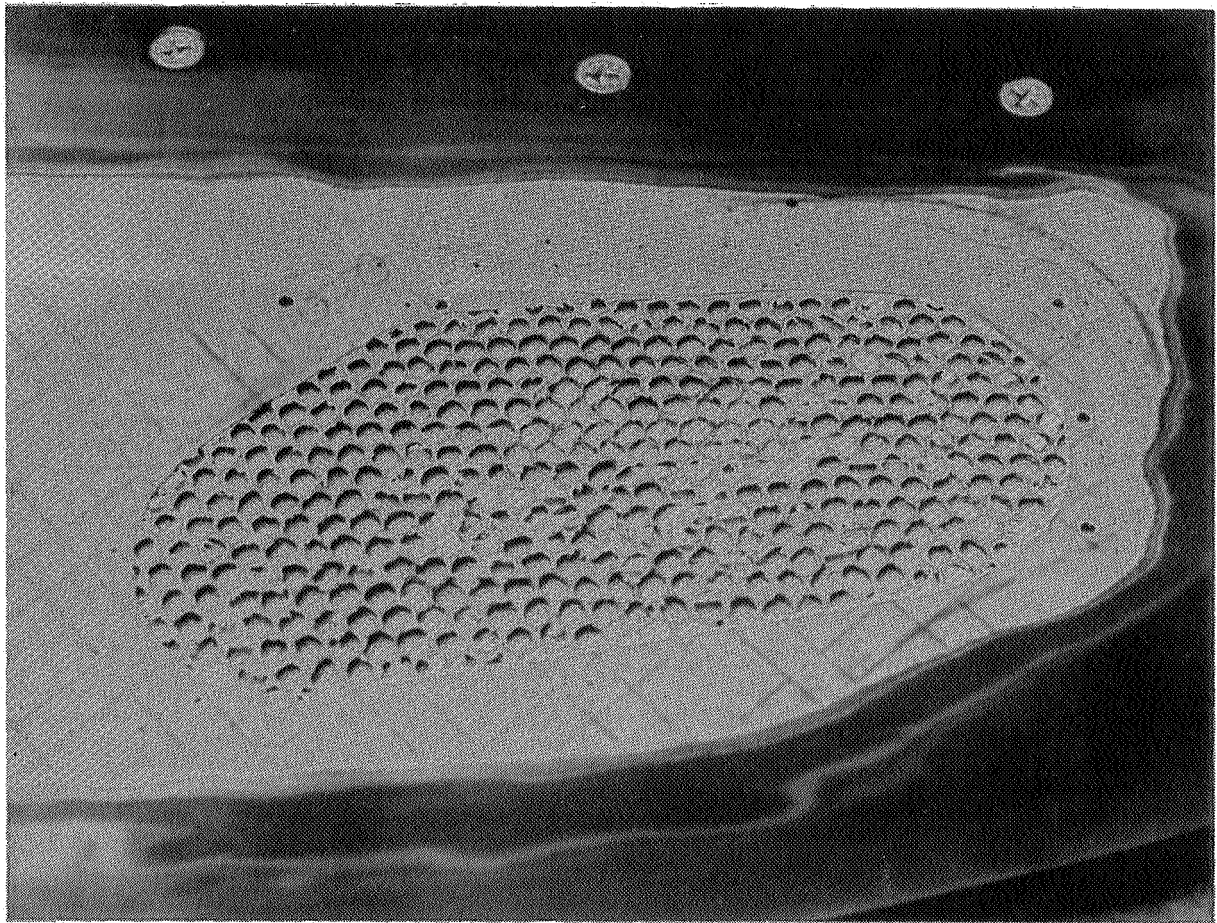
2.2.1 Description of the problem— After about 20 hr of operational testing, approximately 12 in.² (77.42 cm²) of the core of one blade tip was found to have failed, primarily by shearing of the honeycomb through its center (fig. 9). The cause of the failure in the honeycomb core is unknown. The thin shell is highly susceptible to damage from relatively light impact and pressure, but no other failures of the honeycomb core were found in either the baseline or the alternate tips or in any other section of the blade.

2.2.4 Level of severity and monitoring of critical problems— The failure of the honeycomb core was considered to be a critical problem because it reduced the strength of the tip. The same size criteria of 2.5 in. (6.35 cm) described in section 2.1.4 for debonding between the fiberglass skin and honeycomb core was also applied to failure of the honeycomb core. Monitoring was performed by tapping any suspected areas between each flight and documenting the results.

FIGURE 9. Failure of honeycomb core (skin removed)

2.2.3 Repairs performed— The honeycomb core was repaired by replacing the damaged core. The upper skin of the damaged area was removed by carefully grinding the skin away until the core was exposed. The damaged honeycomb was then removed and the inner surface of the lower skin was prepared by sanding and cleaning it (for bonding with the replacement core). A honeycomb plug was shaped to fit the contour of the cavity extending above the surface of the skin 0.25 in. (0.635 cm). The core was bonded to the lower skin and to the existing honeycomb core interface with Hysol EA9309.1 adhesive. After the adhesive cured, the plug was trimmed and sanded to match the upper-skin-surface contour, plus 0.020 + 0.010/–0.005 in. (0.05 + 0.025/–0.013 cm) to allow for crushing of the honeycomb when the skin is applied in accordance with the procedure recommended by the manufacturer, shown in figures 4–10 of reference 4. A skin patch was prepared with a 1-in. (2.54-cm) overlap of the repaired

area and applied to the honeycomb plug with EA9309.1 adhesive; it was clamped during curing. After curing, the clamp was removed and the patch was faired to the existing skin and refinished.

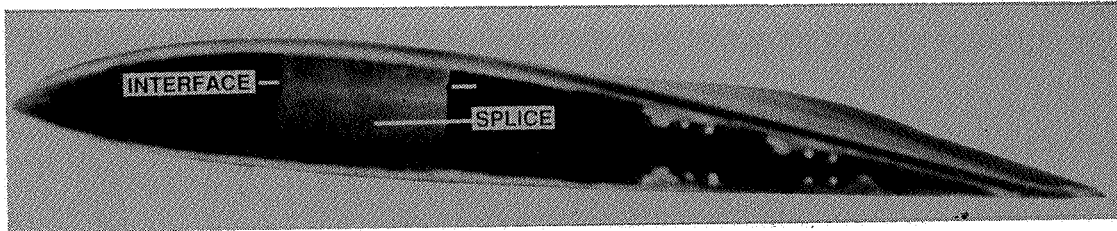
2.3.1 Description of the problem— After 20.1 operational hours several baseline blade tips were found to have failures in the shear splice (a good shear splice is shown in fig. 10). At 25.8 operational hours, two more splices were found to have failed. These debonds, which appeared as cracks, were found at the interface of the splice (one laminate of fiberglass-cured cloth) and the two tangs on the top and bottom of the inner surface of the tip shell (see fig. 11). Two factors contributed to the failures. First, the adhesive at the splice contained voids or did not adequately cover the mating surfaces, or second, the splice was too small and did not provide enough surface area at the interface for a proper bond. Failure in the shear web only occurred in the baseline tips because the alternate tips did not contain shear splices. Once the shear splices were properly repaired no further failures were found.

FIGURE 10. Location of shear splice in baseline tip cover

2.3.3 Repairs performed— Repairs were performed by replacing the existing fiberglass splice or by injecting adhesive into the failed section of the interface. Since most of the original fiberglass splices did not provide enough overlap for a good bond, the original splice was removed and a new one was fabricated to provide a 0.25-in. (0.635-cm) overlap. The original adhesive was cleaned from the web tangs, and the new splice was bonded into place with EA9309.1 adhesive; a specially

made clamp was used to hold the splice in place while it cured. In some cases where a sufficient overlap already existed the debonded area was cleaned, and either EA9309.1 or Hysol 956 adhesive was injected with a hypodermic needle into the debonded area. The new splice was then clamped and allowed to cure.

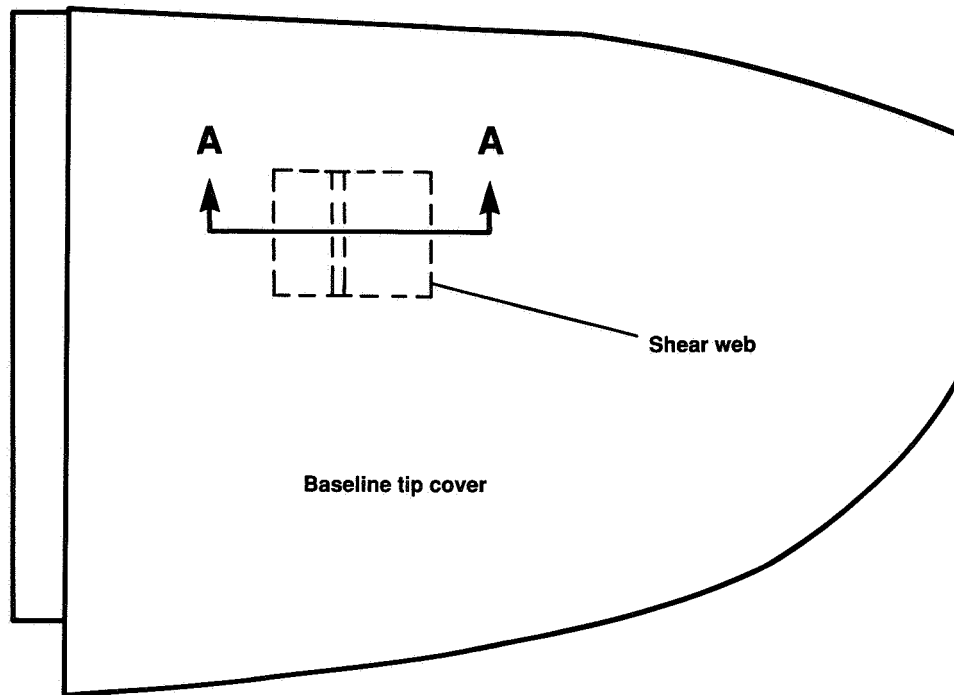
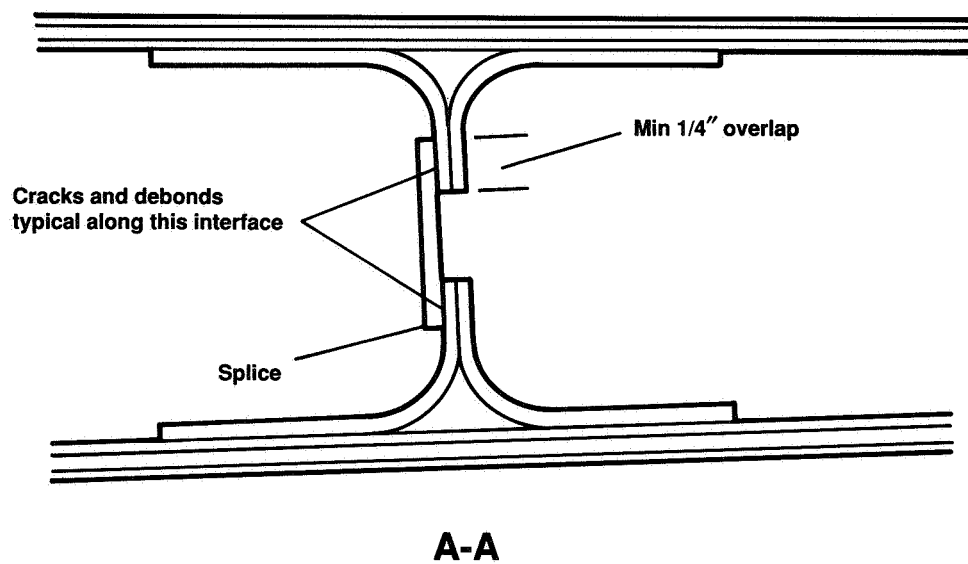
2.3.4 Level of severity and monitoring of critical problems– The shear splice in the XV-15 ATB baseline blade tip is not primary flight structure. It is a secondary structure web used to prevent damage to the tip cover during handling and when the tip is removed or installed. All failures of the tip splice had a bond area less than 0.25 in. (0.635 cm) in width. A 0.25-in. (0.635-cm) crack is allowed in the chordwise direction, for the small voids in the adhesive which may form during assembly or repair of the splice. Because the loads during flight are carried by the fasteners into the spar, it is not expected that a crack will grow during flight. If a crack or debond in the web is less than 0.25 in. (0.635 cm) long in the chordwise direction, it is monitored and repaired during the next convenient maintenance period. All the noncritical cracks and debonds are recorded and visually inspected for growth each time the tip cover is removed.

FIGURE 11. Detail of shear splice in baseline tip cover

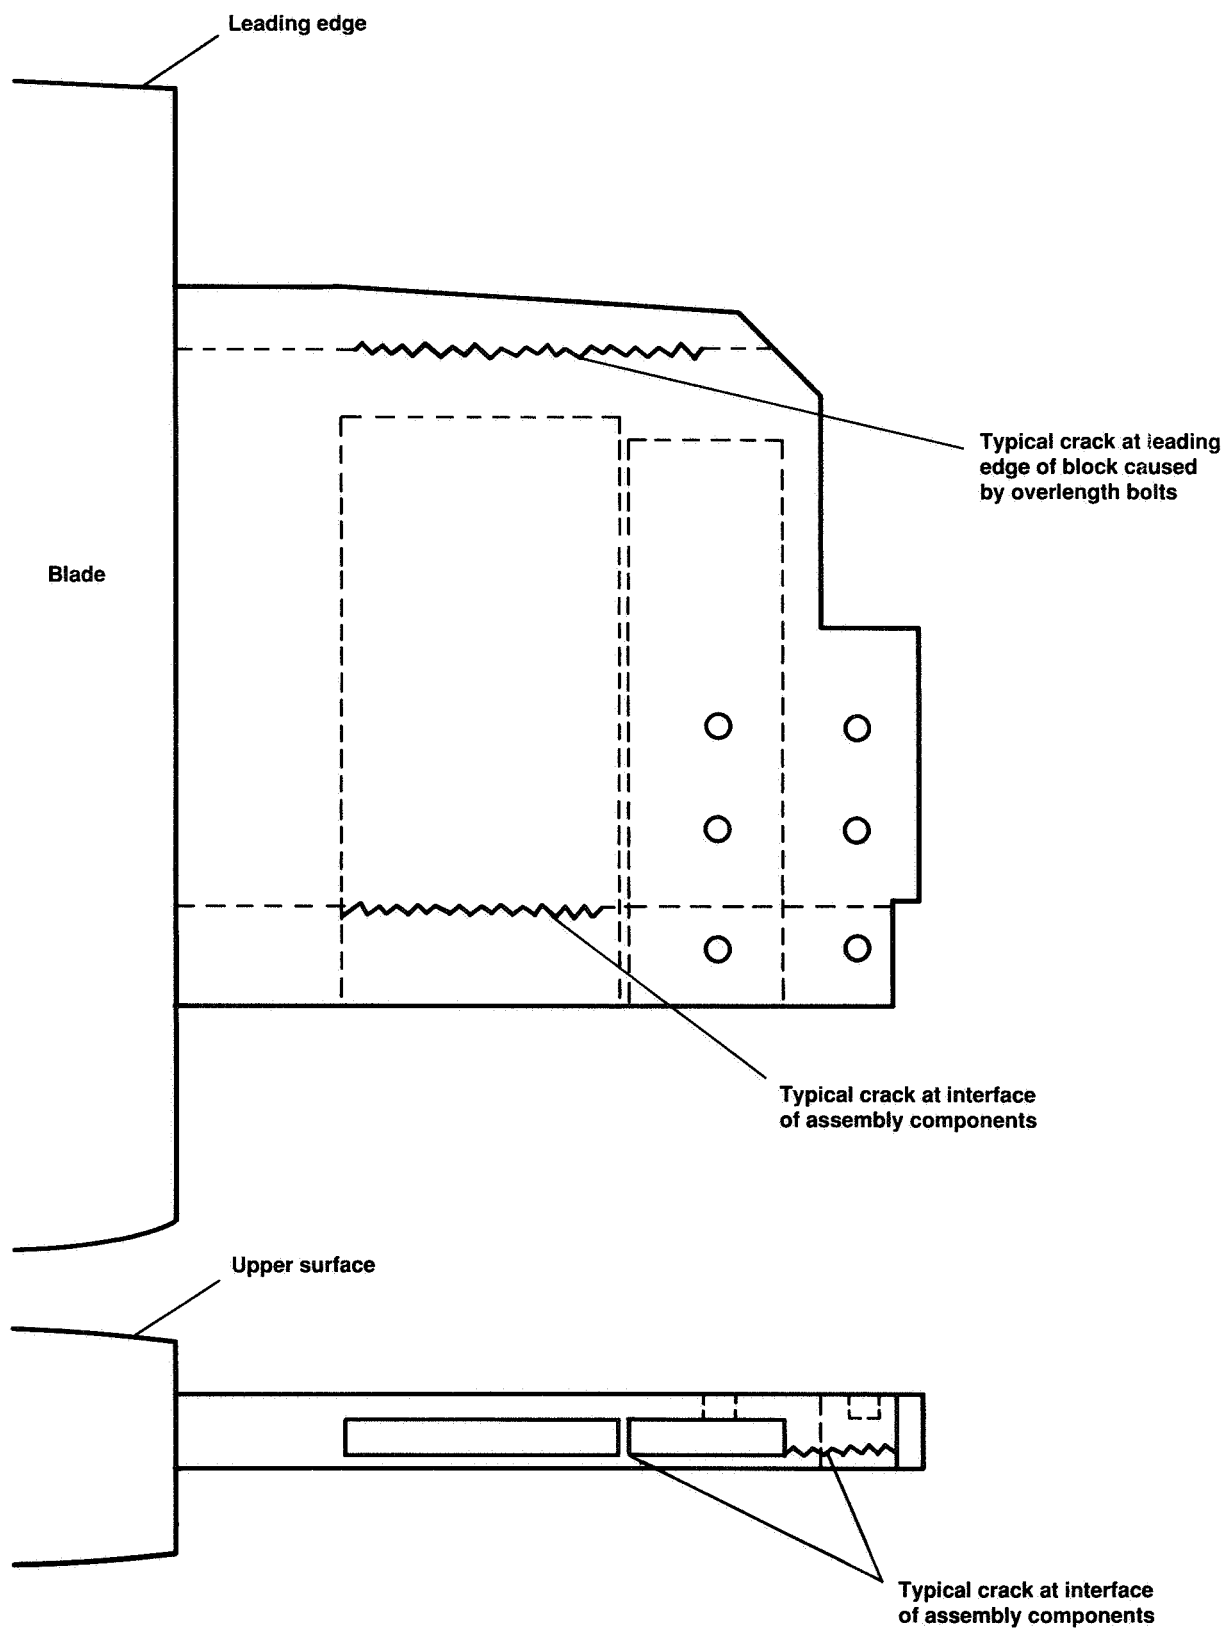
2.4.1 Description of the problem– Before the first flight on the aircraft, many cracks were found in the fiberglass blocks at the interface between the molded weight blocks of each tip-weight-fitting assembly where they are bonded together (fig. 12). Throughout the flight-test activity, the blocks continued to be plagued by cracks at various bond-line locations. Various types of adhesives and repair methods were tried. Since the weight blocks are secondary structure (the weight blocks are held together by fiberglass wraps from the main spar), this problem was not a safety issue. Some of the cracks were caused by the inadvertent use of over-length fasteners, which pushed against a mating block and caused the blocks to separate. Most cracks were formed when the adhesive between the blocks failed during flight or upon assembly. The adhesive at the block interfaces may have squeezed out during curing, causing inadequate bonding of the blocks. Another possibility is that the adhesive did not cure properly or was under-strength during assembly, resulting in lower strength of the interface. A repair procedure was established in which a high-strength adhesive with a long cure time was used, coupled with a procedure to prevent the crack from fully closing during the cure cycle, which ensured that the thickness of the adhesive would be adequate for maximum strength. None of the repaired blocks had further failures.

2.4.2 Inspection procedures– Each time the tips were removed for maintenance or to change the tip weights for blade balance adjustments, a visual inspection of the tip-weight-fitting-assembly fiberglass blocks was performed. Many cracks were easily visible, but cracks that were not visible could be found by causing them to open by applying pressure either by squeezing or by opening the weight cavity. Shining a strong light through the block often helped to highlight the crack.

2.4.4 Level of severity and monitoring of critical problems– Cracks in the fiberglass blocks were not considered to be a critical problem because these blocks were not primary structure (primary retention is provided by the spar extension wraps). The area was therefore inspected for cracks only when the tip caps were removed for maintenance. Any cracks found were repaired before the next flight.

FIGURE 12. Typical cracks in tip-weight-fitting assembly

2.4.3 Repairs performed– All the cracks were at the interface of assembly components, and were repaired by bonding the components. The cracks were opened slightly with a small wedge, and Hysol EA954 adhesive was injected into the crack. The wedge was left in place during curing to prevent the adhesive from being squeezed out. The wedge was then removed, and the tip was replaced.

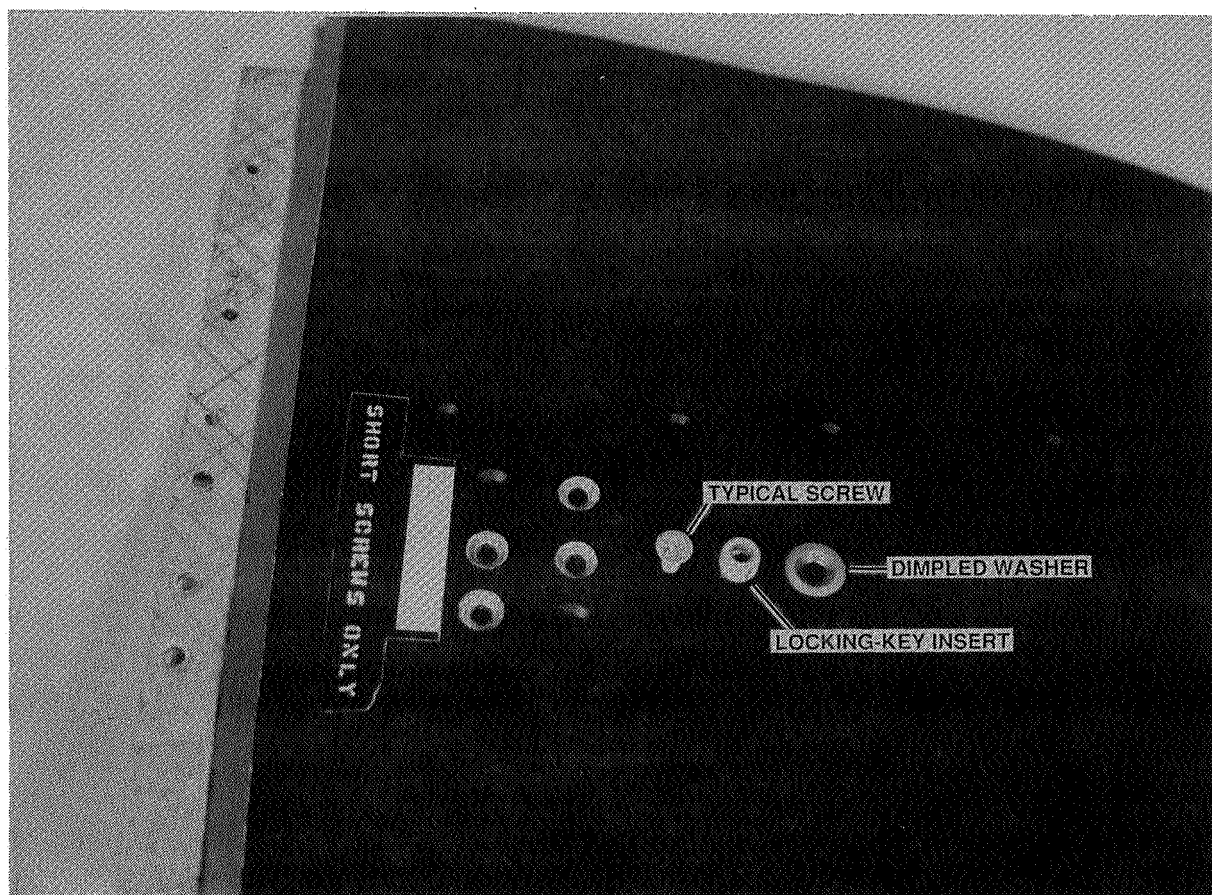
2.6.1 Description of the problem— There were three major types of problems associated with the metal fasteners in the fiberglass on the ATB blades. These problems involved the locking-key inserts, the use of helicoils, and the dimpled washers. Figure 14 shows a typical fastener, locking-key insert, and dimpled washer.

The most common fastener problem was associated with the locking-key inserts located at the outboard end of the main body of the blade in the spar and in the tip weight fitting. Problems included: (1) damage to the fiberglass threads in which the insert is seated; (2) failure of the adhesive, or lack of adhesive, at the interface of the insert and fiberglass; and (3) failure of the fiberglass in the vicinity of the insert. After 25.8 hr of flight time, an insert was found to have pulled loose from the fiberglass nose block. The failure of the insert in a fiberglass block was discovered during a post-flight inspection; it was manifested as a bulge in the skin, about 0.0625 in. (0.159 cm) high, at one of the outboard fastener locations. When the insert was removed it was found to have been fastened with adhesive into a hole in the fiberglass. Apparently the original threaded hole had been too large, so it was drilled out and the insert was glued in place. The glue alone does not provide the retention strength that threads in the fiberglass do. Further inspection showed no other inserts with this deviation; however, a torque test identified a number of inserts that were also loose. Loads and vibration caused the threads in the fiberglass to deform slightly, which loosened the inserts. The inserts were removed and reinstalled with adhesive so that they were securely bonded to the fiberglass threads.

The third problem was with the dimpled washers that are bonded to the skins of the blade and tip beneath the countersunk heads of the retention screws. On some occasions a washer had debonded from the surface of the tip cover. Twisting or warping of the tip had placed high shear loads at the interface of the washer, causing the adhesive to fail. In some cases, the fiberglass skin under the dimpled washer was too thin, and there was a gap at the interface between the tip cover and the blade surface. When the fasteners were torqued down, the surface in the vicinity of the washer warped, causing the bond of the washer to fail. The washer was replaced and the skin under the washer was built up with fiberglass when necessary.

2.6.4 Level of severity and monitoring of critical problems— All of the fastener problems were determined to be critical and were repaired before the next flight. Failure of the insert or washers could cause the fastener to shake loose or crack the adjacent fiberglass structure.

FIGURE 14. Metal fasteners currently used in ATB blade and tip-cover structure

2.6.3 Repairs performed— All the failed metal fasteners were replaced as soon as they were detected. The loose inserts were replaced by removing the insert from its cavity either by pulling it directly out of its hole if the fiberglass threads were badly damaged, or, if the threads were not badly damaged, by knocking the insert's "keys" down into the cavity below the insert so that the insert was free to be twisted out. A new insert was then glued in place with EA9309.1 adhesive. If there was damage to the threads in the fiberglass structure, they were sanded out and the hole was drilled oversize and cleaned. The hole was then coated with adhesive and lined with three layers of fiberglass cloth saturated with the same adhesive, with the first and third layers at 0/90 deg and the second layer at ± 45 deg. Pressure was applied to the fiberglass using a tapered plastic dowel inserted into the hole. After the adhesive cured, the hole was drilled and tapped using a guide to ensure perpendicularity to the surface of the tip. A new locking-key insert was installed with adhesive.

The unbonded dimpled washers were removed and the dimple in the fiberglass skin was cleaned and sanded. The depression in the fiberglass was built up with a mixture of chopped fiberglass cloth and EA9309.1 adhesive. The bonding surfaces of the washers were etched, primed, and coated with adhesive, and the washers were bonded to the blade.

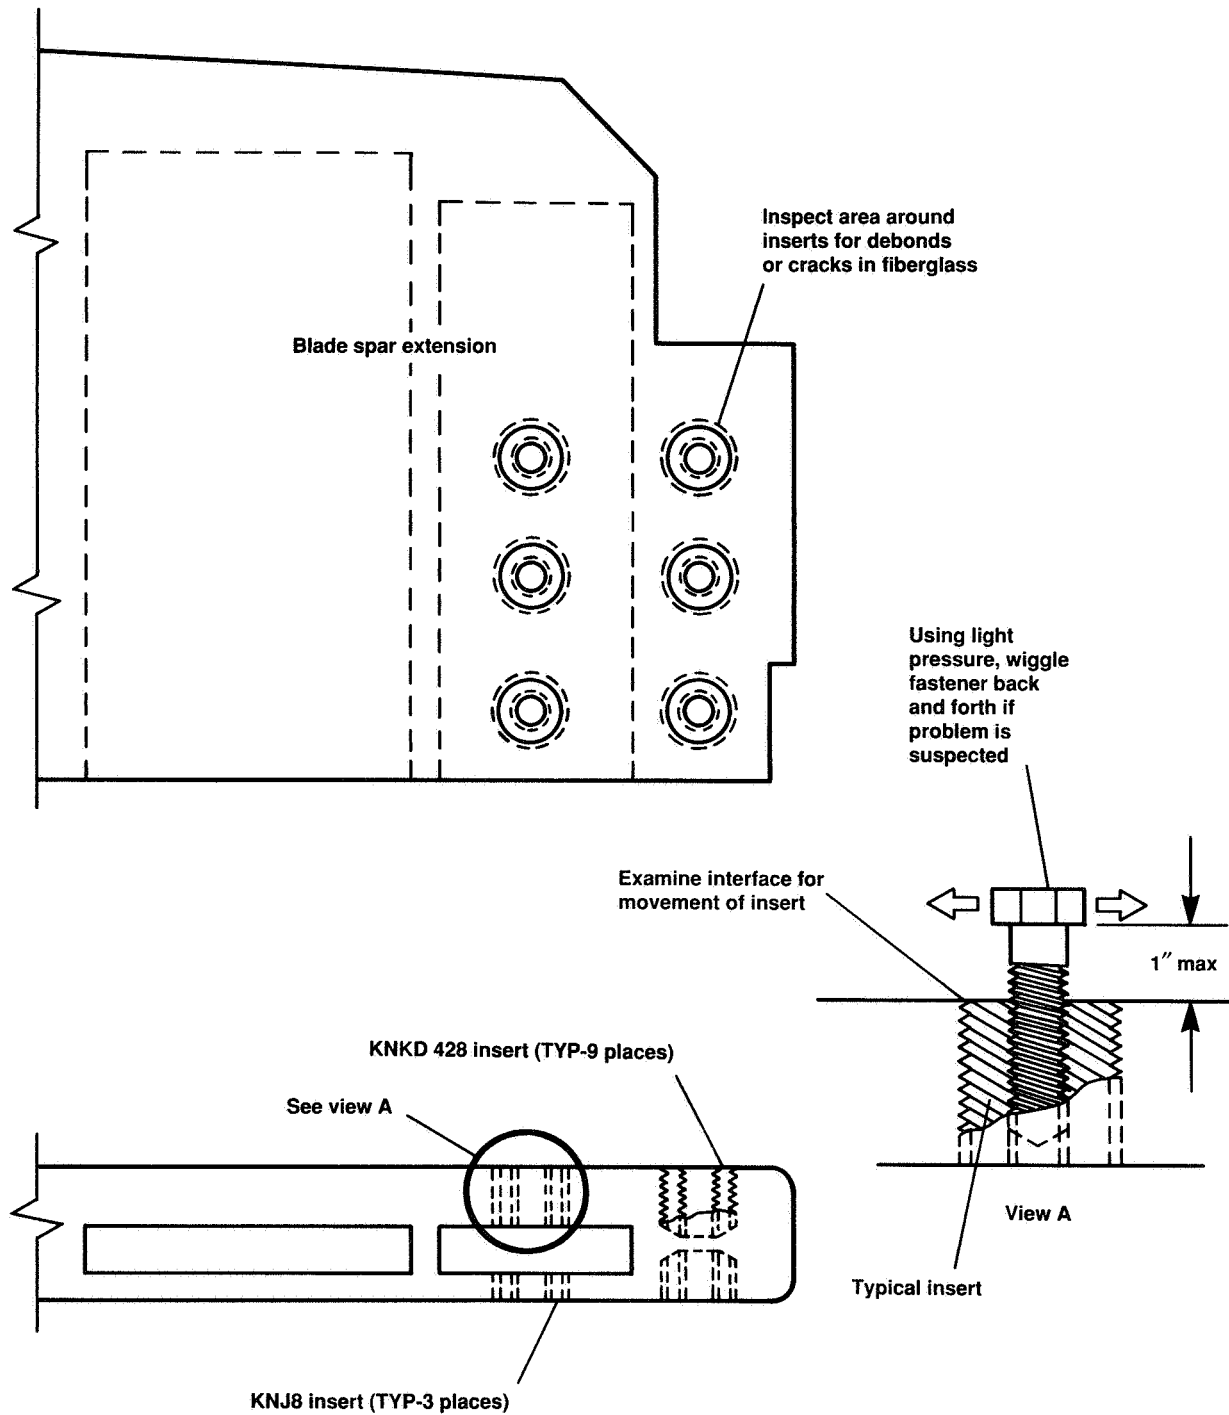
2.6.2 Inspection procedures— A visual inspection was performed on all the metal fasteners visible on the surface of the blade after every flight. The metal fasteners located in the tip weight fitting or under the tip cap were visually inspected when the tips were removed for changing the tip weights or for maintenance. If it was suspected that an insert was loose, a torque test was performed and/or a short fastener with the same threads as the insert was inserted (fig. 15) and, using light pressure (pushing on the fastener too hard could damage the fiberglass threads), the fastener was wiggled laterally by hand while a visual examination was made of the interface of the insert and the fiberglass for unusual movement, debonds, or cracks in the fiberglass. The insert was then replaced, if necessary.

FIGURE 15. Inspection of inserts in spar extension and end of blade
