**EFFECTS OF LONG-TERM EXPOSURE ON LDEF
FASTENER ASSEMBLIES****Steve Spear
Harry Dursch****Boeing Aerospace****Effects of Long Term Exposure on LDEF Fastener Assemblies**

This presentation summarizes Systems SIG findings from testing and analysis of fastener assemblies used on the LDEF structure, the tray mounting clamps, and by the various experimenters.

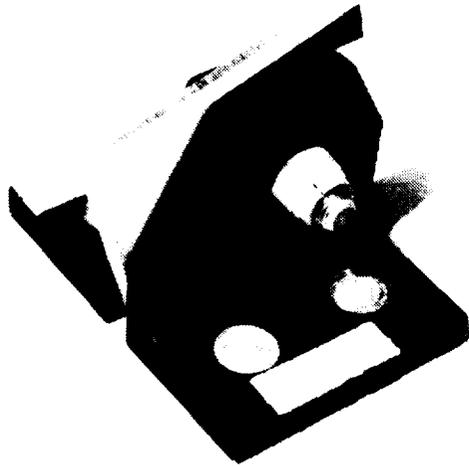
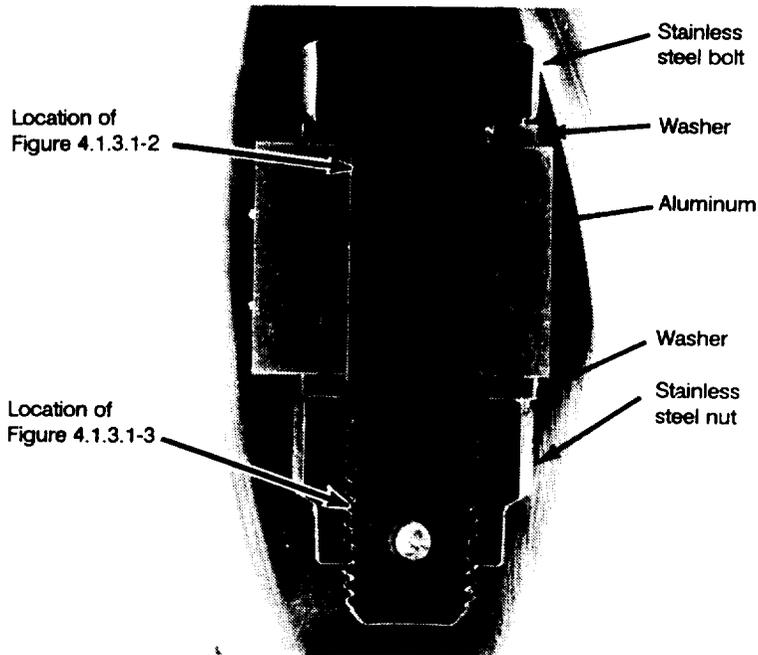
Figure 2 Unassembled Intercostal Fastener Assembly

An undisturbed intercostal fastener assembly (shown in figure 2) was removed from the LDEF structure to investigate its post-flight condition. This fastener was selected because of its availability and not because of any evidence of coldwelding, galling or any other suspect condition.

The stainless steel/aluminum interfaces and bolt/nut interfaces were examined for indications of damage. Closeups of these areas are shown in figures 3 and 4. Metallographic examination of the bolt shank interface revealed no evidence of galling or coldwelding.

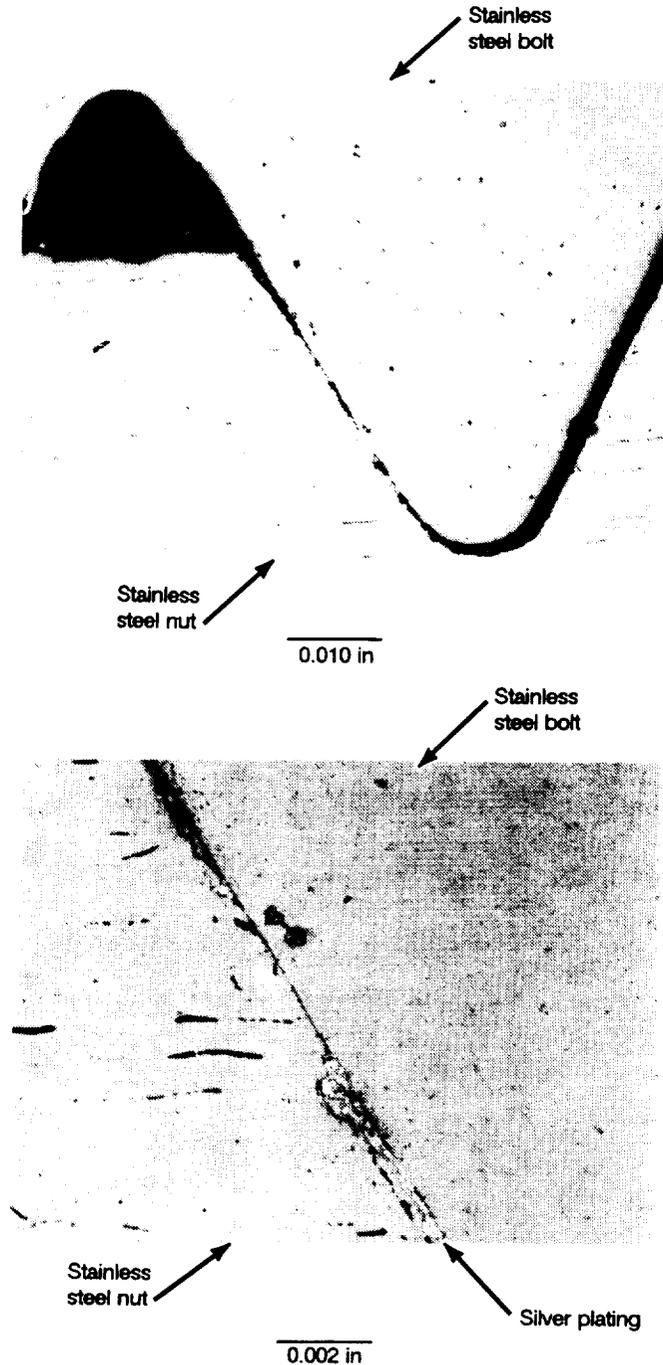
Figure 4 Closeup of Nut/Bolt Thread Faying Surfaces as Indicated in Figure 2 (Note Smearing of Ag-Plating Which Acts as a Lubricant Between the Nut and Bolt.)

The thread mating surfaces also show no evidence of coldwelding; however, some minor galling and smearing of the silver plating is evident. The behavior of the plating is normal because it is specified to act as a lubricant during both installation and removal to prevent galling and seizure of the nut to the bolt (fig. 4).

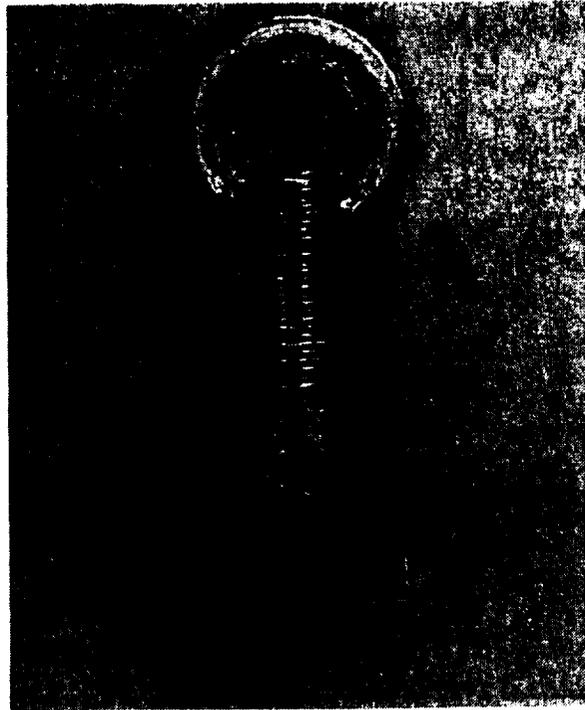
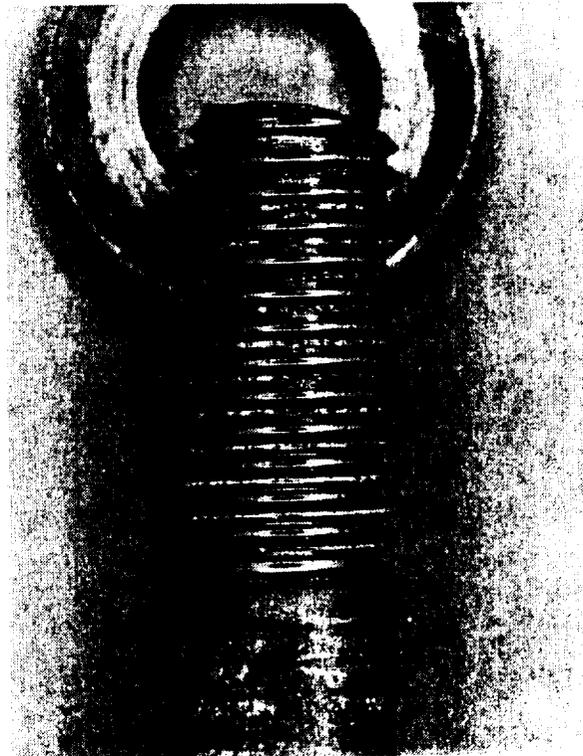
Tray Clamp Fastener With a "B1" Rating

These two photos (fig. 8) show a typical "B1" tray clamp bolt. Both the unseating and prevailing torques were close to the average values. The condition of the bolt threads is nominal.

Unseating torque = 70 in-lb

Prevailing torque = 15 in-lb

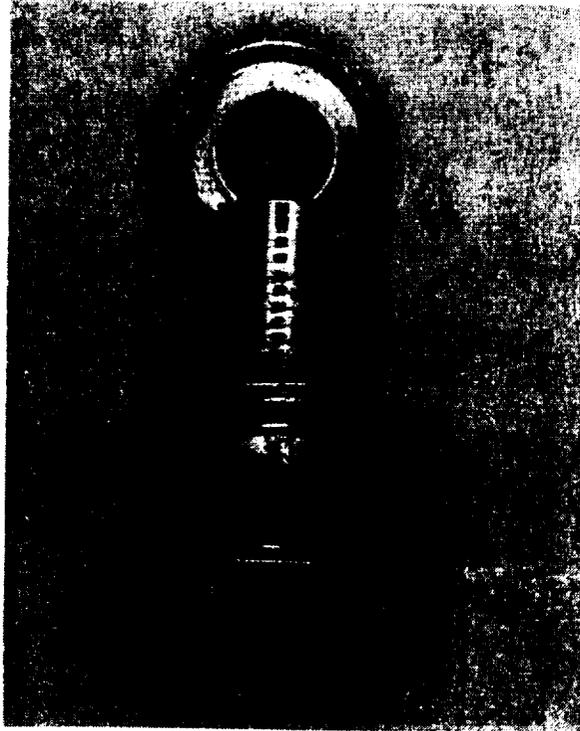
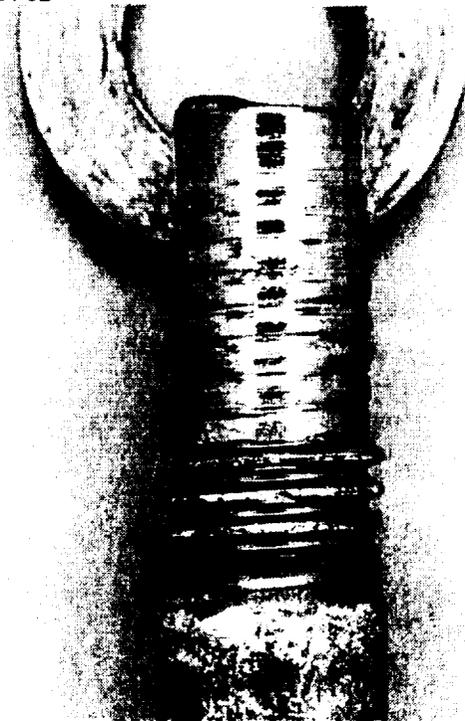
Tray Clamp Fastener With a "B5" Rating

These two photos (fig. 9) show a typical "B5" tray clamp bolt. While the unseating torque was actually below average, the prevailing torque was almost twice the maximum specification value. Note the severely damaged (stripped) threads.

Unseating torque = 190 in-lb

Prevailing torque = 35 in-lb

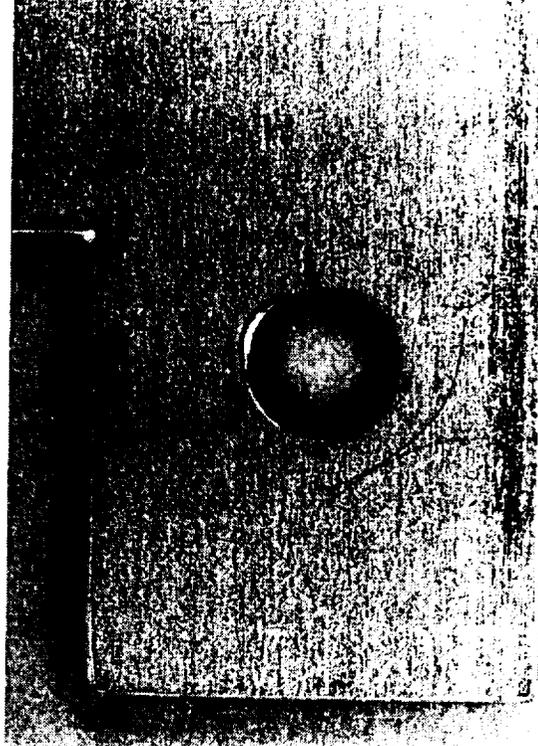
Tray Clamp Shim

As would be expected, the threads of the bolts with the higher prevailing torques generally exhibited greater thread damage. Most of the bolts examined have varying amounts of smears or deposits of aluminum on the grip (unthreaded) portion of the bolt shank, suggesting that there was a hole misalignment between the clamp and structure. Visual examination of a few clamps revealed varying amounts of burnishing in most of the holes. A visual examination of 21 shims (used between the tray clamp and structure) revealed varying degrees of bolt thread contact in the holes. It is thought that this apparent misalignment may have contributed to the high prevailing torques noted for some of the bolts. See figure 10.

Unseating torque of bolt = 62 in-lb
Prevailing torque = Unknown

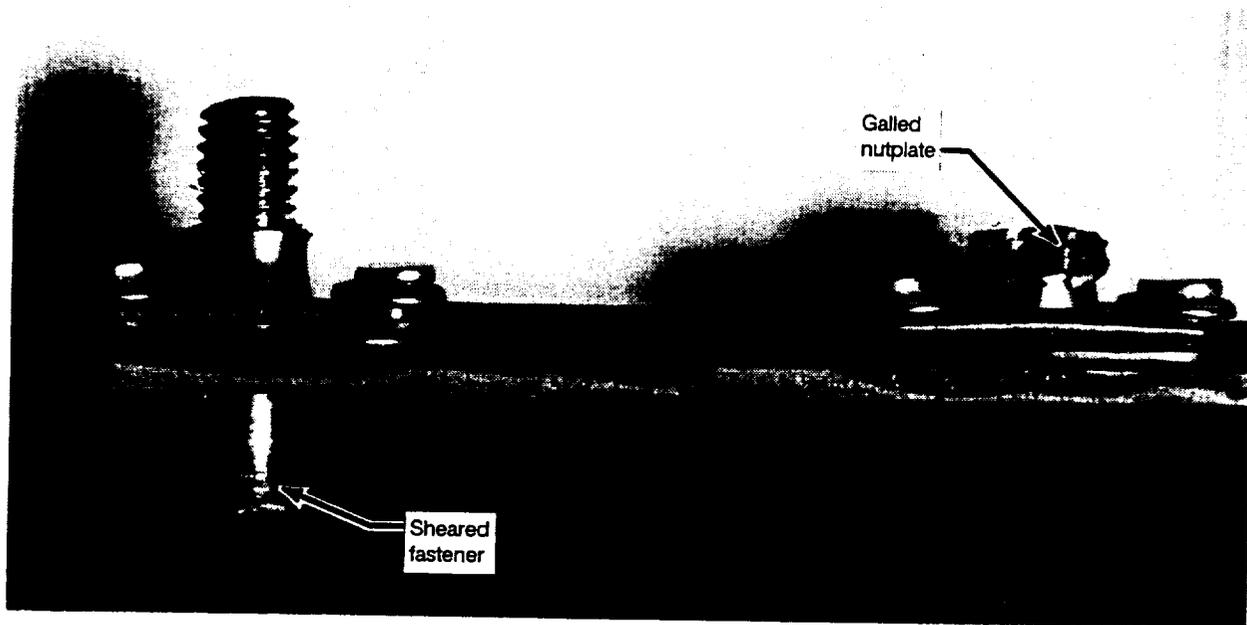
A0175 Sheared Fastener and Galled Nutplate

Further investigation determined that the nut plates had the original MoS₂ dry-film lubricant removed by acid stripping prior to installation. This was done because of possible concerns about volatilization and contamination while on-orbit. The MoS₂ was replaced with cetyl alcohol. Initial speculation was that the fasteners may have coldwelded on-orbit because of insufficient lubrication provided by the cetyl alcohol.

Unseating and prevailing torques were obtained for the majority of the fasteners by Dr. Vyhna. Several fasteners were left undisturbed for analysis by the System SIG. Examination of one of the two trays at Boeing revealed that some of the nut plates had not been stripped of their dry-film lubricant. Correlation of the torque data with the nutplate lubrication conditions (with or without MoS₂) showed that the average prevailing torques associated with the MoS₂ nut plates was 15 in-lbs as opposed to 64 in-lbs for the bare nutplates. The specification for these types of nut plates (with MoS₂) requires a prevailing torque range of 2 to 18 in-lbs. The average unseating torques were the same for both the MoS₂ and cetyl alcohol nutplates at 31 in-lbs. If coldwelding had occurred in the cetyl alcohol lubricated nutplates (as was initially speculated), the unseating torques would have been substantially higher and there would have been a difference in unseating torque values between the MoS₂ and cetyl alcohol nutplates. The excessively high cetyl alcohol nutplate prevailing torques were a result of severe galling. The removal difficulties were a direct result of lack of adequate lubrication during removal that caused additional galling. This resulted in seizure, thread stripping, and sheared bolts.

This photo (fig. 13) shows two of the severely damaged fastener assemblies from Experiment A0175. Note the severely damaged nut plate and sheared fastener. One of the Boeing fastener experts stated that this was the worst galling he had seen in his 30 years of working with fasteners.

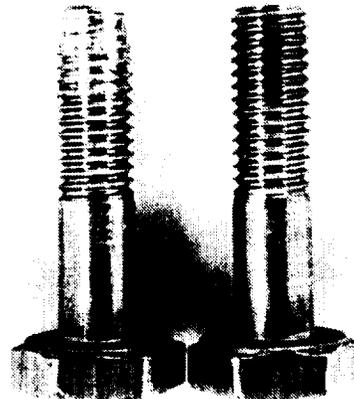
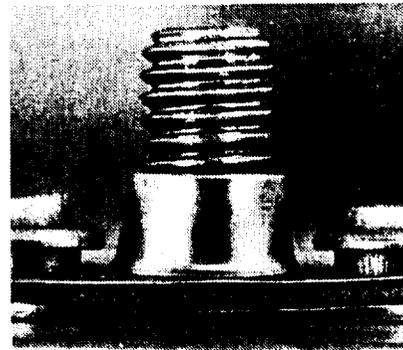
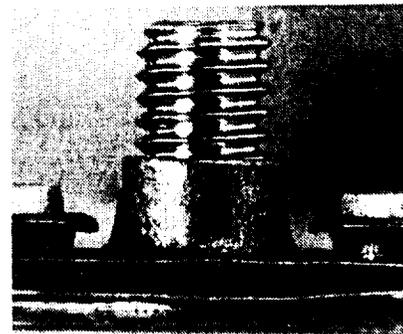
Figure 14 shows typical bolts removed from nutplates that had the MoS2 removed prior to bolt installation and removed from nutplates that had the MoS2 intact. Fourier transform infrared spectroscopy (FTIR) found no traces of the cetyl alcohol remaining in either the nutplates or bolts.

(Top) – Comparison of Thread Conditions of AO175 Tray Bolts Removed from Nut Plates. Undisturbed Assemblies Were Cross-Sectioned. Note Thread Galling Damage on Fastener That Had MoS2 Removed (Center).
