SURFACE CONTAMINATION ON LDEF EXPOSED MATERIALS *

C. S. Hemminger
The Aerospace Corporation
El Segundo, CA 90245
Phone: 310/336-1619; Fax: 310/336-5846

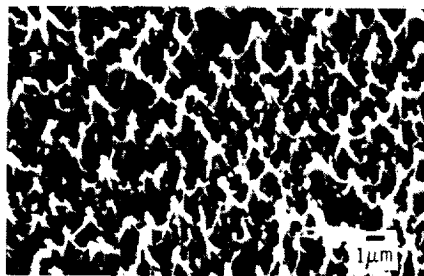
The SEM and XPS results (Ref. 1) for the exposed Ag/FEP surfaces are summarized in Table VII. The leading edge samples, from row 7 to 11, all had roughened surfaces typical of high velocity atomic oxygen erosion of FEP, as seen in Figure 1 for FEP exposed on C11 compared to a featureless control surface. The highly textured surfaces gave rise to diffuse light scattering and the consequent cloudy appearance. The XPS data for the control surface showed carbon and fluorine only. The XPS analysis of the exposed surfaces showed that the surface composition of the FEP remaining after the erosion was indistinguishable in carbon and fluorine composition from the control, with trace amounts of some contaminants (Si, N, S, and Cl) and measurable oxygen present. This oxygen could be from the atomic oxygen interaction or from water adsorption from the atmosphere after retrieval. Water adsorption could be enhanced on the erosion-roughened surfaces

LDEF TRAY C11 EXPOSED TEFLON

CONTROL TEFLON SURFACE

Figure 1. SEM images and surface composition of FEP. A leading edge surface with atomic oxygen erosion is compared to a featureless control surface.

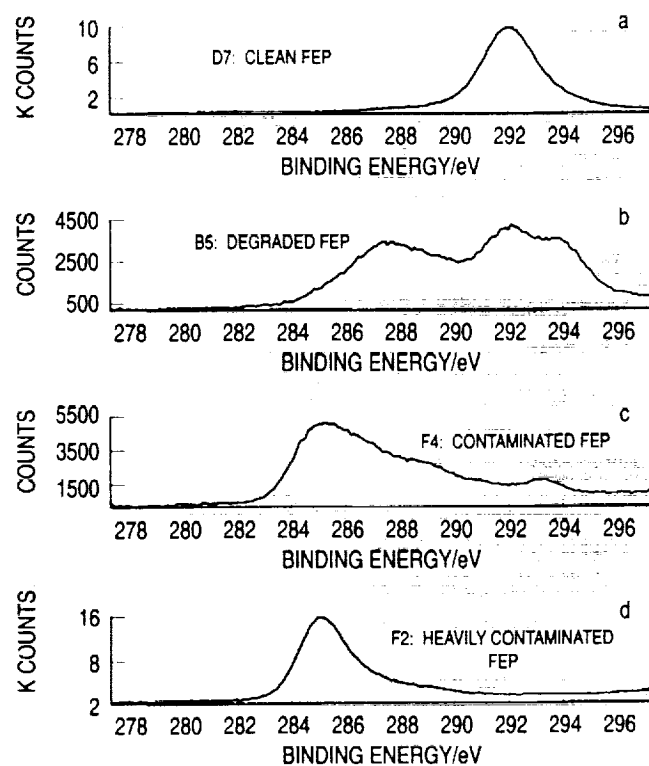
which have much higher surface area than the control. The surface chemistry of these leading edge samples was identical to clean FEP Teflon, judged by a comparison of the F:C mole ratio and the C1s peak shape. The C1s spectrum from the D7 blanket surface is shown in Figure 2a; curve-fitting revealed the major CF₂ peak at 292 eV and moderate CF and CF₃ peaks (approximately 10% each) at 289.5 eV and 294 eV, respectively. This matched the spectrum predicted for FEP with an approximate ethylene/propylene comonomer blend of 90%/10%. It appeared that deposited contaminants and damaged polymer were both removed during atomic oxygen erosion.

XPS data divided the trailing edge surfaces into two categories. The first was characterized by low contamination levels (Si < 1%) and a C1s spectrum, as in Figure 2b, that differs significantly from that of clean FEP, but does not have a major peak at 285 eV. The second category was characterized by moderate to high levels of surface contamination (Si, O, C, N, and S, and sometimes Cl) and a C1s spectrum dominated by a peak at 285 eV, as seen in Figure 2c and d. Contaminant carbon was distinguishable from FEP and degraded FEP carbon by binding energy, and was measured at $\leq 20\%$ of the total surface composition. The C1s peak at 285 eV is predominantly due to C-C bonds, and is thought to build up on the trailing edge surfaces from decomposition products of outgassed silicones and hydrocarbons. The C1s spectrum in Figure 2b arises from degradation of the FEP surface, for which the C1s spectrum is shown in Figure 2a. Curve-fitting shows that the decrease in intensity of the CF₂ peak at 292 eV is accompanied by major increases in intensity at 294 eV, 289.5 eV, and 287 eV, assigned to CF₃, CF, and C-(CF_n)₄, respectively. These changes are consistent with damage to the carbon backbone of the Teflon polymer resulting in molecular weight degradation, new chain terminations, branching, and crosslinking through free radical reactions. The solar ultraviolet (UV) radiation exposure of the LDEF surfaces is thought to have caused this FEP surface degradation. The FEP surfaces were also exposed to the stress of about 34,000 thermal cycles, but the maximum temperatures calculated for Ag/FEP blankets on LDEF are less than 0°C (Ref. 2) and not sufficient to break chemical bonds. Exposure of FEP to the XPS x-ray source for several hours induced similar shifts in the C1s spectrum; almost all of the FEP C1s spectra used for curve-fitting in this study were acquired during the first minute of sample exposure to the x-ray source to minimize surface degradation from the analysis itself. A recent study of the degradation of polytetra-fluoroethylene (PTFE) Teflon by 3 keV electrons showed very similar XPS C1s spectra changes to those seen in Figure 2b as a function of electron irradiation and subsequent heating to drive off volatiles (Ref. 3). Degradation of the PTFE was attributed to the type of damage described above.

Figure 2a. XPS spectrum of the C1s peak of the D7 blanket surface. Representative of clean FEP.

2b. XPS spectrum of the C1s peak of the B5 blanket surface. Representative of degraded FEP.

2c. XPS spectrum of the C1s peak of the F4 blanket surface. Representative of contaminated FEP.

2d. XPS spectrum of the C1s peak of the F2 blanket surface. Representative of heavily contaminated FEP.

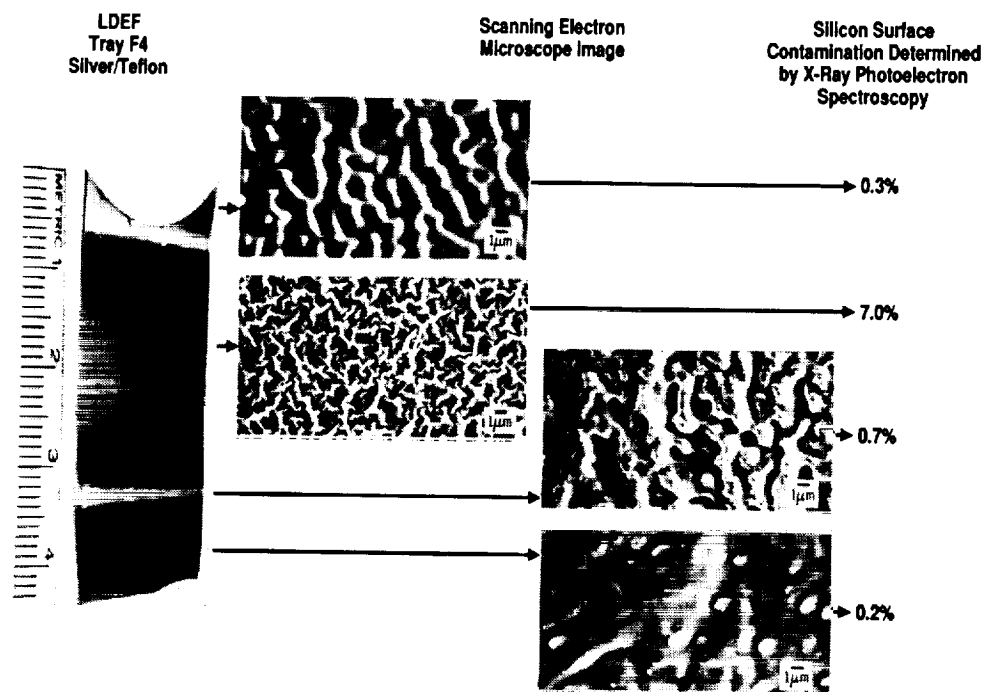
The FEP surfaces exposed on the trailing edge of LDEF underwent changes which were observed both by SEM and XPS. The surfaces lost the smooth, featureless texture of the unexposed FEP, even when the amount of contamination remained low, as indicated by low silicon concentration. SEM showed an intriguing variety of new surface textures. Within short distances on some trailing edge samples, both the surface morphology and surface contamination levels were observed to change dramatically, as seen in Figure 3. The FEP surfaces nearest to the trailing edge row 3 were moderately to heavily contaminated and the blanket surface areas which appear fogged or cloudy on the trailing edge had become sufficiently diffuse to change visibly. The contamination was very nonuniform. It is currently not clear if any causal relationship exists between observed morphology type and surface contamination build-up. It is possible that some morphologies will have a higher probability of trapping or adsorbing outgassed or backscattered species, thereby leading to greater surface contamination buildup. Further from row 3, FEP surfaces showed little texture development and no significant contamination except oxygen, possibly from postflight exposure. It is possible that low atomic oxygen exposure on rows 1, 5, and 6 was sufficient to remove the contaminant overlayer.

Figure 3. SEM images of surface morphology changes observed on a section of the trailing edge F4 blanket surface. The FEP surface appeared visibly patterned, as seen in the photograph on the left. The surface contamination, represented by Si concentration, was very nonuniform.

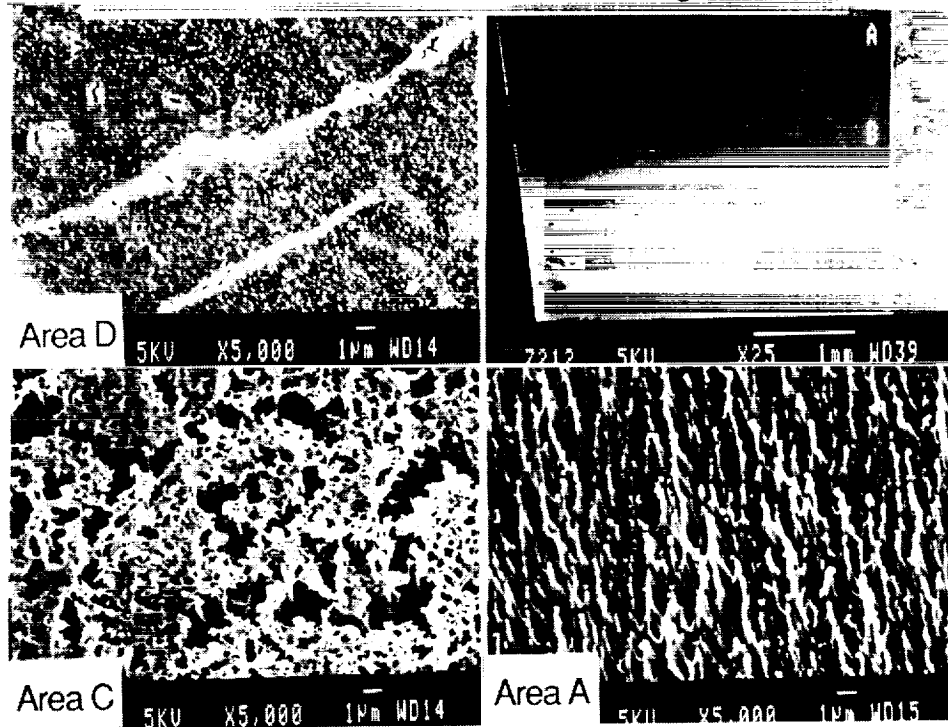
AO Erosion of A10 Thermal Blanket Edge Surface

The Ag/FEP thermal control blanket edges were contaminated, in many cases more than the exposed surfaces. Therefore, the masked edges did not provide good flight "control" samples. The transition zone from the exposed surface to the masked edge was particularly prone to contamination build-up. This was probably the result of the combination of high out-gas flux and radiation. The blankets were bent down around the edges of the tray so that the blanket edges were not rigorously shielded from radiation. SEM images from one transition zone, seen in Figure 4, showed that during atomic oxygen erosion of the FEP surface, undercutting of the contamination and damaged polymer layer played a role in the development of a clean, highly textured surface. Area A, at the periphery of the exposed surface, had a characteristic atomic oxygen erosion pattern. Area D, closer to the blanket edge, was a surface with contamination coverage and UV degraded FEP. Area C, in the center of the transition zone, showed undercutting of the contamination and damaged polymer layer by atomic oxygen erosion. The development of submicron particles of SiO_2 was observed on some edge surfaces by SEM/EDS, as seen in Figure 5. Such particle development was not detected on any of the other samples included in this study. Areas of orange/brown contamination were observed on some Ag/FEP edge surfaces near keyhole-shaped vent slots in the blanket edges. XPS analysis showed these stains to be high in carbon, sulfur, and nitrogen relative to other contaminated areas. The source of contamination was not identified, but it appears to have contained an amine/amide functionality.

Figure 4. SEM images of a transition zone on the A10 blanket edge. Area A has the characteristic atomic oxygen erosion pattern. Area D is a surface with contamination coverage and UV degraded FEP. Area C shows undercutting of the contamination and damaged polymer layer.

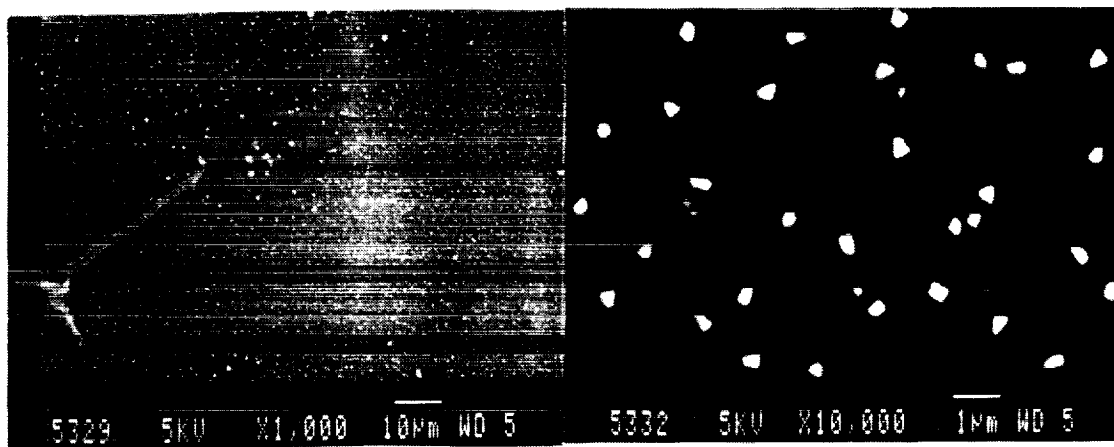
C8: UNEXPOSED EDGE

Figure 5. SEM images of submicron particles of SiO₂ on a masked edge surface of the C8 blanket.
