LONG DURATION EXPOSURE FACILITY
M0003-5
Thermal Control Coatings
on
DoD Flight Experiment

Charles J. Hurley
University of Dayton Research Institute
Dayton, OH

INTRODUCTION

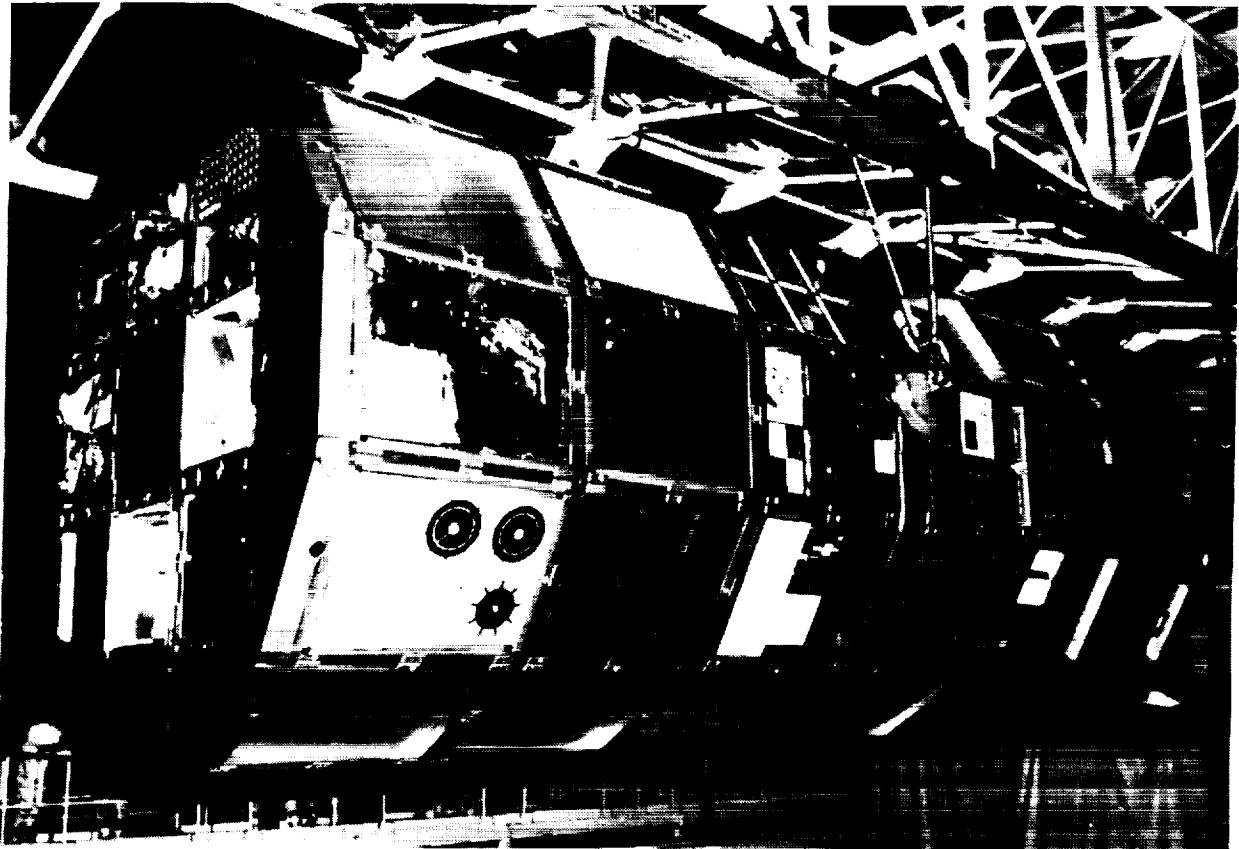
Figure 1. LDEF in Orbital Processing Facility

The photograph in figure 1 shows the extensive damage done to some of the experiments on the leading edge side and the space end of the vehicle. The M0003 experiment is located near the center of the vehicle at the scuff plate.

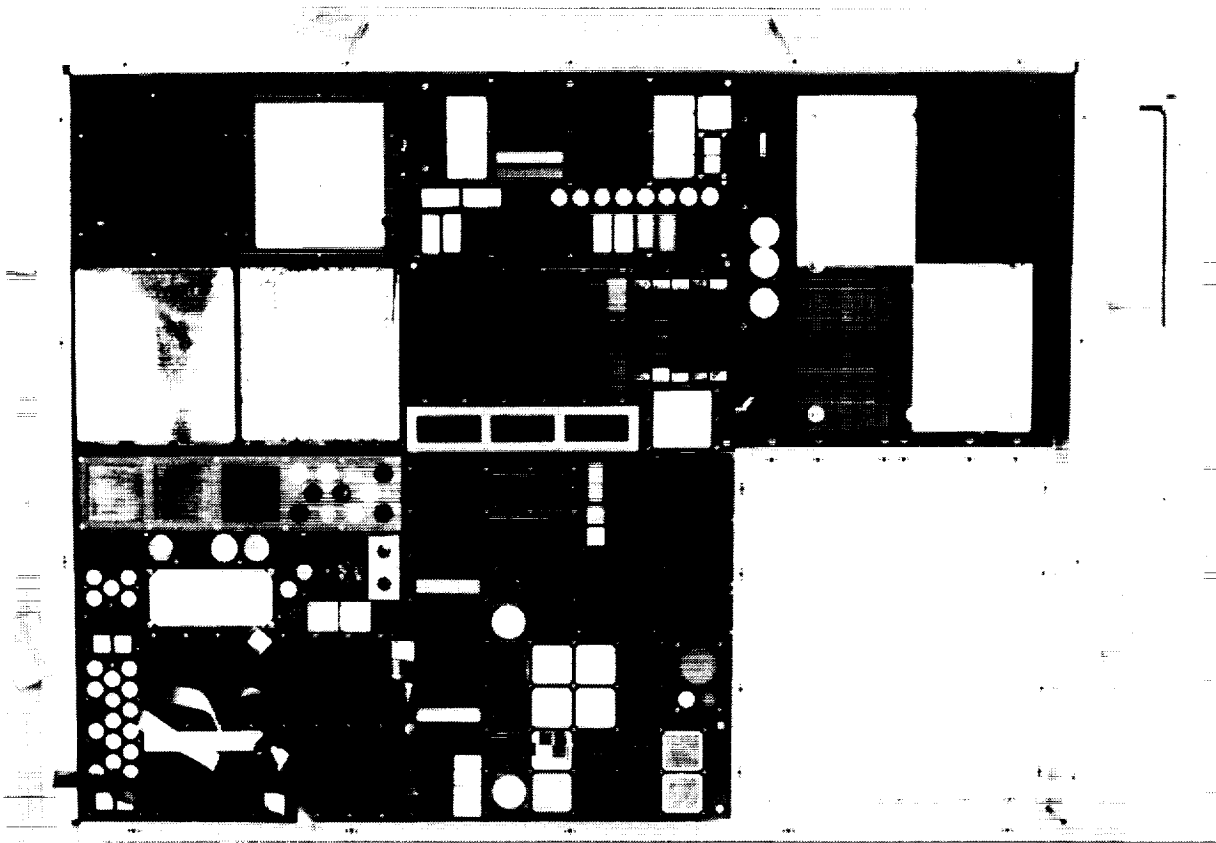
Figure 4. M0003 Post Flight Leading Edge Tray

A photograph of the recovered M0003 leading edge tray originally located in the D9 position is shown in figure 4. Among the various areas of visible damage, note the condition of the polymeric films portion of the M0003-5 experiment located in the lower left quadrant of the tray. The thermal control material discs and squares are located in the far lower left quadrant. Atomic oxygen contributed some physical damage to the materials, especially the front surface. Silver mirrors and radiation contributed some color changes.

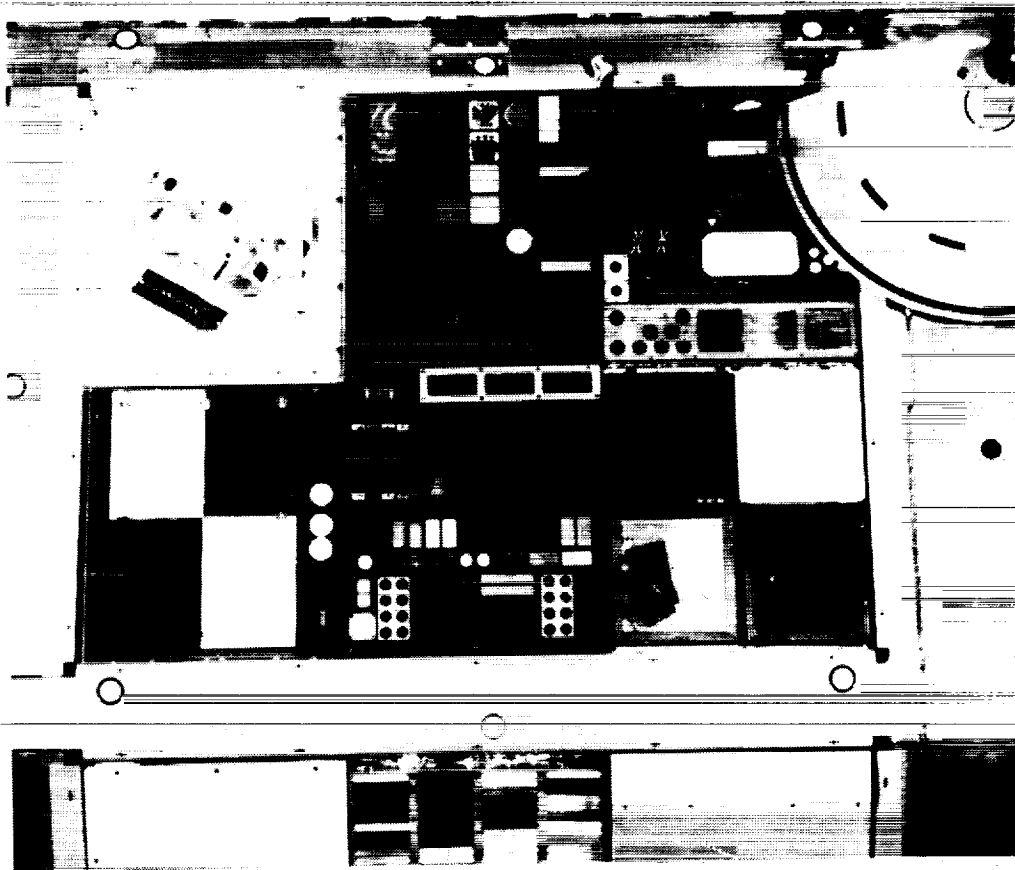
Figure 5. LDEF/M0003 IN SAEF II

The photograph in figure 5 shows the M0003 experiment and the surrounding trays. Note the extensive damage to the experiment located in tray D10 immediately above tray D9 M0003 experiment tray. Also observe the serious damage that occurred to the M0003-1 experiment located in the lower right quadrant of the tray. Damage is also evident to the M0003-5 polymer film materials. The thermal control discs are partially obscured by the scuff plate.

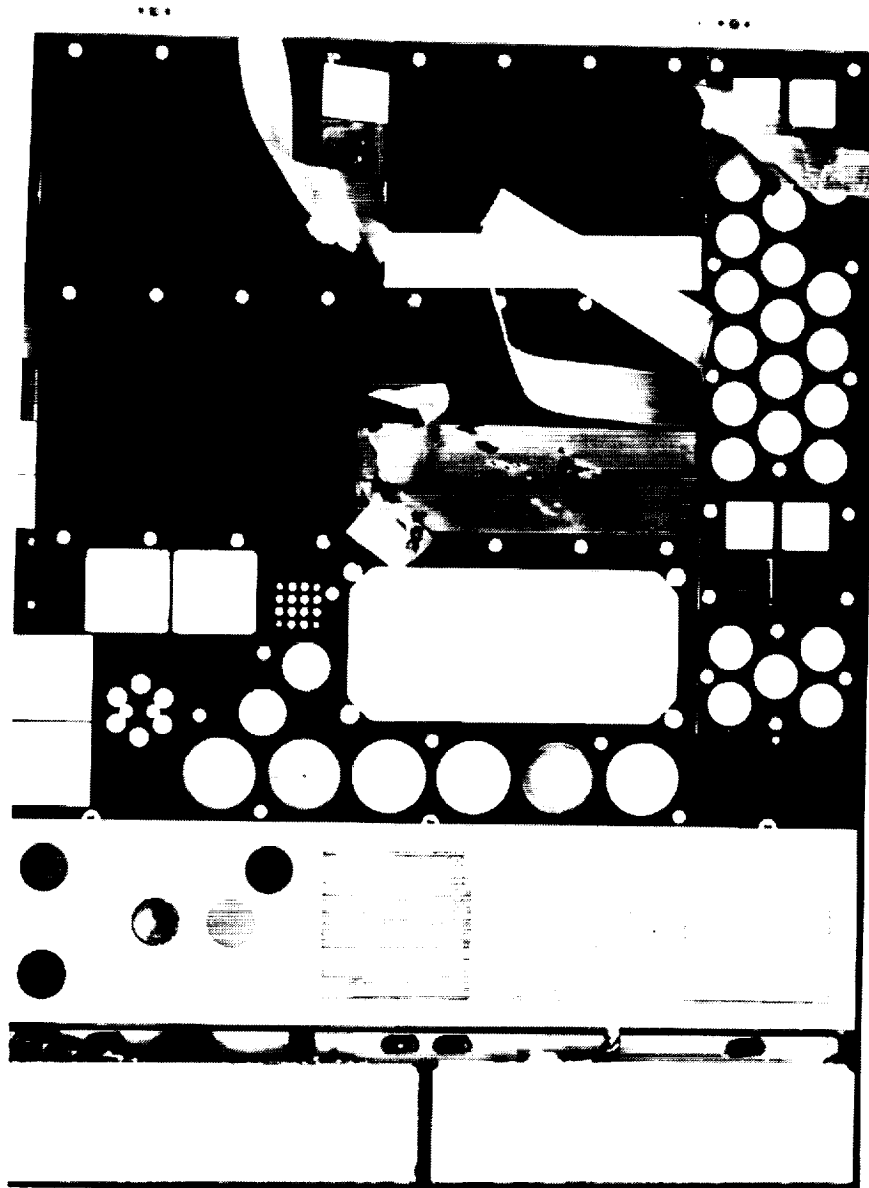
Figure 6. M0003-5 Post Flight Leading Edge Tray Closeup

The photograph in figure 6 below shows a closeup of the M0003-5 experiment materials. Note the extensive damage to the polymeric film strips. There is obvious physical damage, discoloration and debonding of the materials. The thermal control materials discs are located on the right hand side of the photograph. The most evident damage are the two front surface silver mirrors which were destroyed by atomic oxygen.

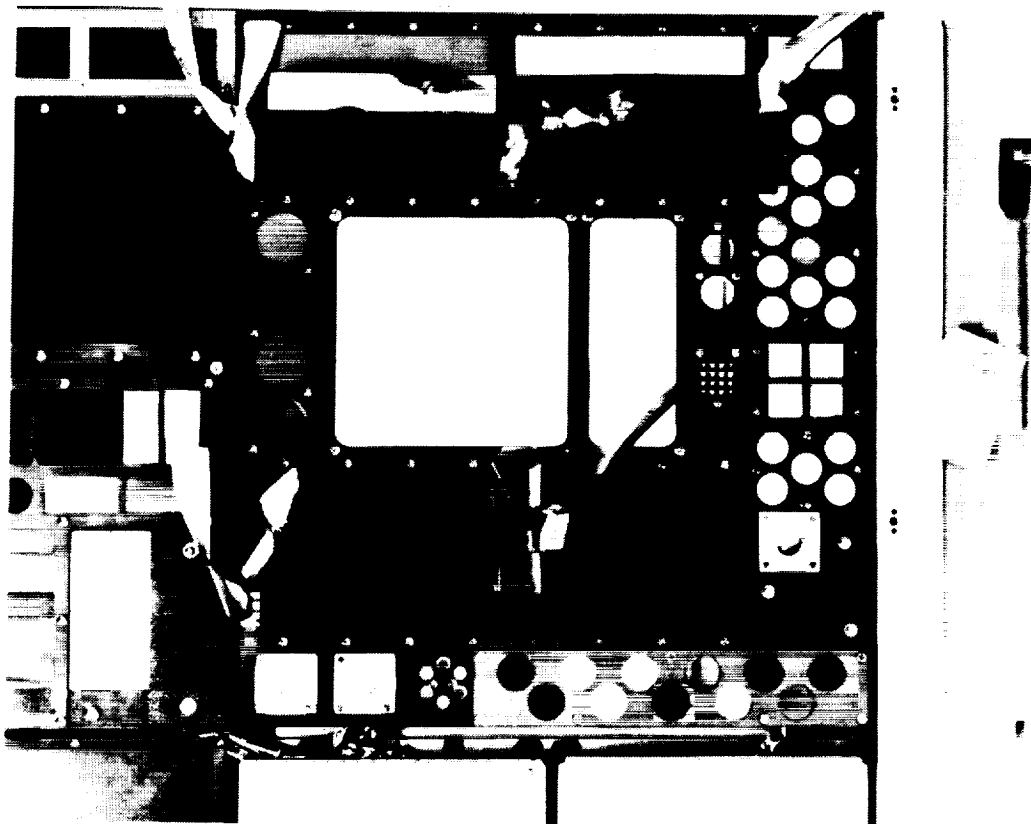
Figure 8. M0003 Post Flight Trailing Edge tray

The photograph in figure 8 shows the post flight materials in the recovered trailing edge tray. Among the various areas of visible damage, note the condition of the M0003-5 polymeric film strips located in the upper right quadrant of the tray. The thermal control materials discs are located on the right side of the photograph. Contamination has discolored many of the specimens.

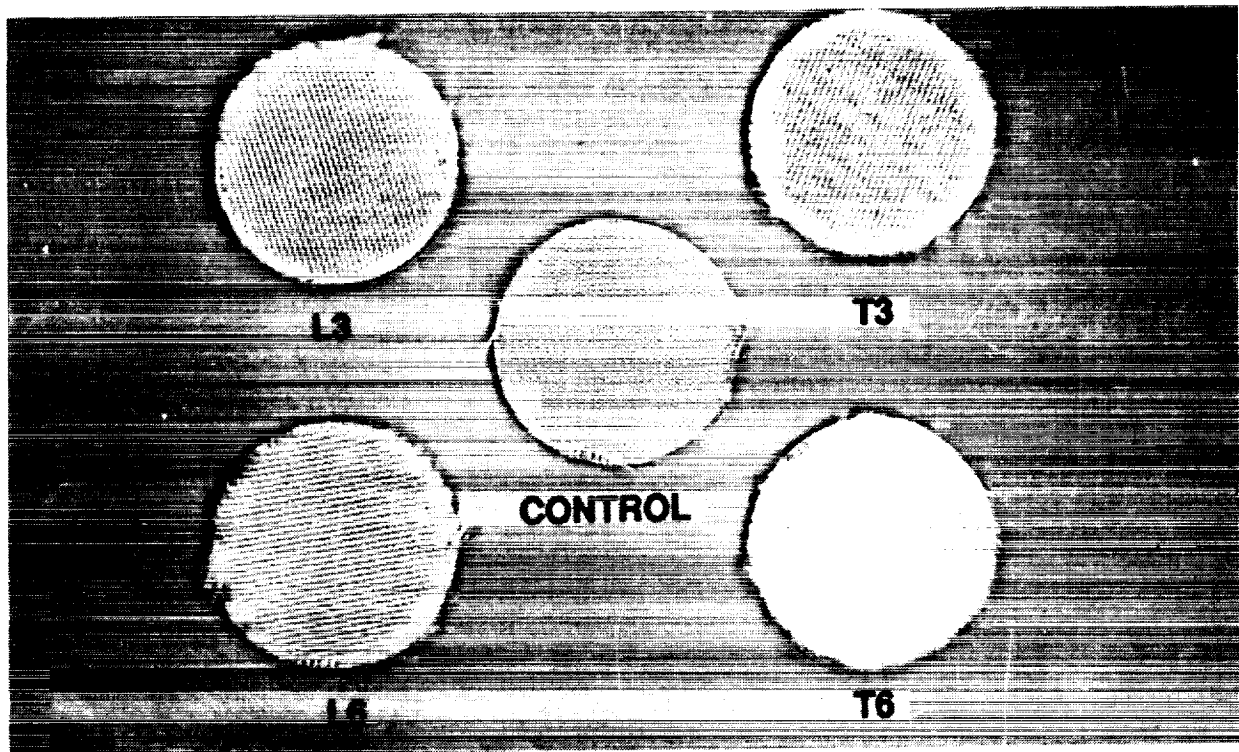
Figure 12. Comparison of Quartz Fabric 7 micron Specimens

Some fabric fraying is present at the rim of the specimen. The adhesive bond between the Quartz fabric and the substrate appears to be intact.

The exposed surface of the specimen exhibits a non-uniform distribution of a light-tan discoloration. The cloth weave shows no evidence of damage. The perimeter of the specimen is not discolored but the edges are frayed. The adhesive bond between the quartz fabric 7 micron and Al mounting disc appears intact.

The exposed surface of the specimen is discolored a yellowish tan. There is debris on the surface of the specimen. The weave pattern shows no evidence of damage. The perimeter of the specimen is not discolored, but the edges are frayed. The adhesive bond between the Quartz fabric 7 micron and the aluminum mounting disc appears intact.

The exposed area of the specimen is nonuniformly discolored a light brown. The weave pattern is undisturbed except for one small localized area. The perimeter of the specimen is clean and white with frayed edges. The adhesive bond between the Quartz fabric 7 micron and the aluminum mounting disc appears intact.

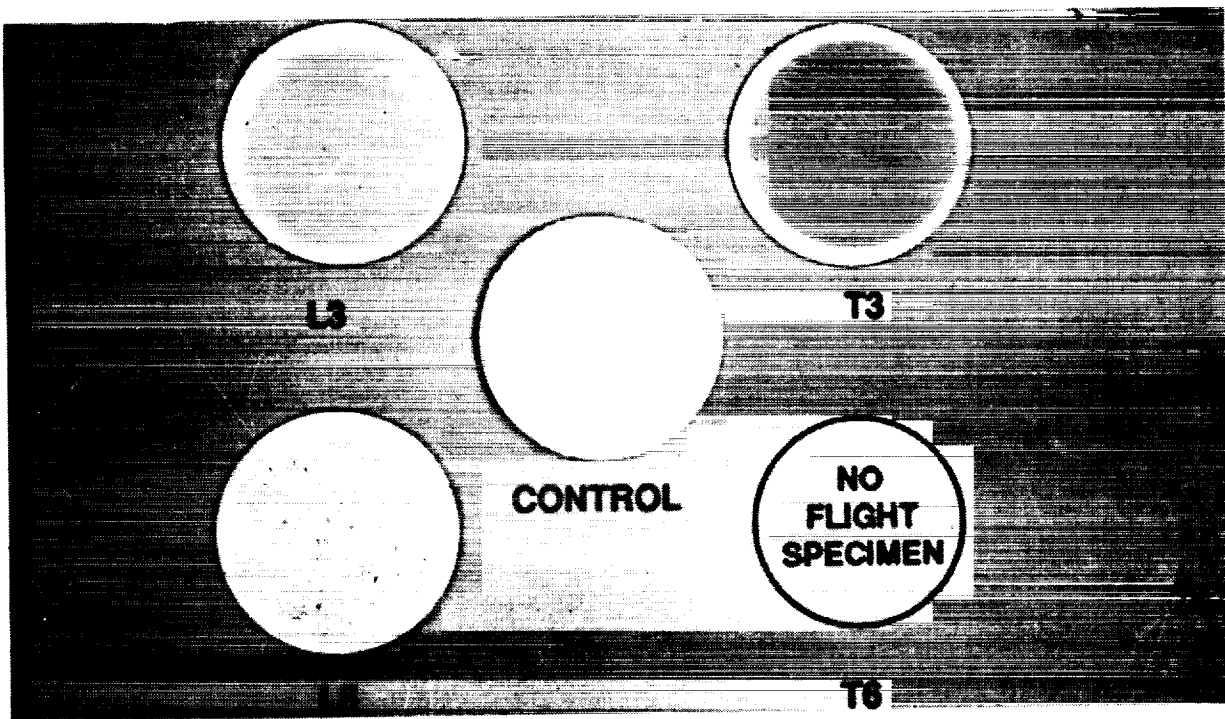
Figure 30. Comparison of DC92-007 White Silicone Coating Specimens

The exposed surface area of specimen is discolored a dark yellow, is moderately reflective and has extensive cracks in the coating. There are dark particles and fibers present on the exposed surface area. The coating perimeter of the specimen is white, reflective and slightly damaged.

The exposed surface area of the specimen is discolored a deep yellow-gold. There is an extensive network of cracks and fractures in the exposed area. There is a sheen or glazed appearance to the surface. Scuff marks and black particle debris are on the surface. The perimeter of the specimen is white, shiny, reflective and undamaged.

The exposed surface area of the specimen is yellow and slightly specular. The surface is rough in texture. A large amount of fibers and particles are present on the surface. The perimeter of the specimen is white and specular with debris.
