CLEANING OF A THERMAL VACUUM CHAMBER
WITH SHROUDS IN PLACE

William R. Bond
NSI Technology Services Corporation

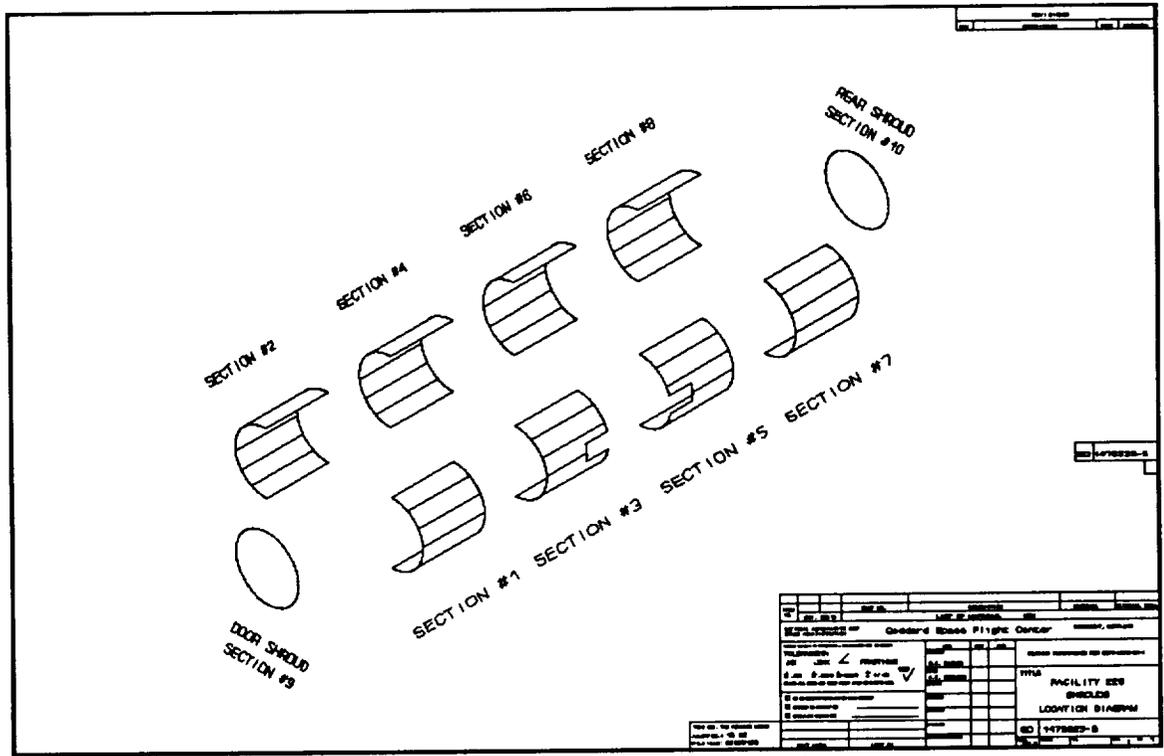
Figure 1 - Facility 225 Shroud Arrangement

major vacuum components were also substantially unchanged. The rotary piston pump and rotary lobe booster pump did not come with the chamber but were of similar age to the originals. Inside the chamber the thermal system consisted of front and rear shrouds and four pairs of side shrouds. (Figure 1) Shrouds 3 and 5 have cutouts to allow an opening for the old solar simulator source.

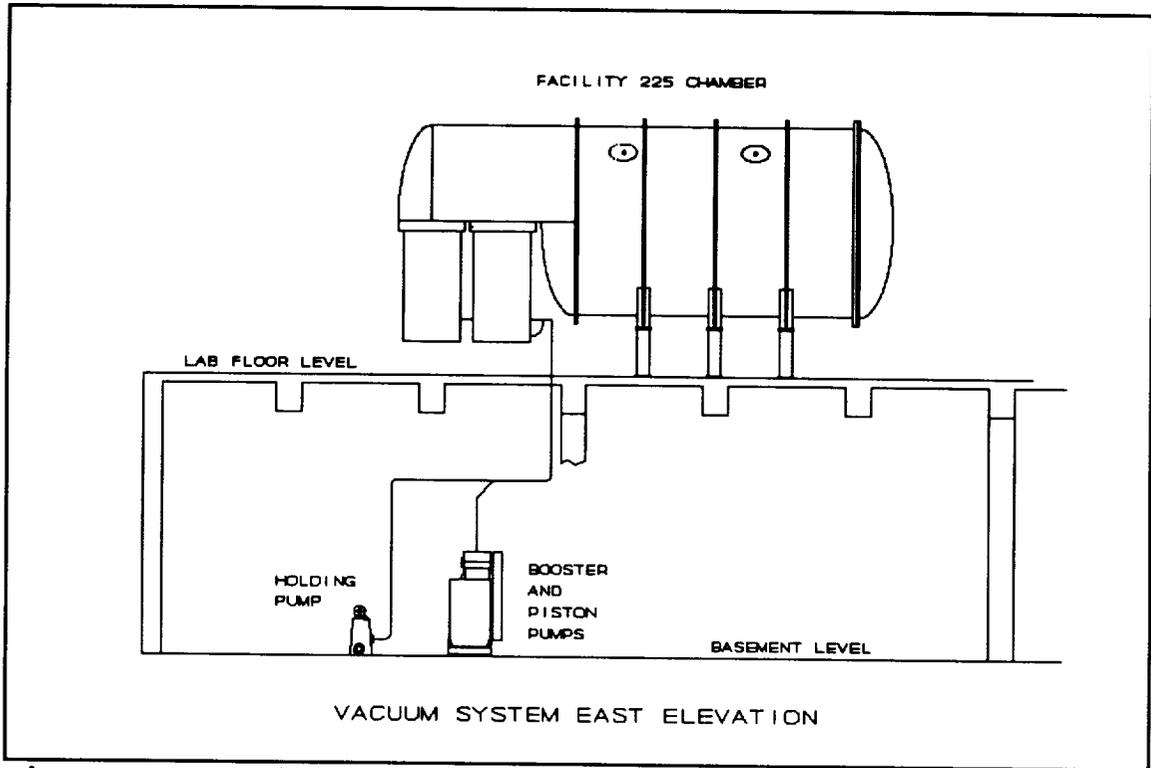
Figure 2 - Facility 225 Vacuum Pump Locations

Besides the previously mentioned piston and booster pumps, the vacuum system consists of three diffusion pumps and a small rotary piston pump. All of the mechanical pumps are located in a machine room in the basement. (Figure 2) The three diffusion pumps are located at the back of the chamber behind the rear shroud. No valves exist between the diffusion pumps and the chamber. The diffusion pumps use an oil described as 100% mixed isomers of pentaphenyl ether. Based upon the MSDS provided with the oil, the boiling point is 476°C and the flash point is 288°C.
