NASA Technical Memorandum 104759

Analysis of Impactor Residues in Tray Clamps from the Long Duration Exposure Facility

Part 1: Clamps from Bay "A" of the Satellite

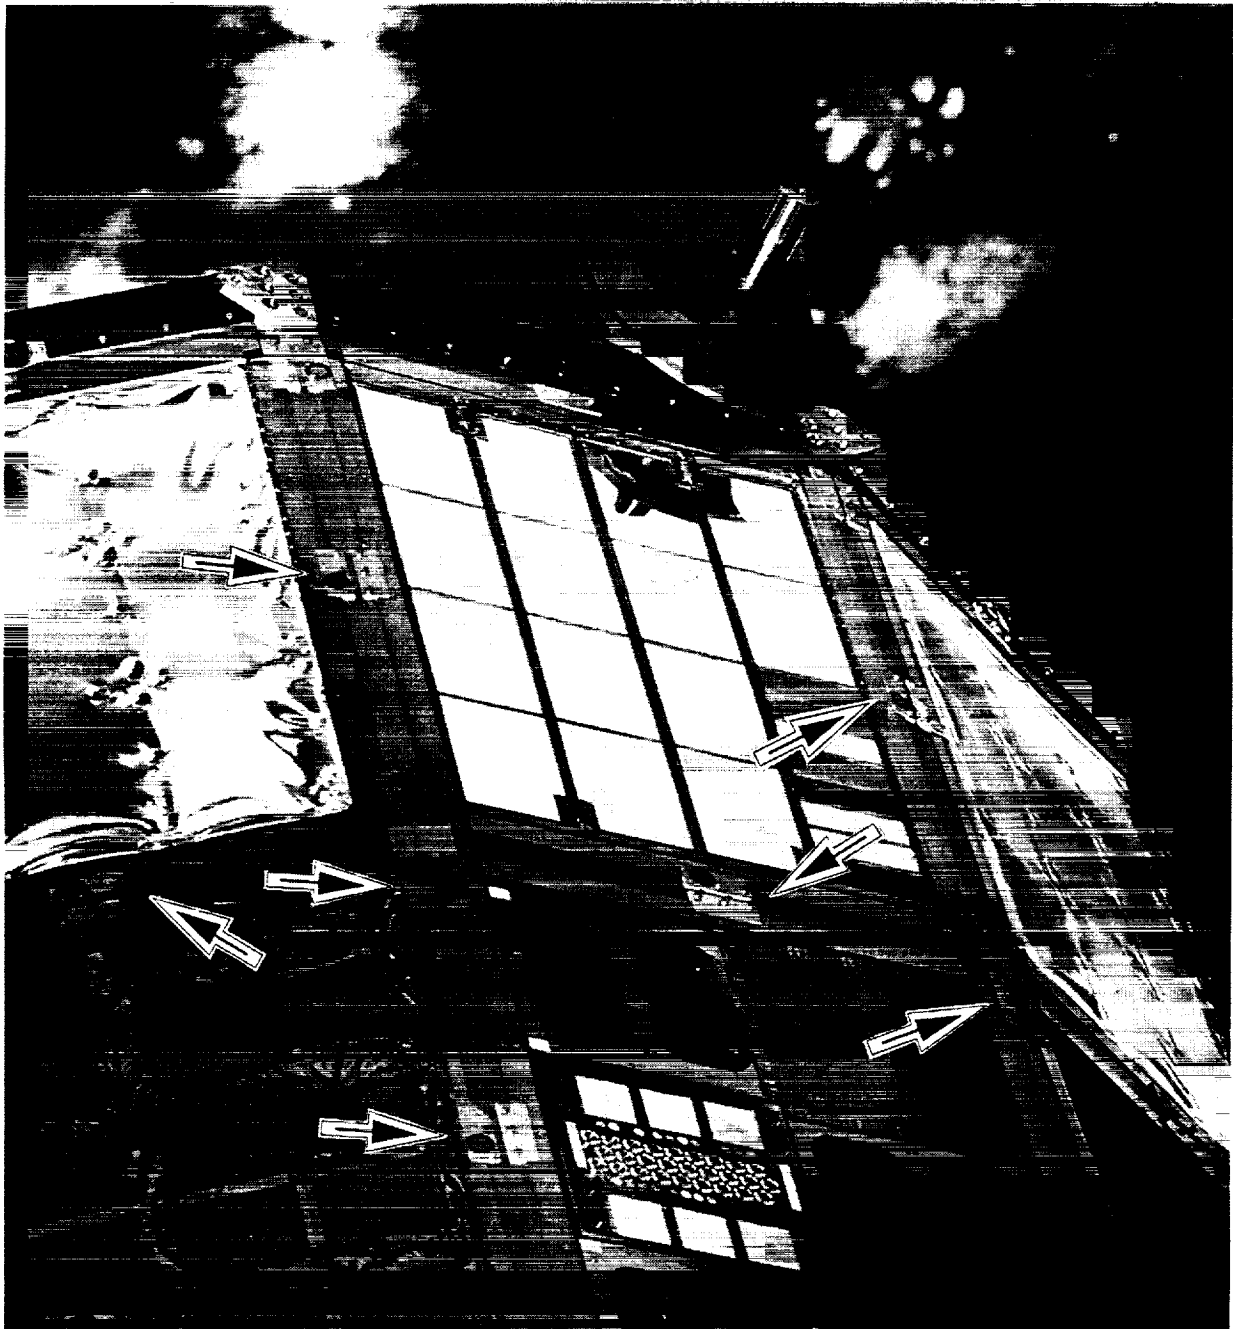
FIGURE 1. A photograph taken of the trailing/Earth edge of the Long Duration Exposure Facility (A03) during the STS-32 retrieval mission. The arrows placed on the photograph show the location of clamps used to hold experiment trays in place during their exposure in low Earth orbit. The circles or round patches on some of the clamps are test paint coupons. Several possess impact craters but, because of surface contamination impact residues, these were not characterized here.

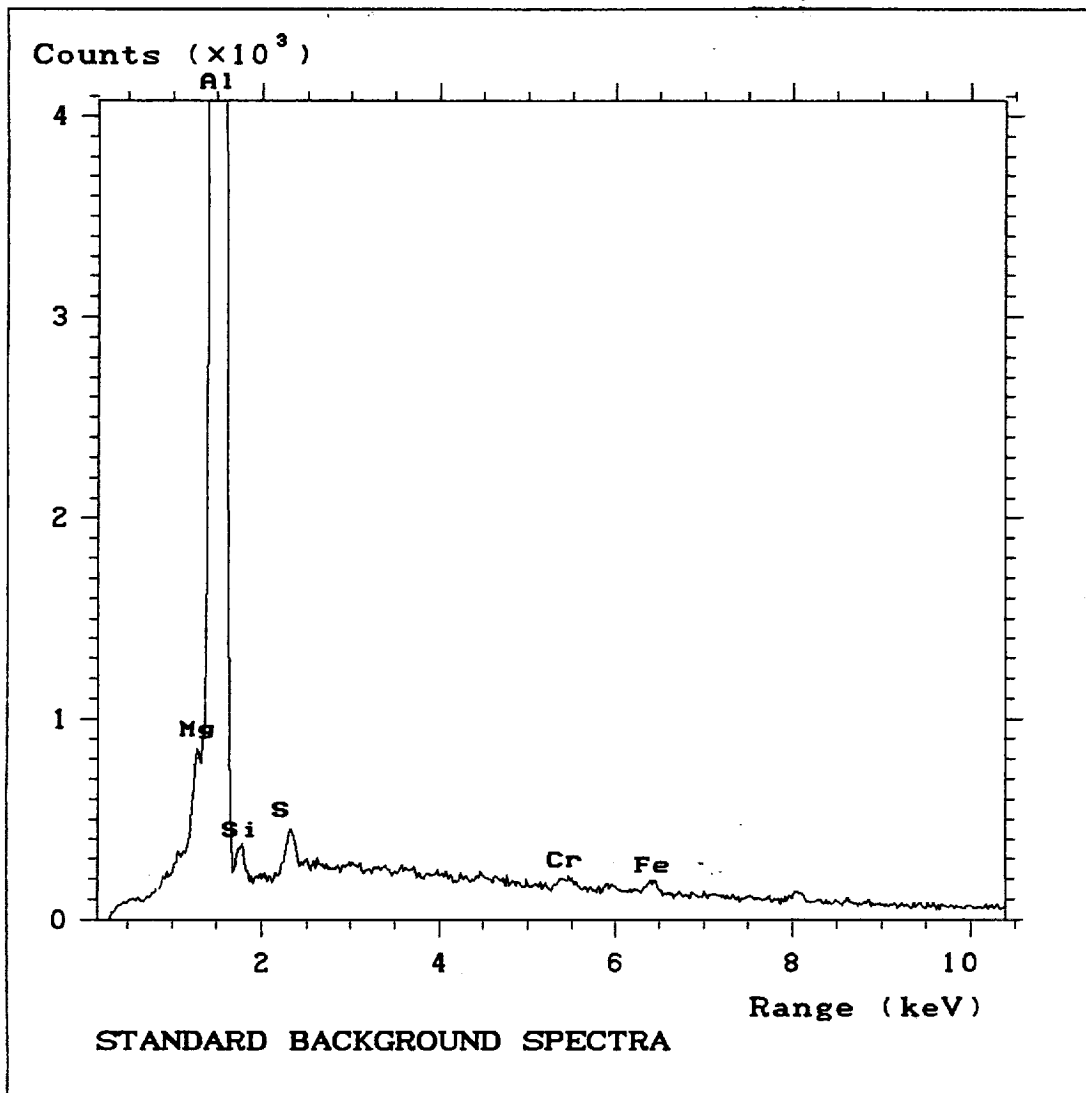
FIGURE 8. Many of the impacts analyzed by SEM/EDXA had no residue detected. These impact features are categorized as being unknown in origin. During analysis, no peaks above background were discernible; only the typical clamp materials were present. This spectra illustrates the typical composition of impacts with no detectable residue found.

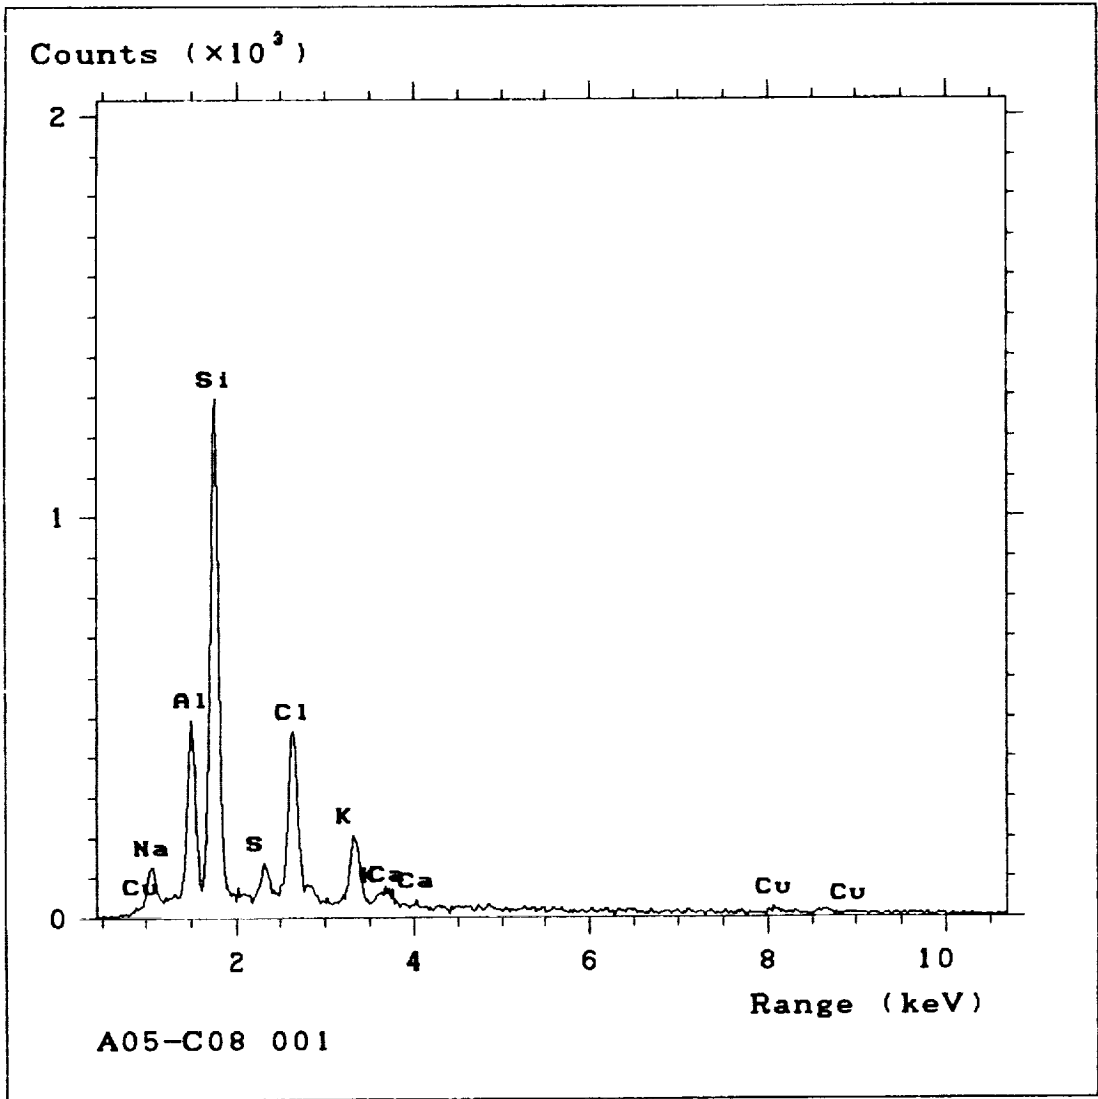
CLAMP NUMBER A05 CO8

<u>IMPACT NUMBER</u>	<u>DIAMETER</u>	<u>GENERAL COMPONENTS</u>
001	180	Contamination
