Debris/Ice/TPS Assessment And Integrated Photographic Analysis For Shuttle Mission STS-53

January 1993

DEBRIS/ICE/TPS ASSESSMENT
AND
PHOTOGRAPHIC ANALYSIS
OF
SHUTTLE MISSION STS-53

December 2, 1992

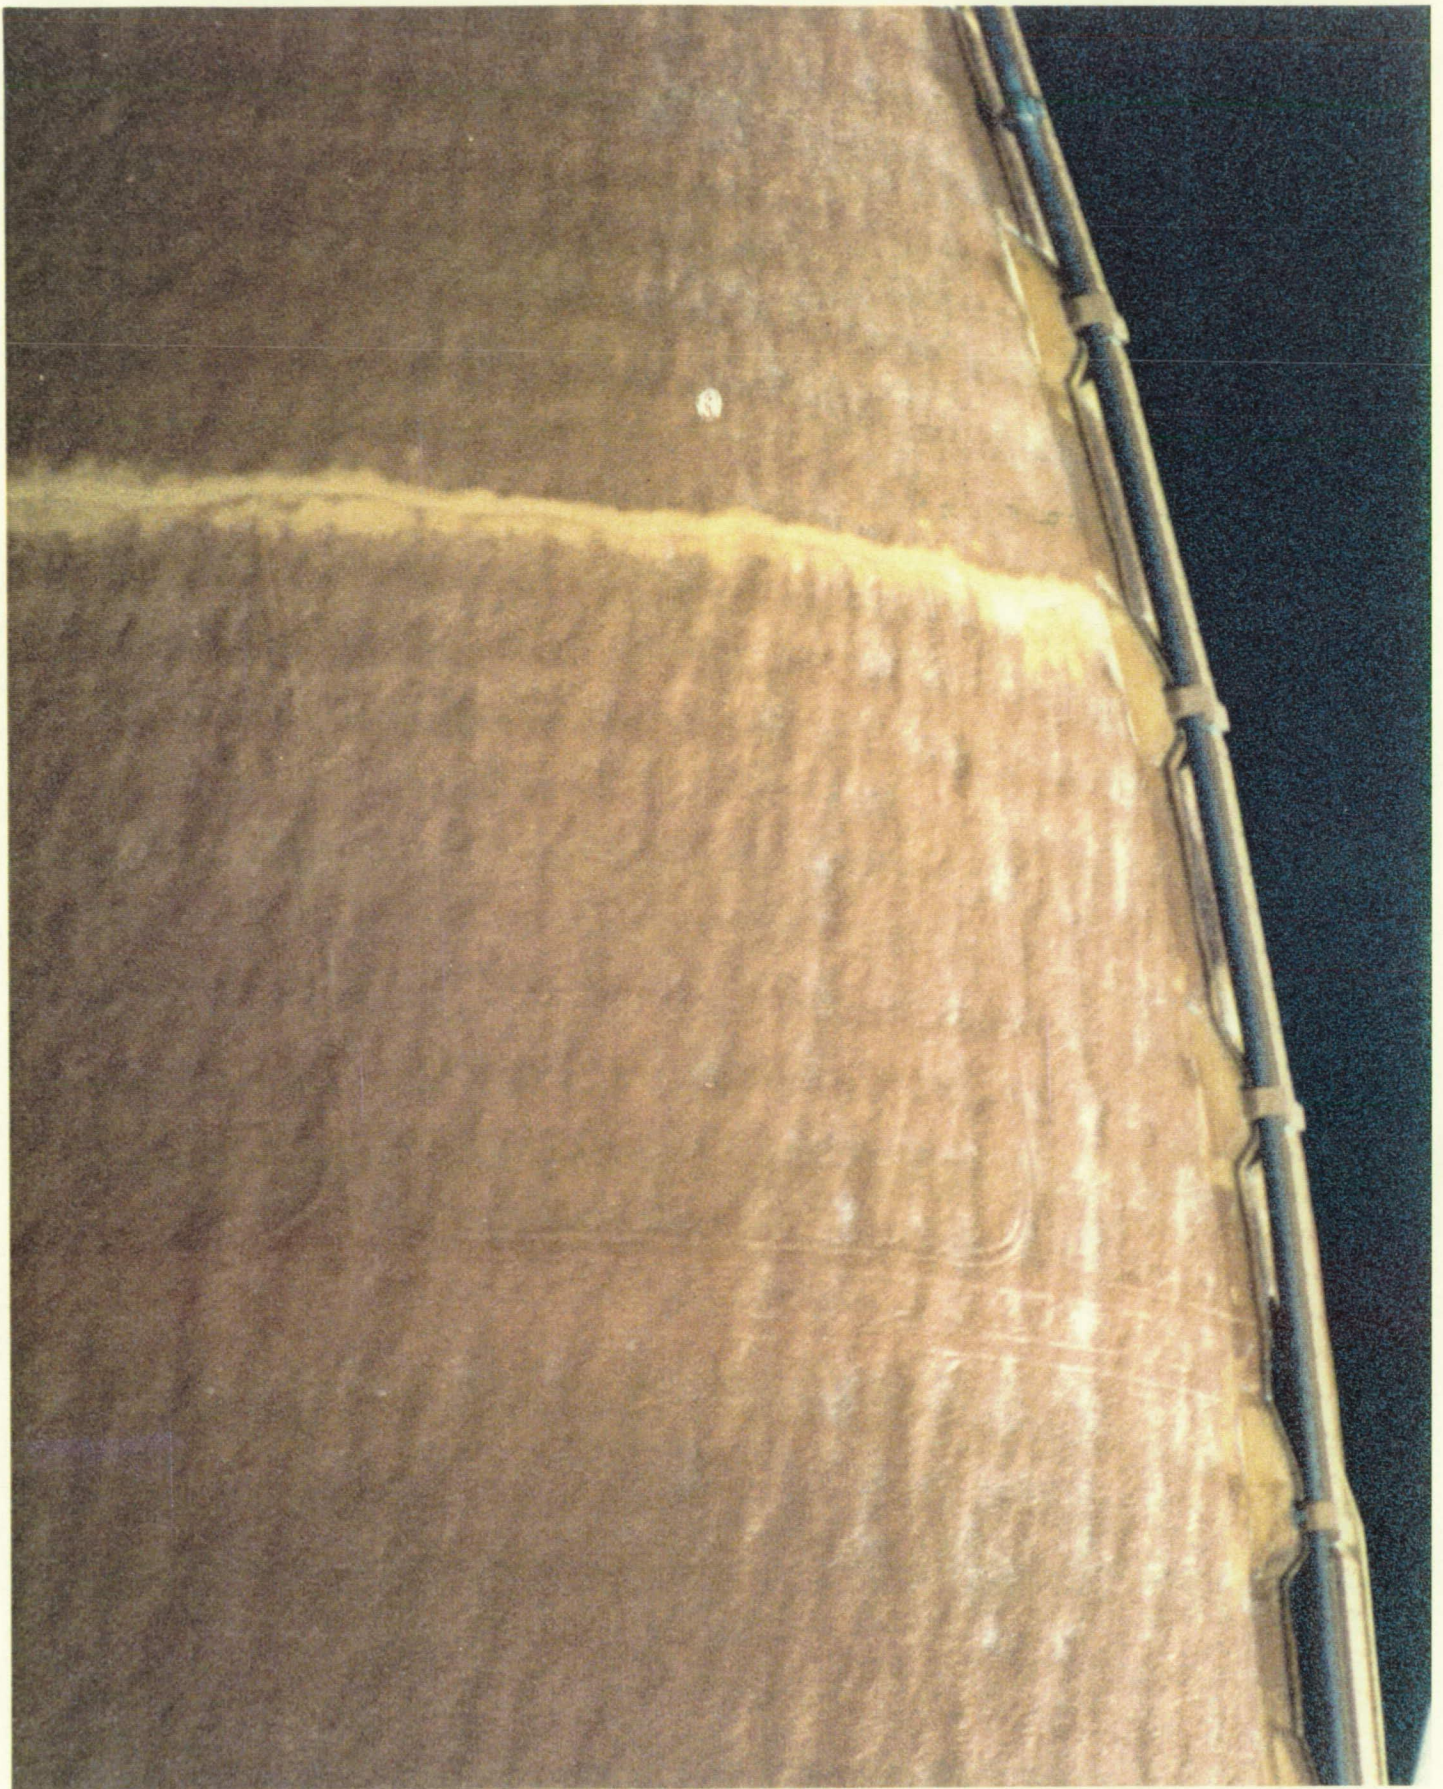
Anomaly 002 recorded ice accumulation on the +Y+Z quadrant acreage of both LO2 and LH2 tanks. Ice Team observations determined the ice thickness exceeded 0.0625 inches, which was an LCC violation. Launch was delayed until ambient warming melted the ice/frost formations. A second on-pad visual inspection at 0730 hours revealed ice/frost conditions were acceptable for launch.

At the time of the Ice Inspection, condensate on the LO2 tank barrel section +Y+Z quadrant was freezing and changing to ice with a frost covering. The ice thickness exceeded the 1/16 inch allowed in the LCC.

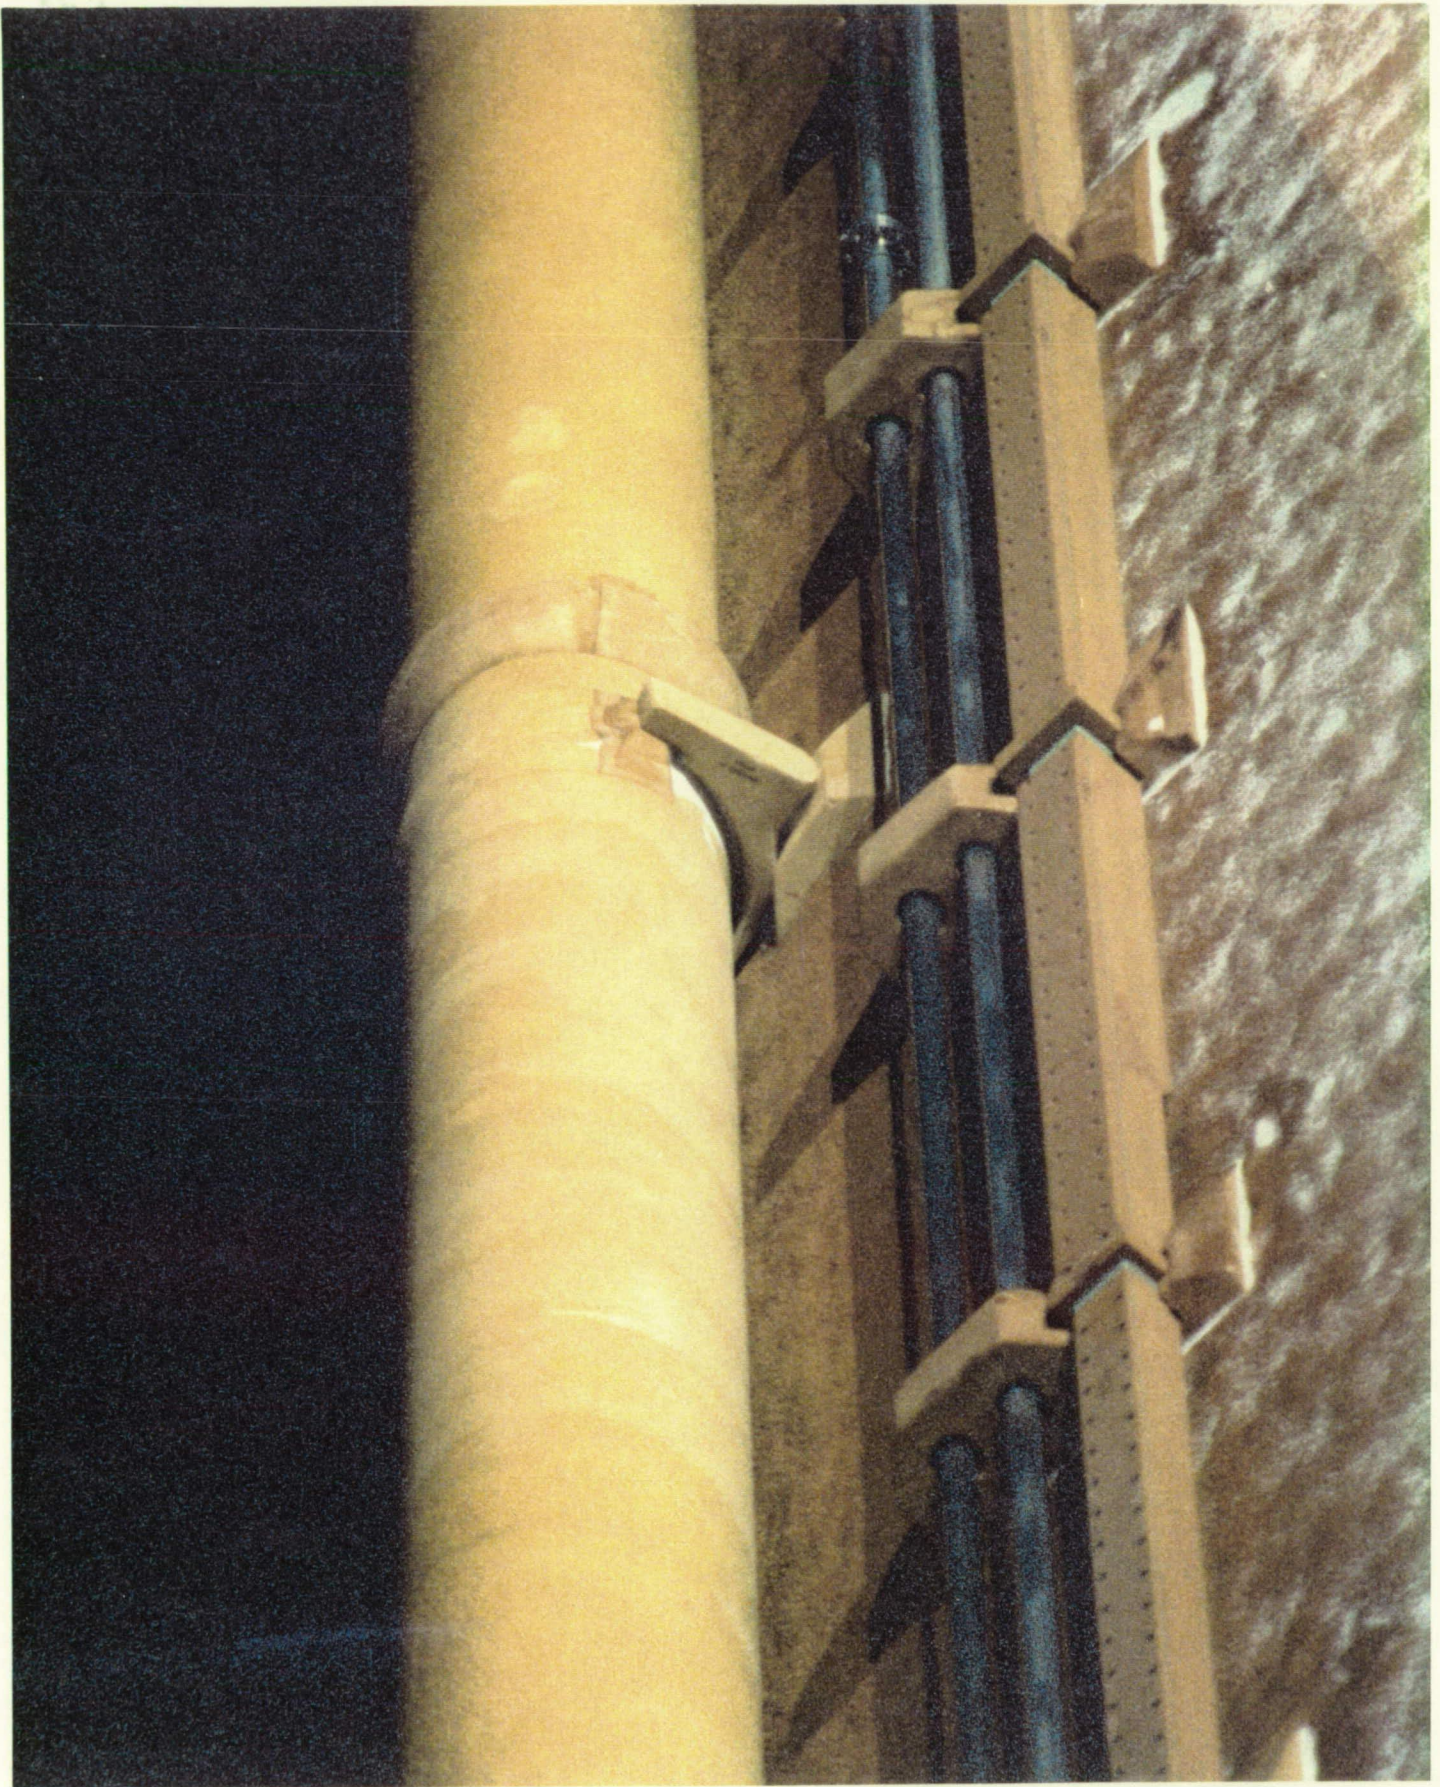
Ice/frost had formed on the LH2 tank acreage, in the L02 feed line support brackets, and along the cable tray ramps

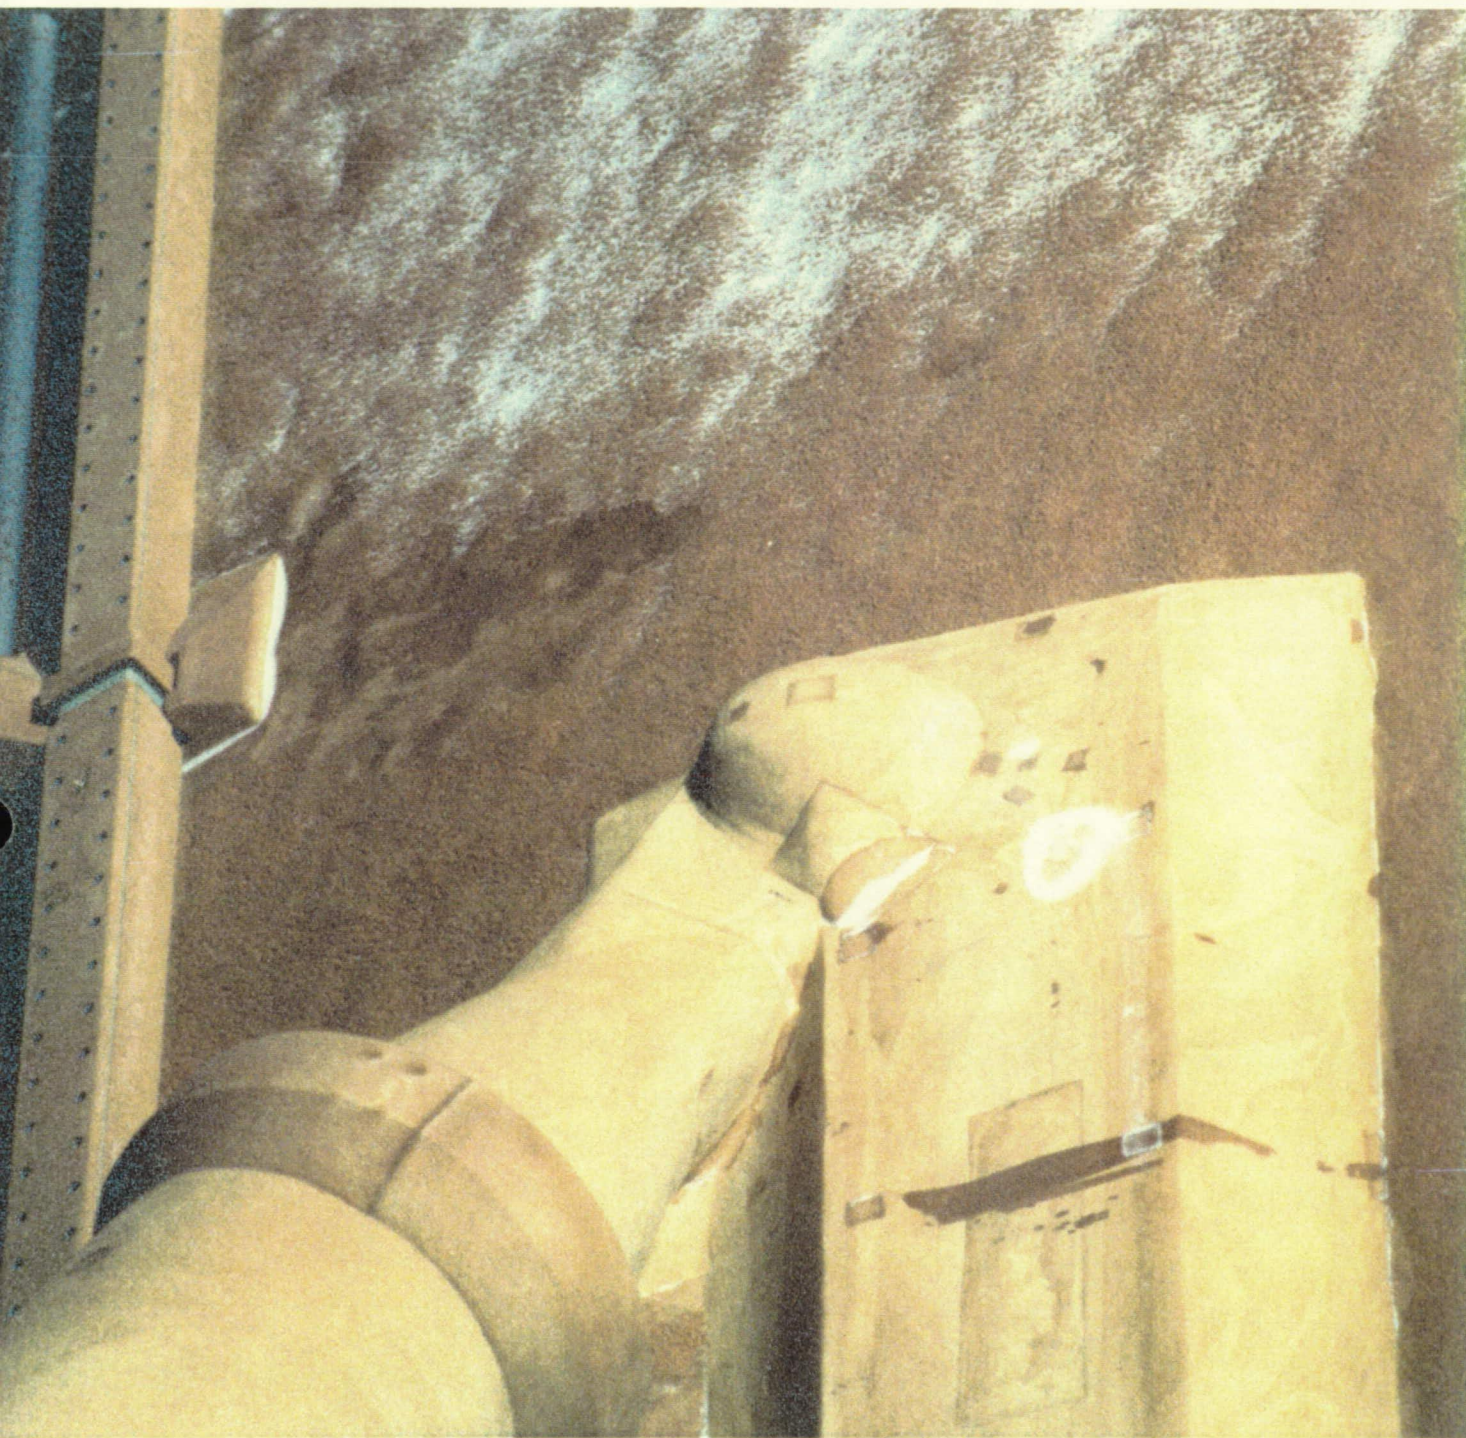
Ice/frost had formed on the lower LH2 tank TPS acreage and along the cable tray ramp bondline closeouts. An ice/frost formation on the +Y longeron closeout was emitting vapors, but exhibited no offset.

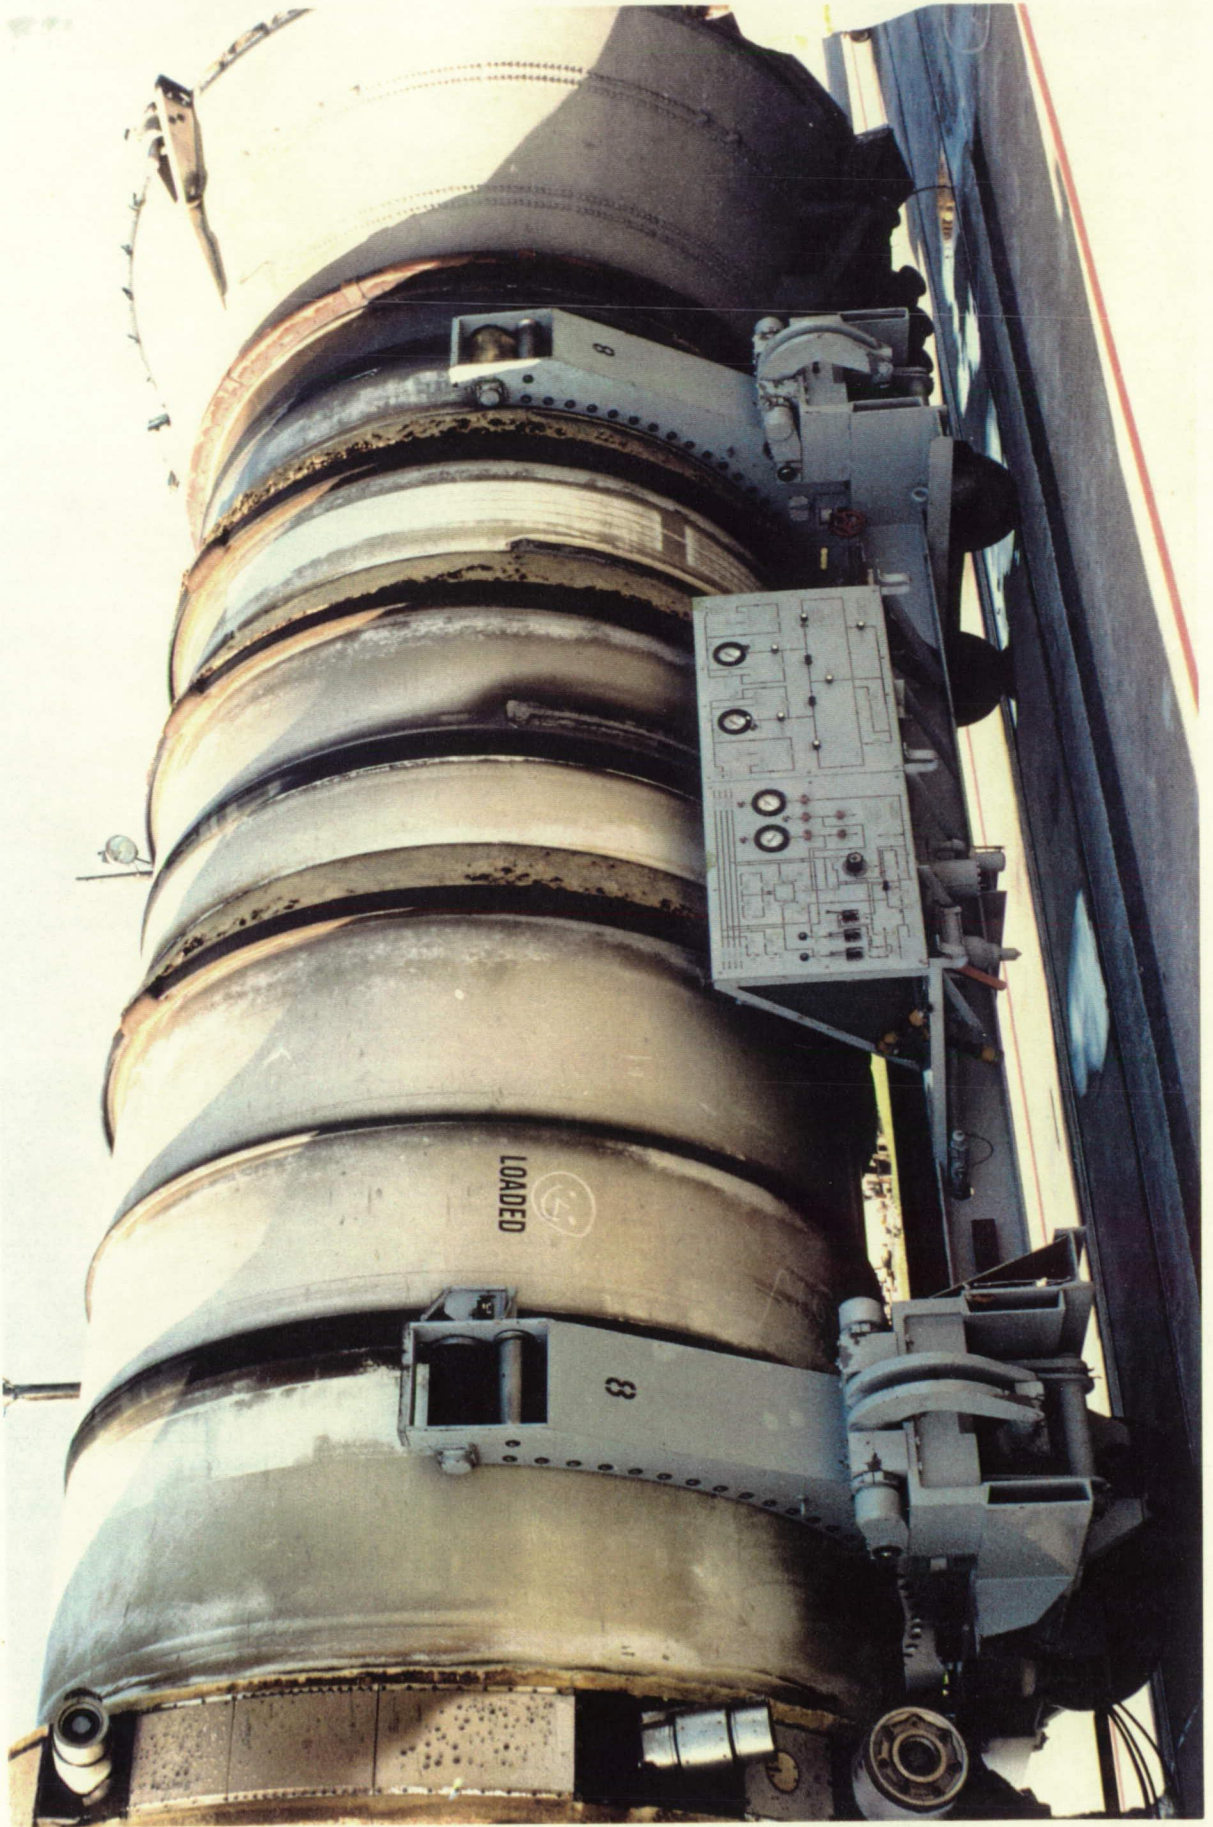
Post flight condition of the LH aft booster. The ET/SRB aft struts, ETA ring, IEA, and IEA covers appeared undamaged. Two aft booster stiffener rings sustained water impact damage.

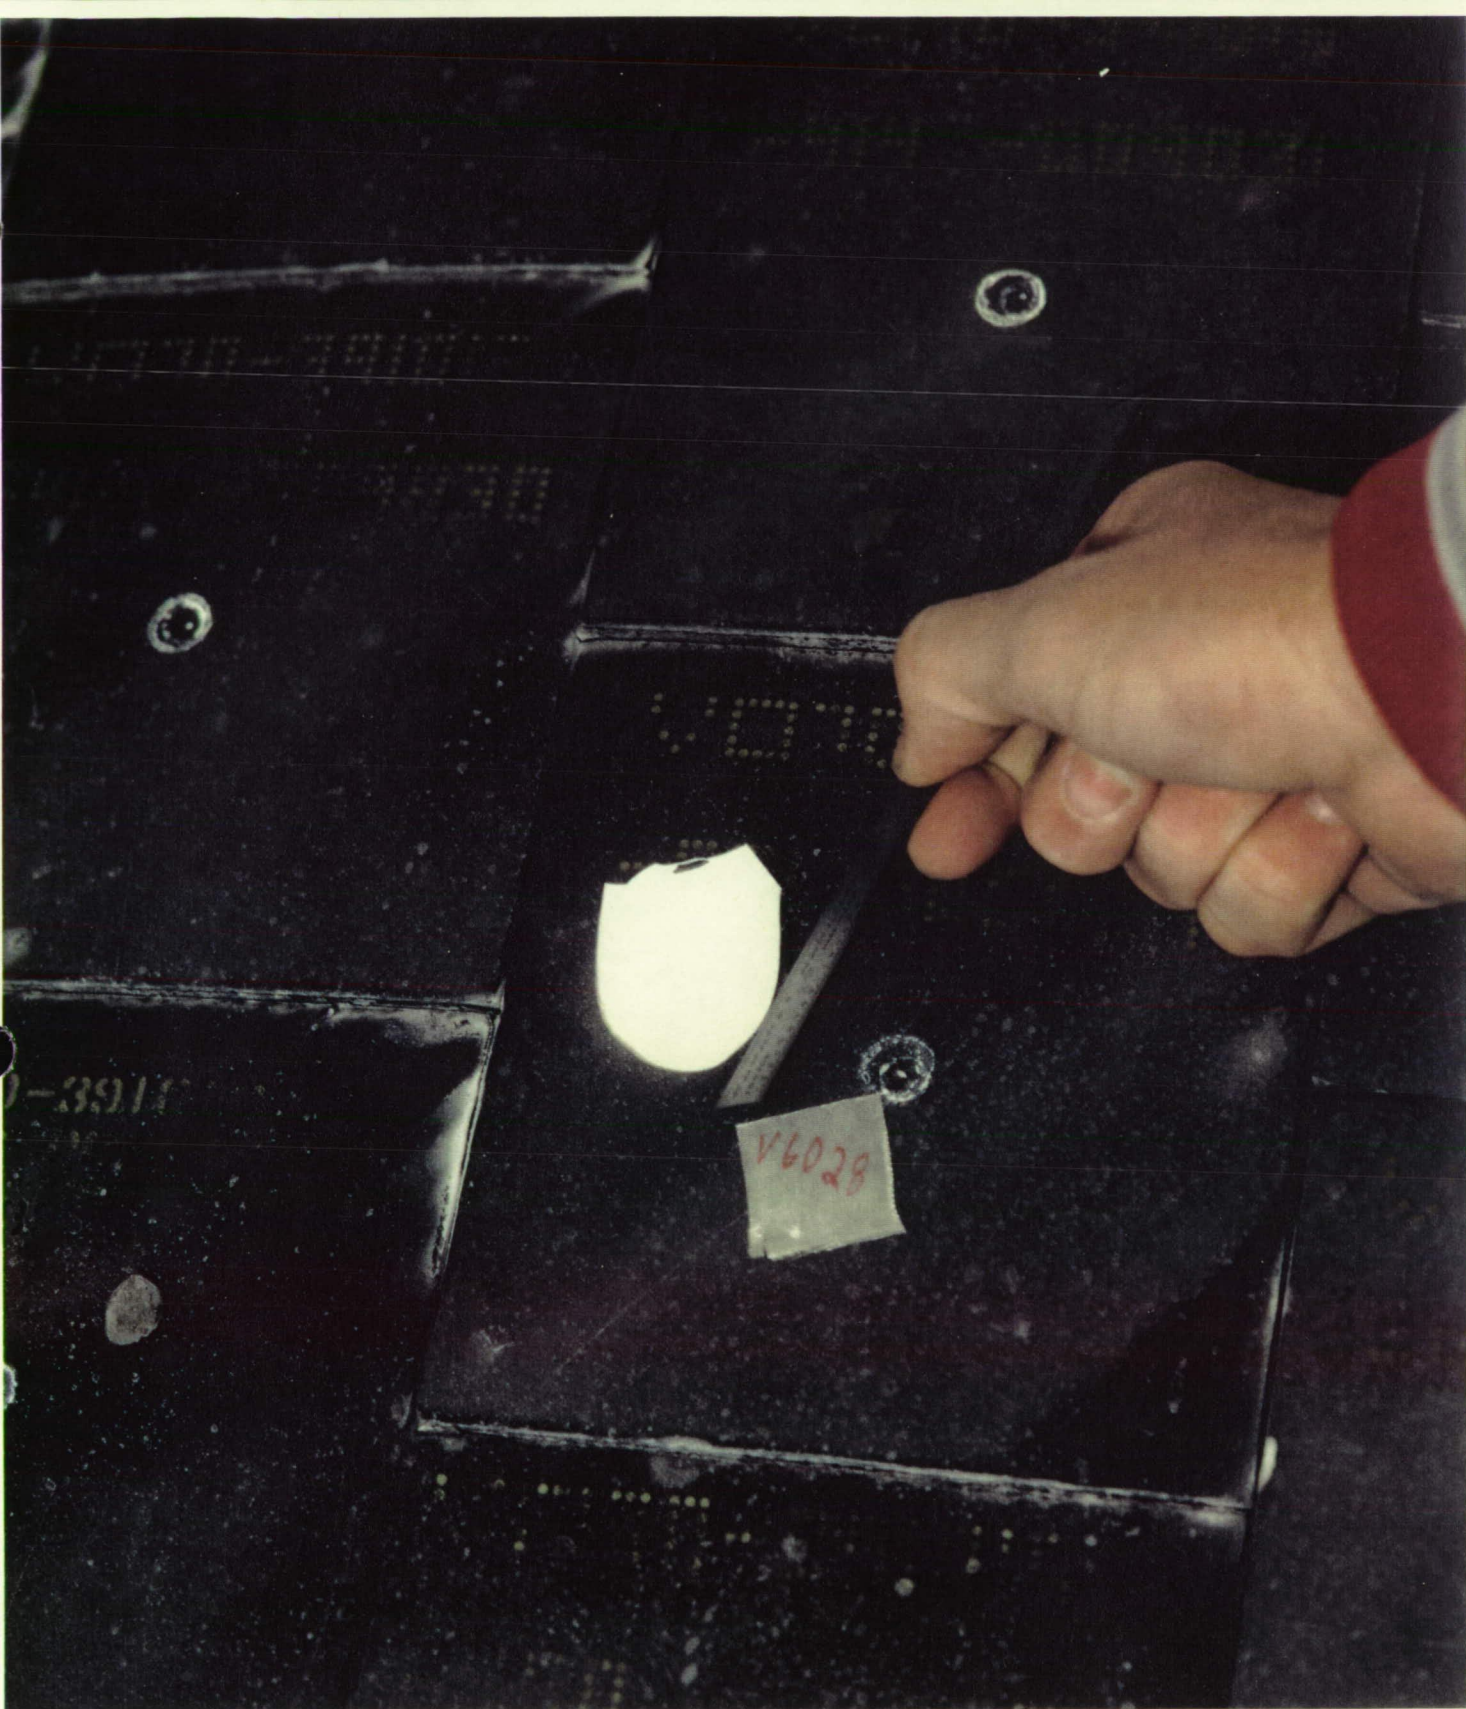
The tile material which was found embedded in the RH SRB aft skirt BSM fairing insulation may have originated from a tile on the Orbiter forward RH lower surface. The area of missing material from this tile included some OEM tile identification markings similar to that found on the particles embedded in the BSM TPS.

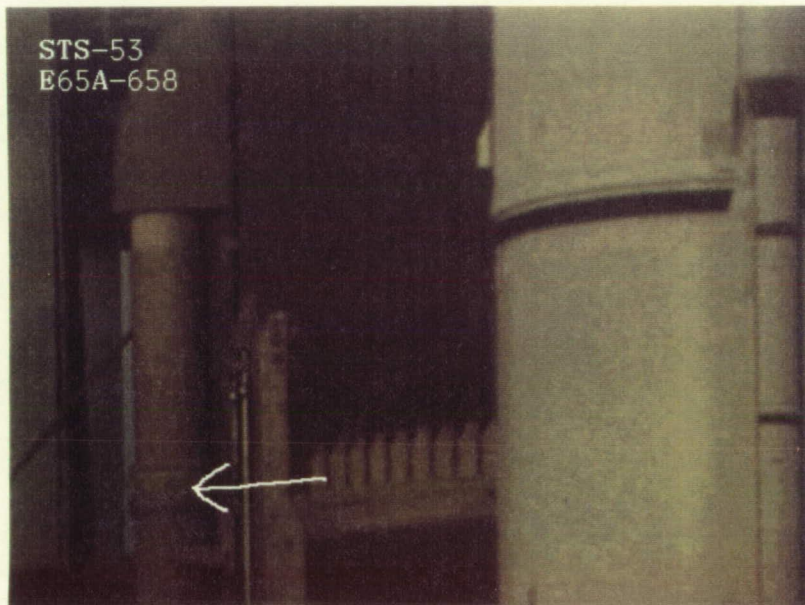
Figure 2.1.1.1 Light Colored Debris Falling Aft along South Side of ET

Multiple light colored pieces of debris, probably ice, were first noted above the ET/Orbiter umbilical disconnects and then fell aft along the vehicle prior to liftoff. The debris originated from the ET LO2 feedline upper bellows. Debris falling aft from above the ET/Orbiter umbilical disconnects has been observed on previous missions. None of the debris appeared to strike the vehicle.

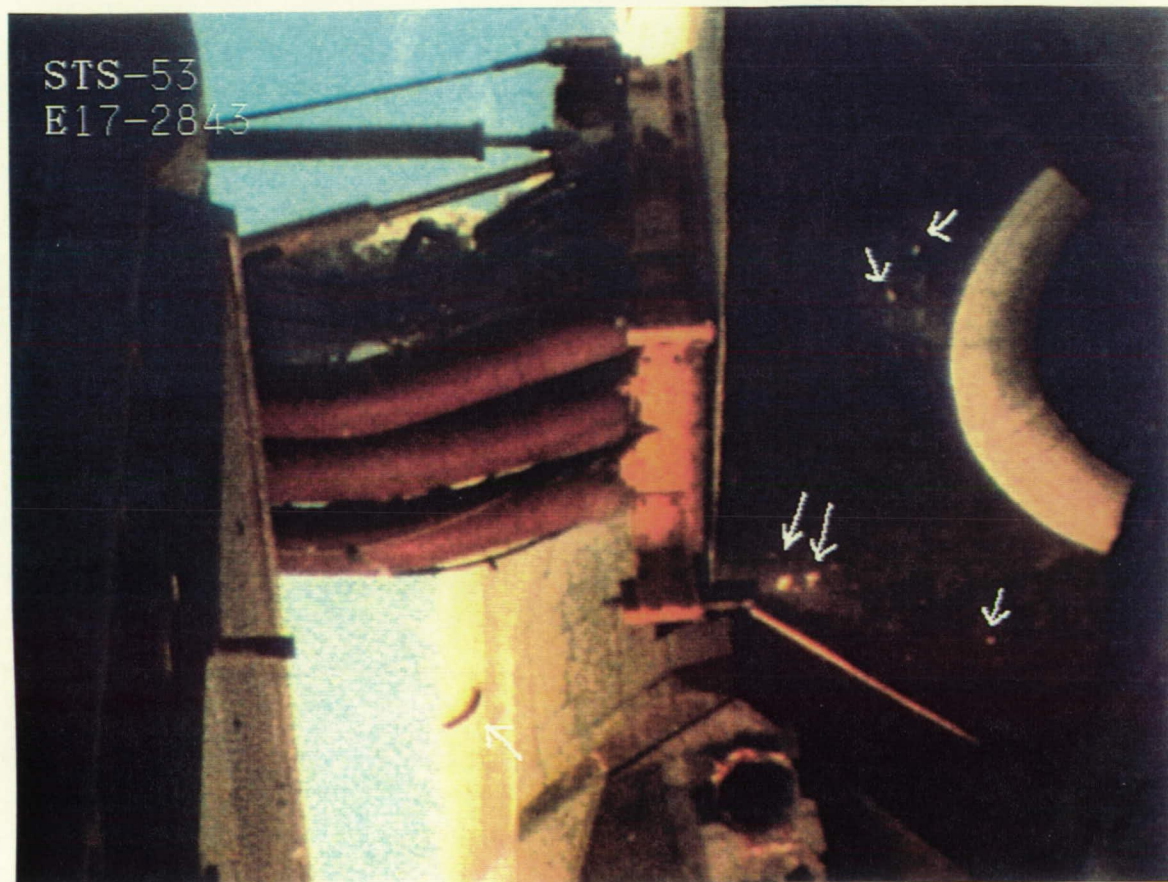
Figure 2.1.1.5 Debris from the LO2 TSM Carrier Plate

A single red rectangular shaped piece of debris fell aft from the LO2 TSM feed line area prior to liftoff. A single, light colored, rectangular piece of debris first noted in the LO2 TSM carrier plate area fell aft prior to liftoff. No further photographic analysis has been requested.

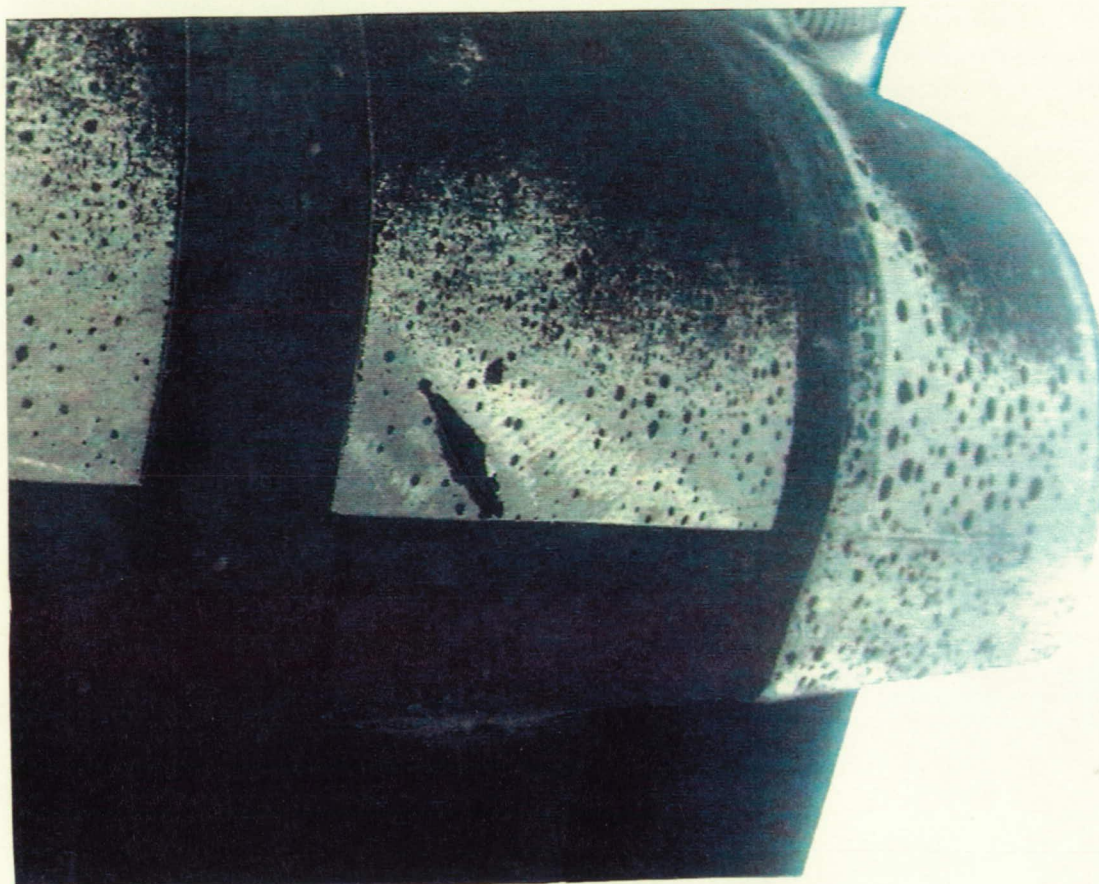
Figure 2.1.4a Elliptical Debris Strike on the RSRB Aft BSM Triple Motor Housing

An elliptical scar was noted on the RSRB aft BSM triple motor housing during post recovery inspection. The elliptical scar showed evidence of contact with a Thermal Protection System (TPS) tile. The damaged motor cover was over the center of the triple motors (separate from the fourth motor). The damage was 3" long x 0.5" deep and very narrow. The damaged area was sent to two separate laboratories for independent analysis (USBI and MSFC). Chemical analysis showed that the scar had a high silicon content. A quarter inch piece of debris was found imbedded in the crack. The recovered debris appeared to have original equipment manufacturer (OEM) tile identification markings. The only missing tile material from the Orbiter's lower surface with these markings was located on the Orbiter forward right hand lower surface. The Photo/TV Analysis Project was asked to review all of the STS-53 films in which the RSRB was visible. The results are given in Appendix D Task #11.

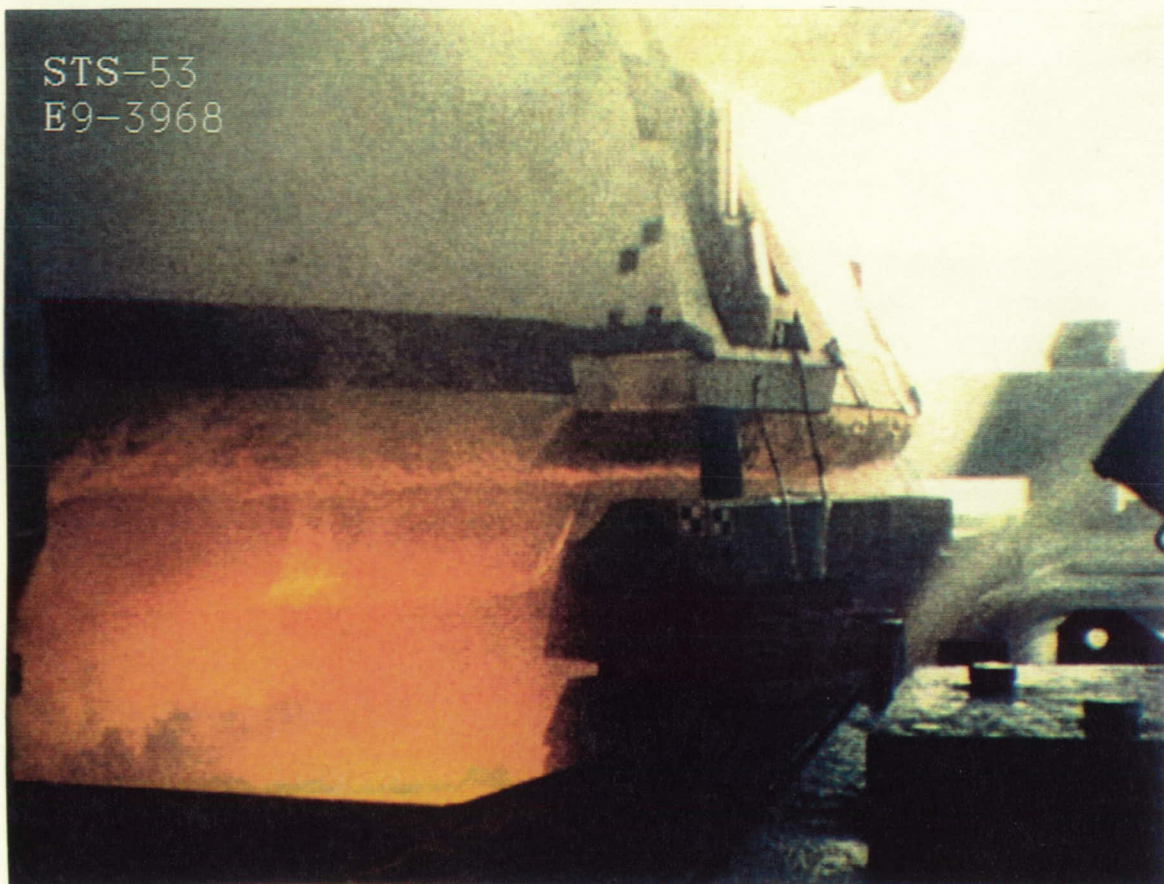
Figure 2.2.1 Holddown Post #M-1 Bolt Hangup

A holddown bolt hangup was noted at HDP #M-1. The bolt retracted after the vehicle cleared the length of the bolt. No further photographic analysis has been requested. The bolt released from the RSRB and retracted to its normal position after extending 9.4 inches above the shoe (Appendix D Task #12).

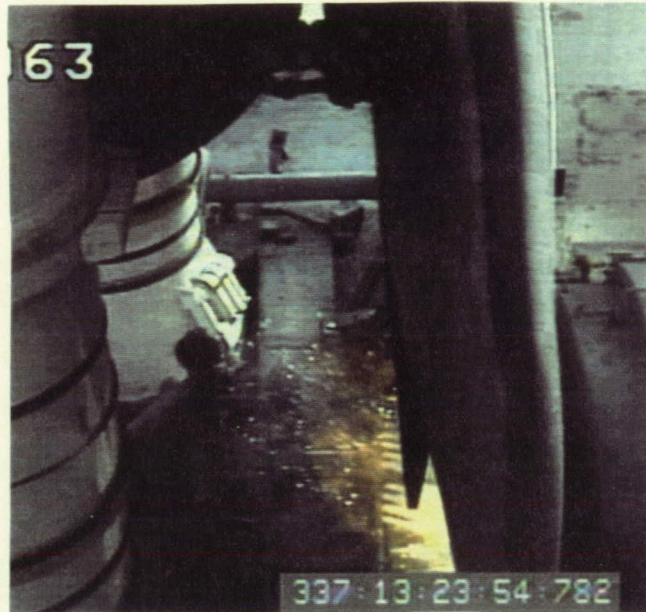
Figure 2.2.3 Orange Vapor Under the Body Flap at SSME Ignition

Orange vapor, possibly free burning hydrogen, was noted near the SSMEs just prior to SSME ignition. The view from OTV-063 showed this vapor moving north under the body flap (possibly due to winds from the southwest). Similar orange vapors have been observed on previous missions. No further photographic analysis has been requested.

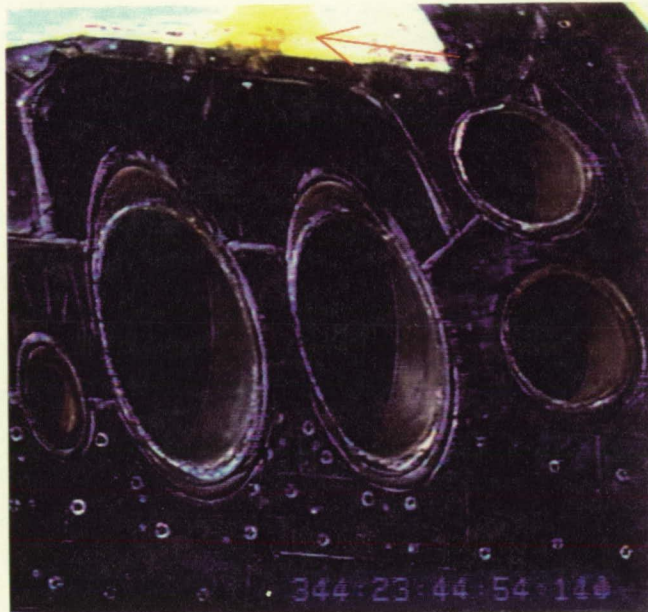
Figure 2.5.3.1 Nitrogen Tetroxide Leak Leaves Discoloration on Orbiter

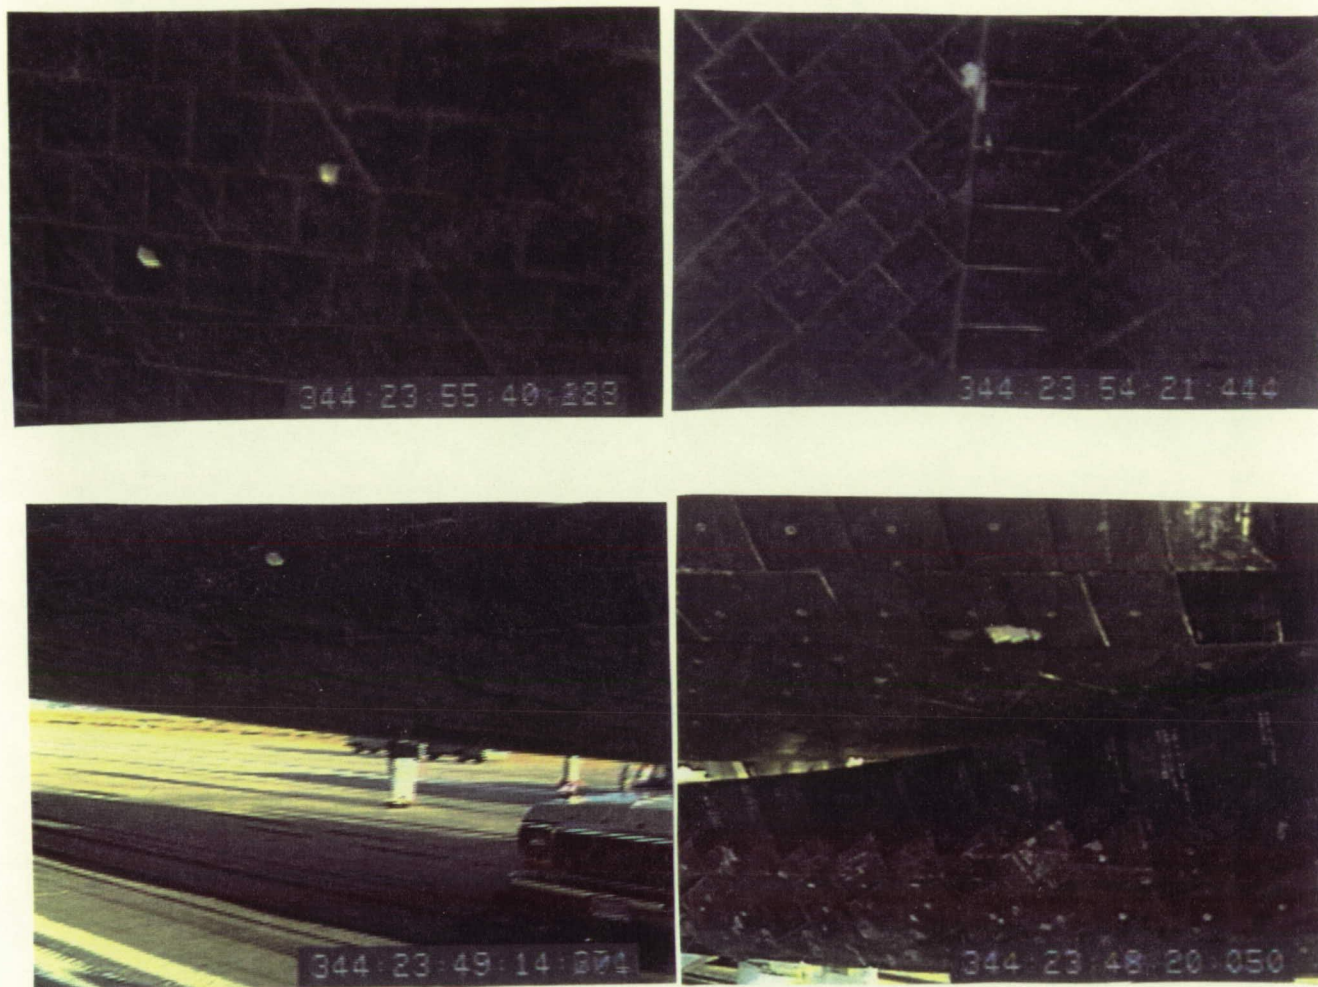
Figure 2.5.3.2a Damage to Lower Surface of the Orbiter TPS

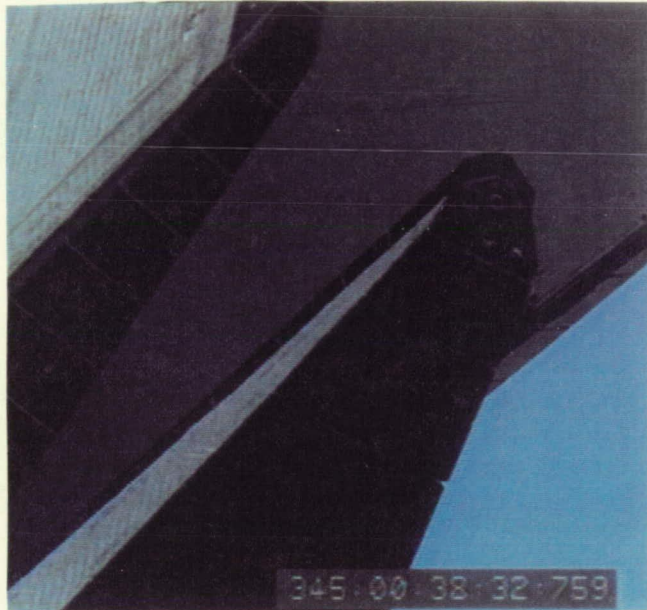
Figure 2.5.3.2b Scarring to the Vertical Stabilizer Stinger

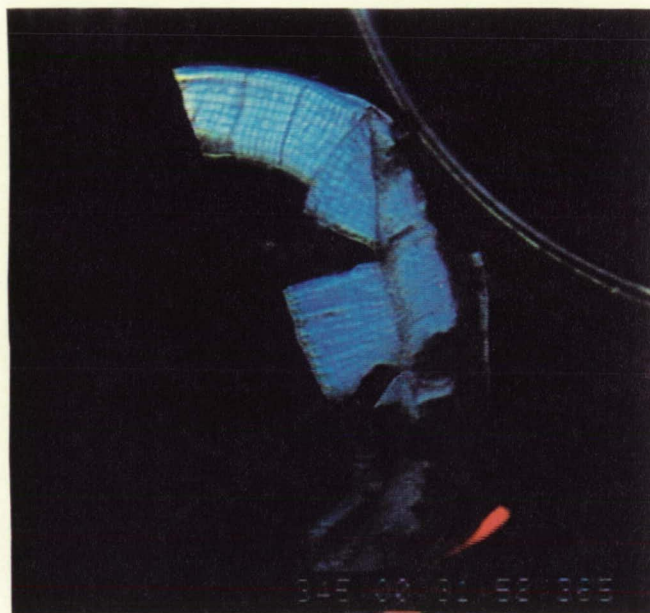
Figure 2.5.3.3 Tear in the DMHS on SSME #2

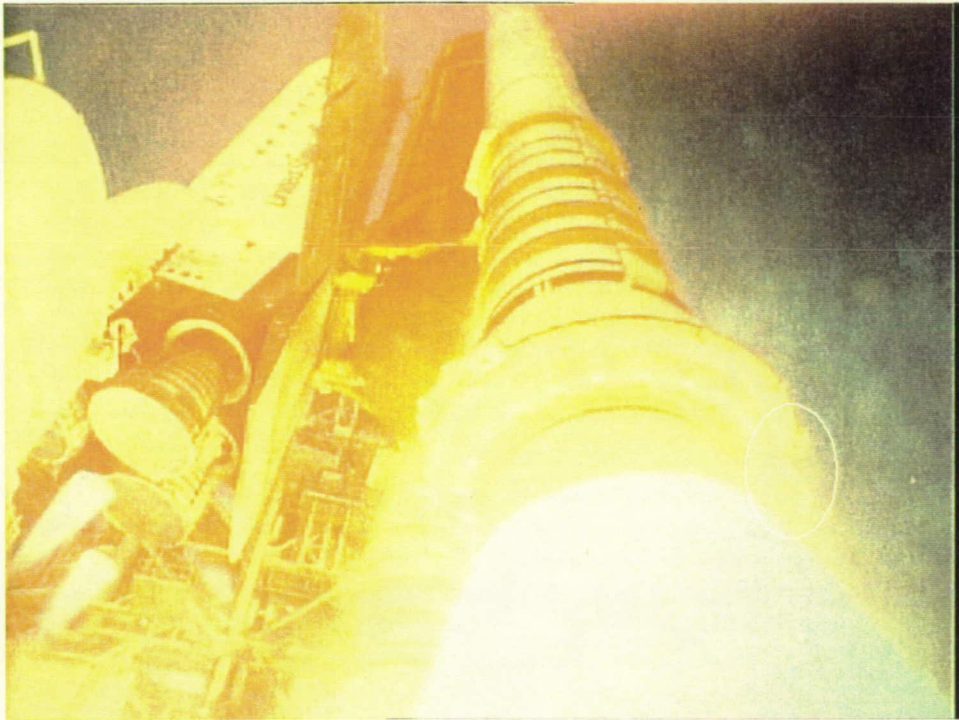
Figure 1
Loose Piece of Thermal Curtain Tape

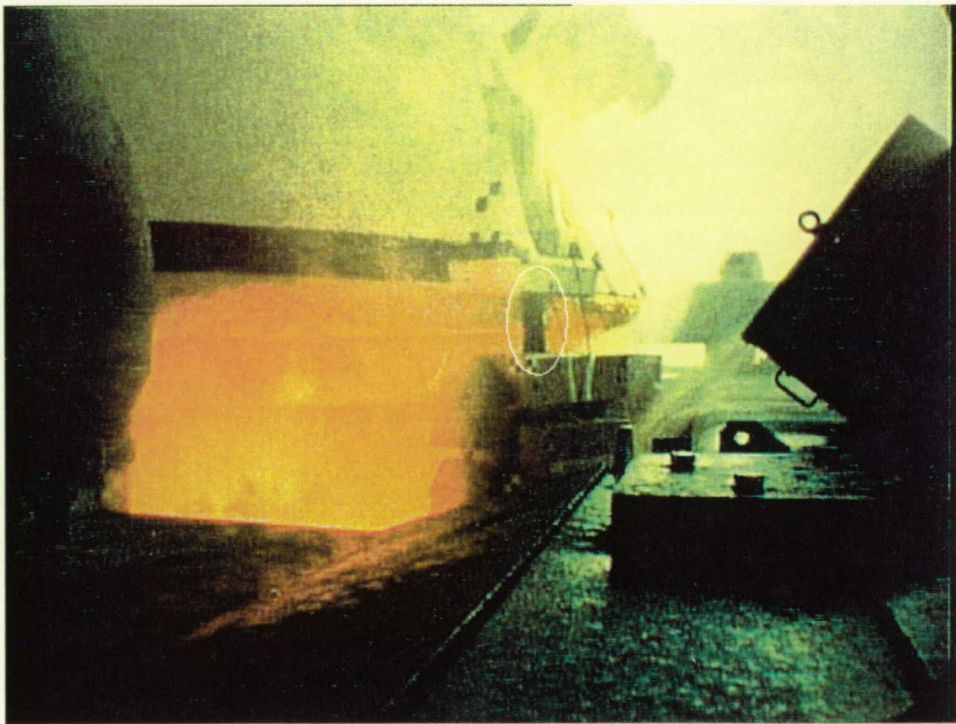
Figure 2
Holddown Post M-1 Stud Hang Up
