TETHERED SATELLITE SYSTEM CONTINGENCY INVESTIGATION BOARD

FINAL REPORT

TETHERED SATELLITE SYSTEM (TSS-I)
CONTINGENCY INVESTIGATION BOARD
SIGNATURE PAGE

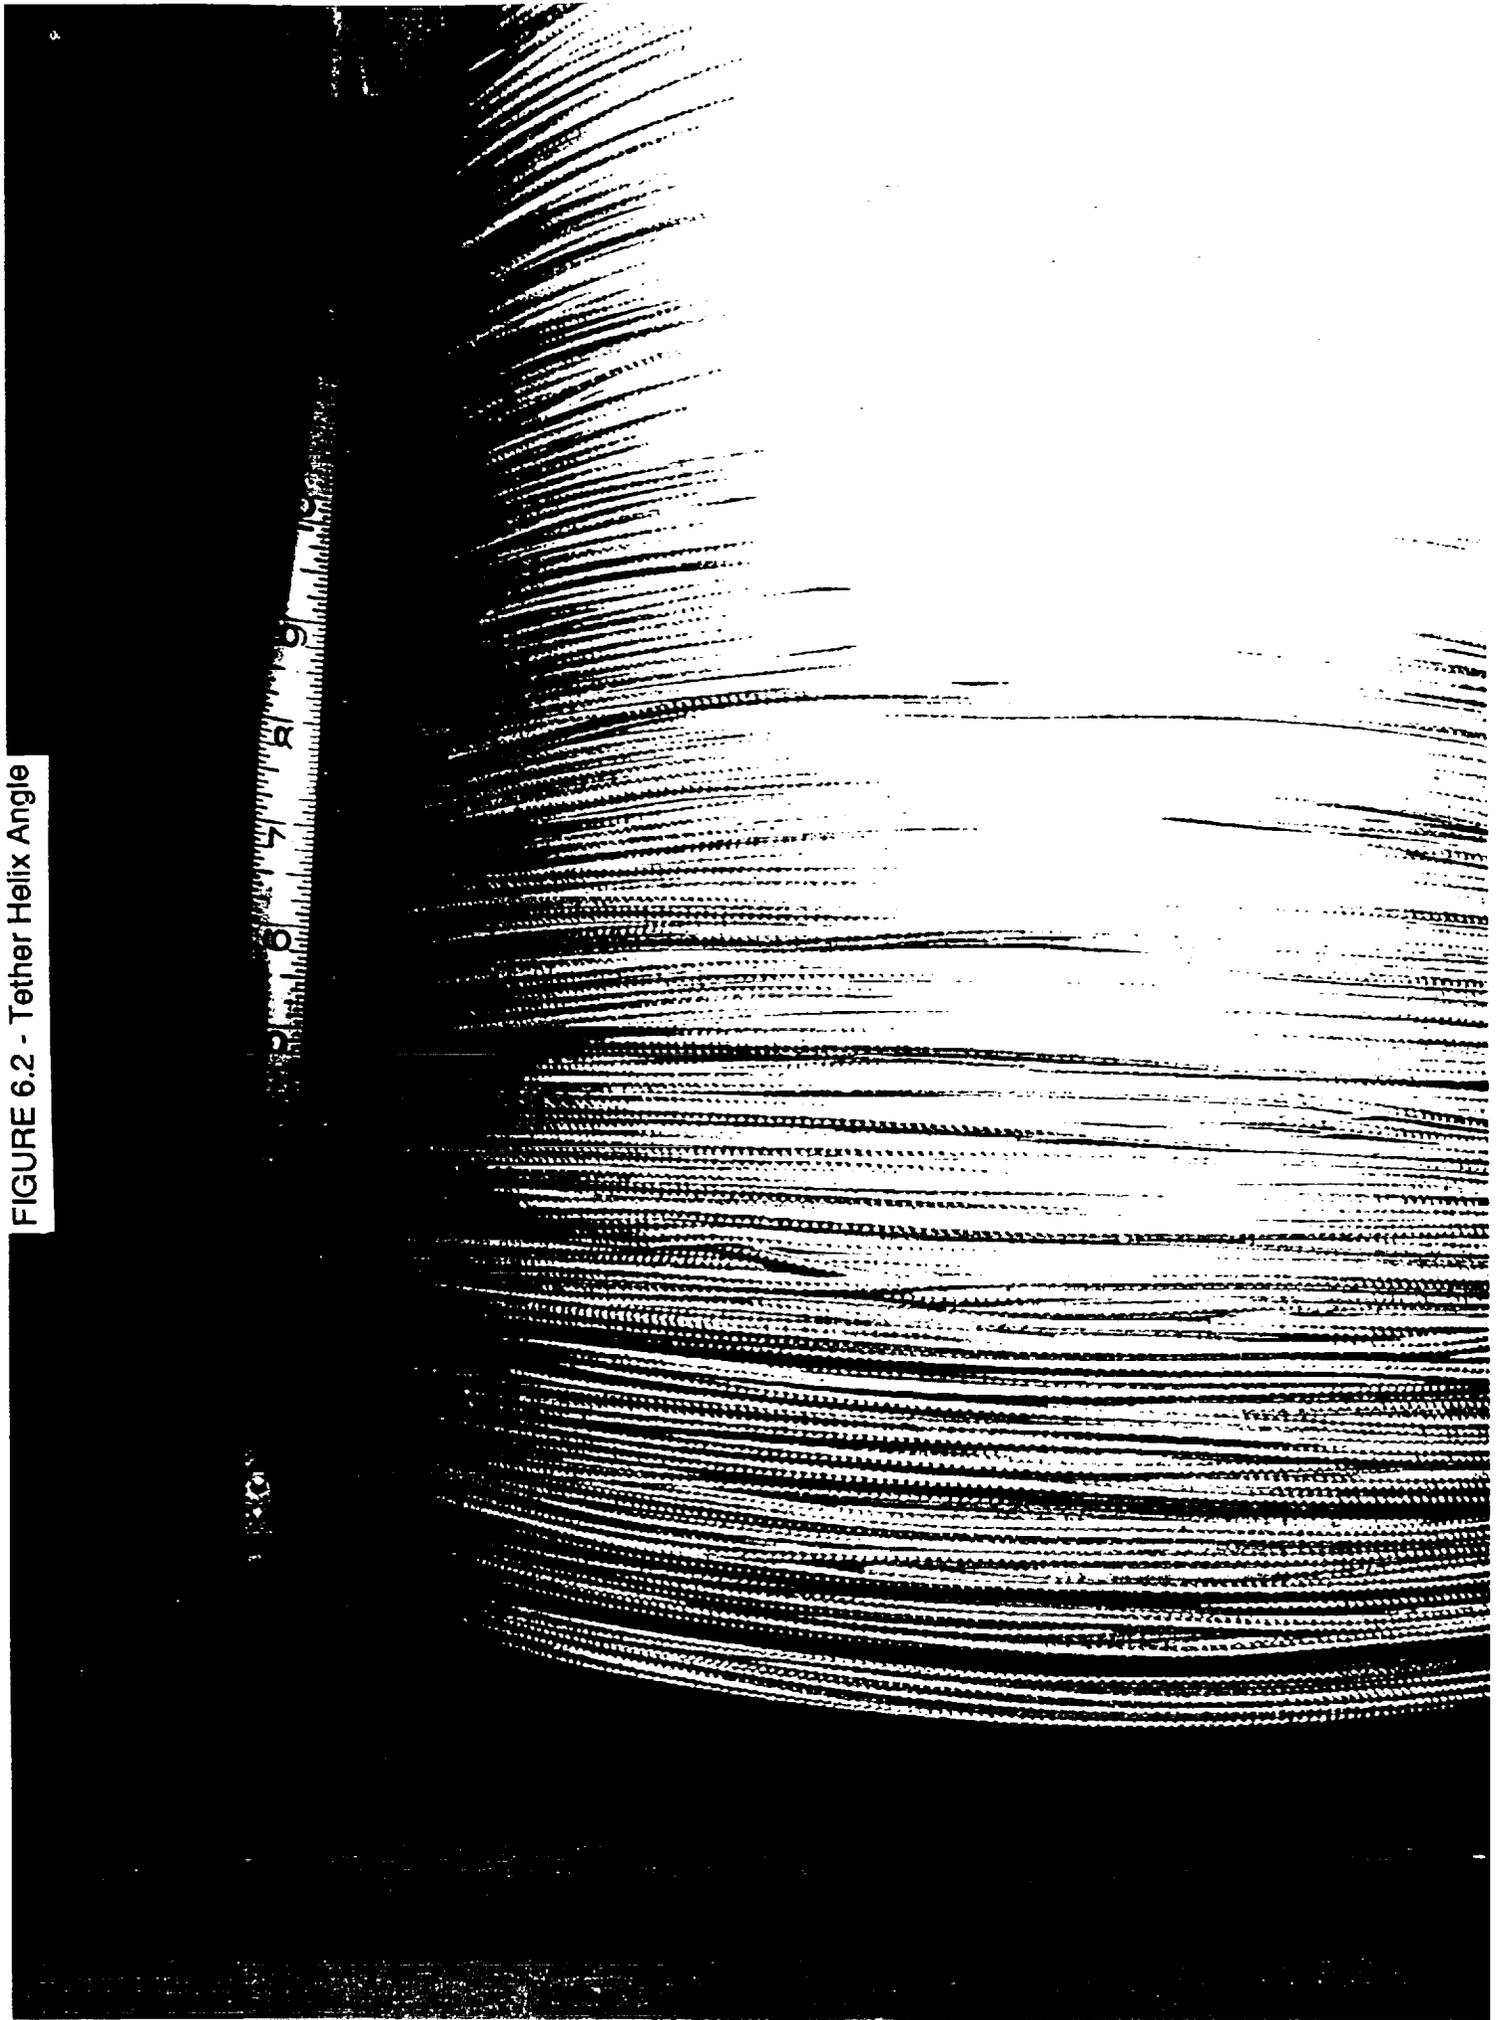
FIGURE 6.2 - Tether Helix Angle

- confirmed that the ball screw collar had contacted the threads on the bolt (Figure 6.1a and 6.1b)
- 2) A large helix angle in the tether lay was found in the second layer of tether (Figure 6.2)
 - 3) The level wind was 57.2 cm (22.5 inches) from the bolt. This dimension correlates to the 256 meters retrieved during the mission and indicates the level wind apparently operated correctly in the retrieve direction (Figure 6.3).

The large helix angle of the tether that was found in the initial observations corroborated that the ball nut collar contacted the bolt at 170 meters and stopped traversing the ball screw while tether was still being pulled from the reel (the tether lay moved down the reel). As the angle of the tether entering the level wind pulleys increased, system friction increased and finally stopped deployment at 256 meters. When retrieval was initiated, the helix was generated as the level wind was reversed and tether was rewound on to the reel.

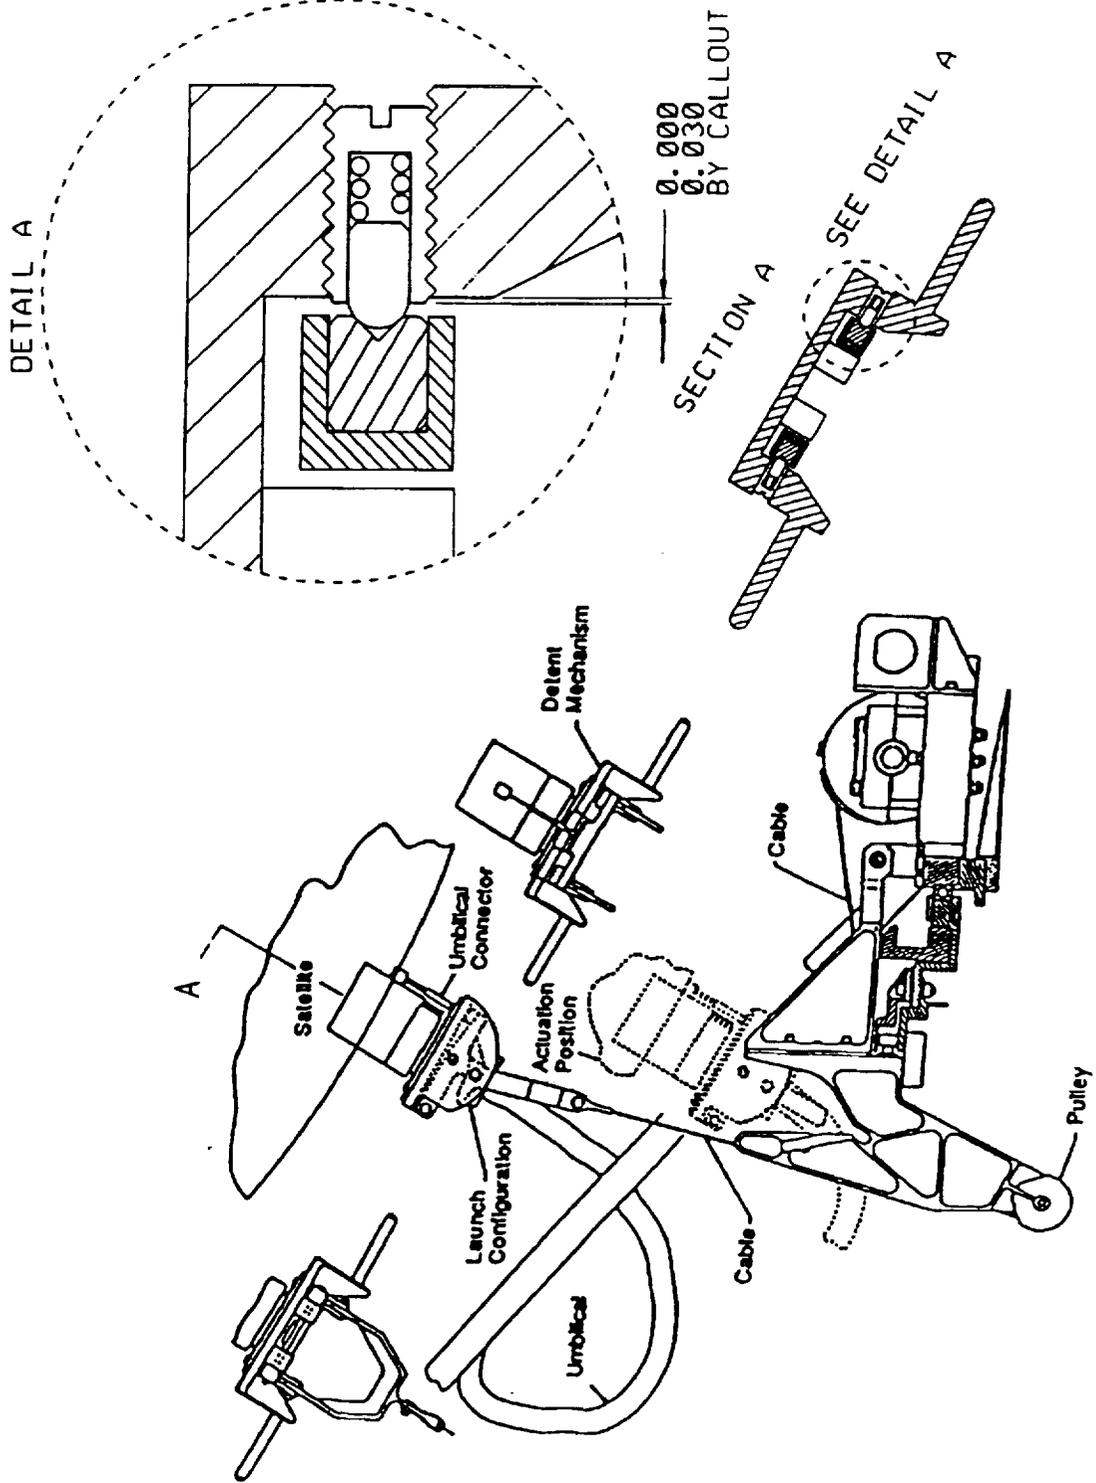
Figure 6.7

Post-flight visual inspection of flight hardware prior to pull test showed no obvious damaged parts or obstructions. After pull tests, inspection of the two vlier pin assemblies and their interface with the actuator assembly showed that the protrusion of vlier pin assembly shoulders from the housing assembly did not meet drawing specifications (Figure 6.7). The hardware drawings called out a 0.030 inch maximum

protrusion from the housing assembly; however, the two shoulders extended 0.051 and 0.072 inches in the post flight hardware, resulting in clearances between the actuator assembly and the shoulder of the vlier pin assembly of zero on one side and 0.005 inch on the other side . This out of specification condition likely occurred preflight, when adjustments to the vlier pins were made to meet a 214 newtons separation force to prevent premature umbilical release during the mission. In addition, personnel performing the adjustment indicated that to meet this separation force requirement, one of the vlier pins had bottomed out and was then backed off slightly. However, this adjustment was performed after all thermal vacuum tests were completed; the effects of this adjustment were never tested prior to flight at mission temperature extremes.

The "excessive force at ball detent", can prevent pivot arm movement and will not allow proper lanyard activation of the connector separation spring. This situation is believed to have been caused by the improper adjustment of the vlier pin (Figure 6.7) in the pivot arm actuator assembly and by the low temperature in flight environment. Post flight visual inspection and measurement of protrusion of the vlier pins (housing shoulder) confirm that an interference between the vlier housings and actuator assembly can exist. At low temperatures, such as experienced during the mission, this clearance problem could have resulted in an interference between the shoulder of the vlier pin housing and the actuator assembly; this situation would not allow proper movement of the actuator assembly. The detent separation force was increased (adjustment of the vlier pin) from the specification value of 111 newtons to 205 newtons after completion of the thermal vacuum tests. This critical configuration change was not tested in a thermal vacuum simulation of the flight environment prior to the mission.

To complete anomaly cause validation, the project and/or working group should perform thermal tests on the U2 assembly at simulated mission environmental conditions with flight hardware at KSC (perform thermal vacuum test on U2 assembly if required). Additionally, the project and/or working group should review test specifications and determine if system design was adequately verified to meet mission environments.
