NASA Technical Memorandum 104580

Automated Inspection of Solder Joints for Surface Mount Technology

**Robert M. Savage
Hyun Soo Park
Dr. Mark S. Fan**

March 1993

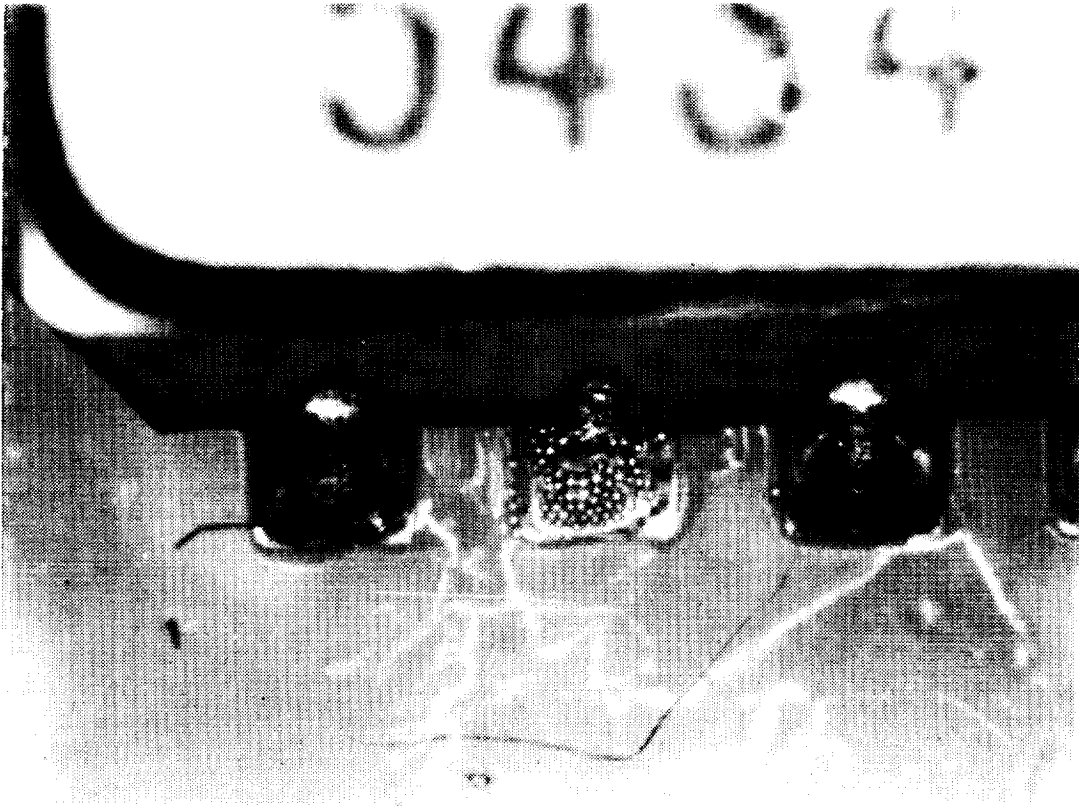
DEVICE TYPE:	20 Pin LCC
DEVICE NUMBER:	U12 - LCC array
PIN NUMBER:	10
MAGNIFICATION:	23 X
ACTUAL DEFECT:	Solder balls present on pin 10
AIS DEFECT:	No defects identified on pin 10
COMMENT:	The automate inspection system failed to detect the presence of the solder balls.

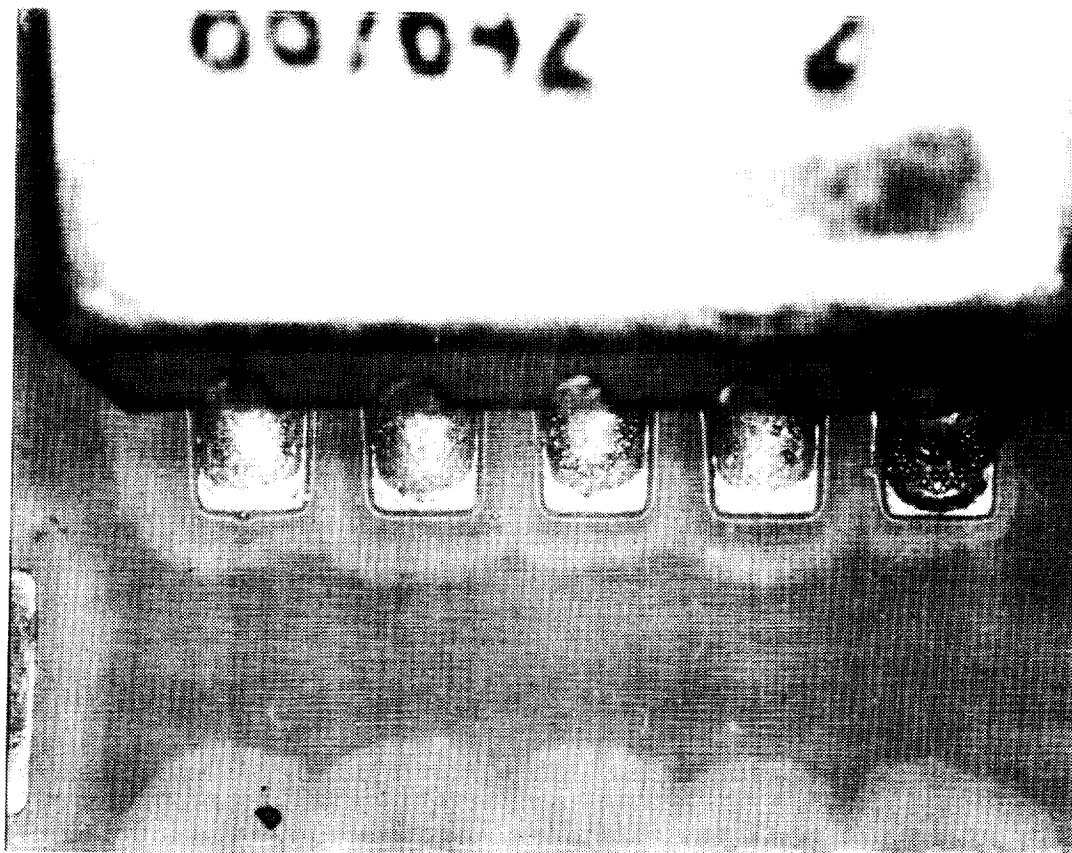
DEVICE TYPE:	20 Pin LCC
DEVICE NUMBER:	U16 - LCC array
PIN NUMBER:	8 thru 12
MAGNIFICATION:	16 X
ACTUAL DEFECT:	Non-wetting on pins 8 thru 12
AIS DEFECT:	No defects detected on pins 8 thru 12
COMMENT:	The automated inspection system failed to detect the presence of non-wetting and solder balls.

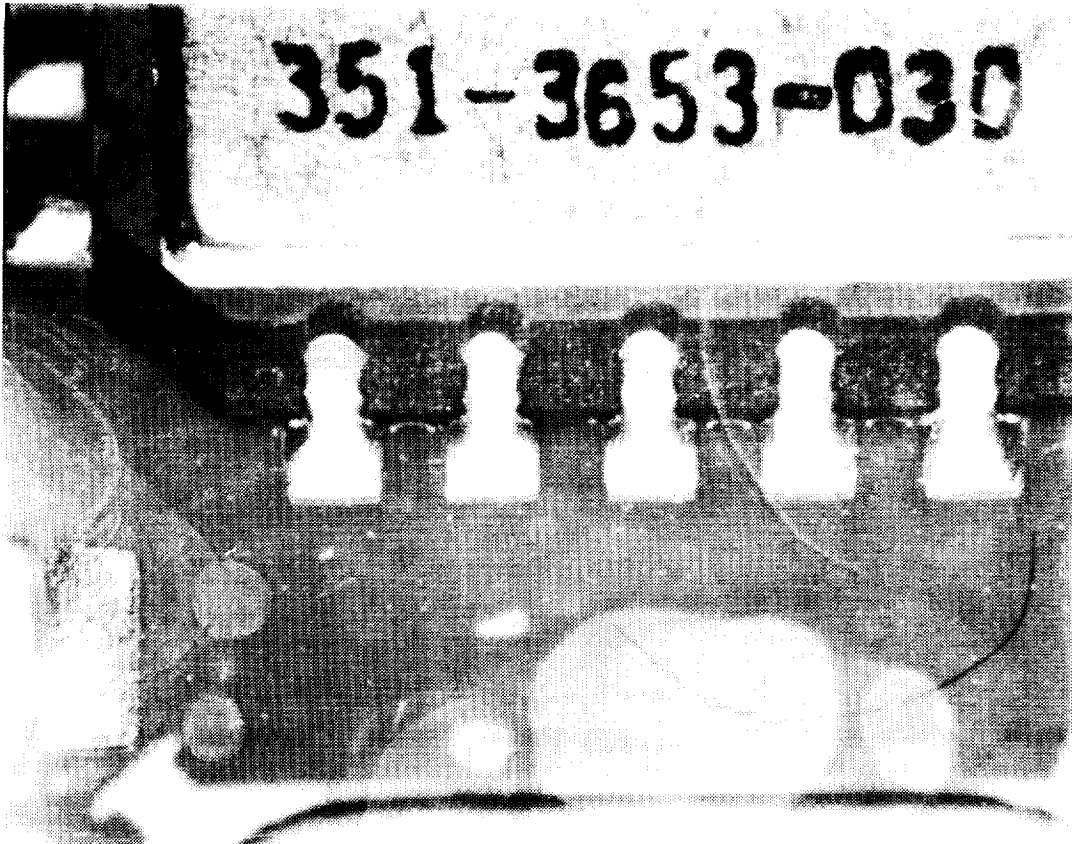
DEVICE TYPE:	20 Pin LCC
DEVICE NUMBER:	U32 - LCC array
PIN NUMBER:	8 thru 12
MAGNIFICATION:	13 X
ACTUAL DEFECT:	Insufficient Castellation fillet
AIS DEFECT:	None
COMMENT:	The automated inspection system could not detect insufficient castellation. In some cases it identified good joints as insufficient castellation.

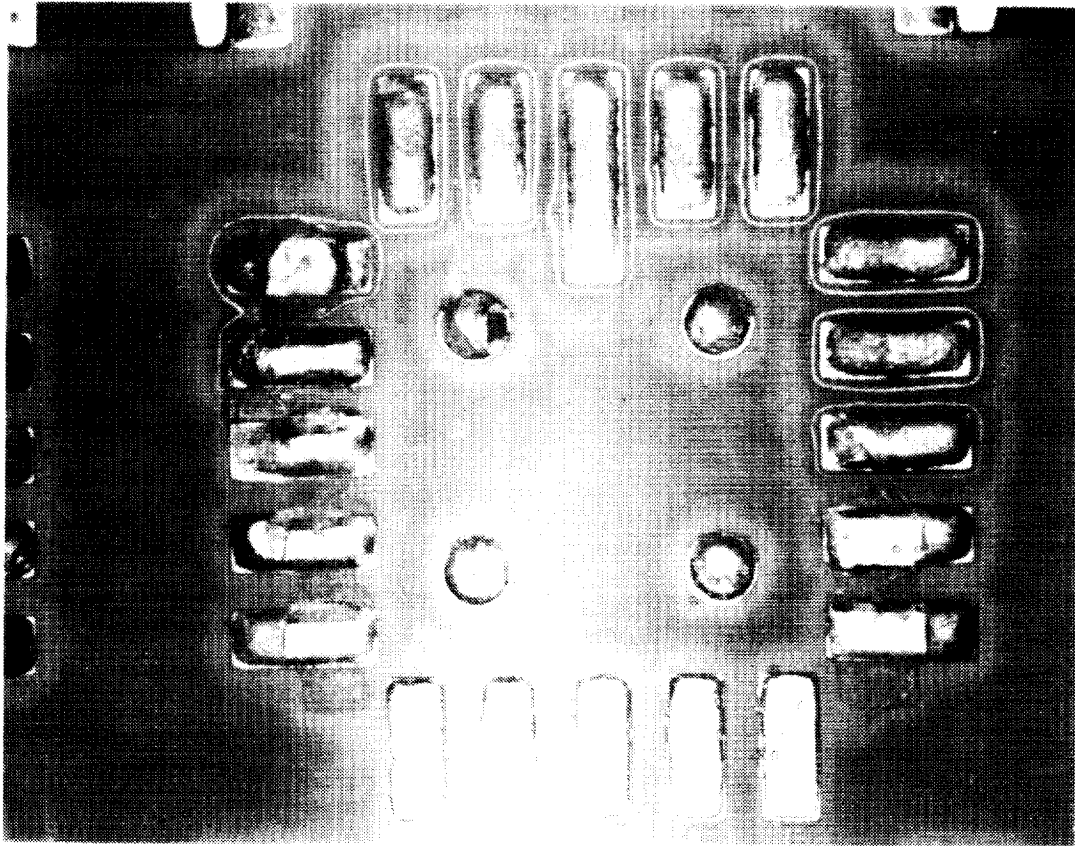
DEVICE TYPE:	20 Pin LCC
DEVICE NUMBER:	U93 - LCC array
PIN NUMBER:	N/A
MAGNIFICATION:	7.5 X
ACTUAL DEFECT:	Missing component
AIS DEFECT:	Numerous
COMMENT:	The AIS machine identified numerous soldering defects when no component was present.

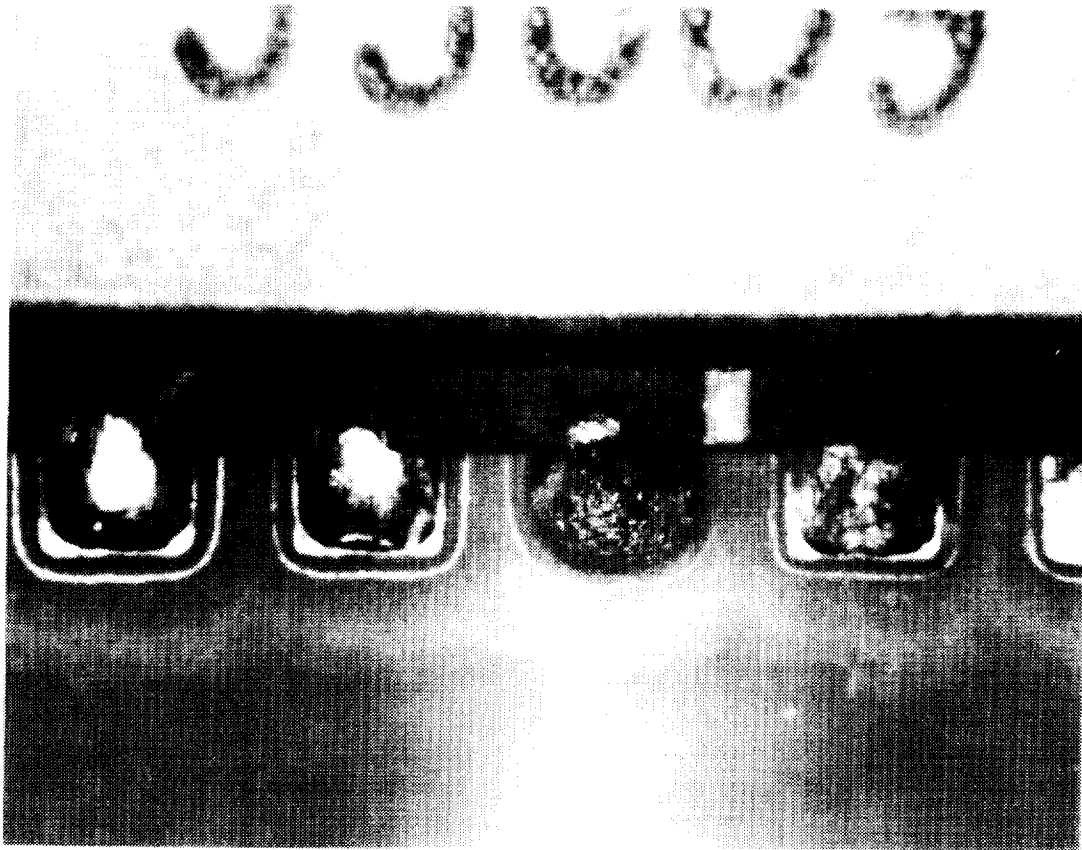
DEVICE TYPE:	20 Pin LCC
DEVICE NUMBER:	U98 - LCC array
PIN NUMBER:	11 and 12
MAGNIFICATION:	20 X
ACTUAL DEFECT:	Excess solder on pin 11, Non-wetting on pin 12
AIS DEFECT:	Excess cast on pin 11
COMMENT:	The AIS machine correctly identified excess solder condition almost every time but failed to identify non-wetting.

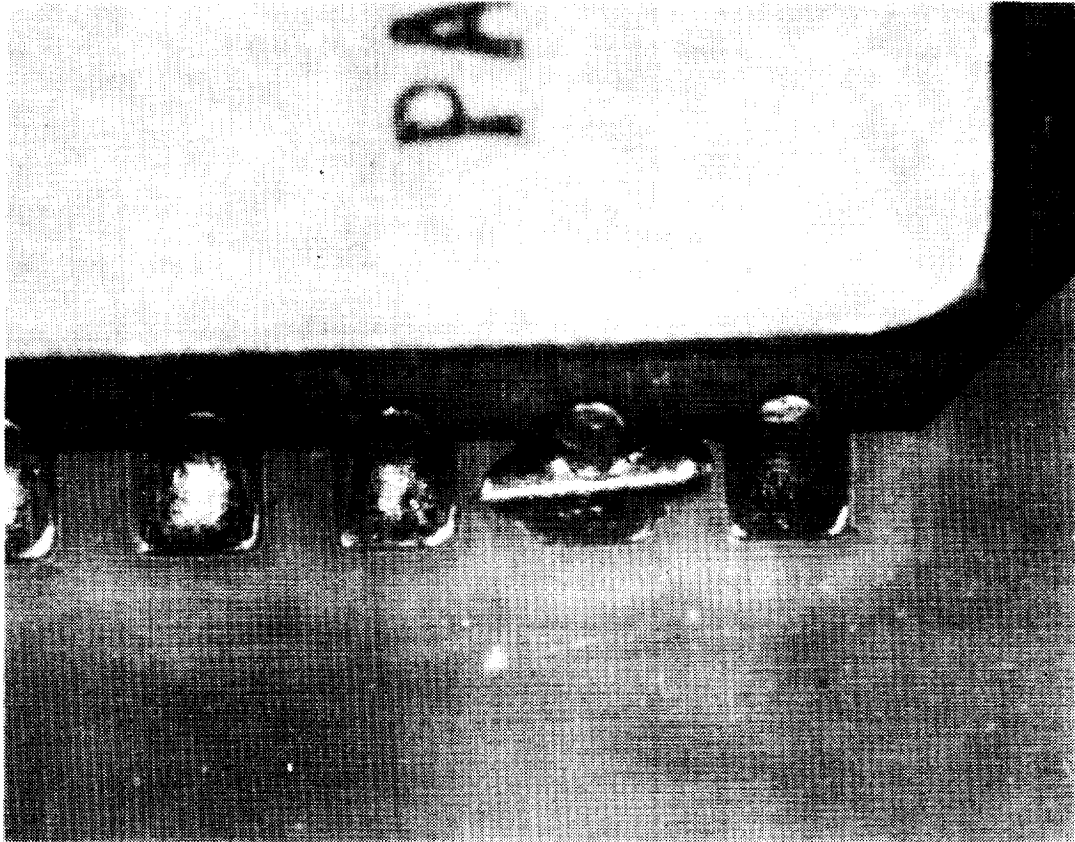
DEVICE TYPE:	20 Pin LCC
DEVICE NUMBER:	U16 - Serial No. 9110-1
PIN NUMBER:	7
MAGNIFICATION:	16 X
ACTUAL DEFECT:	Gold wire in solder joint
AIS DEFECT:	Excess cast
COMMENT:	The AIS could not identify contaminated solder joint.

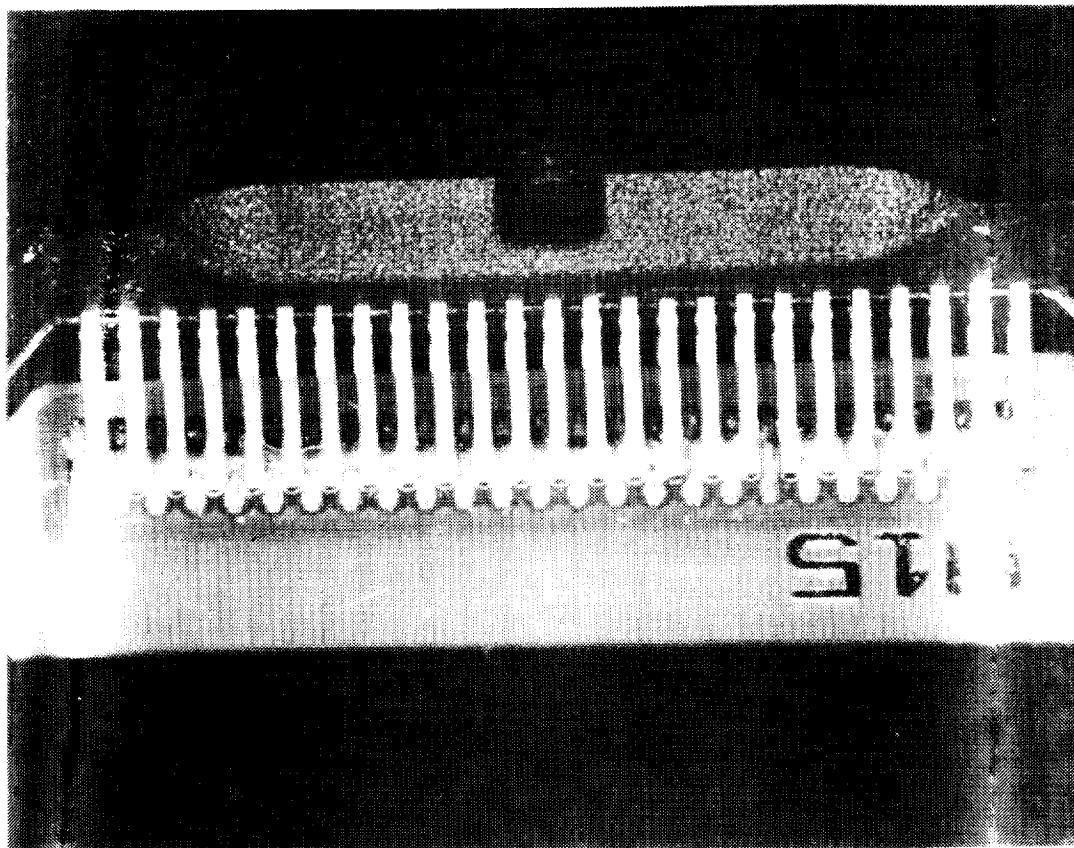
DEVICE TYPE:	100 Pin BQFP
DEVICE NUMBER:	U15 - Serial No. 105
PIN NUMBER:	1 thru 13, 89 thru 105
MAGNIFICATION:	6.3 X
ACTUAL DEFECT:	Misalignment and bridging on almost every pin.
AIS DEFECT:	Various
COMMENT:	The AIS machine incorrectly identified totally lifted lead, it identified some bridging, but not all, and it identified some bridging. The machine did not identify any defects on pin 13 even though it was misaligned and bridged.

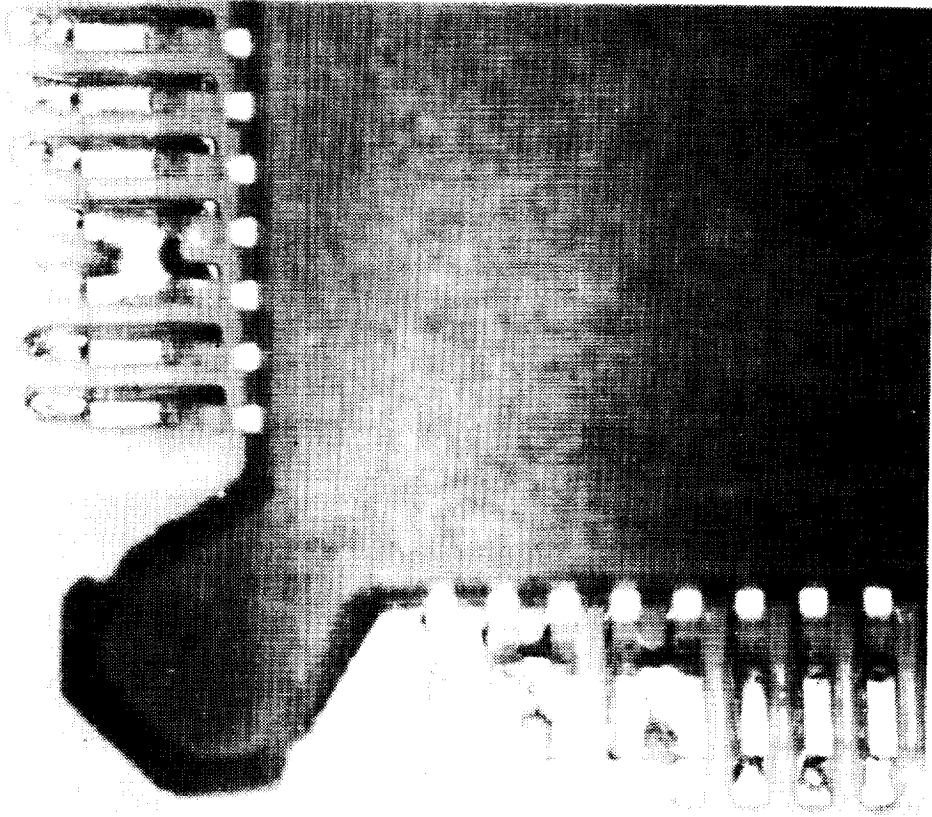
DEVICE TYPE:	100 Pin BQFP
DEVICE NUMBER:	U16 - Serial No. 105
PIN NUMBER:	32 thru 46
MAGNIFICATION:	10 X
ACTUAL DEFECT:	Pins 35 and 36 bridged, 40 and 41 bridged, 42 and 43 bridged
AIS DEFECT:	Pin 35 bridged, 36 not bridged, 42 thru 46 misaligned and pin 41 totally lifted.
COMMENT:	The AIS machine missed the bridging on pins 36, 40, 41, 42, and 43. Pins 42 thru 46 were not misaligned.

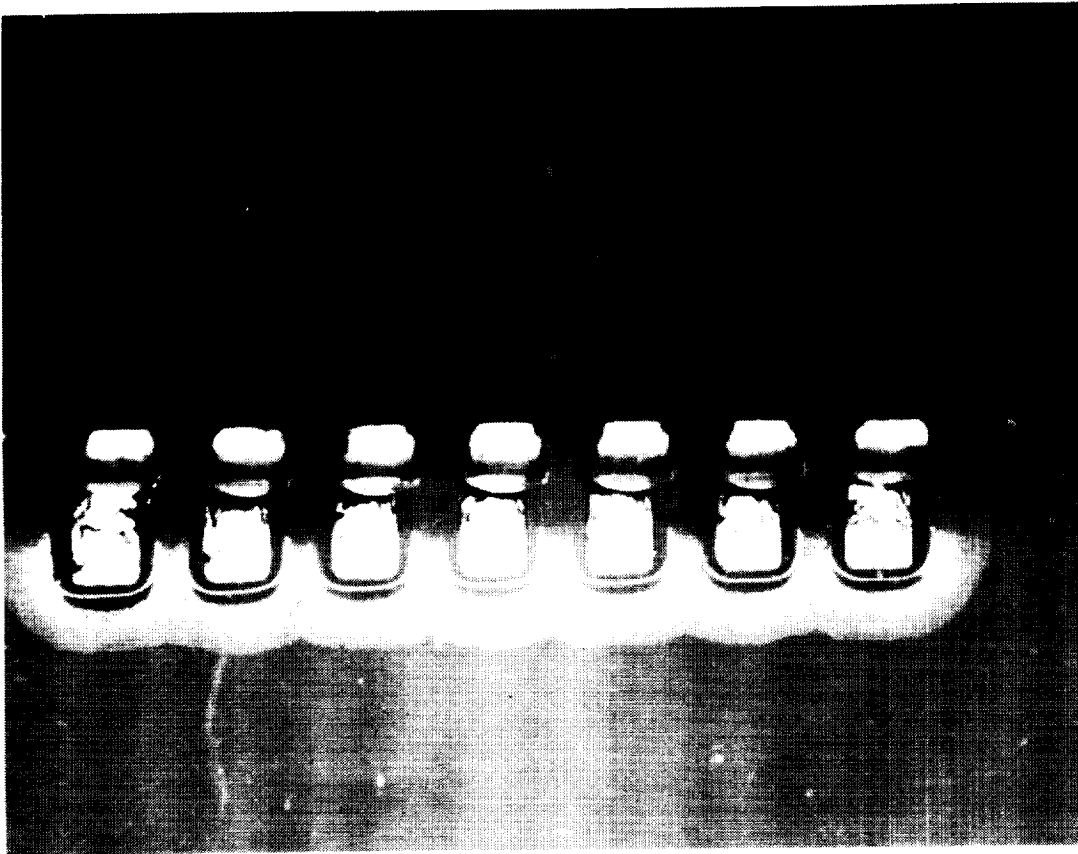
DEVICE TYPE:	28 Pin PLCC
DEVICE NUMBER:	U14 - Serial No. 105
PIN NUMBER:	19 thru 25
MAGNIFICATION:	10 X
ACTUAL DEFECT:	None
AIS DEFECT:	Misalignment for all pins on all four J-leaded devices on the PCB.
COMMENT:	None of the J-leaded devices were misaligned on the PCB according to visual inspection.

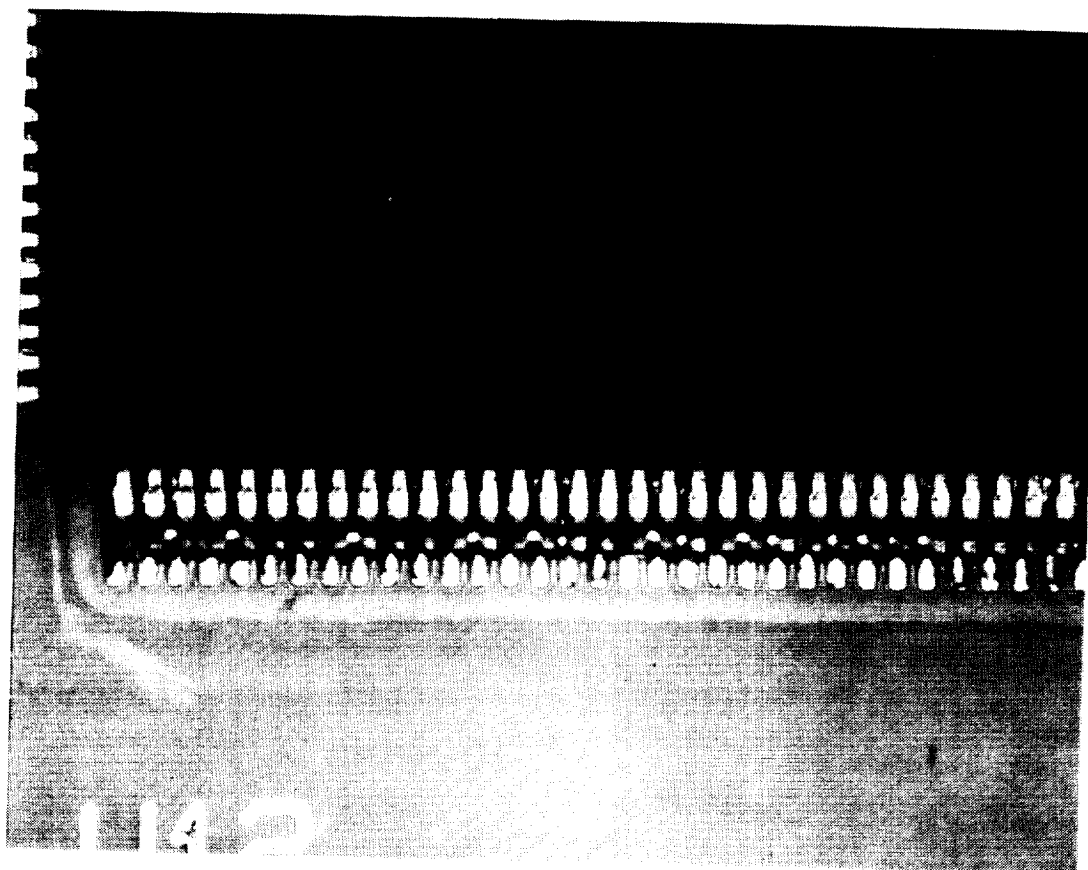
DEVICE TYPE:	208 Pin QFP
DEVICE NUMBER:	U5 - Serial No. 105
PIN NUMBER:	53 thru 84
MAGNIFICATION:	6.3 X
ACTUAL DEFECT:	Misalignment and bridging
AIS DEFECT:	Identified some of the misalignment and bridging.
COMMENT:	The AIS machine missed quite a few defects. As an example, pins 54 and 55 are bridged, but the machine only identified pin 55 as bridged. It failed to identify pins 53, 62, 65, and 69 as misaligned.

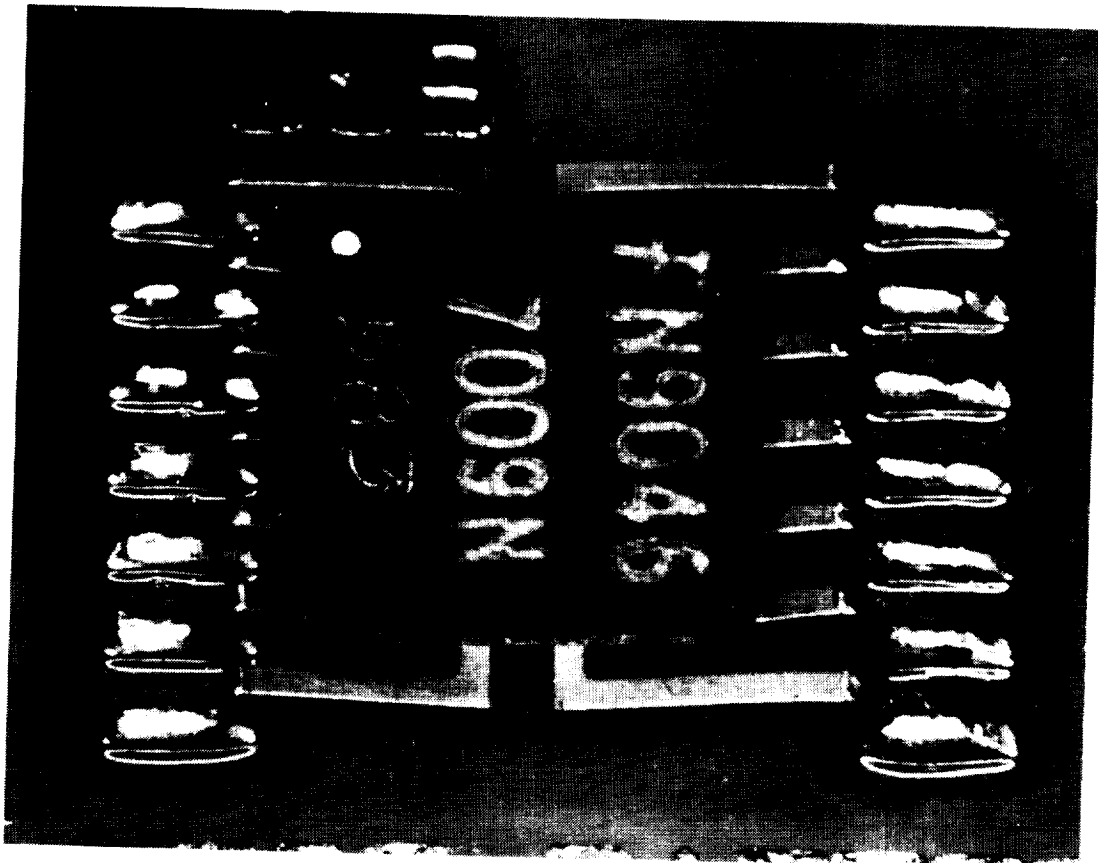
DEVICE TYPE:	14 Pin flat pack
DEVICE NUMBER:	U19 - Serial No. 105
PIN NUMBER:	All
MAGNIFICATION:	7.5X
ACTUAL DEFECT:	Excess solder on all the leads
AIS DEFECT:	Identified almost every lead as totally lifted
COMMENT:	None of the leads on the flat pack were lifted off the pad.

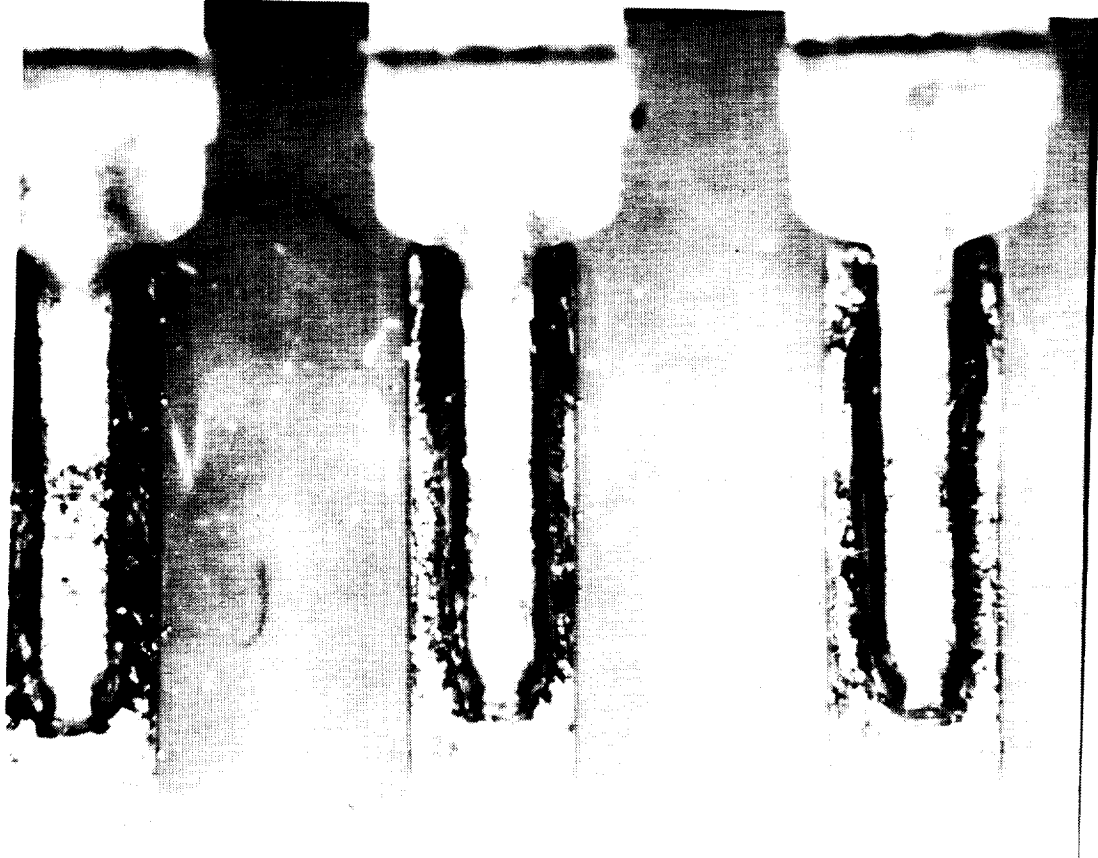
DEVICE TYPE:	20 Pin DIP
DEVICE NUMBER:	U1 - Serial No. 105
PIN NUMBER:	6,7,8
MAGNIFICATION:	17 X
ACTUAL DEFECT:	None
AIS DEFECT:	Misaligned Y and Totally lifted for pins 6,7 and 8.
COMMENT:	The AIS machine incorrectly identified misalignment and lifted leads. The 3 pins in the photo did not have any defects.

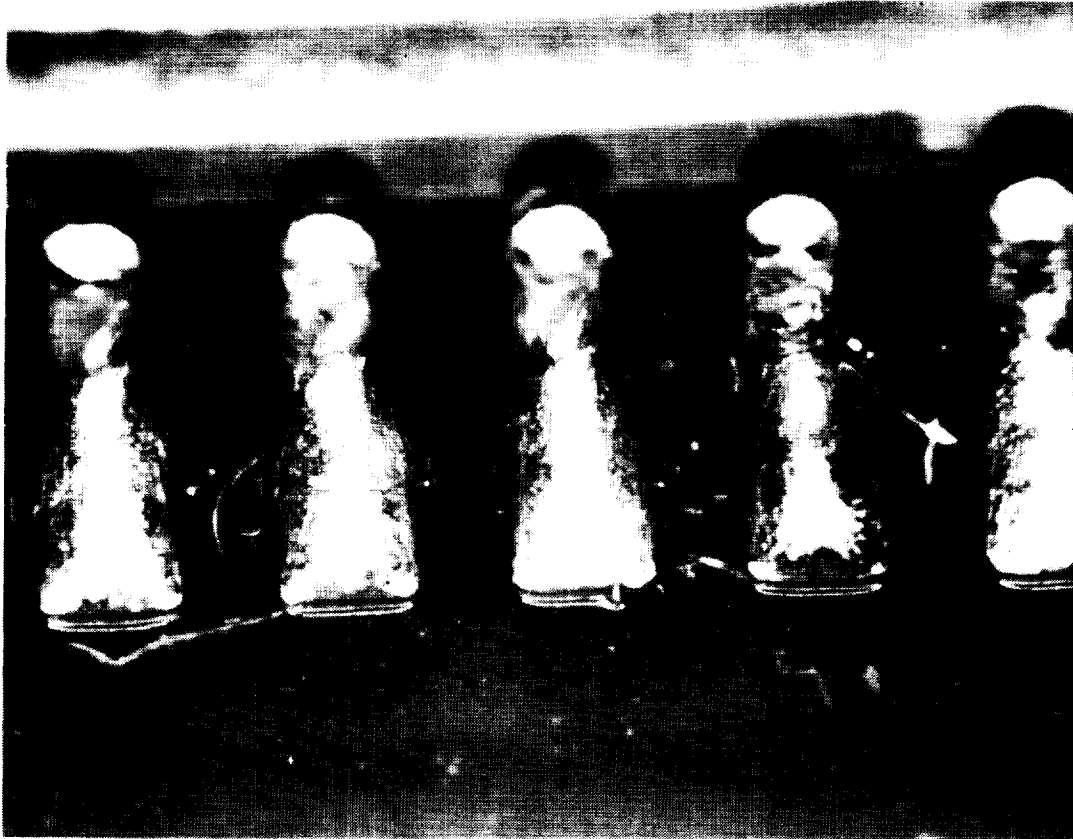
DEVICE TYPE:	40 Pin LCC
DEVICE NUMBER:	U10 - Serial No. 105
PIN NUMBER:	40
MAGNIFICATION:	32 X
ACTUAL DEFECT:	Flux contamination
AIS DEFECT:	Insufficient pad and insufficient cast.
COMMENT:	The AIS machine failed to note any presence of flux on pin 40. On pin 37, the machine identified the defect as insufficient cast and also excess cast.
