SPACE ENVIRONMENTAL EFFECTS ON LDEF COMPOSITES: A LEADING
EDGE COATED GRAPHITE EPOXY PANEL

SUMMARY

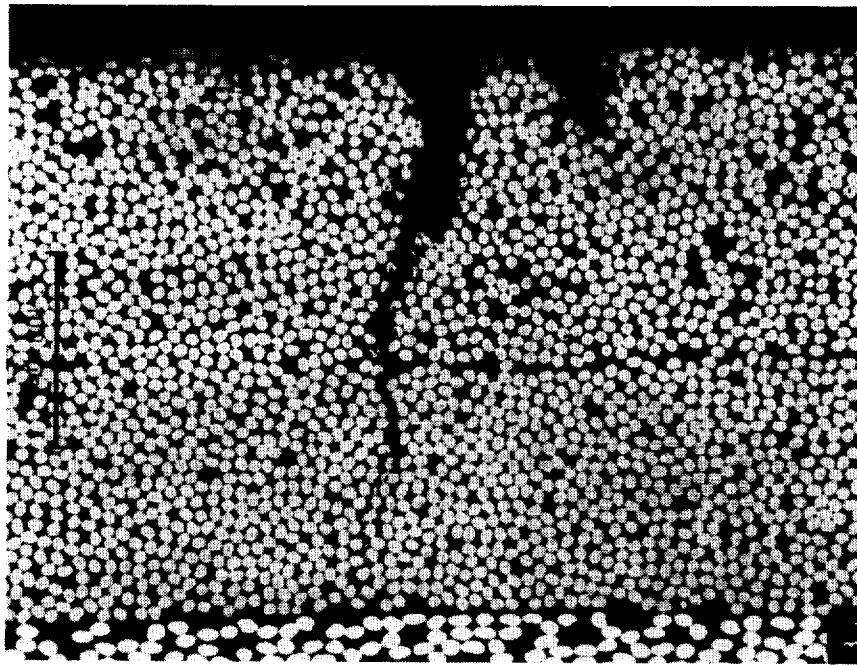
FIGURE XVII - CROSS SECTIONAL PHOTOMICROGRAPH OF MICROCRACK IN SURFACE PLY OF EXPOSED Z306 COATED T300/934 PANEL QUADRANT

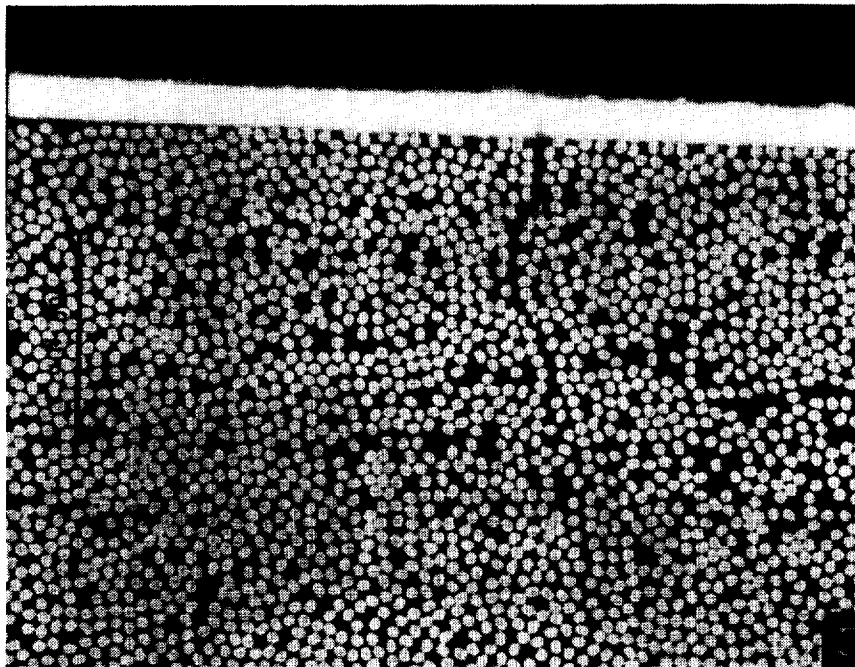
AO-microcrack interaction was also observed for a crack in the A276 white coated region. Figure 18 shows a thermal cycle induced microcrack in the surface ply of the A276 coated quadrant. Careful observation reveals that the crack has propagated through the coating allowing limited AO attack of the substrate. The coating breach, which is visible with the unaided eye on the panel surface, was present during flight as evidenced by the signs of AO erosion in the crack. Crack propagation through the A276 coating was unexpected as the coating has a strain to failure of 30-50%. The limited AO erosion in the substrate microcrack suggests that propagation through the coating occurred later in the mission. The substrate crack which would have developed before most of the AO exposure may have created stresses in the coating which accelerated AO attack of the coating over the crack.

FIGURE XVIII - CROSS SECTIONAL PHOTOMICROGRAPH OF MICROCRACK IN SURFACE PLY OF EXPOSED A276 COATED T300/934 PANEL QUADRANT
