Joseph J. Mallon, Joseph C. Uht, and Carol S. Hemminger
The Aerospace Corporation
2350 E. El Segundo Blvd.
El Segundo, CA 90245
Phone: 310/336-1619, Fax: 310/336-5846

ABSTRACT

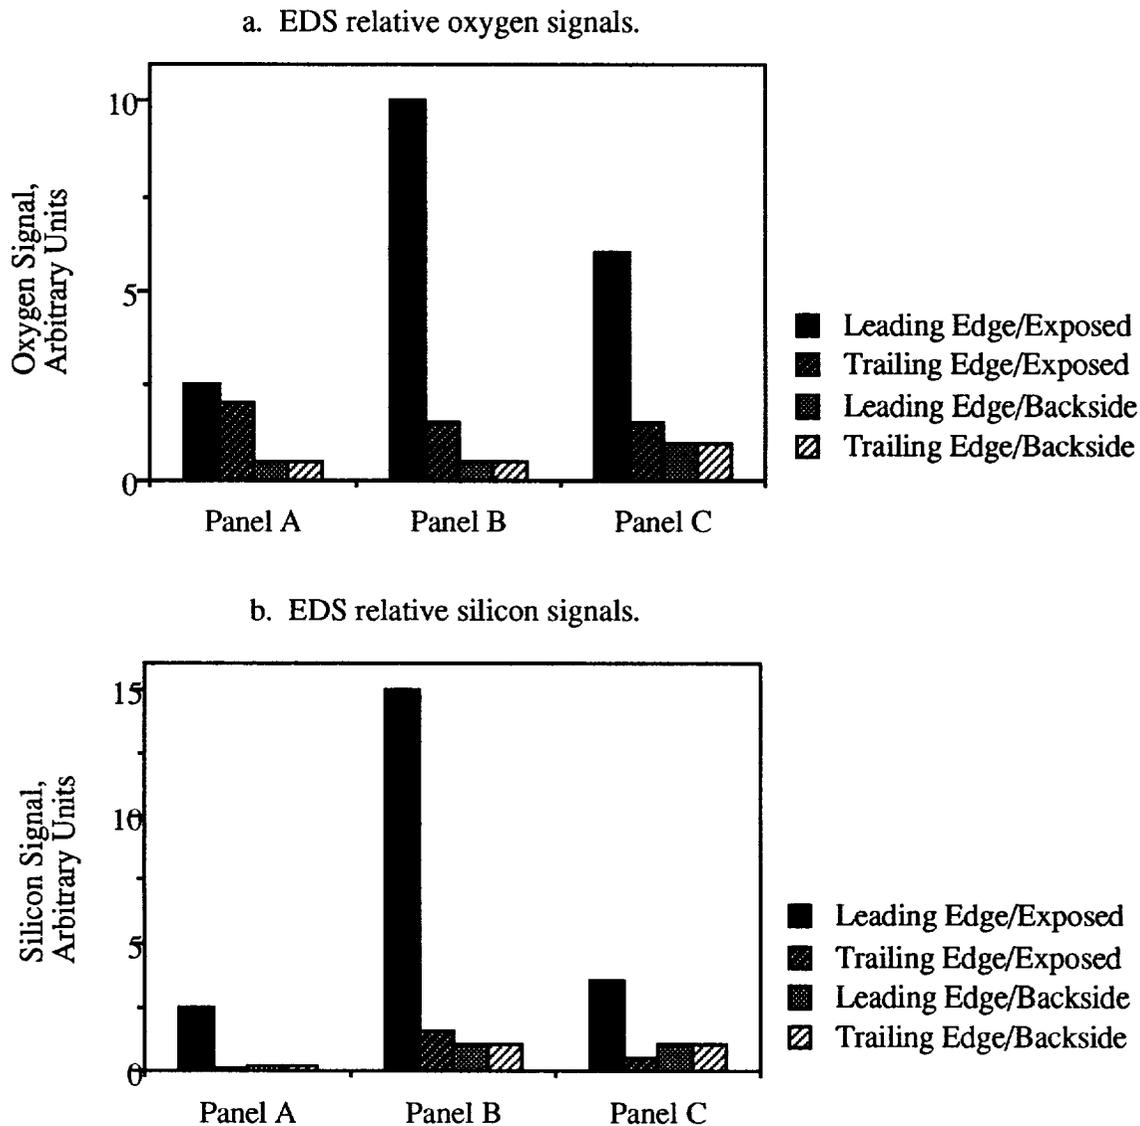
Figure 8. EDS surface composition of samples compared as a function of exposure.

At 15 kV, X-ray information for EDS surface composition determination comes from a depth of $\leq 1 \mu\text{m}$. The EDS data showed that all of the composites flown on LDEF were contaminated with Si and O. Low levels of Cl and Cu were also present on most of the analyzed samples. Other minor contaminants detected on one or more surfaces included Ca, Al, S, P, Mg, Ni, Fe, and Ti. In each case, the O concentration was higher on the exposed face than on the backside face, and higher on the leading edge exposed surface than on the trailing edge exposed surface, as seen in Fig. 8a. EDS data are not readily quantified for the low atomic number elements, such as C and O. Therefore, comparison of relative

surface concentrations has been approximated for these composite samples by using elemental peak heights (arbitrary units) after setting all of the carbon peaks to the same height. This should be a valid approximation since carbon from the fabric and organic matrix is the dominant component in the volume analyzed (SEM analysis of the sample cross sections and XPS analyses do not show thick contaminant overlayers on the exposed surfaces). It is seen in Fig. 8b that the silicon concentration was higher on the leading edge exposed surfaces than on the trailing edge exposed surfaces or any of the backside surfaces. The exposed surface of L-B had higher silicon and oxygen concentrations than the exposed surfaces of L-A and L-C, which is consistent with the lower extent of erosion on L-B observed in the micrographs.

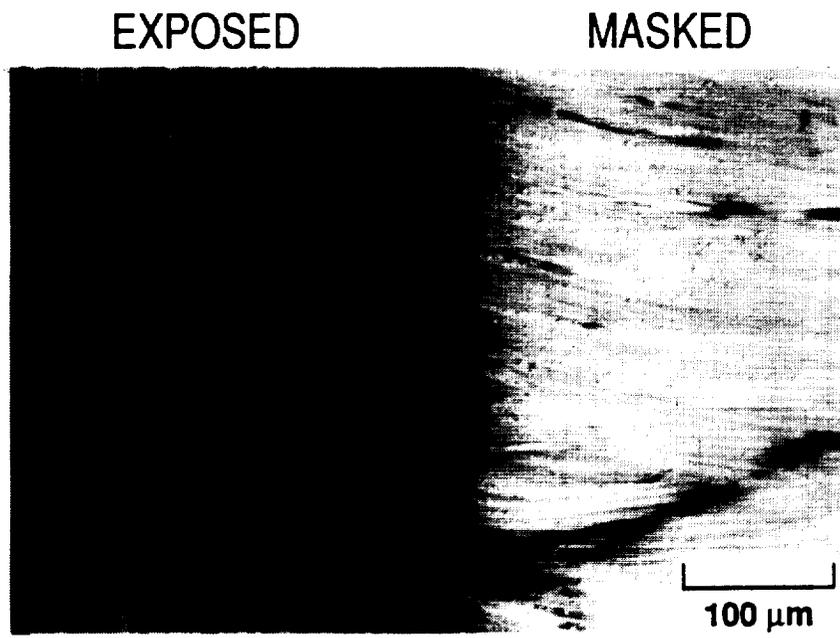
Figure 3. SEM micrograph of L-C surface showing details of exposed and masked areas.

The erosion process resulted in a morphology on all the leading edge samples that is best visualized by examining the micrographs of the surface and of the cross-sectioned samples. Figure 2 shows that a leading edge exposed surface is characterized by large crevasses that have developed predominantly parallel to the long axis of the fibers. This emphasizes the weave pattern of the carbon fiber tows in the fabric. However, the surface SEM micrographs do not clearly elucidate the condition of the remaining exposed fibers, even at higher magnification, as seen in Fig. 3. The optical micrograph cross section of the L-A surface shown in Fig. 4a highlights the "peak and valley" morphology associated with crevasse development on the exposed surface. Note that crevasses parallel to the cut of the cross section may not be seen. The area on the left side of the optical micrograph, where the sample was masked, shows the relatively smooth preflight condition of the surface. Higher magnification SEM micrographs of the L-C cross section are shown in Figs. 5-6. They show that the crevasses traversed both fibers and matrix, and most appeared to have steep sides and a well-defined tip. The crevasses ranged from 10 to 100 μm in depth, and no undercutting of the matrix relative to the fibers was apparent along the sides of the crevasses.

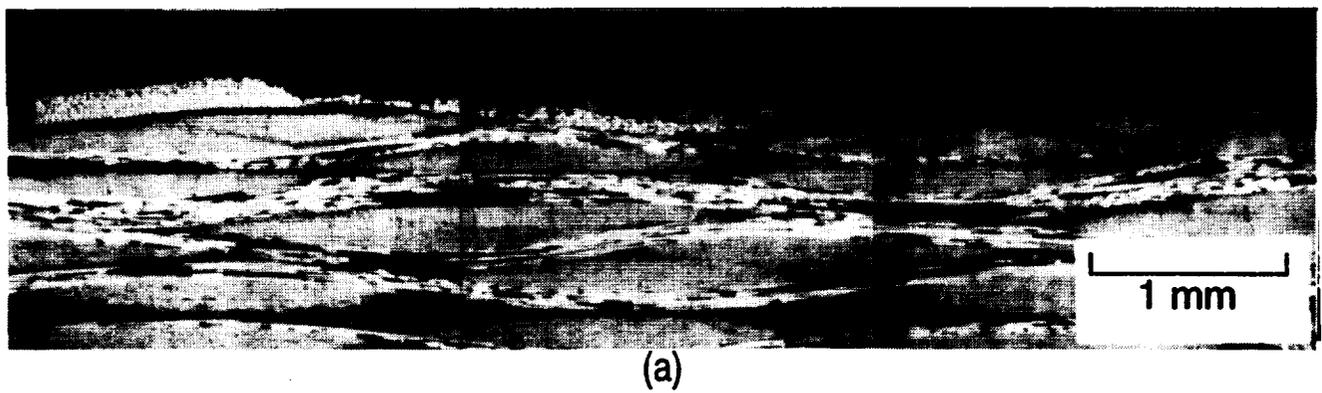
It was estimated from the cross-section optical micrographs that the erosion depth on L-A and on L-C was about 125 μm . The measurements were taken at the left side of the micrographs (see Fig. 4), where there is an edge between the masked and exposed areas of the surface. Individual crevasses reflect erosion depths less than or greater than the value at the edge. The optical micrograph of L-B, shown in Fig. 4b, showed features similar to those in the micrographs of L-A and L-C. However, the average depth of erosion from Fig. 4b appeared to be 25 to 50 μm , and was difficult to measure because of the

Figure 4. Optical micrographs of (a) L-A cross section and (b) L-B cross section.

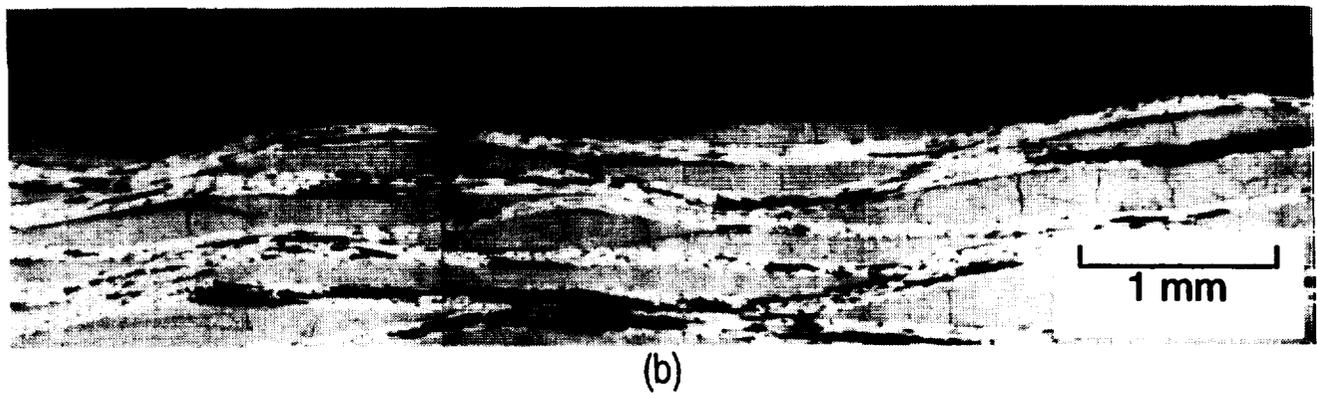
The addition of PPQ to the HA-43 matrix did not have an obvious effect on the erosion rate or pattern of erosion for L-C relative to L-A. L-B, however, was eroded only 20 to 40% as deeply as the other two composites, as seen by comparing Fig. 4b to 4a. Examination of L-B at high magnification, as seen in Fig. 7, revealed well-defined crevasses comparable to those on L-A and L-C in appearance, but on average less enlarged. The panel for samples L-B and T-B, fabricated using PAA prepared in our laboratory, had the lowest resin content (about 40% lower than the other two panels). In this case, the lower reaction efficiency of the fibers relative to the organic matrix would contribute to the lower erosion rate observed for L-B. With so few samples, it can only be noted at this point that resin content and/or the details of resin composition/fabrication may play an important role in the overall composite erosion rate.

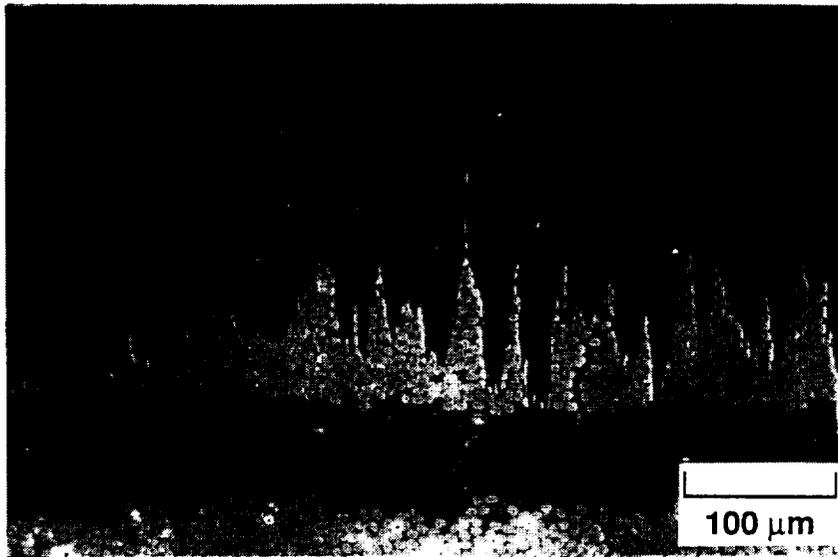
Figure 5. SEM micrograph of L-C cross section contrasting surface crack with surface crevasses .

At this point, it may be useful to distinguish between "cracks" and "crevasses." Cracks form when two previously united sections of the composite become separated. There is no net loss of material during crack formation. The cracks observed in the samples were probably caused by thermal stresses during molding or during flight. In contrast, crevasses resulted from removal of fiber and matrix material, and were characterized by sharp triangular cross sections. Crevasses were completely absent on trailing edge sample surfaces, suggesting that they developed on leading edge surfaces as a result of atomic oxygen erosion. Figure 5 shows a section of L-C that contains both a surface crack and surface crevasses. The crack is narrow, uniform in width, and extends further into the sample interior than the wider, triangular crevasses. Note that the intersection of the crack with the surface did not cause a crevasse to form. In general, we found no correlation between the location of cracks and crevasses, and, as seen in Fig. 5, crevasses were more numerous than cracks.
