Debris/Ice/TPS Assessment and Integrated Photographic Analysis for Shuttle Mission STS-55

(NASA-TM-107559) DEBRIS/ICE/TPS
ASSESSMENT AND INTEGRATED
PHOTOGRAPHIC ANALYSIS FOR SHUTTLE
MISSION STS-55 Final Report, 22
Mar. - 7 May 1993 (NASA) 136 p

Gregory N. Katnik
NASA/Kennedy Space Center

DEBRIS/ICE/TPS ASSESSMENT
AND
PHOTOGRAPHIC ANALYSIS
OF
SHUTTLE MISSION STS-55

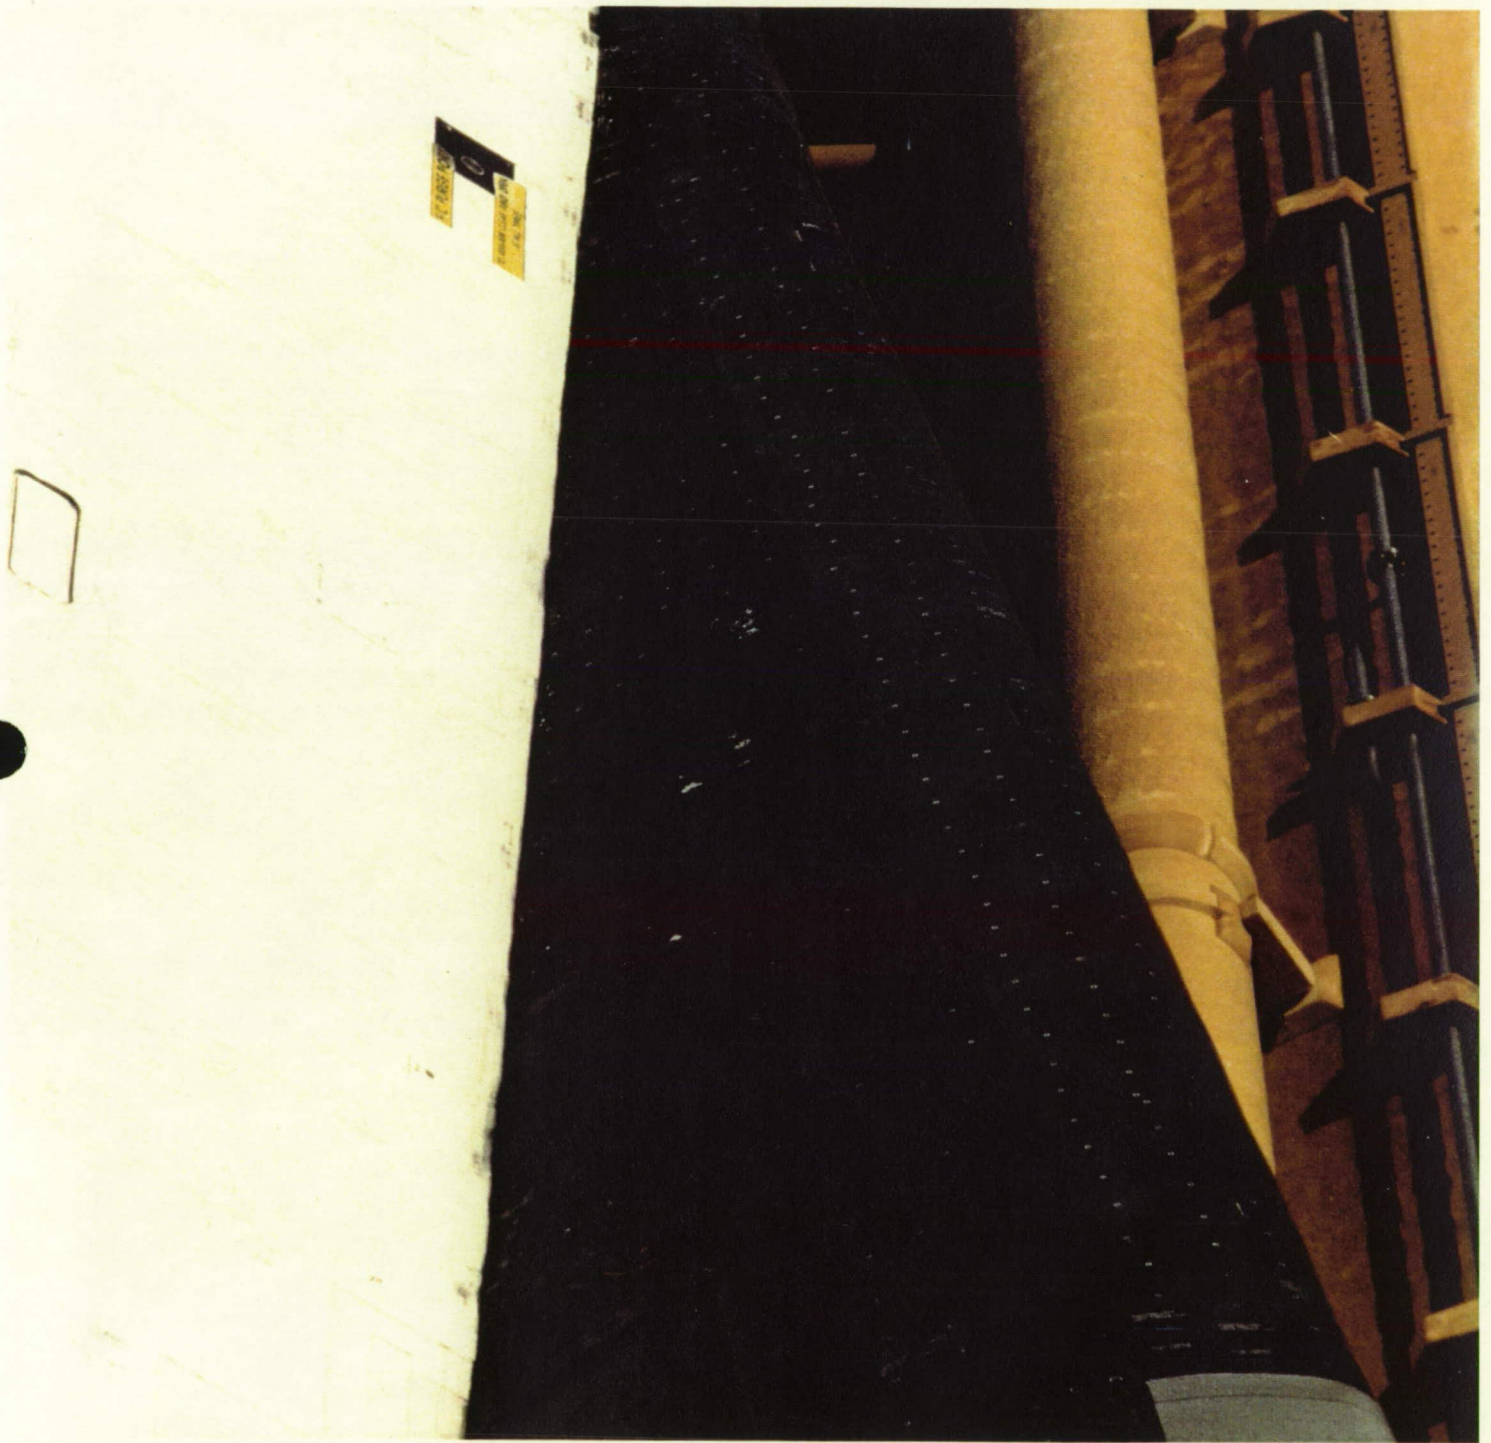
A coating of black paint was missing from three tiles
on the right wing leading edge extension

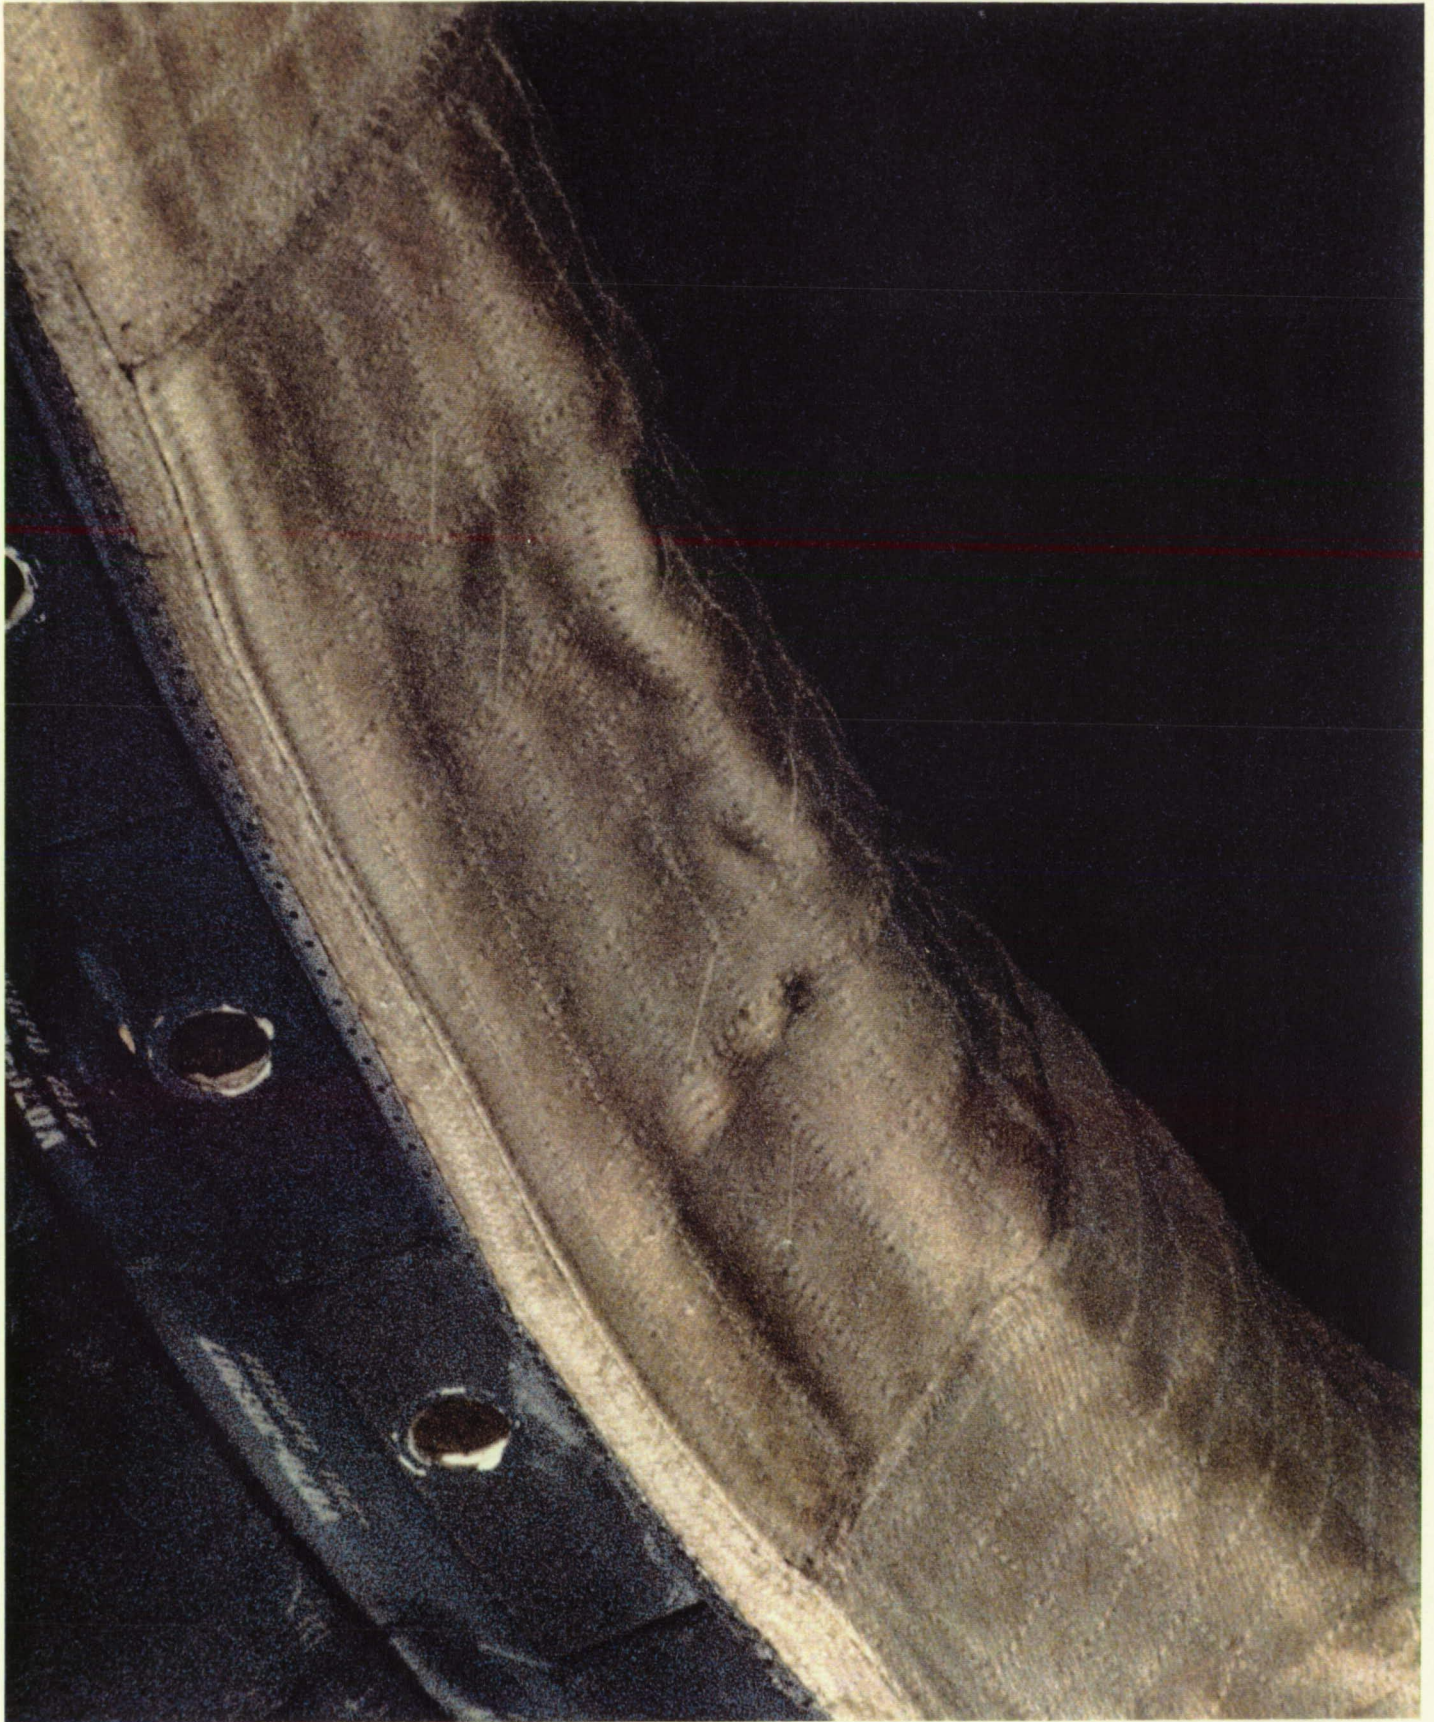
The Orbiter SSME #2 Dome Mounted Heat Shield (DMHS) closeout blanket appeared to be scorched and discolored

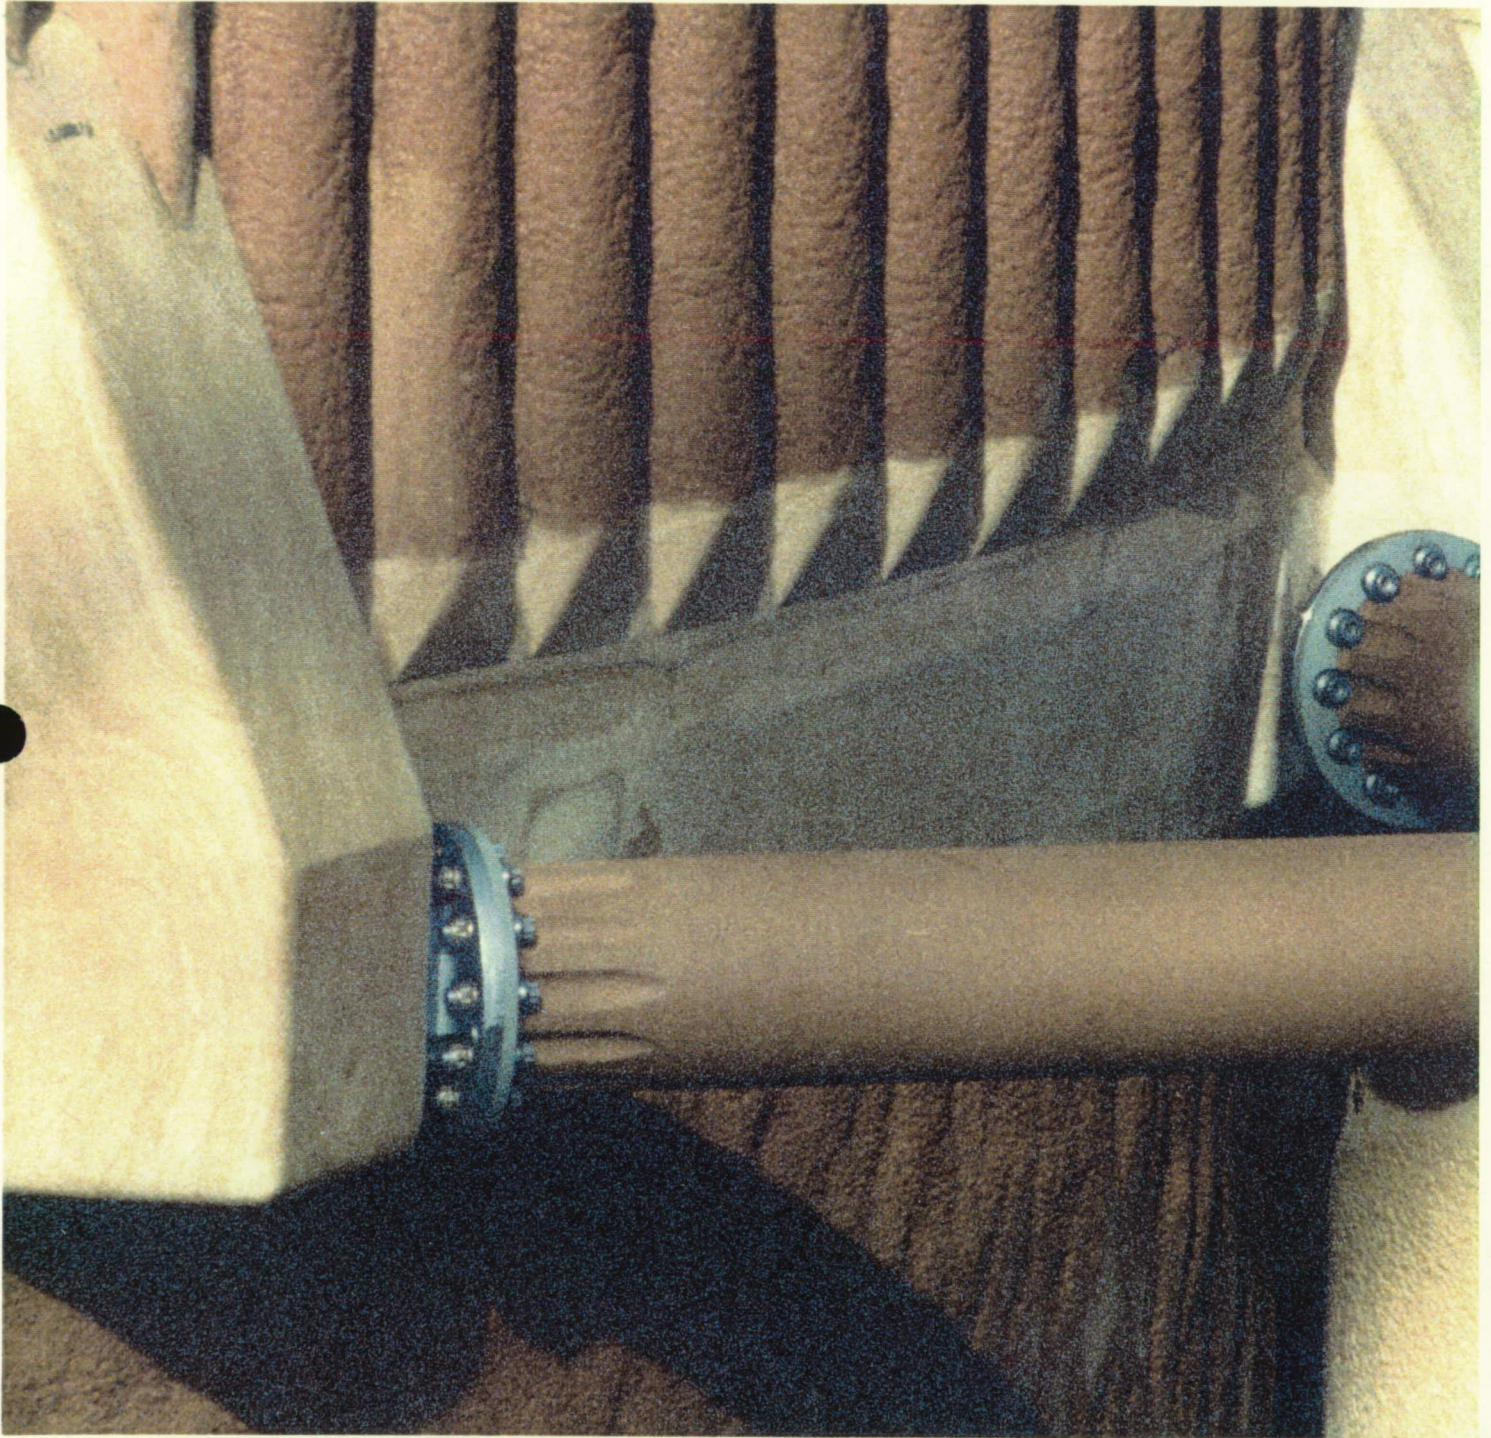
Bipod jack pad closeouts were intact and flush with adjacent LH2 tank-to-intertank flange closeout foam

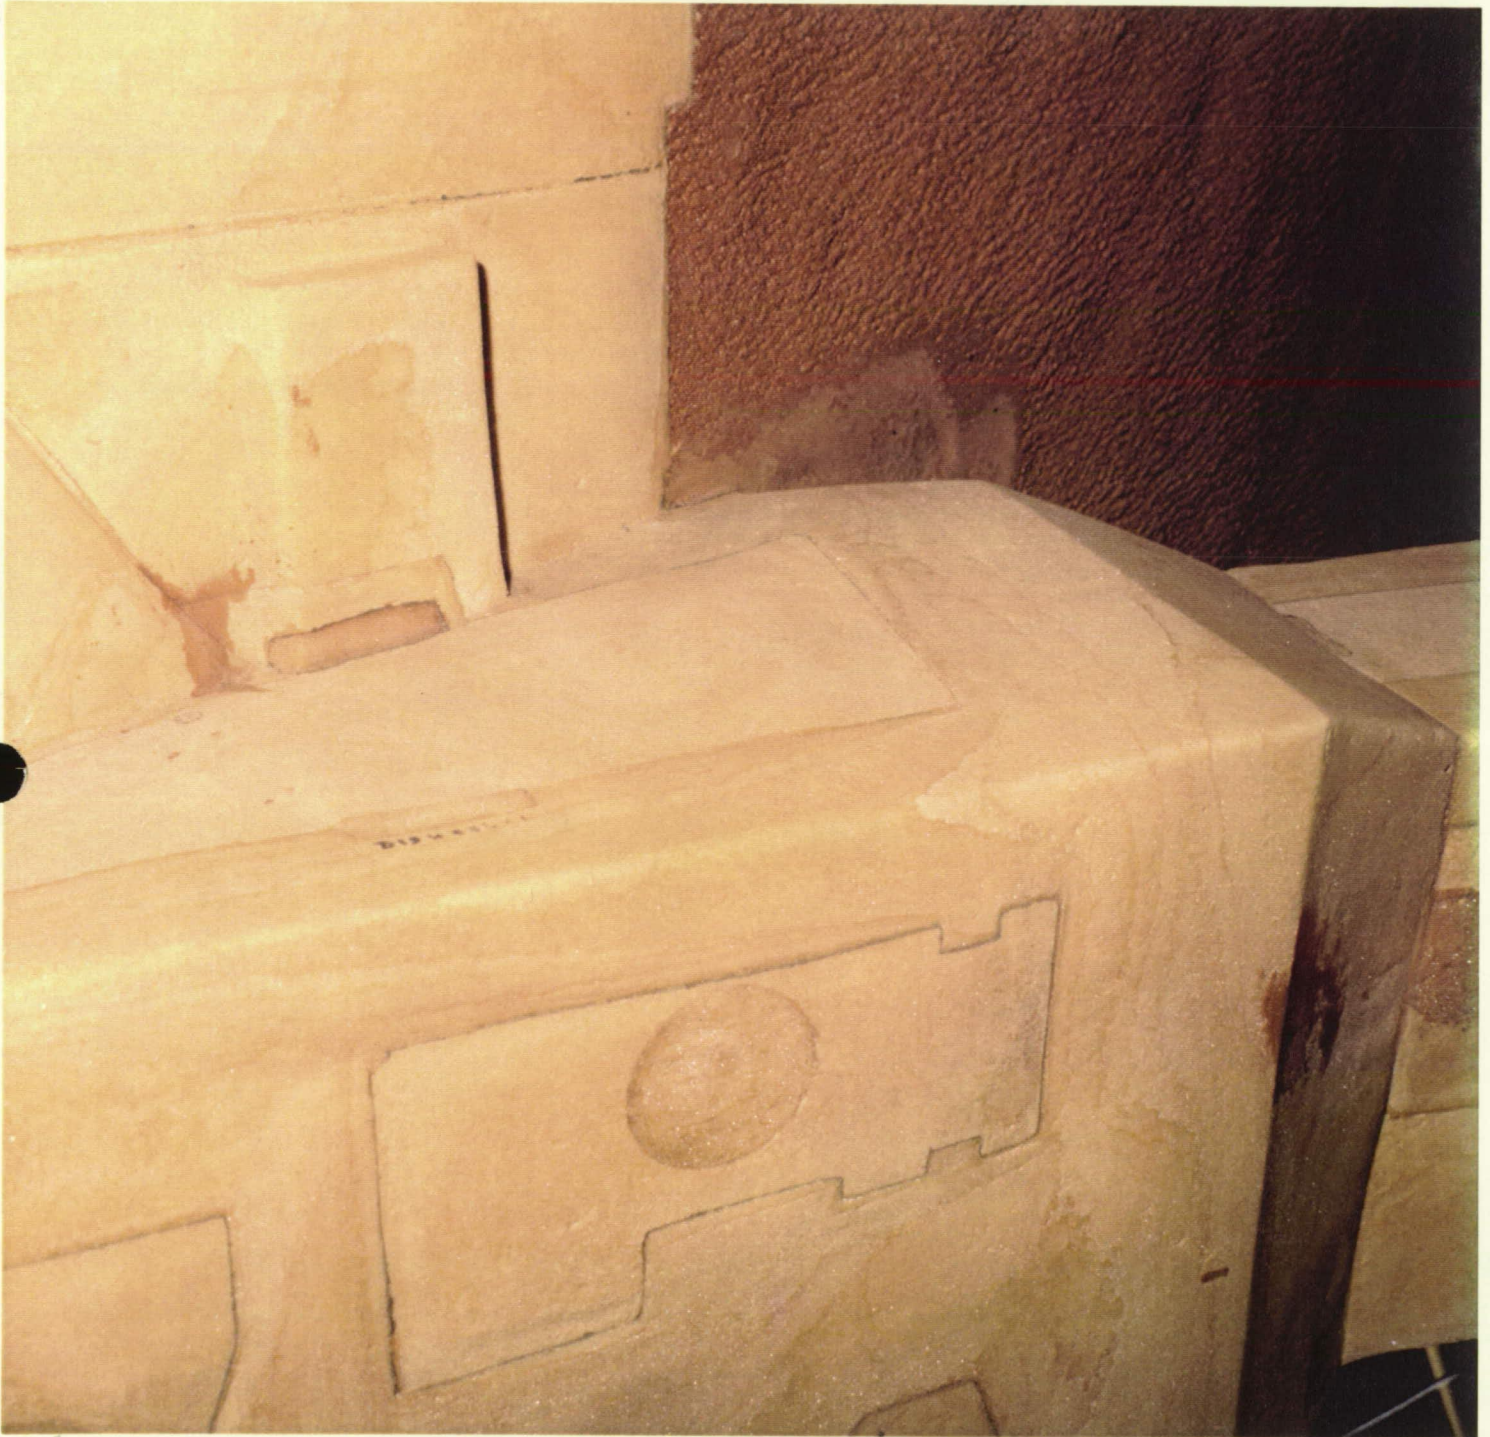
A 4-inch long crack was present in the -Y vertical strut cable tray forward surface TPS near the longeron closeout interface. The 1/4-inch wide crack exhibited no offset and was not filled with ice or frost. The appearance of the crack was expected due to the elimination of the stress relief gap at the factory.

Pre-launch view of the left (-Y) vertical strut cable tray TPS after one cryogenic loading. Cracks in the foam typically occur in this area due to the elimination of the stress relief cut.

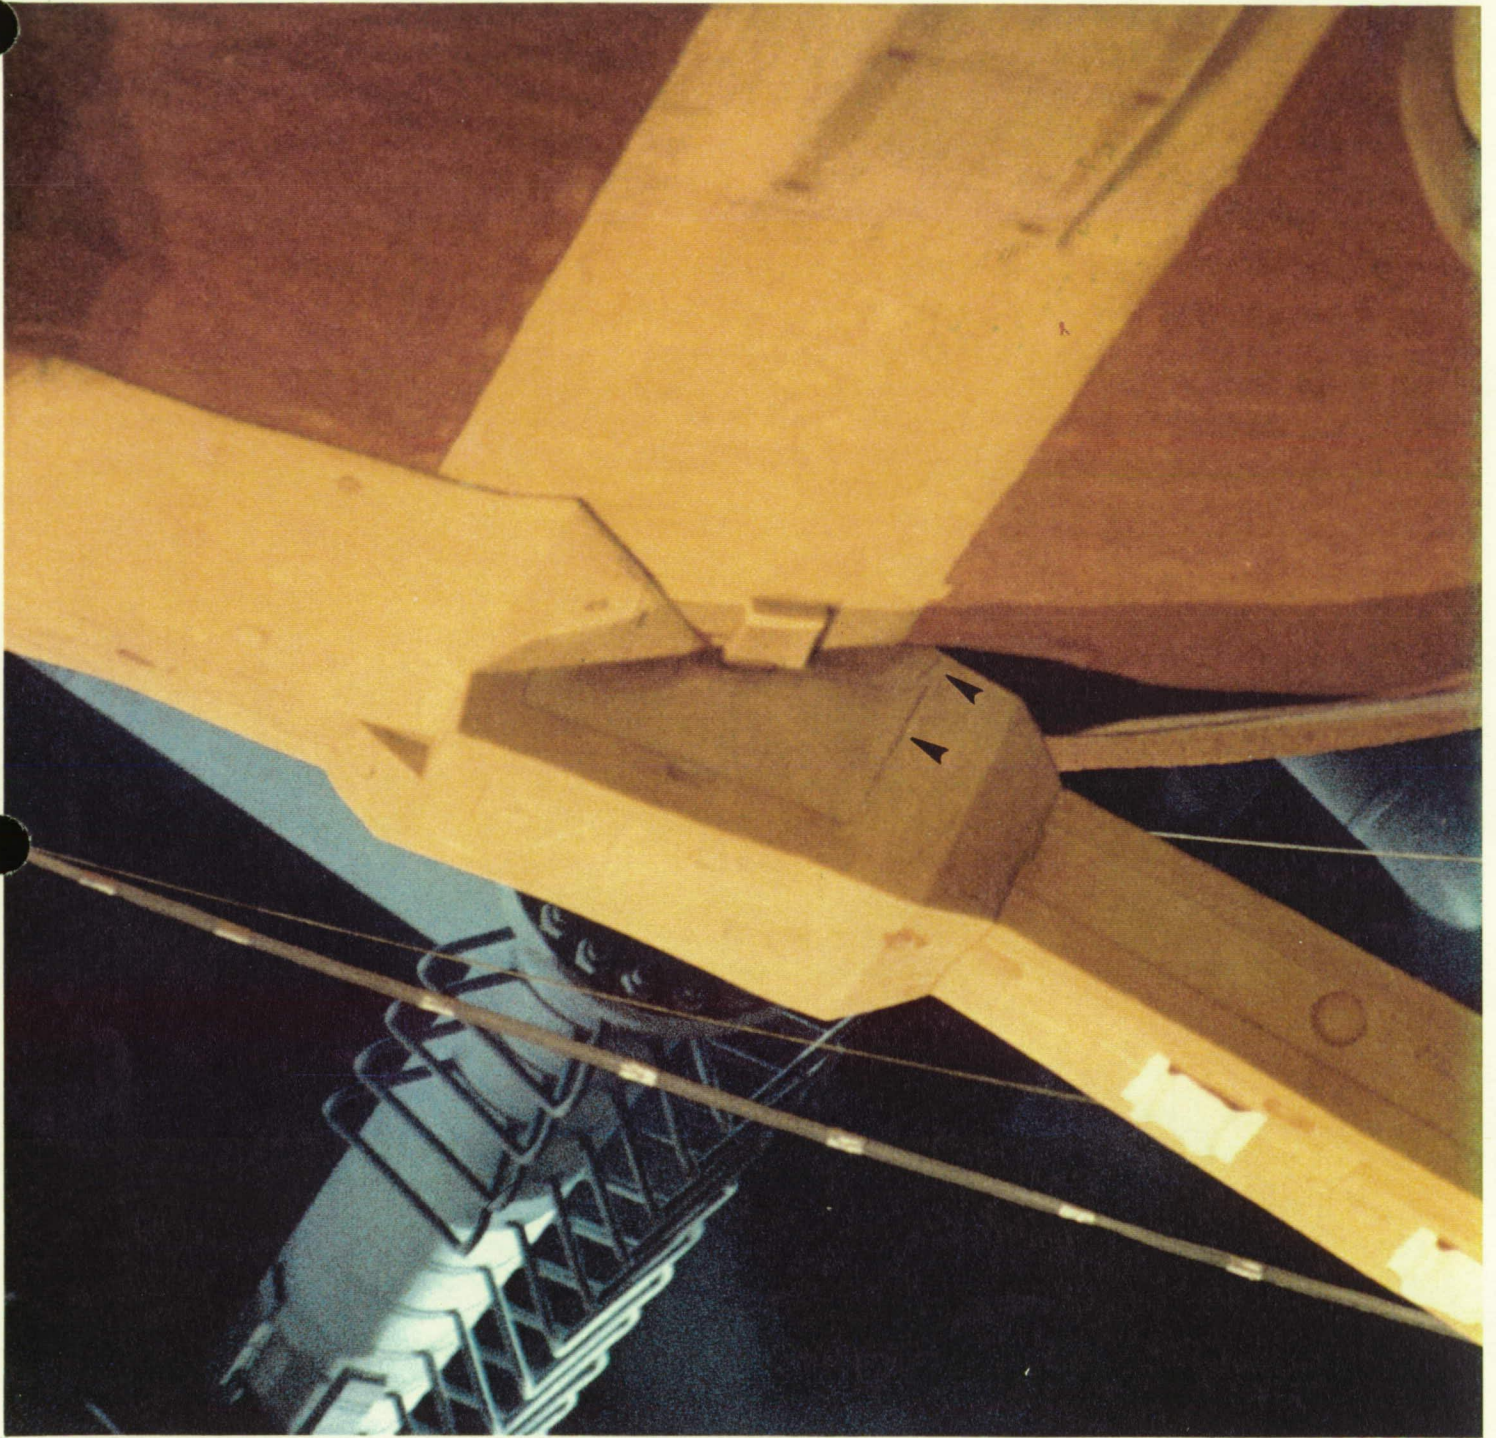
A 4-inch long by 1/4-inch wide crack in the -Y vertical strut cable tray forward surface TPS near the longeron closeout interface propagated outboard. A second crack, 10 inches long, by 1/4-inch wide occurred along the bondline in the center of the cable tray closeout and propagated inboard. Continued propagation of both cracks in flight would most likely result in one long crack on the forward surface of the cable tray foam. The cracks exhibited no offset and were not filled with ice or frost. The condition was acceptable for flight per the NSTS-08303 criteria.

A 4-inch long crack in the -Y vertical strut cable tray forward surface TPS near the longeron closeout interface propagated outboard. A second crack, 10-inches long, occurred along the bondline in the center of the cable tray closeout and propagated inboard. Continued propagation of both cracks would most likely result in one long crack on the forward surface of the cable tray foam. The condition was acceptable for flight.

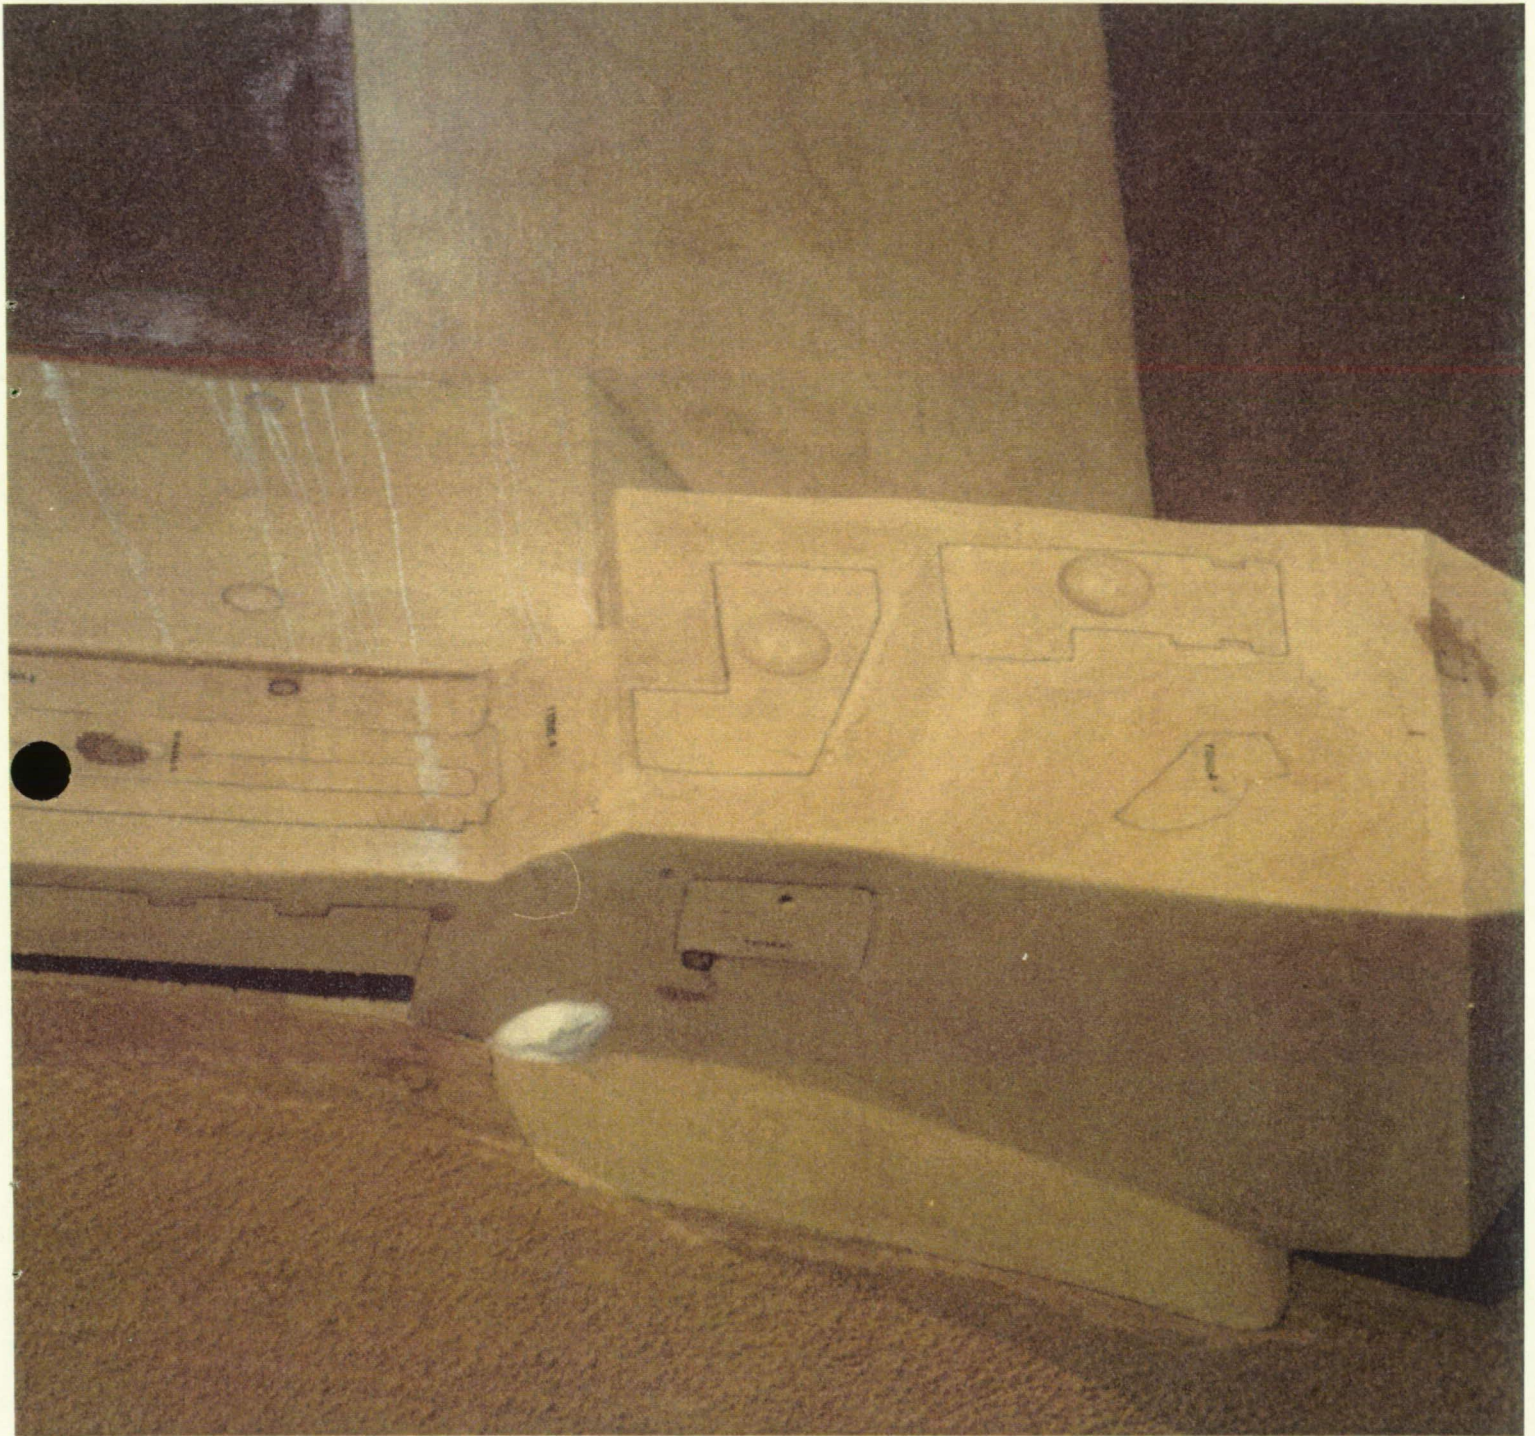
A small crack in the TPS with associated ice/frost formation was present at both +Y and -Y vertical strut-to-tank interface aft edges.

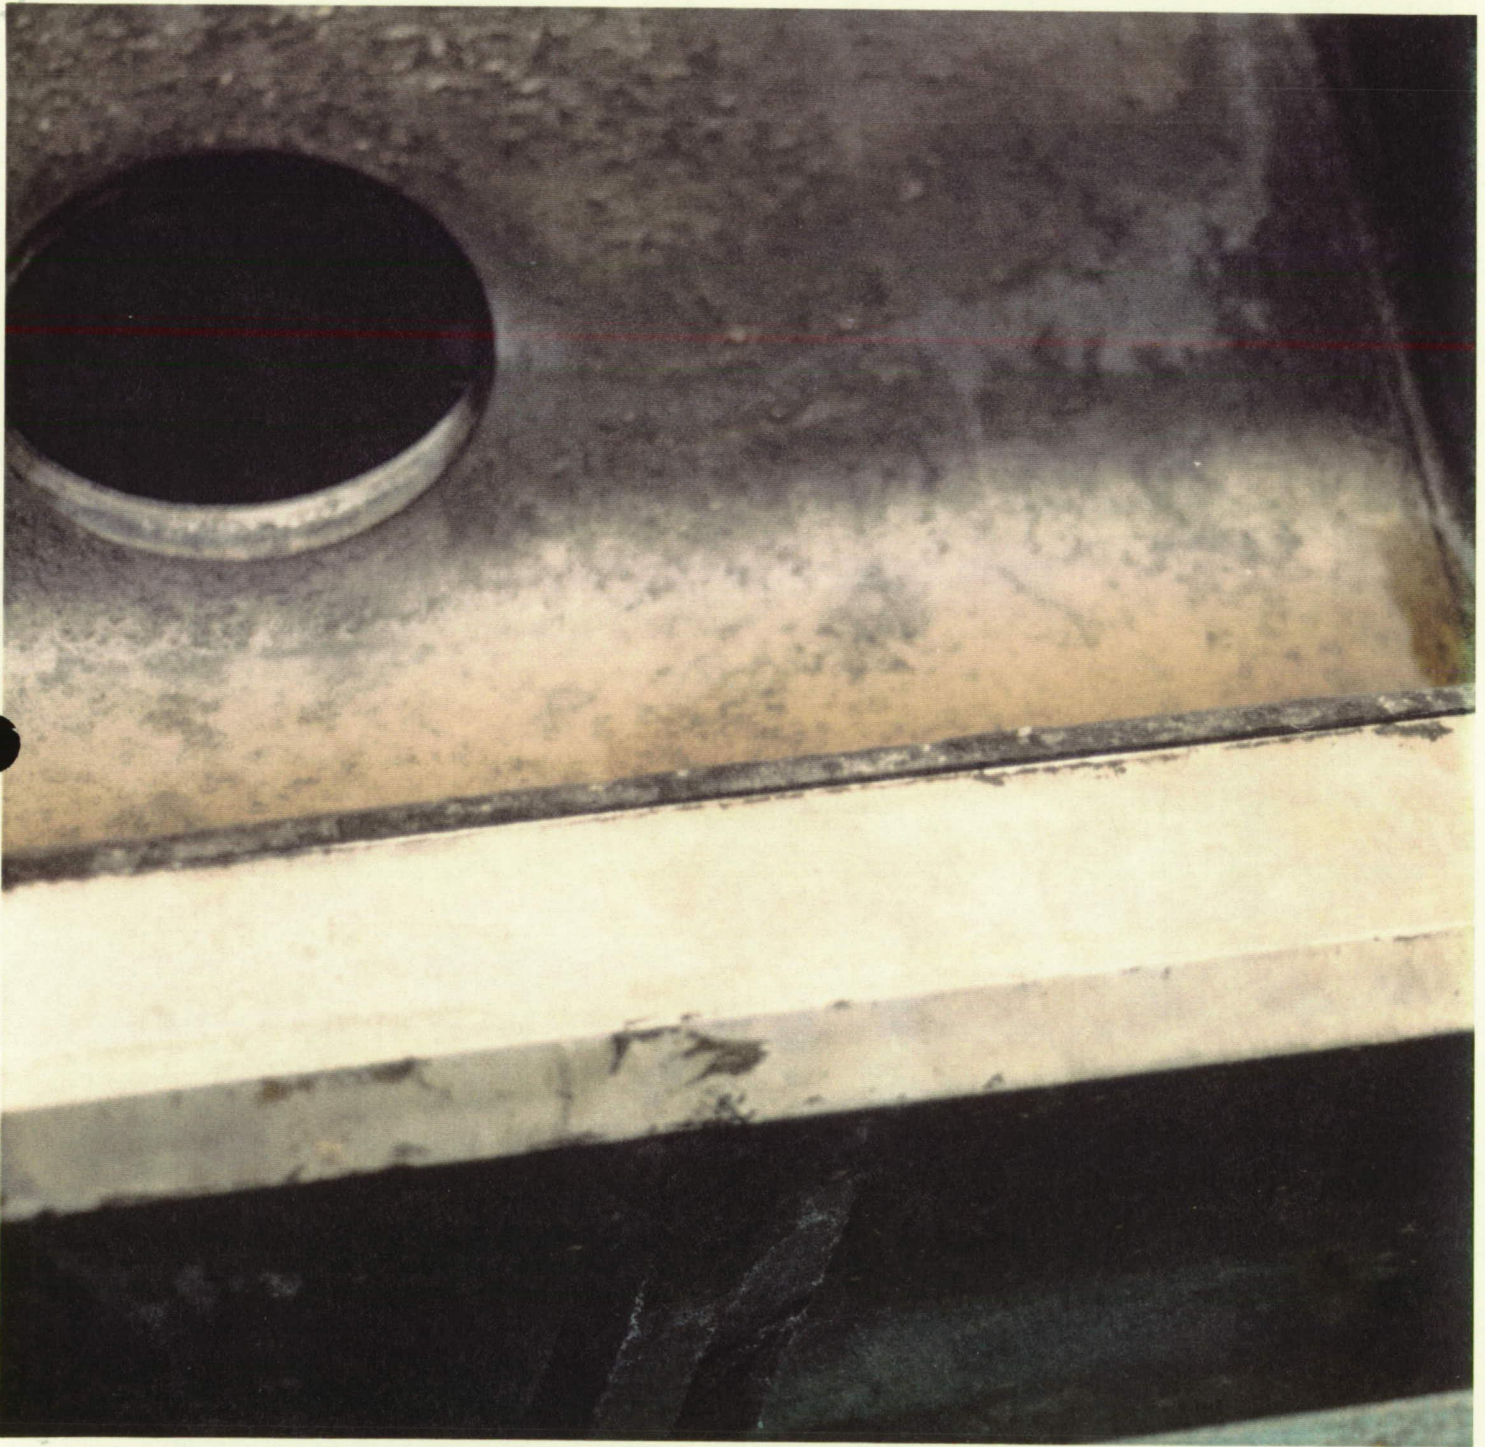
All south holddown post shoe EPON shim material was intact
but slightly debonded at the sidewall of HDP #2

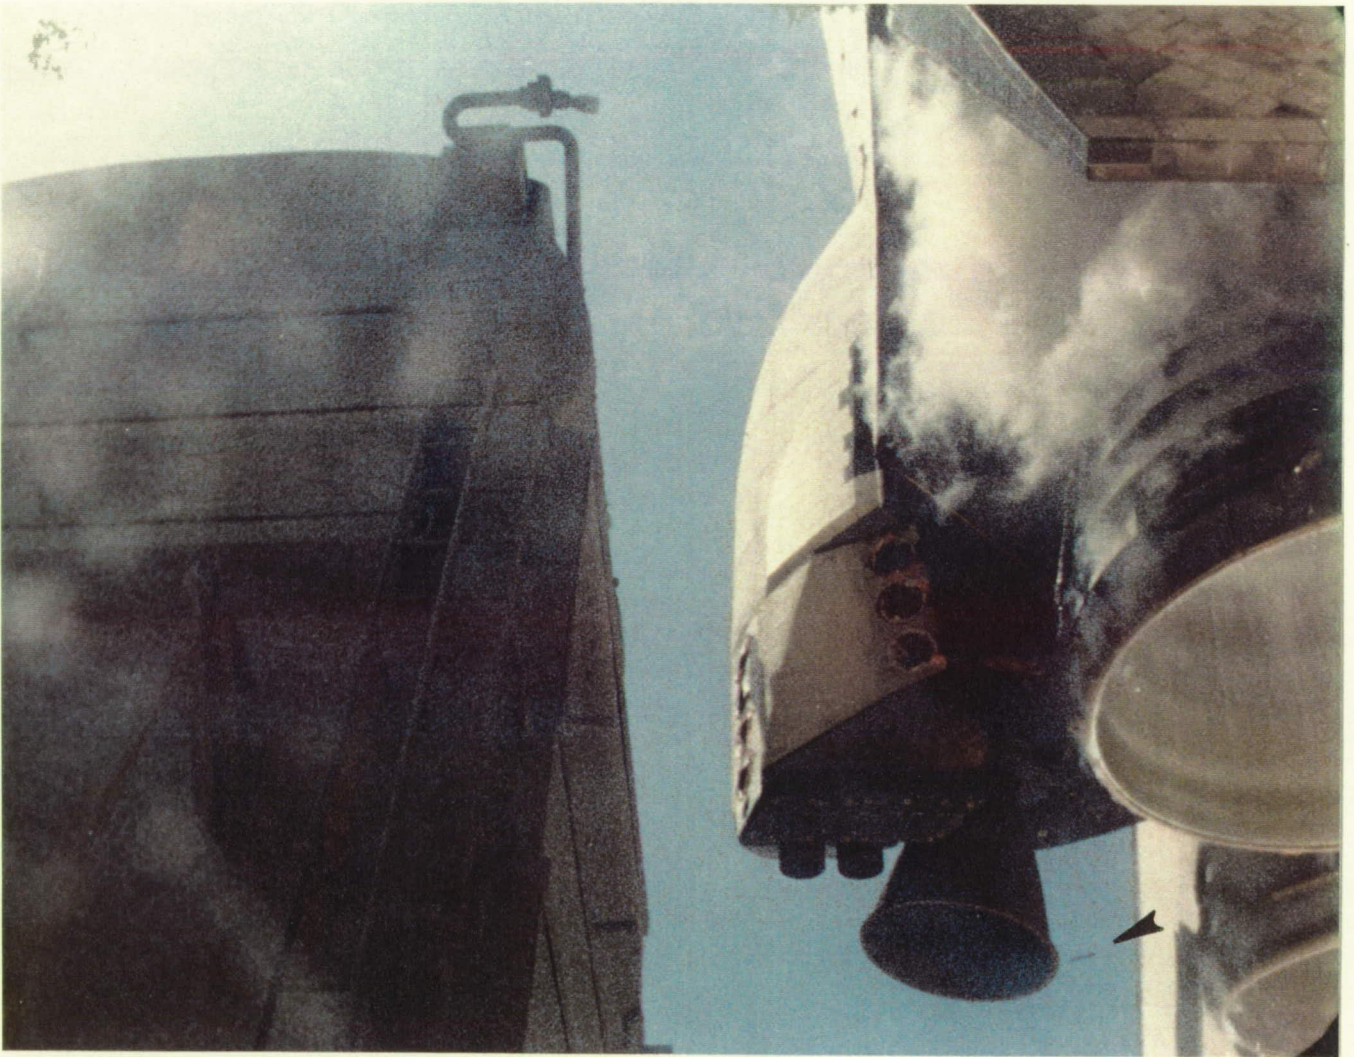
A dark, slender, debris object fell from the right aft RCS stinger area and was most likely a tile gap filler

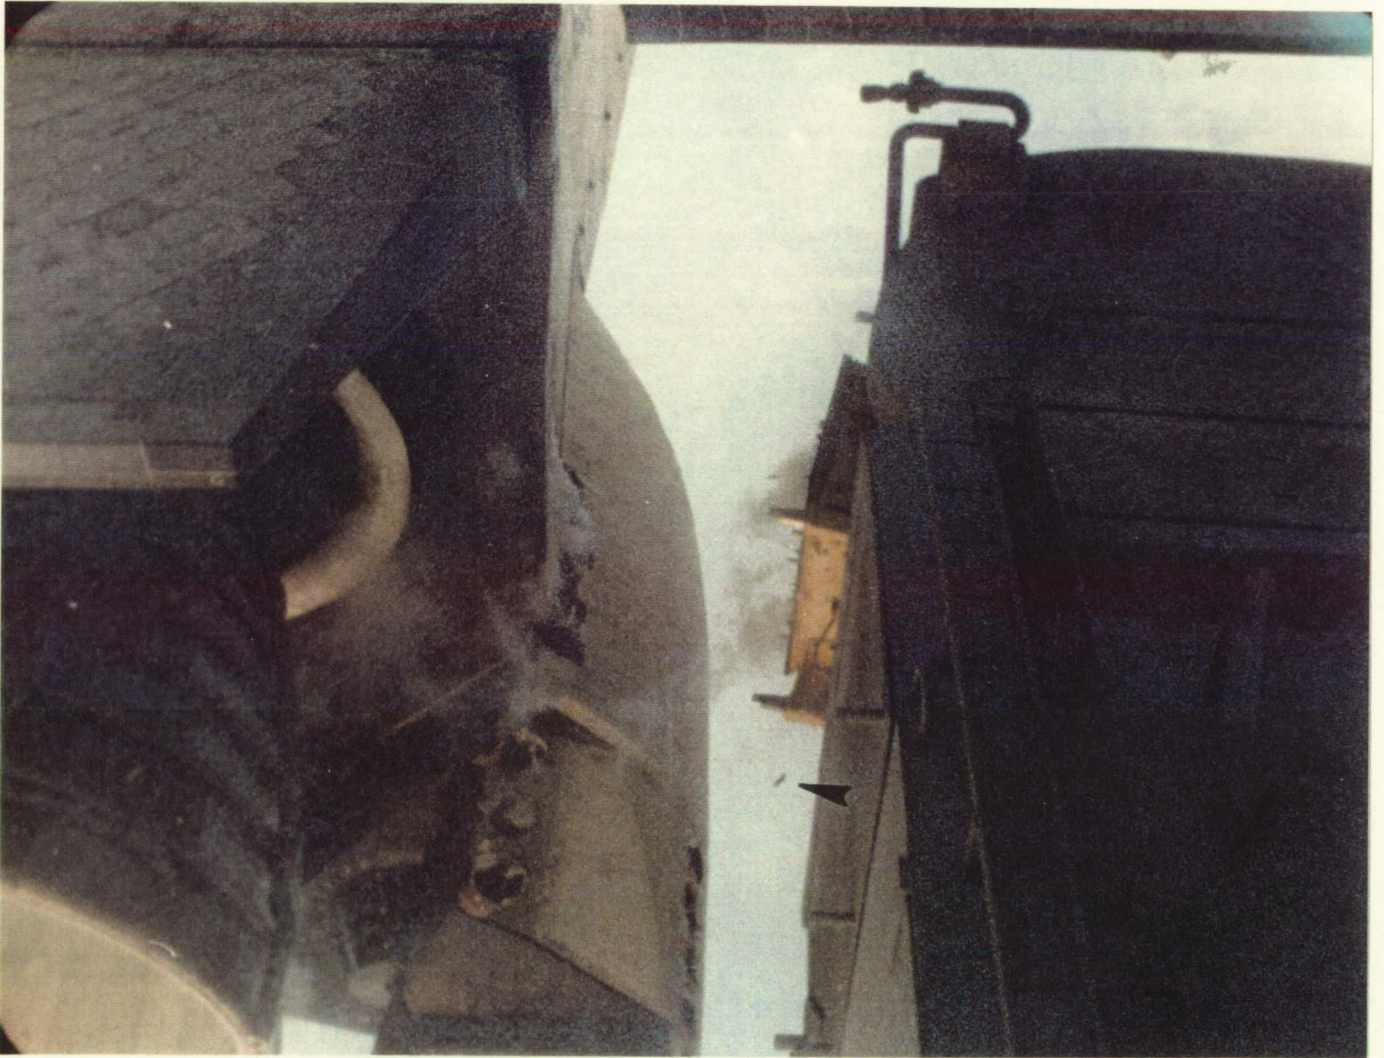
A 3" x 0.5" GSE shim fell from the LH2 T-0 umbilical carrier plate shortly after T-0

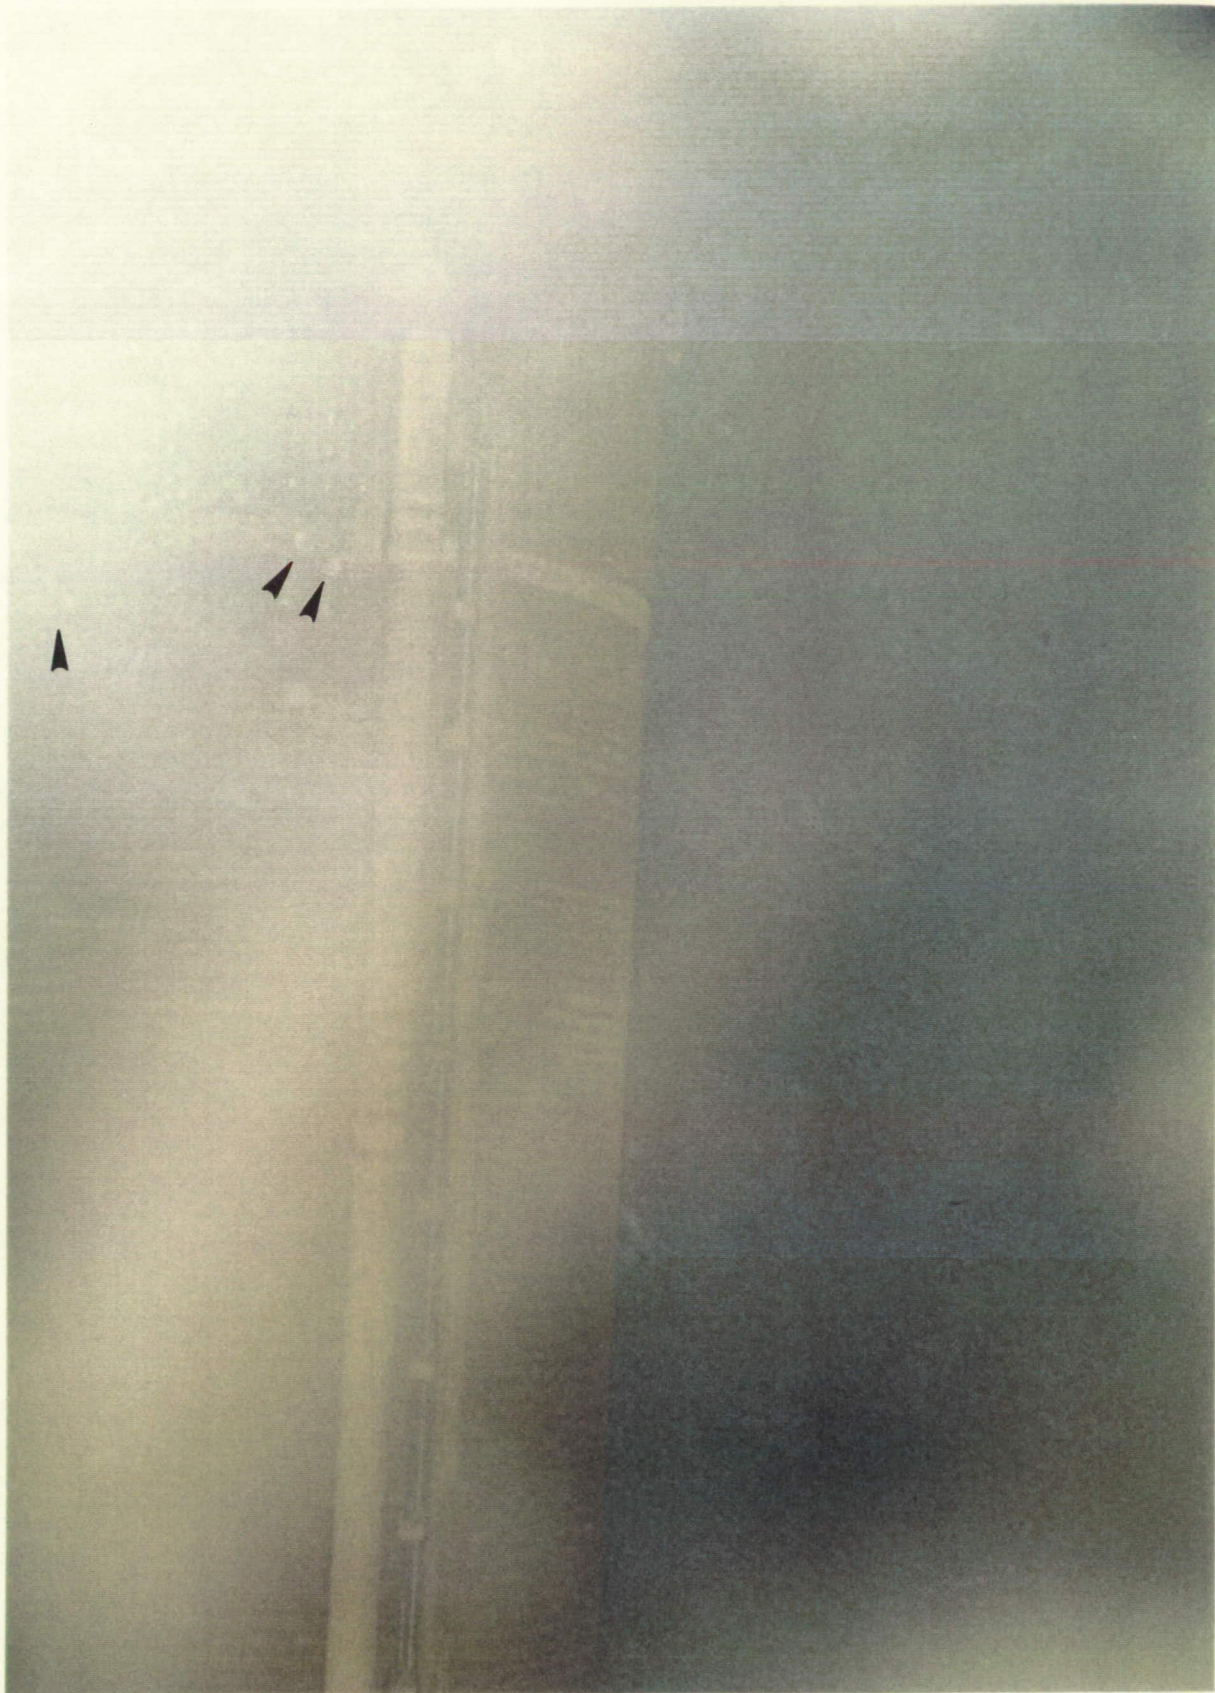
The right (+Y) bipod jack pad closeout was missing and green primer exposed. Three 6-inch divots are visible in the LH2 tank acreage TPS near the intertank splice. At least 15-20 small, shallow divots occurred in the intertank acreage TPS forward of the bipods.
