Debris/Ice/TPS Assessment and Integrated Photographic Analysis for Shuttle Mission STS-55

(NASA-TM-107559) DEBRIS/ICE/TPS
ASSESSMENT AND INTEGRATED
PHOTOGRAPHIC ANALYSIS FOR SHUTTLE
MISSION STS-55 Final Report, 22
Mar. - 7 May 1993 (NASA) 136 p

Gregory N. Katnik
NASA/Kennedy Space Center

DEBRIS/ICE/TPS ASSESSMENT
AND
PHOTOGRAPHIC ANALYSIS
OF
SHUTTLE MISSION STS-55

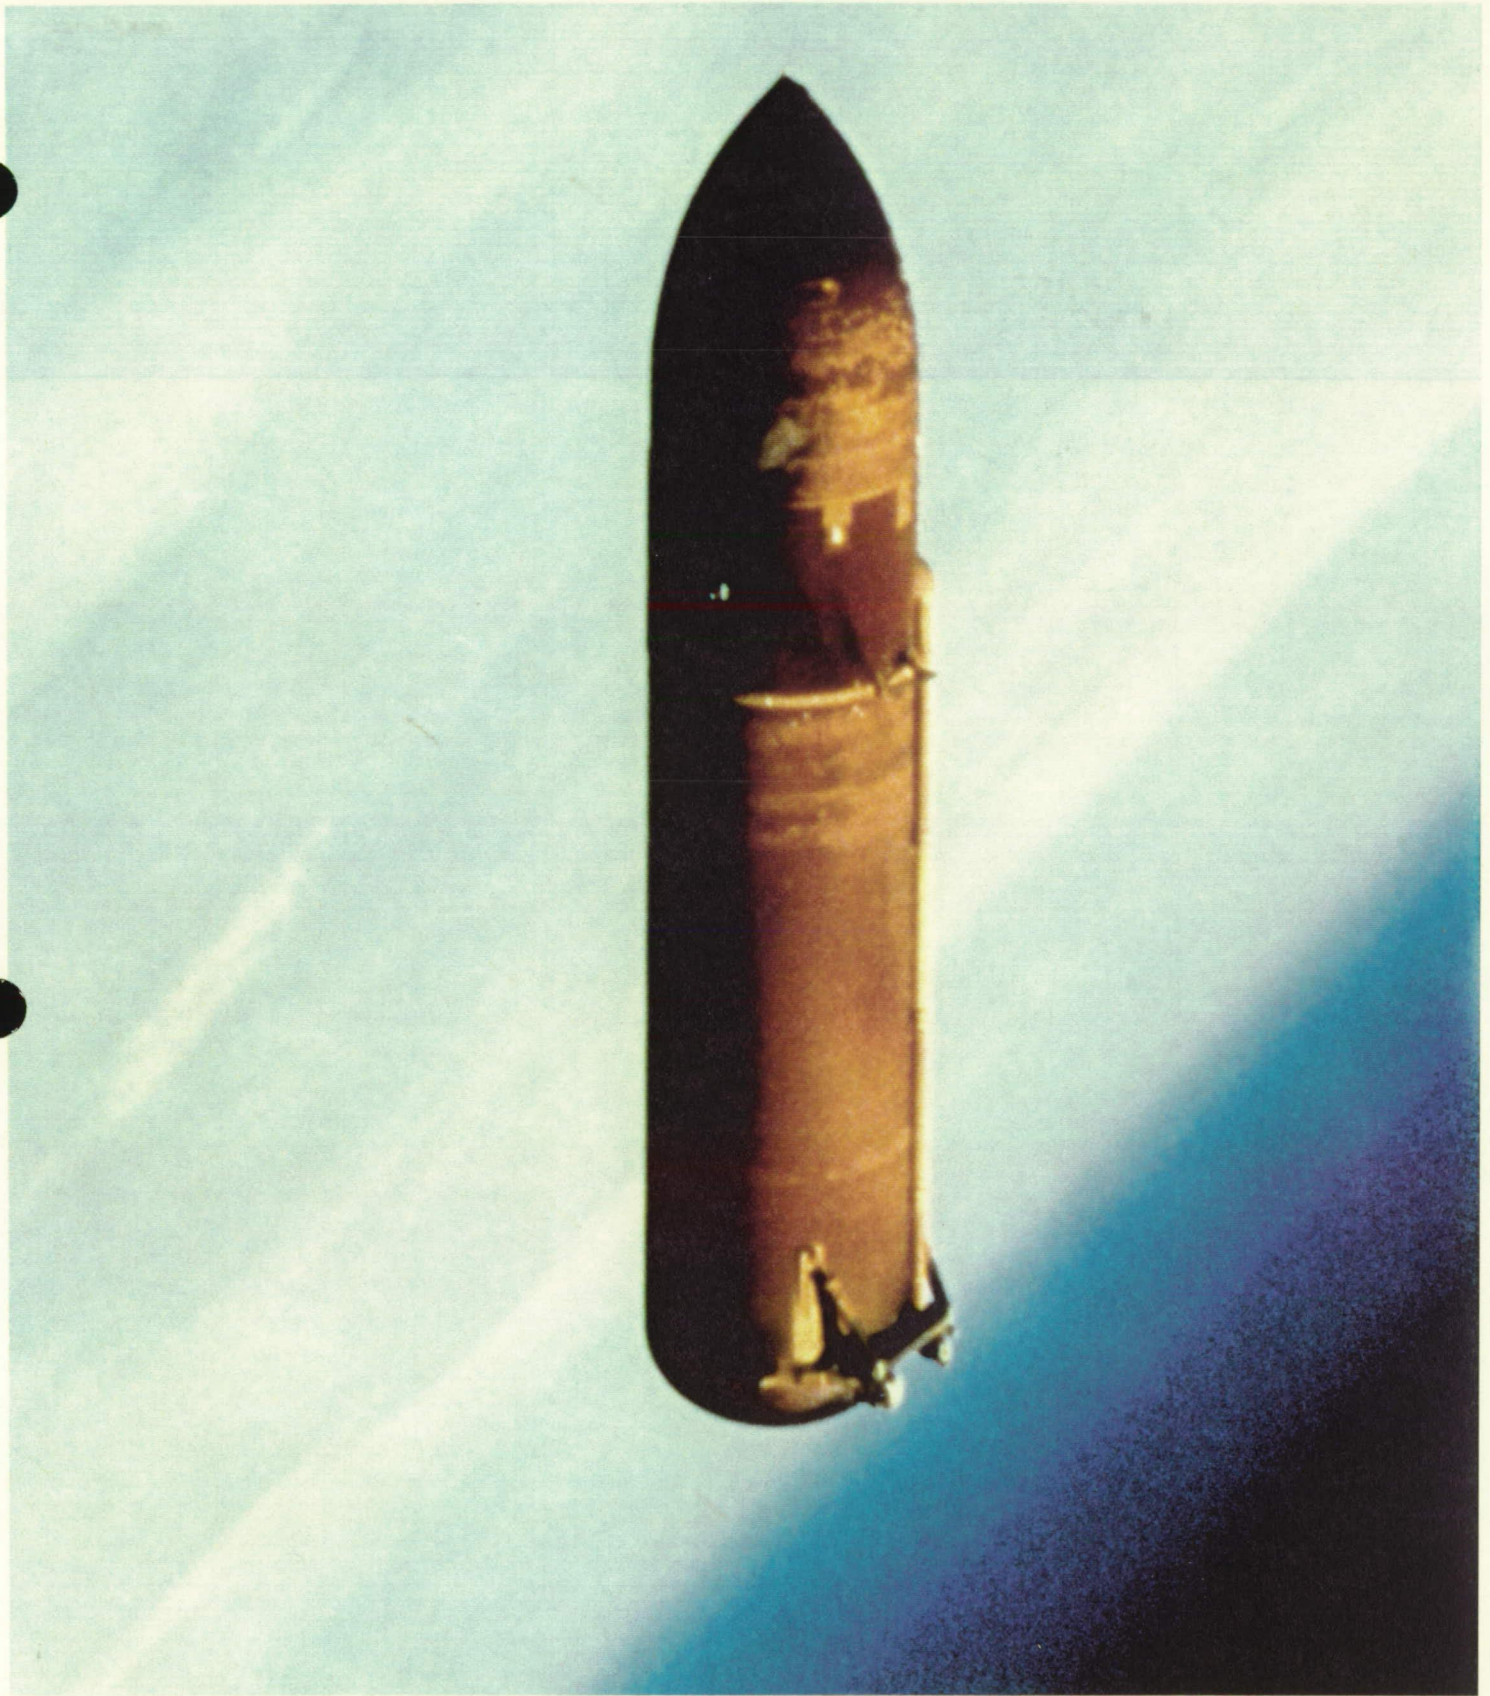
Six divots, 6-8 inches in diameter, were present in the LH2 tank-to-intertank flange closeout. One 8-inch divot occurred in the intertank acreage between the left bipod ramp and the -y thrust panel. Four 6-inch divots are visible in the LH2 tank acreage TPS near the intertank splice.

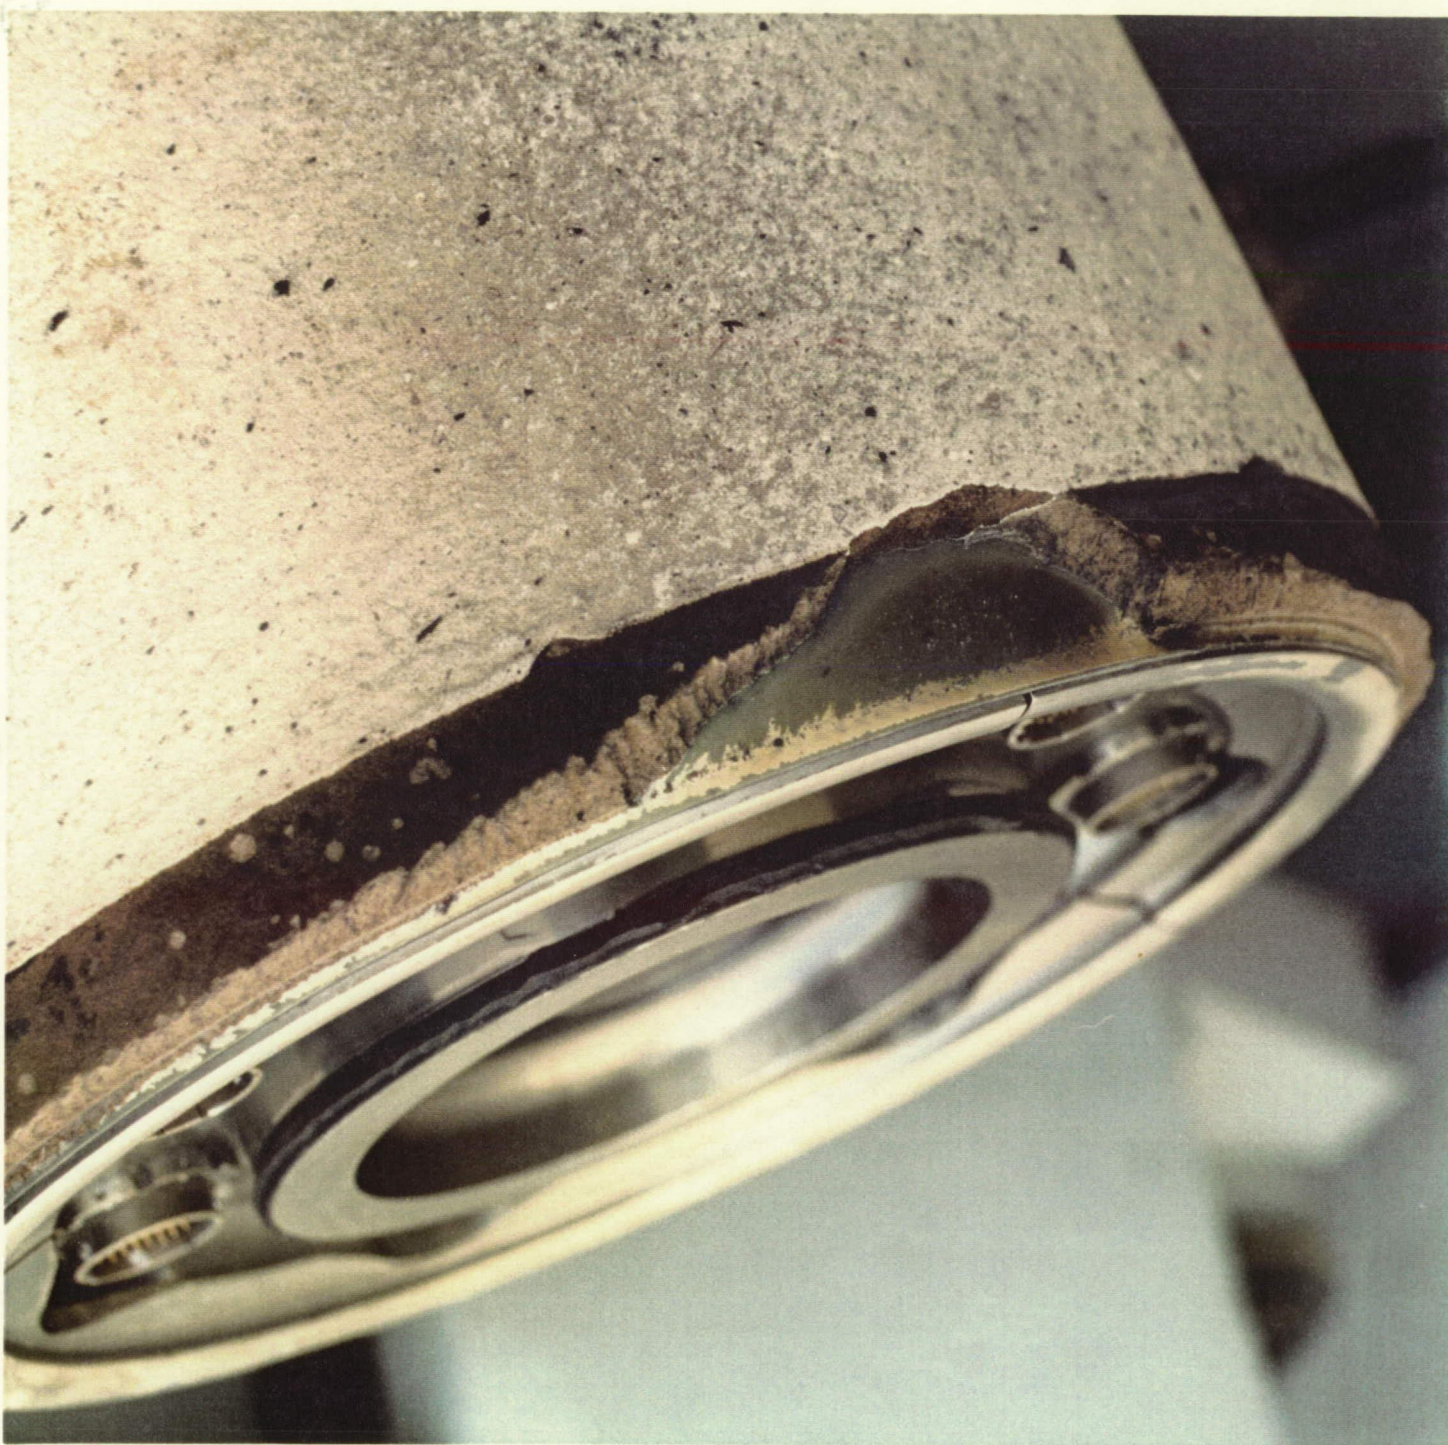
K5NA, 3"x2" in size, was missing from the upper strut fairing

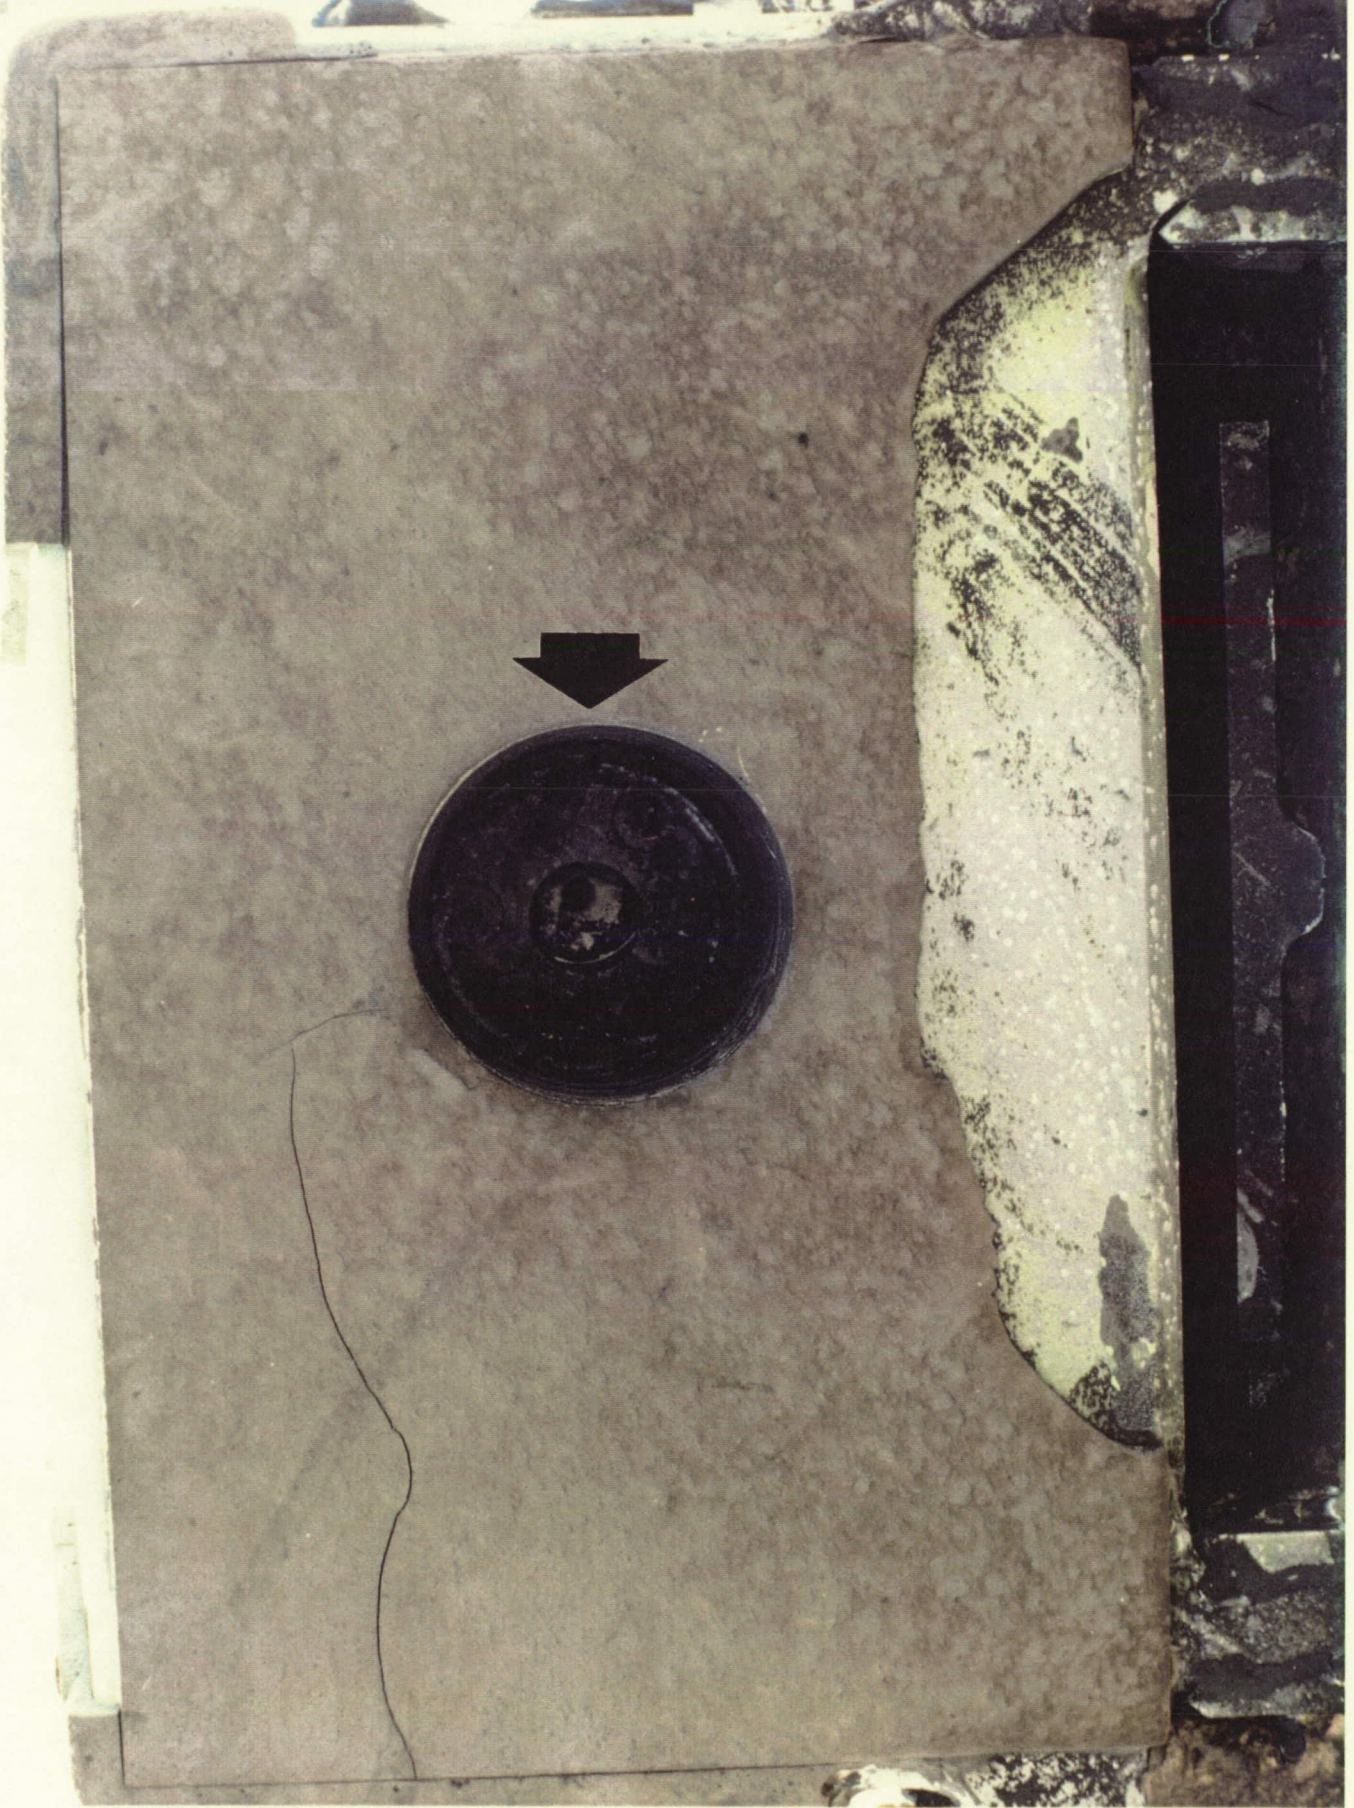
Although the DCS plunger was seated, an NSI detonator was wedged between the HDP #4 stud hole wall and the plunger

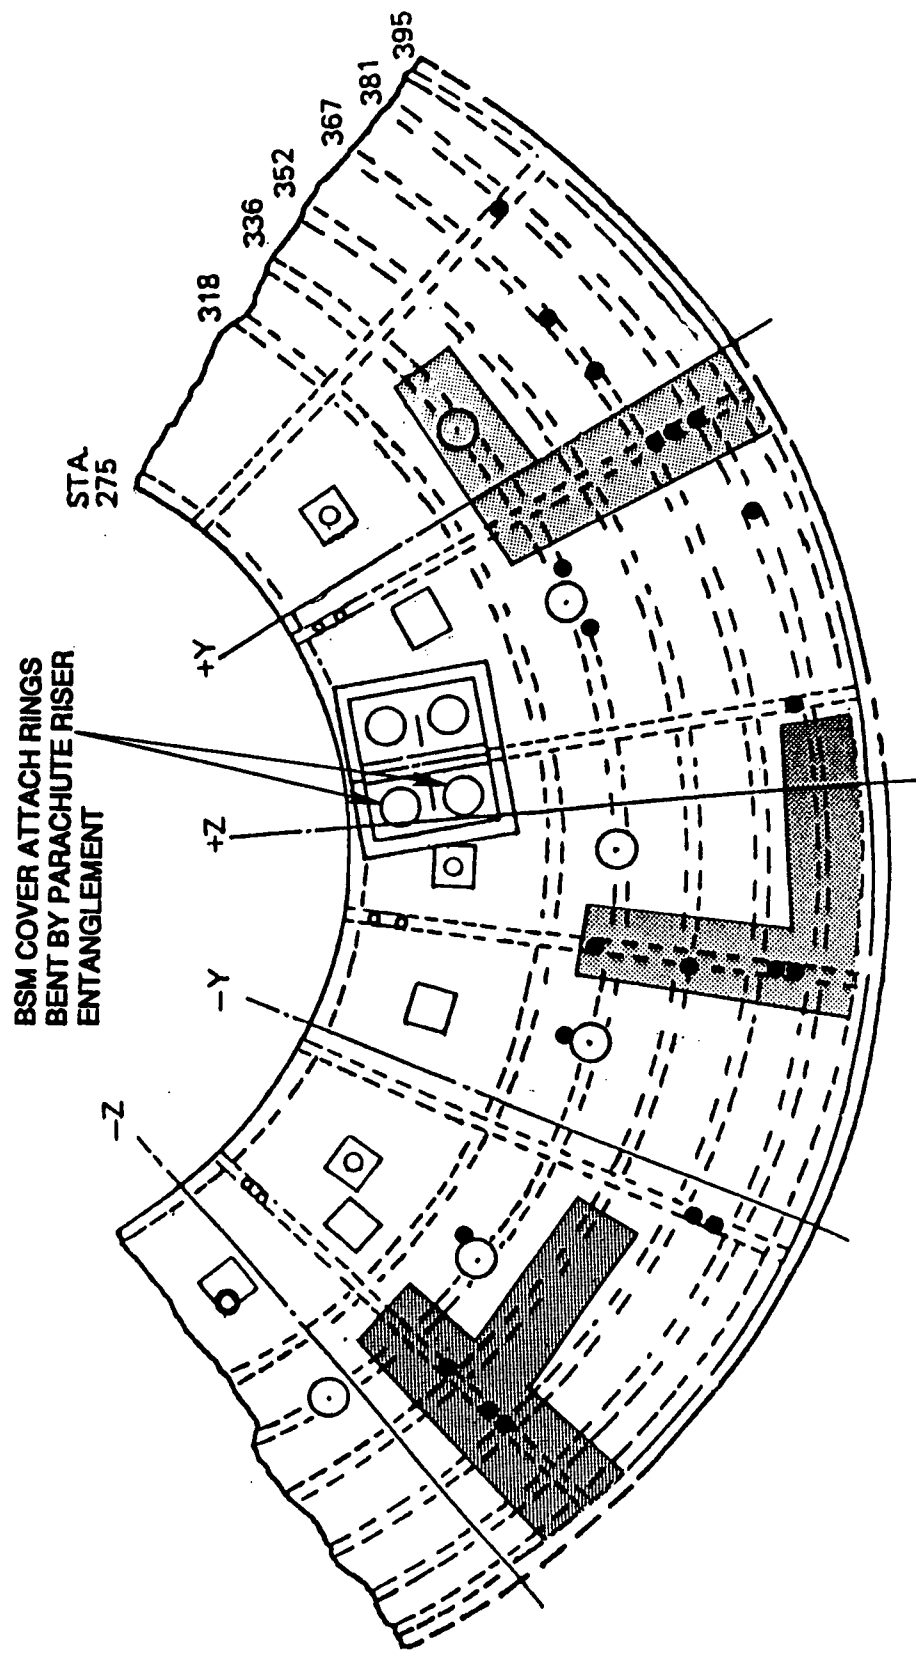
FIGURE 10. LEFT SRB FRUSTUM

BSM COVER ATTACH RINGS
BENT BY PARACHUTE RISER
ENTANGLEMENT

MISSING TPS
○ 1" DIA (OPEN
BLISTER WITH
LAYERED MSA)

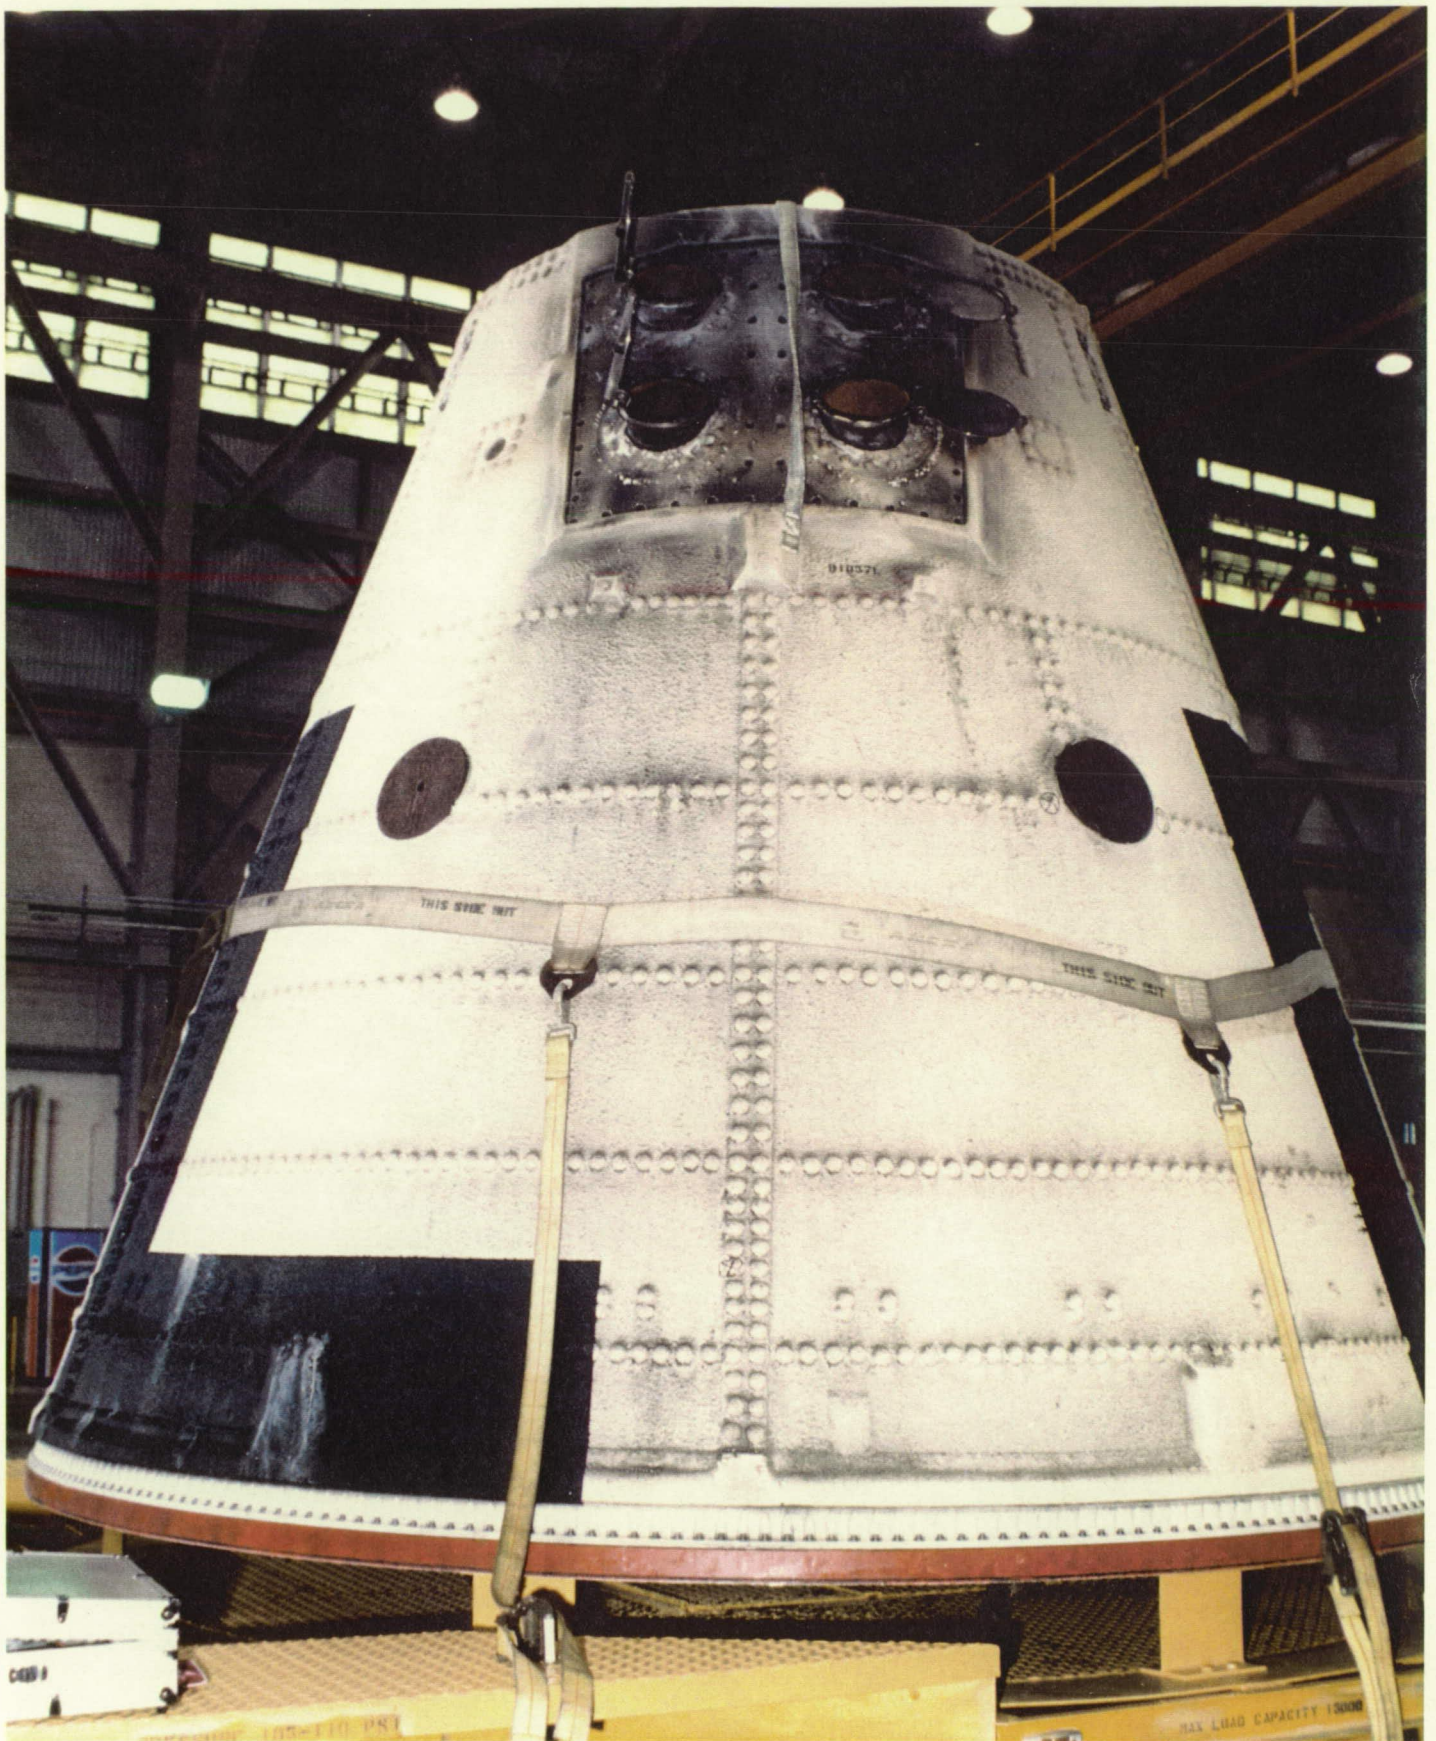
The LH frustum had a total of 21 MSA-2 debonds over fasteners. The BSM aero heat shield covers were locked in the fully opened position, though the two left cover attach rings had been bent by parachute riser entanglement.

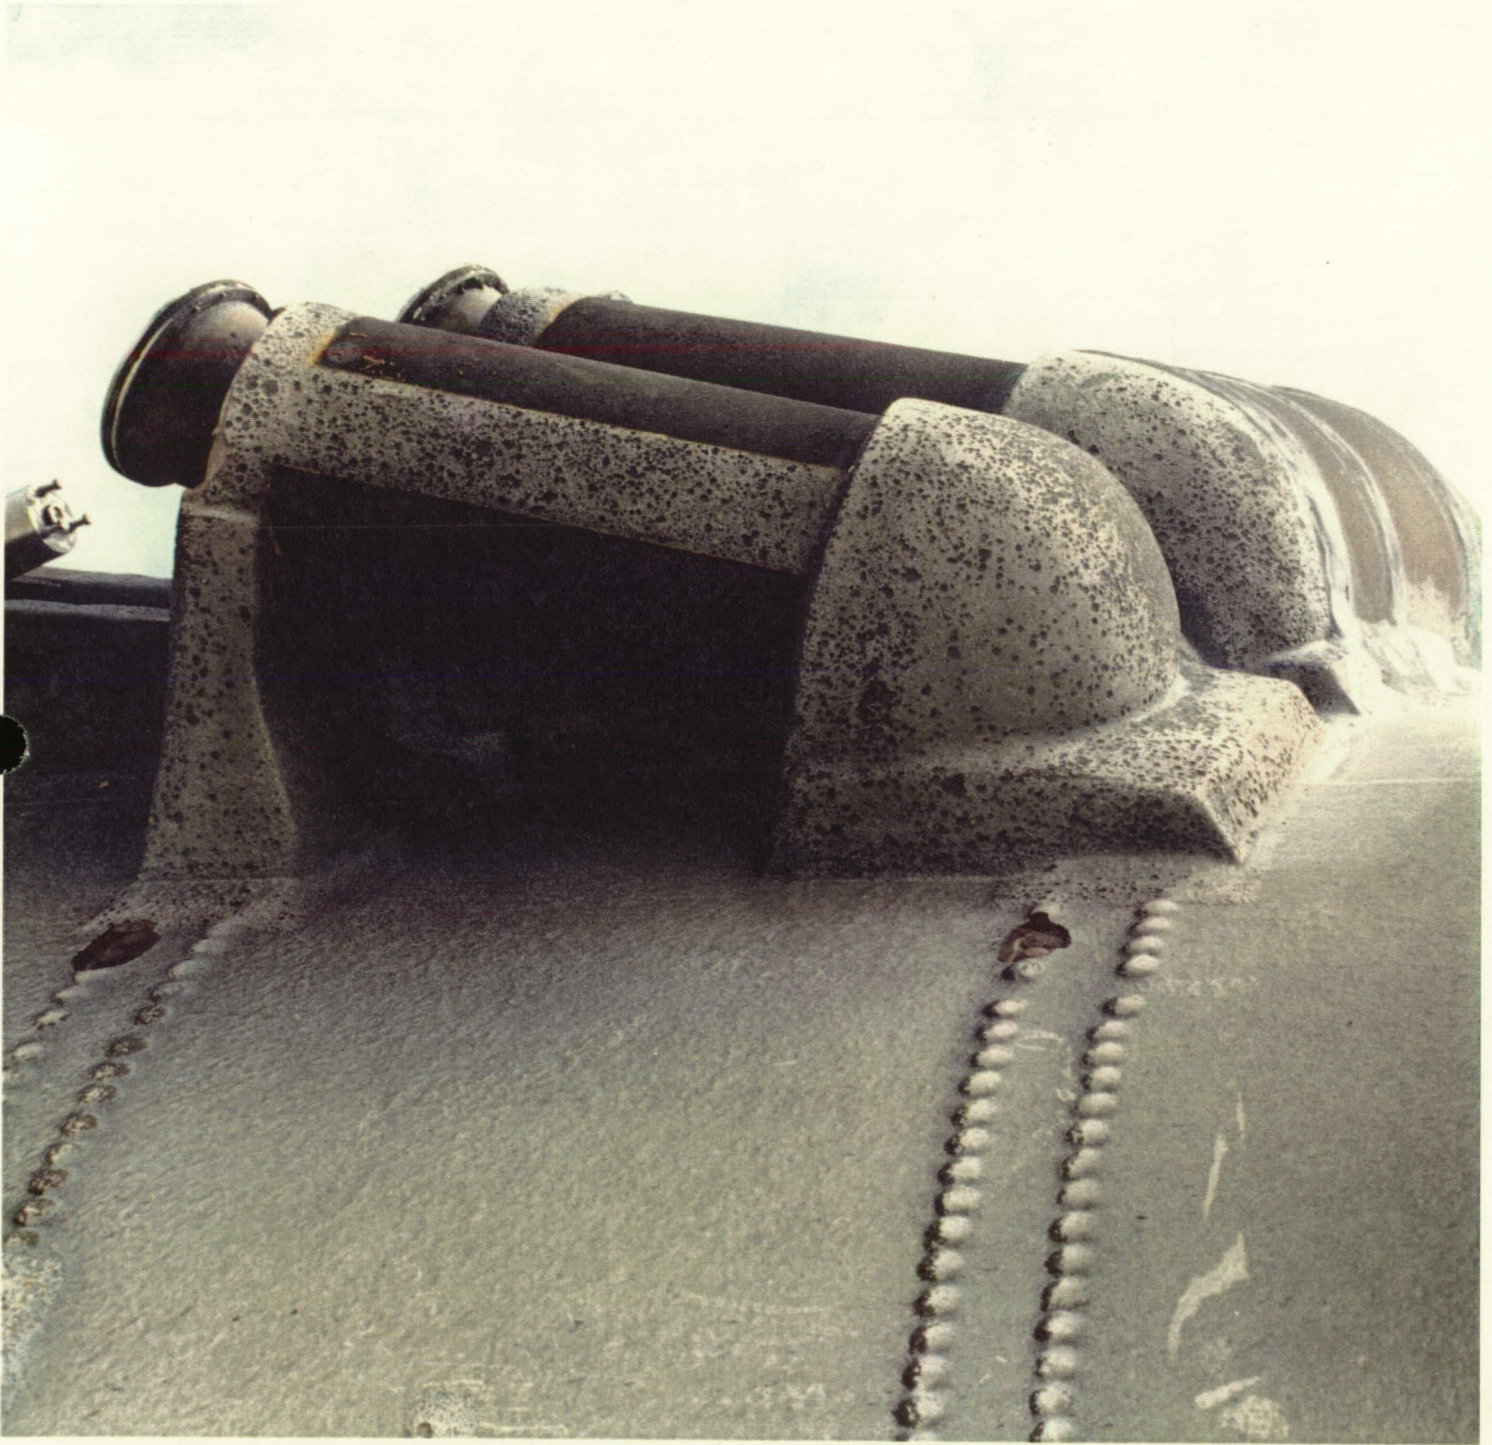
Five areas of MSA-2, the largest of which measured 3" x 2.5", were missing from the aft skirt acraege MSA-2.

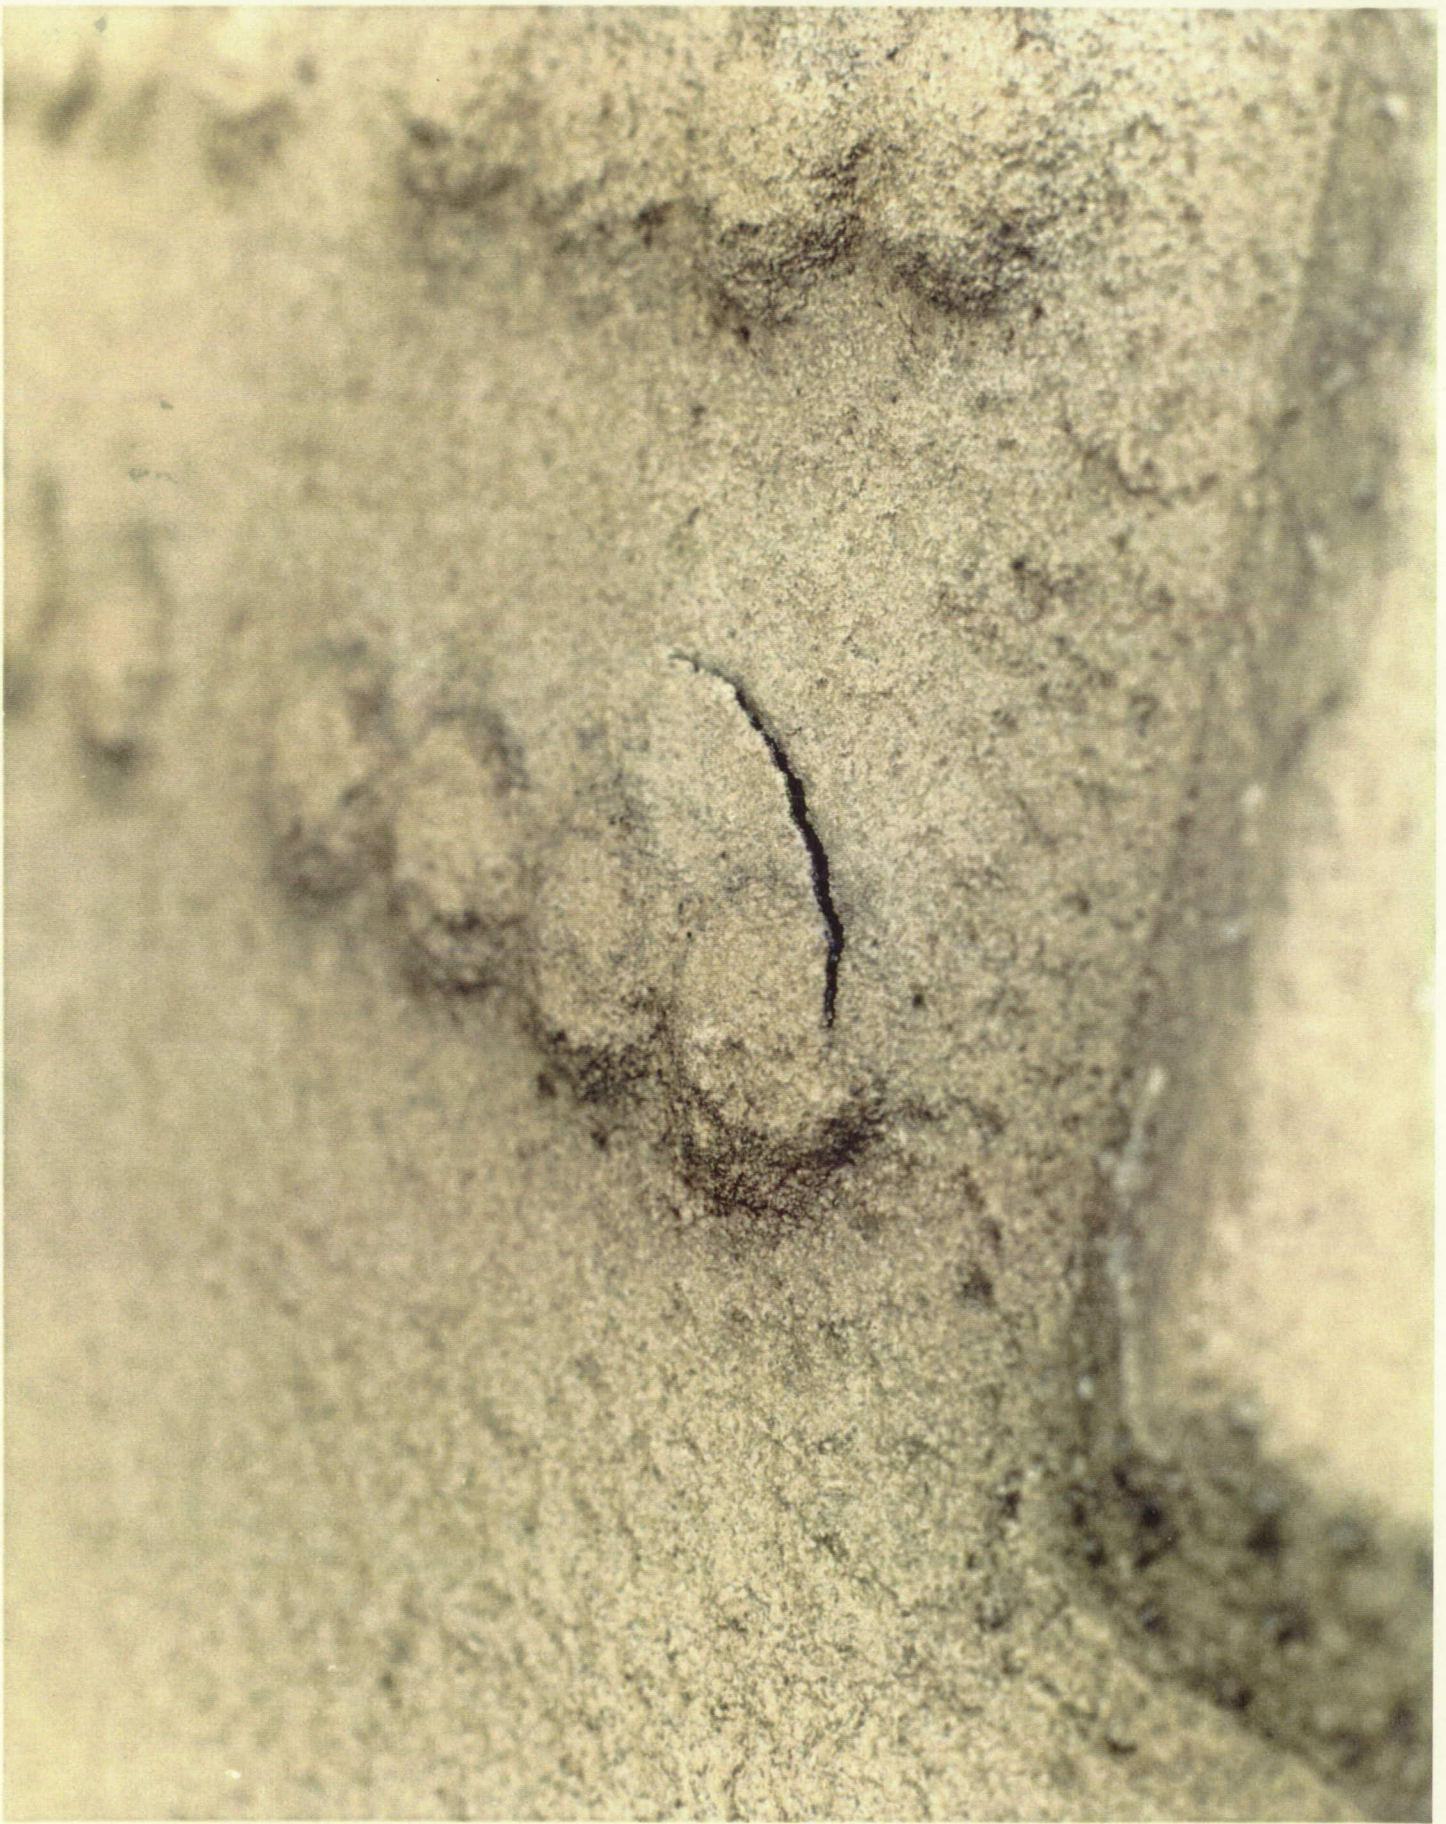
Two areas of MSA-2 were debonded on the aft skirt acreage

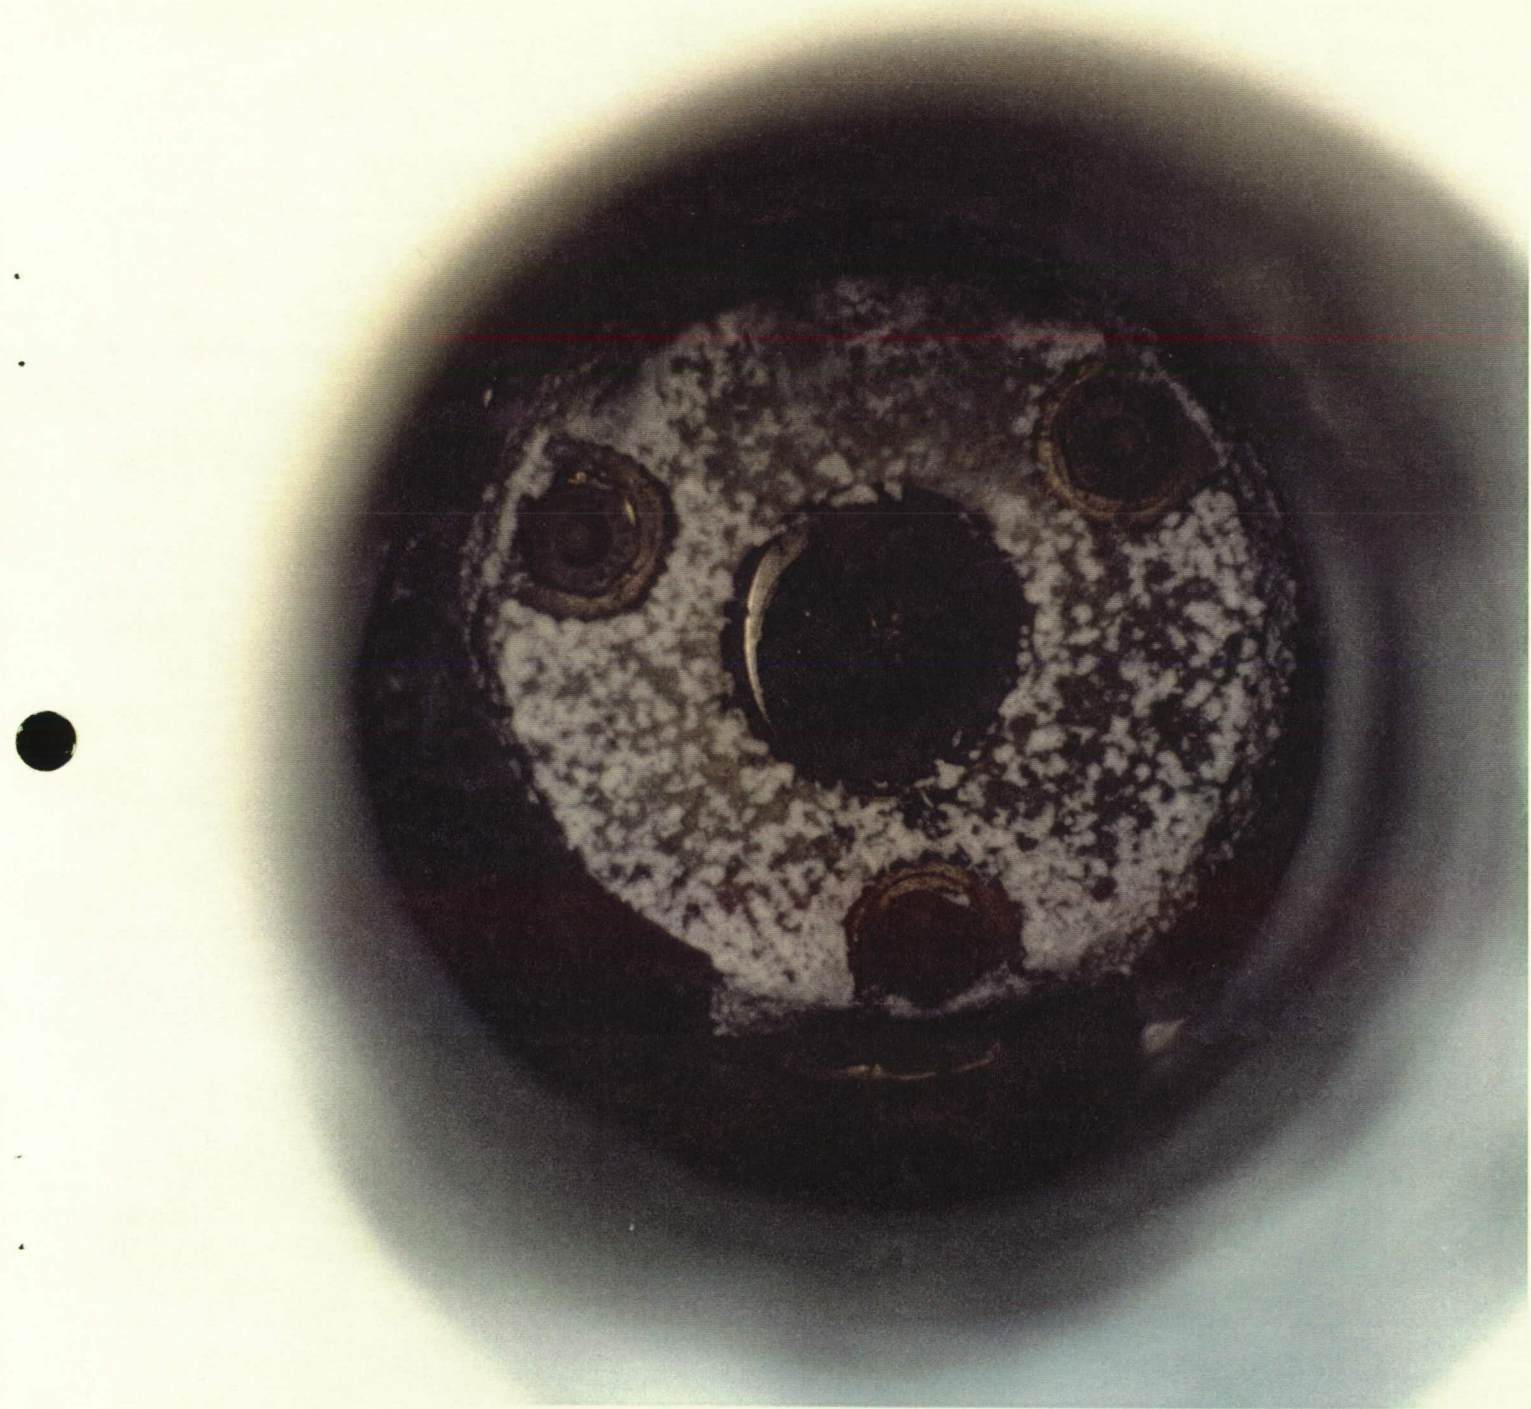
The HDP #5 Debris Containment System plunger was obstructed by frangible nut halves. The other three DCS plungers were properly seated.

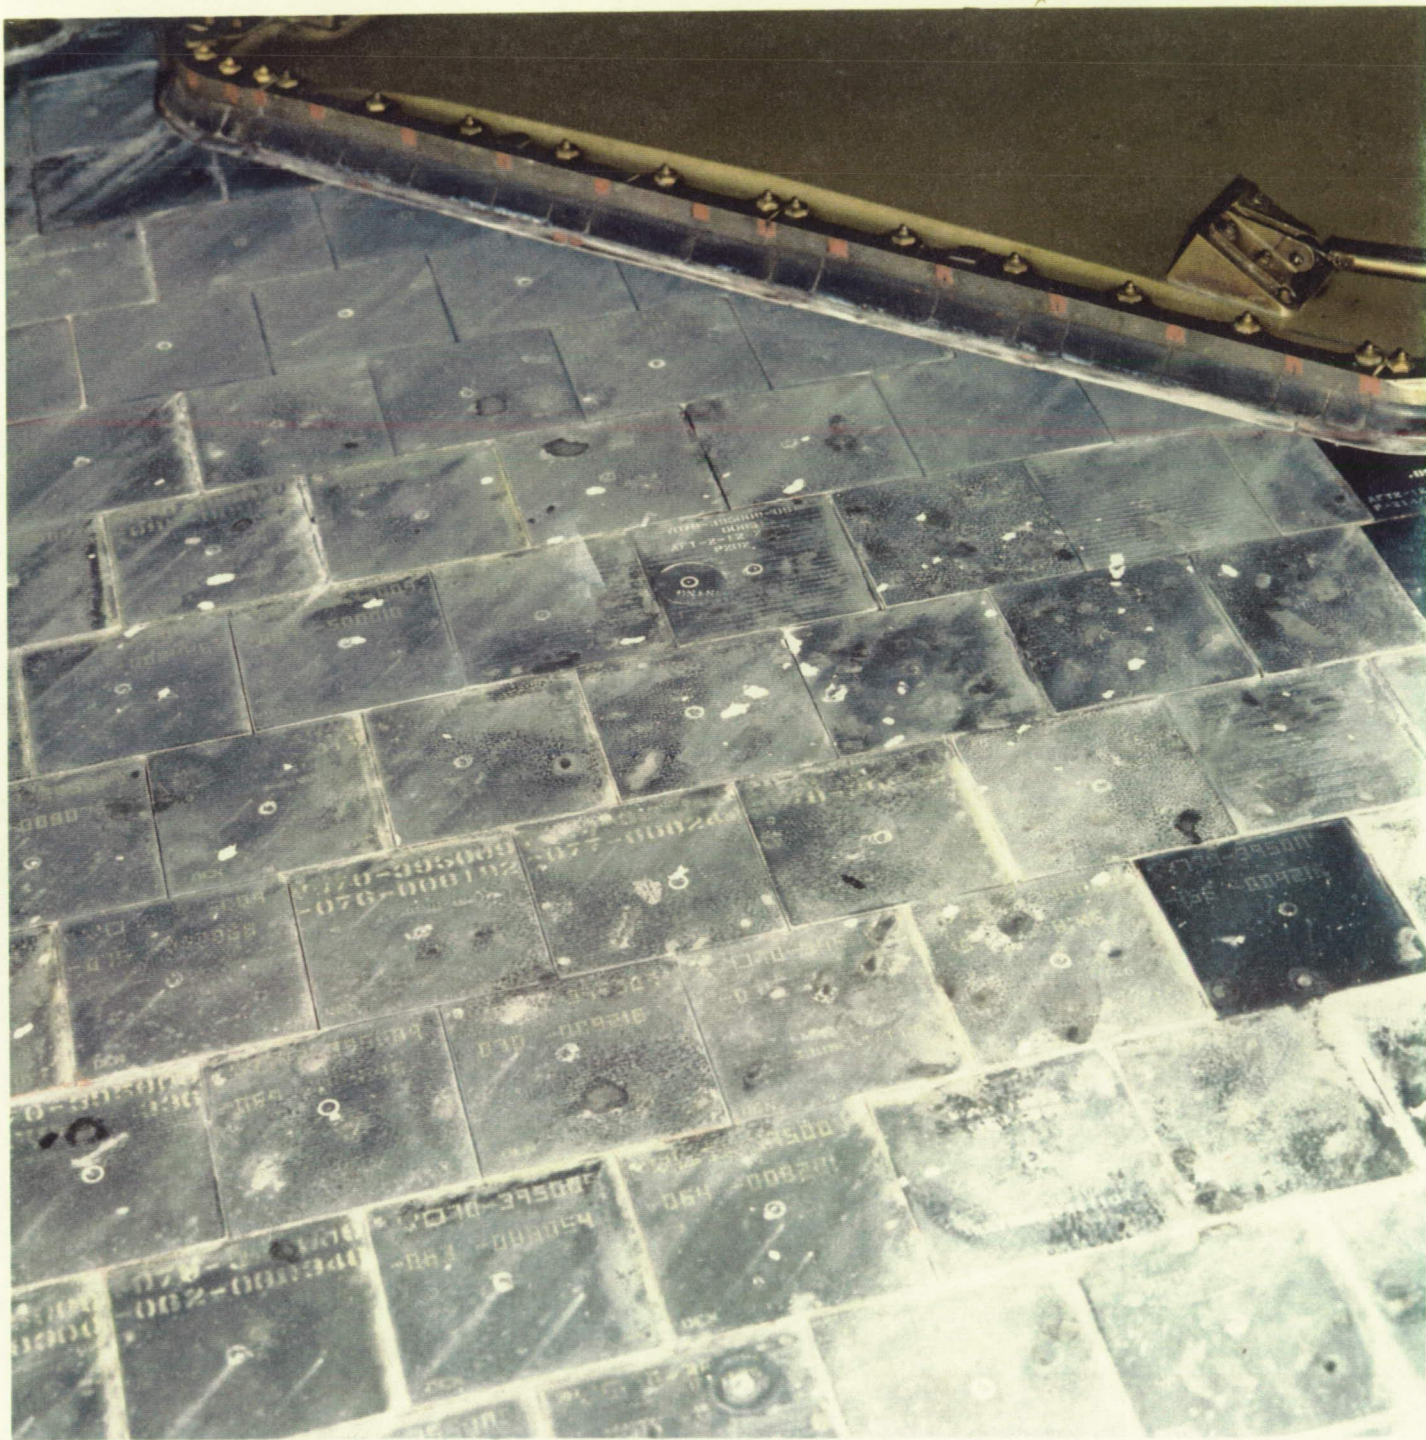
The Orbiter lower surface sustained a total of 128 hits. The majority of this damage occurred in a cluster near the ET/ORB LH2 umbilical. Similar clusters have been observed on previous flights and are attributed to impacts from the umbilical purge barrier and/or ice during ascent.

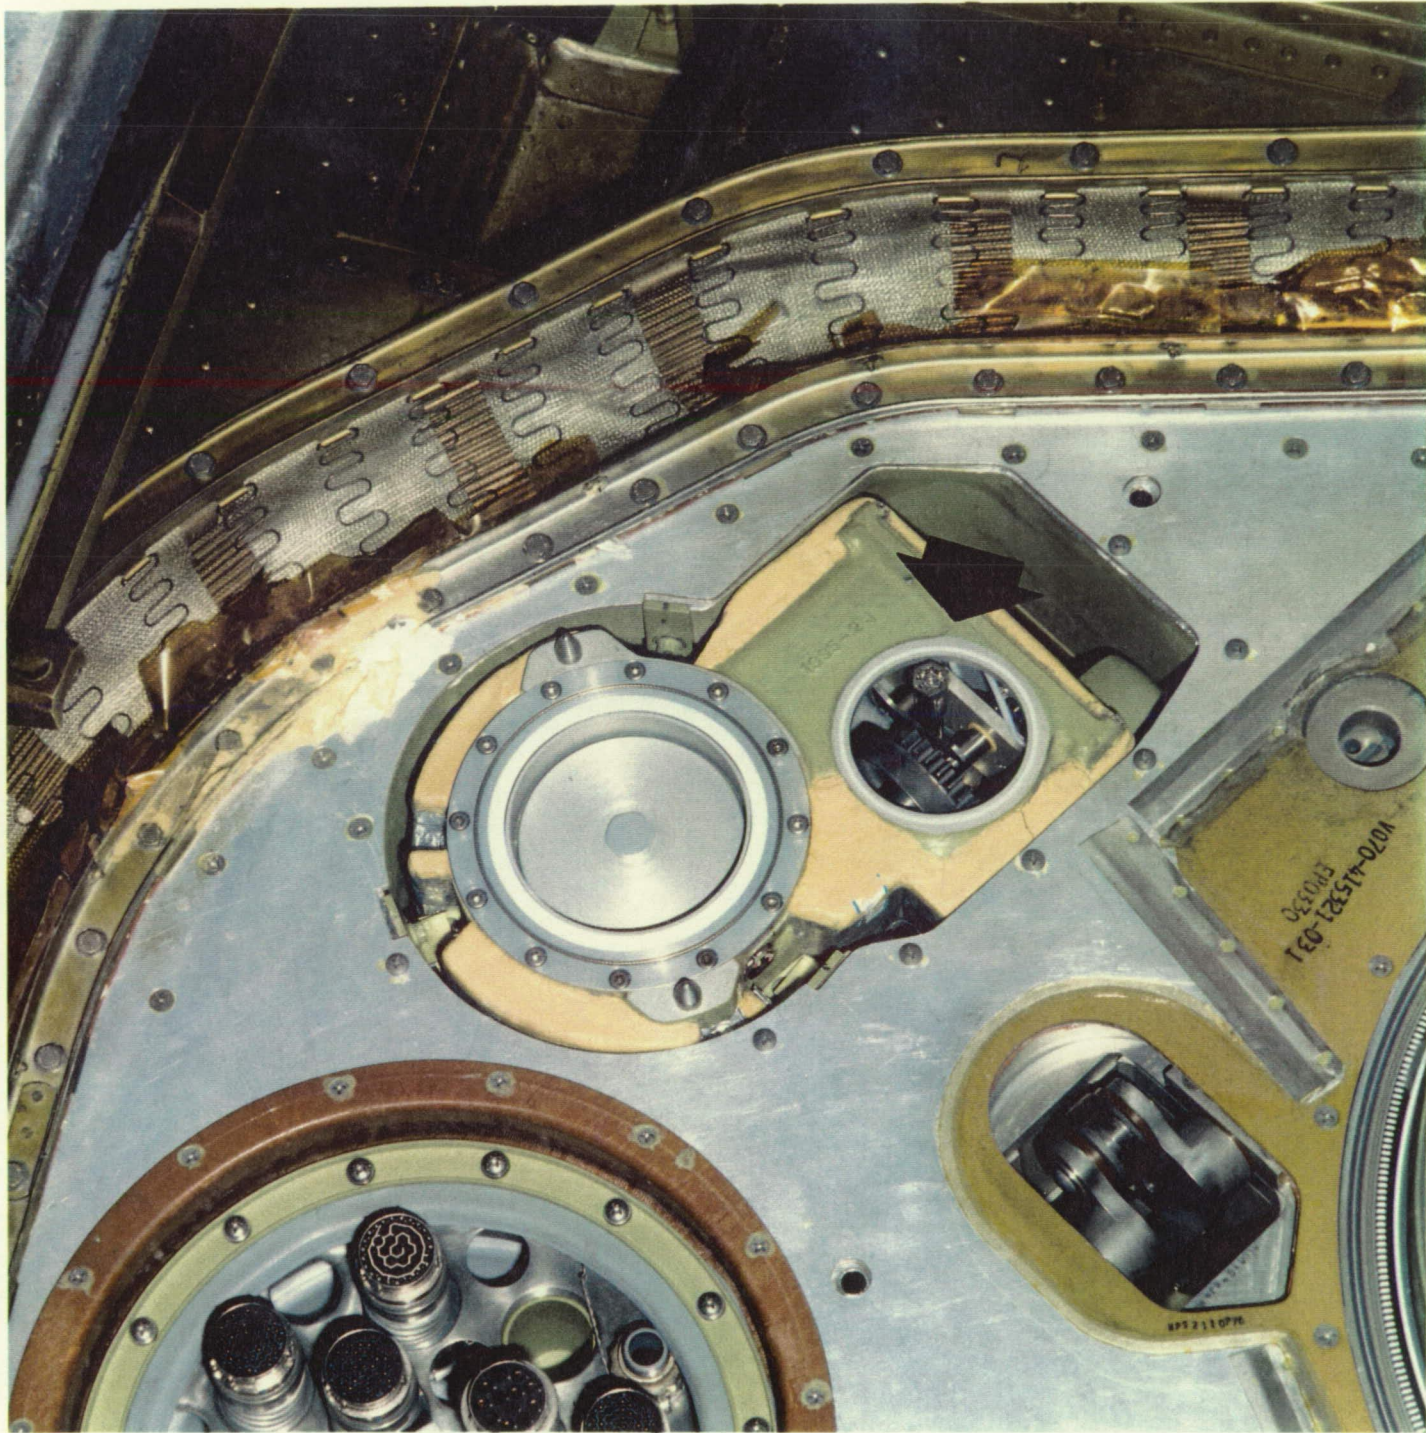
During separation of the External Tank from the Orbiter, an MPS sensor indicated the LH2 recirculation line valve may not have closed properly. Photography from the umbilical camera showed no anomalies on the ET side of the LH2 disconnect. Visual inspection of the Orbiter LH2 recirculation line interface after landing revealed the disconnect actuator (PD3) was in the open position (should have been closed). The disconnect flapper was in the proper position since it is spring loaded closed and cannot cycle without the ET disconnect in place. The seal plate behind the flapper exhibited some deformation. The disconnect will be replaced.

Visual inspection of the LH2 4-inch line interface revealed the rack (arrow) was extended and protruding beyond the nominal mold line. The seal plate behind the flapper exhibited some deformation.
