Debris/Ice/TPS Assessment and Integrated Photographic Analysis for Shuttle Mission STS-55

(NASA-TM-107559) DEBRIS/ICE/TPS
ASSESSMENT AND INTEGRATED
PHOTOGRAPHIC ANALYSIS FOR SHUTTLE
MISSION STS-55 Final Report, 22
Mar. - 7 May 1993 (NASA) 136 p

Gregory N. Katnik
NASA/Kennedy Space Center

DEBRIS/ICE/TPS ASSESSMENT
AND
PHOTOGRAPHIC ANALYSIS
OF
SHUTTLE MISSION STS-55

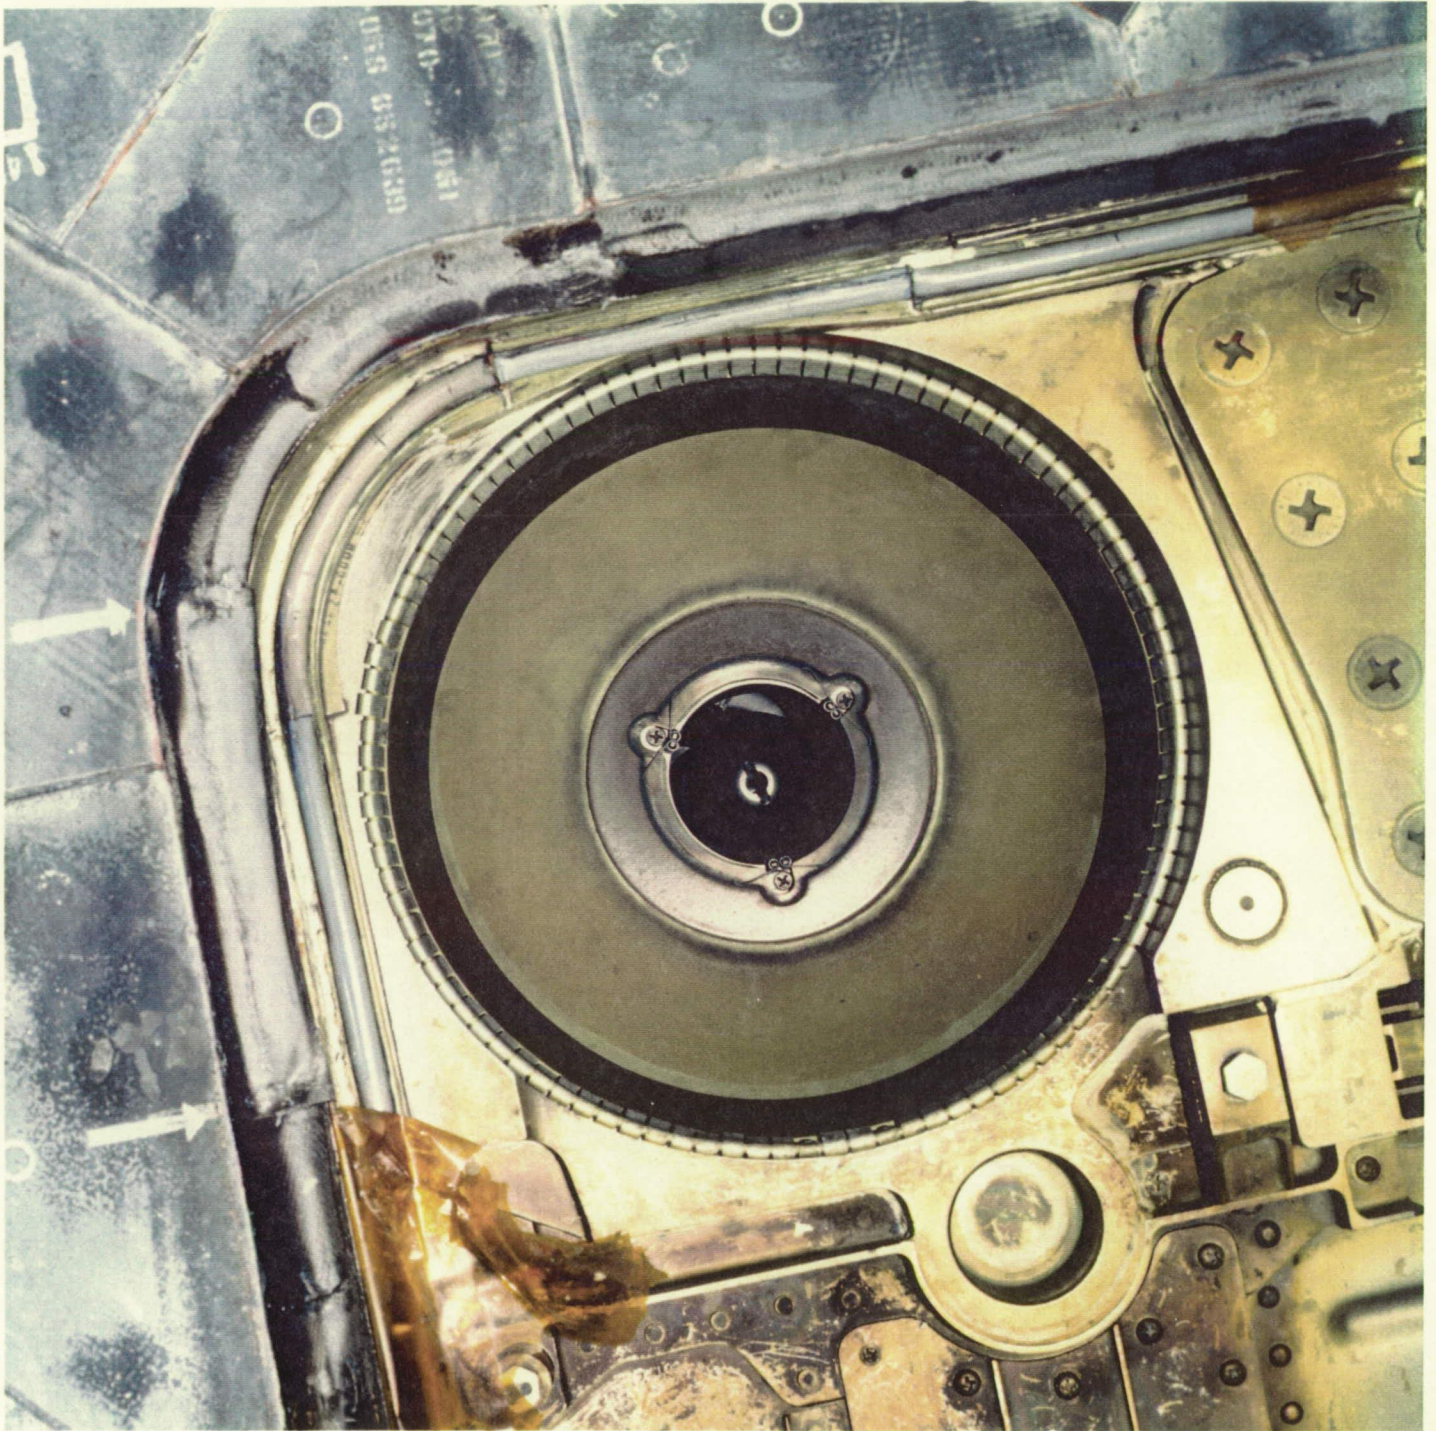
The right ET/ORB attach point (EO-3) hole plugger had not seated and was obstructed by a frangible nut half

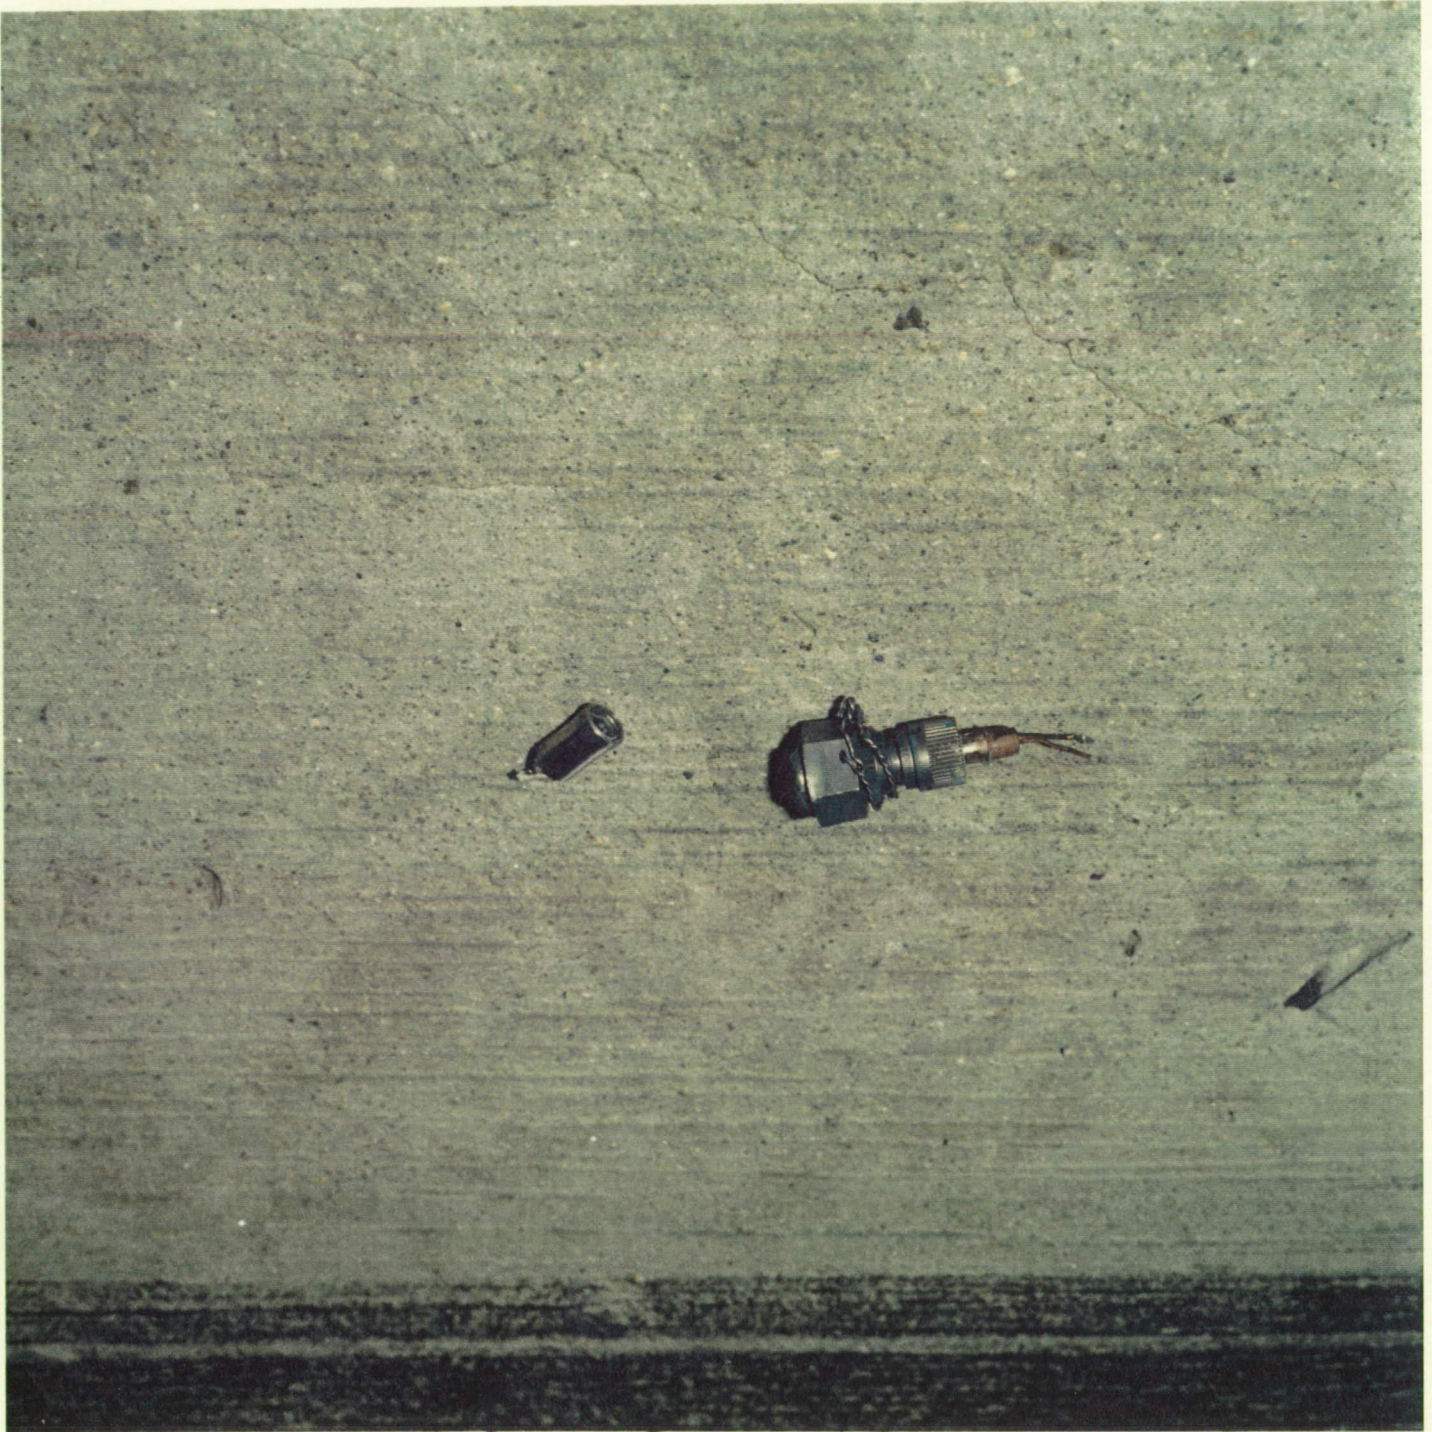
Two ordnance fragments were found on the runway below the
L02 ET/ORB umbilical after the ET doors were opened

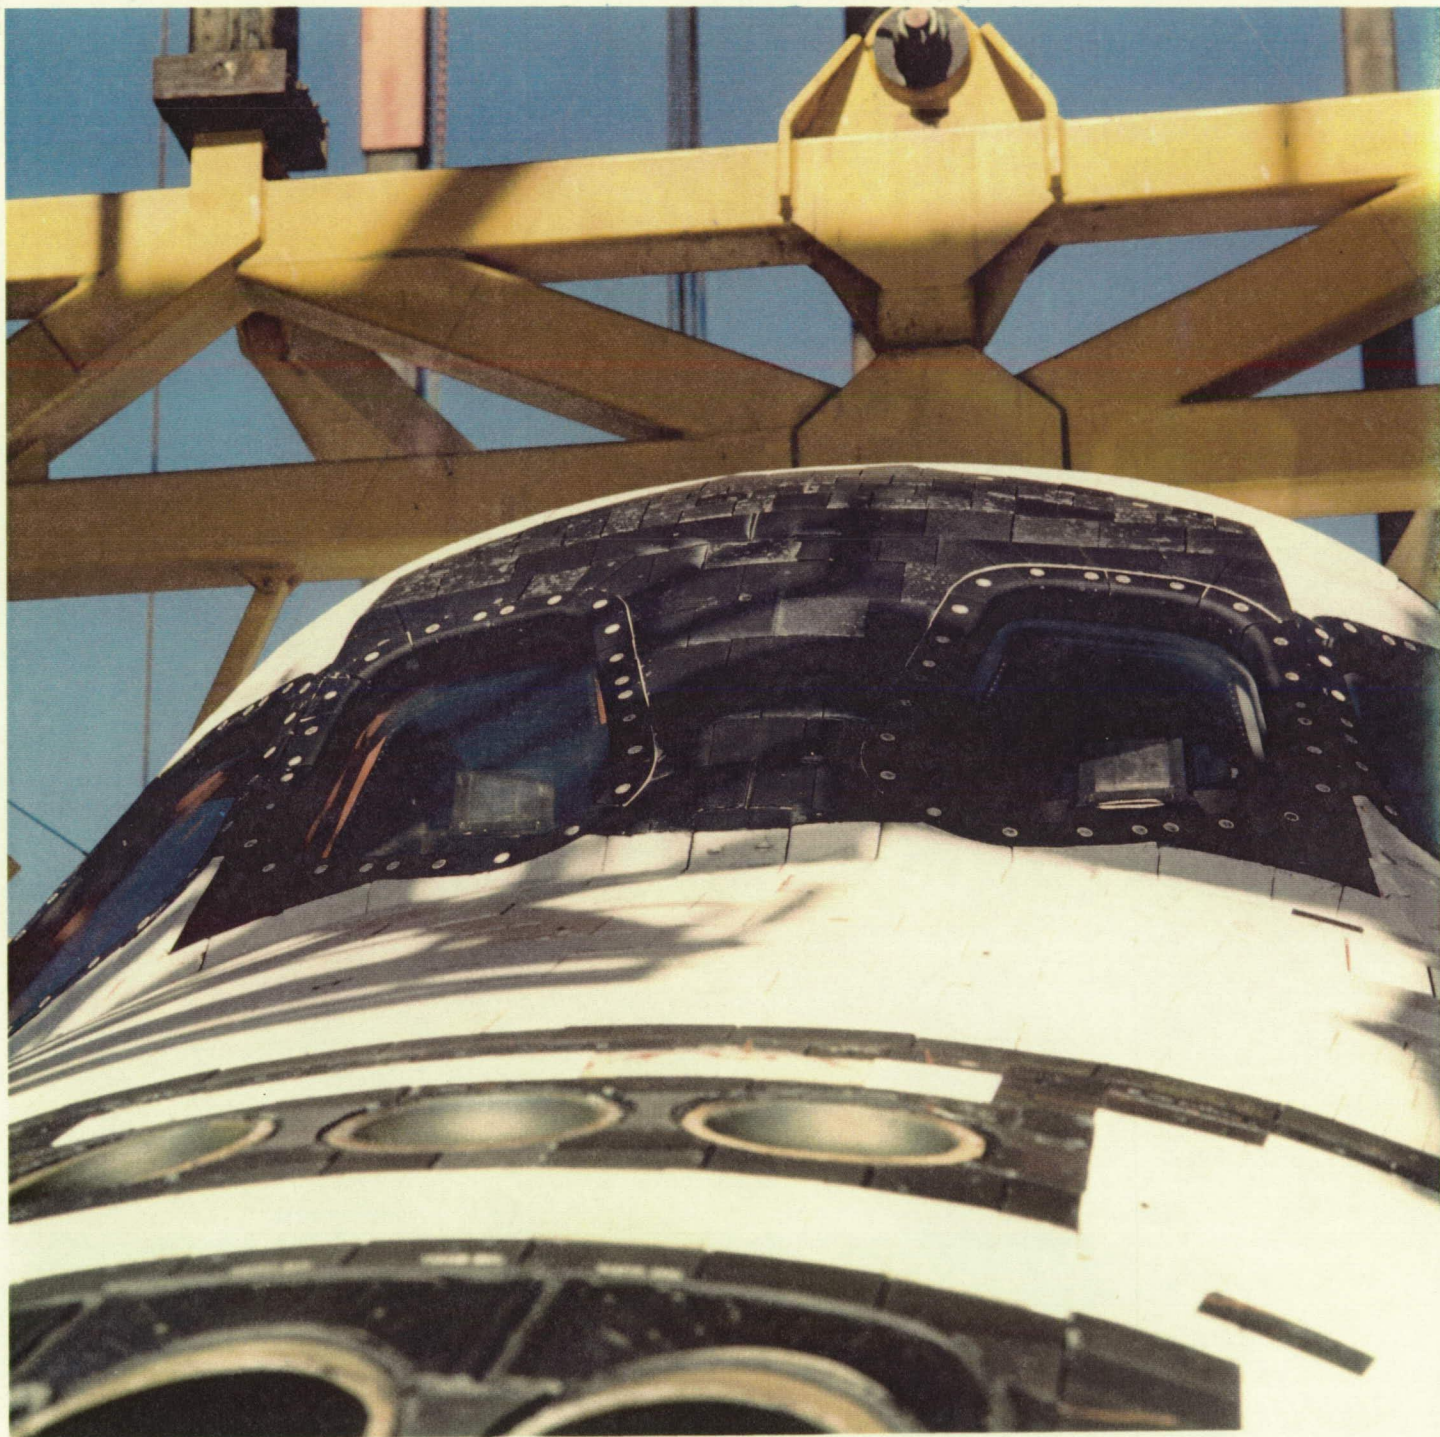
All Orbiter windows exhibited typical hazing with the greatest amount present on windows #3 and #4

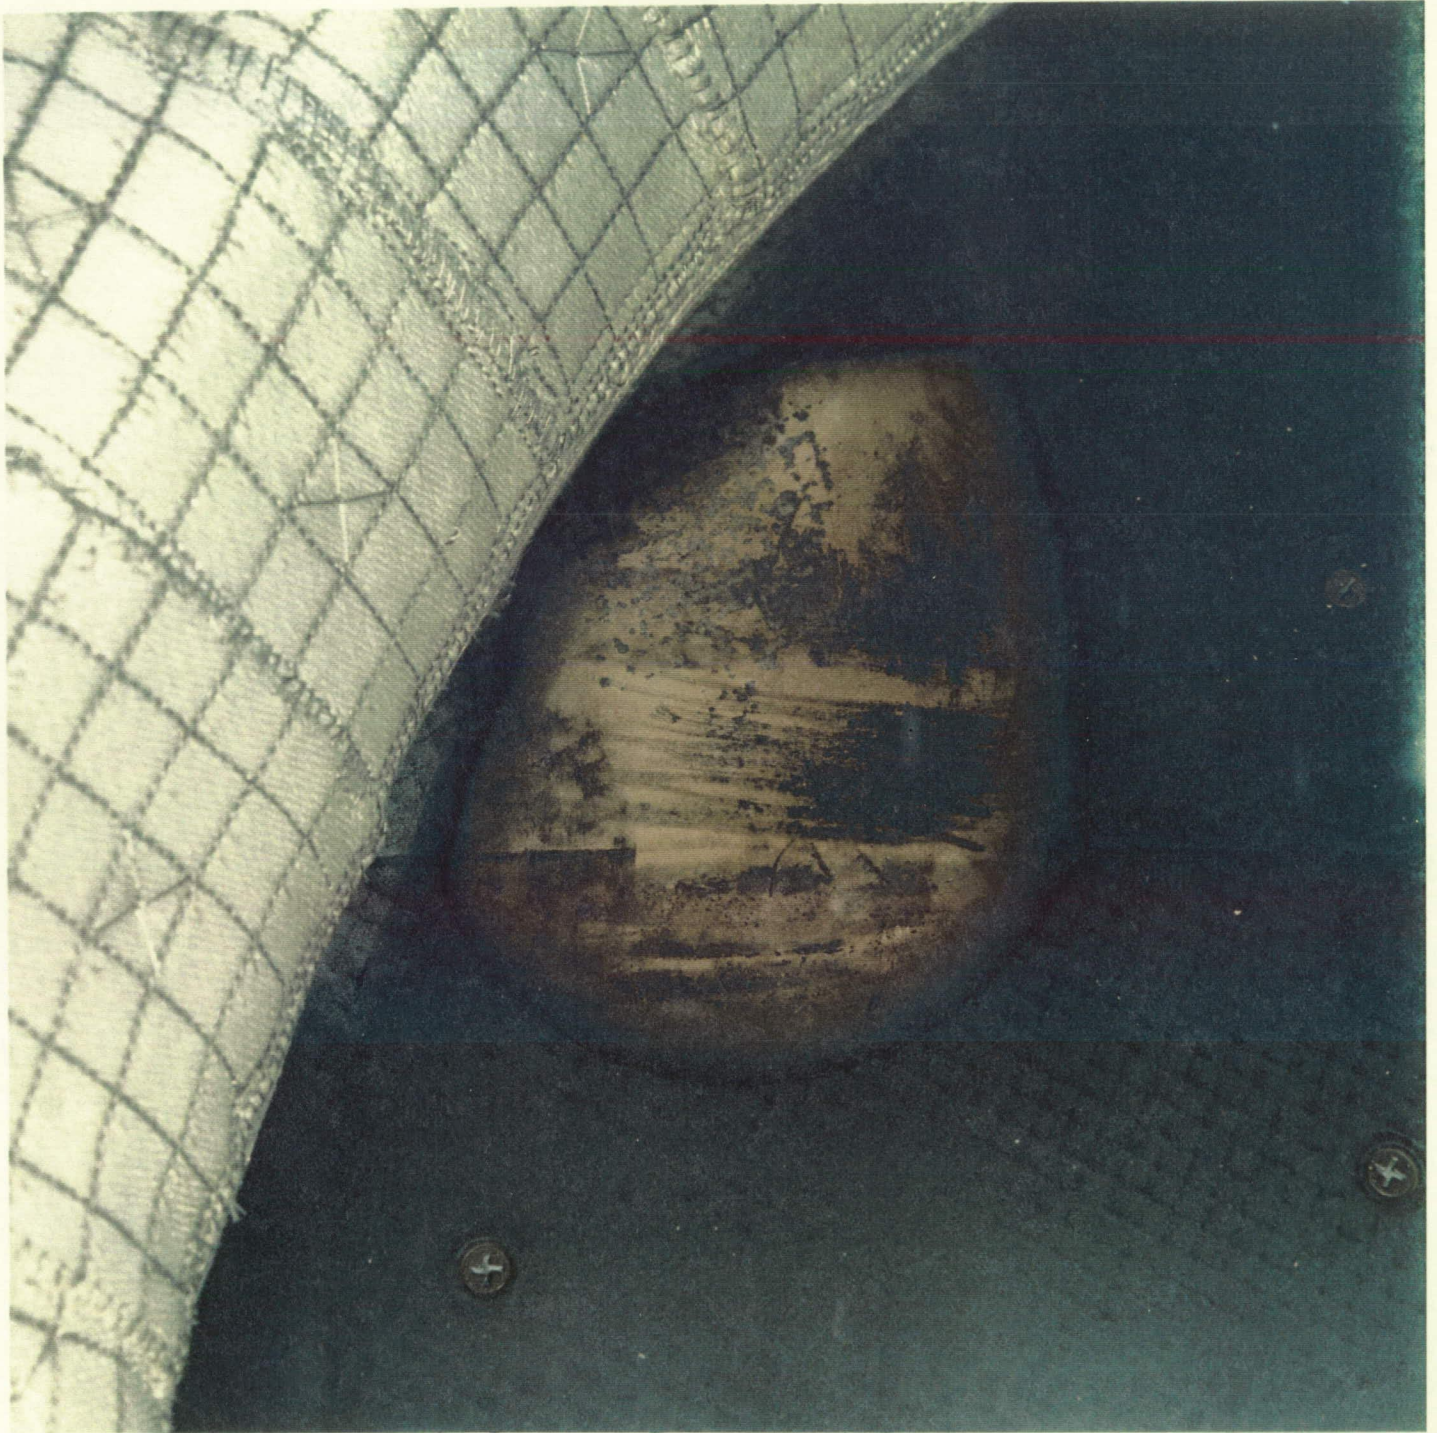
A 1-foot square oval-shaped area of residue was present on the SSME #3 engine mounted heat shield at the 4:00 o'clock position

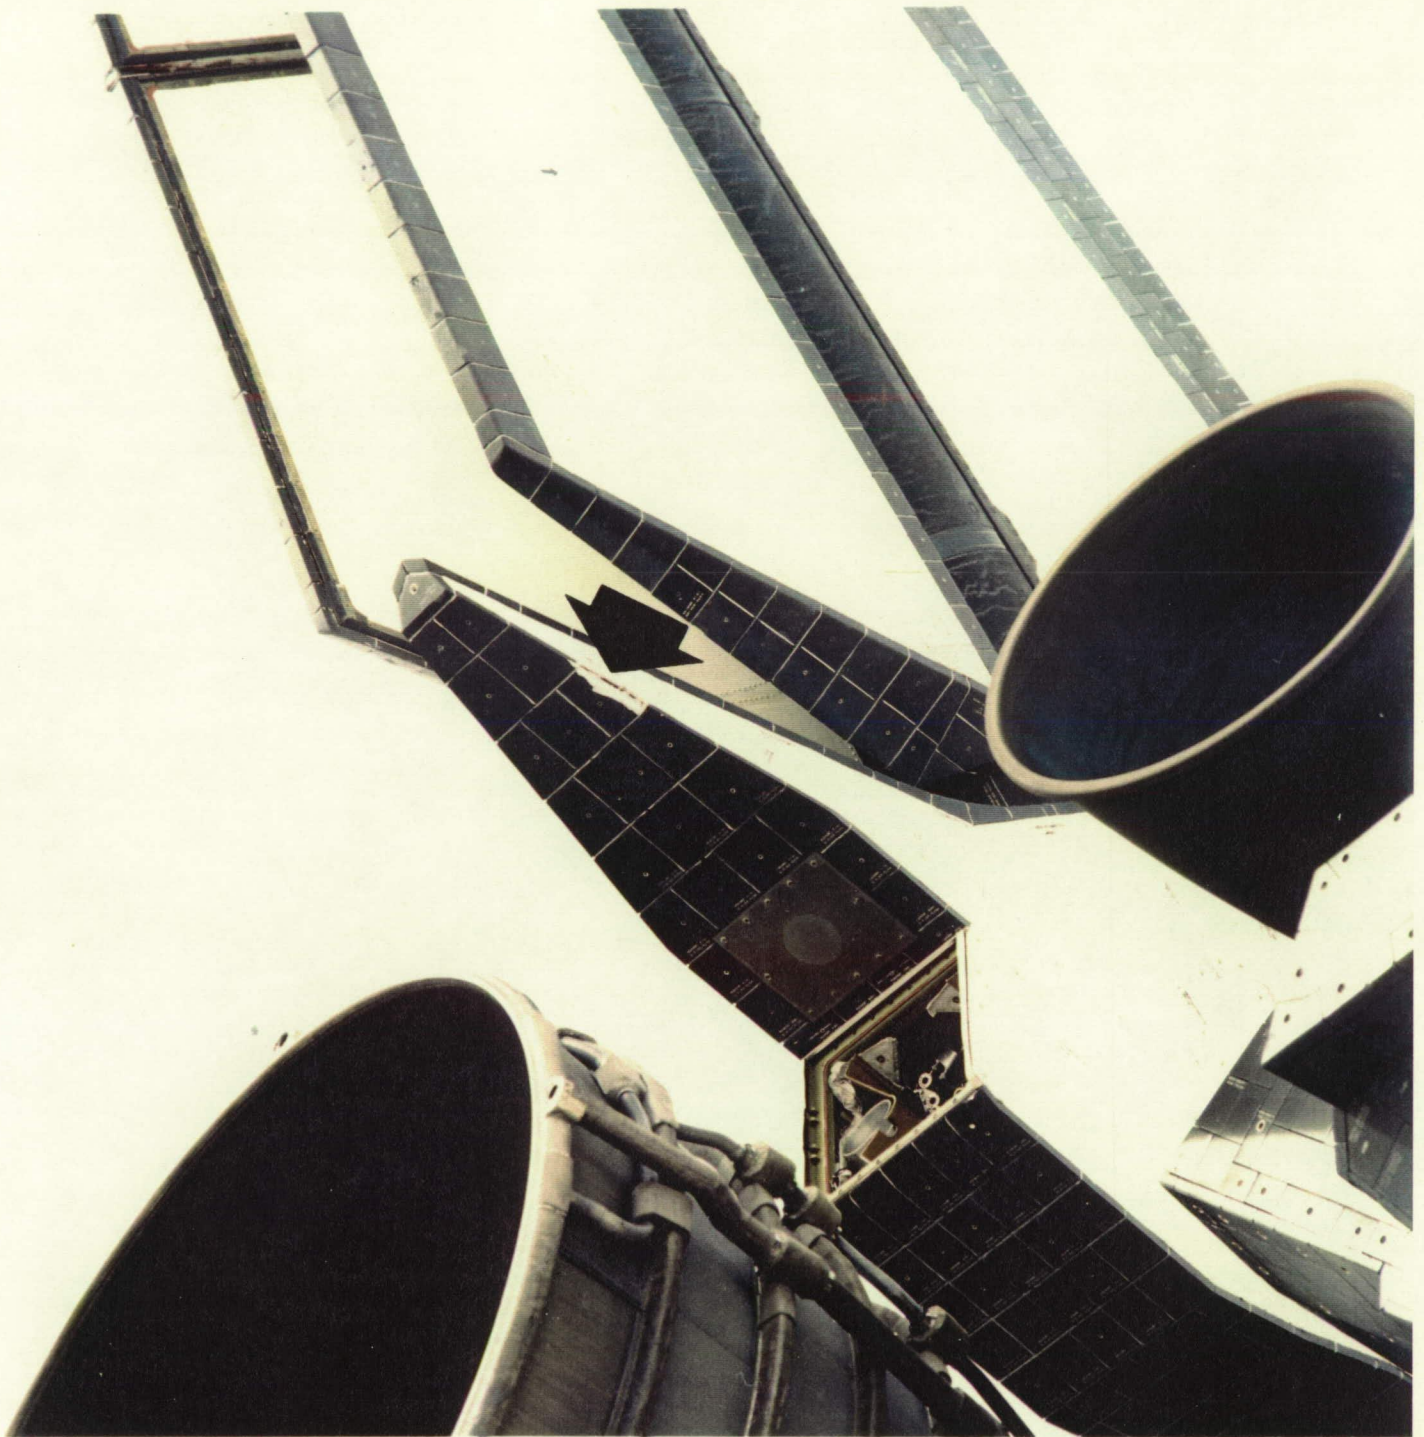
A post landing inspection of EAFB Runway 22 was performed immediately after landing. Eleven pieces of black tile were recovered in the approximate area of the drag chute deployment. These tile fragments originated from the rudder/speed brake "stinger", which is an area damaged on previous uses of the drag chute by contact with the parachute riser lines. Aside from the damage to the vertical stabilizer stinger, the drag chute appeared to have functioned nominally. All drag chute hardware was recovered and appeared to be in good condition.

Eleven black tile fragments were found on the runway in the general area of drag chute deployment. The tile pieces originated from the vertical stabilizer "stinger", which is an area damaged on previous uses of the drag chute by contact with the parachute riser lines.

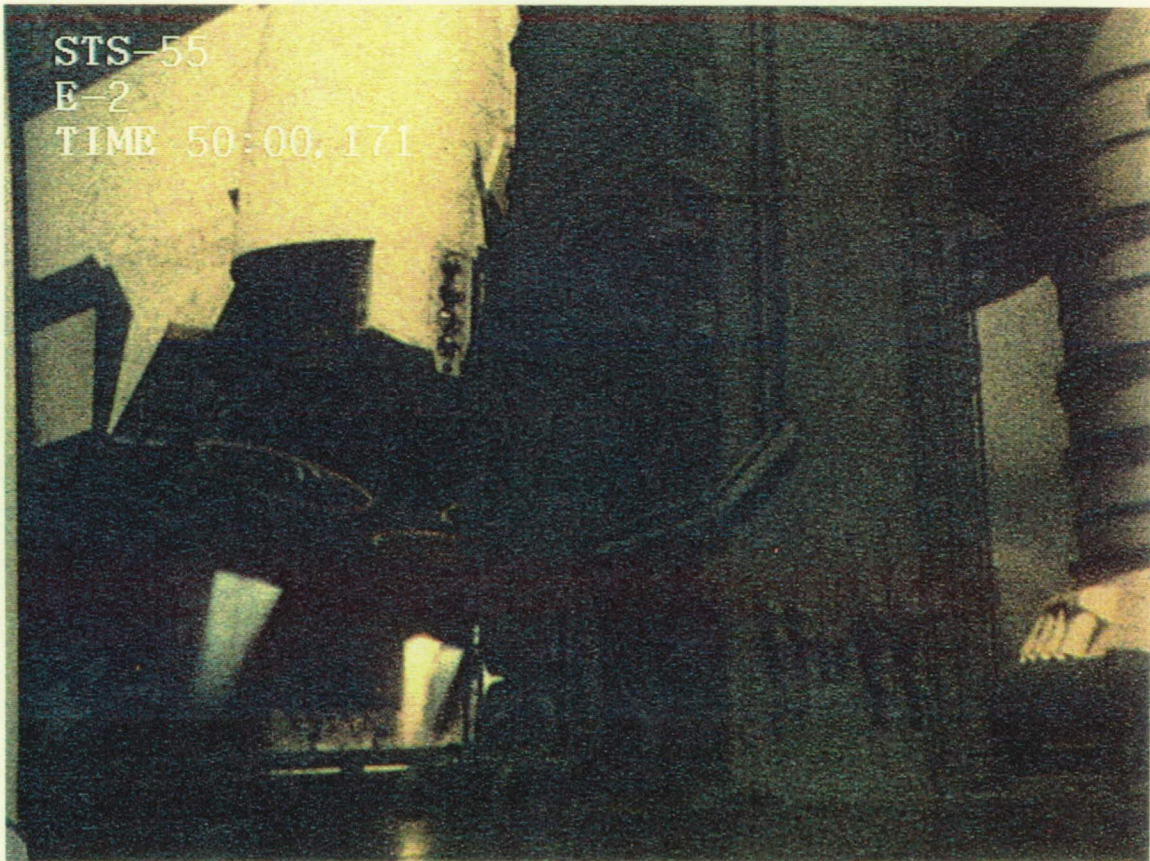
Figure 2.2.2 SSME #2 Plume Discoloration

A white discoloration was noted in the SSME #2 mach diamond at 0.144 seconds MET. This type of phenomenon has been seen on several previous missions.

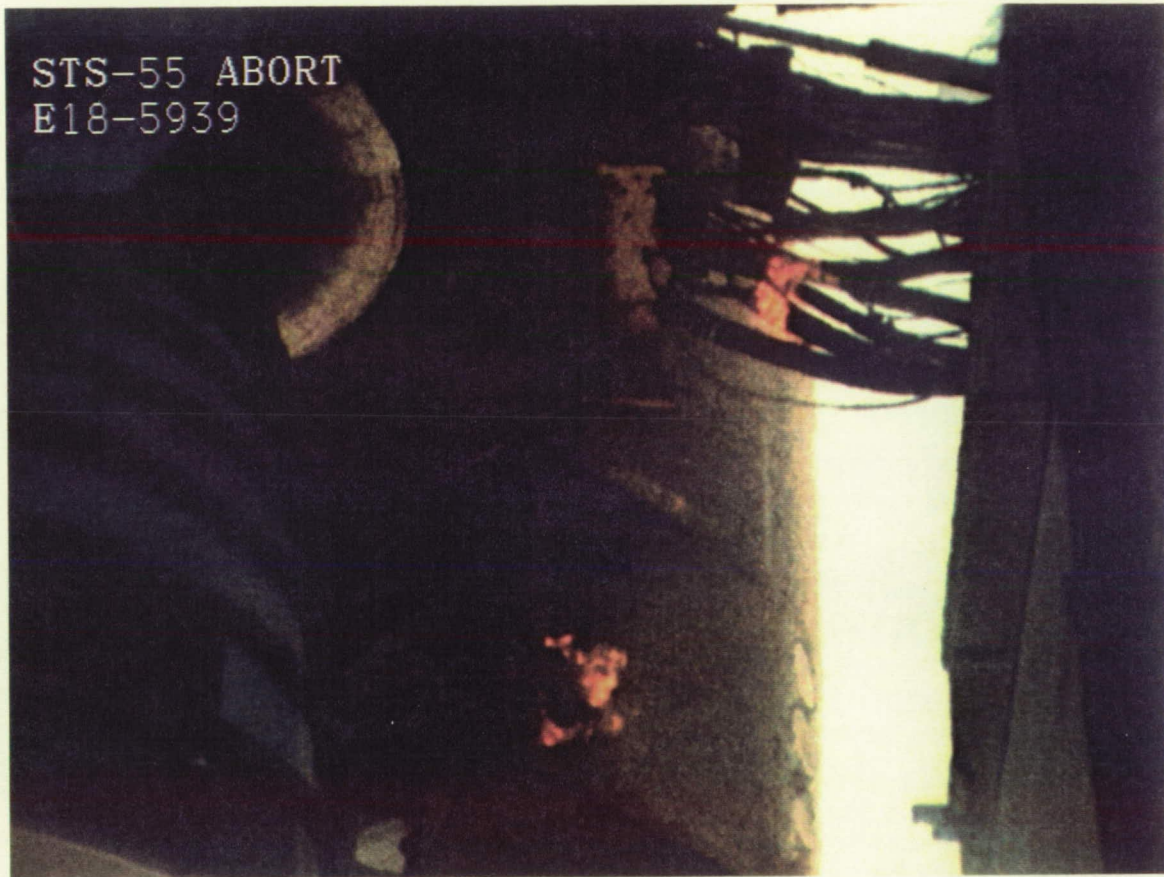
Figure 2.7.1.2.4 (A) Orange Vapor/Flames Near LH2 T-0 TSM Umbilical

Orange vapor or flames were noted at the lower lines of the LH2 T-0 umbilical area.

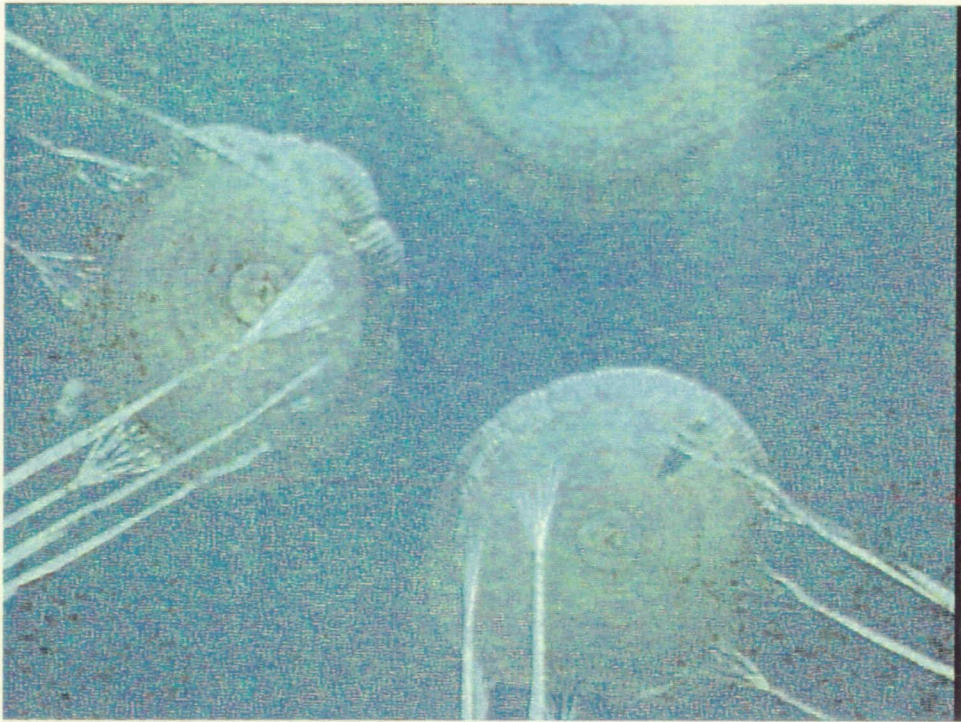
Figure 1.

Rip in Right SRB Main Parachute
