CRATERING IN GLASSES IMPACTED BY DEBRIS OR MICROMETEORITES

David E. Wiedlocher and Donald L. Kinser
Department of Materials Science and Engineering
Vanderbilt University
Nashville, TN 37235

ABSTRACT

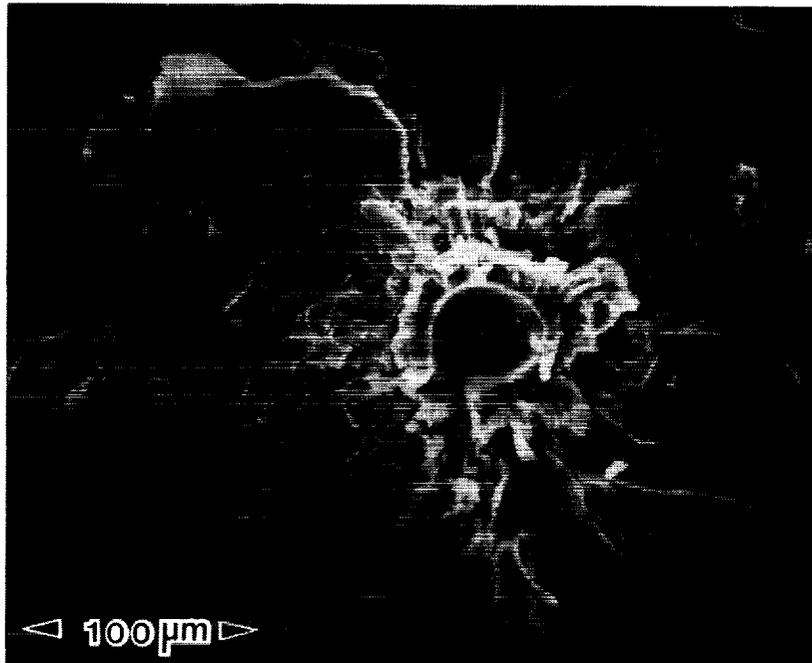
Four impacts occurred in glass samples and three occurred in glass-ceramic samples located on the trailing-edge of the satellite. Scanning electron microscopy revealed 6 of the 7 impacts contained a central crater lined with melted glass as illustrated by one of the three impacts in Zerodur shown in Figure 1. The central pit is surrounded by a zone of fragmented material with numerous radial cracks extending into the sample. The annular region adjacent to the melt zone is missing numerous fragments which spalled and were generally lost. Remnants of debris, presumed to originate from the fragmented area, were captured in the melt zone in this sample and several others. The region away from the impact site also displays damage from grit blasting with silicon carbide which was part of the sample preparation previously described⁴.

Figure 1: Scanning electron micrograph of impact in Zerodur displaying melt crater formation.

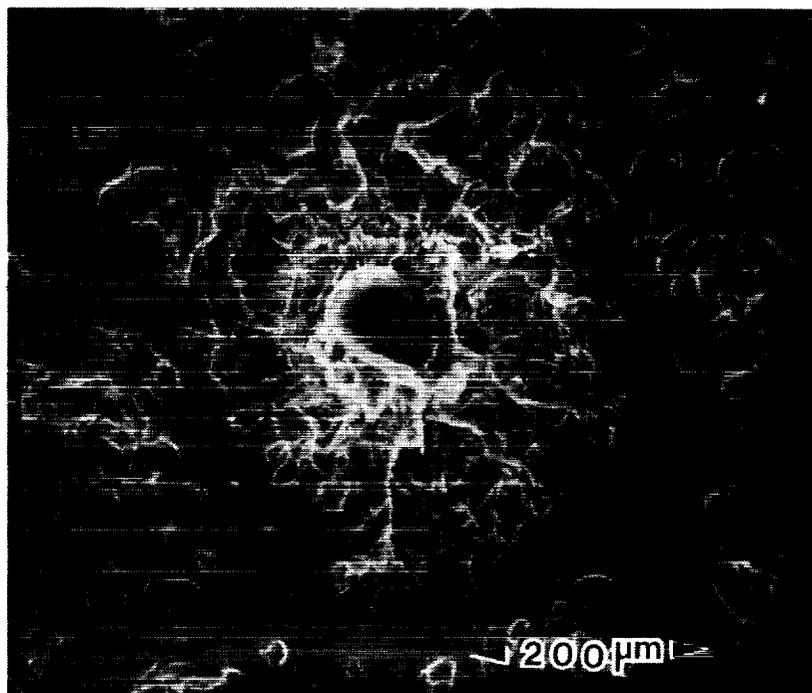
Damage surrounding the impacts extends to a radius about 5 times the central pit radius as seen in the micrograph of an impact site in Pyrex shown in Figure 2. Pre-flight sample preparation damage, not due to micrometeorite or space debris impact, is also apparent in this micrograph. Bubbles escaping the melt region of a BK-7^a sample shown in Figure 3 indicate temperatures and pressures at impact reached those needed for vaporization of the micrometeorite and/or glass. Evidence of vaporization was observed in BK-7 and soda-lime-

Figure 2: Scanning electron micrograph of impact crater in Pyrex displaying impact melting.

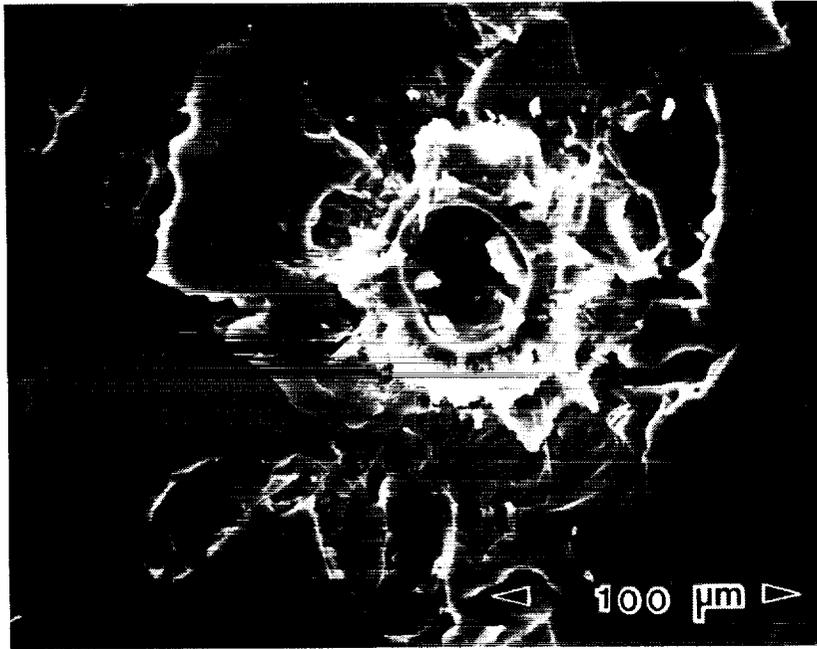
The bubbles observed in surfaces of BK-7 and soda-lime-silica glasses clearly indicate that these samples suffered pressure/temperature conditions in which boiling occurred. These phenomena may be a consequence of the energy delivery to these samples being higher than other samples or may be a consequence of the relative volatility of these two glasses. These two glasses are clearly the most volatile of those glasses examined in that they include relatively low boiling components unlike the Pyrex or fused silica glasses which did not display evidence of bubble evolution.

Figure 3: Scanning electron micrograph of impact crater in BK-7 glass displaying melt zone and trapped bubbles.

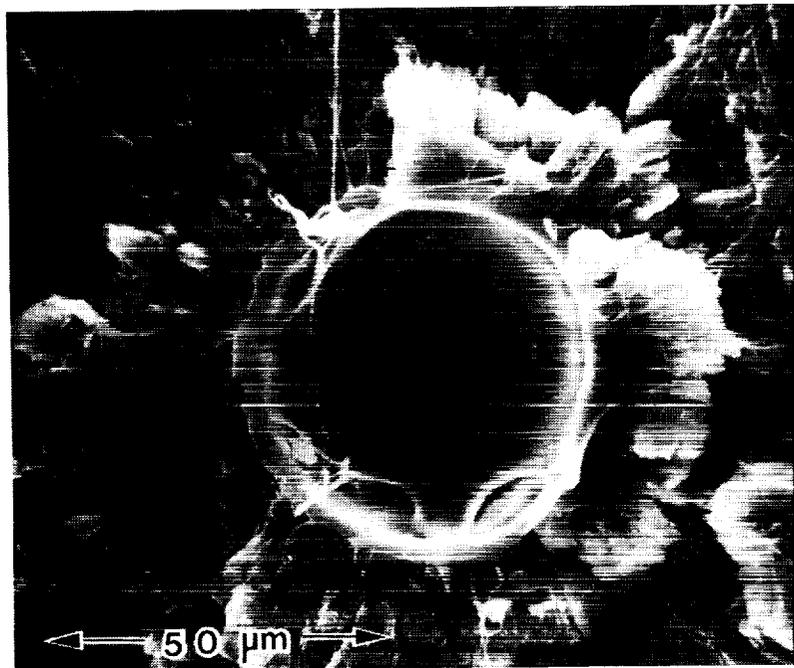
silica^b glasses which contain volatile components. Impact features in fused silica include glass fibers which extend from the melt crater as a consequence of molten glass jetting as shown in Figure 4. Fibers as long as 100 μm were observed projecting from the fused zone. One of the three impacts observed in Zerodur^a shows no evidence of melting as shown in Figure 5. Careful study of this sample at higher magnifications reveals fragmentation down to dimensions of the order of 0.5 μm . The damage associated with this impact is similar to that of impacts displaying melting except in the central fusion zone. Radially unsymmetric splash in the ejecta field of the Pyrex^c sample visible in Figure 6 indicates the micrometeorite may have impacted at an oblique angle. The crater appears to be nearly circular; however, the splash produced by the impact is strongly directional.

ejecta, the time to pull fibers 100 microns in length was about 2×10^{-8} seconds.

Figure 4: Scanning electron micrograph of impact crater in fused silica glass displaying jetting of molten glass and resulting glass fibers extending from melt crater.

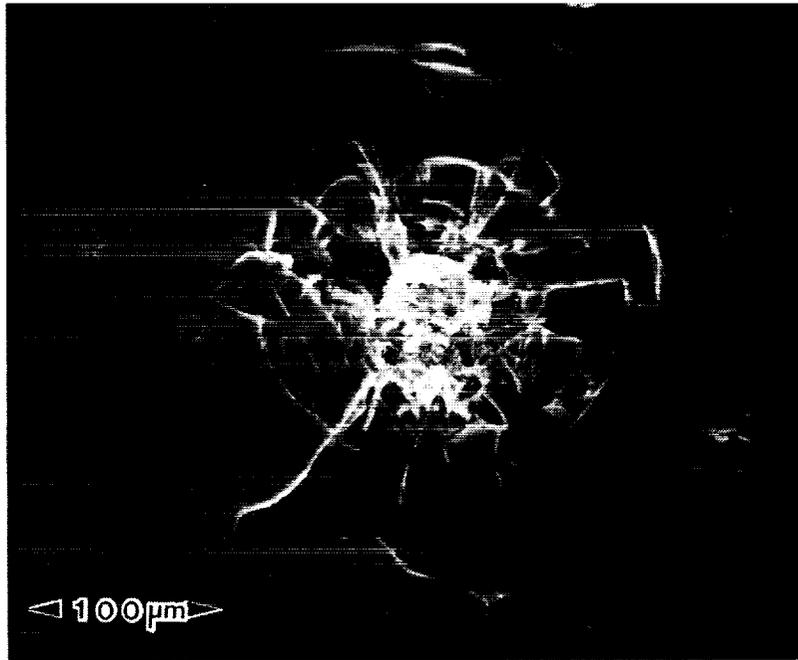
Figure 5: Scanning electron micrograph of impact site in Zerodur which displays no evidence of impact fusion.

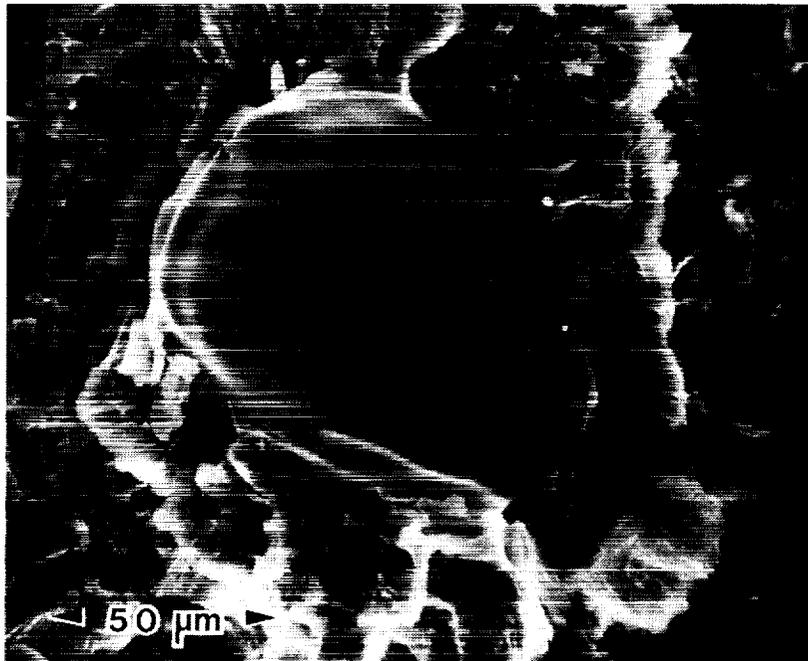
10° from the surface plane of the target. Projectile shape largely determines crater shape, even for normal impact. Impact features believed to arise from meteorites incident at angles between 20° and 45° have been observed in lunar craters⁵. The unsymmetric glass ejecta or debris field associated with the impact in the Pyrex sample is evidence that impact occurred at an oblique angle. As previously discussed, the formation of frozen strands of glass develops in the early stages of impact. This would account for the extension of filaments in the direction of impact before excavation of the crater was complete. Also, radial cracks extending from the impact extrapolate to an origin off center of the excavation in the direction of the splash. These observations indicate the projectile velocity had a large component in the direction of the debris field.

Figure 6: Scanning electron micrograph of impact crater in Pyrex displaying unsymmetric splash of ejecta possibly arising from oblique impact.
