NEW RESULTS FROM FRECOPA ANALYSIS

Christian Durin  
CNES RA-DP EQ/QM  
18, av E. Belin Toulouse FRANCE  
Phone (33) 61 28 14 39, Fax (33) 61 27 47 32

This paper discusses new results from the ongoing analysis of the FRECOPA's (FREnch COoperative PAssive payload) system hardware. FRECOPA (AO138) was one of the 57 experiments flown on the LDEF satellite. The experiment was located on the trailing edge (Tray B3) and was exposed to UV radiation (11,100 equivalent sun hours), ≈ 34,000 thermal cycles, higher vacuum levels than the leading edge, a low atomic oxygen flux and minor doses of protons and electrons. Due to LDEF's extended mission (5.8 years), CNES decided to set up a team to analyse the FRECOPA system. Initial results were presented at the First Post-Retrieval Conference, June, 1991. This paper summarizes the results obtained since then.

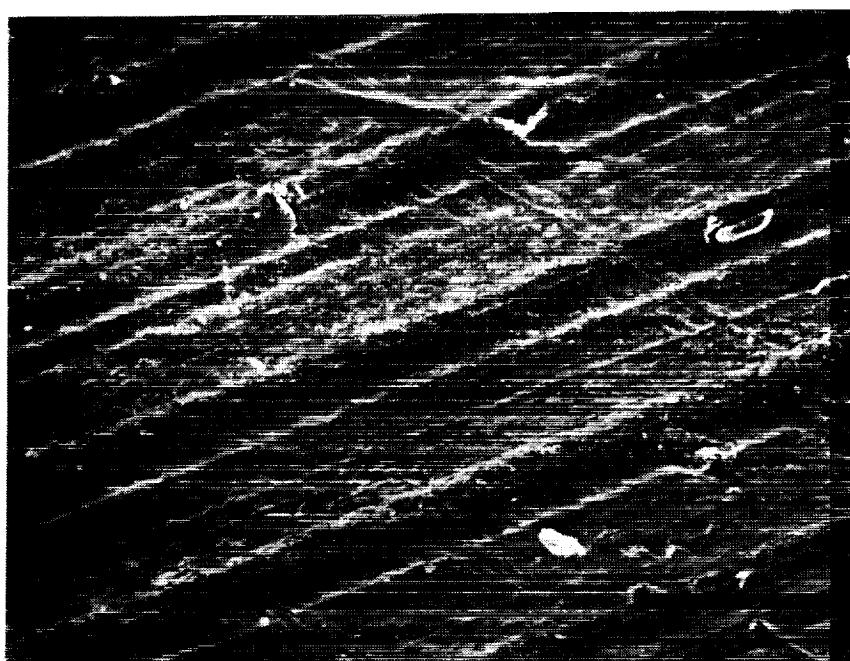
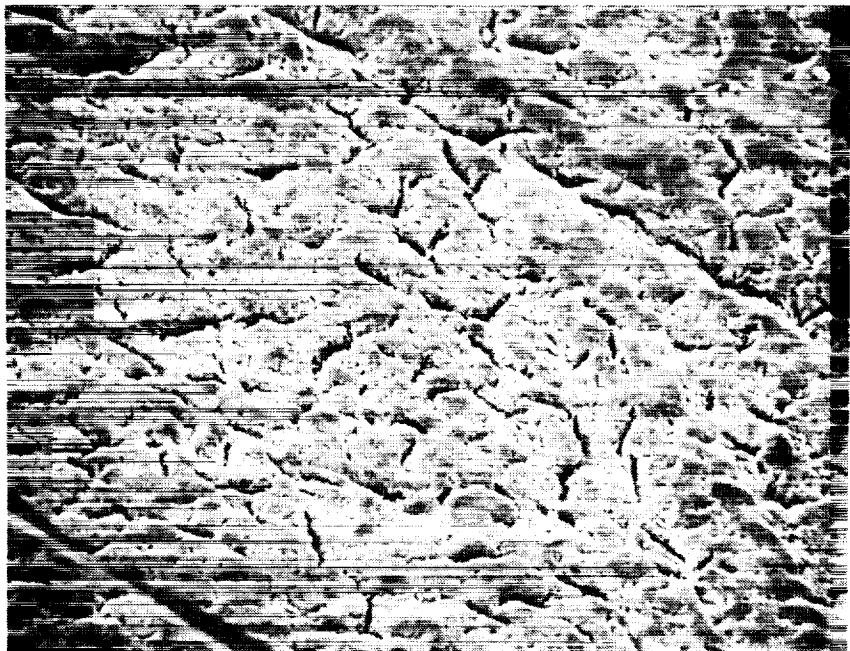
Figure 2. Delrin gears, SEM observations

On the DELRIN gears, however, all the parts exposed to UV radiation were discolored. Electron microscopy (as seen in fig. 2) showed extensive ageing of the material. The matrix was cracked and slight erosion was seen in this zone. Similar observations had already been made with other mechanical parts made of DELRIN in the FRECOPA experiment.

*The use of unprotected DELRIN in precision mechanical assemblies can therefore pose problems in space applications.*

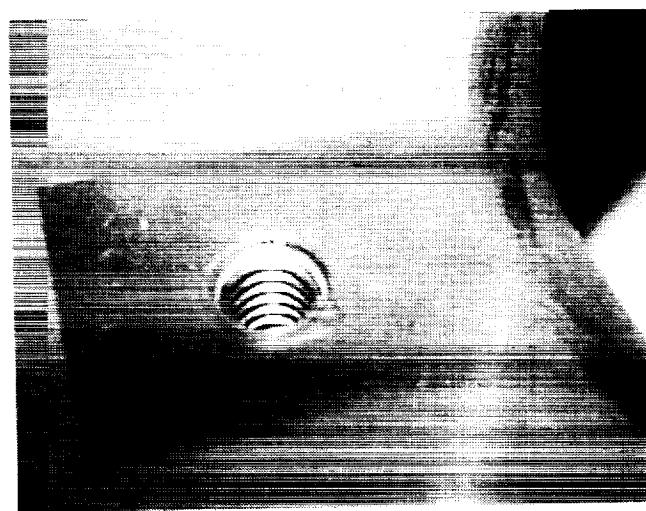
**Figure 3. Gears and motor hold-down clip shadows  
on the main structure**

All the exposed zones were subject to ageing with a change of colour (black becoming grey) and some areas were cracked.

In the places where the gears had acted as screens, their shadows were left on the underlying structure (as seen in fig. 3).

Fine measurements carried out in these zones to determine the alteration of the thermo-optical properties did not show significant variations.

*The thermal coating showed signs of ageing; its use in long-term missions should be considered in relation to its exposure.*

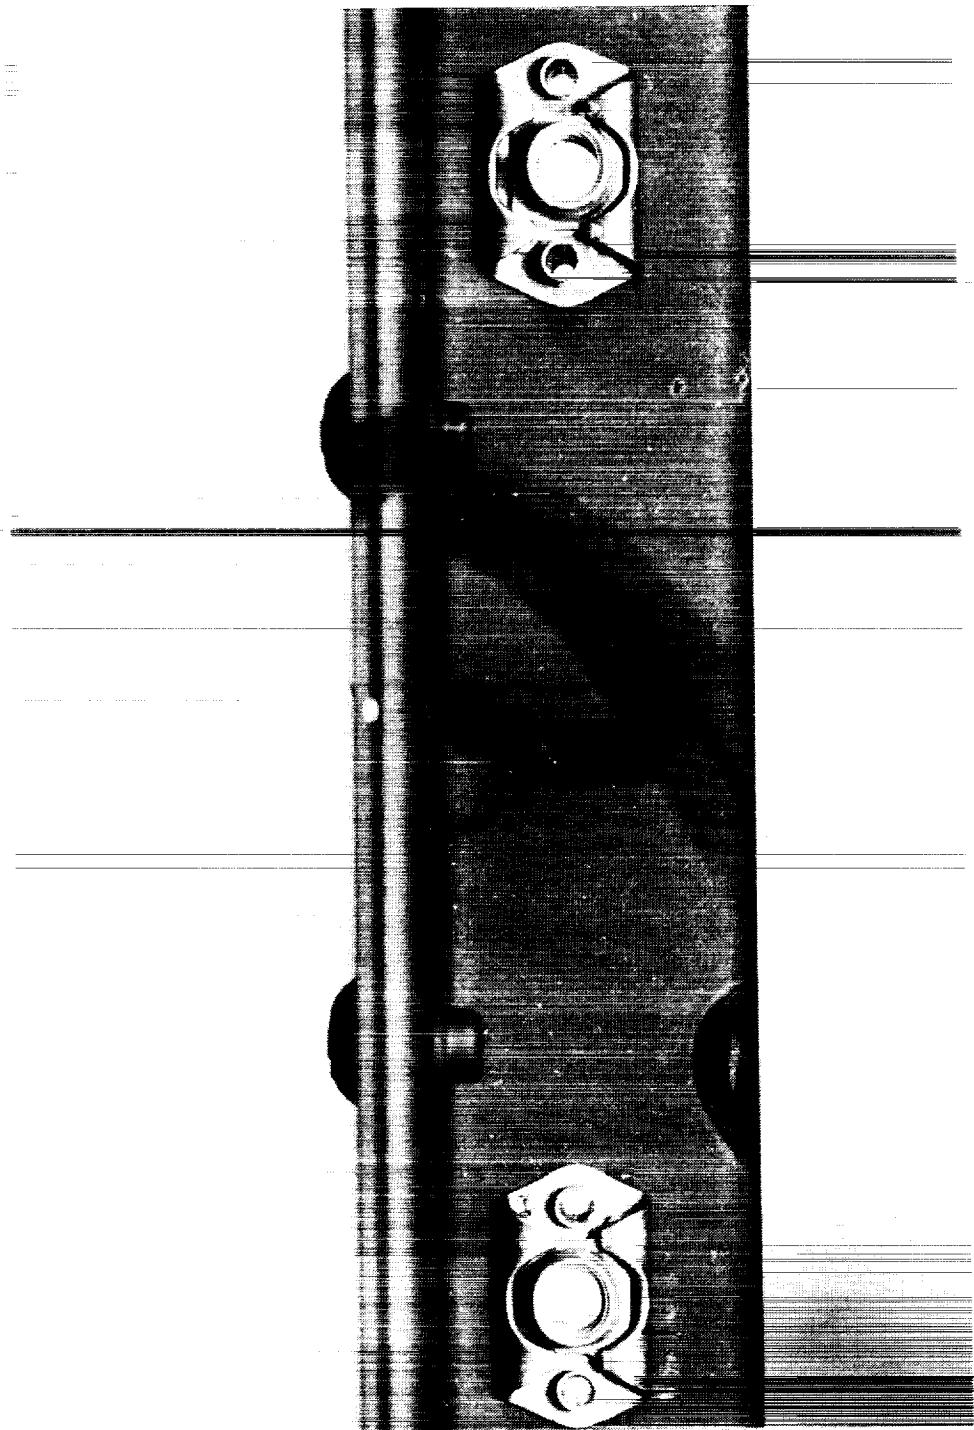
Figure 4. Bolt and wire shadows  
on the back face of the tray

On the structure, other samples analyzed concerned surfaces exposed to varying contaminant fluxes. Other zones (shadows of bolts and electric wires, as seen in fig. 4.) with difficult access presented the same signs of contamination.

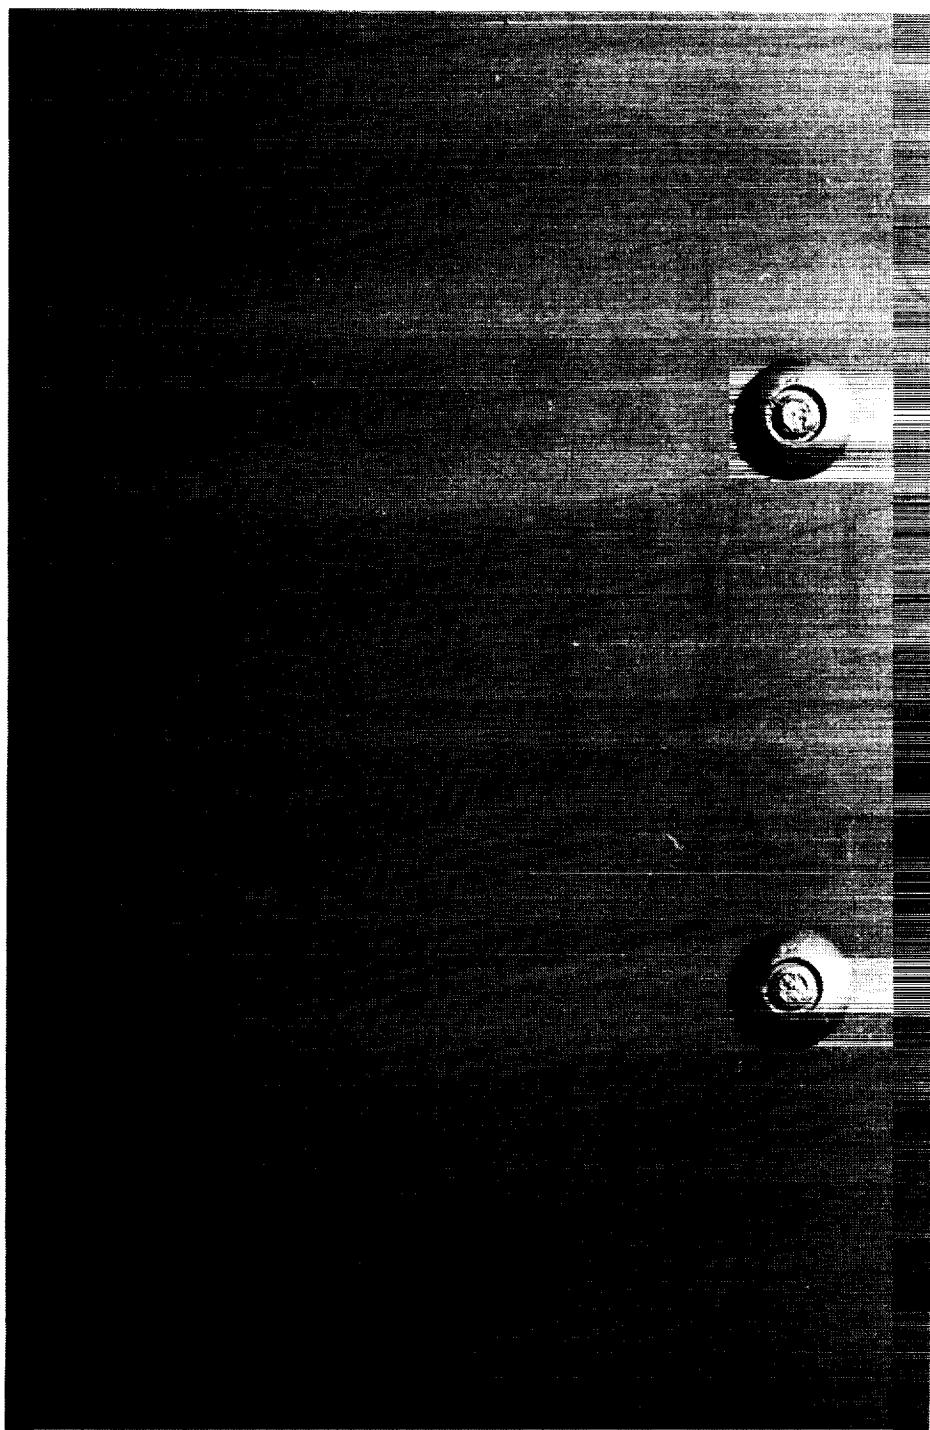
Figure 5. Rivets shadows on the lateral sides of the tray

- our third task was to analyse the multiple shadows around the rivets on the outer surface of the support (as seen in fig 5.). The reference zone was out of the shadows, the contaminated zone was inside the shadow or shadows (see figure below).

- . Presence of SiO<sub>2</sub> and heavy elements (Cu, Ag, In) on the light part of the right-angled bracket.
  - . Rivets: contamination with a layer of SiO<sub>2</sub> around the shadows (20 Å) and on the large dark area (30 Å) but no SiO<sub>2</sub> was detected on the white zone.

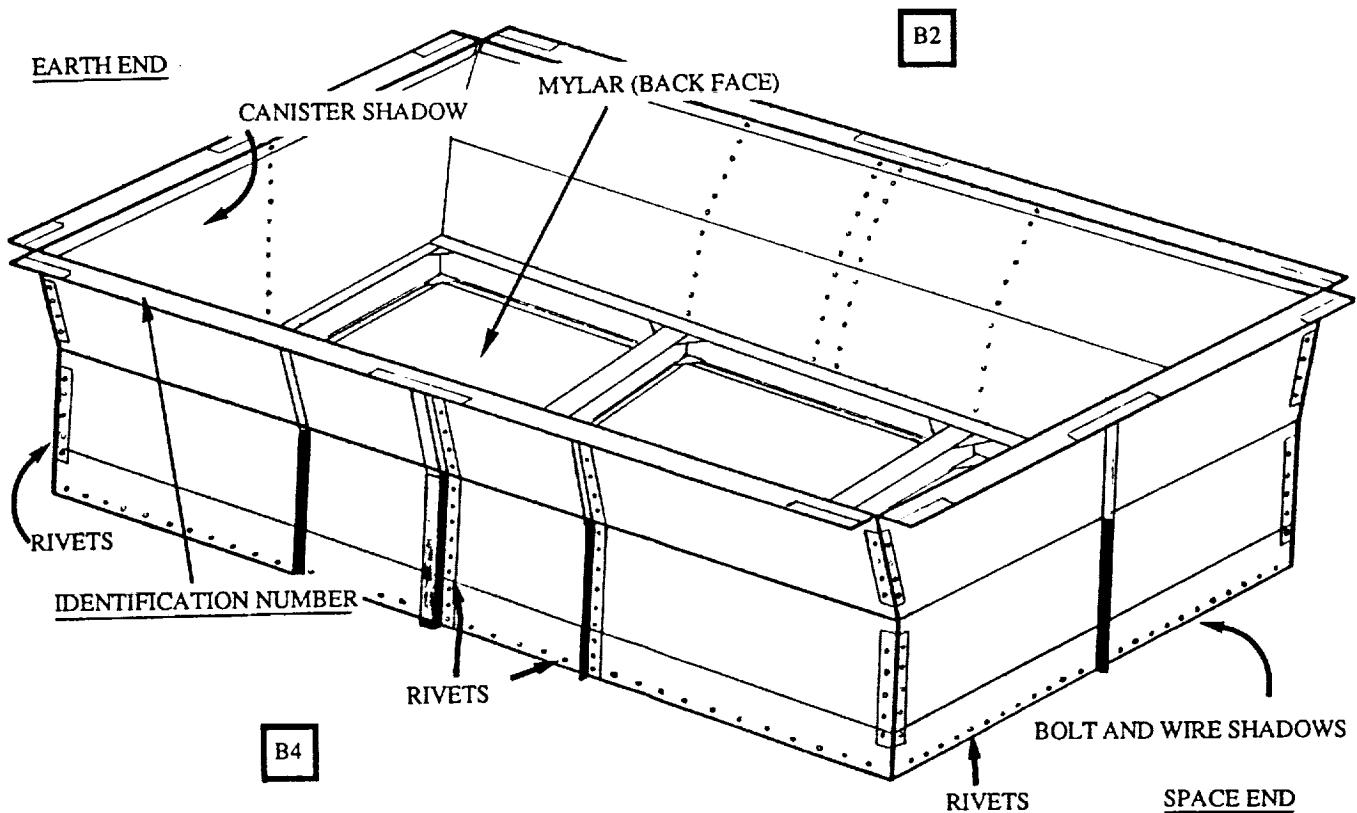
Figure 6. Areas analysed on the tray

The various surfaces concerned are indicated in the figure 6.

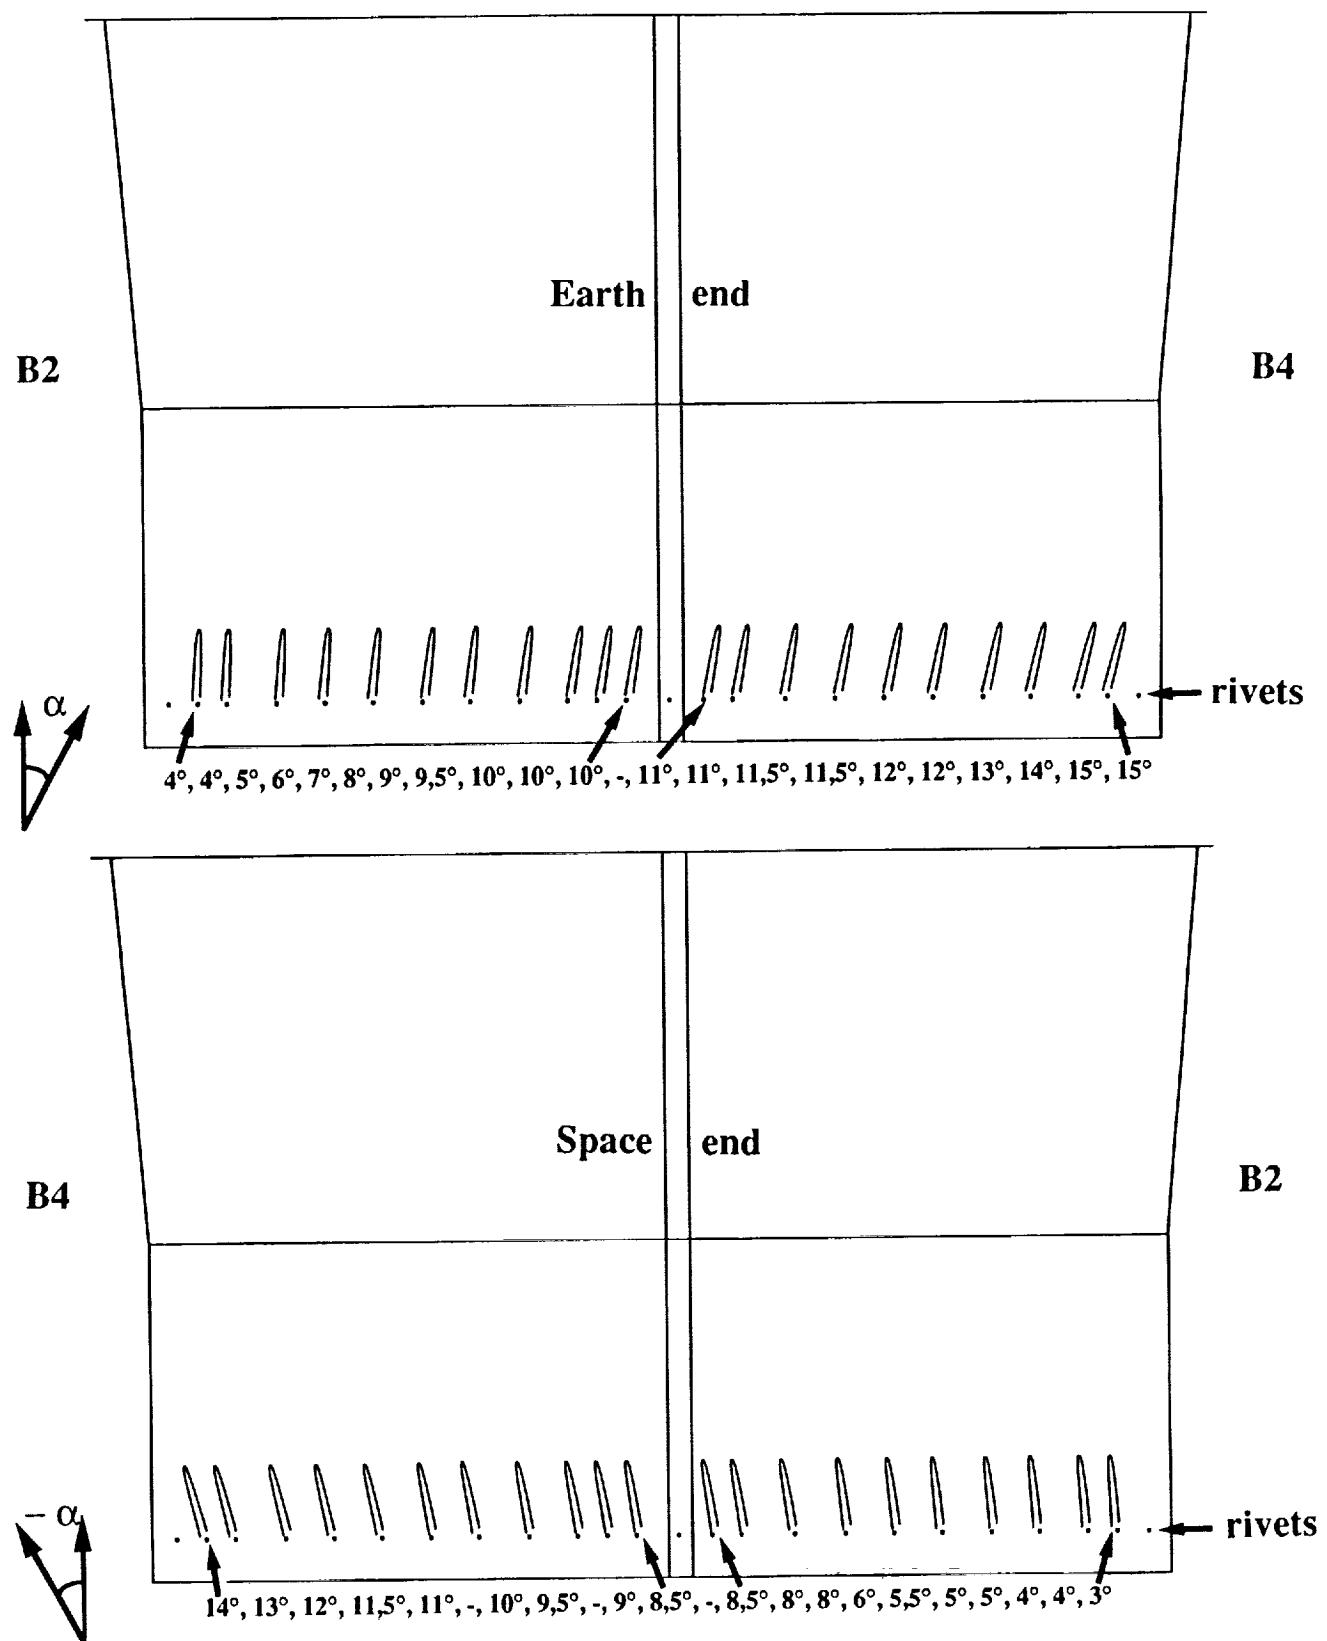
Figure 9. Angle measurements on rivets shadows

Multiple shadows indicate fluxes from several directions (as seen in fig 8.). The direction is from the inside of the LDEF towards space. We measured the variation of the rivet shadow angle on three of the surfaces of the support; on the fourth, this was impracticable (as seen in fig 9. for Earth and space end). The variations seem to indicate one or two sources of flux. A scale drawing (as seen in fig 10. for the space end) indicates the origin of the fluxes to be the inter-plate gaps (as seen in fig 11.) which must have let through atomic oxygen and UV radiation, which were able to react with the materials (silicone paint) present inside the satellite and/or draw in contaminants.

The processes of material degradation and the chemical reactions are probably at the origin of the differences of thickness measured for the contaminants (SiO<sub>2</sub>).

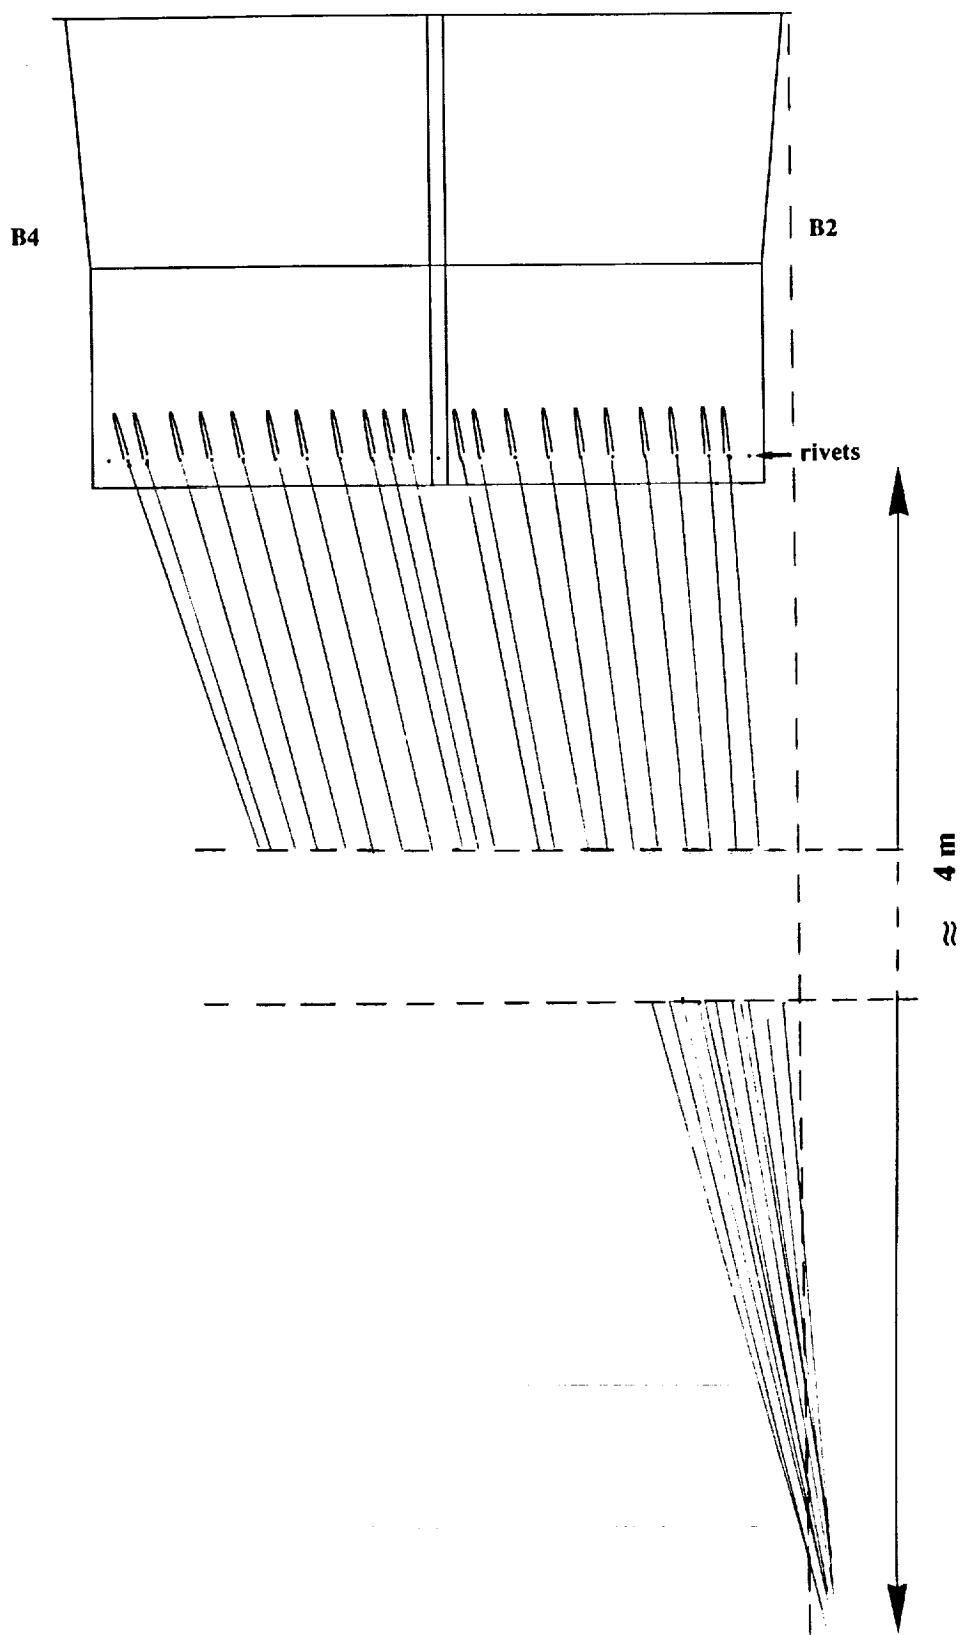
Figure 10. Origin of contamination flux (space end)

*These results demonstrate that the problem of contamination can be more important than expected and that numerous contaminants can be found even inside the satellite, which would be very prejudicial for optics and for sensitive mechanisms.*
