DEGRADATION OF OPTICAL
COMPONENTS IN A SPACE ENVIRONMENT

Linda L. DeHainaut
John R. Kenemuth
Cynthia E. Tidler
USAF Phillips Laboratory/LITC
Kirtland AFB, NM

SUMMARY

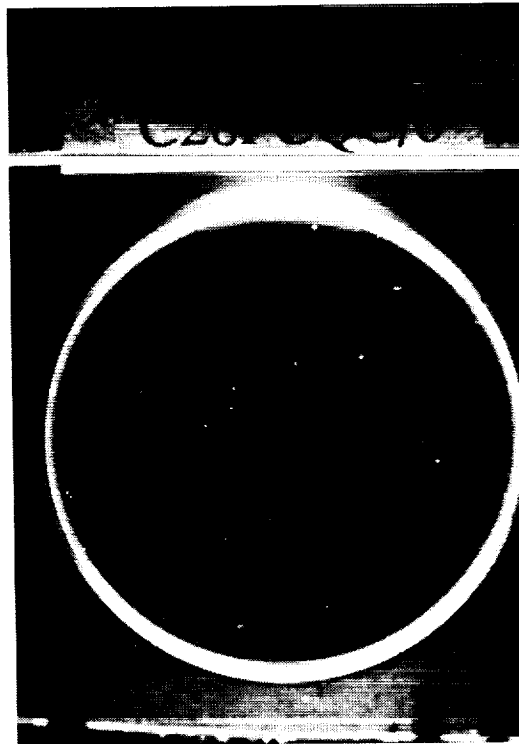
FIGURE 2: Full surface photograph of MgF_2 coated fused silica control sample.

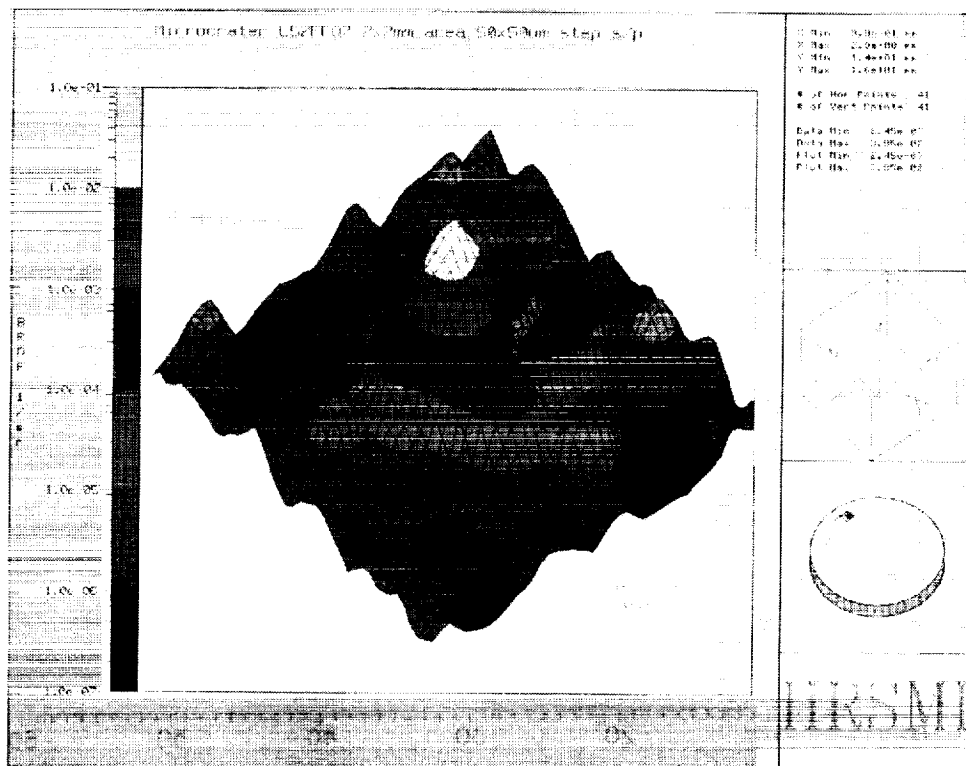
The effects of micrometeoroid damage are important for brittle materials. Investigators have found fracture lines extending 2 cm from impact sites [2]. Figure 10 is a scatter map of an impact site on the LE, 70 month, fused silica sample. Scatter intensity from the center of the crater is five orders of magnitude greater than the sample background. Fracture lines extending from the crater are high scatter sites on the surface and are indicated in the mapping by rows of peaks. The intensity of the peaks is between one and three orders

of magnitude greater than the surface background. This map demonstrates the severe scatter effects of impact damage on brittle materials.

FIGURE 10: Scatter map of a micrometeoroid impact site on fused silica.
See color photograph on page 1564.

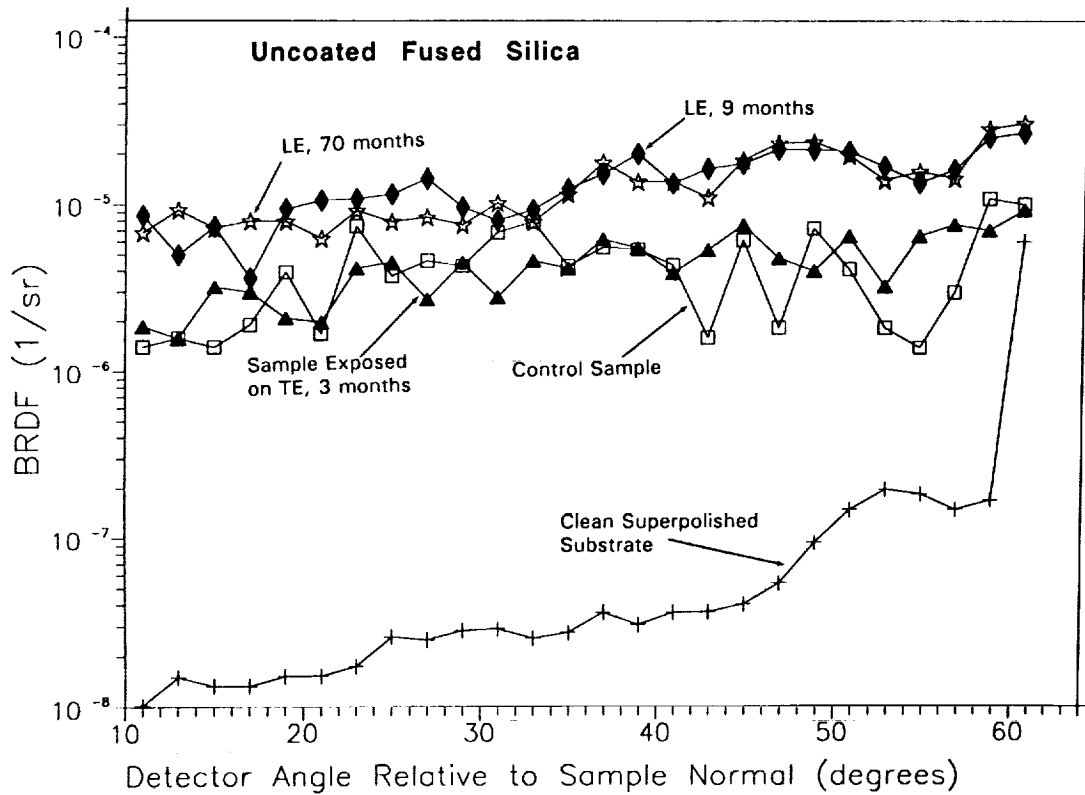
A graph of scattered intensity versus detector angle for various uncoated fused silica samples is shown in Figure 11. Eleven measurements were taken across each sample, and the eleven data points for a given detector angle were averaged to give one data point on the graph. The line defined by "+" symbols is scatter measured from a clean superpolished substrate which is not part of the LDEF sample set. The other four graphs represent data from uncoated fused silica samples. The data shows the expected trend between TE and LE samples. The ground control sample and the TE, 3 month sample are the lowest scattering of the four samples, while the LE samples are the most highly scattering. The two LE data curves have the same shape implying that the contamination and/or contributing to scatter is the same on both surfaces. It is interesting to note that the measured scatter of both the 70 month and 9 month exposed samples is the same. Two possible explanations for this phenomena are: 1) whatever is causing the scatter reached a condition where scatter is no longer affected, or 2) contamination on the 70 month sample was removed by atomic oxygen, radiation, or some other type of scrubbing effect which lowered the scatter to a level comparable to the 9 month exposure sample.

FIGURE 11: Graph of scattered intensity versus detector angle for four fused silica samples.

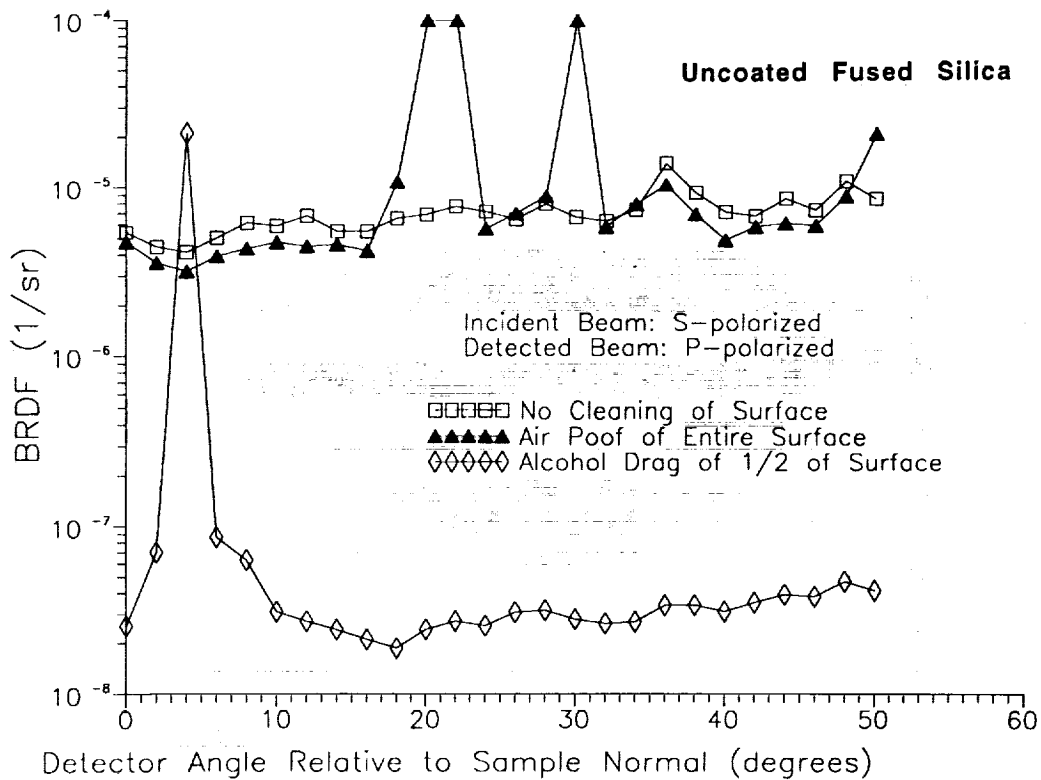
A preliminary attempt to determine the presence and magnitude of scattering from surface contamination was made. Scatter from the unexposed side of the LE, 70 month, uncoated fused silica sample was measured; and the data, represented by squares in Figure 12, shows that the surface is highly scattering. The surface was then blown with an air brush in an attempt to remove contamination, and the scatter measurement was repeated. The data, represented by triangles in Figure 12, shows that the surface scatter was not reduced. An alcohol drag was then performed twice on one-half of the surface, and the scatter was remeasured. The data, represented by diamonds, shows that cleaning the surface reduced the scatter three orders of magnitude. This is a significant reduction in scatter, indicating that there is considerable contamination on the sample surface.

FIGURE 12: Scatter data showing effects of surface cleaning on fused silica sample.

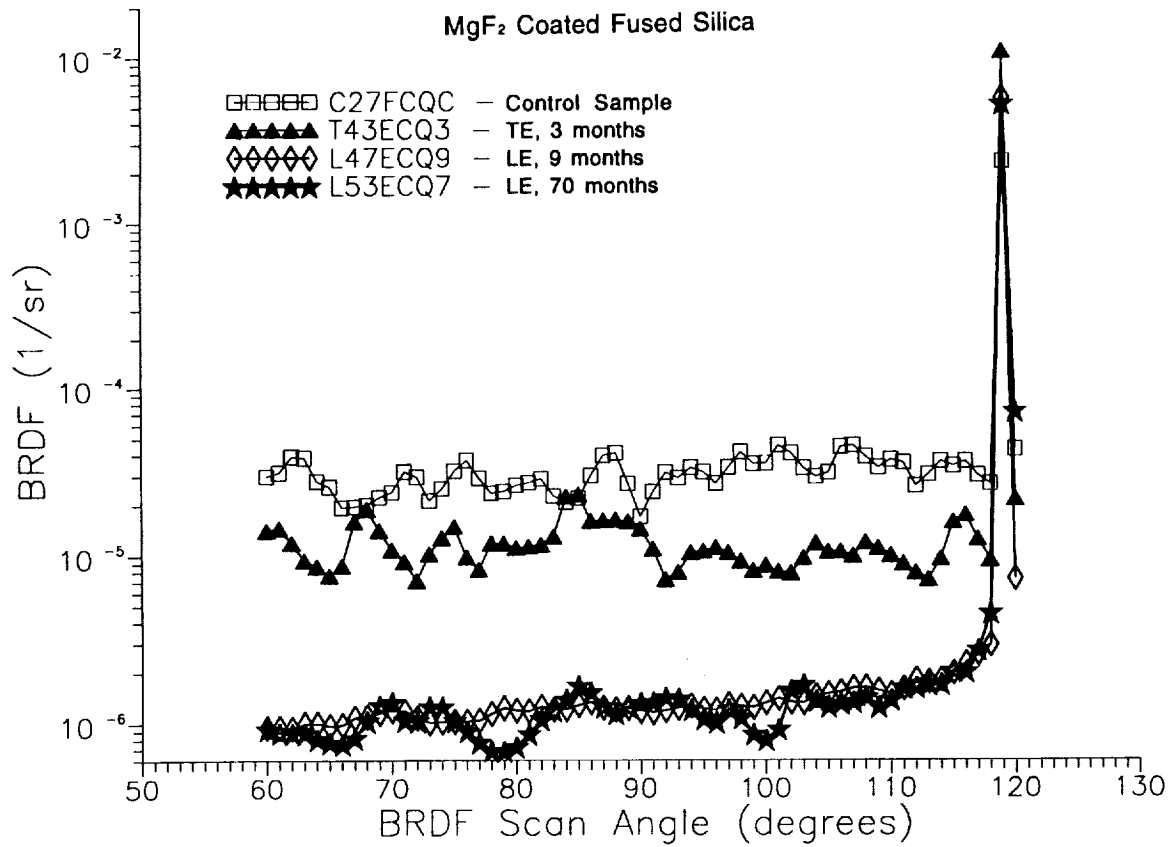
Preliminary scatter data has also been collected on selected MgF_2 coated fused silica samples (Figure 13). Again, we anticipated that the LE samples would be more highly scattering than TE samples. The data, however, shows the complete opposite trend - TE samples are more highly scattering than LE samples. The reverse trend may possibly be attributed to the sample's coating. It has been shown that coating an optic increases its surface scatter; therefore, if the coatings on the LE samples have been removed by the space environment then the LE samples will be less scattering than the TE samples. All ten samples in this sample set will be measured to verify the preliminary data, and tests will be performed to determine each coating's condition.

FIGURE 13: Graph of scattered intensity versus detector angle for four MgF₂ fused silica samples.
