# Hypervelocity Impact Testing of the Space Station Utility Distribution System Carrier

NASA Technical Memorandum 104771

Scott Lazaroff  
*Lyndon B. Johnson Space Center  
Houston, Texas*

July 1993

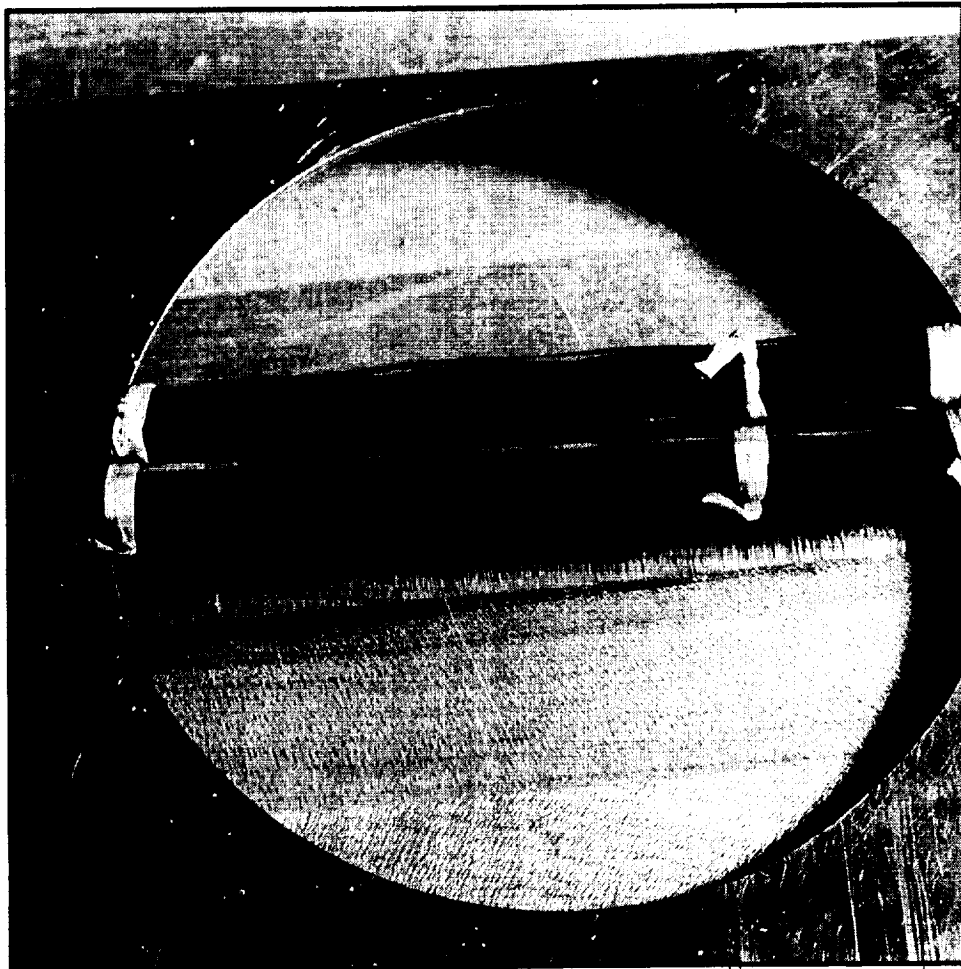
Figure 8. Physical Damage to Secondary Power Lines from HIRL Shot No. 1941

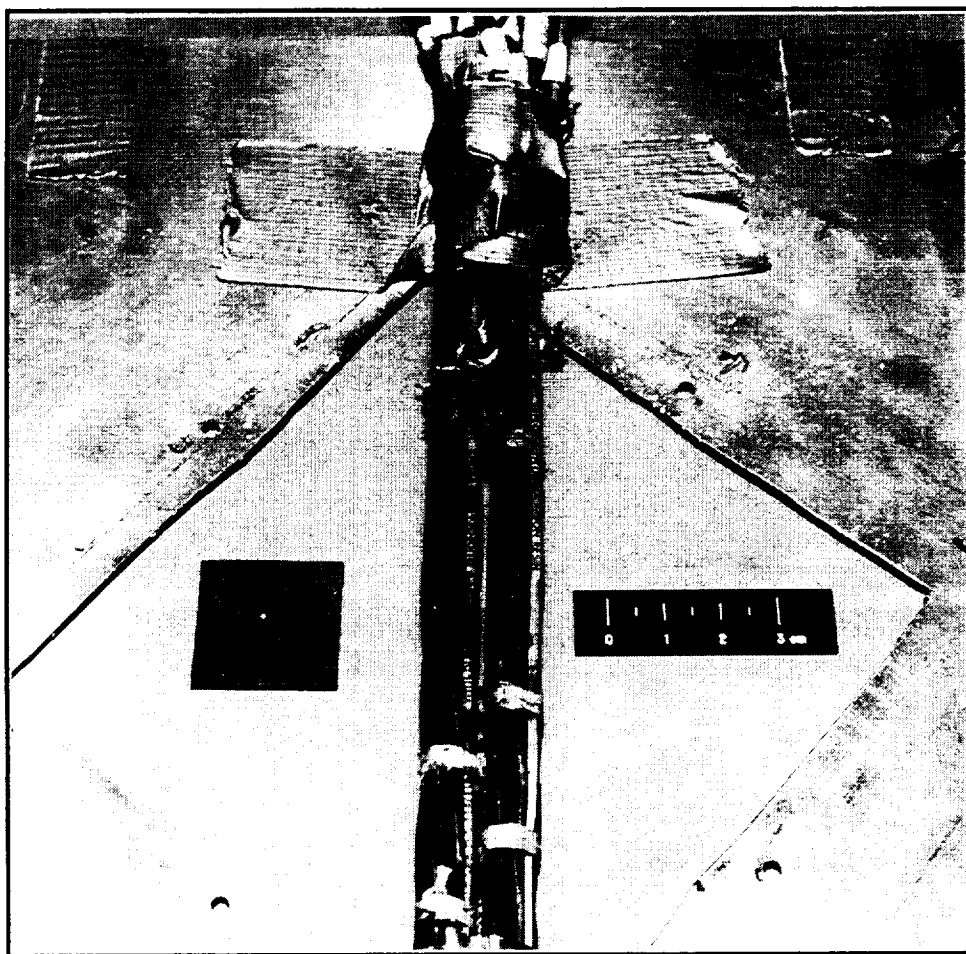
A precise ballistic limit was not determined for secondary power lines. A 2.4 mm (3/32 in.) diameter Al sphere striking the simulated carrier cover at 45° (HIRL shot no. A1494) was the biggest particle fired at the secondary power lines. It caused a large amount of physical damage (figures 10, 11, and 12), and a few of the test article lines indicated some slight increases in resistance during the post-HVI checkout. There was no dielectric breakdown of the insulation on any of the secondary power lines. For this part of the HVI test program, the parameters of A1494 are on the borderline of the ballistic limit curve, and the WSTF active line testing will better establish this limit.

Figure 10. Physical Damage to Secondary Power Lines from HIRL Shot No. A1494

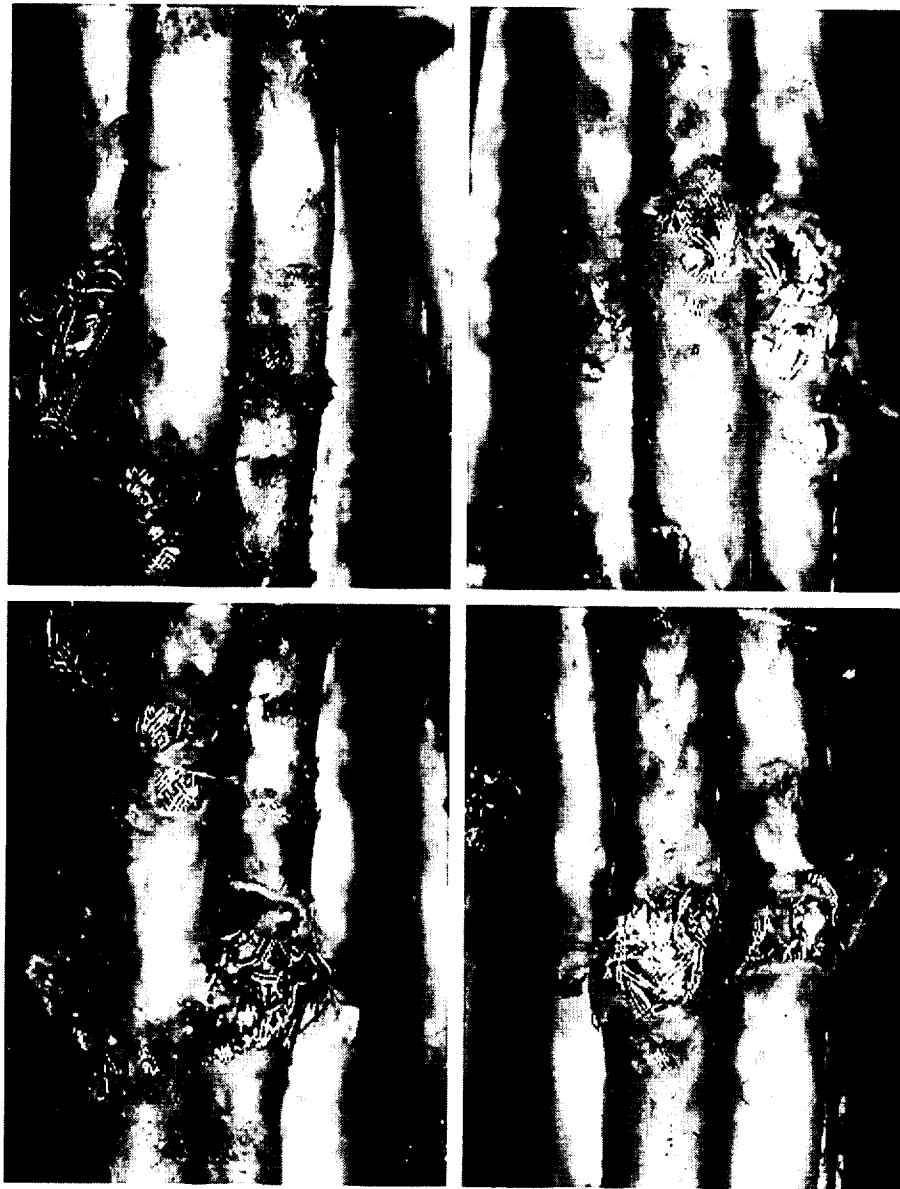
Figure 17. Physical Damage to 1553 Data Bus Lines from HIRL Shot No. A1532 at Magnifications of 6x and 6x for Line A15A and 6x and 6x for Line A15B (starting upper left, going clockwise)

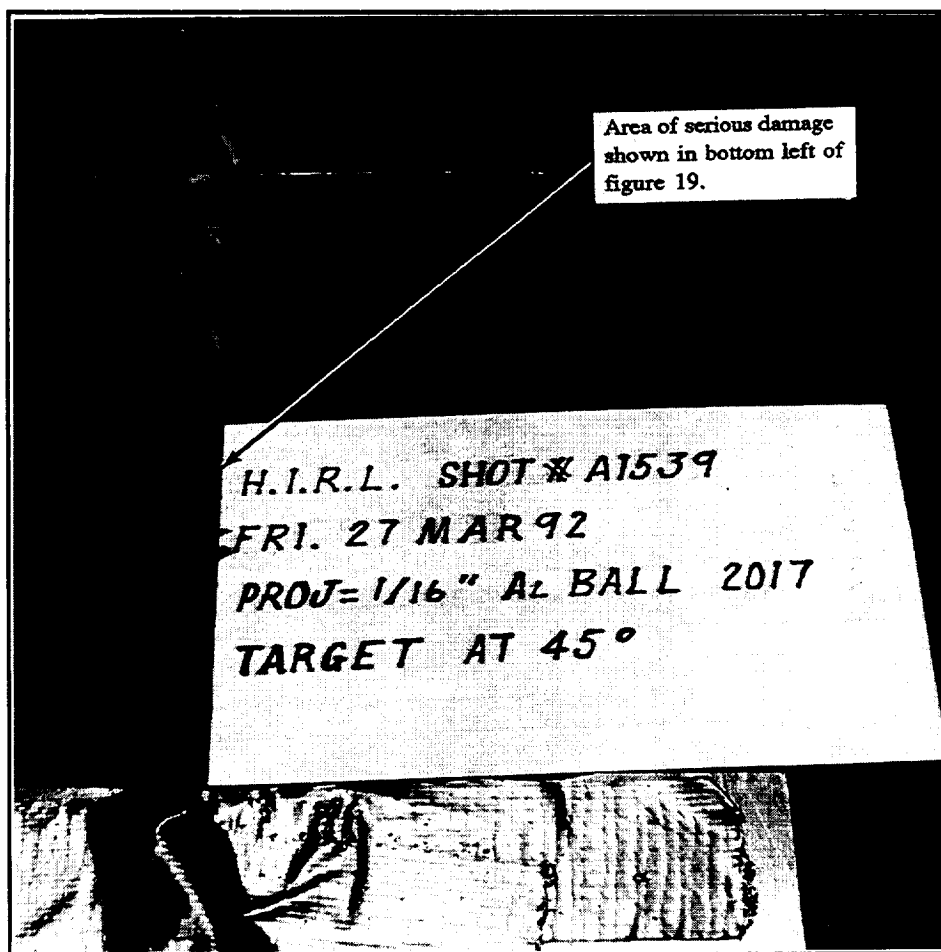
The ballistic limit for the fiber optic lines is found from the HIRL shot no. A1539, in which a 1.6 mm diameter Al sphere impacted the bumper at 45°. The signal losses in the two severely damaged fiber optic lines of shot A1539 were 35.4 and 36.3 dB. Based on the failure criteria, this is significant enough for a functional failure of the line. The physical line degradation associated with shot A1539 can be seen in figures 18 and 19.

Figure 18. Physical Damage to Fiber Optic Lines from HIRL Shot No. A1539

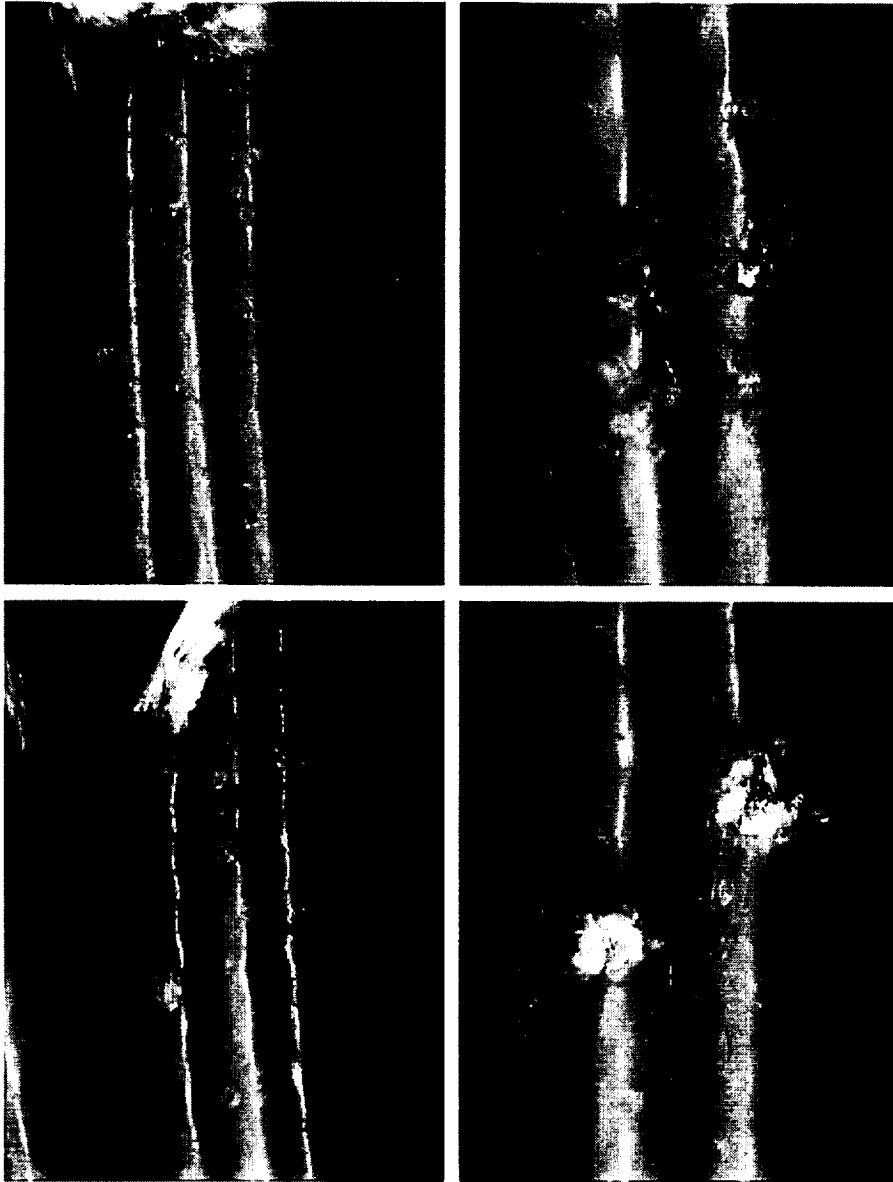
Figure 19. Physical Damage to Fiber Optic Line Bundles from HIRL Shot No. A1539 at Magnifications of 6x, 6x, 10x, and 10x (starting upper left, going clockwise)

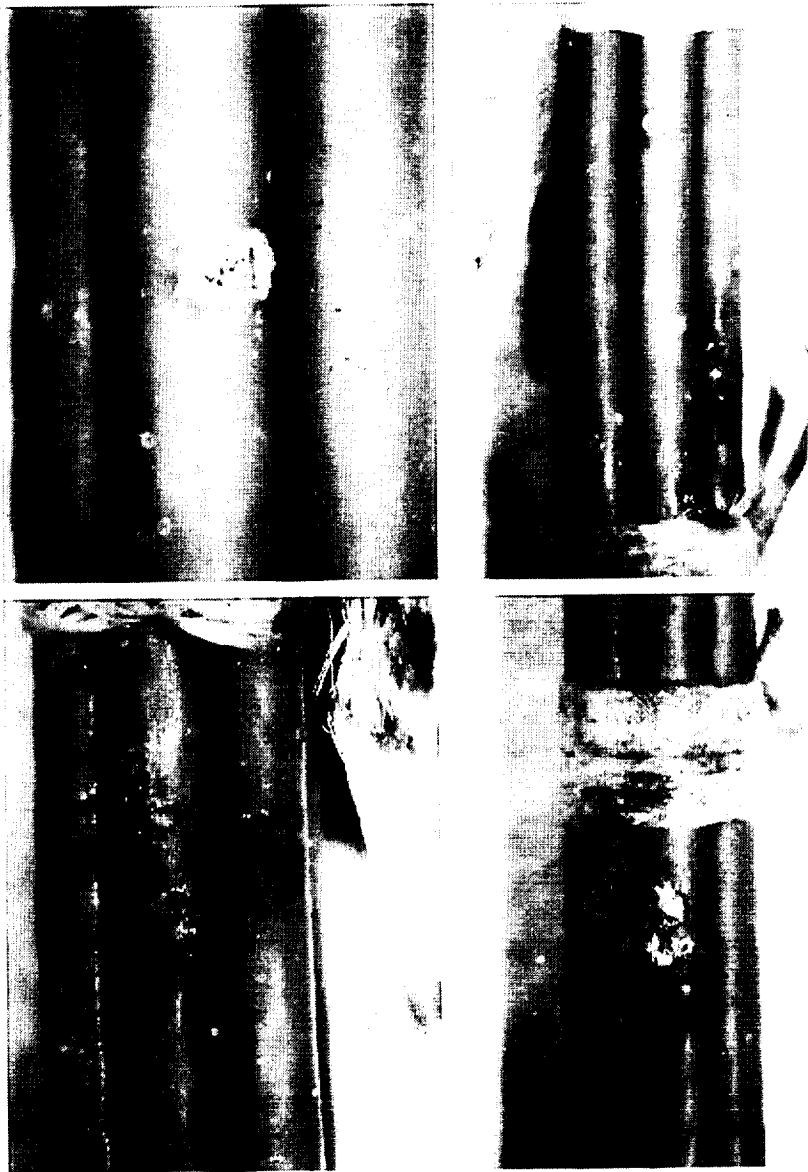
The ballistic limit conclusion is reached because a repeat of the A1539 parameters was made (HIRL shot no. A1578), and the post-HVI check showed no loss of light signal through the line. As seen in figure 20, the physical damage is very similar to the damage to the lines from HIRL shot A1539. Thus in a worst case, the parameters of A1539 and A1578 can cause a failure in the fiber optic lines and therefore they lie on the border of the ballistic limit curve.

Figure 20. Physical Damage to Fiber Optic Line Bundles from HIRL Shot No. A1578 at Magnifications of 6x, 10x, 6x, and 6x  
(starting upper left, going clockwise)

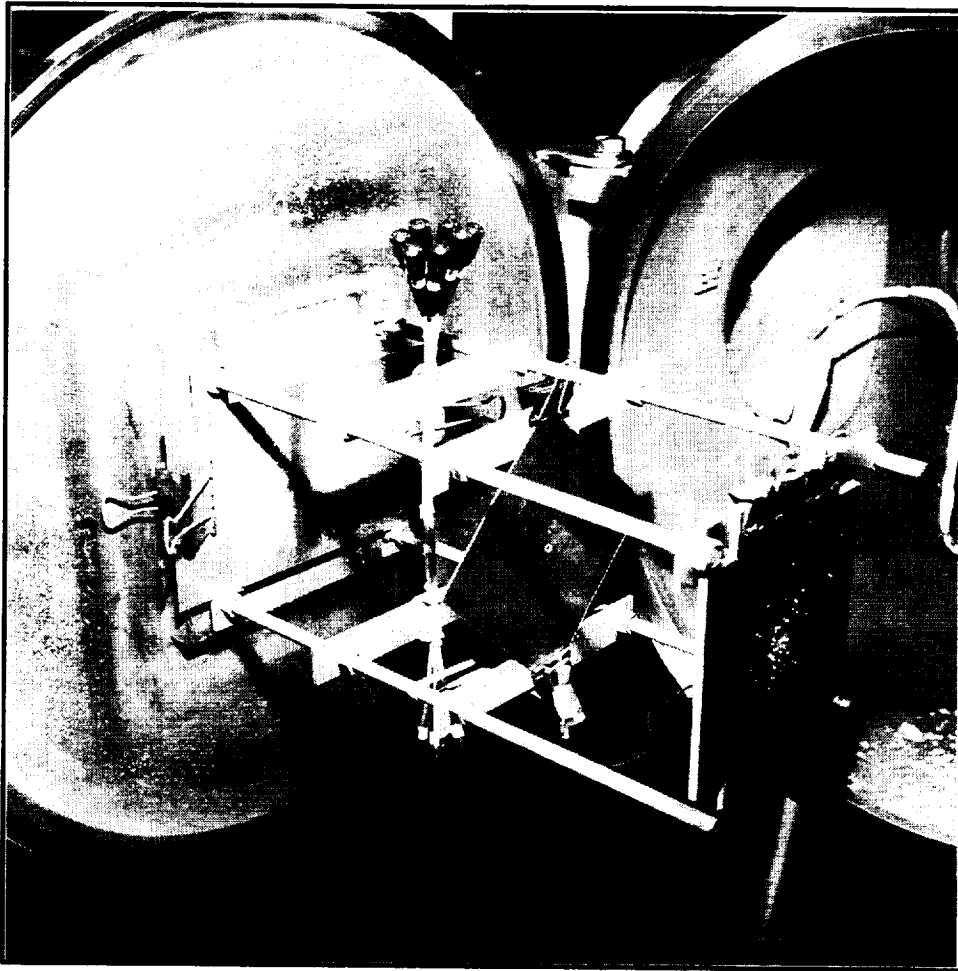
In addition, figures 21 and 22 indicate similar findings described in the secondary power lines summary of results. It can be seen that small particles (< 1.6 mm in diameter) penetrate the bumper, yet cause little physical damage and no functional damage.

Figure 21. Bumper, Fiber Optic Bundle and Witness Plate Mounted in 1.7 mm Light Gas Gun Test Cell from HIRL Shot No. 2020

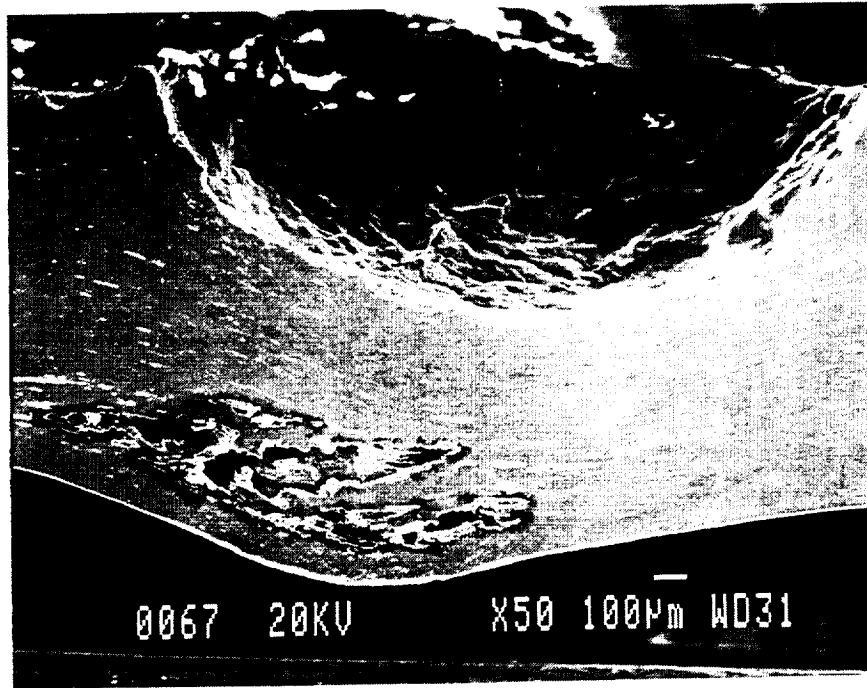
Next, the lines were cut longitudinally and the internal damage photographed. Figure 24 shows a "rift" in a dimple from the inside wall of the HIRL shot no. A1690 test article. The most heavily damaged area of the lines was subsequently cut from the tubes and the external craters and internal dimples documented using a JEOL JSM-820 SEM. The pieces were then sectioned through the crater location and further documented with the SEM. The SEM examination identified the spalling of the internal tube wall surface, showed the interface between the particle debris and the fluid line, and noted the compression of the grain structure at the point of impact. Figure 25 is an example of a typical SEM photo showing a cross-sectional view of the tube wall from HIRL shot no. A1688, a crater, and the resultant spalling of the inner wall.

Figure 25. Scanning Electron Microscope Photo of the HIRL Shot No. A1688 Tube Wall, an Impact Crater, and Inner Wall Spalling at a Magnification of 50x

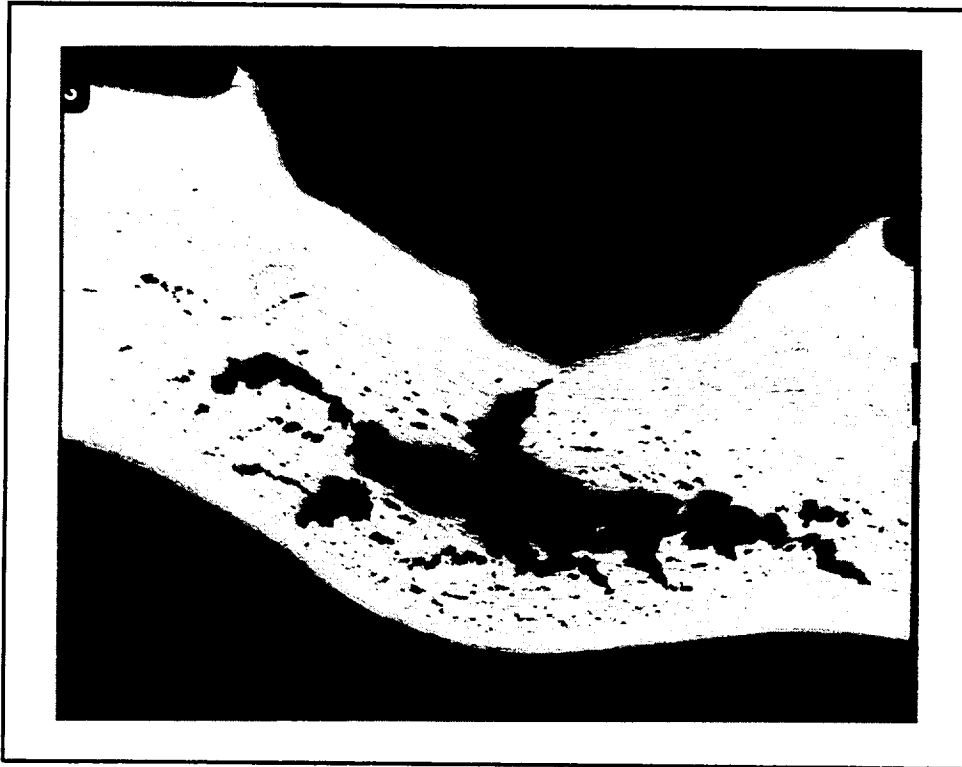
In addition, a cross section of the impact area was looked at using a Zeiss AX10MAT metallograph. These metallurgical cross sections further clarified the degree of spalling of the internal fluid line wall. As can be seen in figures 26 and 27, there is significant damage to the test article from HIRL shot nos. A1688 and A1690, respectively.

Figure 27. Metallurgical Cross Section of Fluid Line from HIRL Shot No. A1690
