# NATIONAL ADVISORY COMMITTEE FOR AERONAUTICS

No. 1637

EFFECT OF PREIGNITION ON CYLINDER TEMPERATURES  
PRESSURES, POWER OUTPUT, AND PISTON FAILURES

By Lester C. Corrington and William F. Fisher

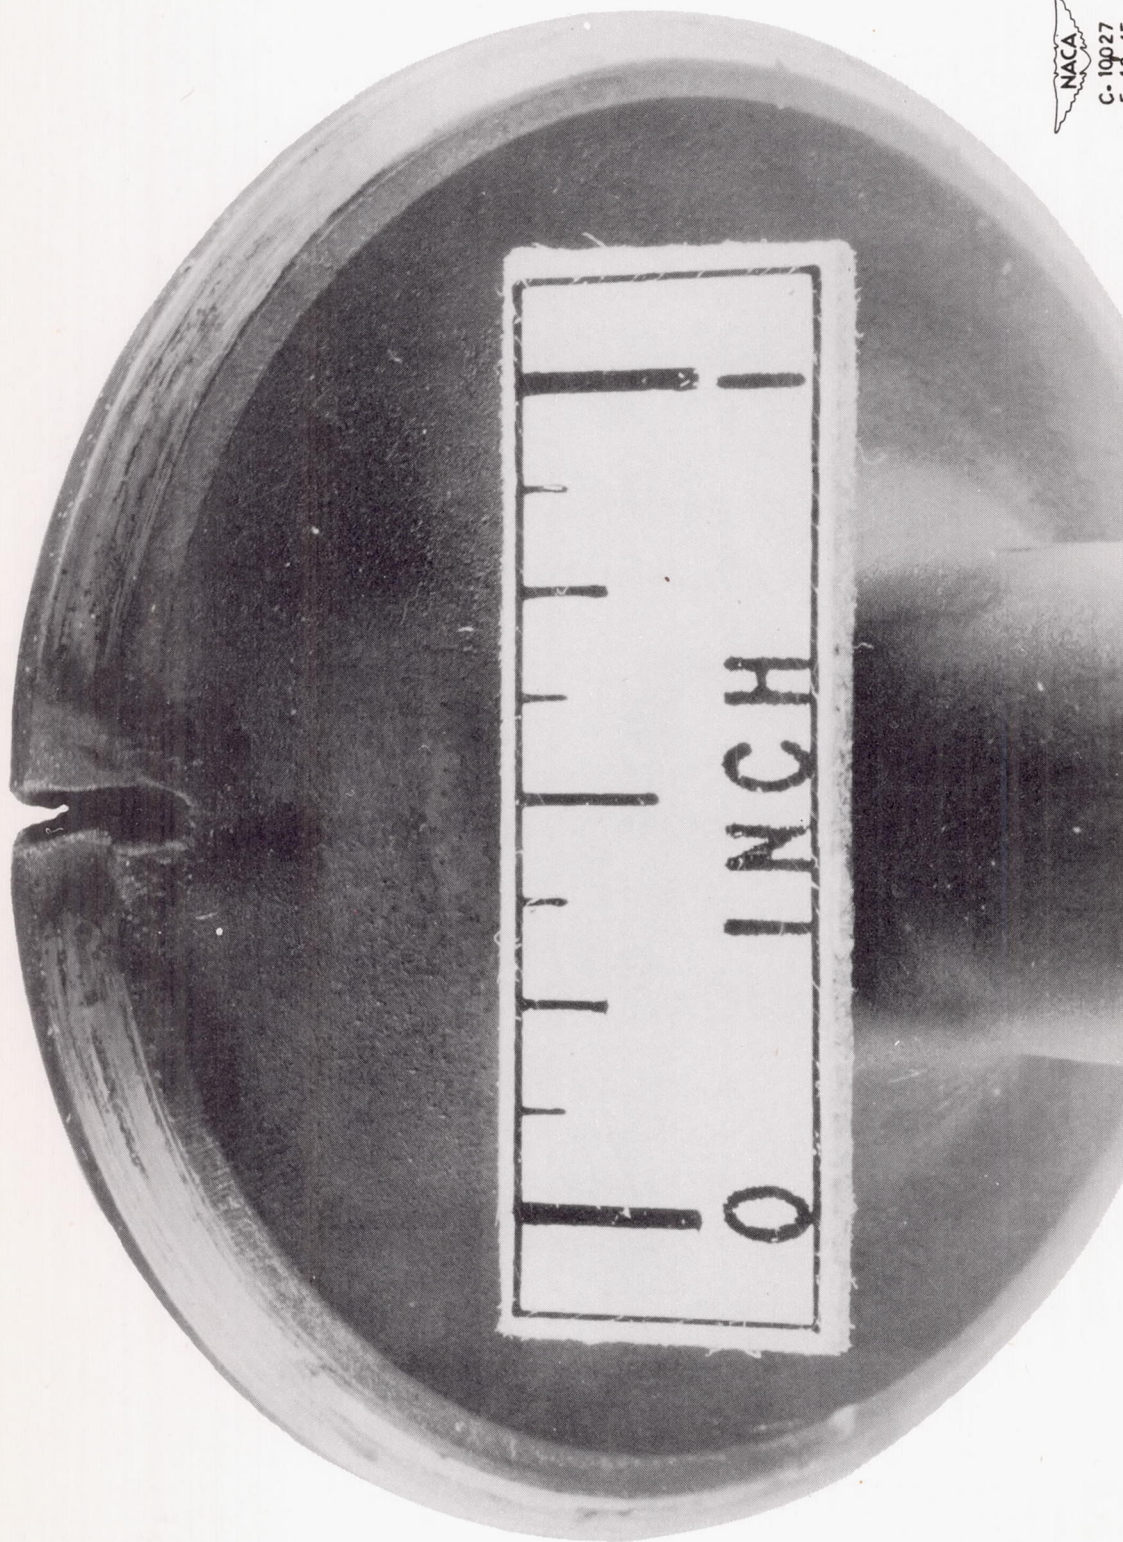
Engine difficulties experienced. - The previously mentioned runs were made with a stock piston, the diameter of which had been reduced 0.005 inch. With this added piston clearance, the only part failures encountered involved the spark plugs and the intake valves. After engine operation under some of the preignition conditions, the center electrode of the exhaust spark plug was found to be burned or melted. On two occasions one of the intake valves was found to be burned (fig. 11). Although piston-ring wear was more rapid than normal, no other failures were experienced in more than 500 preignition runs of the type discussed.

Figure 11. - Intake valve burned during preignition runs.

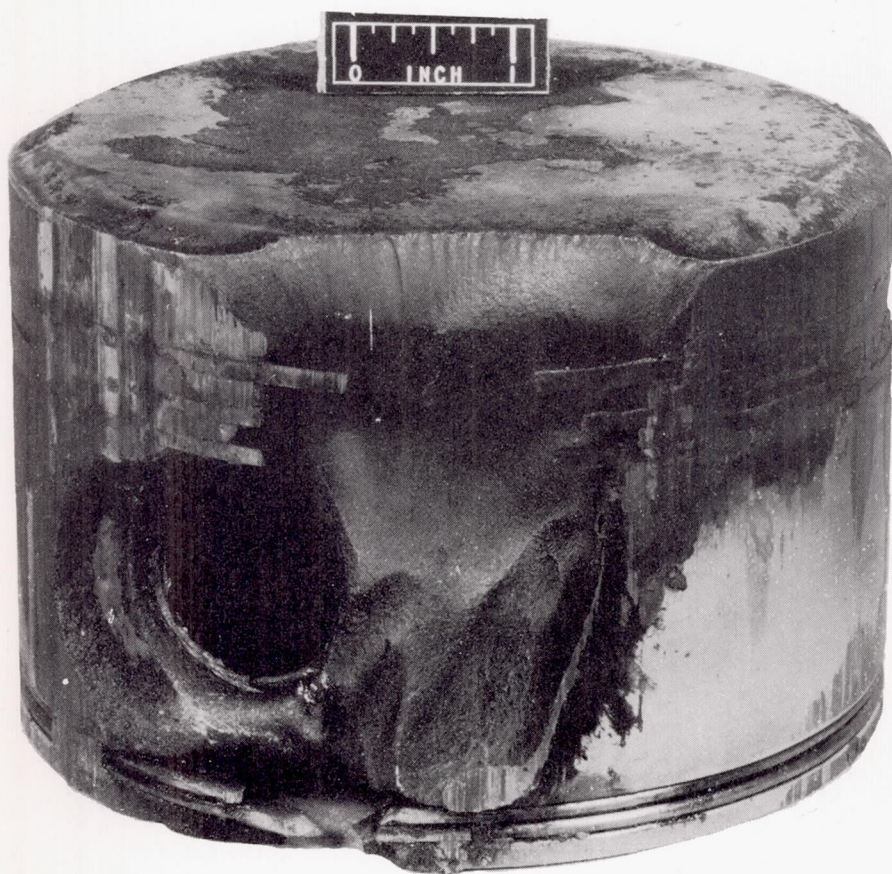
The clearance for the first run was about 0.004 inch less than the normal value (0.021 in.) for the engine. In this run, preignition caused overheating that resulted in piston seizure and consequent melting of the side (fig. 12(a)). With the normal clearance, a higher power level was necessary to cause failure but the failure was of the same nature (fig. 12(b)). The general temperature level of the piston at the time of seizure was apparently higher, however, and a small amount of local melting took place in the center of the crown. When the clearance was increased to 0.005 inch greater than normal, the failure was still a seizure with consequent melting of the side (fig. 12(c)) but more local melting took place in the center of the crown than with normal clearance. A further increase of the clearance to 0.013 inch greater than normal eliminated the seizure (fig. 12(d)) and complete failure was not experienced at the power level investigated. Slightly more severe local melting, however, took place in the center of the crown. On the basis of these runs and a number of unreported preignition investigations, when piston failure is caused by preignition the type of failure depends mainly on the clearance between the piston and the cylinder. With small clearances, the failure occurs through seizure and consequent melting of the side; whereas if the clearances are large enough, melting will probably occur wherever the piston is hottest, in the center of the crown in this instance.

(a) Clearance, 0.004-inch less than normal; imep, 271 pounds per square inch; fuel-air ratio, 0.098.

Figure 12. - Exhaust-side view of piston failures caused by preignition with various clearances between top of skirt and cylinder barrel.

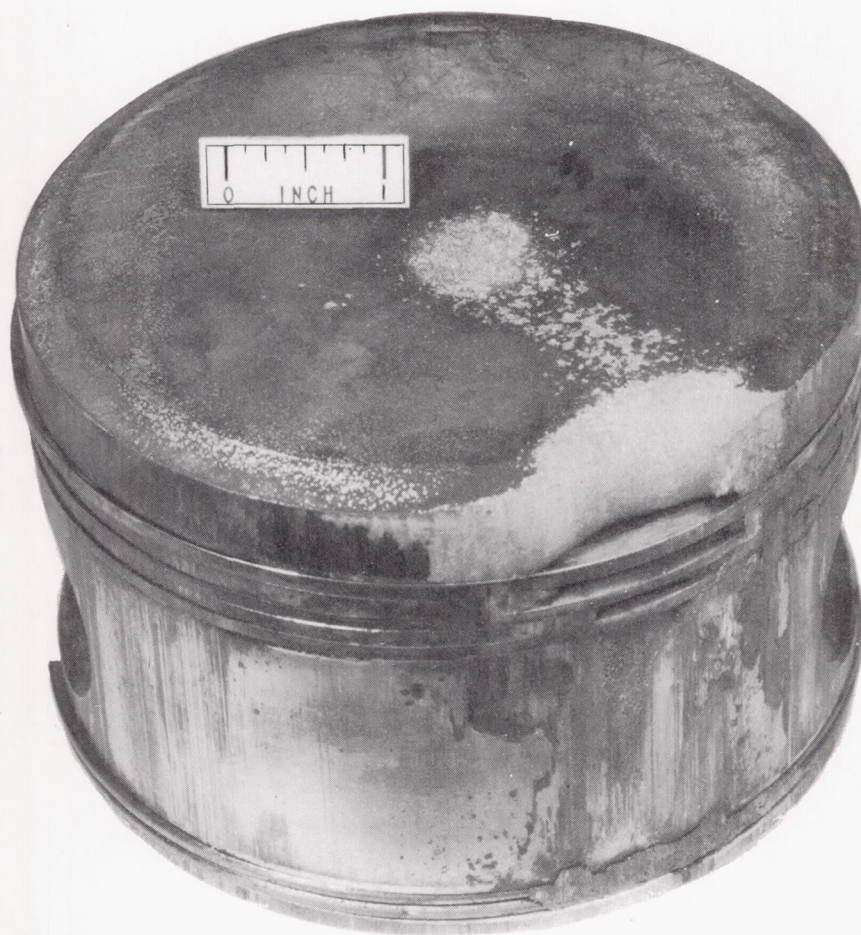
(b) Clearance, normal; imep, 364 pounds per square inch;  
fuel-air ratio, 0.094.

Figure 12. - Continued. Exhaust-side view of piston failures  
caused by preignition with various clearances between top  
of skirt and cylinder barrel.

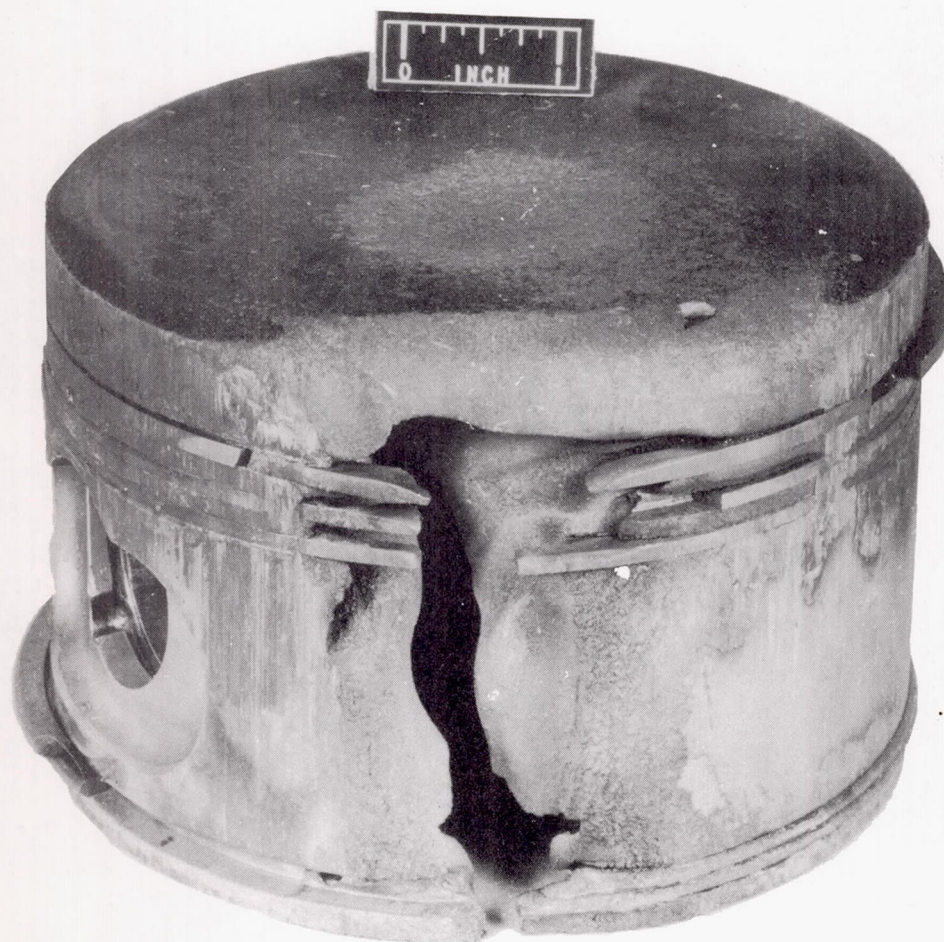
(c) Clearance, 0.005-inch greater than normal; imep, 364 pounds per square inch; fuel-air ratio, 0.094.

Figure 12. - Continued. Exhaust-side view of piston failures caused by preignition with various clearances between top of skirt and cylinder barrel.

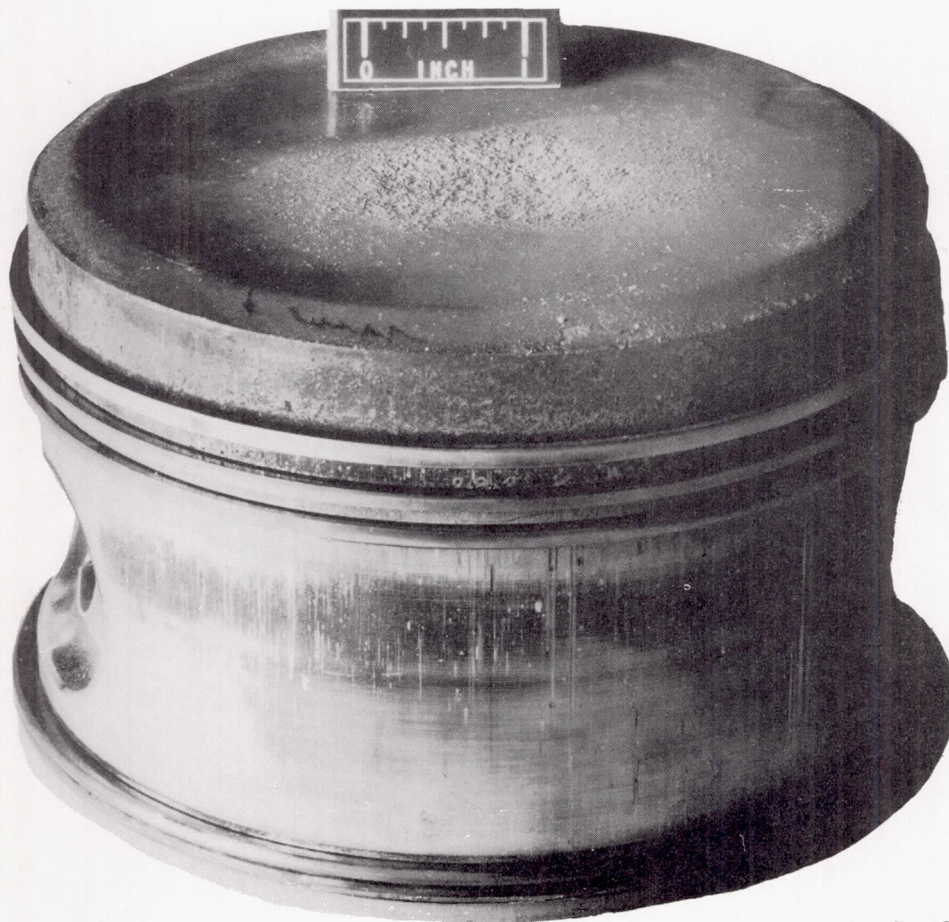
(d) Clearance, 0.013-inch greater than normal; imep, 392 pounds per square inch; fuel-air ratio, 0.092.

Figure 12. - Concluded. Exhaust-side view of piston failures caused by preignition with various clearances between top of skirt and cylinder barrel.

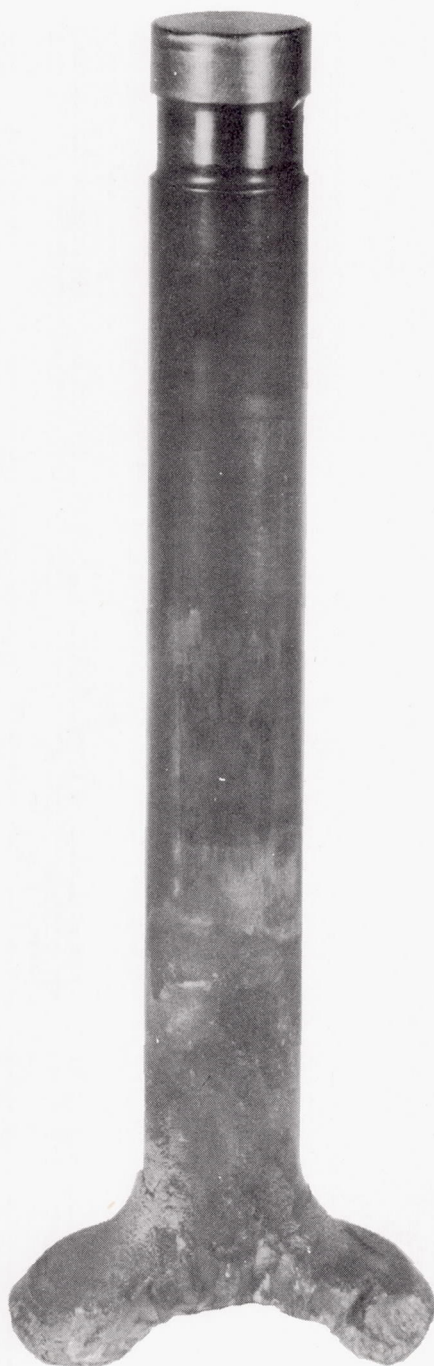
Photographs of damage to other cylinder parts that accompanied the piston failures in two of the runs are also presented. Figure 14 shows an exhaust valve that burned at the time of the piston failure shown in figure 12(b). Inasmuch as two other runs were made at more severe operating conditions without valve failure, it is felt that this failure was brought about by particles of aluminum or other substance lodging between the valve and its seat. Figure 15 shows the damage to the cylinder barrel that accompanied the piston failure shown in figure 12(c). The torching action of the hot gases burned through the barrel into the coolant passage.

Figure 14. - Damage to exhaust valve accompanying piston failure of figure 12(b).

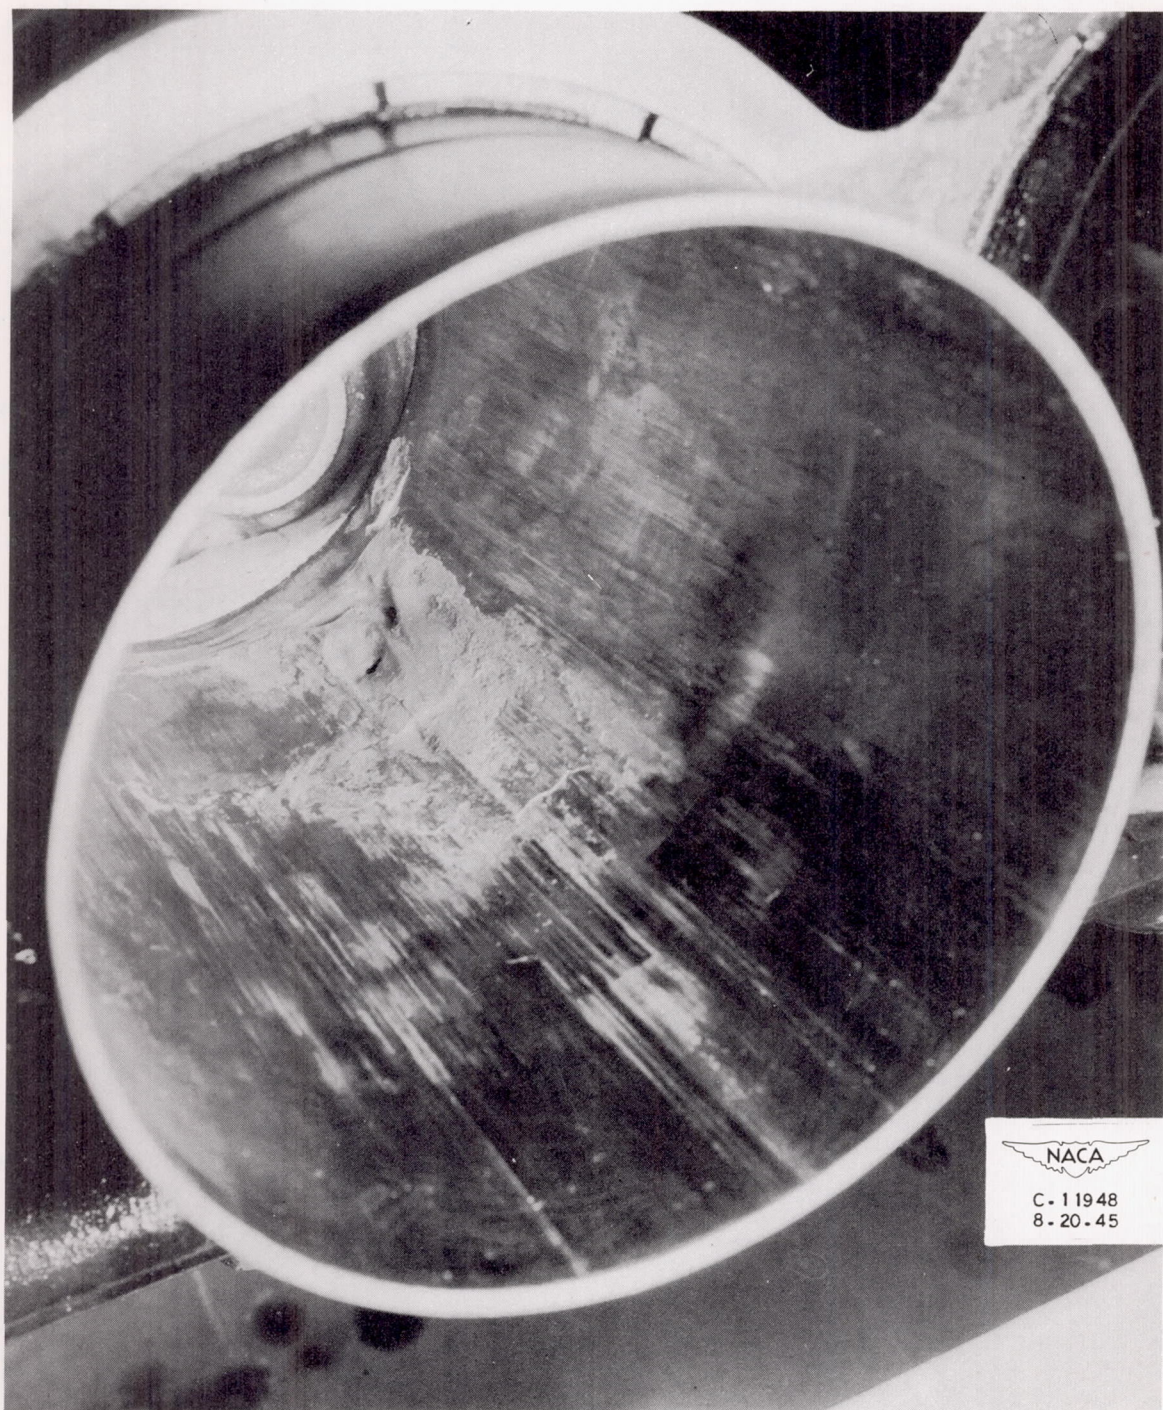
Figure 15. - Damage to cylinder barrel caused by piston failure of figure 12(c).
