# NATIONAL ADVISORY COMMITTEE FOR AERONAUTICS

TECHNICAL NOTE 3973

ORIGIN AND PREVENTION OF CRASH FIRES IN TURBOJET AIRCRAFT

By I. Irving Pinkel, Solomon Weiss, G. Merritt Preston,  
and Gerard J. Pesman

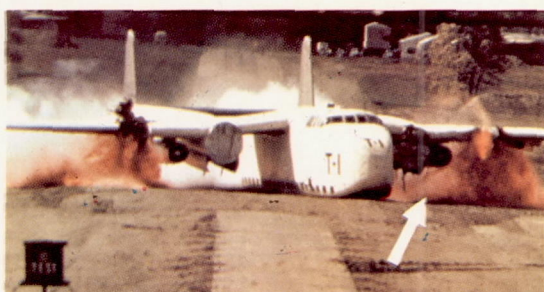
The appearance of the airplane as it struck the barrier is shown in figure 2(a). The cloud of fuel mist (liquid droplets suspended in air) that appeared when fuel spillage occurred while the airplane was in motion is evident at the breach in both wings (fig. 2(b)). Red dye in the fuel accounts for the bright color of the fuel cloud. As the crashed airplane slowed, the fuel mist moved forward of the wing and reached the air inlet on the left engine (fig. 2(c)). A strong cross wind swept the fuel mist away from the engine on the right wing.

(c) Fuel mist entering left engine, 2.5 seconds after initial impact.

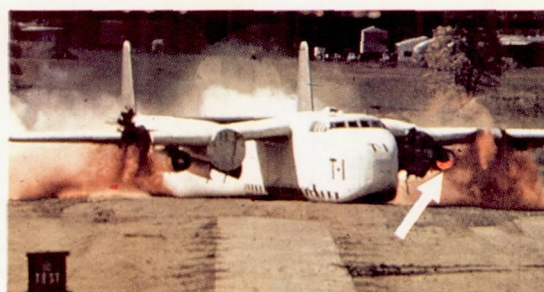
Fuel mist ingested by the left engine was ignited somewhere within the engine. The ignited fuel mist produced the flames at the tailpipe and inlet shown in figure 2(d). These exposed engine flames ignited the fuel spilling from the wing (fig. 2(e)). The flame spread through this fuel to the wing to produce the stable fire shown in figure 2(f).

Flames originating within the engine may also appear at the engine inlet as observed in figure 2(d). The appearance of this inlet flame may be explained in the following way. Burning of ingested fuel in the combustor flame reduces the turbine-inlet gas density. A higher pressure in the combustor is required to pass the gas through the turbine. When an abrupt change in over-all combustor fuel-air ratio is provided by the ingested fuel, the pressure in the combustor required to pass the combustor gas through the turbine may exceed the capability of the compressor at the existing rotor speed. The compressor flow may stall before the turbine can accelerate the rotor to a speed that will provide the necessary pressure. At this moment the combustor flame may propagate upstream through the ingested combustible mixture that fills the stalled compressor and exit at the engine inlet.

(d) Fire at engine inlet and tailpipe of left engine, 2.6 seconds after initial impact.

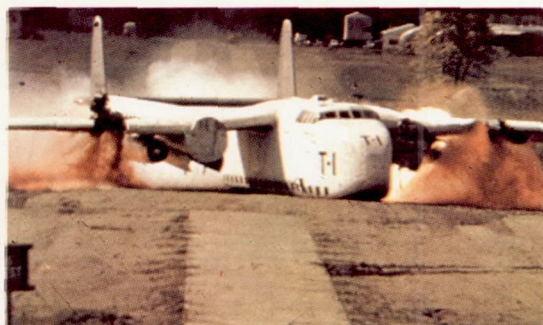
(e) Fire spread to fuel mist issuing from left wing, 2.8 seconds after initial impact.

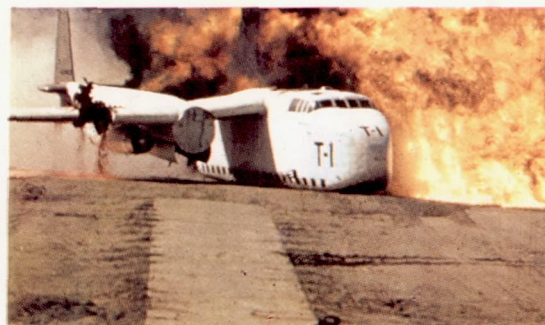
(f) Spread of fire, 4.0 seconds after initial impact.

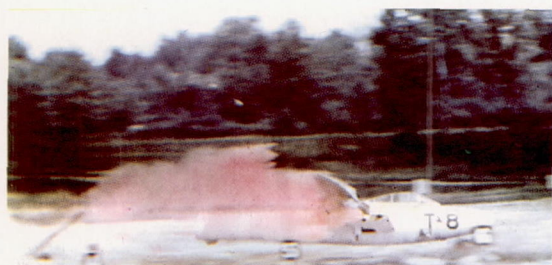
A crash of the F-84 is shown in the sequence in figure 5. Upon passing through the crash barrier the airplane flew over a ditch toward rising ground. The fuel spilled from the damaged wing tanks in mist form and moved to the rear of the airplane (fig. 5(a)), which was traveling about 100 miles per hour. When the nose gear collapsed upon contact

(a) Wing-tank fuel spillage, 0.35 second after initial impact.

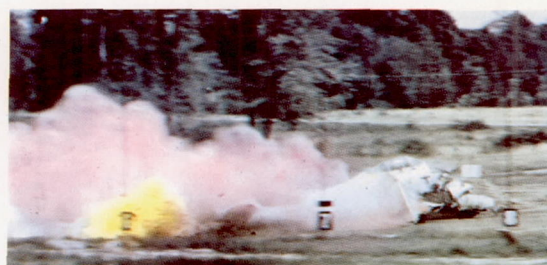
with the ground, the fuselage fuel tank was pierced. Fuel poured from this tank into the engine-inlet duct. Ignition of this fuel within the engine provided a succession of flame puffs issuing from the tailpipe, one of which is shown in figure 5(b). These flame puffs moved into the wake of the airplane and continued to burn as isolated masses. Fuel spilling from the wing was ignited by these flames at the rear of the airplane (fig. 5(c)). The resulting fire moved forward through the fuel spilling from the wing and reached the slowing airplane to produce the fire shown in figure 5(d).

(b) Flames at engine tailpipe, 0.75 second after initial impact.

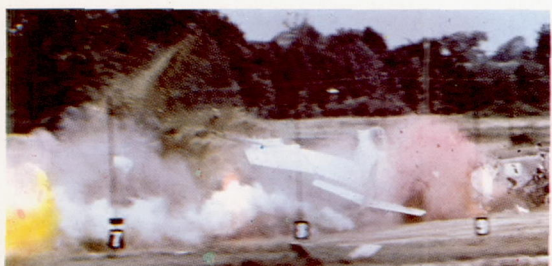
(c) Wing-tank fuel mist, 1.10 seconds after initial impact.

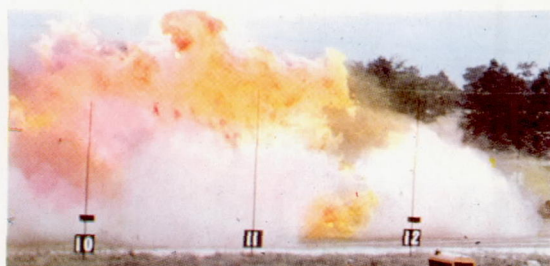
(d) Spread of fire, 2.15 seconds after initial impact.

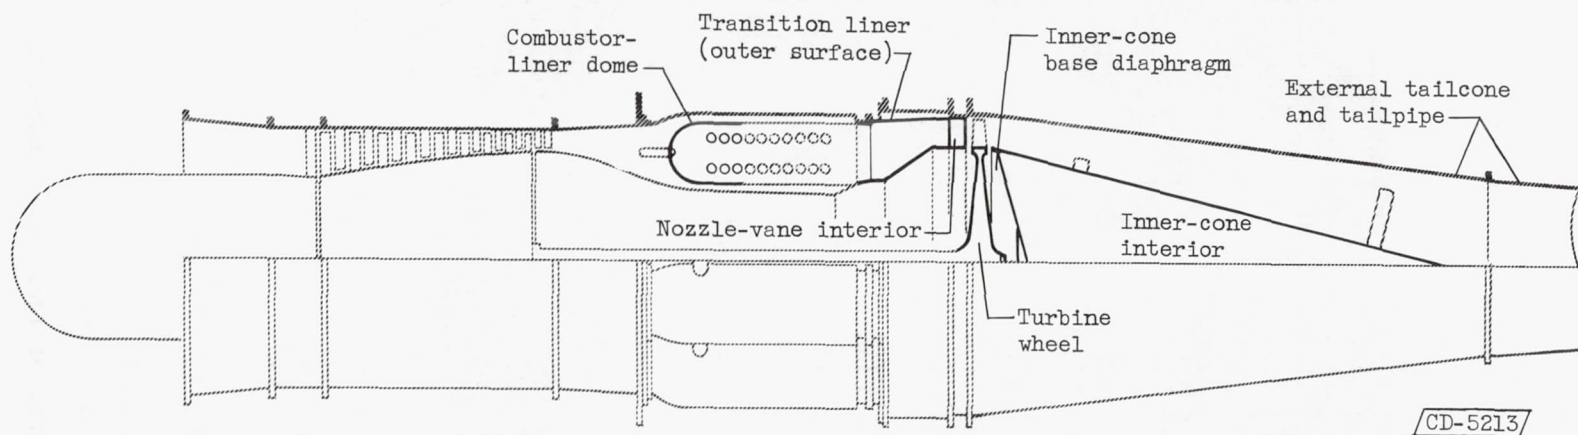
Figure 11. - Hot-metal ignition zones found in J35 engine.

The ignition zones were identified in test-stand engines by the method discussed in detail in appendix C. The technique employed involved the use of fuel sprays local to the engine zone suspected as an ignition source. Following engine operation at rated conditions for a time sufficient to establish temperature equilibrium, the fuel flow to the combustor was turned off and the fuel spray was turned on local to the zone under study. The fuel flow was programmed to maintain a combustible atmosphere in the zone. If ignition occurred, inerting means were installed to prevent the ignition in subsequent tests of upstream zones. By starting at the downstream end of the engine and proceeding upstream in this way, each ignition zone was identified and inerted in turn. As a final check after all the zones were inerted, fuel was injected into the main gas stream to determine whether ignition would occur. In this manner, ignition zones were found on the combustor liner, transition liner, turbine and inner-cone base diaphragm, and tailcone and tailpipe (fig. 11).

Combustor liner: The ignition zone found on the combustor liner was the dome, which lies close to the primary combustion zone. The metal adjacent to the dome is heated by the combustor flame and attains unsafe temperatures in spite of the cooling provided by the adjacent air. Also, in this region the engine air is caused to recirculate by design to provide a zone of low transitional speed and promote good combustion. Both the hot metal of the combustor liner adjacent to the dome and the residual flames previously discussed make this zone particularly hazardous. The size of this zone is difficult to define, since it depends on the air temperature at the compressor outlet, the combustor design, and the ignition characteristics of the combustibles sucked into the engine.

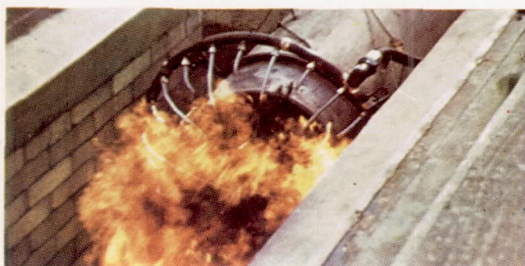
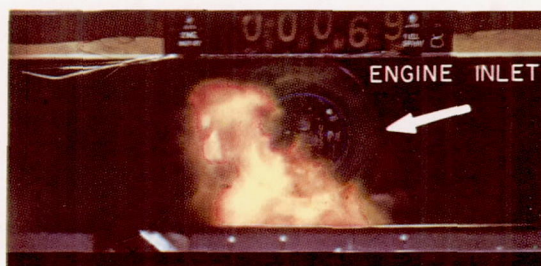
Inner cone: Combustible atmospheres delivered to the turbine wheel from the compressor can enter the interior of the inner cone through vent holes. In some engines these vent holes are located at the base of the tailcone as shown in figure 12. The plane of the inner-cone base is parallel to the turbine wheel. Combustibles entering the cone could ignite on the hot walls of its quiescent interior. The slight damage to the base diaphragm, indicated in the figure, followed ignition in the interior. The resulting flame might ignite the combustible atmosphere streaming through the engine to produce the dangerous flames at the engine inlet and tailpipe shown in figure 13.

Figure 13. - Flames issuing from engine following explosive ignition of fuel within engine.

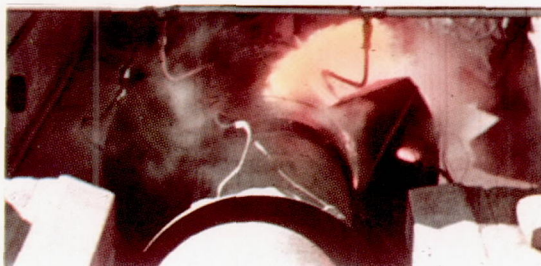
Tailcone and tailpipe: The ignition zones located at the combustor dome, the outside surface of the transition liner, the hollow turbine nozzle vanes, the turbine wheel, and the inner tailcone were all that were found within these engines. Experiments showed that fires could also be obtained when fuels or lubricants contacted the outside surface of the tailcone and tailpipe. The fire produced by jet fuel on an engine tailpipe is shown in figure 14. For engines having a pressure ratio of 5 or less, the unsafe exterior surface extends from the turbine case to the tailpipe exit.

Figure 14. - Fuel ignition on tailcone surface.

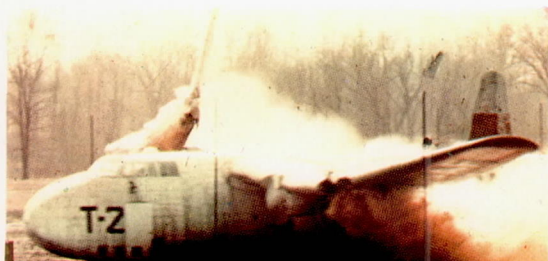
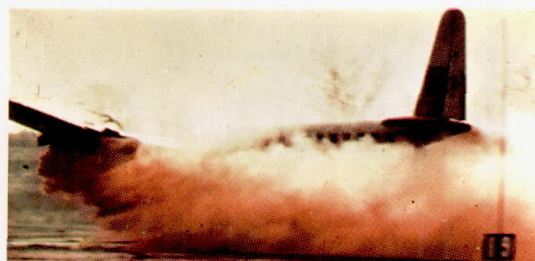
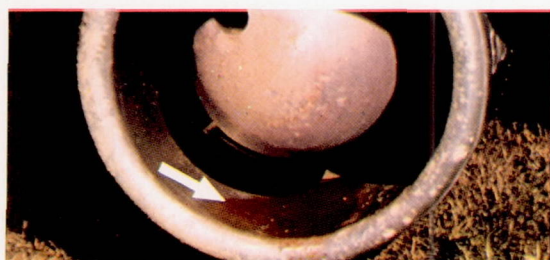
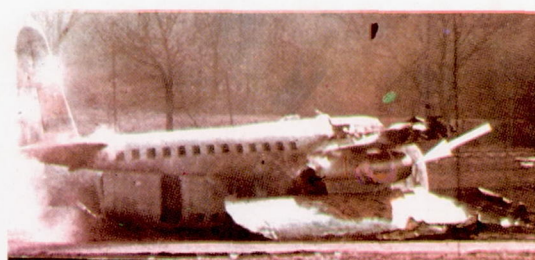
(a) Fuel mist discharging from torn wing, 0.9 second after initial impact.

(b) Entry of fuel mist into left engine, 3.0 seconds after initial impact.

(c) Pool of fuel left in inlet cowl indicating fuel entry into engine.

(d) Fuel spillage on nacelle.

Figure 22. - Crash of C-82 with jet engines equipped with inerting system.

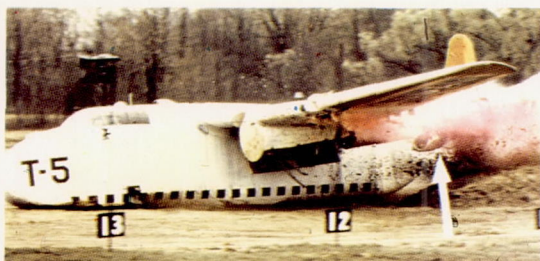
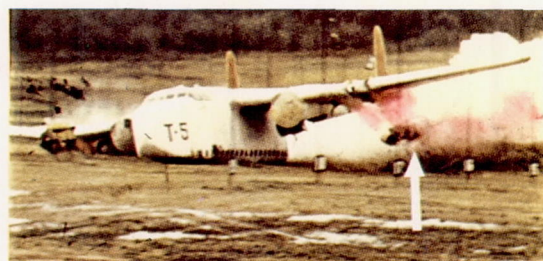
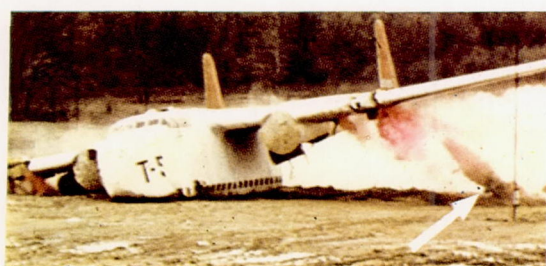
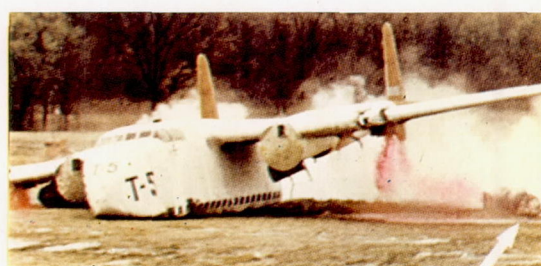
Separation of the engine from the wing is shown in the picture sequence of the crash in figure 24. After separation (fig. 24(a)) the engine tumbled in the fuel spraying into the wake of the damaged wing (figs. 24(b) and (c)) and came to rest in the fuel-wetted slide path of the airplane (fig. 24(d)). The plume of condensed water vapor at the tailpipe (fig. 24(a)) shows that the water inerting system was actuated. No fire occurred.

Figure 24. - Separation of J47 engine from C-82 wing in crash.

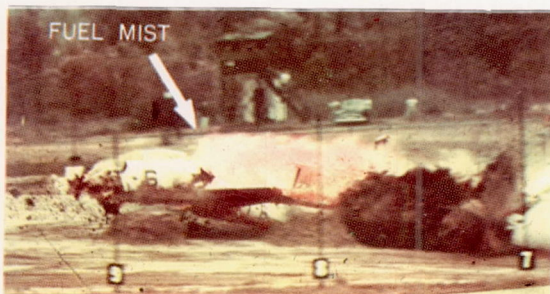
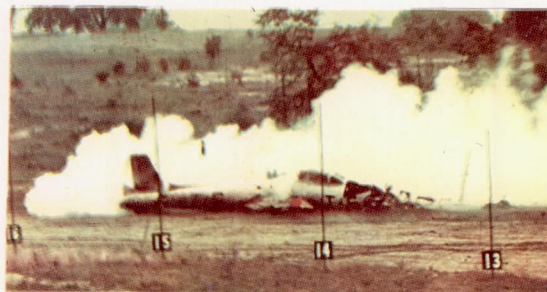
The sequence of events following crash were the same for the F-84 as for the cargo airplanes. Poles at the crash barrier ripped open the wing fuel tanks and produced the fuel mist shown in figure 25(a). Collapse of the nose gear allowed fuel from the torn forward fuselage tank to enter the engine inlet. Vapor issuing from the tailpipe (fig. 25(b)) was provided in part by the fuel that passed through the engine from the damaged fuel tank adjacent to the engine inlet. Evaporation of water from the fire protection system contributed a large part of the vapors formed (fig. 25(b)). Inspection of the engine after crash showed the telltale dye stains left by the red-dyed fuel flowing through the compressor (fig. 26). No fire occurred.

Figure 25. - Crash of F-84 with J35 inerting system installed.

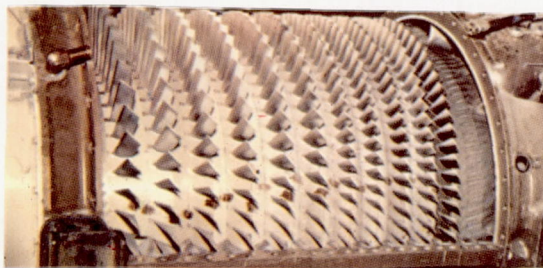
Figure 26. - Fuel-dye stains on J35-engine compressor following F-84 crash.

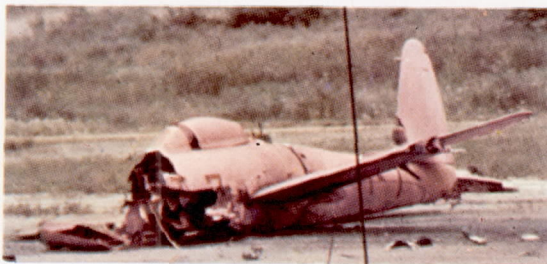
A second crash of an F-84 airplane equipped with the fire protection system was conducted, again with no fire occurring. When the airplane came to rest beyond the crash barrier, complete wetting of the airplane by the red-dyed fuel was observed (fig. 27).

Figure 27. - Extensive fuel wetting of F-84 following crash with inerting system.
